## CRASH TEST PERFORMANCE OF LARGE TRUCK REAR UNDERRIDE GUARDS

**Matthew L. Brumbelow**

Insurance Institute for Highway Safety

Paper No. 11-0074

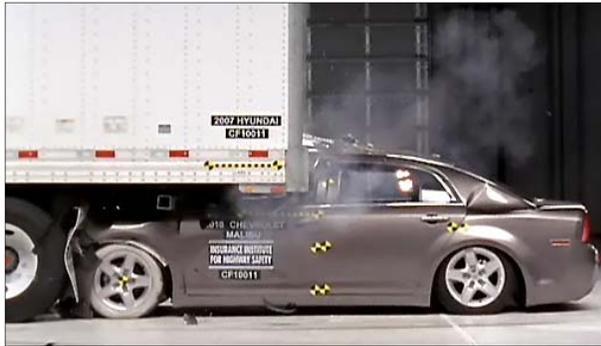
Table 3 summarizes results of the six crash tests, and Figures 4-6 show the 2010 Chevrolet Malibus at the times of maximum forward excursion. In the first 56 km/h full-width test, the 2007 Hyundai guard was ripped from the trailer's rear crossmember early in the crash, allowing the Malibu to underride the trailer almost to the B-pillar. The heads of both dummies were struck by the hood of the Malibu as it deformed against the rear surface of the trailer. Under the same test conditions, the main horizontal member of the 2011 Wabash guard bent forward in the center but remained attached to the vertical support members, which showed no signs of separating from the trailer chassis. The Malibu rebounded rearward from the trailer without underride.

**Figure 4. 56 km/h, full-width tests with 2007 Hyundai trailer (left) and 2011 Wabash trailer (right).**

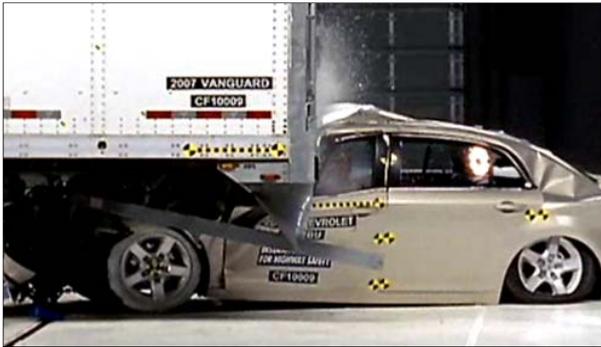
**Figure 5. 56 km/h, 50 percent overlap tests with 2007 Vanguard trailer (left) and 2011 Wabash trailer (right).**

In the 50 percent overlap tests at 40 and 56 km/h, several of the bolts attaching the Vanguard guard to the trailer failed in shear, allowing the Malibu to under-ride the trailer. At the lower test speed, the Malibu's hood was pushed into the base of the windshield, but the trailer itself did not cross the plane of the windshield into the passenger compartment. When struck at 56 km/h, the trailer loaded the driver-side A-pillar and roof, and the driver dummy's head struck the trailer's rear crossmember. In contrast, the Wabash guard was able to prevent under-ride in the 56 km/h, 50 percent overlap test. The outboard end of the guard's horizontal member bent forward early in the test, but the right vertical support remained engaged with the Malibu's left wheel and shock tower, and stopped the car without any indication of separating from the trailer.

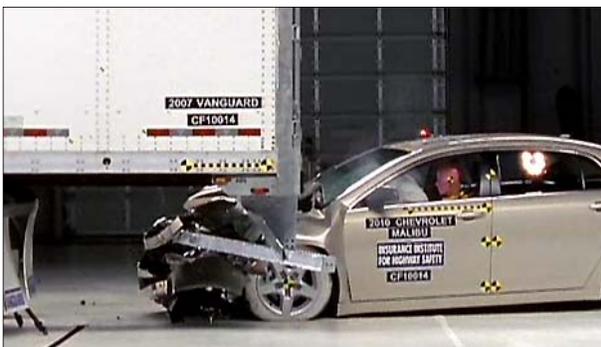
**Figure 6. 40 km/h, 50 percent overlap with 2007 Vanguard trailer (left); 56 km/h, 30 percent overlap test with 2011 Wabash trailer (right).**

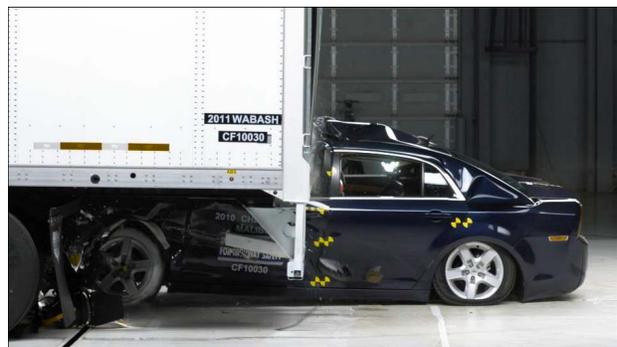
In the 30 percent overlap test, the Malibu's left wheel was aligned just outboard of the Wabash guard's right vertical support. When struck at 56 km/h, the outboard end of the guard bent forward early in the test, and the Malibu underrode the trailer until the front of the car struck the trailer's right rear tires, with the longitudinal extent of the under-ride damage stopping just short of the B-pillar. The driver dummy's head struck the rear of the trailer.

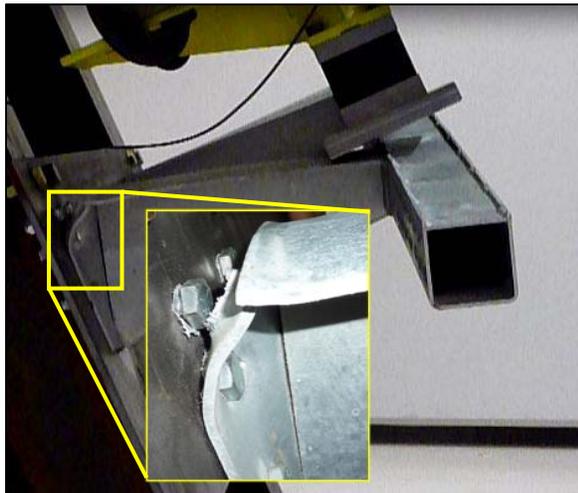
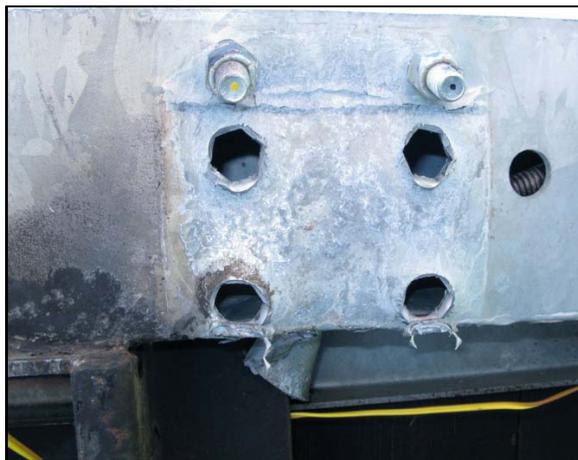
Both the Hyundai and Vanguard guards met the US requirements, with the Vanguard also passing the more stringent CMVSS P3 test. Yet both guards exhibited at least partial failure of their attachments in the quasi-static tests that were similar to those observed in the crash tests with disastrous results. Figure 7 shows how the rearmost edge of the top of the Hyundai's vertical guard support ripped away from two attachment bolts in the FMVSS 223 test and in

**Figure 7. Hyundai underride guard after FMVSS P3 test (left) and Hyundai trailer rear crossmember after crash test, from below (right).**

the crash test. In the crash test, the forward bolts remained attached to the guard but were ripped from the trailer's rear crossmember. The force requirements of both standards at the P3 location are not high enough to guarantee robust attachment designs that can hold the underride guard in place during a crash. In the FMVSS P3 test, the Vanguard achieved a force 157 percent greater than the requirement before its attachment bolts began to fail. Yet some of the bolts fractured in the 50 percent overlap crash at 40 km/h, and when the test speed was increased to 56 km/h, the right half of the guard completely detached from the trailer.
