CRASH-TEST RESULTS TO ANALYSE THE IMPACT OF NON-PROFESSIONAL REPAIR ON THE PERFORMANCE OF SIDE STRUCTURE OF A CAR

Uwe, Schmortte
KTI GmbH & Co. KG
Germany
Paper Number 11-0310

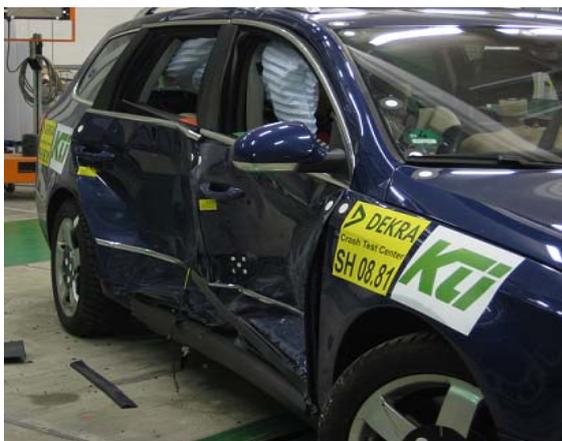
After the side impact the car was severely damaged on the passenger side, as intended. The sill and the floor/undercarriage behind it were particularly distorted. Additionally, the doors and the B-pillar were considerably damaged (Figure 5). There was no damage to the screen pillar or windscreen glass. The pyrotechnic protection/restraint systems (Front and rear passenger side airbags, front passenger belt pre-tensioner and passenger side curtain airbag) were correctly deployed. Overall the car body structure deformed and behaved as expected. As well as the visual analysis, electronic measurement of the car body was carried out. This showed the maximum intrusion to be 161 mm.

Figure 5. Damage to passenger side

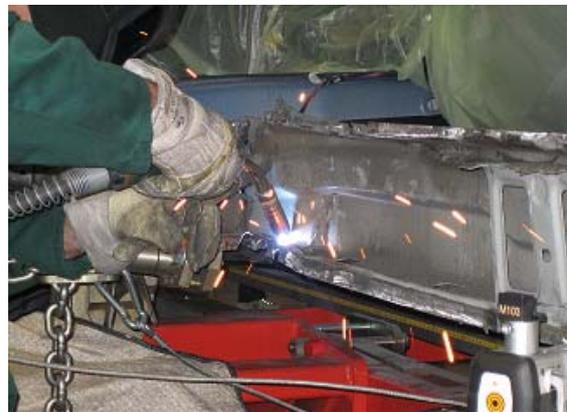
It is recommended that an Inverter type welding machine is used with 10 kA maximum current and a variable pressure (maximum 10 bar) to join the high strength steel safely. The deformed inner sill, made from ultra high strength steel, was re-shaped and partially replaced on a bench then re-fitted using a MAG welding process. Figures 6 to 9 show the non professional repair being carried out.

Figure 6. MAG-welding the inner sill

The “Professional” repair would include complete renewal of the B-Pillar and other deformed structures with components made from high strength steel. A partial repair of such steels is not acceptable, as the structure and therefore the strength of the material will be severely degraded while welding and reforming.

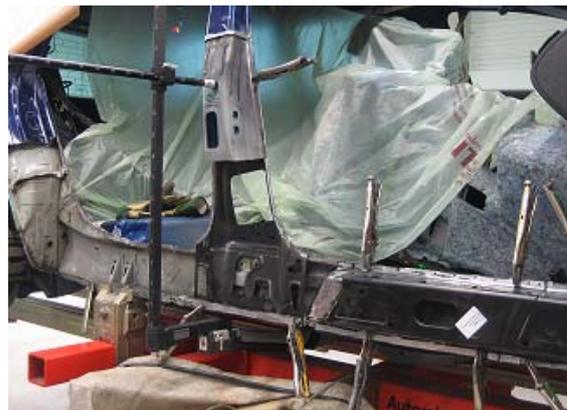
Figure 7. Adapting the lower end of the B-pillar

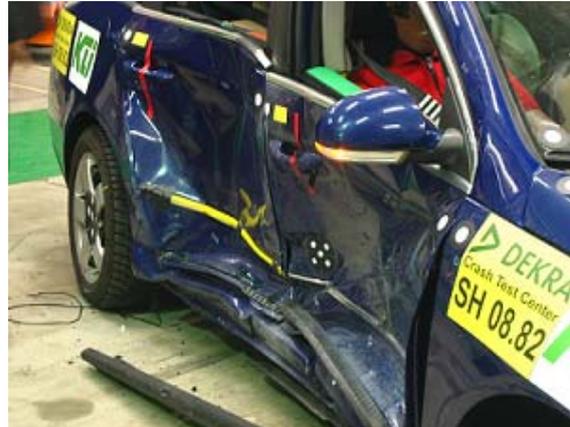
After completing the repair the car was crashed again under the same conditions as the first test in order to make a fair assessment on equal terms. It was immediately evident that there was a substantial difference, with far more comprehensive deformation of the car body after the second impact. The B-pillar had noticeably higher intrusion into the passenger compartment in comparison with the first crash, especially at the lower part at the connection with the sill (Figures 10 and 11). Note: Later measurement of the car body confirmed there was 60 mm more intrusion after the second test, compared to the first crash.

Other differences were noticeable at the cant rail/roof and the transmission tunnel which both displayed severe deformation not seen in the first crash. It seems that the load paths were quite different in the second crash. It was also notable that the top right corner of the windscreen was damaged in the second crash, further indication of changed load paths. These comparisons made it evident that a change of load paths and therefore of the energy dissipation was due to the unprofessional repair. The pyrotechnic protection/restraint systems (Front and rear

Figure 10. Damage after second crash

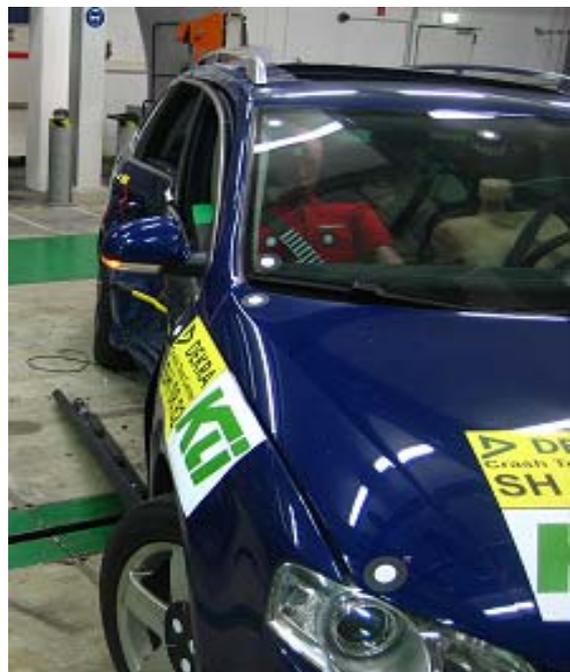
Figure 11. Higher intrusion to passenger compartment

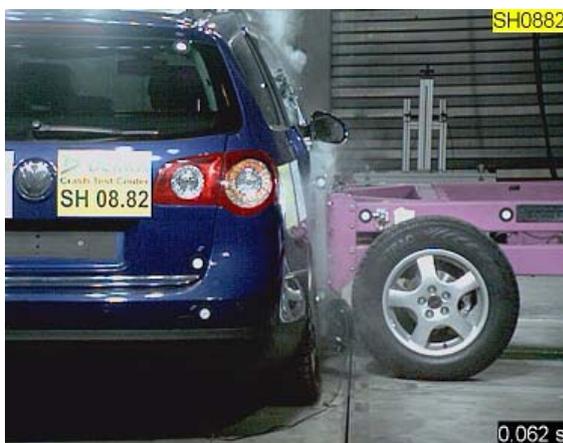
Figure 13. Crash 2

With the help of the time analysis in the high-speed crash-movies we can for instance compare the time of highest intrusion (Figures 12 and 13). The analysis clearly shows higher intrusion at the same moment in time in the second crash test.

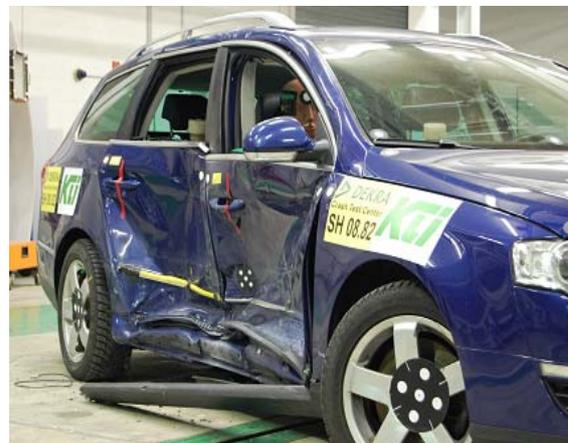
The higher deformation of the B-pillar has an important influence on the intrusion of the doors, which moved further into the seat area of the passenger compartment, increasing the bio-mechanical stress on the occupant, the co-driver in this case (Figures 14 and 15).

Figure 15. Side structure after second crash

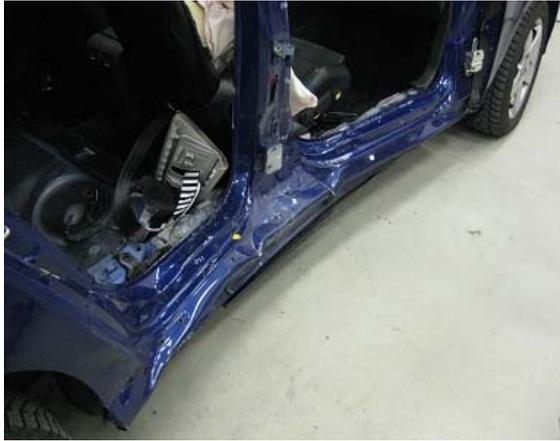
Figure 17. B-pillar and sill after second crash

After removing the doors and the sill trim panel the deeper intrusion can be clearly seen on the side frame (Figures 16 and 17). The movement of the sill has reduced the normal distance between the B-pillar/door and the co-driver's seat dramatically (Figures 18 and 19). Additionally, although the front passenger's side airbag deployed, it was restricted by the close proximity of the seat to the pillar. Consequently a controlled deployment of the bag was not possible because the space between B-pillar and seat was too small, too early in the deformation process.

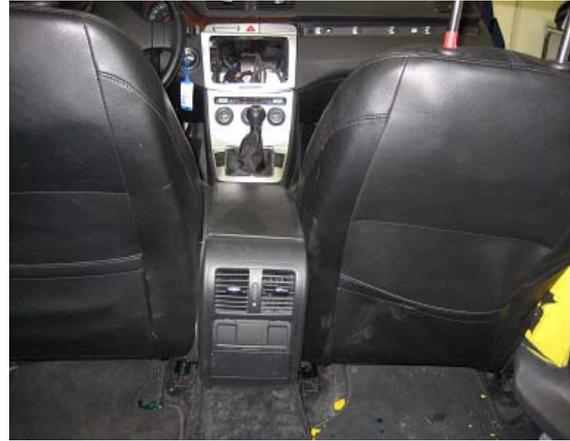
Figure 19. Compressed seat after second crash

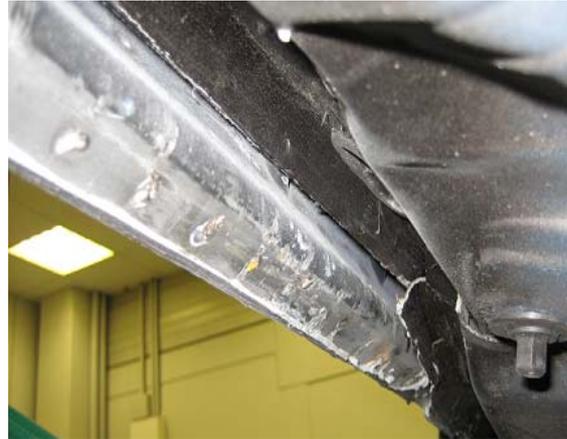
OEM information was not used during the repair after the first crash. Figures 23 and 24 show the disruption at the joining points after the second crash. These are positions where the inappropriate spot welding machine was used. The disconnection between inner sill and floor panel shows that the spot welds have not withstood the impact and were destroyed. The spot welds need to have a minimum diameter of 4.9 mm at a sheet thickness of 1.5 mm. The optimum would have been 6.7 mm diameter. It is clear that the spot welds were inadequate.

Figure 23. Disconnection of the sill after second crash

From the results obtained by this project it is clear that only a repair carried out according to the OEM's information could be described as Expert and Professional. The information would describe the recommended methods and joining procedures, including possible partial repairs in order to guarantee that a repair would have no adverse effect on the protection afforded to passengers in the event of a later collision.

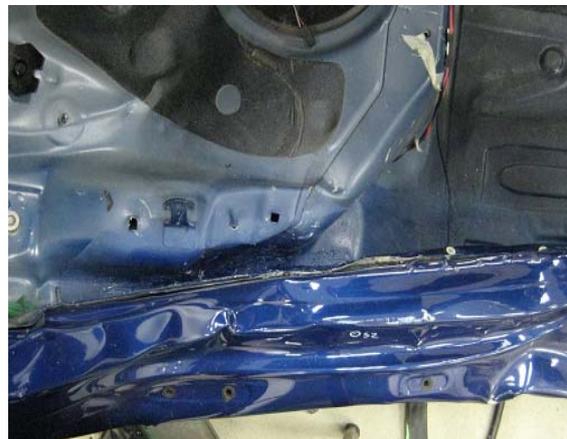
Figure 24. Disconnection of the inner sill after second crash

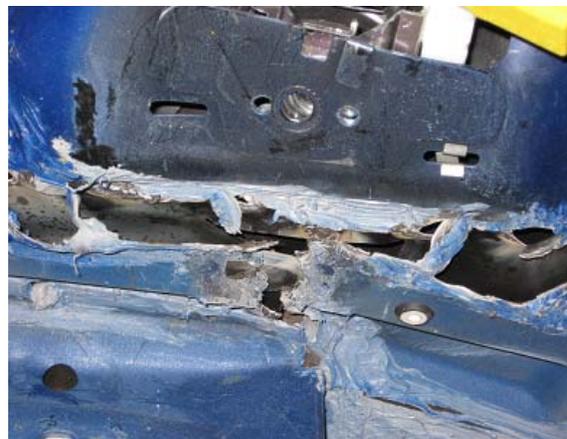
The connection of the B-pillar with the inner sill was joined with MAG welding. The structure of the high-strength steel parts was changed by the welding process and re-shaping. The welded seam was totally broken after the second crash, being unable to withstand the stress and the distortion (Figures 25 and 26).

Figure 25. Disconnection between lower B-pillar

pillar and inner sill after second crash
