SUVS involving: Rollovers, Frontal Offsets and Corner Impacts called FLEES.

CIREN Seattle

HARBORVIEW
MEDICAL
CENTER
INJURY PREVENTION
AND RESEARCH CENTER

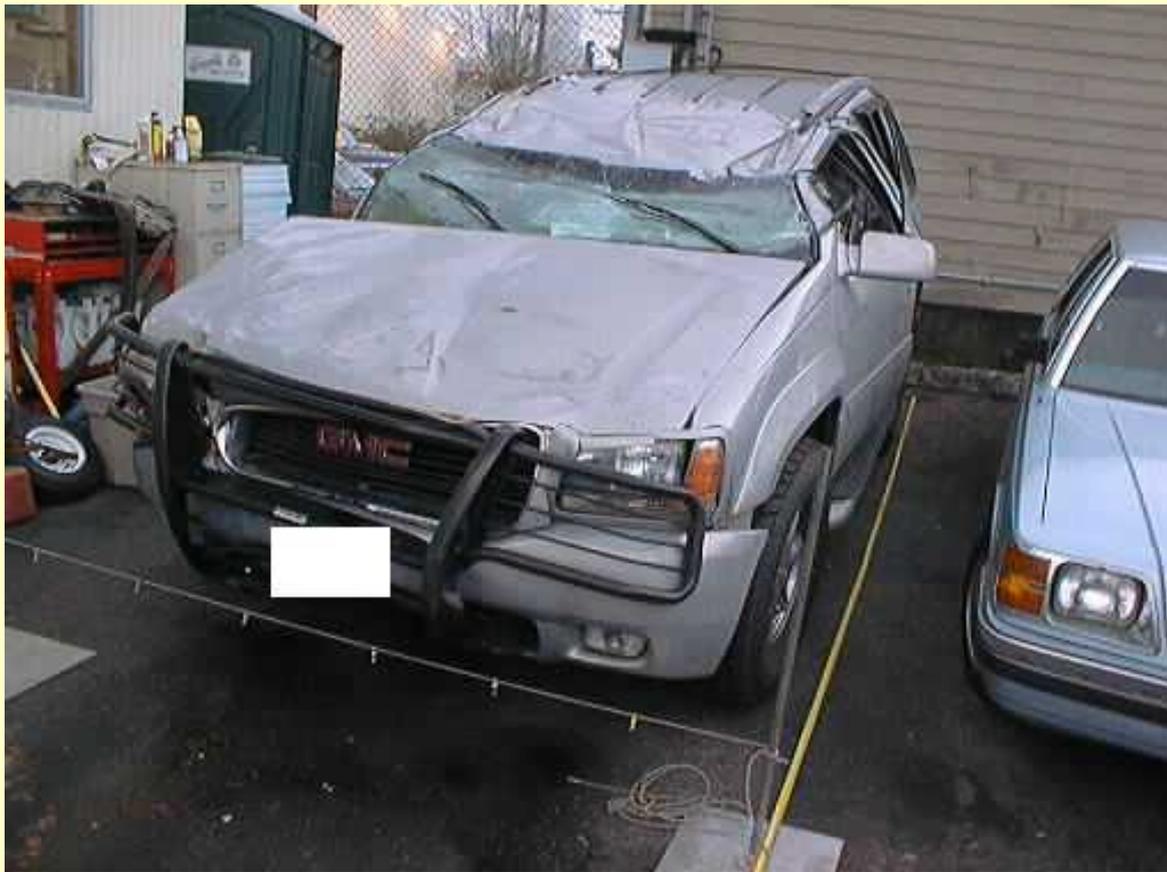
Impact Attenuator - 12FZEW1

Delta V = 10 mph BE

Max Crush = 20 cm @ C6

Rollover - 00TDDO4

Max Crush = 31 cm of Driver Seat Area

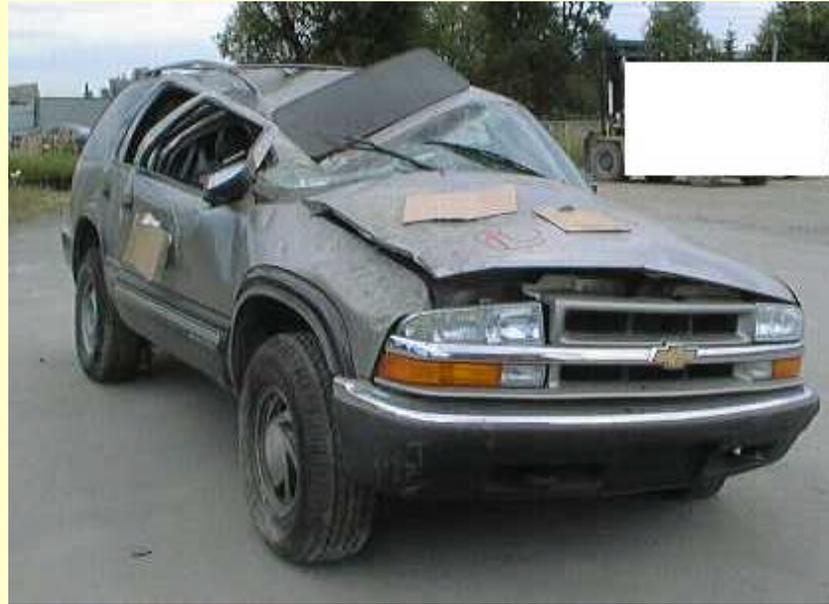
Single Rollover Event
Four quarters

CDC = 00TDDO5

Max Crush = 38 cm
@ Right
windshield header

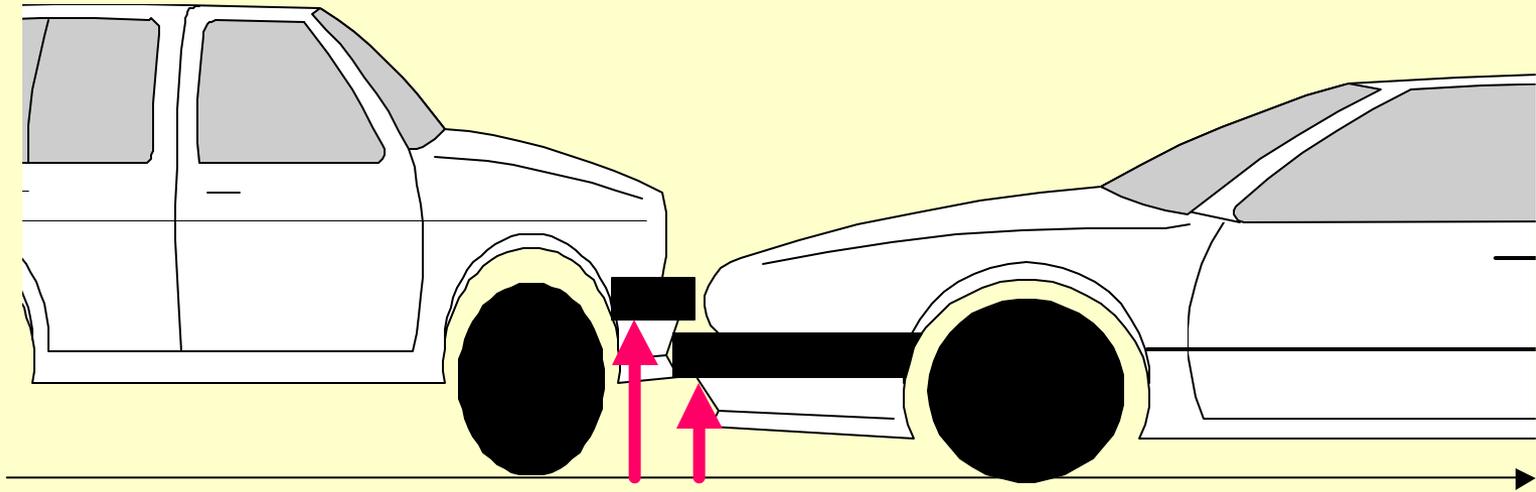
Obvious mismatch in bumper heights

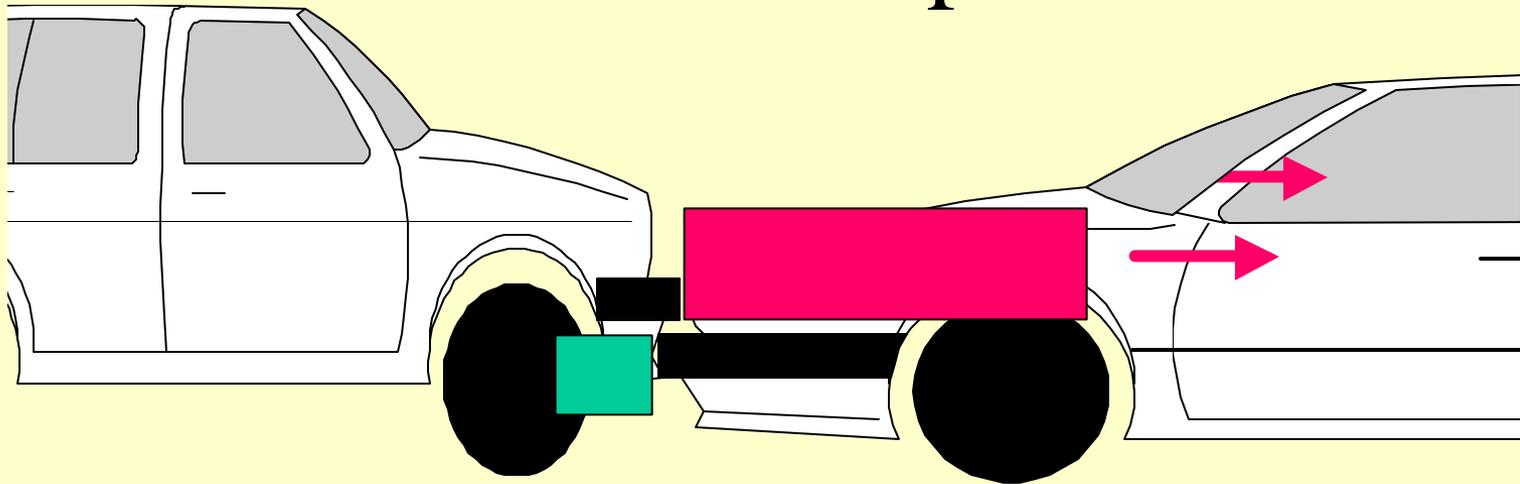
Override impact creates significant intrusion of instrument panel/hood

■ SUV bumper into grill of sedan

■ Sedan bumper into front tire/axle

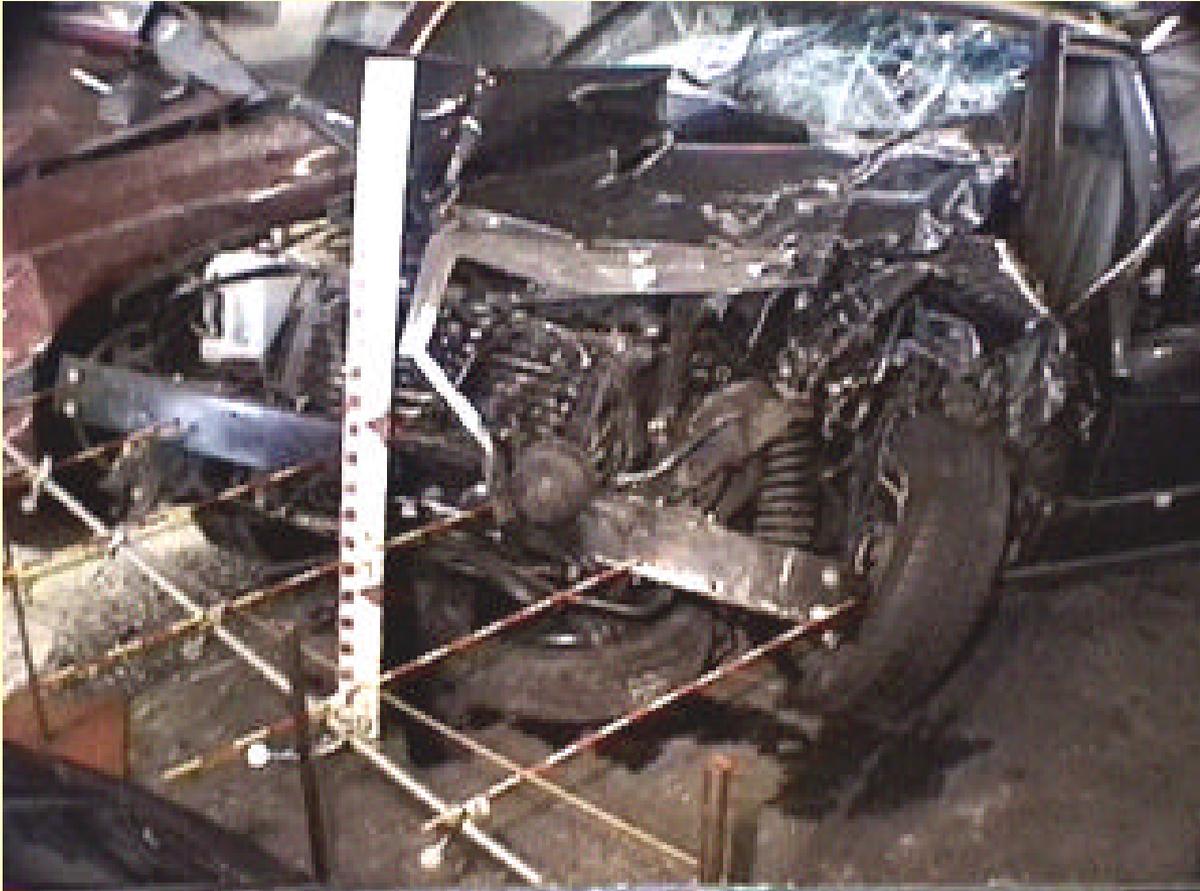
90's Mercedes
190E

Delta V = 25 mph

Offset = 51%

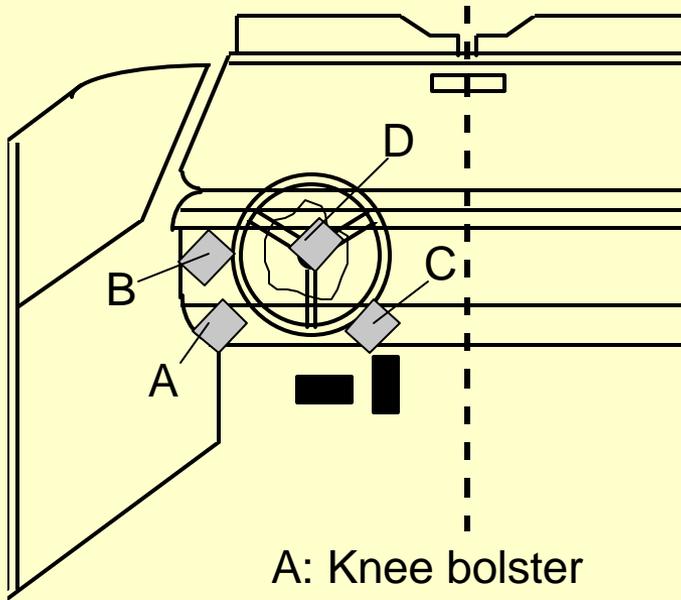
- A: Knee bolster
- B: L inst panel
- C: L inst panel
- D: Airbag

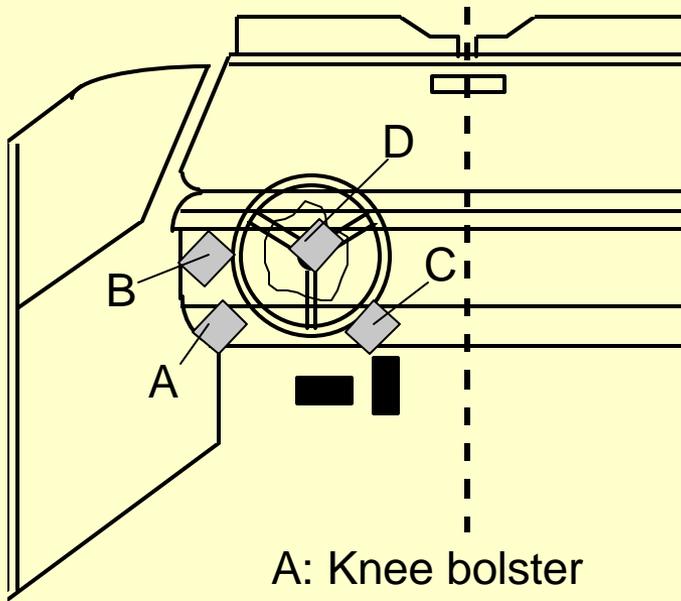
- A: Knee bolster
- B: L inst panel
- C: L inst panel
- D: Airbag

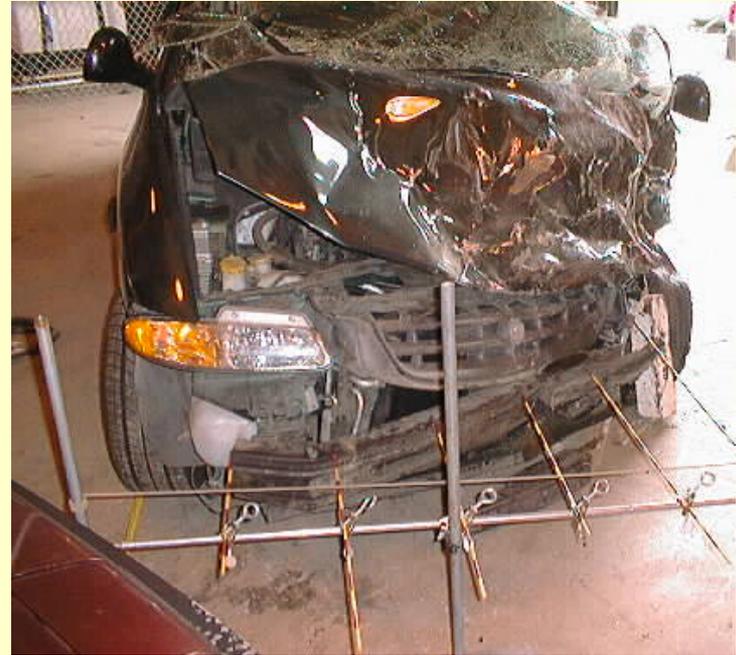
Delta V = 27 mph

Offset = 63%

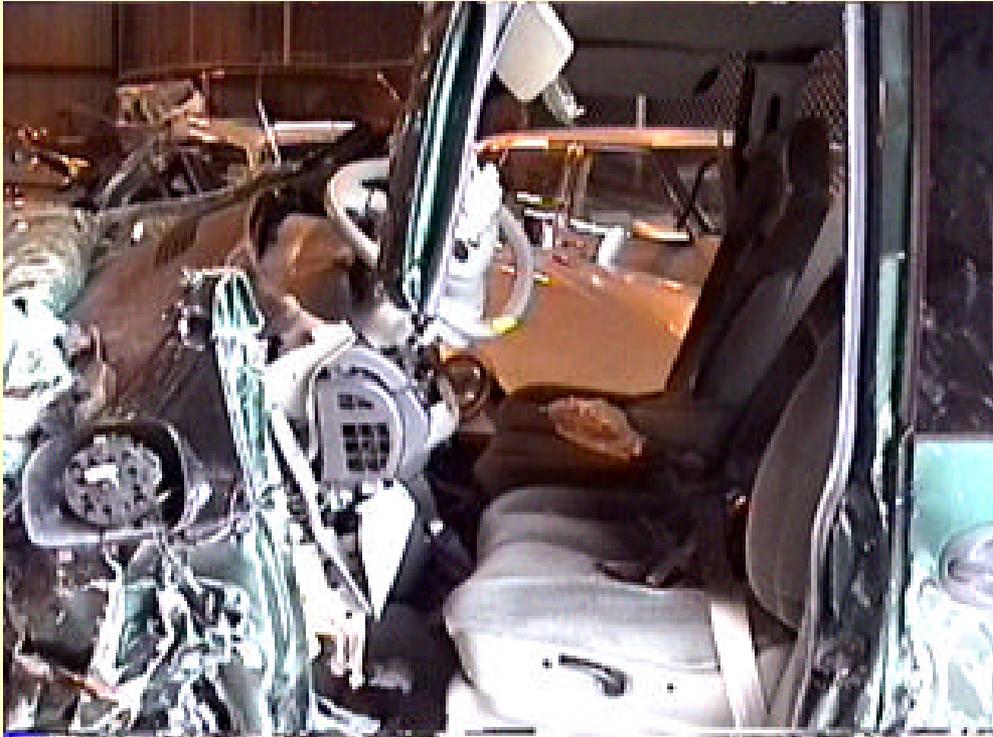
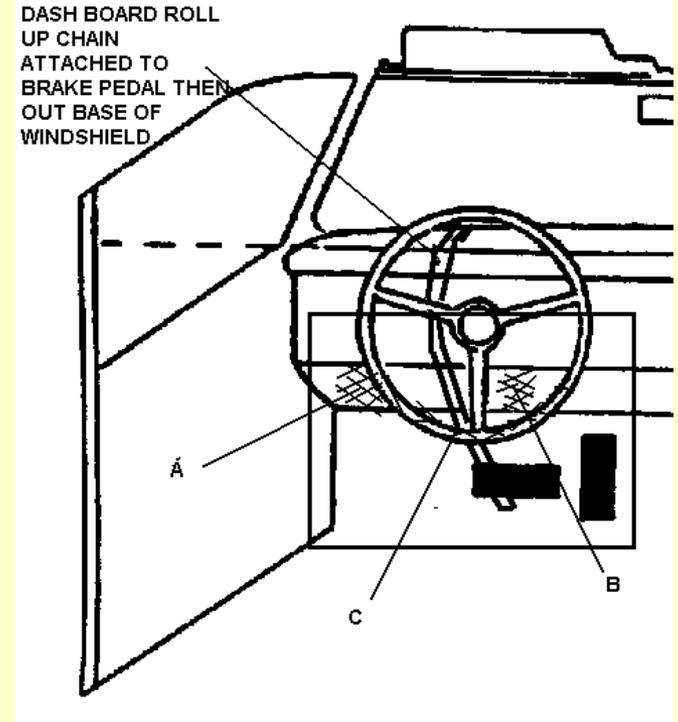
Dashboard Rollup

Dashboard on top of legs with both mid-shaft femurs fx'd

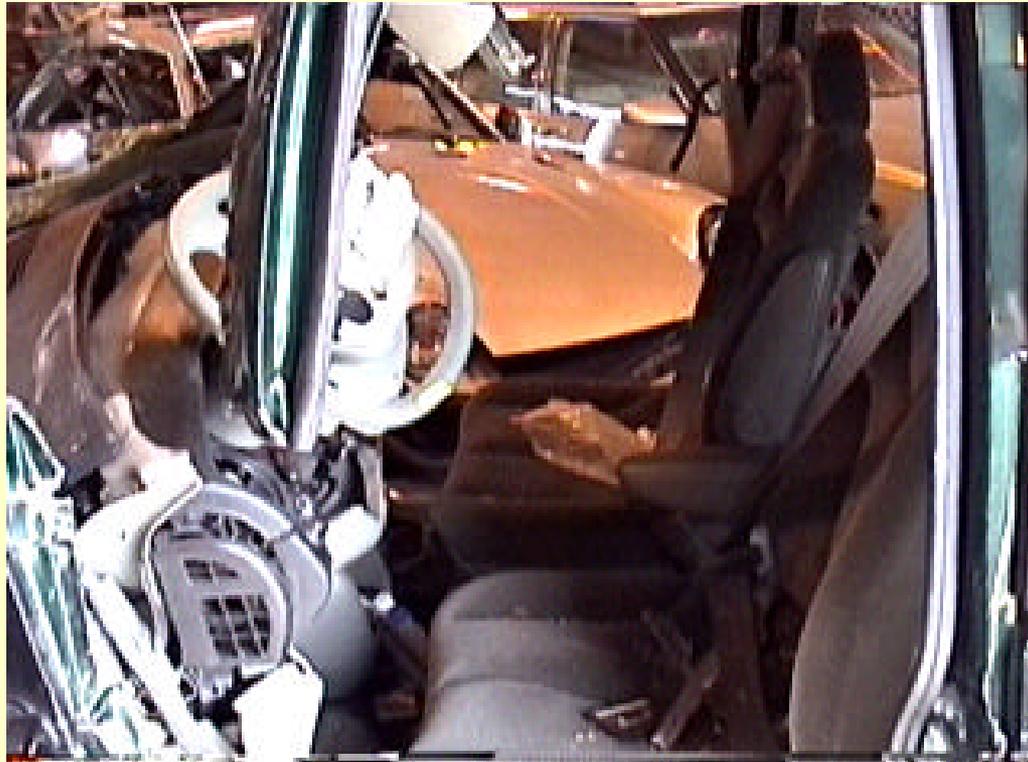
DASH BOARD ROLL
UP CHAIN
ATTACHED TO
BRAKE PEDAL THEN
OUT BASE OF
WINDSHIELD

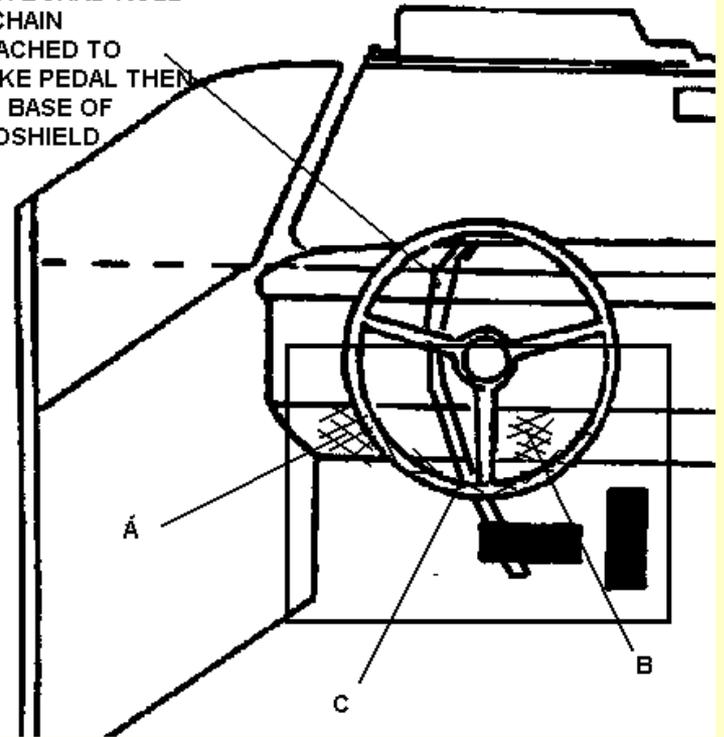
Both Knees contacted into bolster area

Steering Rim Deformity

DASH BOARD ROLL
UP CHAIN
ATTACHED TO
BRAKE PEDAL THEN
OUT BASE OF
WINDSHIELD

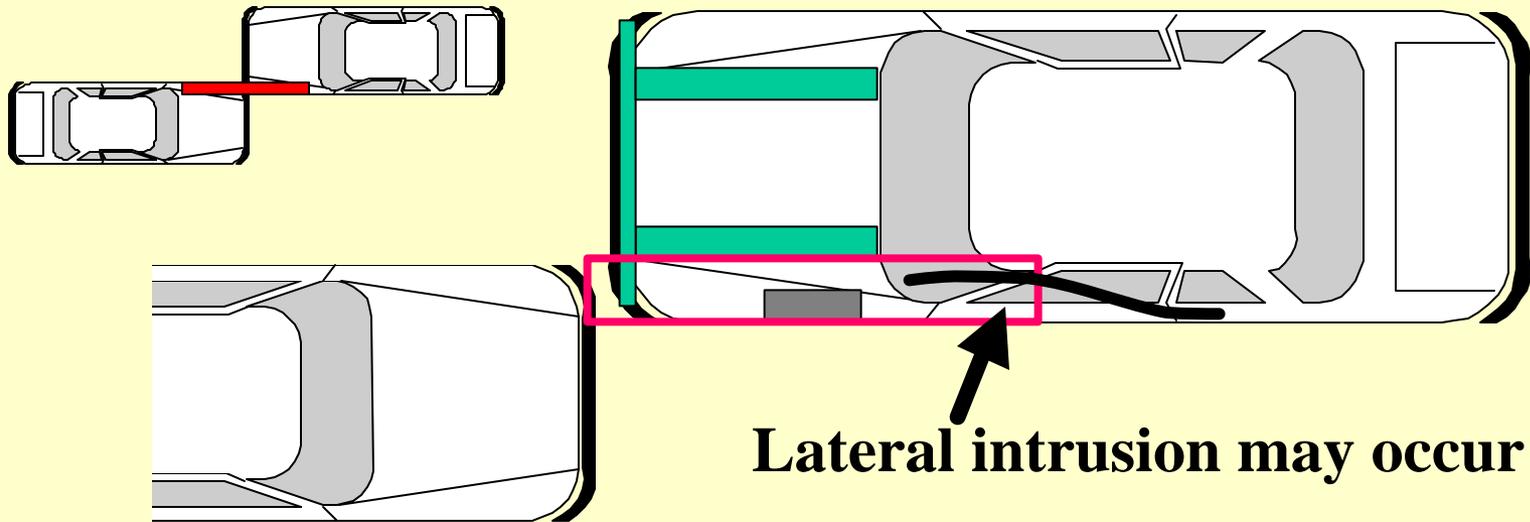
- **Frame rail gets partial hit, or even missed**
- **Bumper frame doesn't extend to corner with any support**
- **With hollow fender well the impact will make contact into the wheel/axle and at the base of A pillar**
- **Longitudinal intrusion of toe pan, instrument panel, steering column, with even lateral intrusion of door and floor panels.**

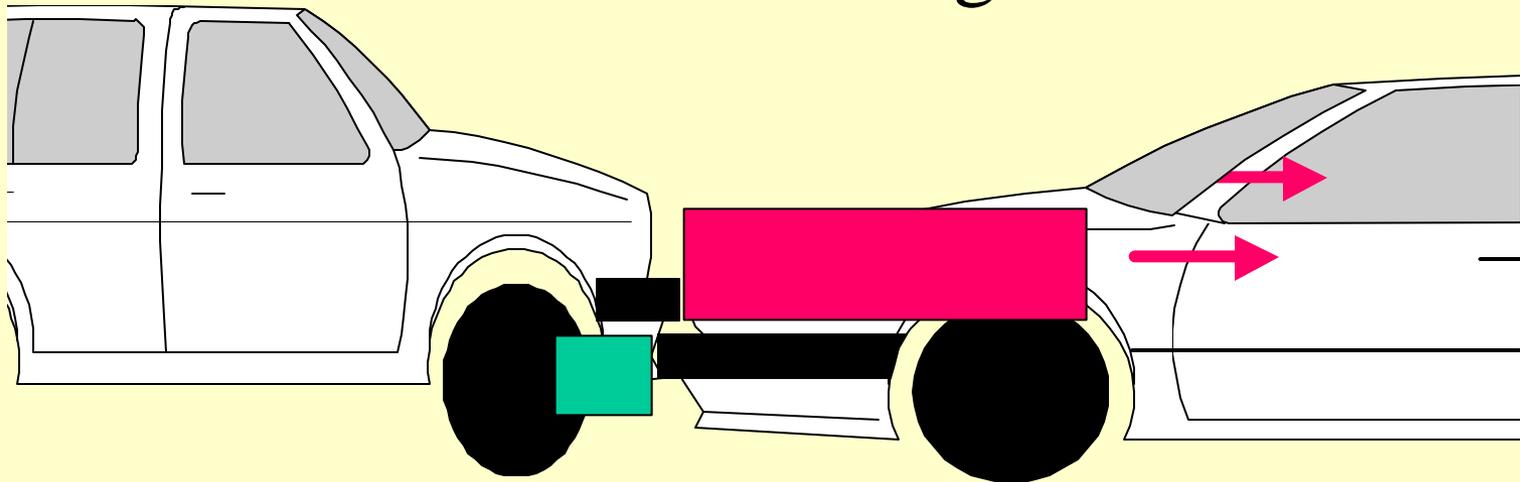
SEVERE COMBO of
Longitudinal and Lateral

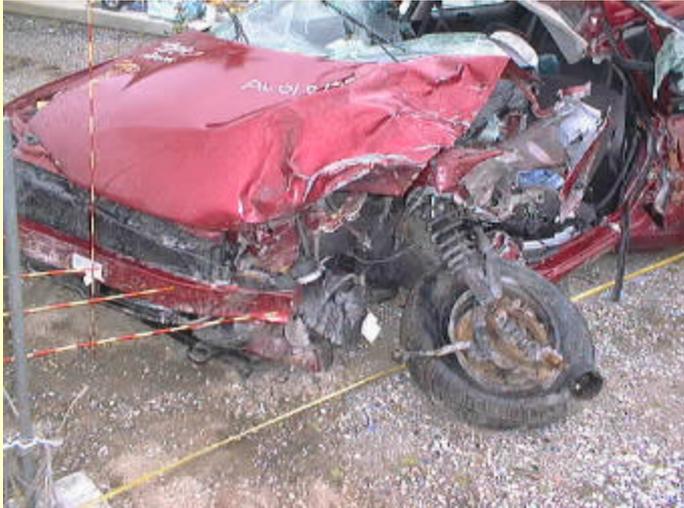
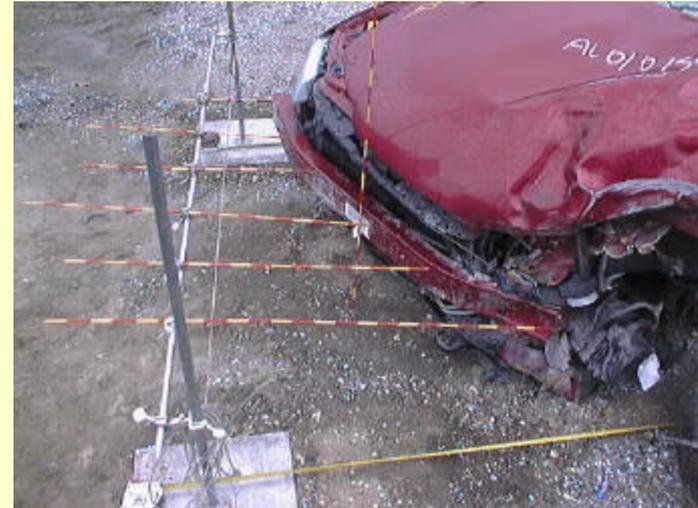
CDC - 12FLEE9

Smash Missing vehicle

Delta V = 20 mph

Database - Severe

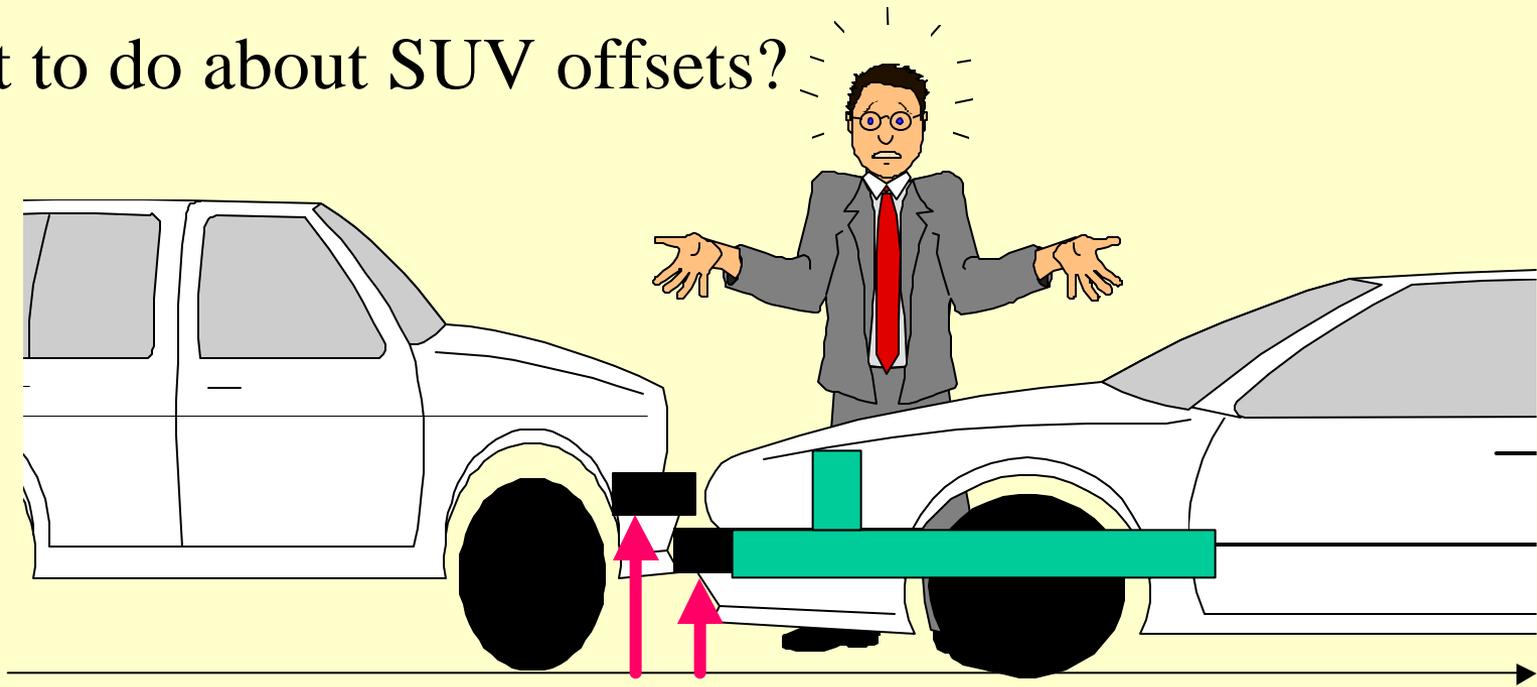
What to do about SUV offsets?

Rather than lower the support on the SUV create a vertical component on the frame rail of the sedan?

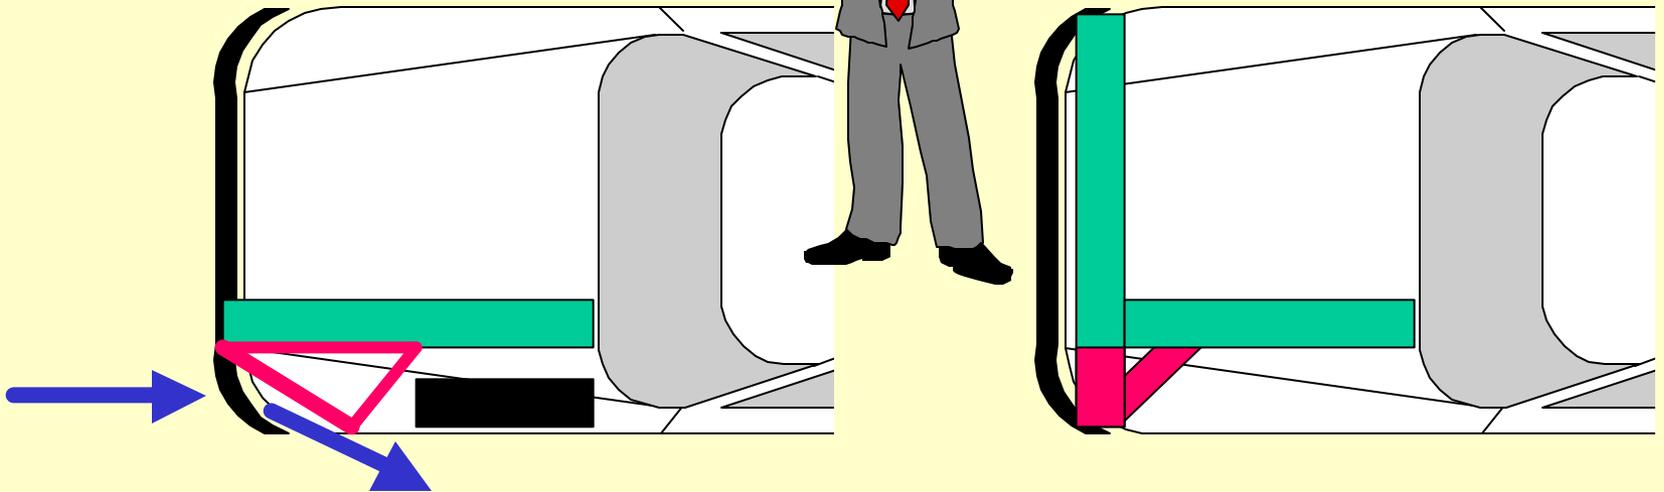
What about the FLEEs?

Need to brace and deflect the impact or extend the bumper support to the corner
