**BUMPER COMPLIANCE TEST  
PROCEDURE EVALUATION**

**DIGITEK CORPORATION  
4818 LINCOLN BOULEVARD  
MARINA DEL REY, CALIFORNIA 90291**

**December 1970  
Final Report**

**U. S. DEPARTMENT OF TRANSPORTATION  
National Highway Traffic Safety Administration  
Washington, D. C. 20590**

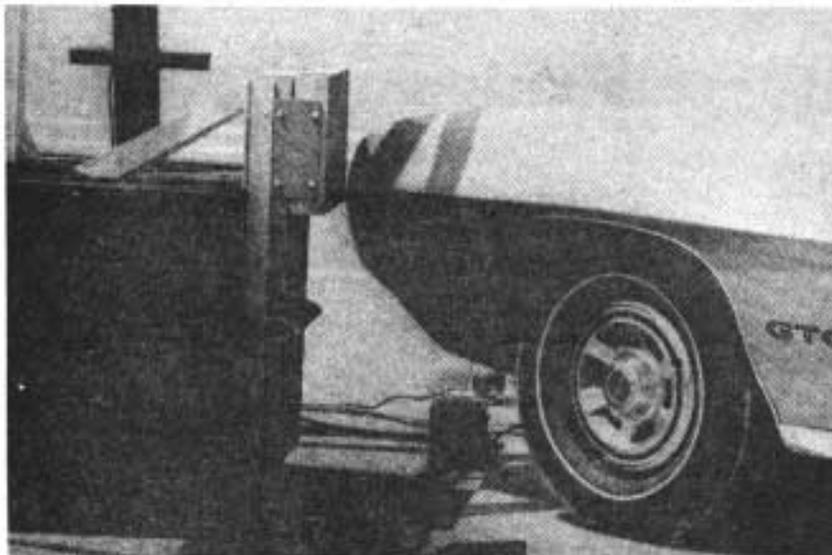
Because of the larger projection of the 1950 Cadillac bumper, it was not directly apparent that most 1969 and 1970 vehicles would fail the proposed impact test geometrically without any dynamic loading. On Monday, June 22, 1970, the following two vehicles were tested according to the proposed test procedure to which they, in all cases, geometrically failed and were not impacted (see Photo Appendix 15-22 and Figure 8 a, b, c, d).

**FIGURE 8 a GTO FRONT LEFT CORNER GEOMETRIC FAILURE**

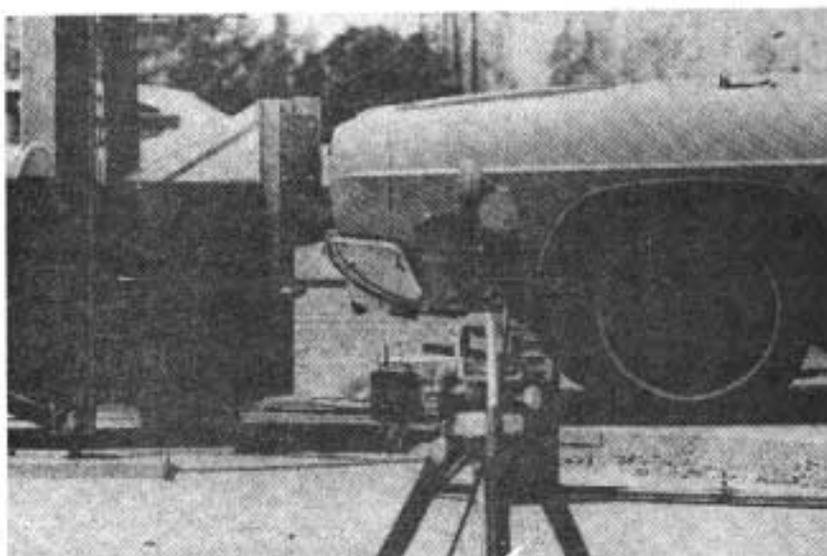
**FIGURE 8 b FORD FRONT CENTER GEOMETRIC**

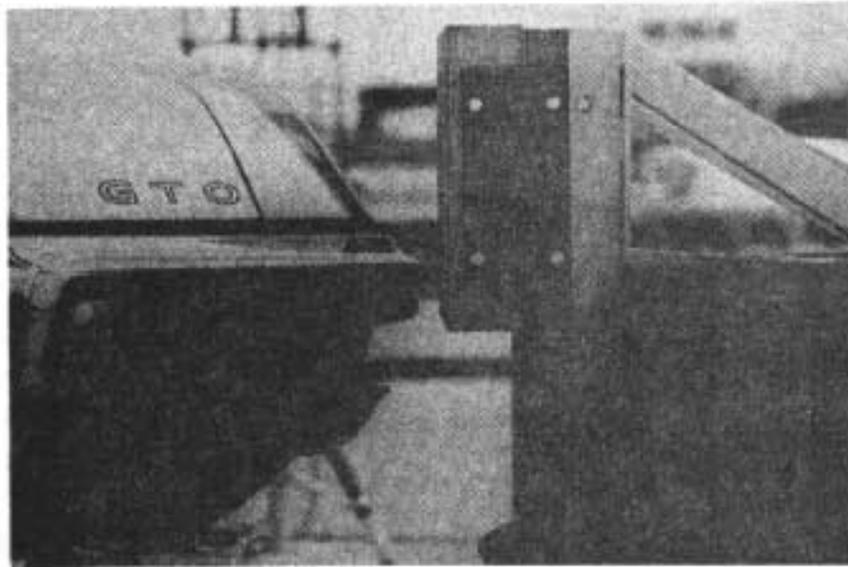
**FIGURE 8 c GTO RIGHT REAR CORNER GEOMETRIC FAILURE**

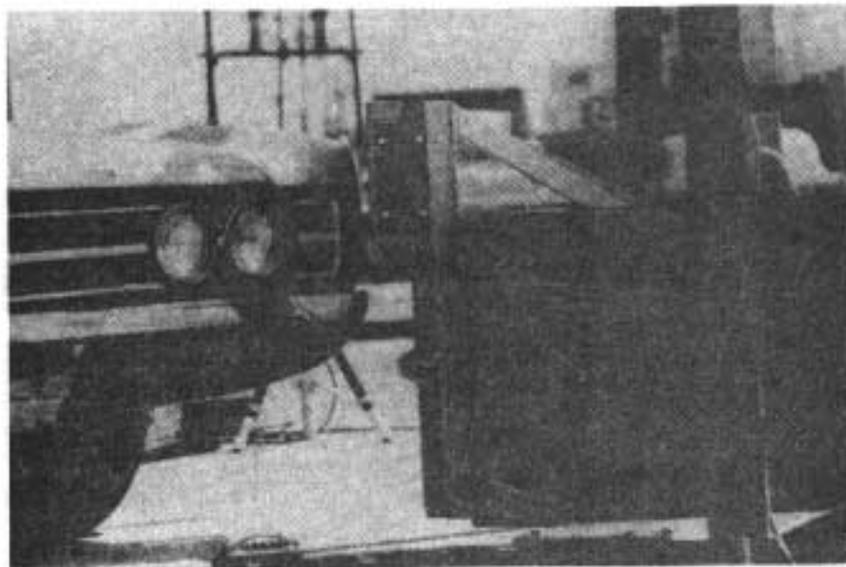
**FIGURE 8 d FORD FRONT RIGHT CORNER GEOMETRIC FAILURE**

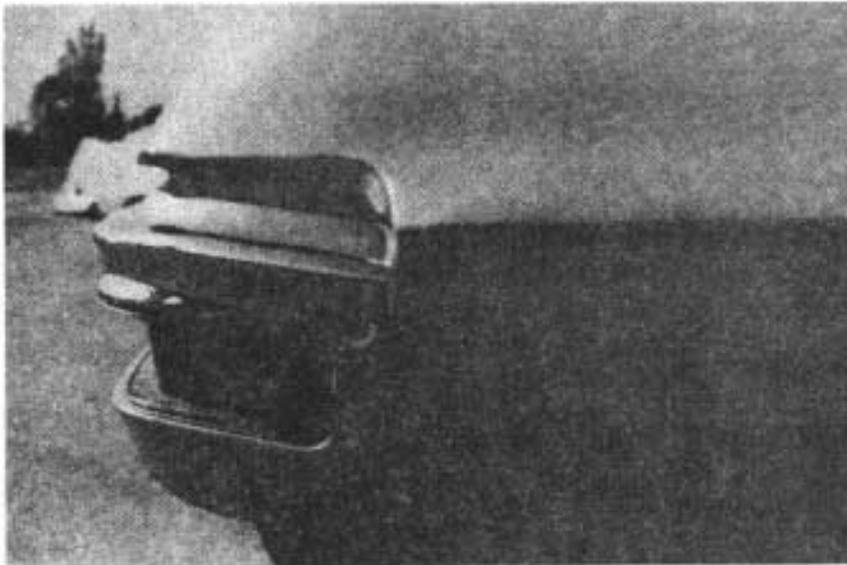
Vehicle damage was found in the form of a bent right rear bumper and quarter panel damage. The cost to restore to "like new" condition was \$48.00 labor and \$95.00 in bumper parts. (The quarter panel was not replaced because it would not effect the strength of the bumper in the next test.) The operational parts of the vehicle were checked and all were found to be functional.

**FIGURE 9** RESULTANT DAMAGE TEST 2 (GTO REAR CORNER 4.4 m.p.h.)

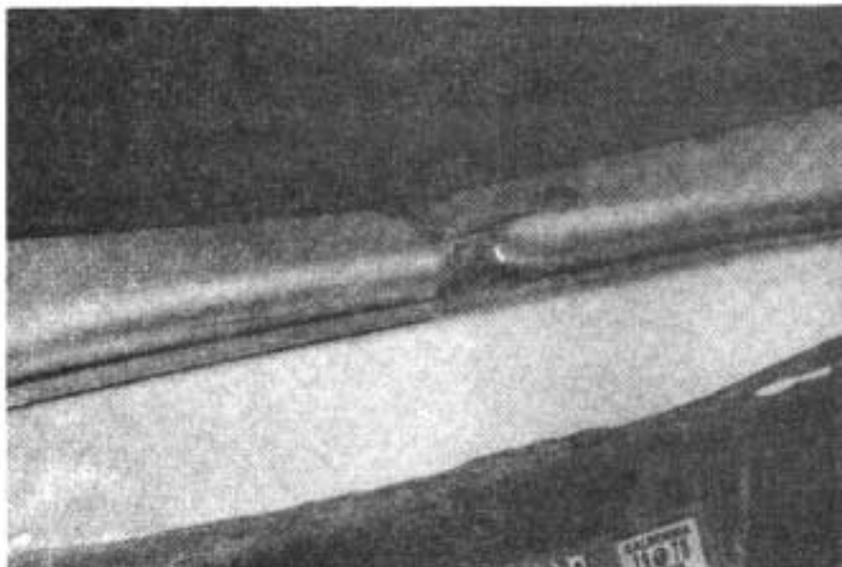
**FIGURE 10** RESULTANT DAMAGE TEST 3 (GTO REAR CENTER)

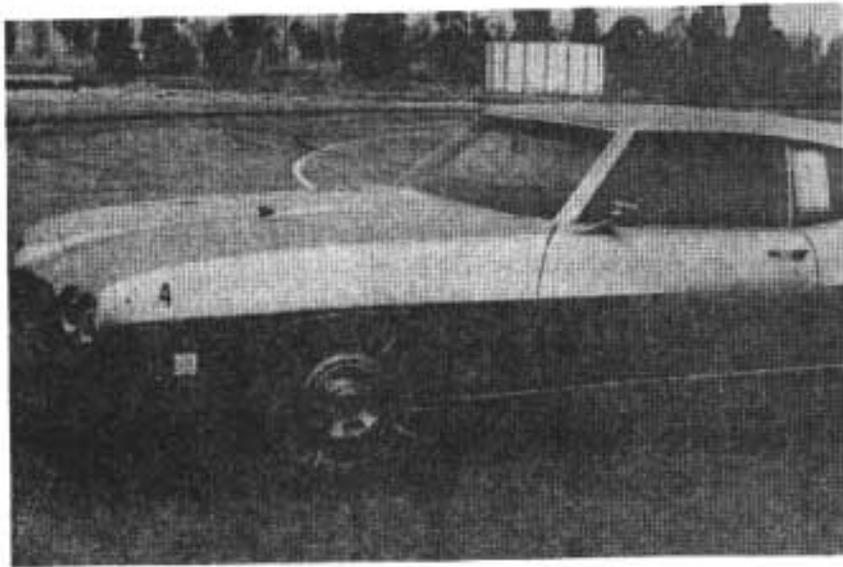
**FIGURE 11** RESULTANT DAMAGE TEST 4 (GTO FRONT CENTER)

The GTO front center impact met failure by the following modes:

- 1) The load concentration generated by Line A was significant enough to embed the entire steel nose in the rubber molding allowing the reference plane to touch the bumper.
- 2) Failure was also caused by a hood latch mechanism which was inoperable because the bumper impinged on the hood end.
- 3) Surface failure also occurred because the left fender moved rearward enough to pinch the left front door.
- 4) The damage estimate to straighten the bumper and not replace it was \$37.25. The cost to fix the bumper, replacing all parts, would be \$235.00 - \$60.00 in labor and \$175.90 in parts. This is the same as Test 1.

Labor (hrs.)	Parts	Misc.	Sublet
<u>Test 4 GTO Front Center</u>				
(vehicle failed)				
Align bumper	2.0			
Paint damage, as nec.	2.0		5.00	
Total Labor Costs	\$ 32.00			
Paint		5.00		
Tax		.25		
TOTAL	\$ 37.25

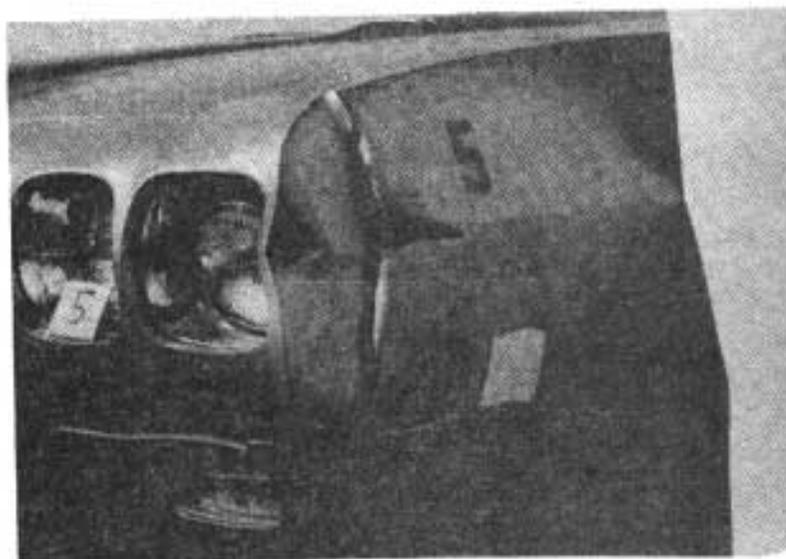
**FIGURE 14 RESULTANT DAMAGE TEST 5 (GTO)**

This vehicle failed to pass the proposed standard by several modes:

<u>Test 5 - GTO Left Front Corner</u>				
(vehicle failed)				
Remove & replace front face bar	2.9	145.00		
Str. back bars	1.5			
Str. left front fender	4.5			
Remove & replace left O/S, H/L	.2	3.90		
Align & str. lower valance	1.0			
Paint damage, as nec.	5.0			
Total Labor Costs	\$ 120.00			
Parts		148.00		
Paint		10.00		
Tax		7.95		
TOTAL	\$ 286.85

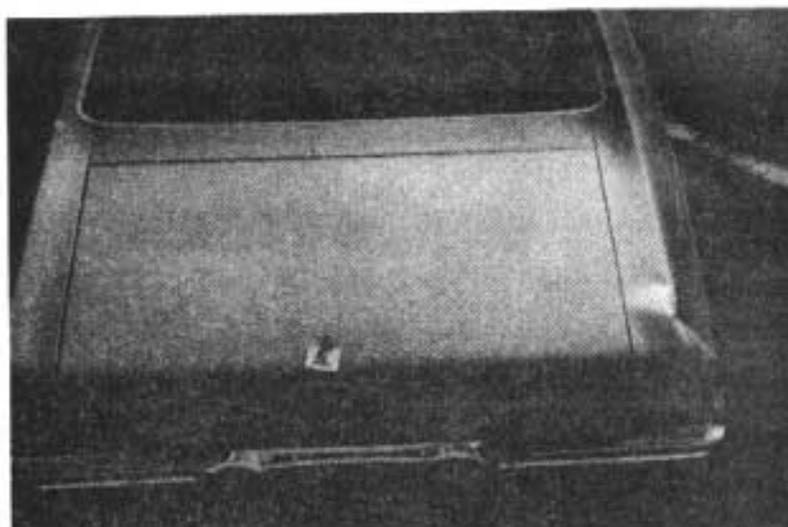
FIGURE 15

setup is included in the real time and high-speed movie, slides and black & white photos (Photos 62-69) (Figure 15). Failure of this GTO rear center impact was found in three modes:

- 1) The reference plane did touch the deck lid as shown in the color slides.
- 2) The trunk was inoperable at the end of testing. This was due to the steel nose slipping through the crack and directly loading the latch mounting.
- 3) The cost to repair was \$168.00.

RESULTANT DAMAGE FROM TESTS 6 and 7 REAR CENTER & CORNER RESPECTIVELY (BOTH 5.03 m.p.h.)

Labor (hrs )	Parts	Misc.	Sublet
<u>Test 6 - GTO Rear Center</u>				
(vehicle failed)				
Remove & replace rear face bar, str. & plate	1.5			65.00
Str. bumper back bars	1.0			
Str. back body panel	3.0			
Str. deck lid & align	3.0			
Paint damage, as nec.	3.5		7.00	
Total Labor Cost	\$ 96.00			
Paint	7.00			
Sublet	65.00			
				<hr/>
TOTAL				\$168.00

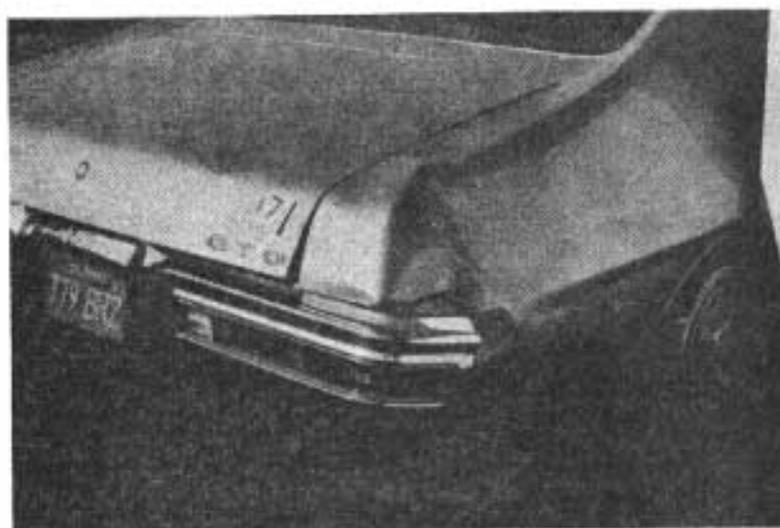
FIGURE 16

During this test, failure was observed by

- 1) The touching of the reference plane to the chrome bumper.
- 2) Severe bumper and Line A intrusion into the fender sheetmetal. The trunk was sprung from previous testing, but it may be assumed that it probably would not have been damaged by this impact.

3) The cost to repair was \$175.30.

Test 7 - GTO Right Rear Corner  
(vehicle failed)

Remove & replace rear bumper, str. & plate	1.5			65.00
Str. bumper back bars	1.0			
Str. right rear quarter panel	7.5			
Paint damage, as nec.	3.0		6.00	
Total Labor Cost	\$ 104.00			
Paint	6.00			
Sublet	65.00			
Tax	.30			
				<hr/>
TOTAL				\$ 175.30

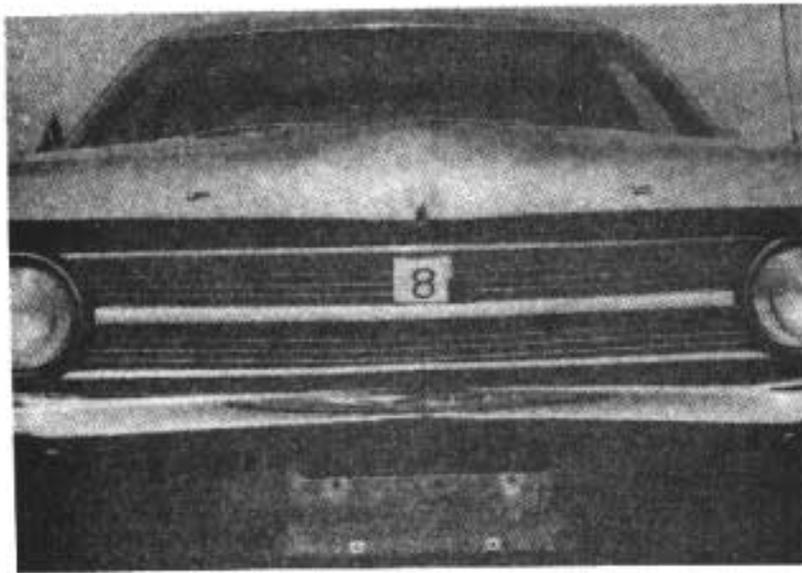
Failure may be found in three modes

2) The bumper yielded in two places. This yielding did not cause any damage to the hood, hood latch or lights. They were all in good working condition.

3) The cost to repair this vehicle was \$123.50. Other data run for the Insurance Institute for Highway Safety showed the cost to repair a similar Galaxie for a 5 mph barrier at \$180.00 or about a 40% increase.

**FIGURE 17** RESULTANT DAMAGE FROM TEST 8 (FORD FRONT CENTER)

Labor (hrs.)	Parts	Misc.	Sublet
<u>Test 8 - Ford Front Center</u>				
(Vehicle Failed)				
Remove & replace front bumper, str & plate	1.4			42.00
Str. bumper back bars	1.0			
Str. hood & align	3.0			
Str. front gravel & align	1.0			
Paint damage, as nec.	3.0		6.00	
Total Labor Cost	\$ 75.20			
Sublet				42.00
Paint			6.00	
Tax				.30
				<hr/>
TOTAL				\$ 123.50

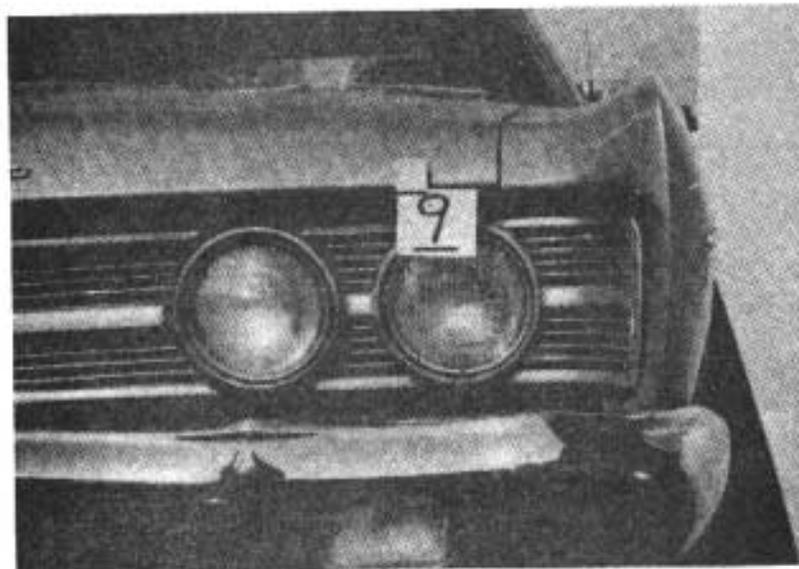
**FIGURE 18** RESULTANT DAMAGE FROM TEST 9 (FORD LEFT FRONT CORNER)

includes high-speed and real time documentation movies, slides, and black & white photos (Photos Appendix 84-90 and Figure 18).

Failure in this impact as defined by this modified face was not found. \* Contact between the vehicle and the reference plane was not visibly noticeable in either the film or the chalk markings. The dent in the bumper denoted that Line A was entrapped and did not slip out. The bumper was pushed back into the fender and there was fender failure, but reference plane contact was not found. The cost of repair to this vehicle was \$96.53.

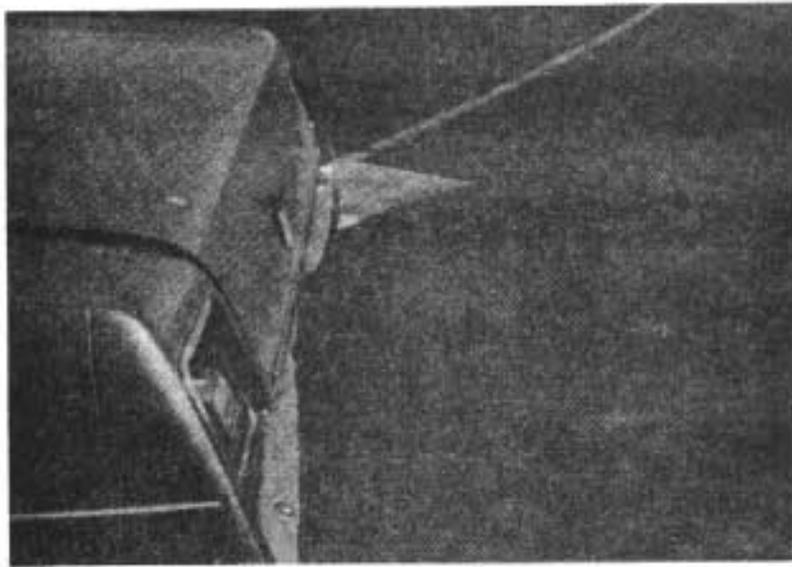
The measured pendulum impact speed was 5.03 mph. The car was unrestrained. The elevation of Line A was matched to the trailing edge of the Ford bumper in its center position. Documentation of this test has been forwarded to NHSB in the form of high-speed and real time movies, slides, and black & white photos (Photo Appendix 91-94 and Figure 19). During Test 10, failure was not found. \* Line A was entrapped in the bumper. No trunk lid closure problem was experienced. Although there was severe bumper bending and bending of other sheetmetal by the bumper, the reference plane did not contact the automobile. The cost to repair was \$149.00.

**FIGURE 19** RESULTANT DAMAGE TEST 10 (FORD REAR CENTER)

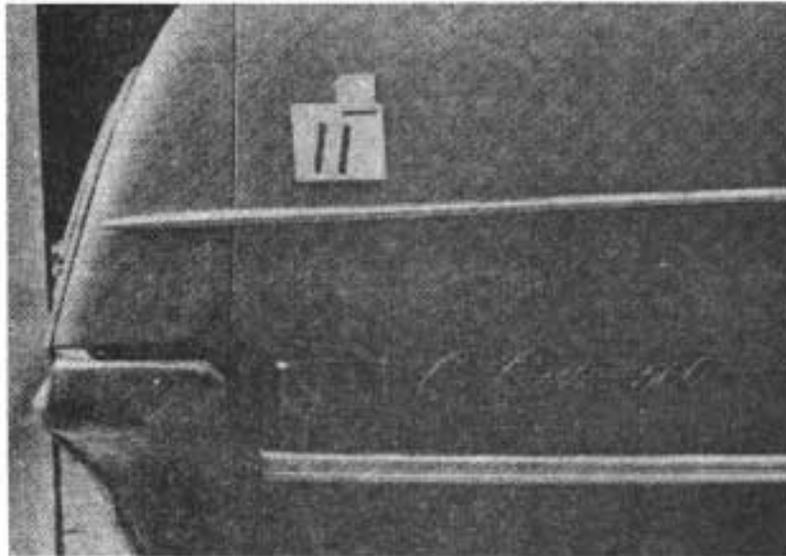
**FIGURE 20** RESULTANT DAMAGE TEST 11 (FORD REAR CORNER)

Test 11 (Ford Right Rear Corner)

The pendulum speed was measured at 5.05 mph. The car was unrestrained. Elevation of Line A was matched to the car bumper trailing edge of the right rear corner. Documentation of the vehicle test setup, impact and results has been sent to NHSB in the form of real time and high-speed film, slides, and black & white photos (Photo Appendix 95-100 and Figure 20). The vehicle failed by several modes. Although Line A was entrapped in the middle of the bumper, there was not enough resistance to keep the reference plane from touching the sheetmetal. The quarter panel buckled and the trunk was operable. Cost to repair was \$120.70.
