BASIC RESEARCH IN AUTOMOBILE CRASHWORTHINESS— TESTING AND EVALUATION OF MODIFICATIONS FOR SIDE IMPACTS

CAL No. YB-2684-V-3

INTERIM TECHNICAL REPORT

CORNELL AERONAUTICAL LABORATORY, INC.

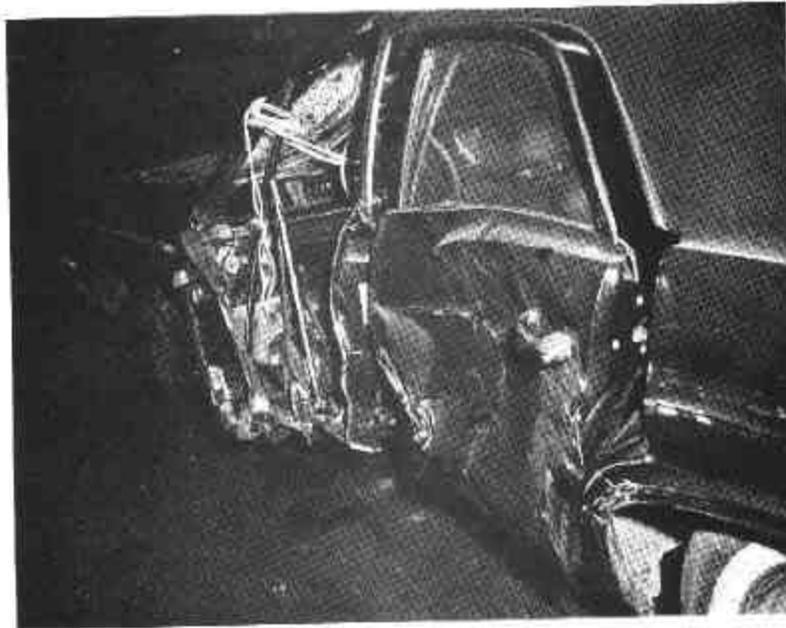
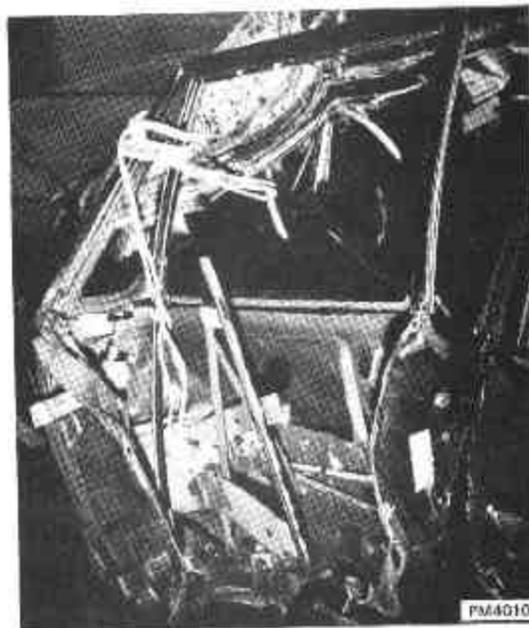
- The strength of the door panel is incompatible with the strength of the supporting posts. Evidence for this observation lies in the many accidents where the impacted door is severely damaged with little apparent damage of the side post or the nonimpacted door. Figure 3-1 shows an accident illustrating this point.
- A preponderance of injuries can be ascribed to low intrusion resistance of the structure rather than high acceleration levels. The injuries include a large number in the pelvic region; head injuries are also common. Similar injury patterns were uncovered by States and States (Reference 2). Figure 3-2 illustrates penetration patterns in pole impacts.

Figure 3-1 SIDE IMPACT ILLUSTRATING RELATIVE
DOOR AND DOOR POST DAMAGE

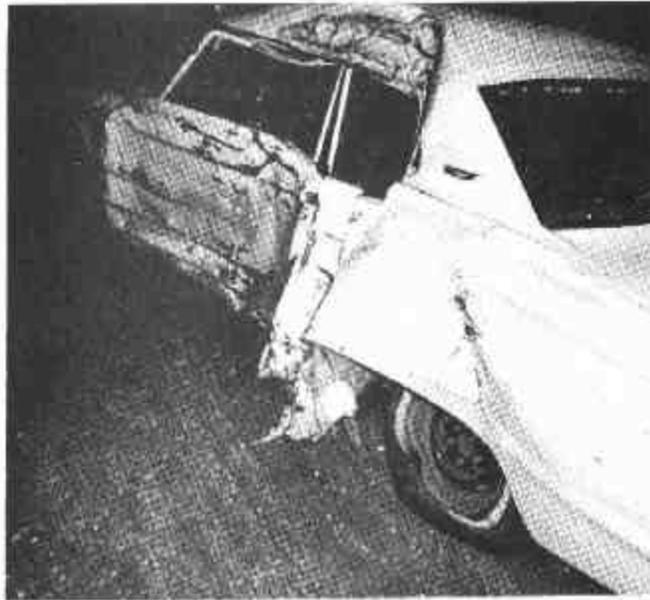
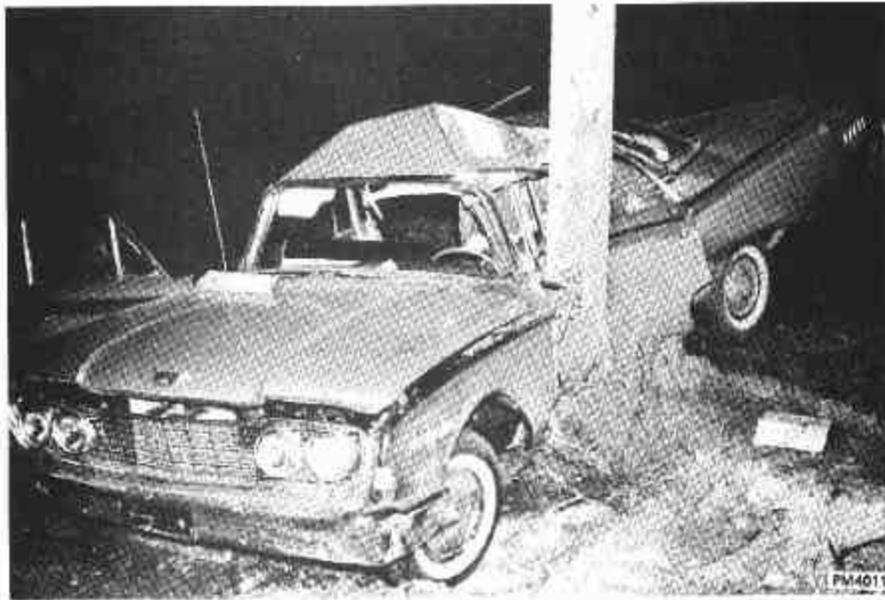
Figure 3-2 SIDE IMPACTS ILLUSTRATING PENETRATION
IN POLE IMPACTS

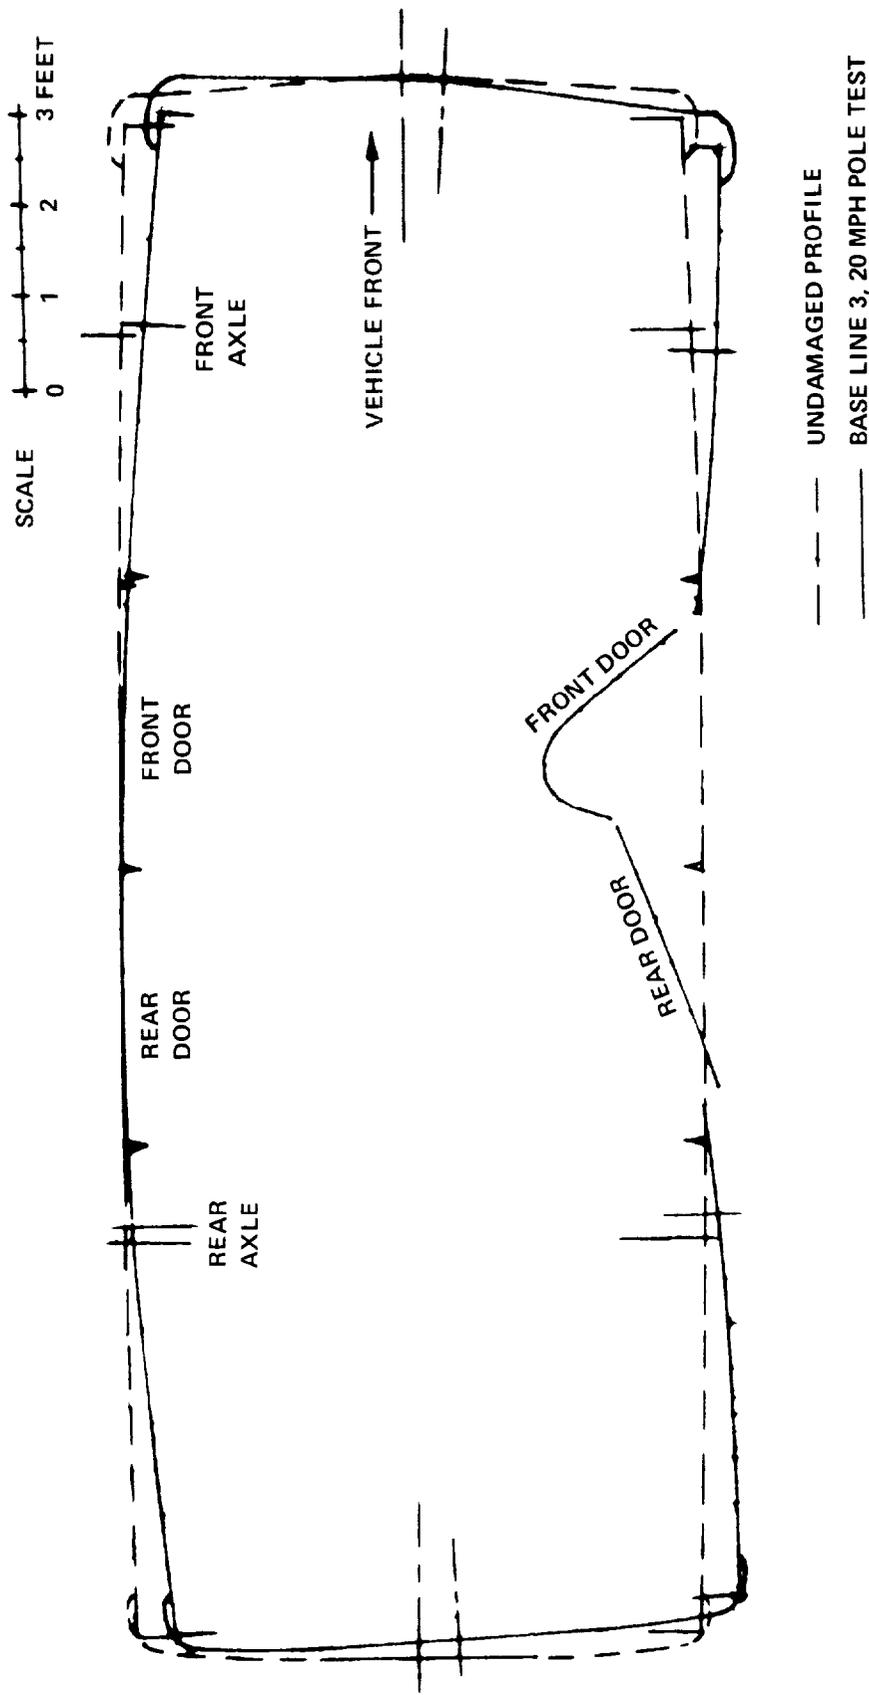
The vehicle deformation and the external shape of the car were determined by measuring around the total periphery of the vehicle at a distance approximately 28 inches above the ground. These data are plotted to scale along with a standard car profile in Figure 5-5. An overall measure of vehicle structural rigidity and impact severity can be obtained from this type of comparison. Note the total body bending tendency.

Figure 5-5 POST CRASH PROFILE OF BASE LINE 3

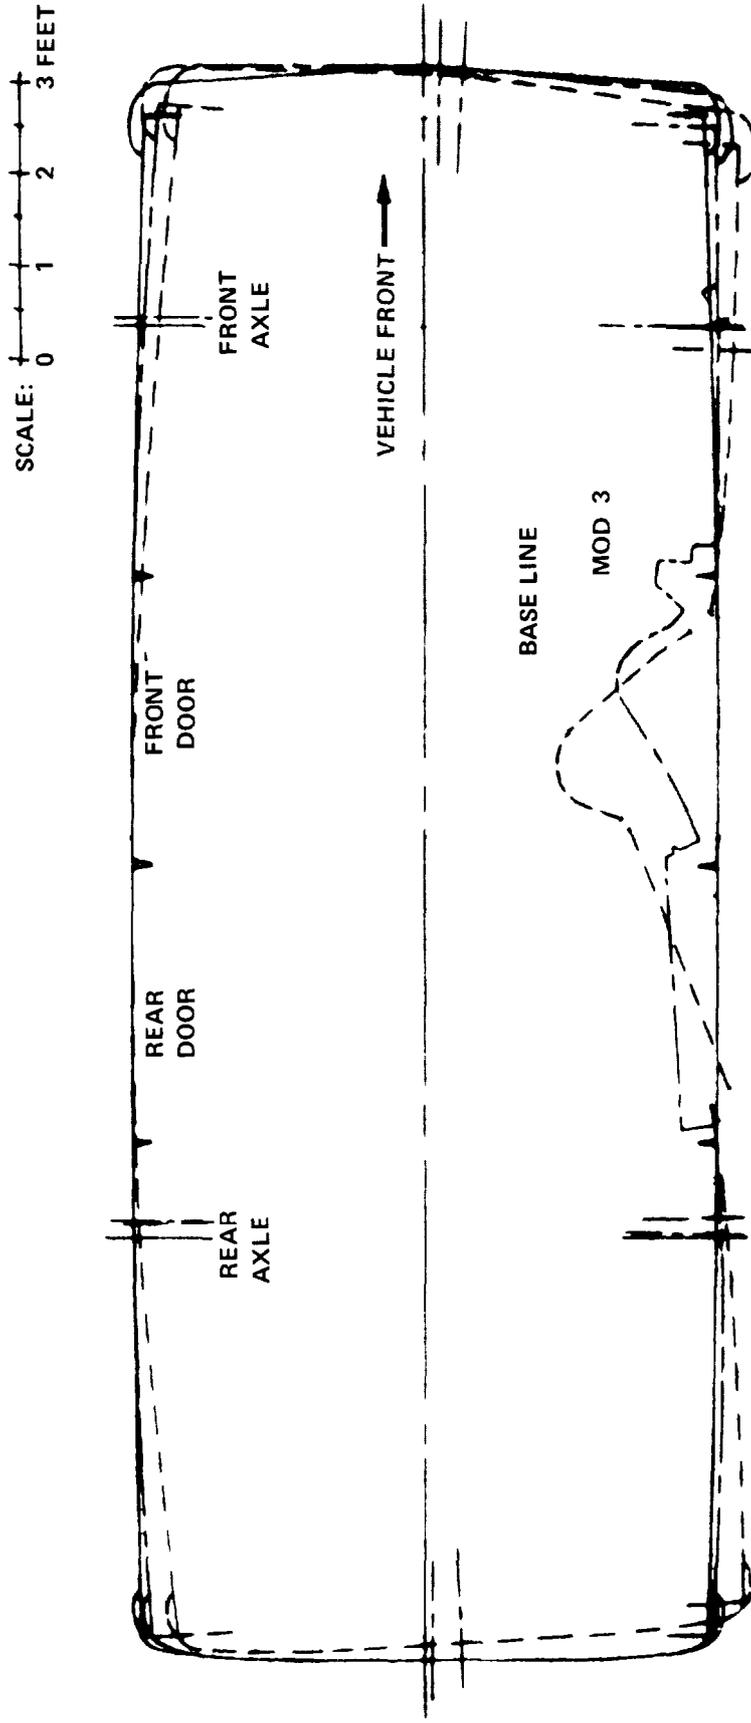
Figure 7-12 POST CRASH PROFILE OF SIDE IMPACT TESTS

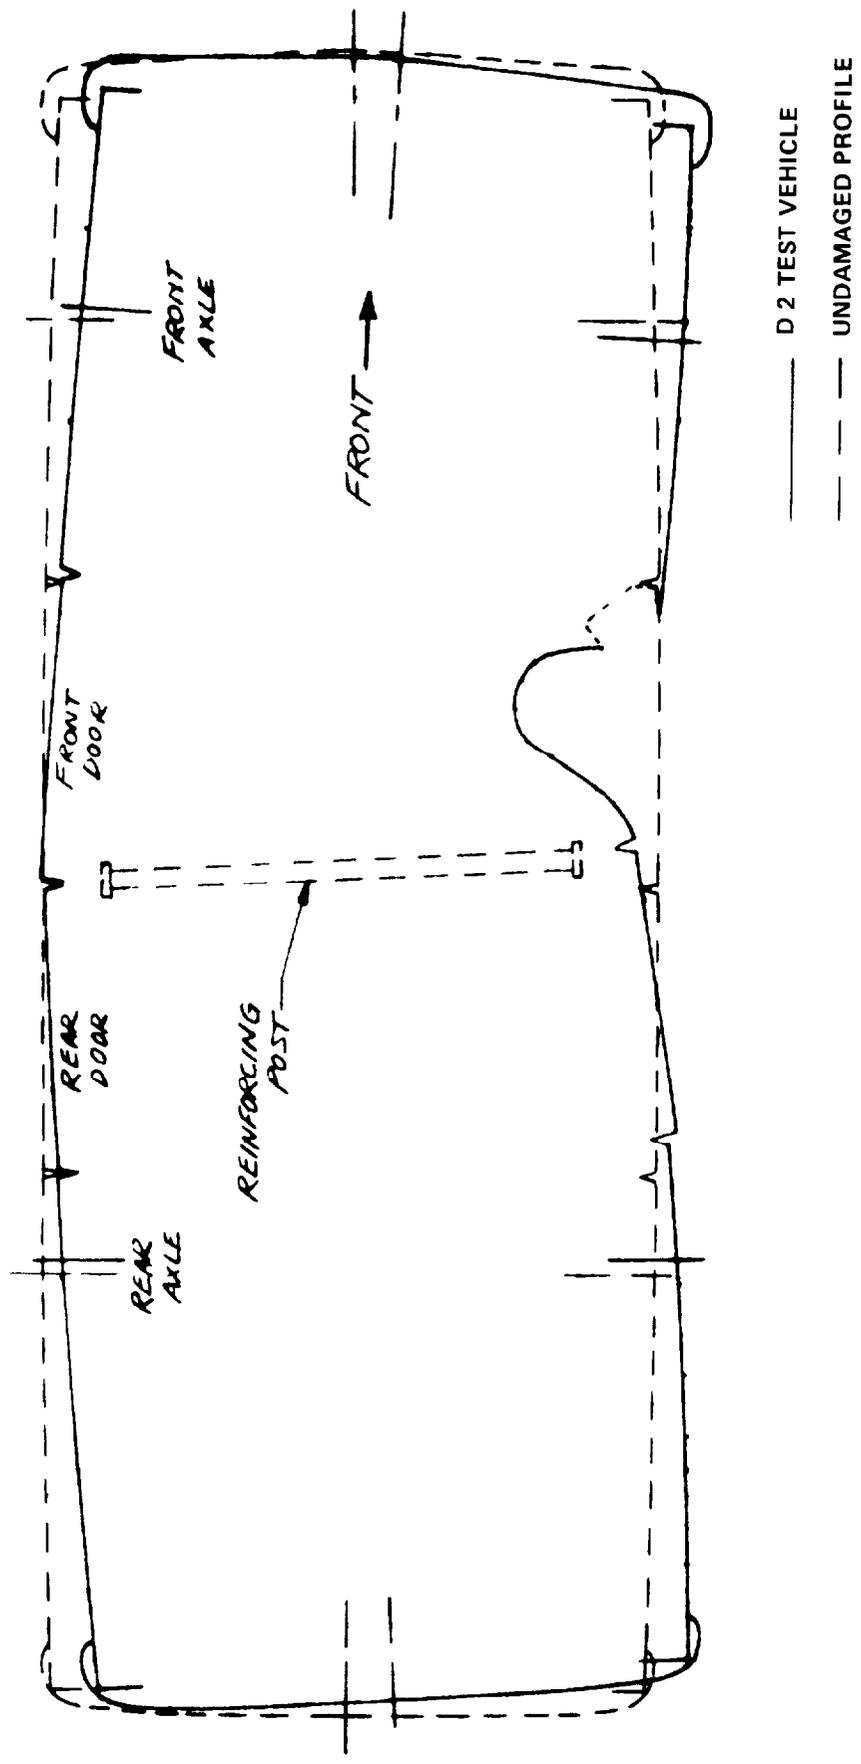
For comparison purposes, a post-crash profile of the D-2 vehicle is presented in Figure 8-6 along with an undamaged car shape. A total permanent deformation of 22 inches can be noted from the scaled drawing, along with bending of the total vehicle.

Figure 8-6 POST-CRASH PROFILE OF D-2

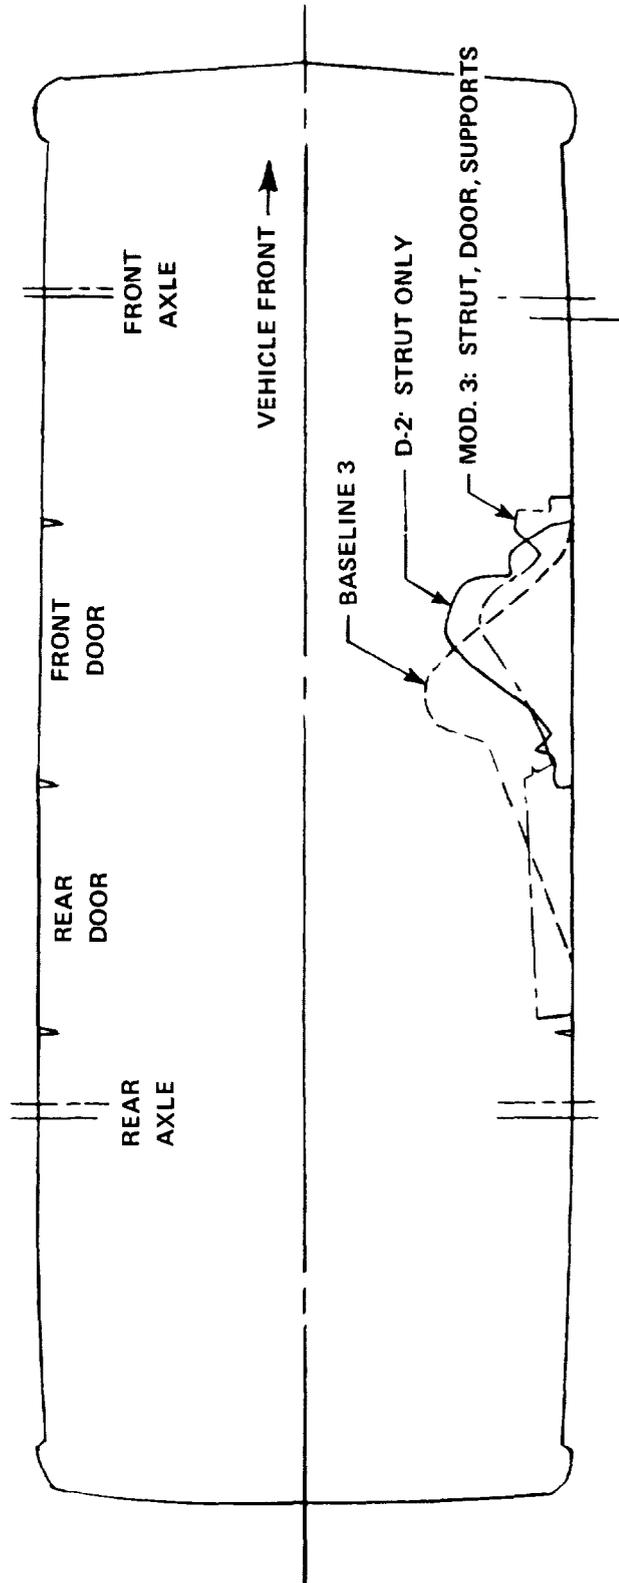
In evaluating overall performance in side collisions, both penetration and the magnitude of the compartment decelerations must be considered. Figure 8-8 shows the deformation caused by pole impact for all three side collisions that have been conducted. It is apparent that the deformation pattern of the D-2 is closer to that of the base line vehicle than to that of Mod. 3, which consisted of a modified door and supports in addition to the transverse strut. The observed deformation pattern correlates with displacements obtained by double integration of the various accelerometers and also with behavior of the frame as observed by a pit camera during the collision.

Figure 8-8 POST CRASH PROFILE OF SIDE IMPACT TESTS

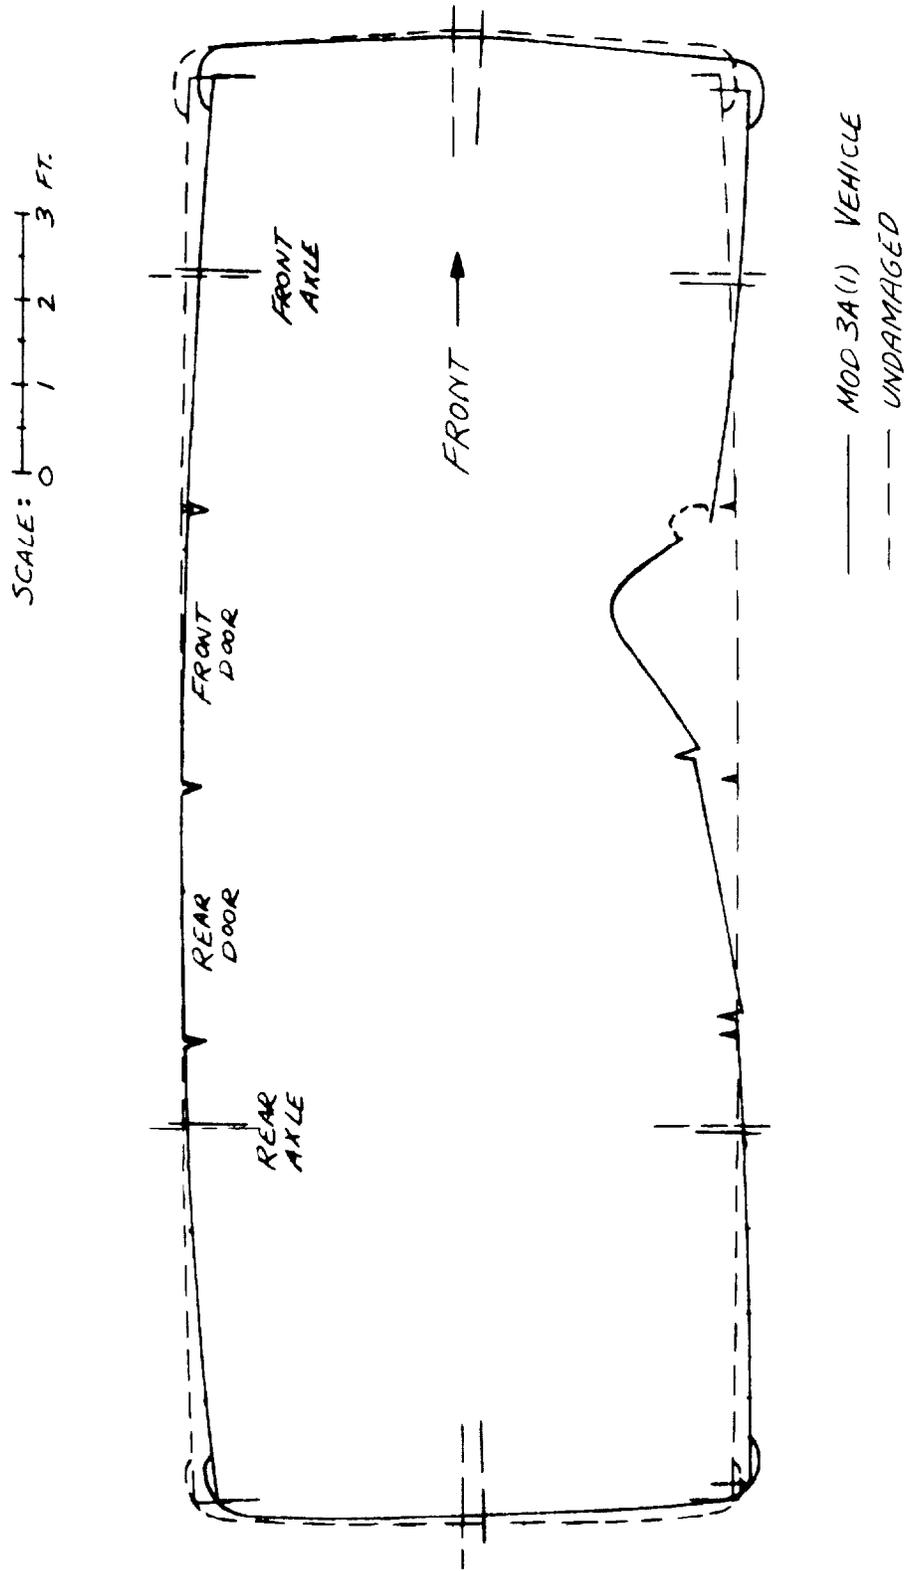
Since the impact velocities for the Mod. 3A(1) and base line tests are very close, a straightforward comparison of performance can be made. The structural modification reduced deformation by about 5 inches; however, the twofold increase in peak g's diminishes the attractiveness of the reduced intrusion. It is apparent that deformation is not being utilized effectively, i.e., in a uniform manner. Figure 9-8 shows that no significant loads were developed during the first 20 msecs of the collision, which corresponds to about 8 inches of deformation. This fact is supported by the low level of

Figure 9-9 POST CRASH PROFILE OF MOD. 3A(1)

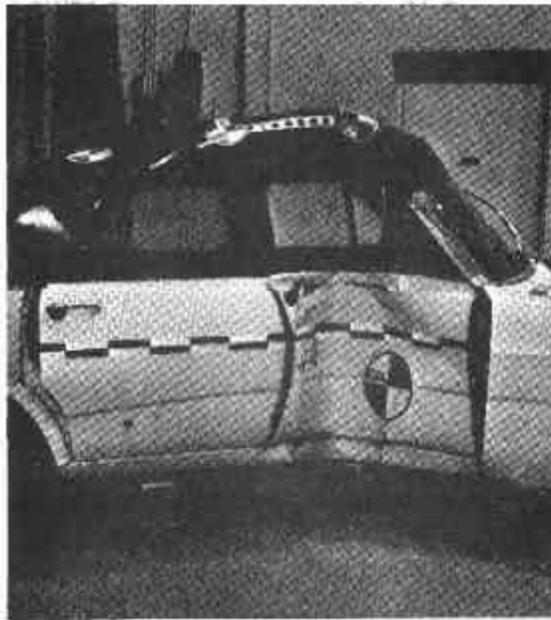
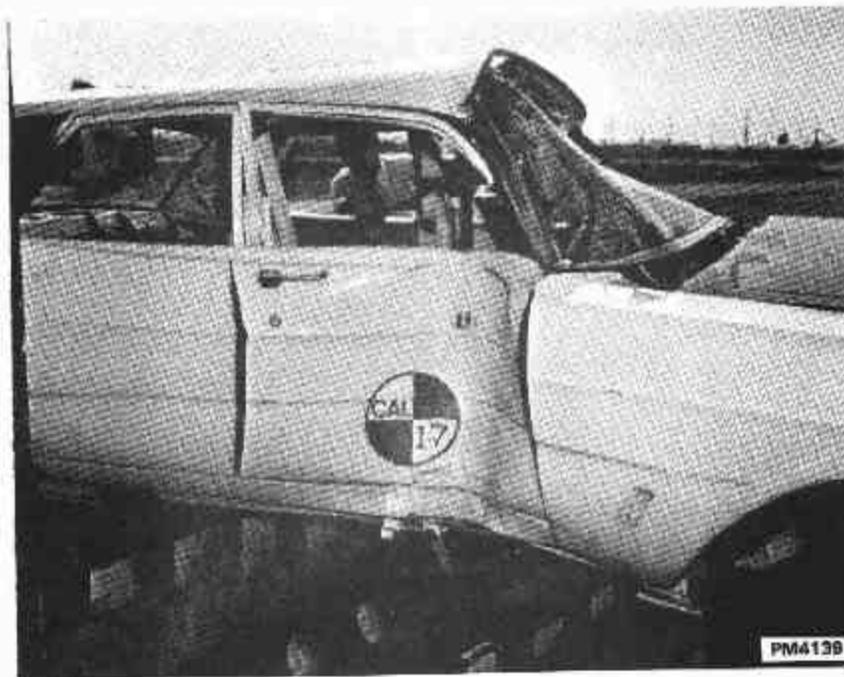
deceleration at the driver's position during the first 10 inches of deformation as indicated in Figure 9-7. This behavior is largely a result of the protrusion of the body shell outside the frame perimeter, as was noted in the design discussion of Section 9.1. The abrupt bottoming against the stiffened frame side rails of the Mod. 3A(1) accounts for the high level of compartment deceleration, as compared with the response of the base line vehicle. Compartment damage for the modified and unmodified vehicles is compared in Figure 9-12.

Figure 9-12 COMPARISON OF COMPARTMENT DAMAGE

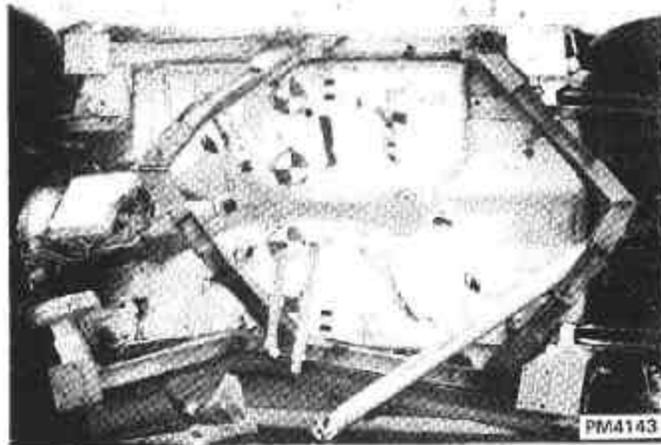
Figure 9-15 FRAME DAMAGE - OVERALL

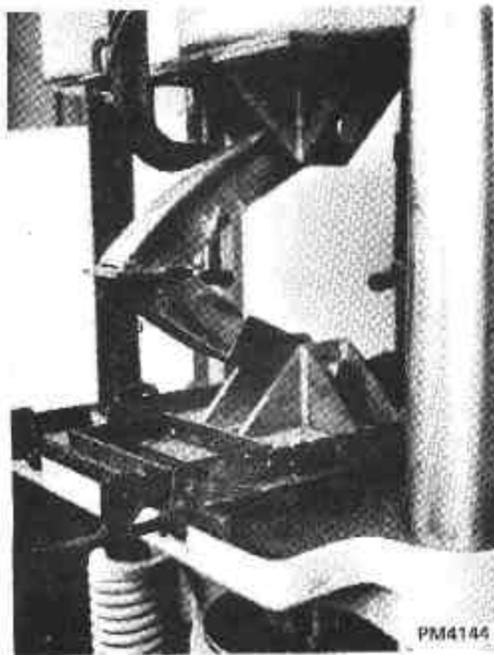
Figure 9-16 DEFORMED SHAPE OF I-BEAM KNEE
STIFFENED WITH WEB PLATES

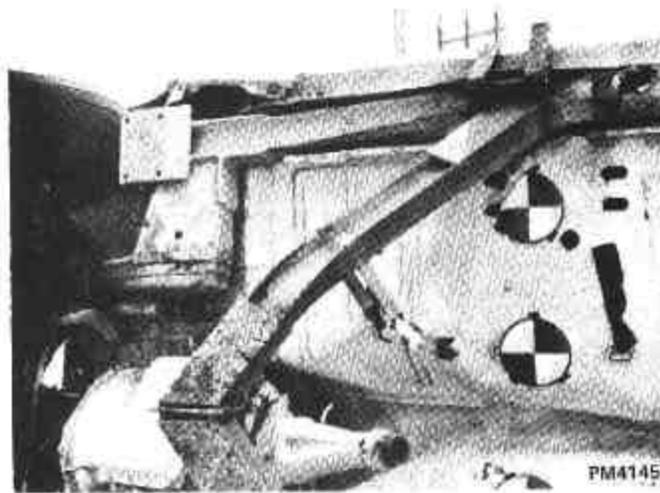
(b) FORWARD KNEE NON-IMPACT SIDE

Figure 9-17 FRAME DAMAGE

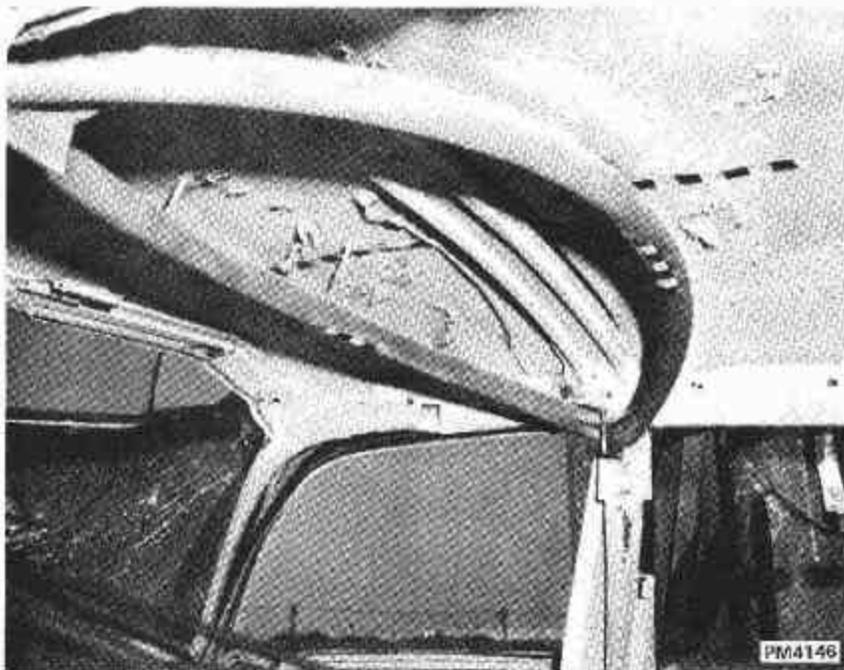
Figure 9-18 is a post-crash photo of the split roll bar, which failed to yield or to absorb energy during the impact. This behavior is attributed to excessive twisting of the I-beam used for the "B" post (see Figure 9-10 (d)). This implies that either the I-beam is too weak in torsion or the roll bar structure is too stiff. Although the roll bar did not operate as planned, it was only a proportionally small feature of the whole, the frame modification being the salient feature.

Figure 9-18 ROLL BAR AFTER IMPACT

In the very limited space available in side impacts with fixed objects, failure to develop significant crush resistance as early as possible is concluded to be a serious design defect. Possible solutions would be to extend the width of the frame side rails to the outer periphery of the vehicle or to substantially reinforce the body shell, particularly the outer door sheet metal. The first approach (extending the frame side rails) is believed to be the more reasonable of the two. The design of the Mod. 3A sister vehicle, Mod. 3A(2), will incorporate changes based on these results in an attempt to improve structural performance, particularly deceleration uniformity. For example, the design will be changed to prevent twisting of the "B" post. Major changes cannot be made, however, since the Mod. 3A(2) vehicle was partially fabricated along with the Mod. 3A(1).

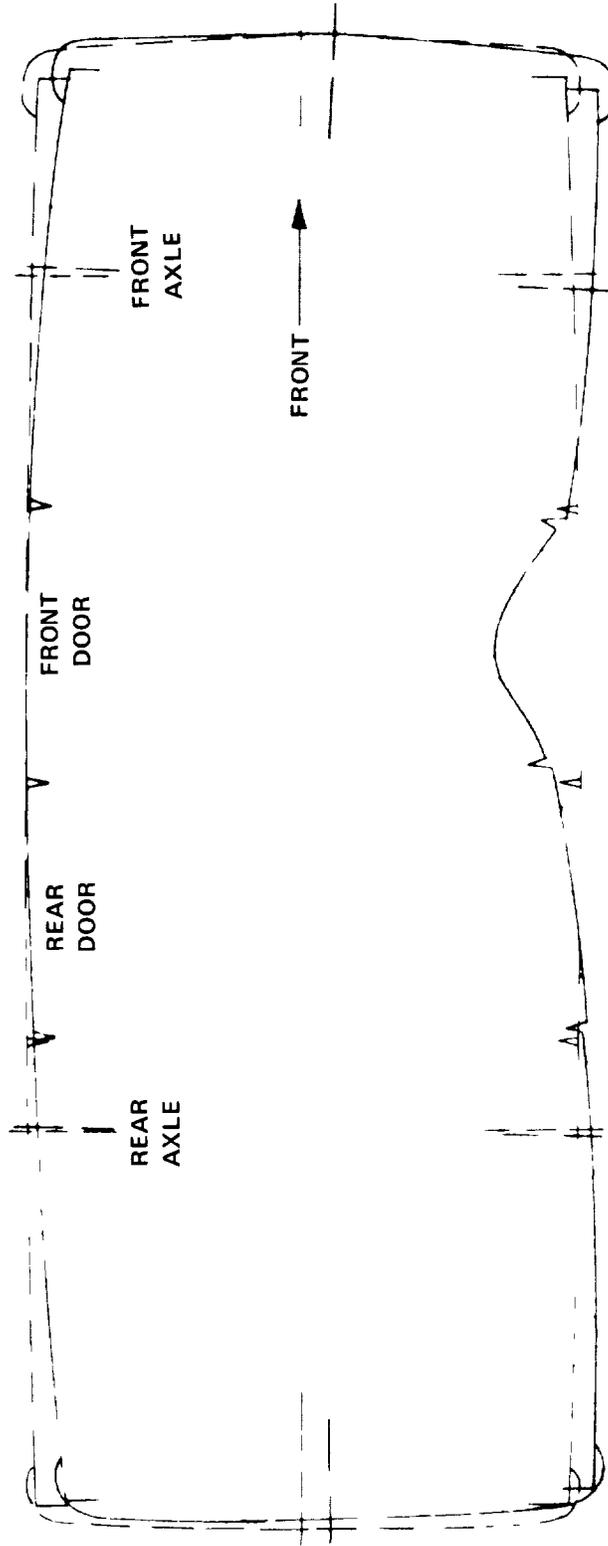
The deformed profile of the impacted test vehicle is shown in Figure 10-7 along with a profile of an undamaged vehicle. The total permanent deformation of 15 inches can be noted in the door when measured from a line connecting the front and rear fenders. Also evident is the slight bending of the total vehicle.

Figure 10-7 TOP PROFILE COMPARISON OF MOD. 3A(2) AND STANDARD VEHICLE

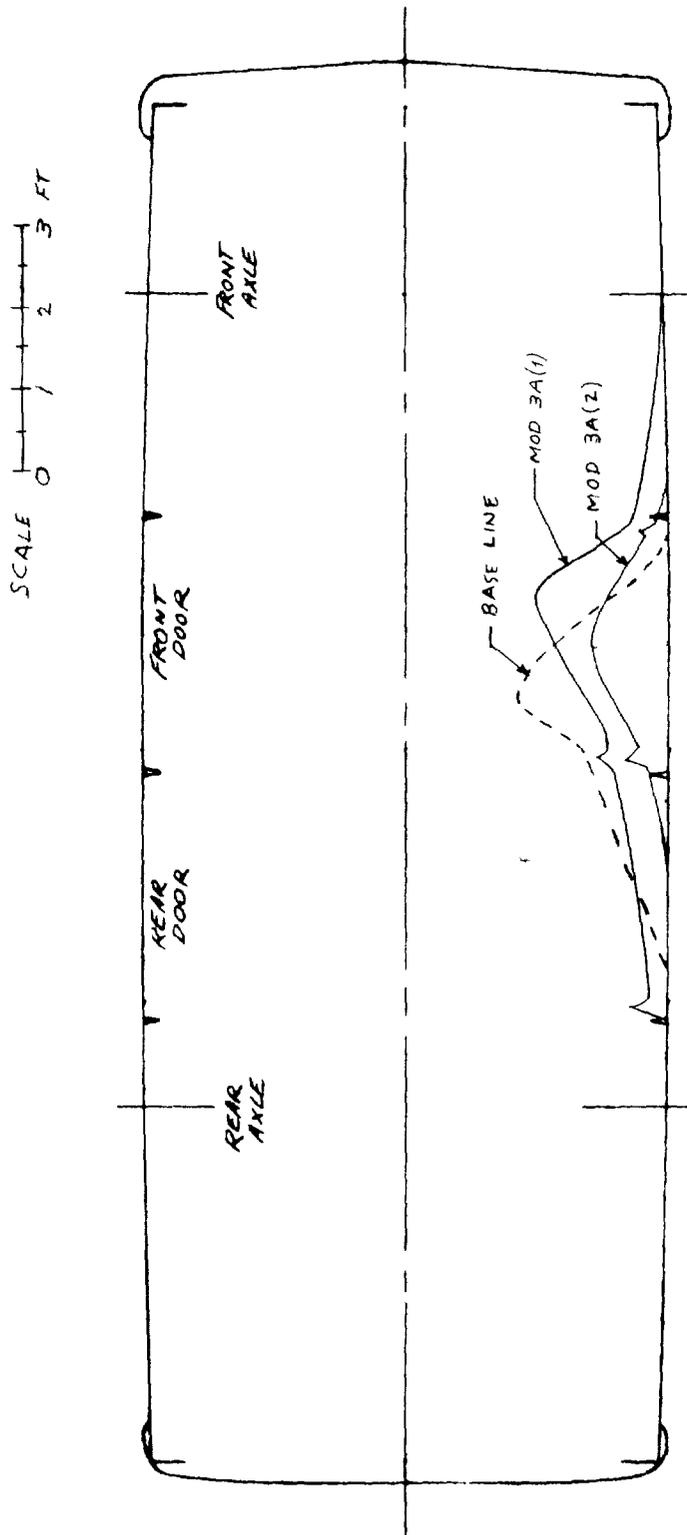
Figure 10-9 POST CRASH PROFILE OF SIDE IMPACT TESTS

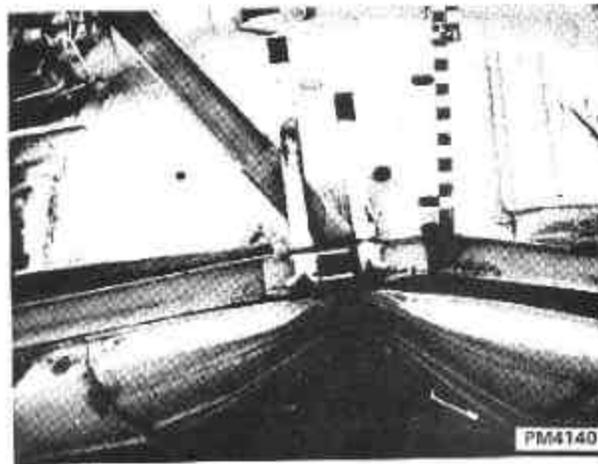
(d) POINT OF IMPACT

Figure 10-12 MOD. 3A(2): FRAME DAMAGE

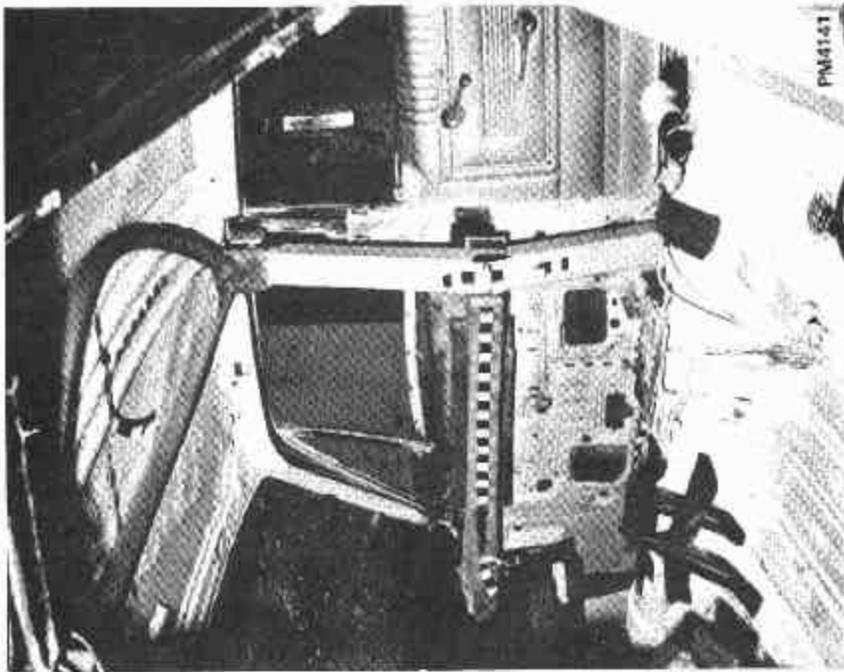
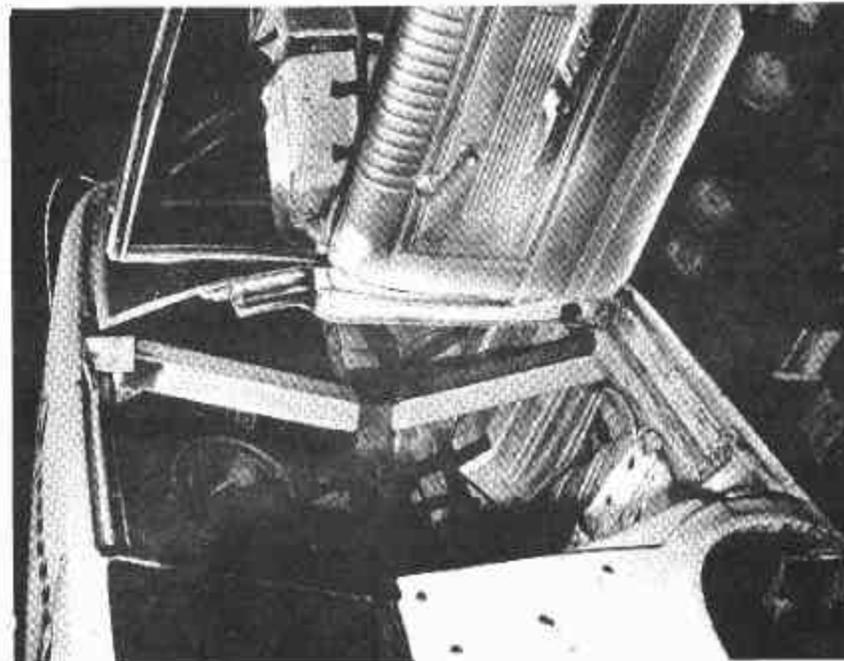
Figure 10-13 MOD. 3A(2): INTERIOR DAMAGE

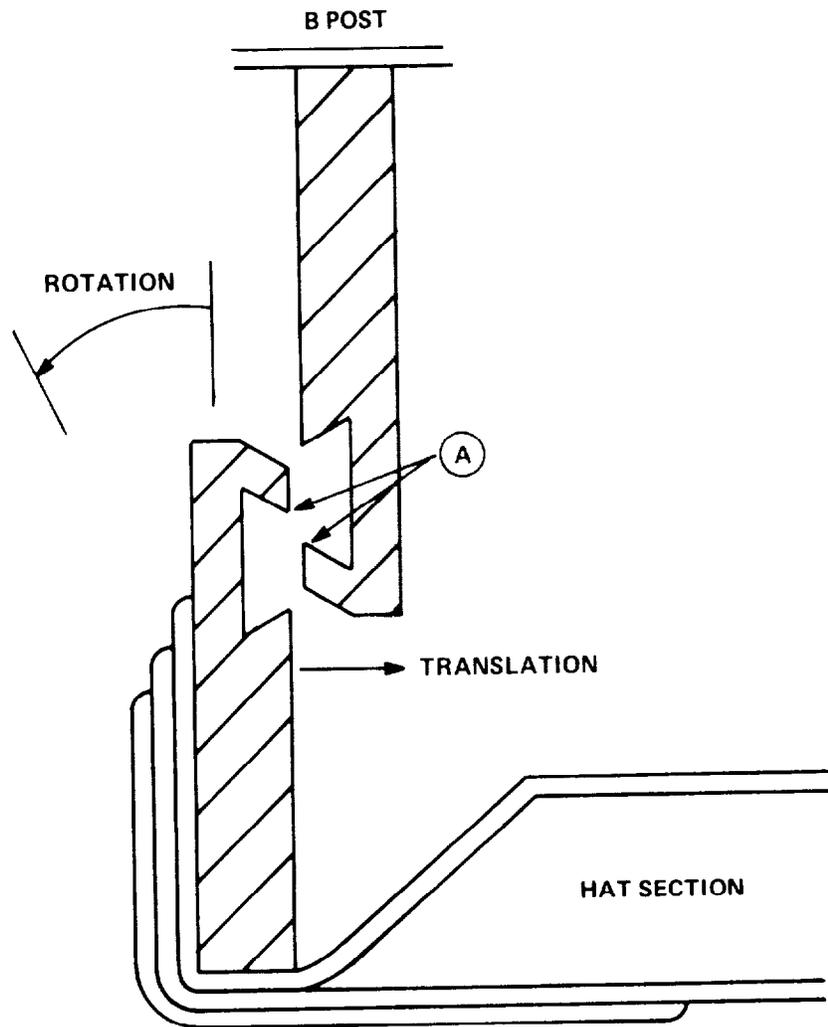
Figure A-2 LATCHING DEVICE TEST NO. 1

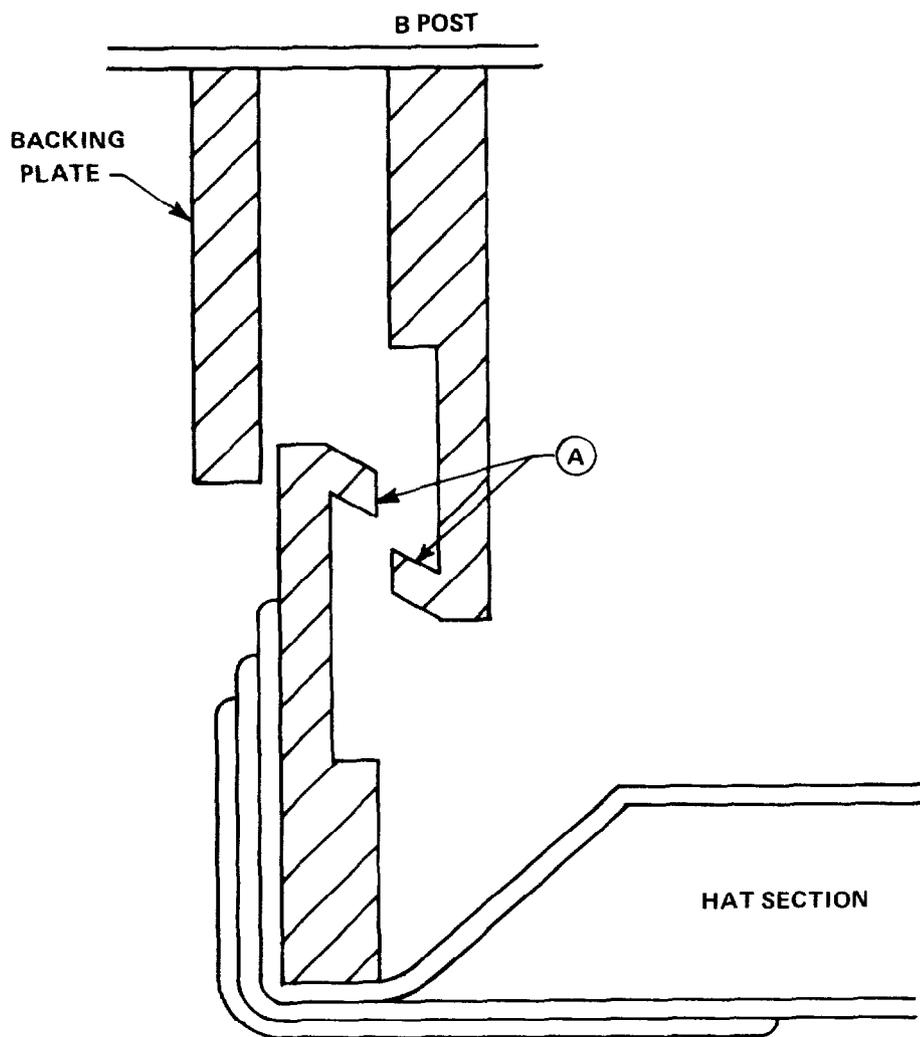
Figure A-3 LATCHING DEVICE TEST NO. 2
