## **STATUS OF NHTSA'S EJECTION MITIGATION RESEARCH**

Paper Number 17-0428

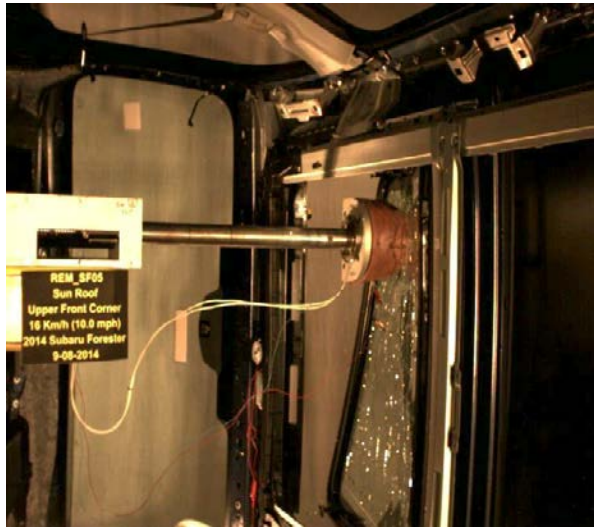
All tests on the Subaru Forester were conducted with the sunroof in the fully closed position, and all displacement values exceeded 100 mm. The displacement measurement was a combination of both the glazing material and moveable system parts. Impacting the upper corner of the forward edge at 16 km/h (SF05) produced the highest displacement value (shown in Figure 13). The failure mode was in the system designed to move the sunroof, as shown in Figure 14. In this system, the forward edge of the glass panel is attached to the aluminum frame through the cable guide. The cable guide travels in a U-channel on the aluminum frame.

**Figure 13 - Maximum Dynamic Excursion on Subaru Forester Movable Panel**

- When tested at 16 km/h, the displacements were 103 and 105 mm.
    - When tested at 20 km/h, the displacements were 150 and 167 mm.
  - For the movable sunroof, there was damage to the system designed to move the sunroof, resulting in large gaps at the periphery in four of five tests. Some modification to the system would be needed to achieve displacements below 100 mm.

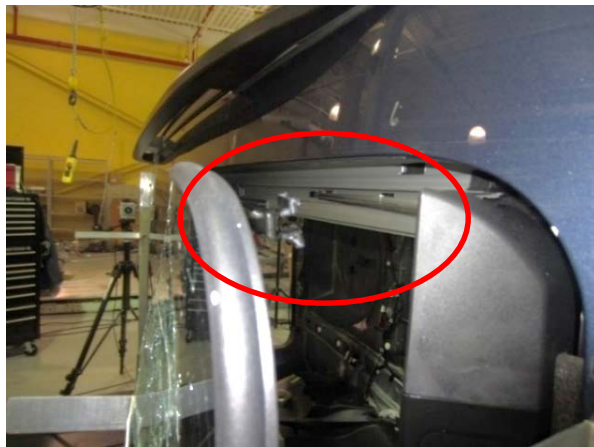
**Figure 14 - Typical Failure Mode at the Rail for the Movable Glass Panel**
