HEAVY TRUCK FRONTAL IMPACTS AND FIRES

Brian Herbst
Lauren Bell
Christopher Clarke
Safety Analysis and Forensic Engineering (SAFE)
USA

Paper Number 23-0165

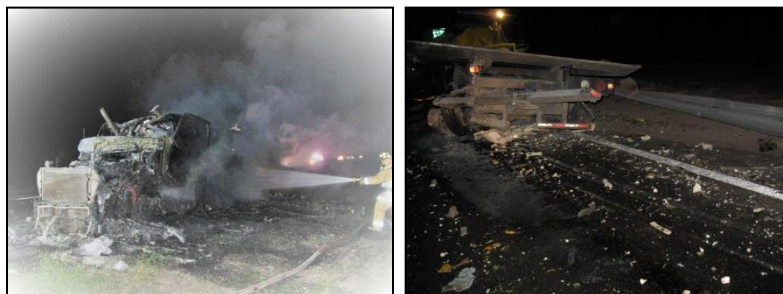
Figure 3. Scene Photographs

A tractor/trailer was travelling east in the number two lane when it side swiped a parked tow truck on the side of the road, resulting in a flash fire. A separate fire source and origin analysis determined that diesel fuel vapor was released from the right fuel tank of the truck and the ignition of these vapors resulted in a flash fire or a "fireball." The fireball engulfed the driver of the tractor/trailer, resulting in burn injuries (See Figure 3).

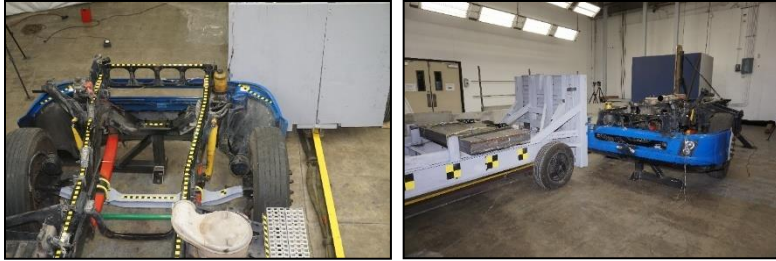
Figure 4. Production Sled Test

A production heavy truck frame including bumper assembly and front axle was subjected to a sled impact on the right side of the front bumper to evaluate the structure's resistance to impact forces. The assembly was rigidly supported by an impact barrier at the rear of the frame and to the floor at several locations along the assembly at approximately

zero degrees of yaw, pitch and roll, so that the striking sled's vertical face would initially contact the vehicle's right front side of the bumper outboard of the interior frame supports (see Figure 4).

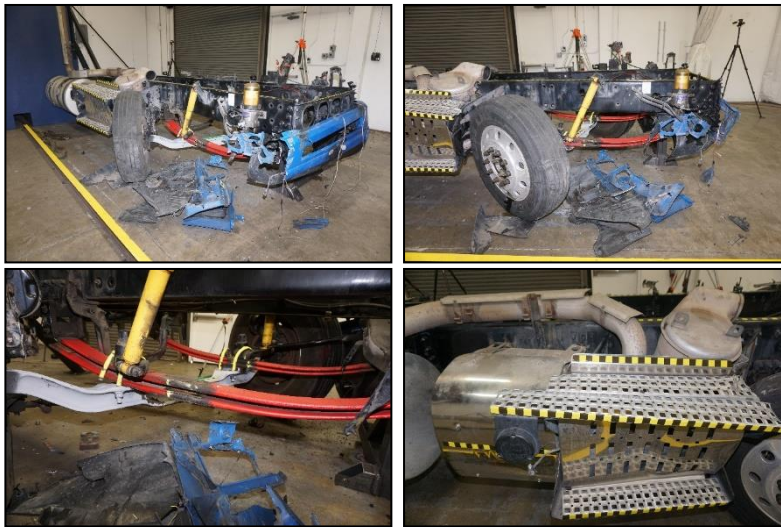
Figure 5. Production Sled Post-Test Photographs

The sled impacted the front of the heavy truck frame assembly at 27.4 mph and decelerated at a peak rate of approximately 11.3 g's displacing 76.0 inches towards the rear of the frame. Prior to impact, the kinetic energy of the sled was approximately 132,000 ft-lb. Utilizing the sled mounted accelerometers filtered at 10 Hz, the peak load was calculated to be approximately 52,600 lb. at a displacement of 66.3 inches.

The test progressed as planned with the striking sled's vertical face impacting the right front side of the bumper assembly. The first contact was to the external plastic fascia of the bumper. The impact tore the fascia and bent the corner support inward towards the frame. The sled continued to move forward striking the right front tire. The leaf spring/axle clamping fixture broke free of positioning pin allowing the axle to move rearwards. As this motion continued, an axle U-bolt failed on both the passenger and driver side of the vehicle. The tire continued to move rearward striking the Diesel Particulate Filter (DPF) and the attached steps. The steps were driven into the Selective Catalytic Reduction (SCR) assembly, which was driven rearward (see Figure 5).

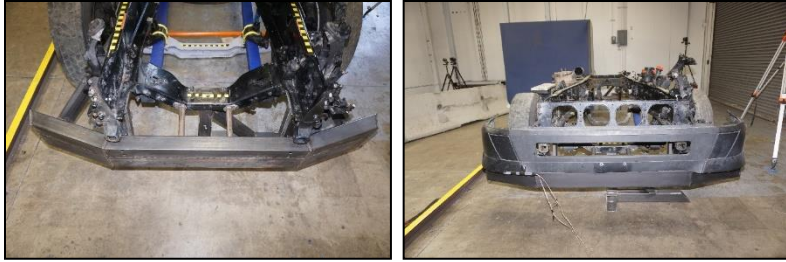
Figure 6. FUPS Sled Test

Additionally, a FUPS system was constructed and attached to a production heavy truck frame, front axle and bumper assembly and was subjected to a similar sled test impact. The main FUPS beam was composed of ASTM A500 six inches by six inches square tube with a thickness of 0.25 inches with a four inches by four inches square tube with a thickness of 0.120 inches welded on top, aligned along the front. The four by four was attached with the production attachment points to the bumper center bumper beam location and the production bumper assembly was placed over the completed FUPS (see Figure 6).

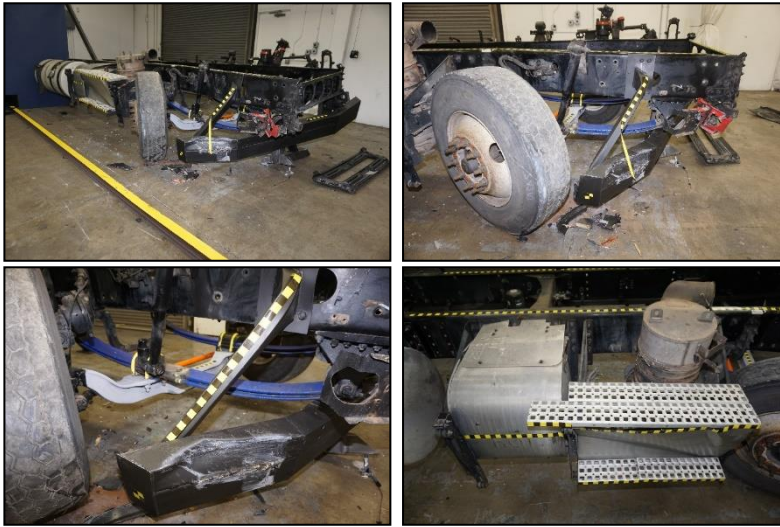
Figure 7. FUPS Sled Post-Test Photographs

The sled impacted the front of the heavy truck frame assembly at 27.1 mph and decelerated at a peak rate of approximately 16.9 g's displacing approximately 47.0 inches towards the rear of the frame before rotating to rest. Prior to impact, the kinetic energy of the sled was approximately 130,000 ft-lb. The striking sled's vertical face impacting the right front side of the bumper assembly. The first contact was to the external plastic fascia of the bumper. The impact tore the fascia and began loading the FUPS. The sled continued to move forward bending the FUPS attachments to the frame. The sled continued to move rearward striking the right front tire driving it rearward. The leaf spring/axle clamping fixture broke free of its positioning pin allowing the axle to move rearwards. The tire continued to move rearward contacting the DPF and the attached steps (see Figure 7).

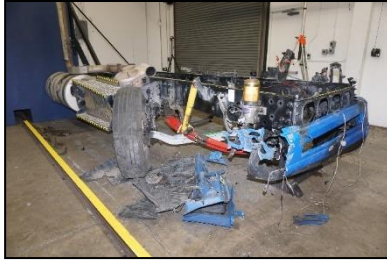
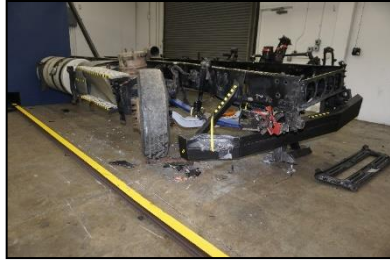
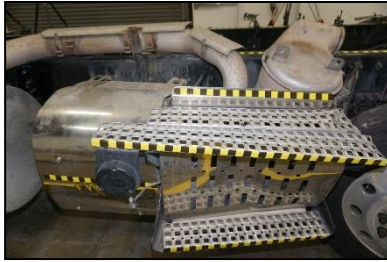
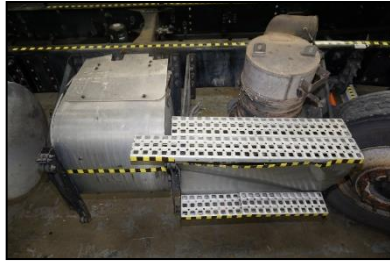
Figure 8. Post-Test Photographs

SAFE's sled testing of a heavy truck production design showed the susceptibility of the front axle under foreseeable crash conditions. SAFE's sled testing shows that a FUPS significantly reduces penetration and results in reduced depth of damage into the truck's structure. A comparison between the production and FUPS tests indicated a displacement reduction for the FUPS test by approximately 40%. Additionally, a FUPS increases the initial stiffness and energy absorption characteristics of the front structure. This increased initial stiffness allows for earlier and faster separation of the sled and reduced probability of interaction with the fuel tank (see Figure 8 and Figure 9).

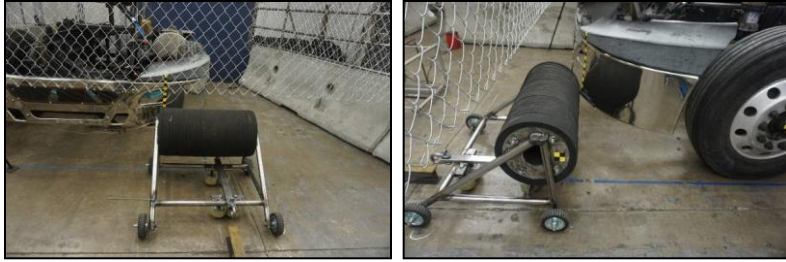
Figure 11. Production Sled Test

A production frame, front axle and bumper assembly were subjected to an impact on the left front bumper in order to evaluate the structure's resistance to impact forces. The frame assembly was rigidly supported by an impact barrier at the rear of the frame assembly and positioned such that a 255 lb impactor designed to approximate the subject bear would initially contact the left front side of the bumper outboard of the frame rails (see Figure 11).

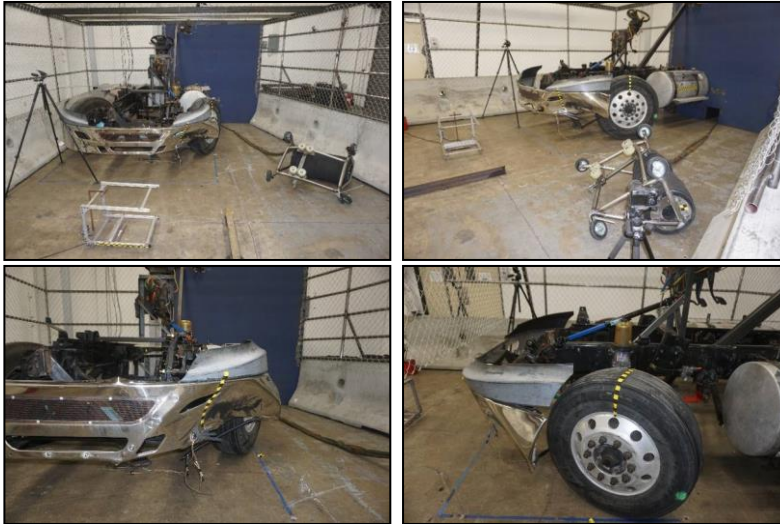
Figure 12. Production Sled Post-Test Photographs

The impactor struck the bumper at 58.0 mph. Prior to impact, the kinetic energy of the impactor was approximately 29,000 ft-lb. The test progressed as planned with the rubber face of the impactor striking the left front side of the bumper. The impact bent the metallic bumper and supporting rods inwards towards the frame and steering box. The impactor began to rotate and then struck the left front wheel assembly. The rotation of the impactor continued as its forward motion stopped. The wheel assembly rotated outward, and the impactor moved away from the chassis in a lateral direction before striking the surrounding test containment barriers and coming to rest. The left front tire continued to rotate outward until the impactor disengaged from it. At that point, the rotation of the tire reversed and the leading edge of the tire moved towards the frame. This causes the steering wheel to forcefully spin and would impact the ability to steer or control the truck (see Figure 12).

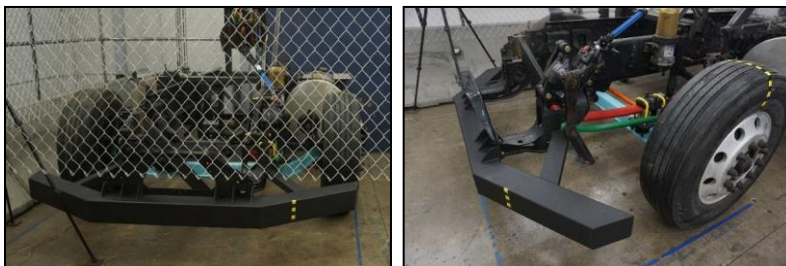
Figure 13. FUPS Sled Test

A FUPS system was constructed and attached to a production frame, front axle and bumper assembly, and was subjected to a similar sled test impact. The main FUPS beam was composed of ASTM A500 six inch by six inch square tube with a thickness of 0.25 inches (see Figure 13).

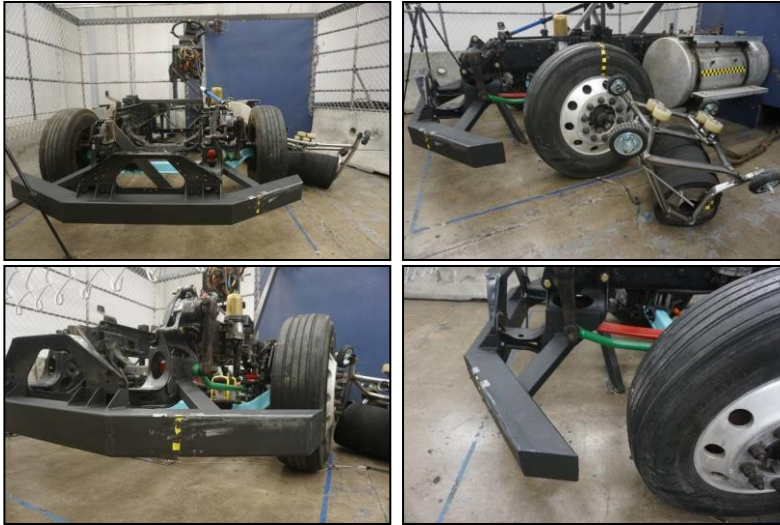
Figure 14. FUPS Sled Post-Test Photographs

The impactor struck the bumper at 59.6 mph. Prior to impact, the kinetic energy of the impactor was approximately 30,000 ft-lb. The rubber face of the impactor struck the left front side of the FUPS. The impact caused the impactor to go into a counterclockwise rotation (as seen from above). At approximately 90 degrees of rotation, the impactor came into very light contact with the front tire. The impactor continued to rotate, moving away from the chassis before striking the surrounding test containment barriers and coming to rest (see Figure 14).

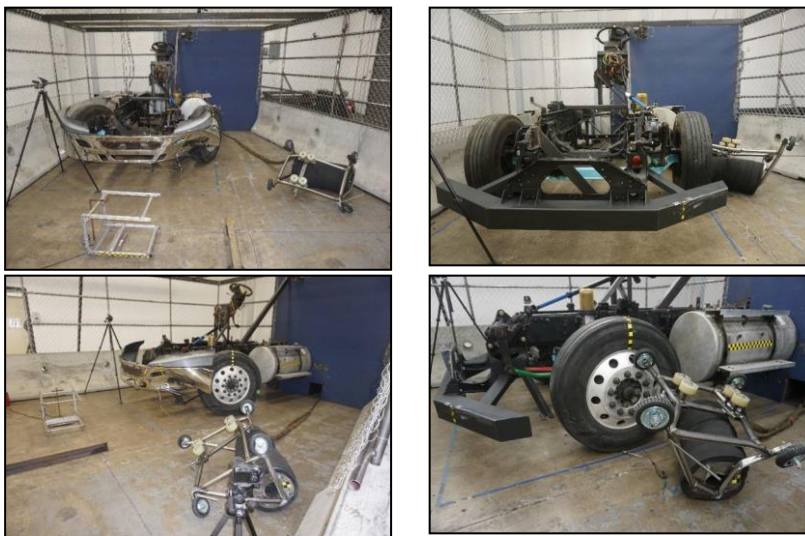
Figure 15. Post-Test Photographs

This sled testing shows that the production design allows for significant engagement and rotation of the steer wheel during a collision with a foreseeable roadway object, like an animal, which would affect the driver’s ability to control the directionality of the truck. The testing also showed that a FUPS virtually eliminates wheel assembly engagement, preserving steering control (see Figure 15).

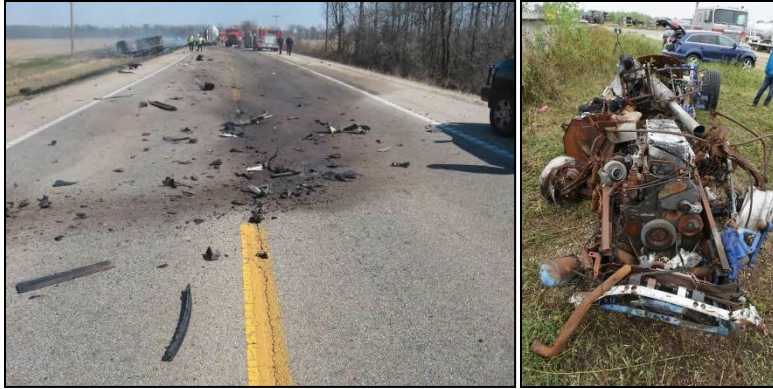
Figure 16. Scene and Vehicle Photographs

An SUV crossed the roadway centerline and impacted a heavy truck (both travelling at approximately 50-55 mph) in an offset orientation and outside of the heavy truck frame rail, causing major damage to the left front of both vehicles. The impact compromised the truck’s side saddle fuel tank, leading to a large fire (see Figure 16).

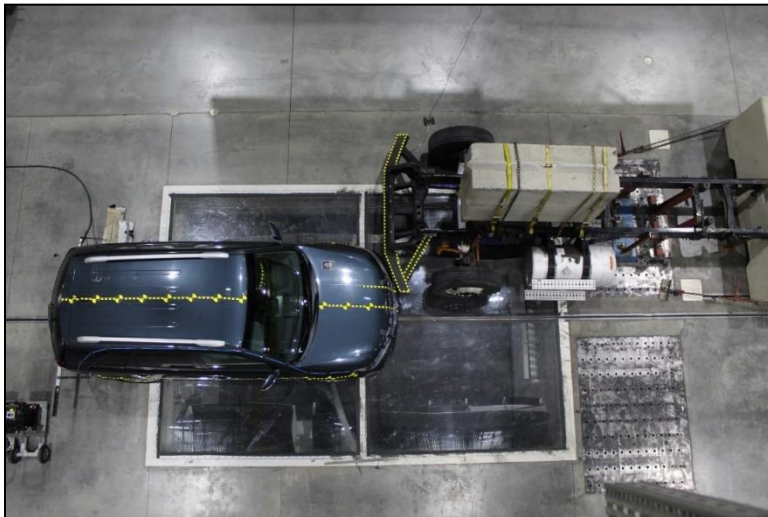
Figure 17. FUPS Full Scale Crash Test

In order to investigate if a FUPS could protect the heavy truck steering and fuel tank from significant damage, a full scale crash test was conducted with a FUPS equipped chassis. The main FUPS beam was composed of an ASTM A500 rectangular tube six inches by eight inches with a thickness of 0.25 inches. The truck chassis was rigidly mounted at the rear in a level orientation parallel to the direction of travel of the impacting SUV. The front of the FUPS equipped chassis was supported by the front axle assembly and was ballasted with approximately 7,000 lbs of concrete blocks in order to represent a typical front axle load. The SUV struck the driver's side of the FUPS equipped chassis with 35% overlap (on the SUV) and a 0° PDoF at 55 mph (see Figure 17).

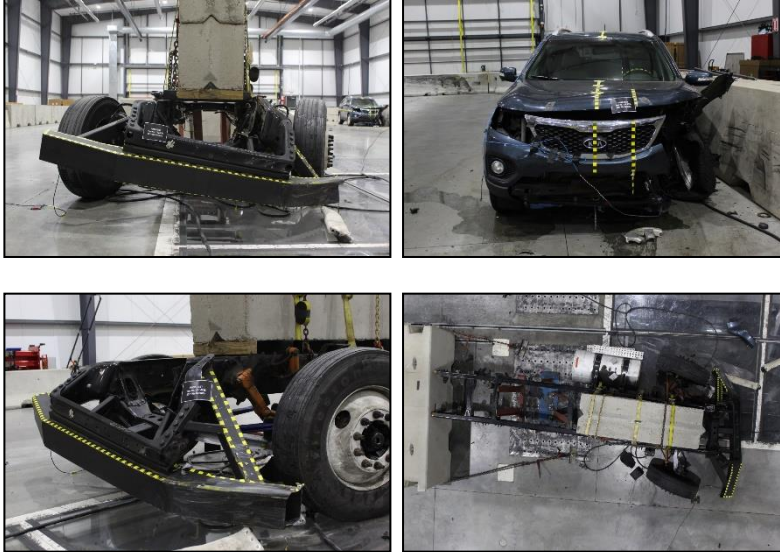
Figure 18. Post-Test Photographs

The SUV impacted the FUPS, distorted it, overloaded many of the bolted attachments, and contacted the left steer tire. Ultimately the SUV was deflected away from the truck and ran into the test containment barriers. The steer tire rebounded and the axle remained attached to the truck suspension, although the entire side had been shifted rearward. The front suspension and front axle assembly remained intact, and the rearward displacement of the front wheel assembly was limited such that the front tire did not make contact with the fuel tank during the test. In addition, all steering linkages remained intact, and the steering mechanism was observed to be functional after the test, indicating steering control would have been maintained after the impact. Full scale testing showed that a properly constructed FUPS was able to effectively deflect a mid-sized SUV at 55 mph, while protecting the front axle and fuel tank (see Figure 18).
