FRONTAL CRASH INCOMPATIBILITY OF HEAVY GOODS VEHICLE IN CRASH TEST WITH PASSENGER CAR

Paper Number 23-0321

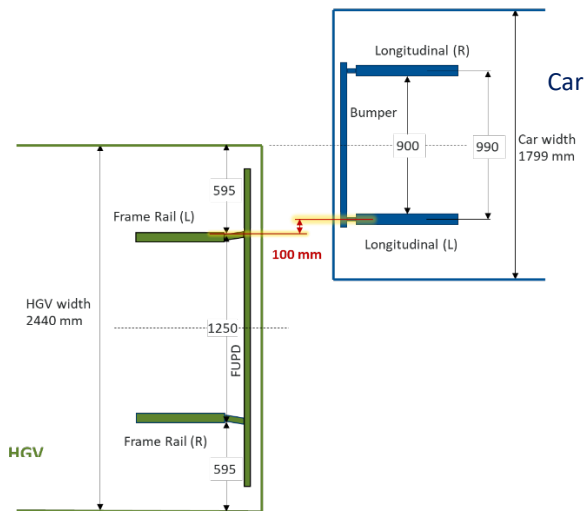
The lateral placement of the main longitudinal and frontal cross beam structures (FUPD on HGV and bumper cross beam for car) are shown in Figure 6. Note that the left longitudinal in the car is outboard of the HGV's left frame rail but both cross beams overlap identifying the potential for structural interaction.

Figure 4. Lateral Alignment of main structures.

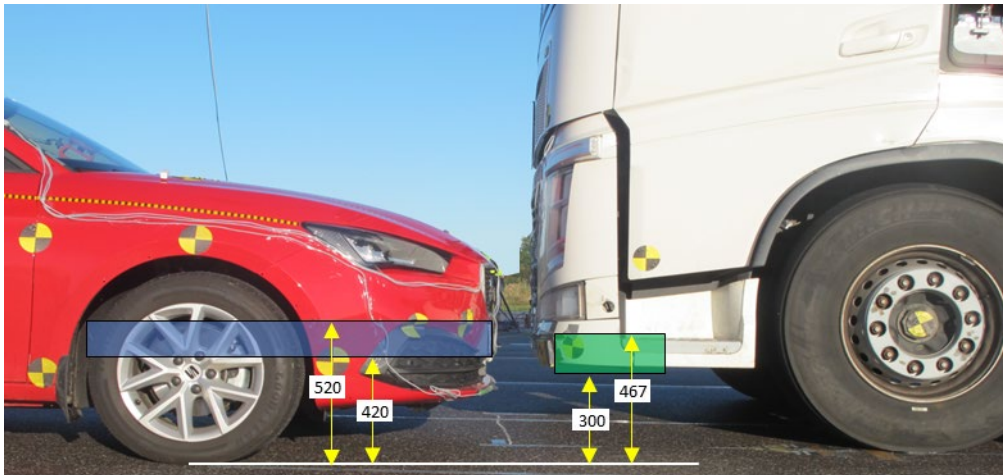
The bumper of the car is mounted on the main longitudinal as illustrated in Figure 5. The original ground clearance was 420 mm to the underside of the bumper beam which has a 100 mm section height. The FUPD's lower surface was measured to be 300 mm above the road surface before the test. It has a section height of 167 mm. The HGV has an energy absorbing FUPD design. It is "hung" from the main frame rails and has energy absorbing struts that control the rearward deflection of the FUPD [6]. The tested HGV has type approval for this FUPD in accordance with UNECE R93 [6].

Figure 5. Vertical alignment of main frontal structures.

Notwithstanding the poor horizontal alignment seen in this test, the vertical misalignment also contributed to the poor results and would have contributed to a poor test outcome even if the horizontal alignment was improved. Figure 5 show that the centerlines of the FUPD and car bumper do not line up. Regulation 93 requires that for N3 HGVs (over 12 tonnes), FUPD cross beams must have a minimum 120 mm vertical dimension and with a lower edge no higher than 400 mm in the unladen condition [6]. There are no requirements for FUPD positions when the vehicle is loaded.

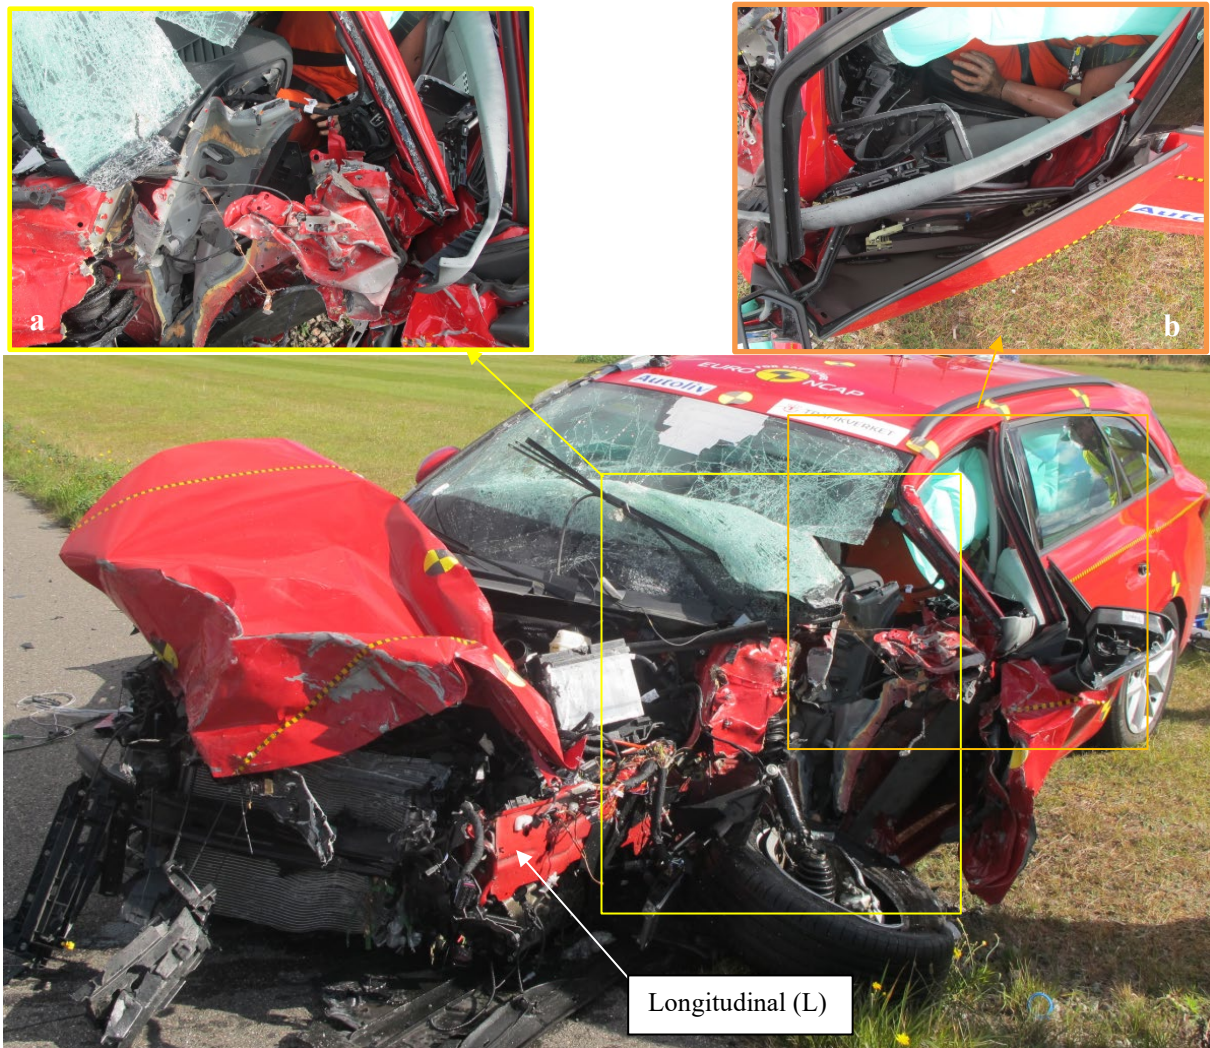
The passenger car displayed the most deformations of the vehicles involved in the test, as expected. The car's structures outboard of the left longitudinal were peeled off and pushed rearward (Figure 9). The left longitudinal is easily identified and is essentially undamaged. The lower A-Pillar base at the beltline has been pushed laterally outward from the vehicle, compromising the occupant compartment. Figure 9 inserts a & b provide different views of the A-Pillar, driver door region. The dummy was not ejected from the vehicle.

Figure 9. Damage to Car.

The test demonstrated the severity of frontal crashes when there is a large mass difference between the vehicles. What is most striking from the test is the lack of structural capacity in the HGV FUPD. Figure 9 highlights the lack of structural interaction between the two vehicles where the main energy absorbing structures, the car longitudinals, are completely intact. The contact surface between the vehicles was limited to the softer outboard structures which were pushed rearward (car left fender and A-pillar) or sheared off (HGV). Metal fracture cannot be considered a desirable vehicle response in this type of crash.

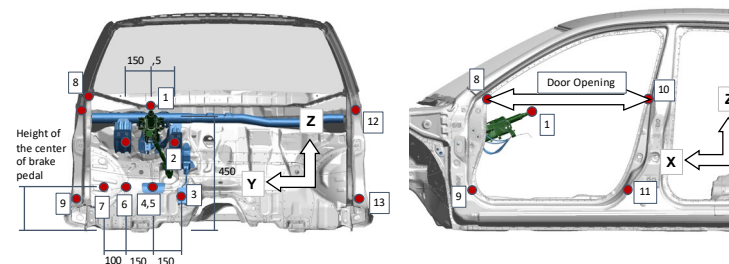
The interior intrusions were most notable in the left A-Pillar regions. Figure 10 shows the measurement reference points. Some footwell measurements were not possible to measure post-test and thus no intrusion values are available. The steering wheel and foot pedals exhibited 20-50 mm rearward deformation. Interestingly the left foot rest (Point 7) was not as affected as much as the left A-Pillar base (Point 9) even though there is only

212 mm lateral difference between them. The instrument panel intrusion to the right of the steering wheel was 38 mm.

Figure 10. Intrusion measurements (Negative X values indicate intrusion). Right: Intrusion measurement locations shown in a generic interior which does not correspond to the actual tested car.

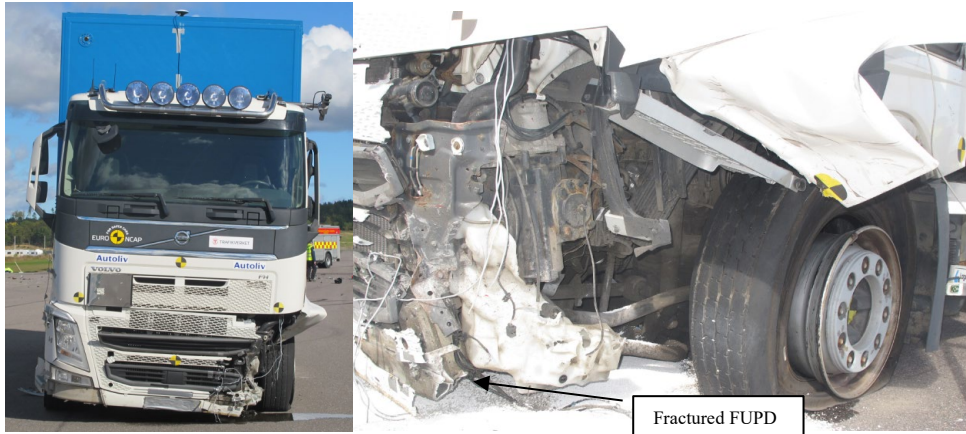
The left outboard section of the FUPD on the HGV fractured at the connection bracket to the energy absorbing element. This fracture eliminated potential for intended interactions between the HGV FUPD and car's main structural members. The HGV steering arm separated from the steering rack and the steering servo was sheared from the frame rail where it is mounted. The car bumper loaded the left front tire of the truck, puncturing it and driving the rim rearward. Figure 11 shows the damage to the HGV which was confined to the structures below the cab. As seen in Figure 8, the combination of steering system damage and punctured left front tire caused the HGV to move laterally to the left after the impact.

Figure 11. Damage to the HGV.

The two main reasons for the poor interaction are the lack of structural alignment (originally foreseen in Figure 4, Figure 5) and the contact loads that exceeded the FUPD legislated requirements. R93 requires that the FUPD does not deflect rearward more than 400 mm when horizontal loads are applied separately to loading points “P1” and “P2” (Appendix B) [6]. These loads are based on the HGV mass but are not required to exceed 80 and 160 kN, respectively. In a crash, these points may be loaded simultaneously and simulations indicate crash interface forces easily exceed 400 kN during a frontal crash of this configuration.

The consequences of the loading observed in the crash test was that the FUPD was not able to prevent passenger car underride and resulted in the extreme loading to both vehicles. Had the FUPD been able to engage and activate the longitudinal in the car, the crash loads would not have been limited to the car tire and HGV frame. As seen in Figure 15, the car was loaded primarily through the wheel into the A-pillar. If the FUPD was stronger, the loads would have been distributed across more structures (Figure 15, right) and would not have compromised the passenger compartment as much. While the occupant compartment was not completely breached, the car deformations represent an unstable condition that could be much worse in a similar crash.

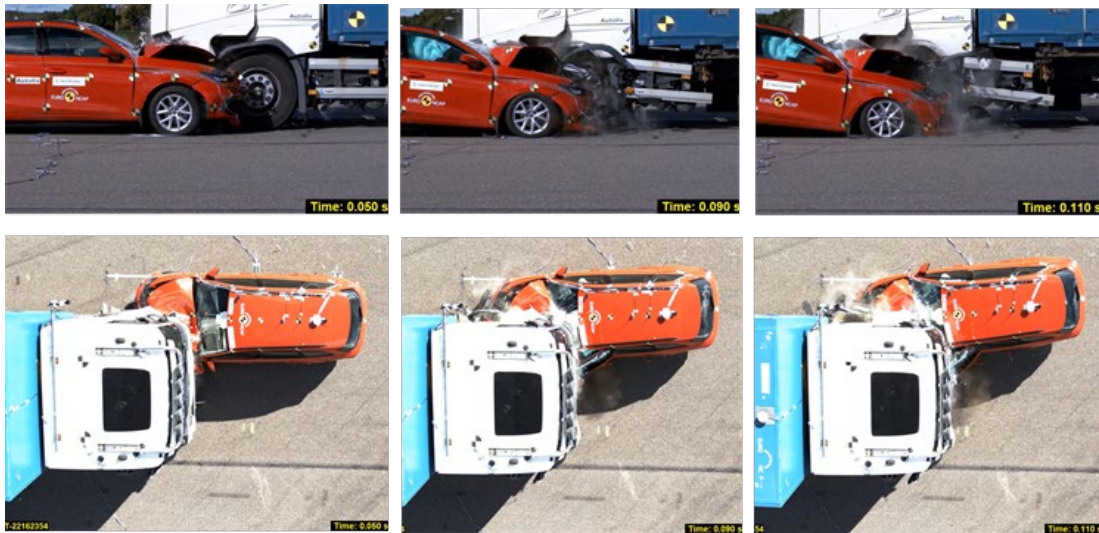
Figure 12. Crash Loading at 50, 90 and 110 ms.

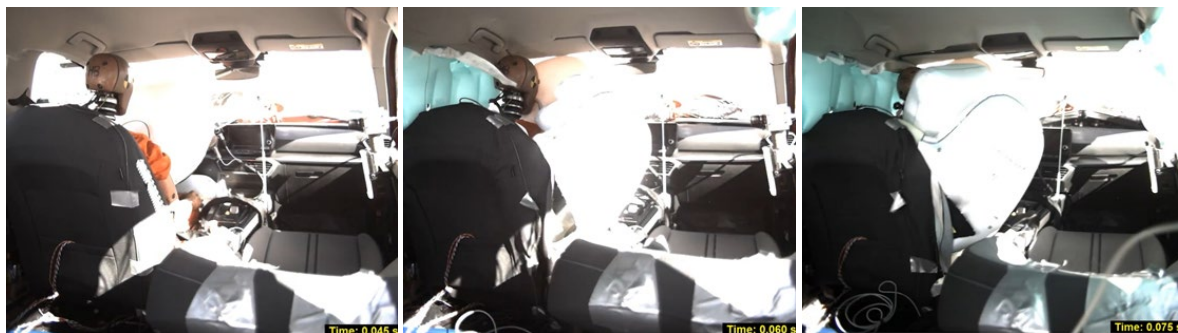
Due to failure of the onboard high speed video cameras, only the first 80 ms of the impact was recorded and it was not possible to identify all the occupant kinematics during the collision. It was possible to see that the driver's head slid to the left of the driver airbag (Figure 14) and moved towards the left A-Pillar through a gap between the driver airbag and inflatable curtain, Figure 14. The gap developed as the steering wheel (and airbag) displaced rearward and right from its original position (Figure 10) in combination with A-pillar deformations that reduced the tension in the strap between the front and rear attachment points of the inflatable curtain. With reduced head impact mitigation from the inflatable curtain, high lateral head accelerations dominated the head injury criteria calculations which suggest the dummy's head struck the left A-pillar during the impact.

Figure 14. Occupant kinematics at 45, 60 and 75 ms into the crash.

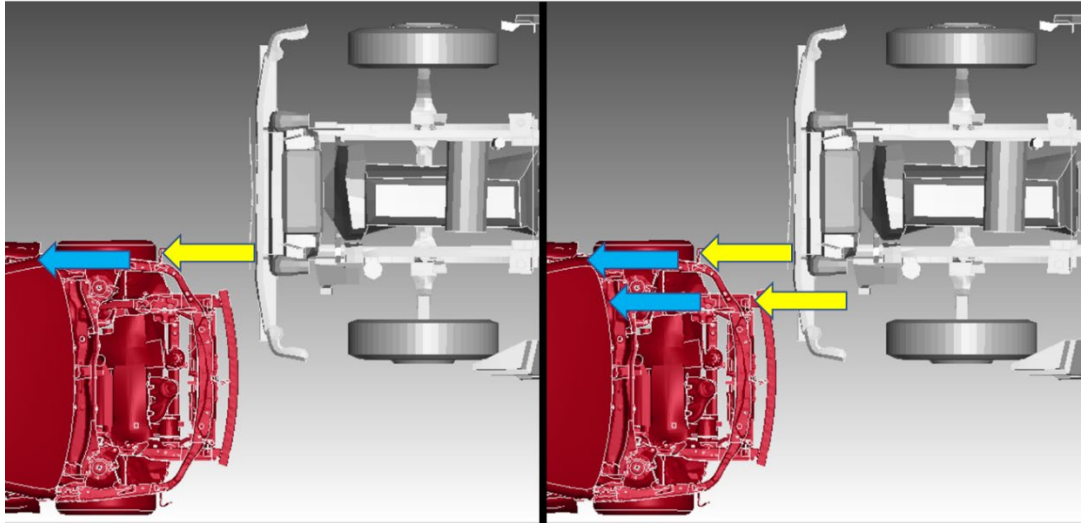
Figure 15. Load paths observed in test (left) and possible (right) with increased FUPD capacity.

A future truck front-end could optimally consist of both a front structure that can better prevent under-ride and through a forward extension with energy absorbing capability to reduce crash loads to the opponent. Improved structural interaction would allow passenger car restraint systems to perform more efficiently.

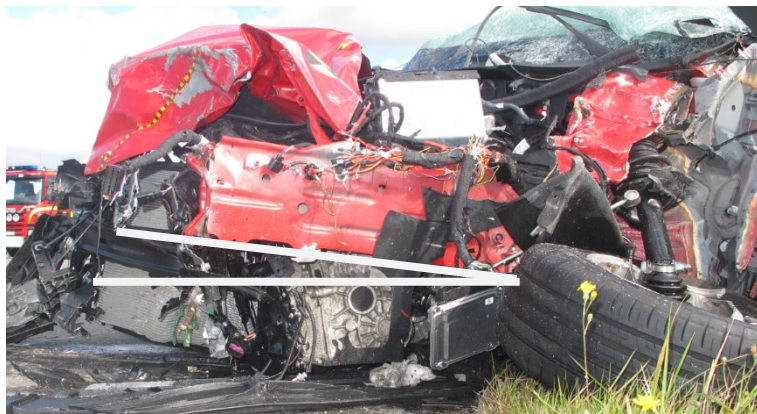
The car's left longitudinal appeared to be slightly bent upwards, indicating that its original engagement with upper part of the FUPD caused the car's longitudinal to slide over top of the FUPD, which later contacted the engine structures positioned lower than the longitudinal. The VC-Compat [8] and FIMCAR [18] projects reported that even for passenger car impacts, bumpers that are slightly misaligned vertically lead to diminished structural interaction and reduced compatibility.

Figure 16: Front Longitudinal Deformation and Apparent Upward Rotation
