FIREWORTHINESS OF CABIN EXHAUSTER VENTS AND THE EFFECT OF AGEING

Christopher Clarke
Brian Herbst
Lauren Bell
SAFE
USA

Jack Bish
SAFE Laboratories
USA
Paper Number 23-0324

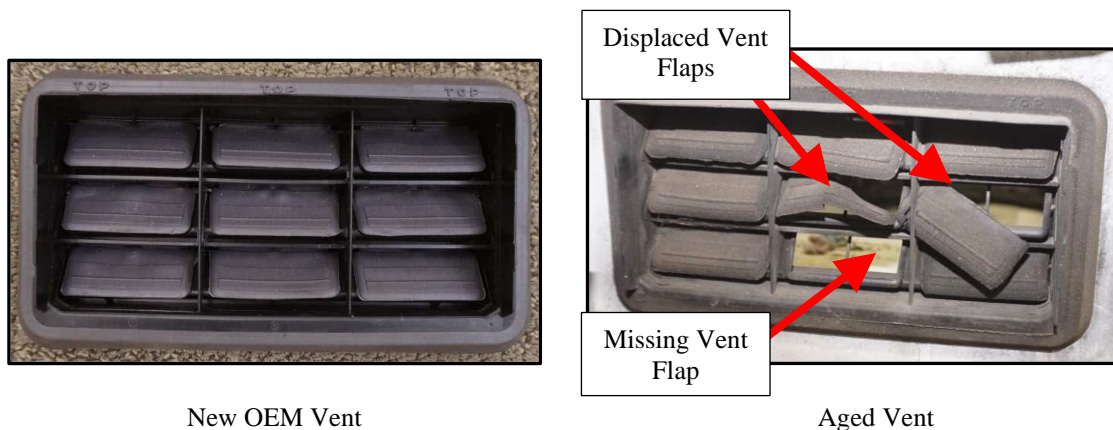
Figure 2: New OEM vs Aged Vent Comparison

Exhauster vents are typically positioned behind the vehicle's rear bumper but that does not preclude them from damage and degradation. Throughout their lifetime, exhauster vents are subject to environmental factors, road debris and temperature changes that cause material degradation. Figure 2 below shows an aged exhauster vent obtained from an exemplar 2013 model year sedan compared to a new OEM replacement vent for the same vehicle. The elastomeric flaps in the aged vent have degraded significantly, two of the flaps have become displaced and one of the flaps is missing.

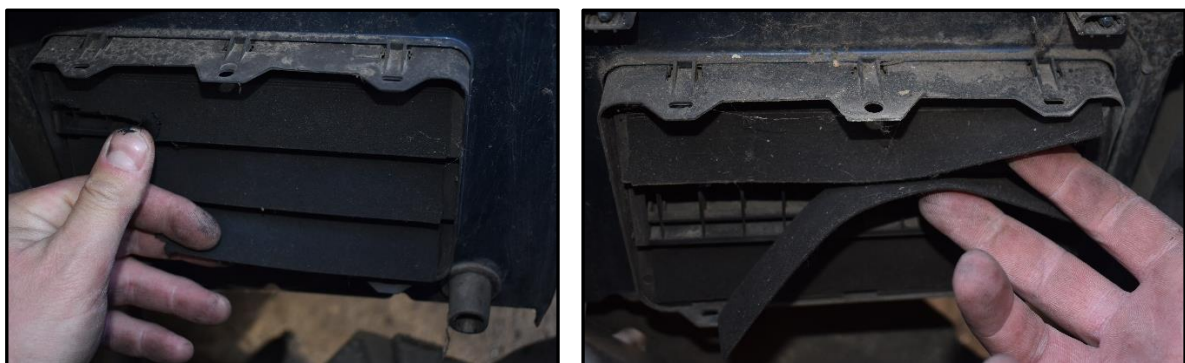
Figure 3: Exhauster vent 4a driver's side (Left) and 4b passenger's side (Right)

| Vehicle Number | Model Year | Degraded Material | Displaced Flaps | Missing Flaps |
|---|---|---|---|---|
| 4a | 2004 BMW X3* | Yes | No | No |
| 4b | 2004 BMW X3* | Yes | Yes | No |

*Flaps inoperable, material disintegrated when touched

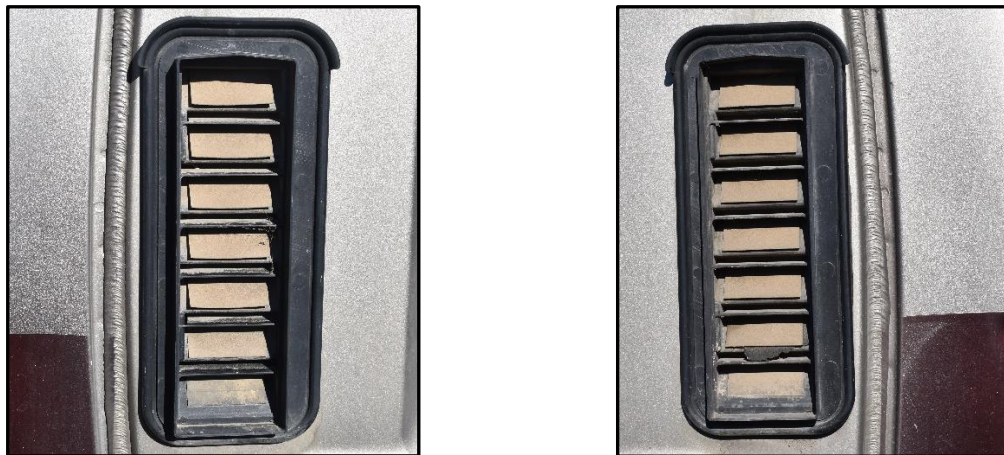
Figure 4: Exhauster vent 7a driver's side (Left) and 7b passenger's side (Right)

| Vehicle Number | Model Year | Degraded Material | Displaced Flaps | Missing Flaps |
|---|---|---|---|---|
| 7a | 2003 Chevrolet K1500 | Yes | No | No |
| 7b | 2003 Chevrolet K1500 | Yes | No | No |

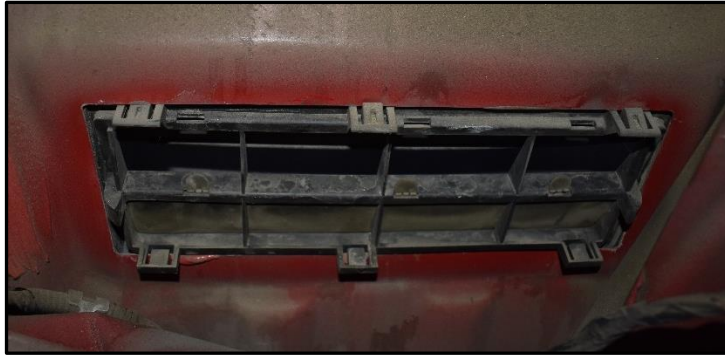
Figure 5: Exhauster vent 12

| Vehicle Number | Model Year | Degraded Material | Displaced Flaps | Missing Flaps |
|---|---|---|---|---|
| 12 | 2004 Hyundai Elantra | No | No | Yes |

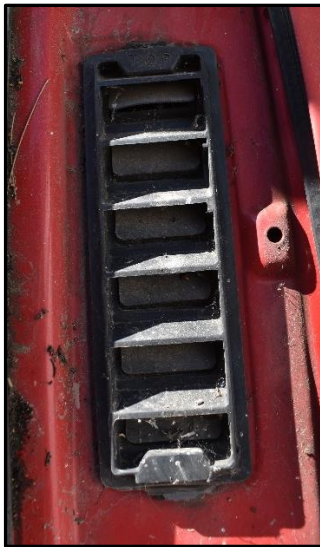
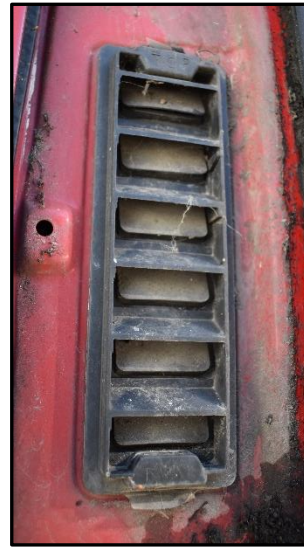
Figure 6: Exhauster vent 15a driver's side (Left) and 15b passenger's side (Right)

| Vehicle Number | Model Year | Degraded Material | Displaced Flaps | Missing Flaps |
|---|---|---|---|---|
| 15a | 1996 Jeep Grand Cherokee | Yes | No | No |
| 15b | 1996 Jeep Grand Cherokee | Yes | No | No |

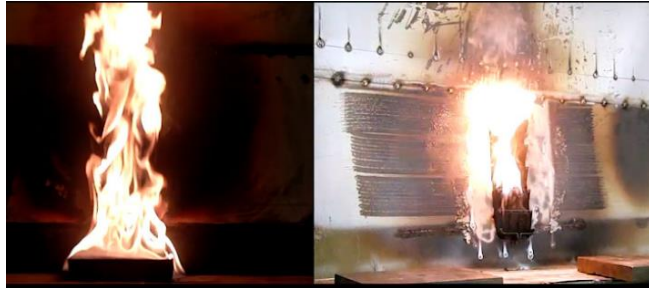
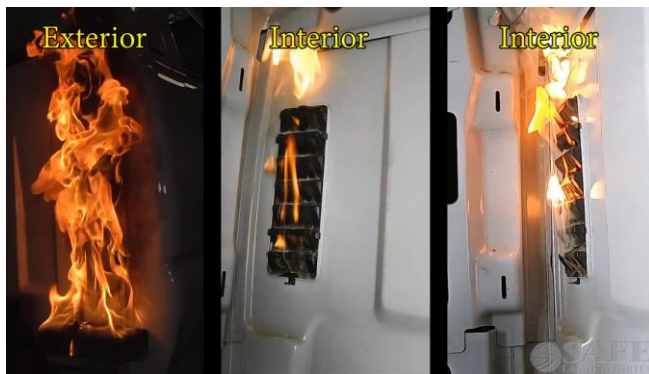
Figure 8: Test Results

In the new OEM vent test, fire broke through and ignited the inside of the vent at approximately 78 seconds after ignition and the vent had fallen completely out of the opening by approximately 99 seconds. In the aged vent test, flames were first visible on the interior side of the exhauster vent at approximately 42 seconds after ignition and the vent had fallen completely out of the opening by approximately 53 seconds after the fire was ignited. Figure 8 shows the point when the fire ignited the inside portion of the vent in each test.

New OEM Vent
~78 seconds

Aged Vent from 18 Year Old
Exemplar Cab
~42 seconds

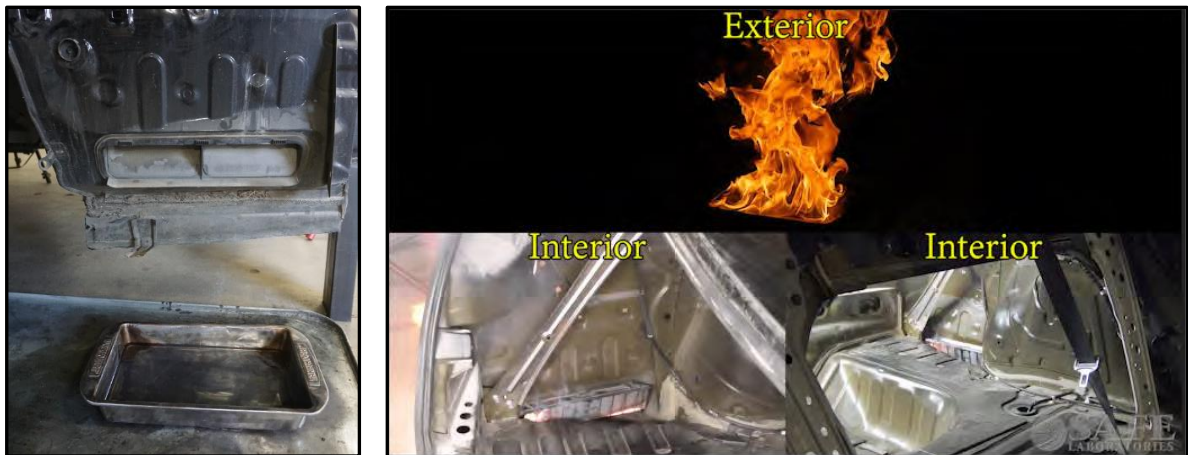
Figure 9: Test Setup and Results

Burn testing was conducted to evaluate the fire resistance of the vent design used on a 2014 import sedan. A rear clip obtained from an approximately 7 year old exemplar vehicle was tested with the aged vent that arrived with it. The test was run using gasoline in a burn pan positioned underneath the exhauster vent and igniting it with an external source. Flames were first visible on the interior side of the exhauster vent at approximately 24 seconds after ignition, shown in Figure 9. The vent was completely engulfed and was melted out of the cut-out by approximately 40 seconds after ignition.

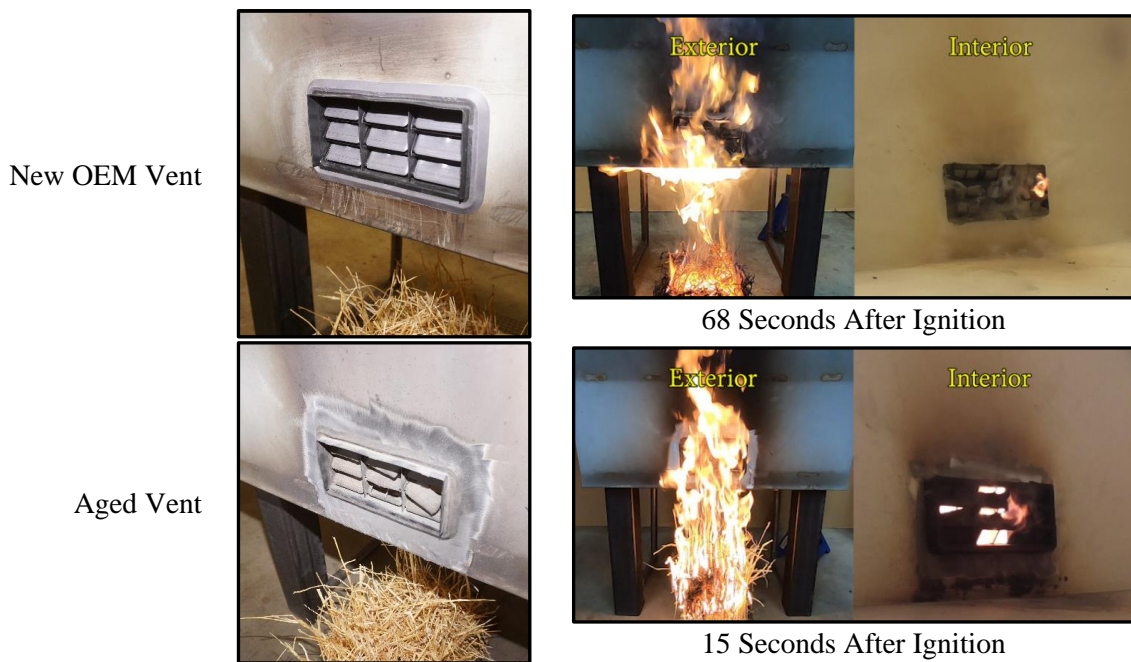
Figure 10: Test Setup and Results

A pair of burn tests was conducted to evaluate the fire resistance of the vent design used in a 2013 model domestic sedan. The vents were fitted in a steel panel benchtop fixture and straw was positioned underneath each vent and ignited with an external source. The first test evaluated a new OEM replacement vent and the second evaluated an aged vent obtained from an exemplar vehicle that was approximately 8 years old at the time of testing. Flames began coming through the new OEM vent approximately 68 seconds after ignition, and flames were observed coming through the aged vent 15 seconds after ignition. The benchtop testing is shown in Figure 10.

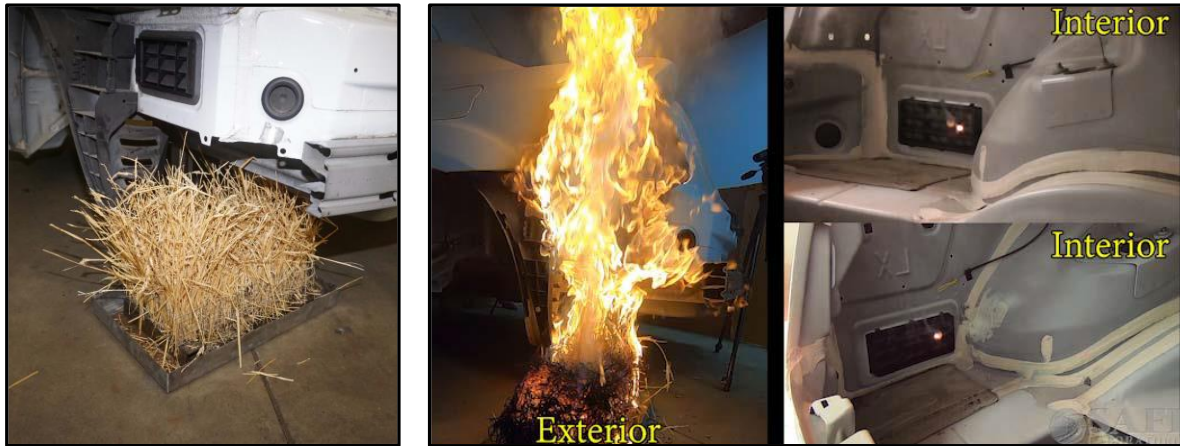
Figure 11: Test Setup and Results

An additional burn test was conducted on a new replacement OEM vent installed in the rear clip of an equivalent vehicle using straw similarly positioned underneath the exhauster vent and ignited with an external source. Flames were first visible on the interior side of the exhauster vent was at approximately 71 seconds after ignition, shown in Figure 11.

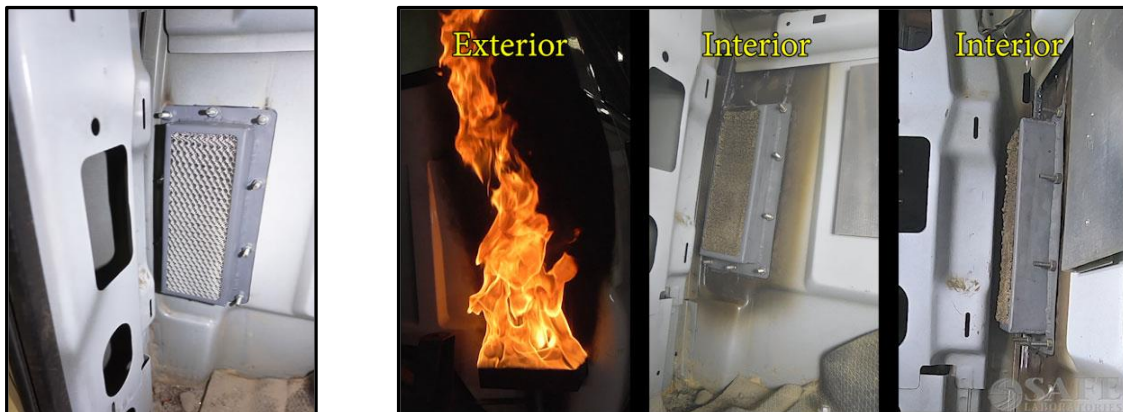
Figure 12. Test Results

An improved design flame arrestor type vent was evaluated under burn conditions identical to those of the production test. A steel housing was fitted around the interior of the OEM exhauster vent. A commercially available flame arrestor type fire resistant vent assembly consisting of an aluminum honeycomb core with an intumescent coating encased with perforated sheet metal on one side and a fine stainless-steel mesh on the other was installed in the housing. The improved design exhauster vent was subject to the same test procedure used to evaluate the OEM pass-throughs. The fire burned for approximately 564 seconds and no flames were able to pass through the exhauster vent, shown in Figure 12.

In the production vent test, flames were visible in the occupant compartment approximately 42 seconds after the gasoline in the burn pan was ignited. Therefore, the improved vent design resisted the fire for a significantly longer time period than the production design and could likely have continued to resist fire for a longer period of time. The results of test series 1 are summarized in Table 2.

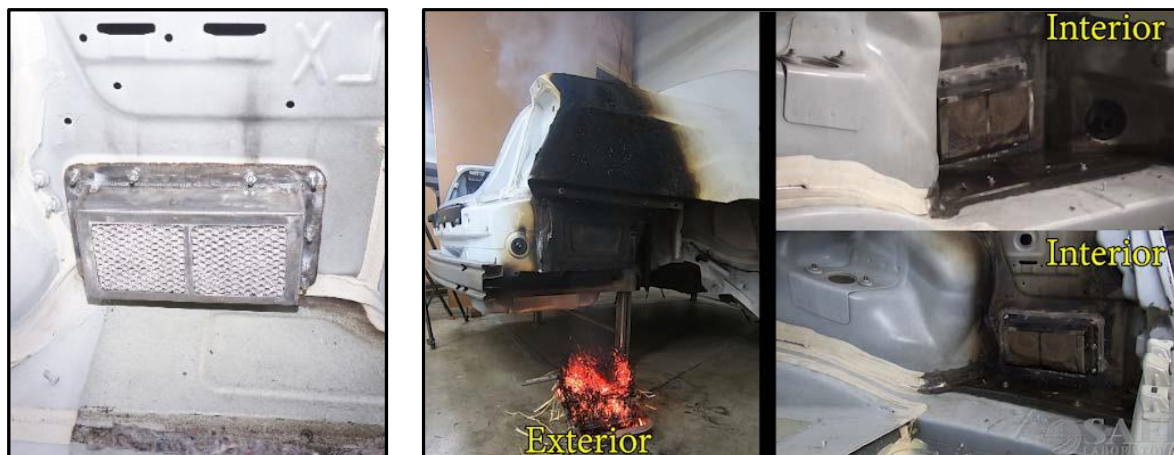
Figure 13: Test Results

An improved design flame arrestor type vent was evaluated under burn conditions identical to those of the production test. The vent design was improved by constructing a housing around the interior of the OEM exhauster vent opening capable of fitting on top of an OEM vent assembly. The housing was fitted with a commercially available flame arrestor type fire resistant vent assembly. The assembly consists of an aluminum honeycomb core with an intumescent coating encased with perforated sheet metal on one side and a fine stainless-steel mesh on the other. The OEM elastomeric vent assembly was not installed for the test in order to evaluate the performance of the flame arrestor alone. The improved design vent was subject to the same test procedure used to evaluate the OEM vent. The fire burned for approximately 221 seconds at which time the fuel source was consumed and no flames were able to pass through the exhauster vent, shown in Figure 13.

In the production vent test flames were visible in the occupant compartment approximately 71 seconds after the straw was ignited. Therefore, the improved vent design resisted the fire for a significantly longer time period than the production design and could likely have continued to resist fire for a longer period of time. The results of test series 3 are summarized in Table 3.

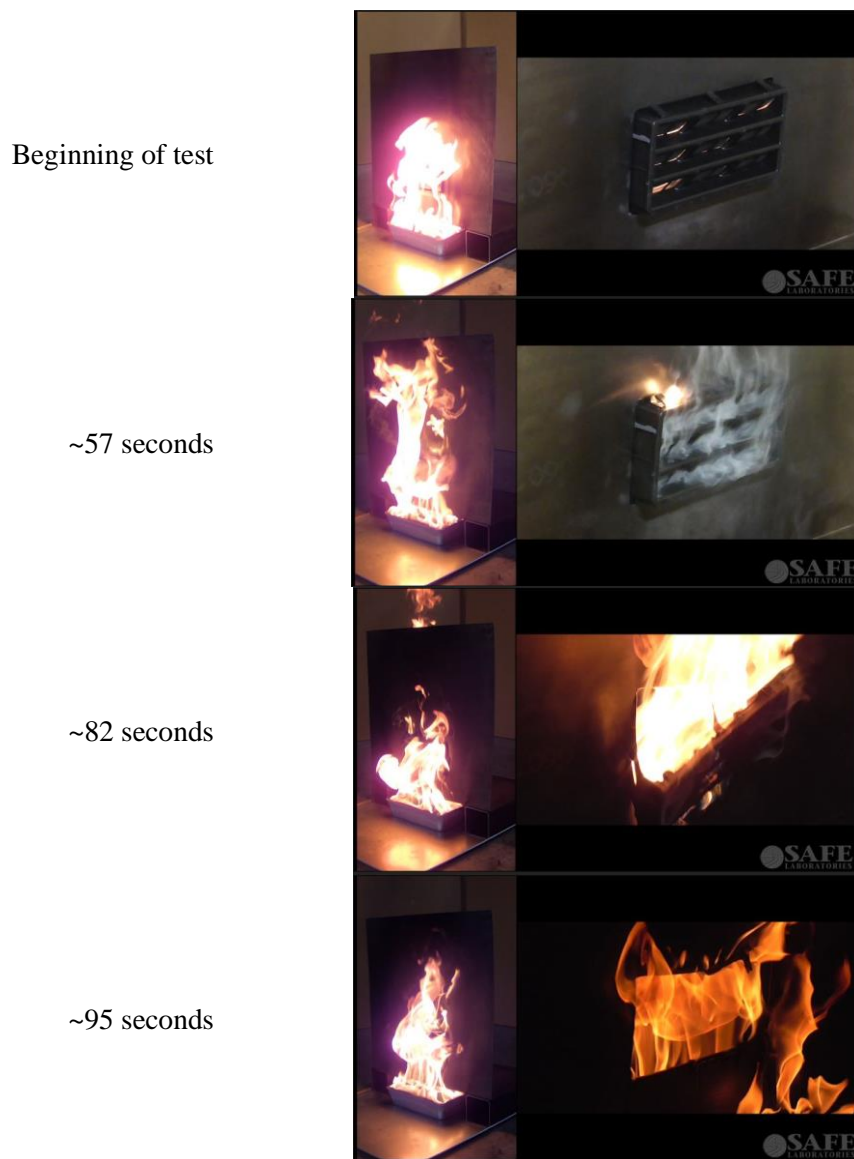
Figure 15: Baseline Test Results

A new OEM replacement vent of the same design evaluated in Test Series 3 was subjected to burn testing. Fire was observed to have started on the inside of the vent approximately 57 seconds into the test. This time was approximately 10 seconds shorter than observed in Test Series 3, but the gasoline fuel source ignited more quickly and was located slightly closer to the vent. After approximately 82 seconds the vent was observed to be falling out of the opening. At approximately 95 seconds the vent was observed to be burning on the inside of test fixture. Figure 15 shows the progression of the test.

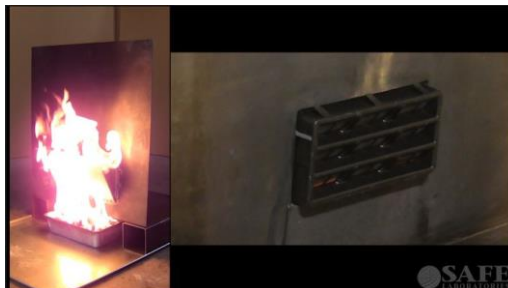
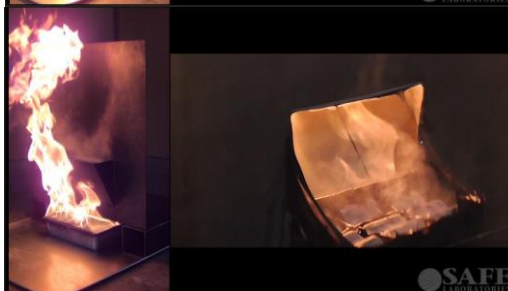
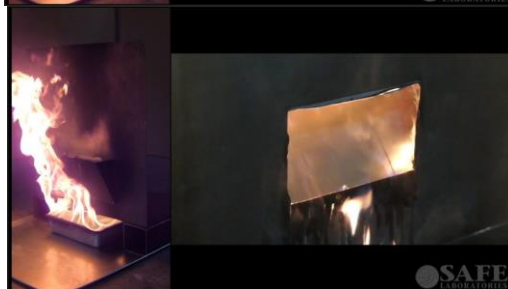
Figure 17: Test Results

A new OEM vent was fitted in the test fixture behind the diverter shield and subjected to burn testing. As the test progressed, some smoke was observed to emanate from the interior side of the vent but it did not ignite. At approximately 285 seconds, the plastic vent assembly had melted to the extent that it fell into the interior side of the test fixture. However, it did not ignite. An elastomeric flange from the exterior side of the vent remained in place, stuck to its original position on the exterior side of the opening in the fixture. This flange eventually caught fire and fell away from the opening, propagating the fire to the inside of the vent opening. At approximately 522 seconds, the body of the vent on the inside of the test fixture was observed to have ignited. Figure 15 shows the progression of the test.

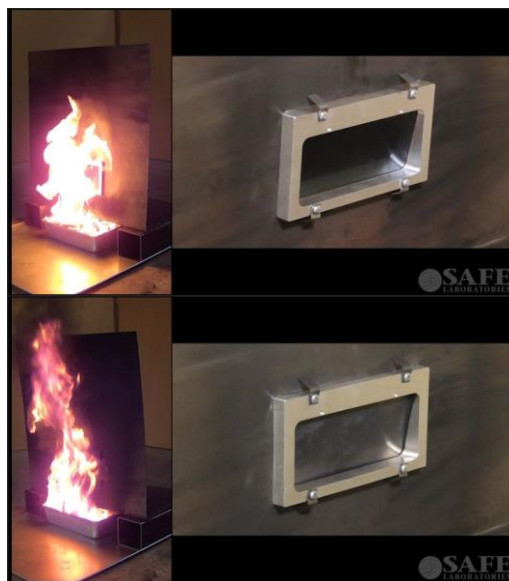
Figure 19: Test Results

The all metal vent assembly was installed in the test fixture and subjected to burn testing. The vent assembly remained intact during the test and did not ignite. Some slight warping of the flap was observed during the test. The gasoline burned out after approximately 20 minutes. Figure 19 shows the beginning of the test and shortly before the gasoline burned out.
