EJECTION THROUGH SIDE WINDOWS: RELEVANCE AND COUNTERMEASURES

Vittorio Giavotto
Politecnico di Milano
Italy
Paper No. 530

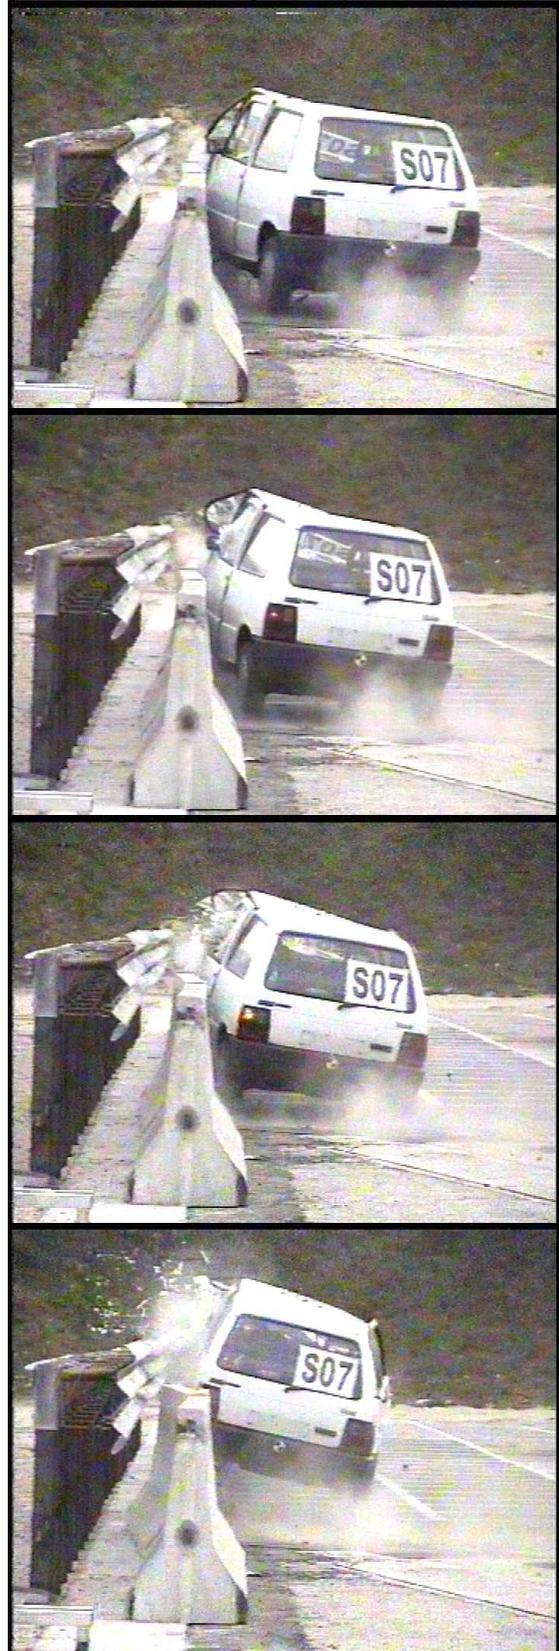
Figure 19. Collision with New Jersey barrier - Tempered glass windows.

The first test was carried out with the concrete barrier, with standard tempered glass windows. In Figure 19, we see a sequence of pictures of the crucial phase of the test, taken from a video recording. The collision is violent enough, but the vehicle's acceleration is within tolerance limits.

In the first photo, we see an appreciable deflection in the front left side window frame, pushed outwards by

the dummy's head, and considerable deformation in the windscreen frame, which has already caused the detachment of the windscreen itself.

In the second photo, we clearly see the dummy's head heavily deforming the glass, which is already shattered but still in place. In the subsequent photos, the head goes out the window completely and the window shatters in a shower of fragments that prevent a clear view. Then, in a standard test against a barrier that passed the acceptance tests, partial ejection of the dummy's head took place.

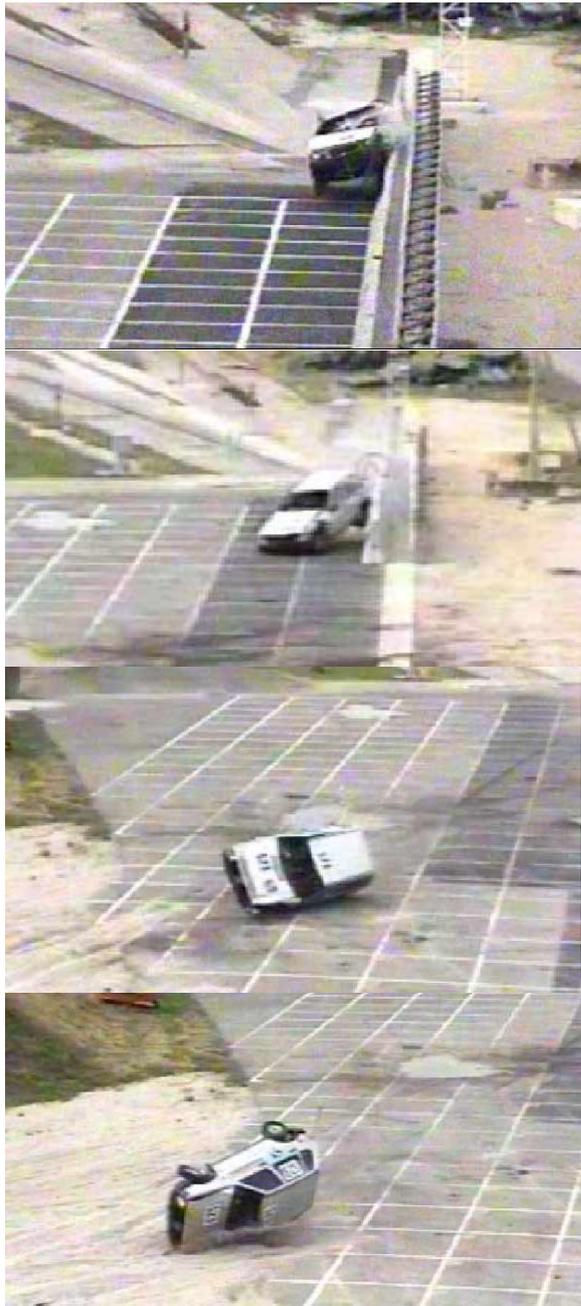
Figure 20. Collision with New Jersey barrier Laminated glass windows.

In Figure 20, we see a sequence of pictures of the test against the New Jersey barrier with laminated glass windows. The collision is very violent, the vehicle rises up during impact, falls heavily to the ground with a considerable yaw and then completely overturns.

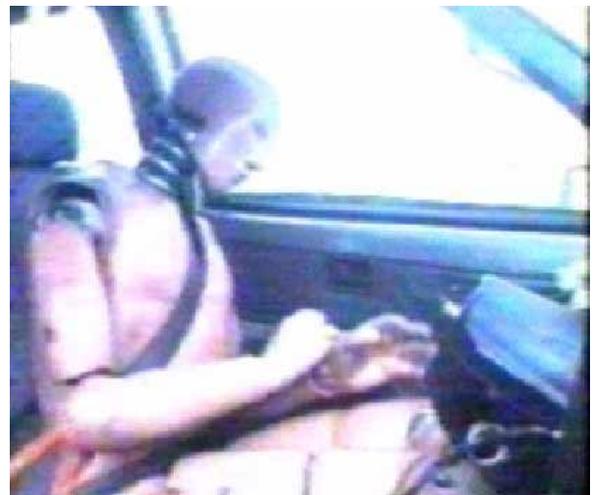
Figure 21, from a high-speed shot taken by a movie camera situated inside the passenger compartment, shows the containment of the dummy's head.

Figure 21. View from inside at the moment the head collides with the laminated glass.

The violence of the impact knocked the windscreen out of its housing, but the front right side window successfully contained the dummy's head, bending without breaking (Figure 21).

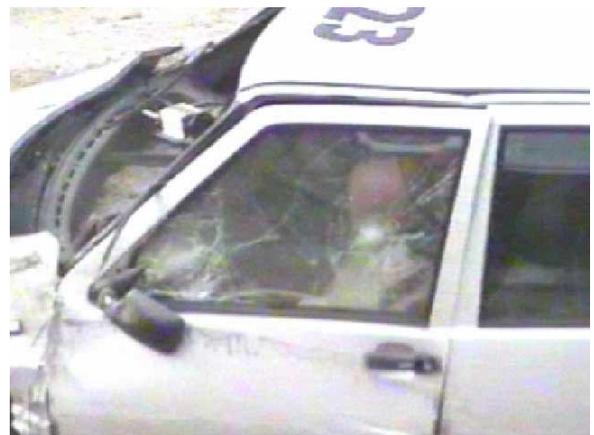
Figure 22. The laminated glass window after crash and complete overturning.

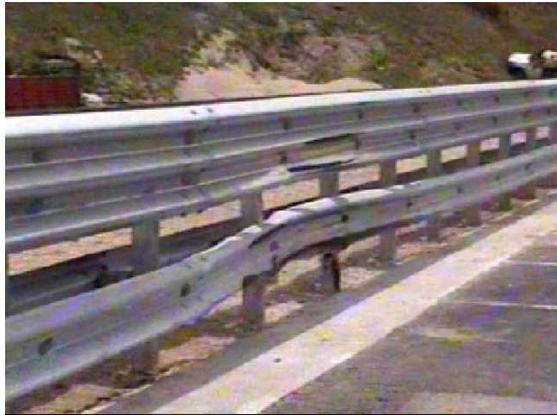
The two subsequent tests were performed against a double-rail metal barrier, which can be seen in Figure 23, bent out of shape after one of the two tests. It can be seen that contact took place on both rails.

Figure 23. The barrier after the test.

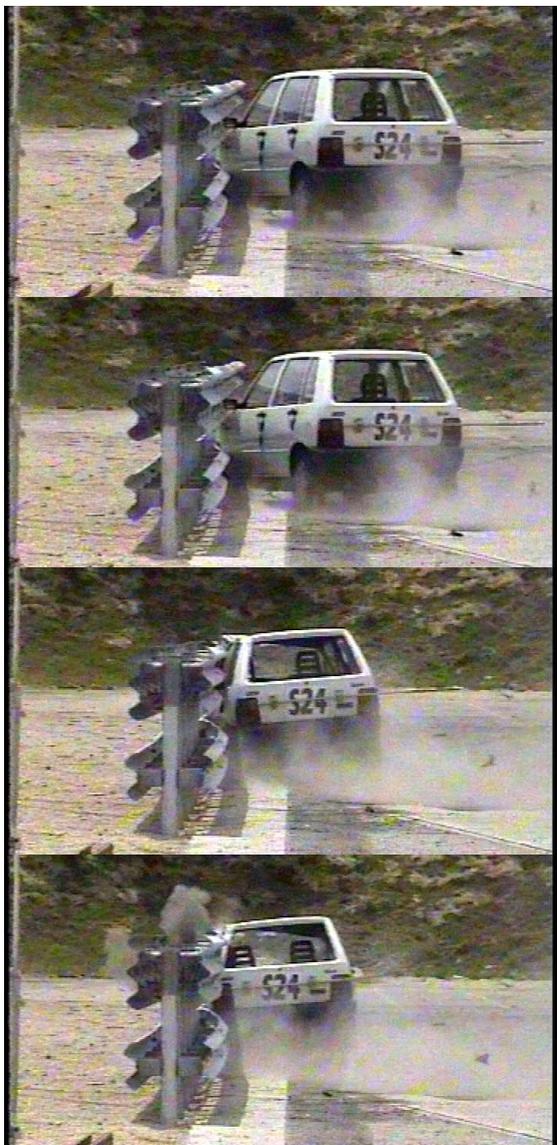
Figure 24. Metal barrier with laminated glass.

Figure 24 shows a sequence of pictures taken during the test with the same barrier and a laminated glass window installed in the front left door. The pictures highlight the depth of the contact between the upper railing and the vehicle at the height of the door window. Despite this, the laminated glass did not break (Figure 25) and successfully contained the dummy's head (Figure 26 from high speed video).

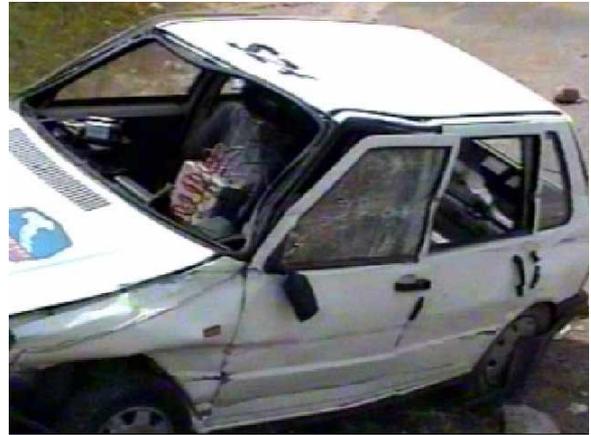
Figure 25. The laminated glass window after impact with the metal barrier.

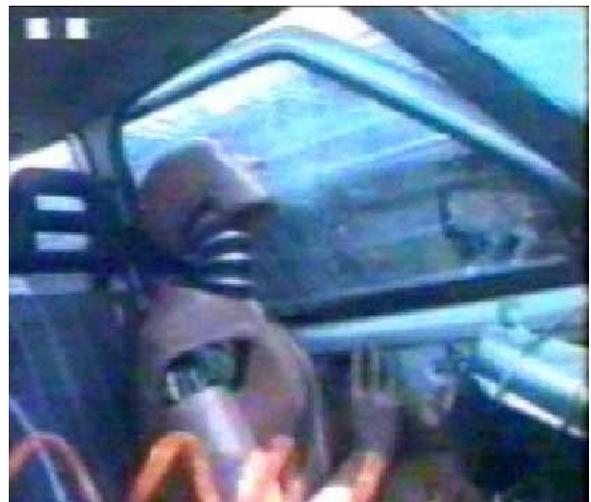
Figure 26. Containment of the dummy's head during impact.

The HIC index was calculated at 584 s, well below tolerance limits.

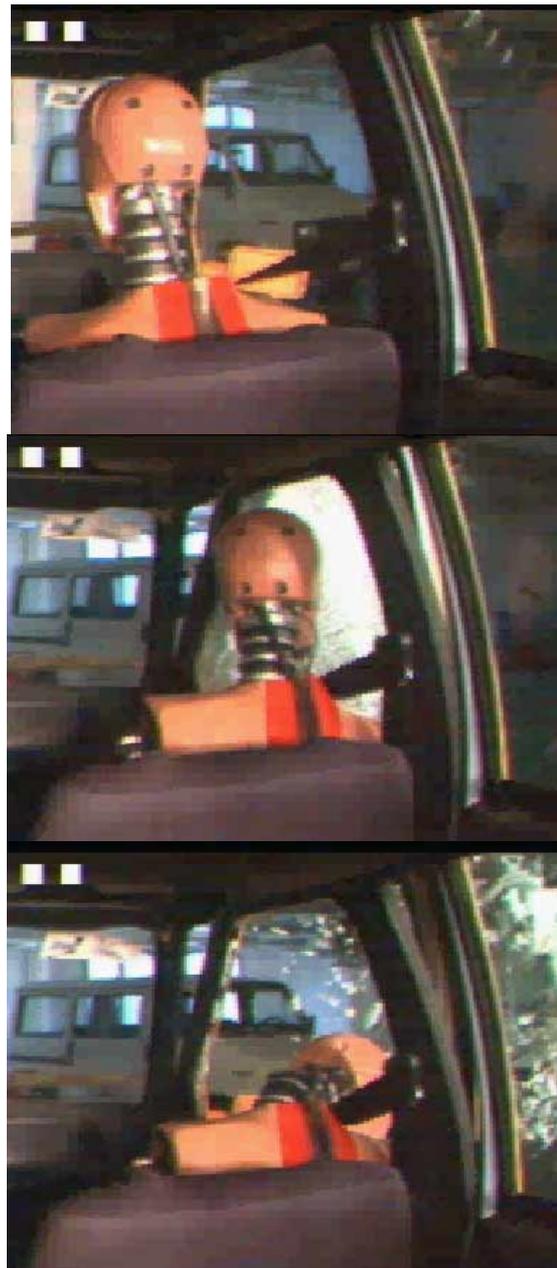
Figure 29. Test with tempered glass window.

We see that the tempered glass shattered and there was ejection of the entire head and part of the neck.

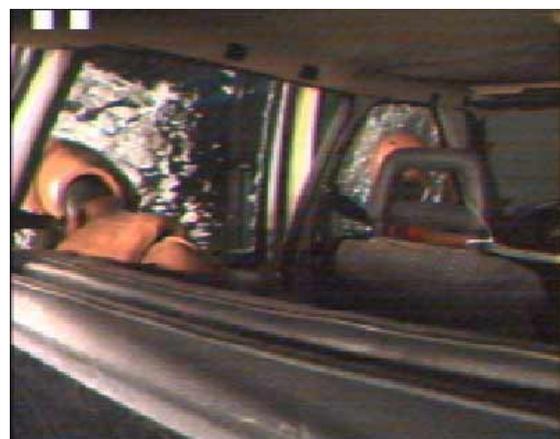
Figure 30. Test with laminated glass front window and tempered glass back window.

As was seen in previous tests, the laminated glass window bent without breaking, preventing ejection, whereas the tempered glass window shattered, allowing ample ejection of the head.

This is clearly seen in Figure 30, taken from inside during the test, and in the sequence in Figure 31, from the outside.

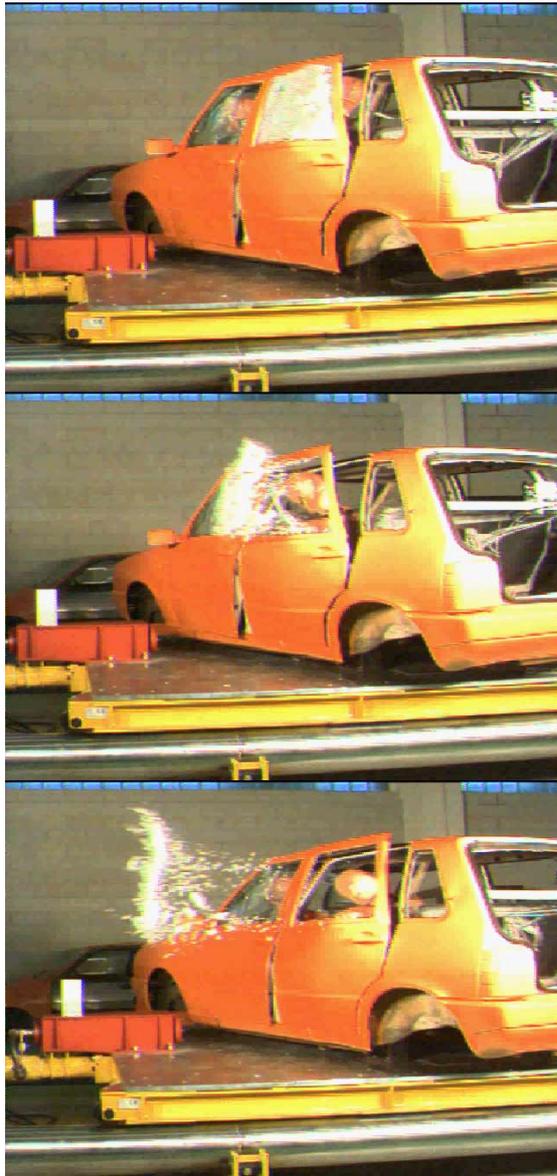
Figure 31. Test with laminated glass front window and tempered glass back window.

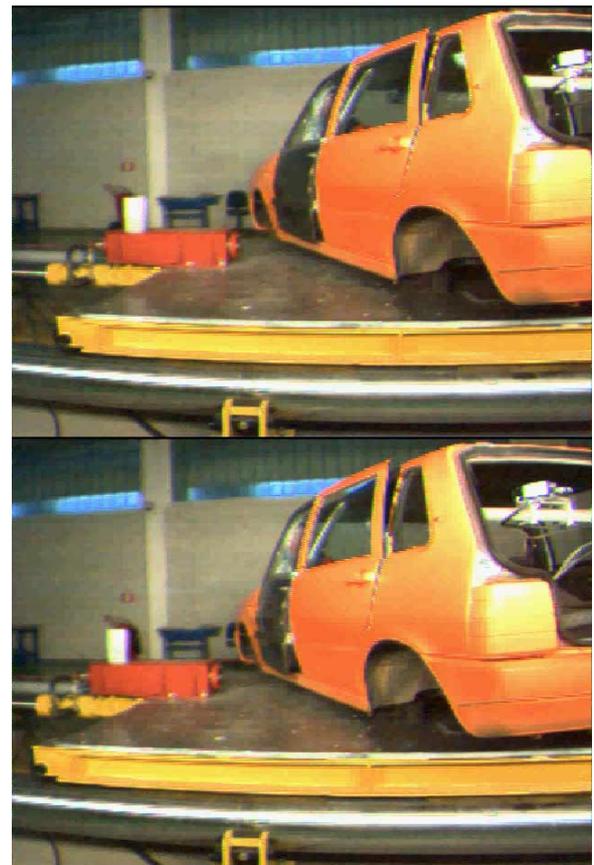
In the second test, on the left, the laminated glass window contained the dummy's head, despite significant buckling in the front left door frame (Figure 32).

Figure 32. Test with laminated glass.
