RESEARCH TO EVALUATE SAFETY TECHNOLOGIES FOR VULNERABLE FUEL TANKS

Paper Number 230

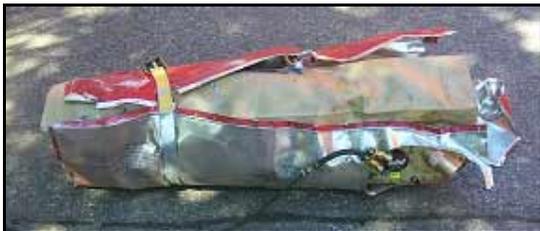
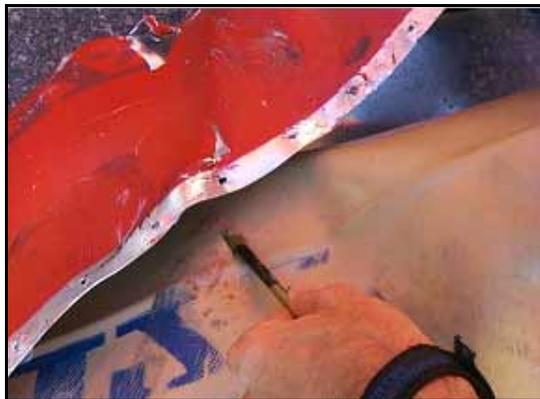
In the first test, the outer container of the fuel cell consisted of a riveted aluminum enclosure held in place by two steel brackets that supported the tank from underneath. During impact, the outer casing ripped open from a combination of direct loading from the bullet vehicle and from hydrodynamic pressure from the expansion of the internal bladder that was compressed between the vehicle frame rail and the bumper of the bullet vehicle.

Figure 8. Damage to the fuel cell aluminum housing (a) cut in fuel cell caused by sharp aluminum surface (b)

With the aluminum container ruptured, the fuel cell inside was ejected from the truck. In the process, all the fuel lines connected to the tank were severed. The

filler tube was disconnected from the tank, but a reverse flow flapper valve in the tank prevented spillage at the filler spud. Additionally, a rollover valve on the vent line prevented fuel leakage from the severed vent hose. There were no provisions in the fuel supply line to prevent fluid loss in the event that the line was severed and consequently it leaked fuel. However, the majority of fuel spillage stemmed from a tear in the bladder that was discovered along its lower inside edge. The damage was caused by the rear mounting bracket/strap that failed during the impact and perforated the aluminum outer housing creating sharp edges on the inside of the housing that cut or punctured the bladder. The damaged aluminum cover and fuel cell puncture are shown in Figure 8.

A second fuel cell system was assembled addressing the shortcomings identified by the results of the first test. Enhancements to the second fuel cell included fabricating the outer housing from steel rather than aluminum with through bolts instead of rivets to secure the hosing cover and the end plates of the container. The mounting brackets, which previously supported the tank from underneath, were replaced with brackets from which the tank was suspended. The intent of the new bracket arrangement was to allow the tank to deform without being restricted by the mounting brackets. To prevent fuel leakage from severed fuel lines, self-sealing breakaway connectors were installed on the fuel delivery and returns lines. As with the previous fuel cell, the vent line relied on an internal rollover valve.

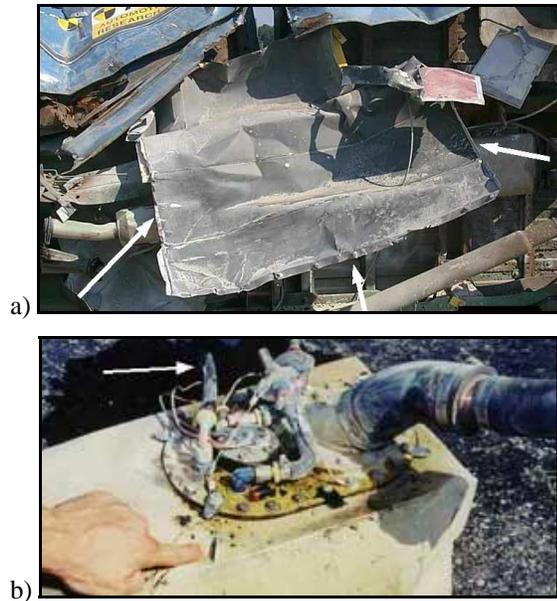
Despite the enhancements to the outer container and the mounting system the tank bladder was again ejected during the impact. The bolts that fastened the outer container together pulled through the sheet steel and the outer container unraveled allowing the bladder to be ejected. The top cover of the container tore along the rear-mounting bracket adjacent to the bladder bulkhead, resulting in a sharp pointed corner that perforated the top surface of the bladder.

In the process of being ejected the breakaway connectors on the fuel and return lines disconnected as intended and no leakage resulted. The vent line was severed, but no leakage occurred due to the upright orientation of the tank. The vent line contained a rollover check valve located inside the tank. This valve was not exercised in the crash. The fuel cell laceration and the ruptured steel container are shown in Figure 9.

Figure 9. Steel housing for bladder [arrows show ruptured seam (a)]; cut in top of fuel cell [arrow shows sealed break-away fuel coupling (b)]

Fuel leakage was minimal following the crash although it was apparent that leakage from the puncture in the bladder would have been inevitable had the bladder been lying on its side rather than upright.

There are three grades of fuel cell bladders FT3, FT3.5 and FT5 offering increasing resistance to tearing and puncture. An FT3 bladder was used in both tests, therefore, by incorporating a higher rated bladder and by designing better protection for the bladder, it may be possible to improve its resistance to damage from direct exposure to slash or puncture hazards. Further research to improve the bladder was not initiated, because the alternatives for relocating the tank appeared to be more economical.

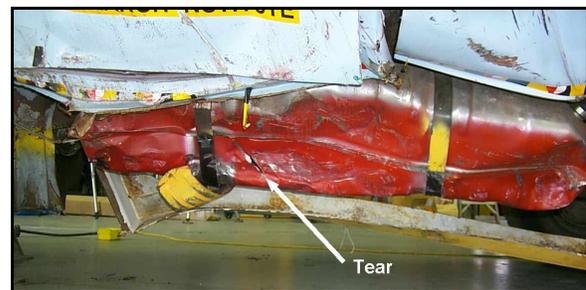
Notwithstanding the additional bracing of the rear support, neither the protective frame nor the vehicle structure to which it was bolted were capable of resisting the severe downward torque applied by the impacting vehicle, thereby, leaving the tank exposed and vulnerable to direct loading by the bullet vehicle. A significant tear in the tank resulted in excessive fluid loss. Damage to the tank and frame are shown in Figure 10.

Figure 10. Damage to the tank protective frame

A retest of the tank protection system was performed with a second system based on the initial frame except with two additional attachment points to specifically counteract the downward moment applied by the impacting vehicle. The front end of the guard was fastened vertically to the cab floor and

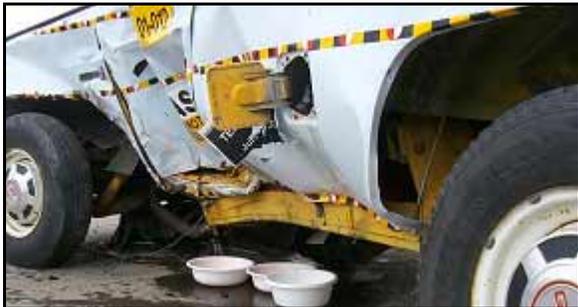
A plastic tank was installed for the second test instead of a steel tank as used initially. Despite the improved performance of the protective frame, the guard compressed the tank cutting the top outside front corner of the tank resulting in excessive fuel leakage. The damage to the modified tank protective frame is shown in Figure 11. The damaged area of the tank was not exposed directly to the impacting vehicle. Rather, the damage was likely caused by the truck's structure which intruded into the tank space.

Figure 11. Damage to the modified tank protective frame

Development of the tank protection system was discontinued because the system performed poorly, and it was heavy and costly.

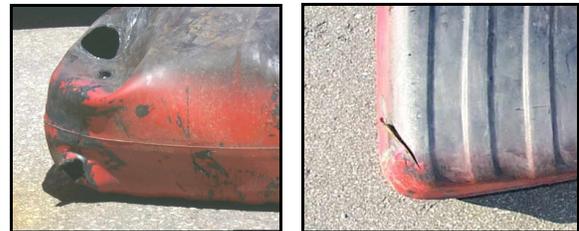
Tears in the tank, as a result of excessive deformation, were only one of the failure modes. Punctures and cuts from aggressive components on the truck itself or on the bullet vehicle were also prevalent. Damage to the tanks is shown in Figure 12. The available aftermarket plastic tank did not offer any improvements over the existing OEM steel tank. Considerable additional development appeared necessary for significant improvements. This approach was discontinued.

Figure 12. Puncture and slash damage to plastic tank

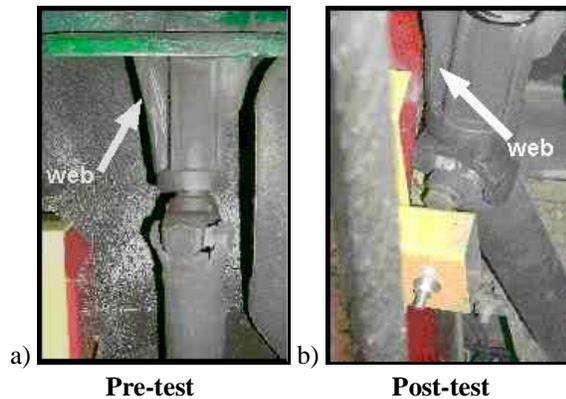
Relocating the tank between the frame rails reduces its vulnerability to side impact, but may increase vulnerability in some other crashes. In severe crashes into a rigid frontal barrier the engine and transmission move rearward. An aggressive web on one of the alternative transmission produced a leak in one frontal barrier test. In addition, the drive shaft may buckle in the direction of the tank causing damage. Figure 14 shows the location of the aggressive transmission web and the drive shaft relative to the tank before and after a frontal crash test.

Figure 14. Drive shaft and transmission clearance in severe frontal crash – before (a) and after (b)

The final center-mounted tank design addressed both of these undesirable loadings. The transmission contact was mitigated by increasing the tank to transmission clearance and by chamfering the corner of the tank to reduce the stress concentration when contact occurs. The drive shaft contact was addressed by maintaining OEM drive shaft clearance for center-mounted tanks and by positioning the tank brackets to resist drive shaft loading. The tank thickness of 1.52 mm. provided added protection compared with 0.86 mm. in the OEM tank.

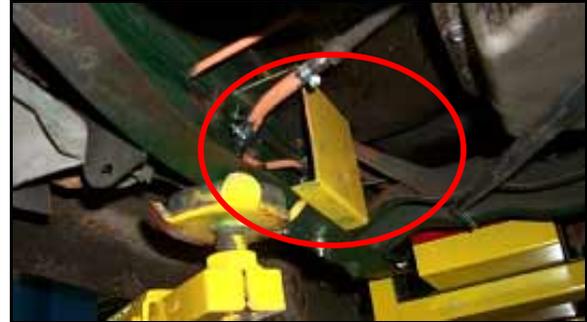
The Caprice impact produced extensive deformation to the pickup frame. In some cases the fuel lines and/or fuel selector valves were severed by being pressed between the inside of the frame and the engine. This problem was aggravated in one test in which the exhaust manifold had been removed. In that test, the fuel line was severed when entrapped

Figure 15. Shielding plate to protect fuel lines from entrapment by the transmission

between the frame and a flange on the transmission. To improve the survivability of fuel lines, a structural shield was added inside the frame to protect the fuel filter. The shield is shown in Figure 15. No fuel line ruptures occurred on tests with the shielding in place.

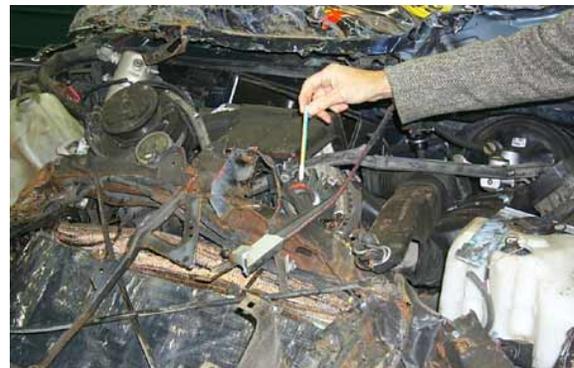
It was found that the front hood of the bullet Caprice was peeled away in the side impact tests exposing many sharp edges. Figure 16 shows the protruding alternator and other sharp edges that scraped the bottom of the pickup tank in a crash test. These hard points may have contributed to the tear in the OEM tank shown in Figure 10. For the center-mounted tank, the hard points resulted in scraping and minor gouging of the tanks. However, no leakage occurred from this source in any tests of the center-mounted tank.

Figure 16. Caprice engine compartment after test showing hard points that contacted the fuel tank

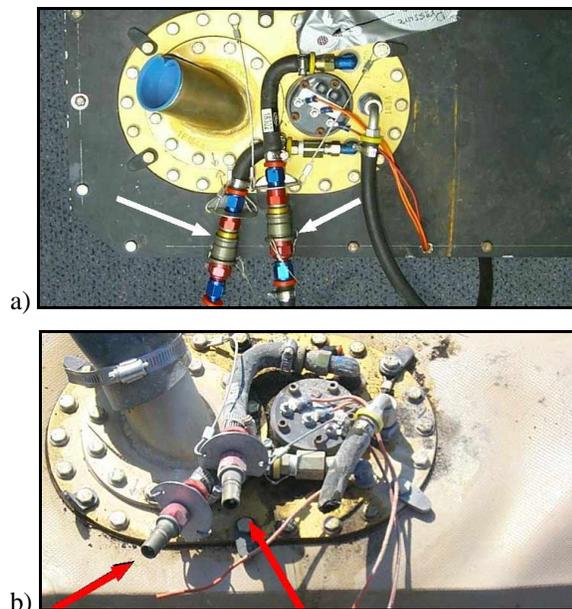
Self-sealing breakaway connectors were installed on the fuel delivery and returns lines on the racing fuel cell. In a Caprice test, the fuel lines connectors disengaged and no leakage occurred. The self-sealing breakaway connectors are shown in Figure 17 before and after the test.

Figure 17. Self-sealing break-away couplings in fuel line before test (a) and after test (b)

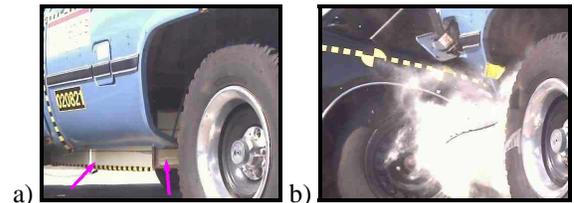
The fire suppressant panels that were affixed to the tank fractured during the test and a cloud of fire suppressant powder could be seen in the video engulfing the underside of the truck. The fire panels can be seen in Figure 18 before the initiation of impact and after the release of the fire suppressant has begun.

Figure 18. Fire panels installed on the fuel cell [see arrows in (a)] and the initiation of the cloud of fire suppressant during impact (b)

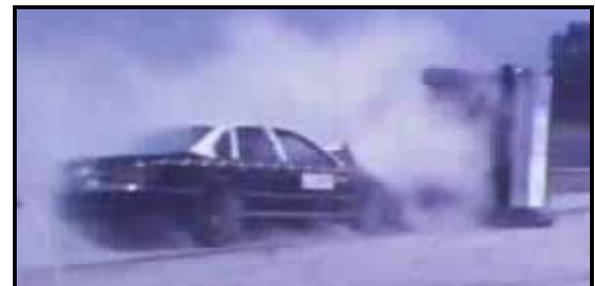
The suppressant cloud remained for the duration of the impact event and was still present approximately 3 seconds after impact when the truck rolled over, at which time forward movement of the vehicles had ceased. The suppressant cloud, immediately after the truck rolled onto its side, is shown in Figure 19.

Figure 19. Fire suppressant cloud immediately after the truck rollover
