# WORLD SID-50M FITNESS ASSESSMENT IN FMVSS NO. 214 MOVING DEFORMABLE BARRIER AND OBLIQUE POLE CRASH TESTS

**Whitney Tatem**  
**Allison Loudon**  
NHTSA  
USA

Paper Number 23-0340

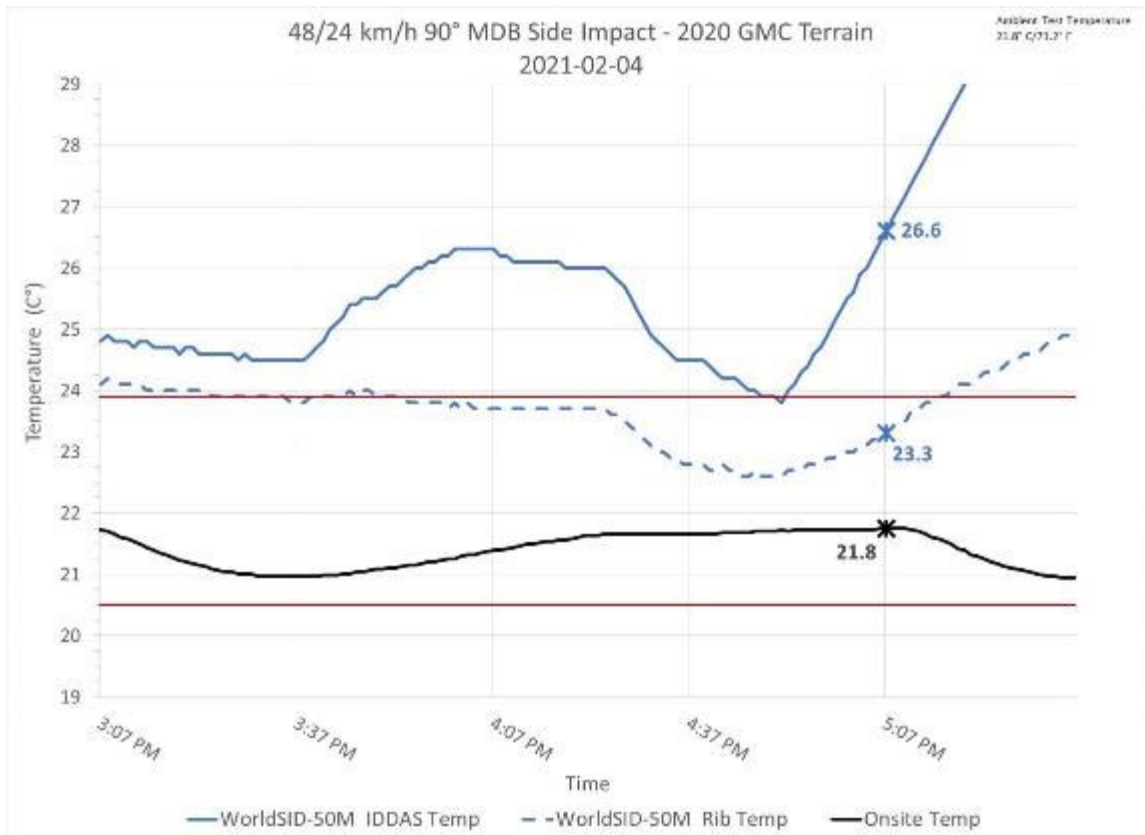
The Hyundai Veloster pole test, 11604, was the first test that the fume extractor was used in to cool down the WorldSID-50M following trigger check. It was extremely effective in cutting down the time required for the ATD to cool down. On subsequent tests, including 11606 as seen in Figure 10, the fume extractor was implemented whenever there was any sort of delay with the ATD DAS turned on. As displayed in Figure 10, the final switching ‘ON’ of the DAS unit occurred ~3:37pm, and the fume extractor was activated ~4:00pm. This prevented the rib temperature (dashed blue line) from exceeding the limit, also preventing any additional temperature related delays. Throughout the remainder of the test series, this device demonstrated good effectiveness at reducing the WorldSID-50M internal temperature in a short period of time.

**Figure 10. WorldSID-50M Rib Temperature Timeline for Crash Test 11606.**

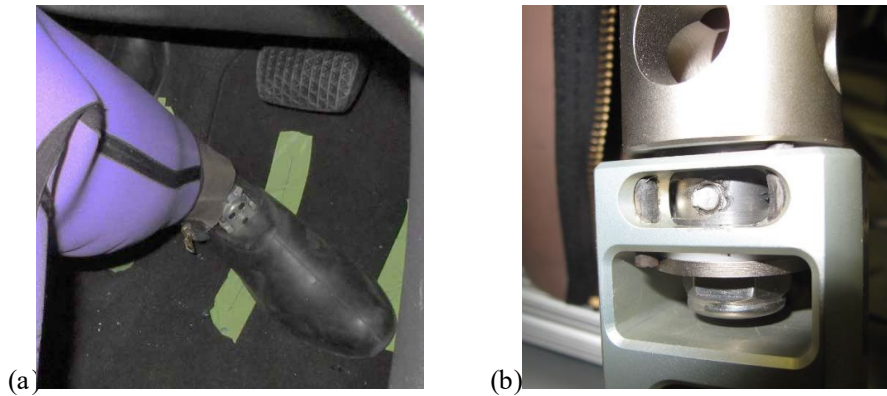
In both GMC Terrain tests, 11606 and 11611, the right foot of WS-L1 was found after the test to have rotated significantly about its Z-axis as depicted in Figure 11(a). Upon closer inspection, it was found that the z-axis radial limit screw had been sheared as shown in Figure 11(b). Visually inspecting the footwell, there were no unusual characteristics that stood out as possible causes of the damage. A high-speed camera was placed in the footwell on the GMC Terrain pole test (11611), and subsequently on the Ford Ranger pole test to gain a better understanding of the foot interaction through the impact event. It appears that the foot engages the brake pedal of the GMC Terrain a bit more behind the face of the pedal compared to how it engages with the Ford Ranger's brake pedal. It is possible that this allows the foot to roll off the Ranger's brake pedal before enough force builds up to shear the bolt, whereas the Terrain's brake pedal does not allow for a similar motion to occur.

**Figure 11. WorldSID-50M ankle damage as observed in both GMC Terrain tests, 11606 and 11611. (a) Right foot rotation about the z-axis, and (b) the sheared z-axis radial limit screw.**

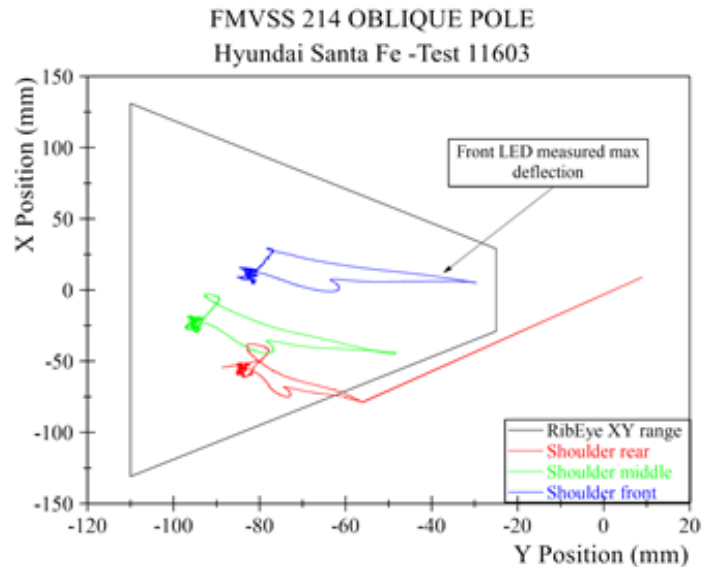
There were seven instances of LEDs travelling out of range during the pole tests. Six of these instances were recorded on the shoulder rib, which is not uncommon in the pole test condition where peak deflection is typically captured by the front or rear LED. When the front LED, for example, measures the maximum deflection of a rib, it is common for the rear LED on that rib to go out of range simply because its starting position is closer to the edge of the range toward which the rib is moving (Figure 13).

**Figure 13. RibEye range plot for the Hyundai Santa Fe oblique pole crash test, 11603.**

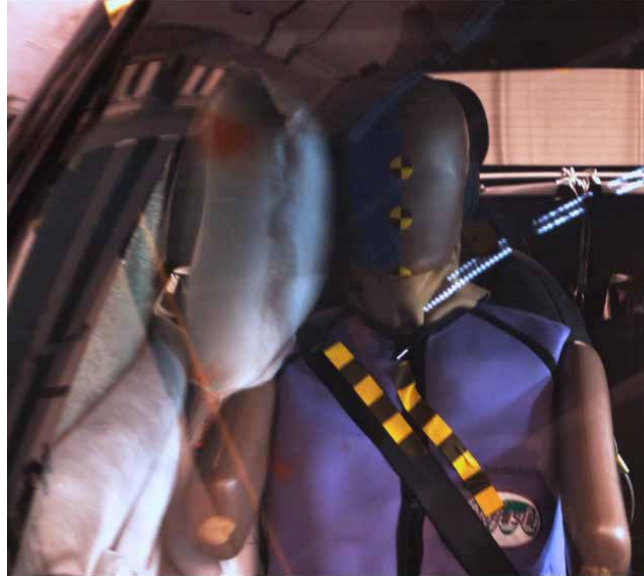
During the Mini Cooper S Convertible pole test (11614), the shoulder rib traveled inward and downward a significant amount due to airbag and intrusion interactions. A still image from the crash test close to the point of maximum shoulder deflection is depicted in Figure 14. The shoulder rib displaced to the extent that it fully blocked the rear LED and partially blocked the middle LED of thorax rib 1 from the top sensor as shown via a CAD model rendering in Figure 15. If the thorax rib 1 LEDs had not been blocked, it would have measured the maximum thorax deflection. Therefore, this blockage prevented the maximum thorax deflection from being recorded. This is the only test, including all past NHTSA WorldSID-50M crash tests, where the maximum thorax body region deflection was not captured.

**Figure 14. Still image of the WorldSID-50M from the 2019 Mini Cooper Convertible crash test (11614) showing ATD interaction with the combination head/torso airbag and intrusion which caused the arm, shoulder rib, and thorax ribs to experience similar loading.**

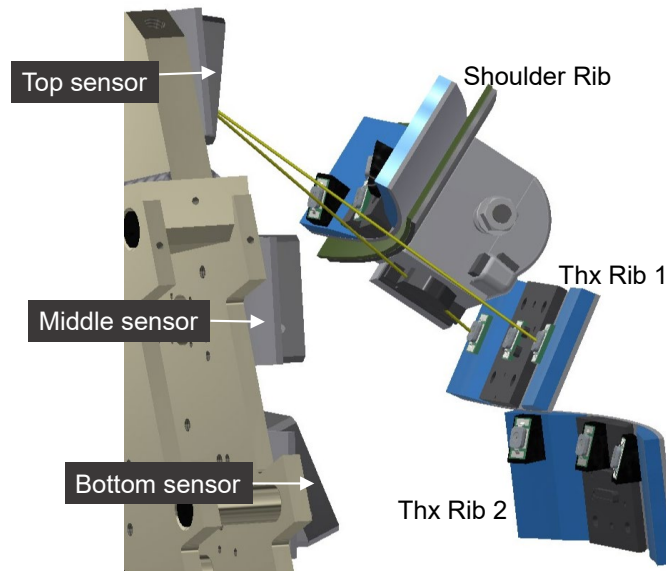
**Figure 15. 3D CAD model of the rib motion during crash test 11614 in which the rear LED on thorax rib 1 is blocked by the shoulder rib. NOTE: Model is shown as a left side impact, but, the test was a right-side impact.**

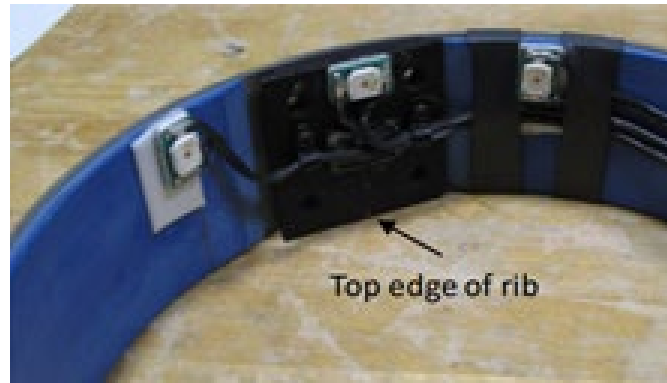
**Figure 16. LEDs on thorax rib 1 of the WorldSID-50M after relocation from the centerline to the bottom edge where only the center LED is horizontally oriented.**

the LEDs on thorax rib 1 were relocated from the centerline of the rib to the bottom edge of the rib, and the middle LED was rotated to be oriented horizontally (Figure 16).
