THE SEVERITY OF BUS ROLLOVER ACCIDENTS

Mátyás Matolcsy

Paper Number: 07 0989

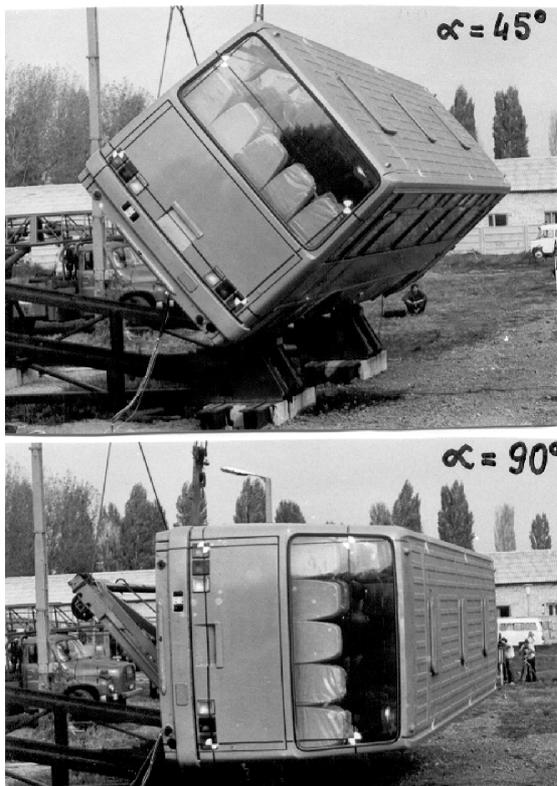
Figure 1. Lateral rollover test

- The bus is rotating around an axis being perpendicular to the vertical longitudinal central plane of the bus. This can happen, if the road has a sharp curve close to a precipice. One accident is known belonging to this type of rollover, happened in Rome, 2005. Only 1-2% of the rollover accidents belong to this type of rollover.
- The bus is rotating around a longitudinal axis being parallel with the main longitudinal axis of the bus. This is the general way of rollover, the so called lateral rollover, at least 98% of the rollover accidents belong to this group. The safety requirements and the approval tests of ECE Reg.66 are based on this type of rollover as it is shown on Fig.1.

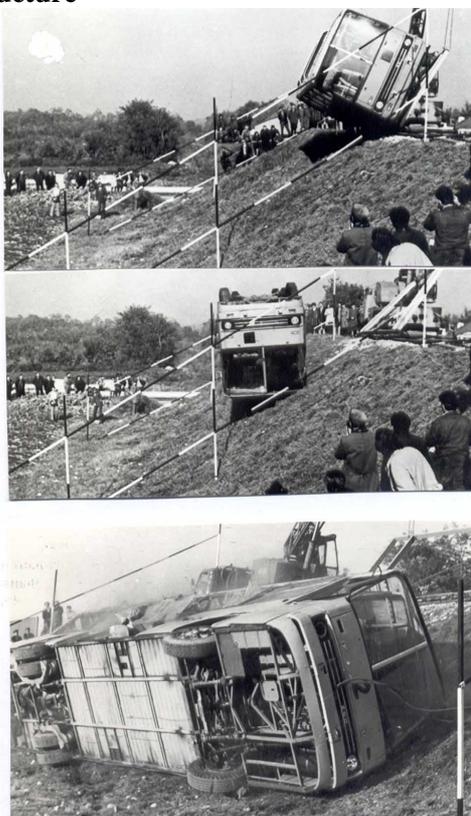
Figure 9. Rollover test with reinforced superstructure

This test series gave a good possibility to compare their results because the same bus types were used, altogether 8 full scale real rollover tests were carried out [4] The most severe test is – producing the most severe dynamic impact load on the cantrail – the version “c”, which, at first glance seems to be the less severe one. Test “b” separated also the weak superstructure (see Figure 8.) from the strong one. Figure 9 shows the same test with the same bus type in which two reinforcing safety rings were installed and the survival space remained intact during the test, the superstructure did not collapse. But the comparison with the test “c” – using the same weak and reinforced buses – showed that the reinforced bus needed some further reinforcement at the rear part of the superstructure (see Figure 10.)

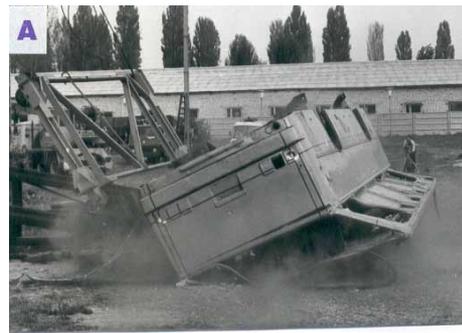
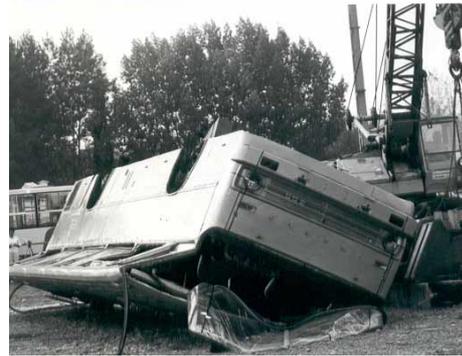
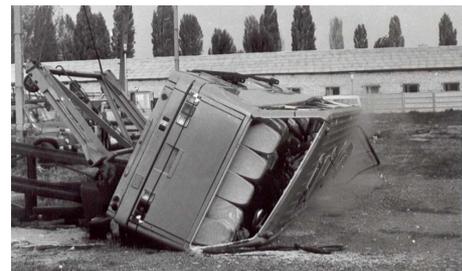
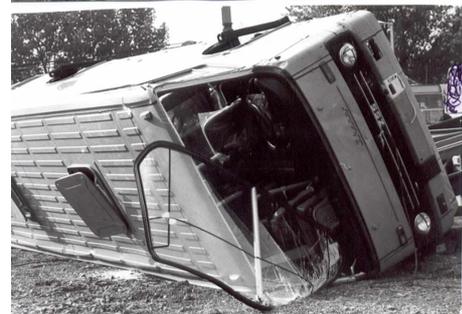
weak superstructure

reinforced superstructure

Figure 10. Comparison with test “c”

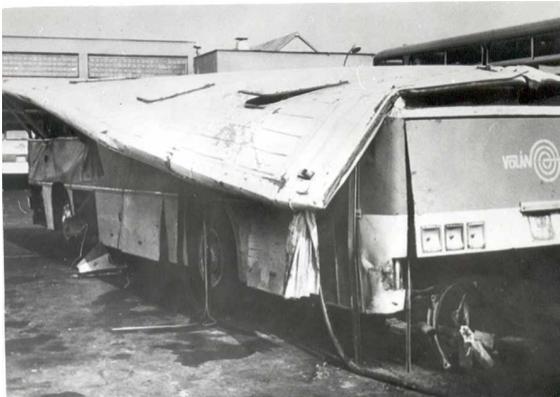
Figure 11. Result of real rollover accident (Superstructure not reinforced)

Many real rollover accidents proved the effectiveness of the recent approval rollover test described in R.66. which is the same as the version “c” on Figure 7. Some examples are shown on the next figures Figure 11. shows the result of a rollover accident, which happened on a slope very similar to the version “b” on Figure 7. after 1,5 rotation. The level difference was around 6 m, the superstructure was “original”, that means without reinforcement. After two steps reinforcement (and approval according to R.66) this reinforced bus had a rollover accident on

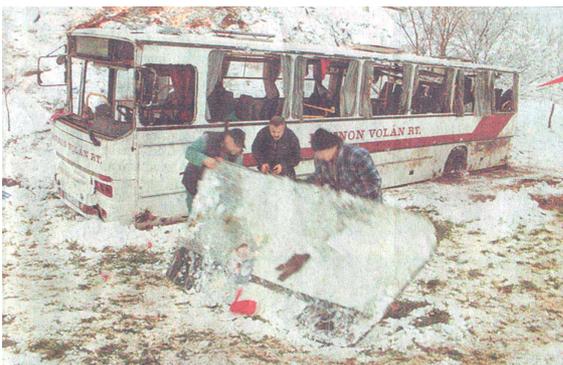
Figure 13. After rollover no significant deformations

a slope given in Figure 12. The level difference was around 9-10 m, the number of rotation $2\frac{1}{4}$ and after this accident no significant deformation could be observed on the superstructure. [5] (see Figure 13.)

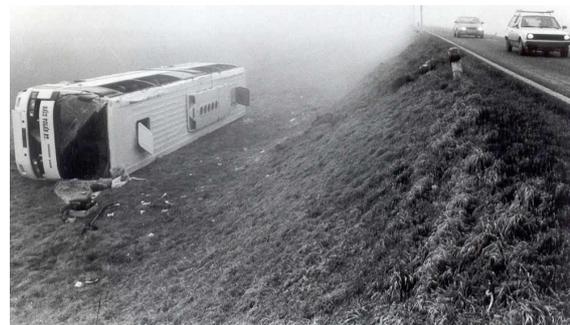
Figure 14. Rollover accident of an approved bus type

Another bus type – also approved according to R.66 – may be seen on Figure 14. after a rollover accident slope, number of rotation $\frac{3}{4}$, the level difference is around 5-6 m. An interesting test was published by Volvo [6] With an approved bus, having the required strength of superstructure a rather severe rollover test was carried out on the slope

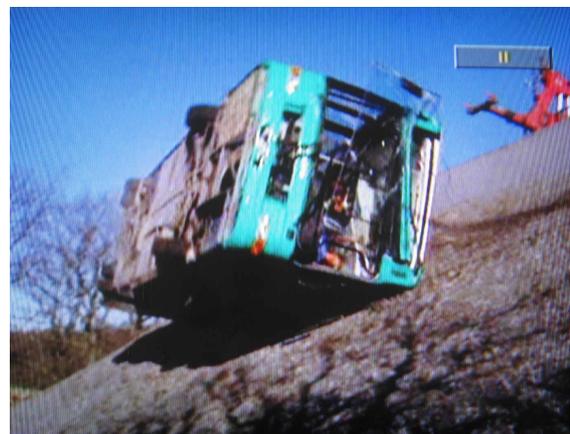
Figure 15. VOLVO's rollover test

shown on Figure 15. After $3\frac{1}{4}$ rotations – the level difference was 17-18 m – the survival space remained intact, the intrusions were avoided. Nine dummies were used in this test, 7 of them had 3pts safety belt, 2 of them were without belt. The belted dummies remained in their seats, (no projection type injury) but the two unbelted dummies flew in the passenger compartment and had untraceable motion. According to our definition, this rollover accident is out of the PRA group (more than 2 rotations, more than 10 m level difference) it belongs to the severe rollovers. But having the required strength of superstructure and wearing seat belt, the survival probability of the occupants is strongly increased even in severe rollover accidents, too.

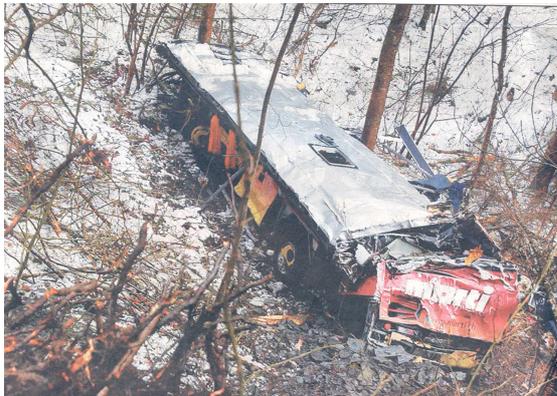
Figure 17. Final position of the collapsed bus

HD tourist coach, 27 occupants on board rolled down from a mountain road. The result: 12 fatalities, 15 serious injuries, 4 of them were in life danger. The path of the rollover process is shown on Figure 16. Next to the road there was a 60-70 m long slight slope on which the bus had 6-7 rotations. After that a steeper section came, finally a 20 m deep rocky precipice completed the path of the bus. The final position and the completely collapsed roof can be seen on Figure 17. Asking the question: was it a severe accident? – both approaches give positive answer, yes it was. But a detailed study proved [3] that if the bus should have had a strong superstructure which did not collapse at the first impact, the bus could slip away on the slight slope and stop before the steeper section. Of course certain injuries could happen in this case, too, but perhaps both approaches could say: no, it was not a severe accident.

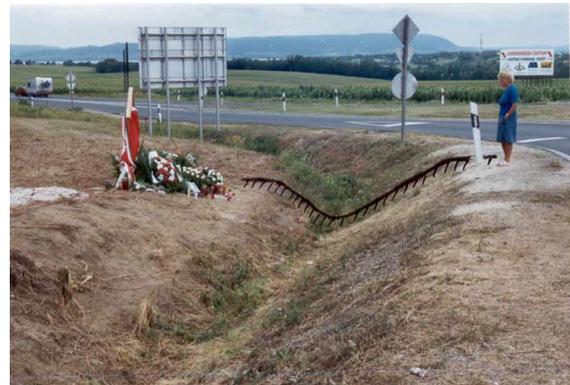
Figure 18. The ditch, in which the bus landed

driver did not recognize the situation, it was gloom, night.) After uncontrolled manoeuvre the bus turned on its side, slipped away on the double-way roundabout 20-25 m and hit the other side of a ditch next to the roundabout. (see Figure 18.) The roof structure completely collapsed as it may be seen on Figure 19. The result: 20 fatalities, 17 serious injuries and 14 slight injuries. [7] The tip over (turned on side) is the less severe rollover based on the 2nd approach. But the first approach says, it is a very severe accident. But if the superstructure should have had the required strength, both approaches could say that this is not a severe accident. The public opinion says: it is unacceptable that in a similar accident (tip over) the casualty rates are so high. And that is the goal of the international regulatory work: to increase the safety, to avoid this kind of results in PRA-s.

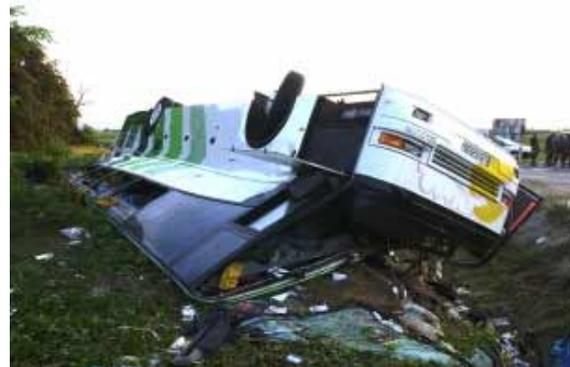
Figure 19. The collapsed roof structure
