DATA ANALYSIS METHODOLOGY AND OBSERVATIONS FROM ROLLOVER SENSOR DEVELOPMENT TESTS

General Motors Corporation

Paper Number 07-0308

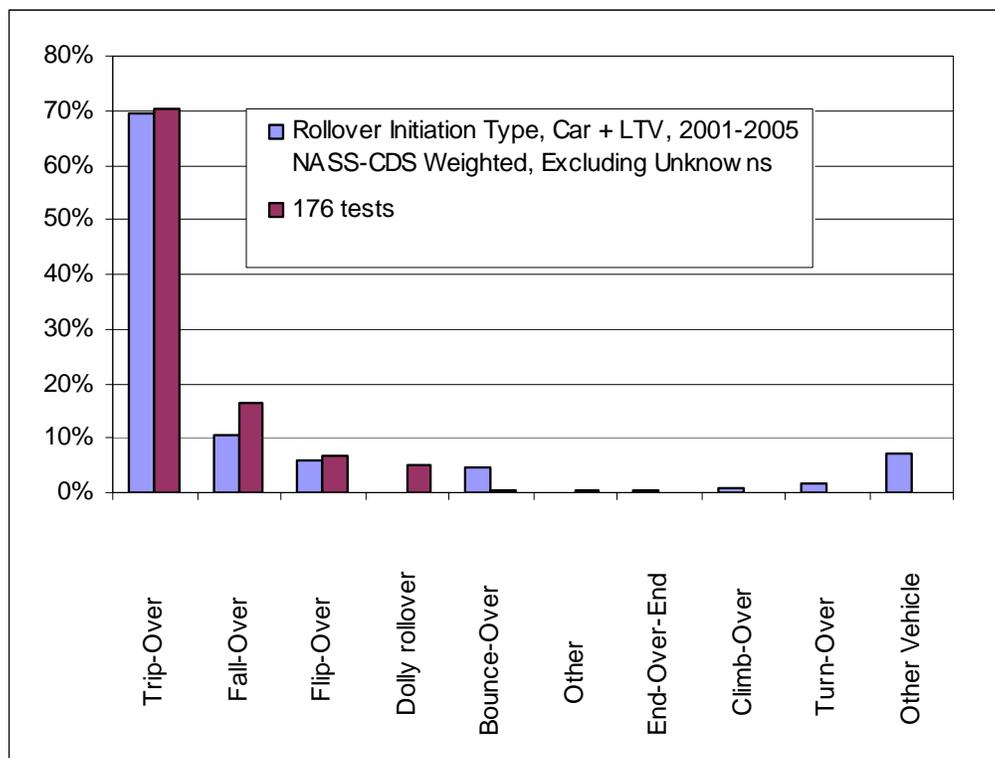
A comparison of field statistics for the types of rollover initiations in the field to the 176 laboratory test dataset under analysis is shown in Figure 1. The trip-over tests make up the largest proportion of the laboratory dataset and reflect the majority of field rollover initiations (2001-2005 NASS-CDS, Cars + LTV's).

Figure 1. Distribution of test types.

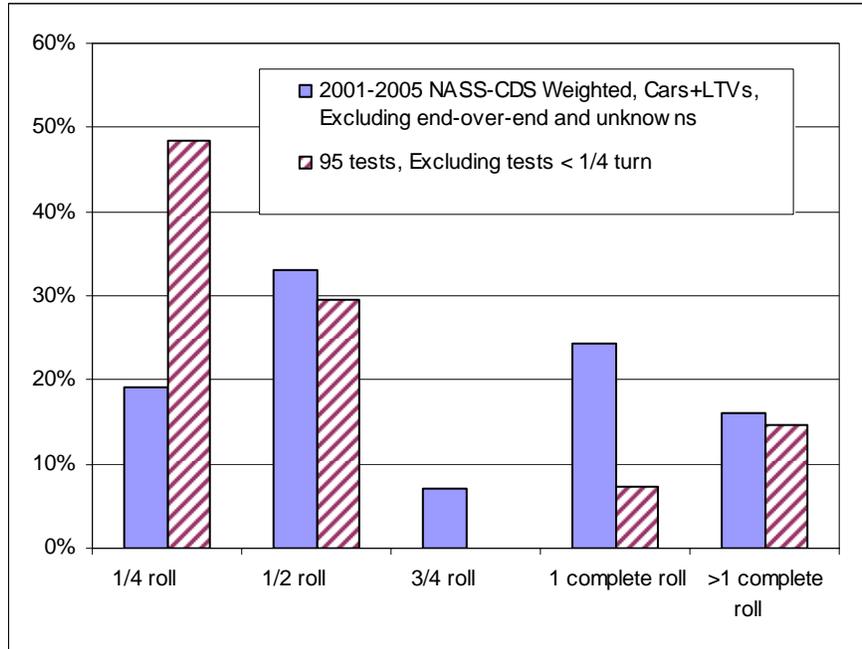
Of the 176 tests under analysis, 95 resulted in a rollover of at least ¼ turn. A comparison of these 95 tests which rolled at least ¼ turn to statistics from field rollovers is shown in Figure 2. The larger

proportion of laboratory tests that rolled only ¼ turn is indicative of the objective of the rollover testing itself - to develop a rollover sensing calibration. This puts an emphasis on simulating vehicle kinematics that approach and/or exceed a "threshold" in terms of vehicle rollover.

Figure 2. Comparison of field data to test data by quarter turn achieved.

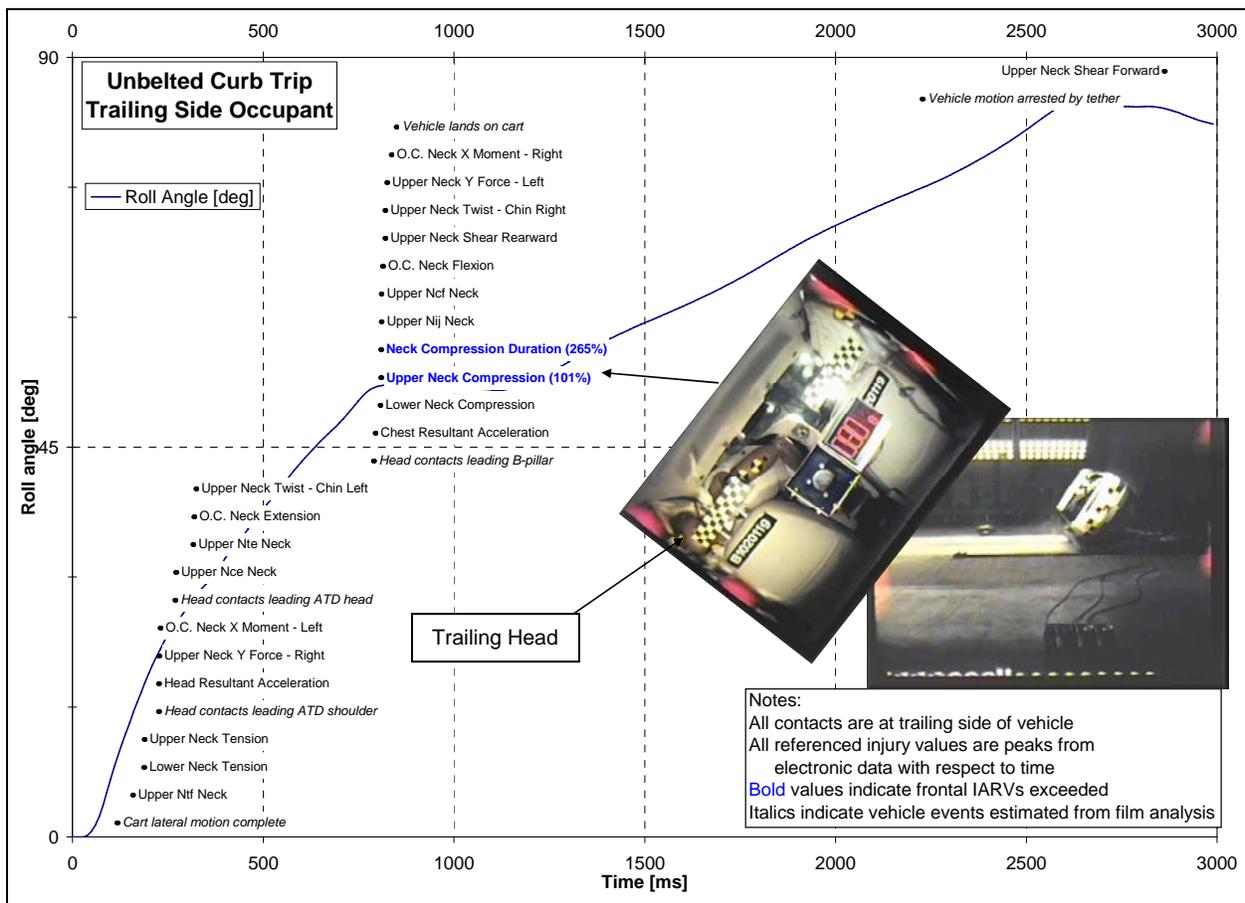
A summary chart was created for each ATD in the 48 tests that had at least one IARV exceeded. This involved a total of 26 leading side ATDs (13 belted, 13 unbelted), and 39 trailing side ATDs (22 belted, 17 unbelted). An example summary chart is shown in Figure 3.

The chart is a tool used to develop a one-page summary of the rollover test. The x-axis represents time in milliseconds, while the y-axis reflects the roll angle of the vehicle. The time at which a peak value occurred is plotted on each chart, along with the

appropriate data label. Data labels in bold show peak ATD loads that exceeded the IARV, while those in italics show observations estimated from film. Film observations may include items contacted by the ATD, as well as estimated timing of dynamic vehicle upper structure deformation. Pictures of the vehicle and ATD orientation at the time at which an IARV was exceeded are also included.

Figure 3. Sample summary chart.

In Figure 3 for example, two IARVs were exceeded on the trailing side ATD during a single impact -- head contact to the leading side B-pillar. At this point in the rollover, the vehicle has achieved only 52 degrees of roll angle.

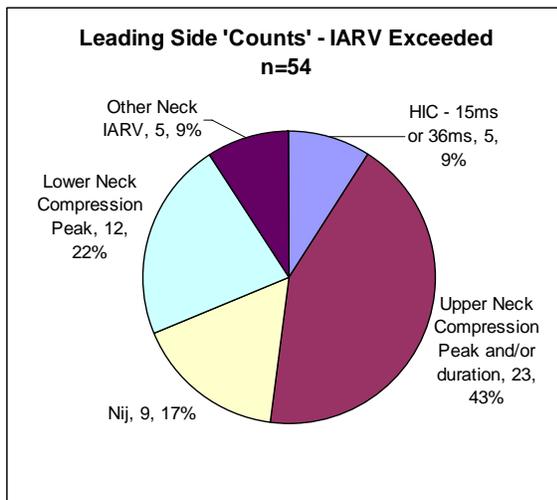
The distribution of types of IARVs exceeded on leading side and trailing side are shown in Figure 4 and Figure 5, respectively. For these tests, the following IARVs were grouped as follows:

1. One upper neck compression IARV was 'counted' if an ATD response exceeded the peak upper neck compression IARV and/or the peak upper neck compression time duration IARV.
2. One lower neck compression IARV was 'counted' if a peak lower neck compression IARV was exceeded.
3. One Nij IARV was 'counted' if one or more Nij (i.e. Ntf, Nce, Nte, Ntf) were exceeded.
4. One HIC IARV was 'counted' if a test exceeded the 15ms and/or 36 ms HIC.
5. The 'Other Neck IARVs' included upper neck shear rearward, upper neck occipital condyle moment left, upper neck occipital condyle flexion and upper neck occipital condyle extension.

Figure 4. Leading side 'counts' – IARV exceeded.

Of the 96 ATDs in the 48 tests, 65 ATDs had at least one IARV exceeded for a total of 127 'counts'. The distribution of exceeded IARVs is similar between leading and trailing side ATDs except for Head Injury Criteria (HIC), which has a larger proportion on the leading side. The lone example of a HIC IARV being exceeded by the trailing side ATD was the result of ATD to ATD contact.

As shown in Figure 4 and Figure 5, approximately 1/2 of the IARVs exceeded were due to upper neck

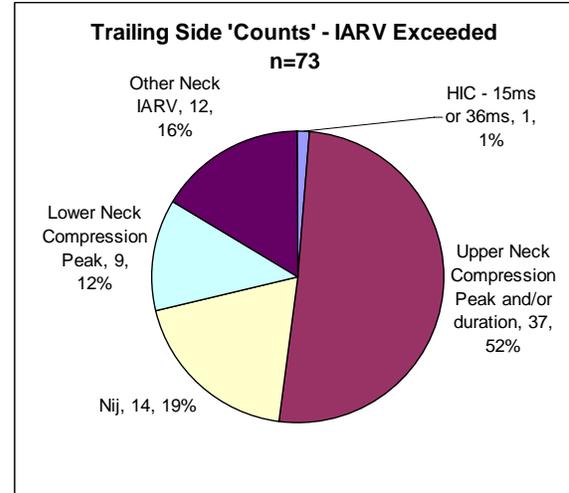
Figure 5. Trailing side 'counts' – IARV exceeded.

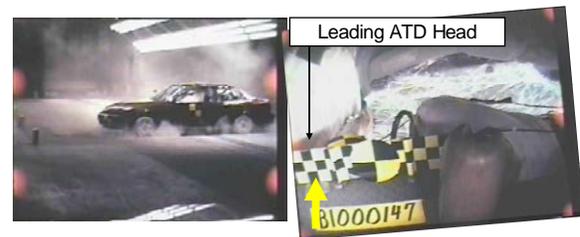
1. Head contact to leading side door at beltline: The unbelted leading side ATD moved toward the trailing side and then moved back toward the leading side resulting in head contact to the leading side door (Figure 6).

Figure 6. Head contact to leading side door at beltline.

during which the motion of the ATD head was arrested prior to stopping the ATD body showed the potential for exceeding a neck compression IARV. This was true regardless of vehicle orientation, location of the head contact, or dynamic deformation of the vehicle's structure, as shown in Figures 6 through 11.

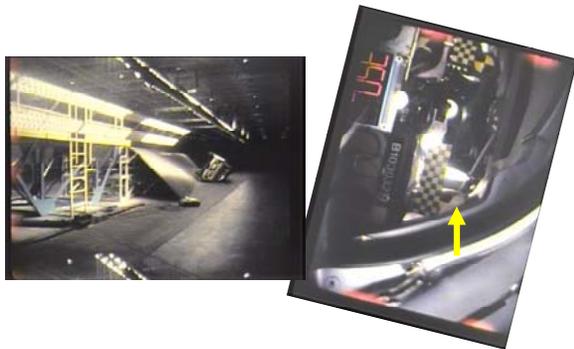
3. Head to leading/trailing side structure at event arrest: These tests were corkscrew ramp flip-over tests where the vehicle was arrested by contacting a row of jersey barriers that were placed in front of the building wall. The time at which the vehicle contacted the jersey barriers is considered to be the event arrest.
4. Head contact to ground or ground/roof rail on leading side: The head of the leading side ATD either contacted the ground through the leading side window membrane (a more lateral outboard motion) or the contact was to the ground with the head in contact with both the leading side roof rail and membrane (a more vertical outboard motion) (Figure 7).

Figure 7. Head contact to ground/roof rail.

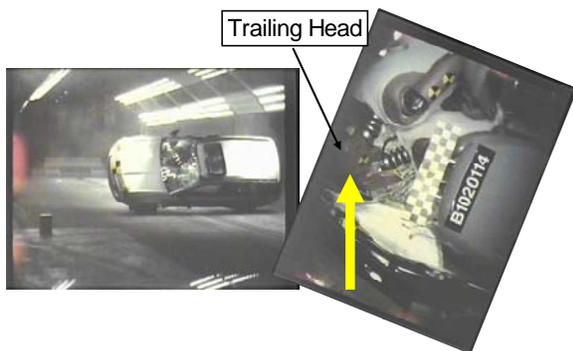
5. Head contact to leading/trailing side structure: The head contacted the roof rail, door frame, roof etc. on the leading/trailing side of the vehicle (Figure 8).

Figure 8. Head contact to leading side structure.

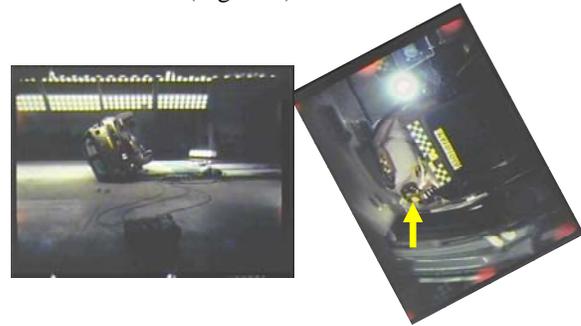
6. Head contact to ground through leading side membrane: The unbelted trailing side ATD moved toward the leading side and contacted the leading side window membrane which was in

contact with the ground due to vehicle orientation. (Figure 9).

Figure 9. Head contact to ground through leading side membrane.

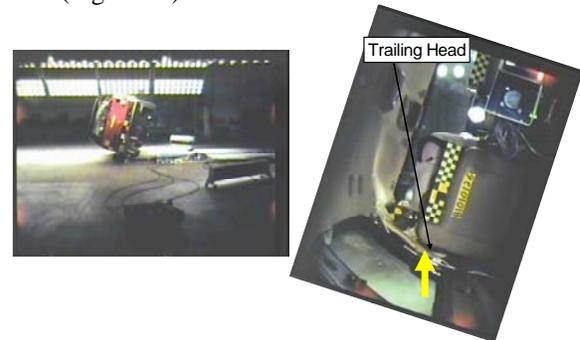
7. Head contact to leading side window membrane: The unbelted trailing side ATD moved toward the leading side and was arrested by the leading side window membrane when the leading side of the vehicle was not in contact with the ground (Figure 10).

Figure 10. Head contact to leading side window membrane.

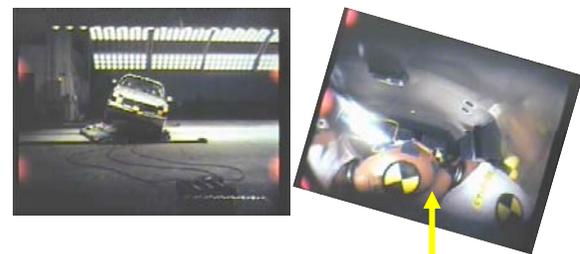
8. Head contact to leading side ATD: The head of the trailing side ATD contacted the leading side ATD (Figure 11).

Figure 11. Head contact to leading side ATD.

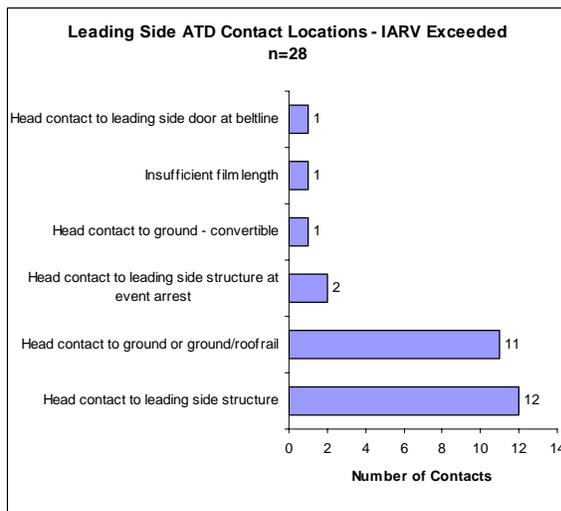
A summary of the locations of contact for a leading side ATD impact during which an IARV was exceeded is shown in Figure 12. The summary for the trailing side is shown in Figure 13. It should be noted that multiple contacts during which an IARV was exceeded occurred in some tests, resulting in 71 contacts during which IARVs were exceeded for the 65 ATDs.

Figure 12. Leading side ATD contact locations – IARV exceeded.

Figure 12 and Figure 13 demonstrate the complex nature of ATD motion in a rollover. Although 82% of leading side ATD contacts were with structure and/or ground, the location of contact varied. For instance, in one test, the ATD head contact was to the leading side door at the belt line, with the vehicle on its wheels (Figure 6). On the trailing side, 63% of trailing side ATD head contacts occurred with the leading or trailing side structure. IARVs were also exceeded through contact to the leading side ATD and through restraint provided by the leading side window membrane.

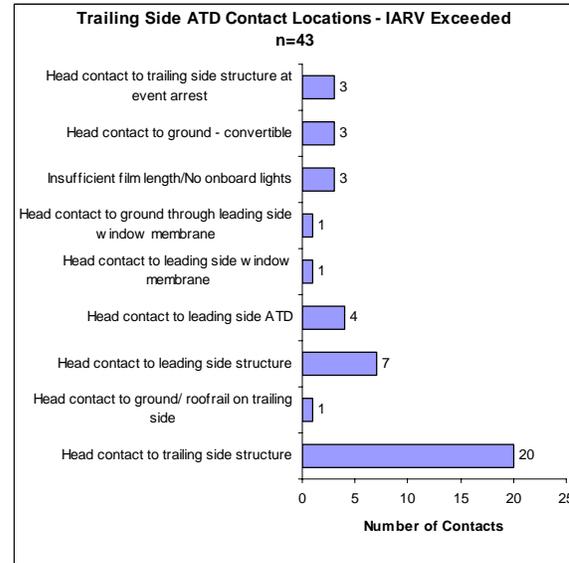
Figure 13. Trailing side ATD contact locations – IARV exceeded.

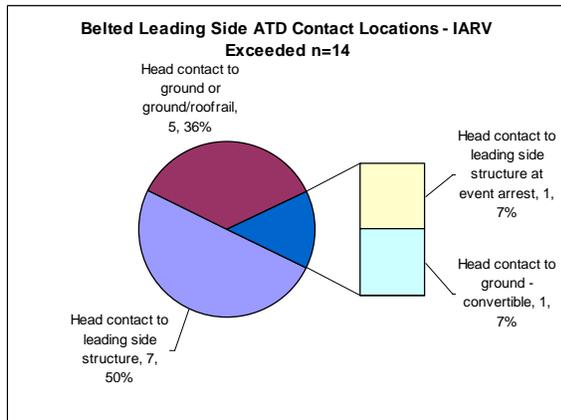
Figure 14 and Figure 15 show a comparison between belted and unbelted leading side ATDs in terms of their contact locations. The distribution of contact locations does not appear to be affected by belt usage for the leading side ATD.

Figure 14. Belted leading side ATD contact locations with IARV exceeded.

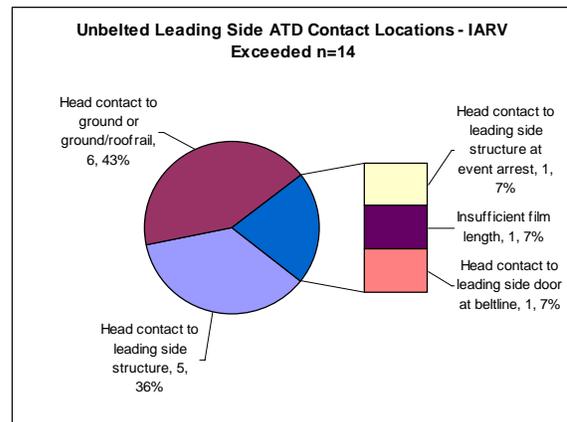
Figure 15. Unbelted leading side ATD contact locations with IARV exceeded.

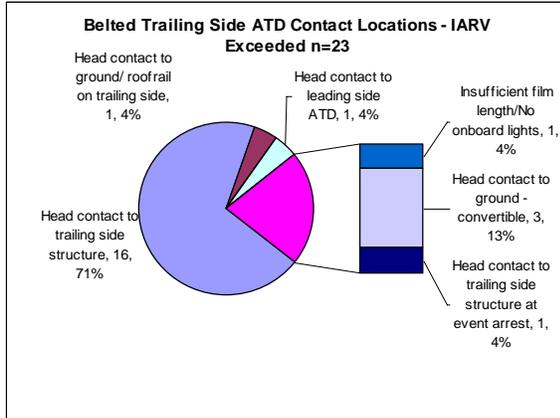
Figure 16 and Figure 17 show the distribution for contact locations for belted and unbelted trailing side ATDs demonstrating that belt usage strongly influenced the trailing side ATDs contact location.

Figure 16. Belted trailing side ATD contact locations with IARV exceeded.

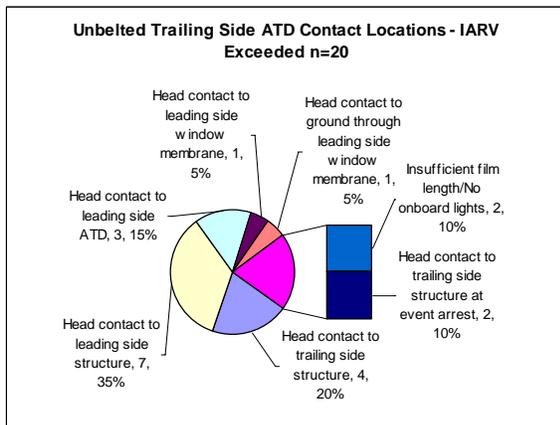
Figure 17. Unbelted trailing side ATD contact locations with IARV exceeded.

For the unbelted trailing side ATDs, 60% of the contacts occurred on the leading side of the vehicle, while only 20% were to the trailing side structure.

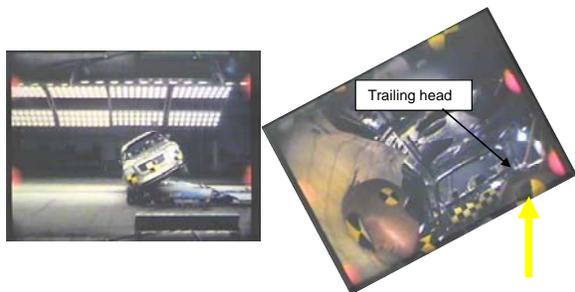
For the belted ATDs, contact occurred primarily to the trailing side structure, although belt usage did not preclude head contact with the leading side ATD (Figure 18).

Figure 18. Belted ATD head contact to leading side ATD.

On the trailing side, the HIC IARV was exceeded once, due to belted trailing side ATD head contact with the shoulder of the leading side ATD (Figure 18).

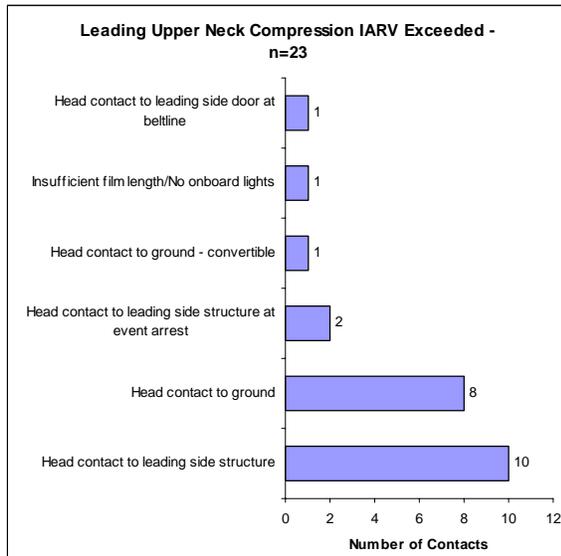
compression loading. Figure 19 and Figure 20 show the distribution of contact locations during which the upper neck compression IARV was exceeded.

Figure 19. Leading side ATD upper neck compression IARV exceeded – ATD contact location.

Table 8 shows the vehicle orientation for tests during which the upper neck compression IARV was exceeded. As demonstrated in Figure 19 and Figure 20, upper neck compression IARVs were exceeded through contact with the ground, door, roof rail, roof, window membrane or the other ATD. Any contact

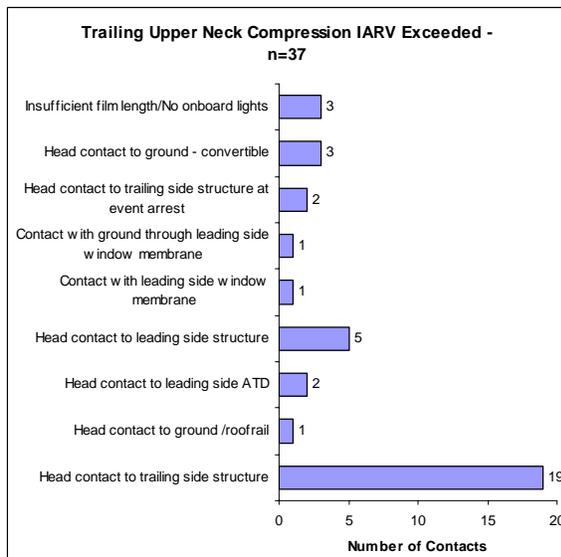
Figure 20. Trailing side ATD upper neck compression IARV exceeded – ATD Contact Location.
