FIELD TEST OF A COOPERATIVE INTERSECTION COLLISION AVOIDANCE SYSTEM FOR VIOLATIONS (CICAS-V)

Virginia Tech Transportation Institute

Paper Number 09-0478

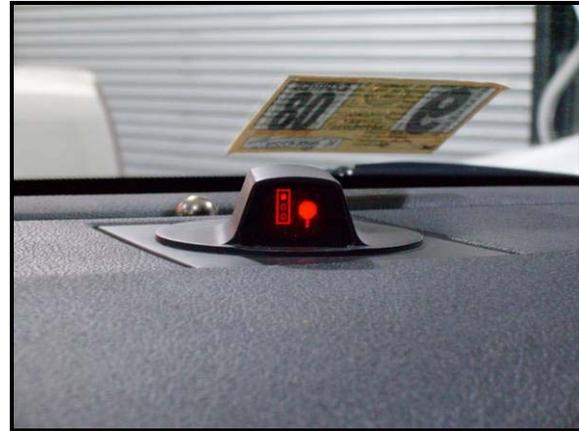
The visual warning is displayed by a dash-mounted icon (Figure 1) positioned at the vehicle centerline

near the cowl of the windshield. As implemented in the vehicle, the visual icon was 11.6 mm (0.46 inches) high and 11.6 mm (0.46 inches) wide. It was illuminated as either steady, continuous blue (advisory), or flashing red (warning).

Figure 1. The visual display is located on the dash of the experimental vehicle.

The post-drive questionnaire was completed by the 13 drivers who received the total 49 valid warnings at stop-controlled intersections. Data show that drivers found the alerts useful, effective at communicating a possible violation, and attention getting. There were also several potential negative trends in responses. More drivers responded that, when receiving a violation warning, they tended to brake without checking for following traffic. Also, drivers tended to find the alert annoying when it was deemed unnecessary. This response is not surprising, and, in part, motivated the change to Stop-Controlled Algorithm 2. Three drivers admitted to intentionally trying to activate the warning system and three drivers said they would have turned the system off if they could. It is interesting to note that both aspects of the visual DVI, the blue "intersection ahead" icon and red flashing visual alert, were viewed less favorably than the speech alert and brake pulse warning. Several drivers noted, in the open-ended comment section, that they did not notice the visual icons. Suggested potential improvement to the visual DVI included a more conspicuous visual display that was a little larger and placed closer to the driver.

DVI was ineffective in communicating the intended information and not easily detected. Drivers often did not complete the questionnaire, presumably because they did not notice the blue icon. These results are consistent with the other questionnaire results that indicate that drivers often did not notice the blue “intersection ahead” display. Interestingly, many drivers took the time to provide feedback in the final open question on the questionnaire. Overall, drivers expressed a desire to have the display be more conspicuous.
