REAR IMPACT TEST METHODOLOGIES: QUASISTATIC AND DYNAMIC

Paper Number 09-0533

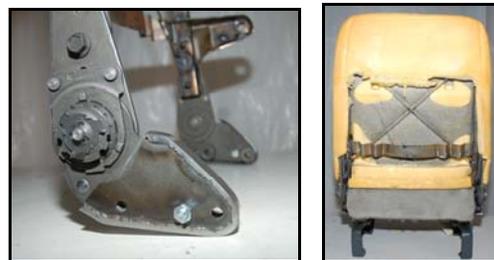
Sled Test 1 – For Sled Test 1, a production right front early 1990’s vintage Chevrolet Lumina seat was tested in conjunction with a reinforced right front seat from an equivalent vehicle. The reinforced seat was originally equivalent to the OEM seat, but was reinforced with the addition of a second recliner mechanism. The attachment of the recliners to the lower seat structure was also reinforced. Lastly, the lower seat back cross member, which was originally a straight tubular structure, was replaced with a flat strap that could act as a pelvic catcher strap. Figure 6 shows the dual recliners with reinforcements and the pelvic catcher strap.

Figure 6. Test 1 Reinforced Seat

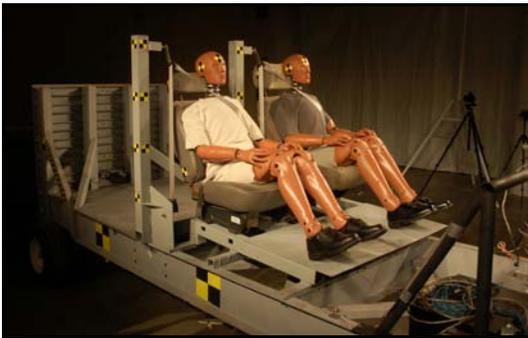
A 50th percentile Hybrid III male ATD with seated pelvis was placed in each seat and normally belted with the OEM restraint, which included a locking latch plate. The OEM seat was set to its full rear track position. In this position, the upper seat track was found to overhang the lower seat track significantly at the rear. Recognizing this as a potential failure mode contributing to rearward seat back deflection, the lower seat tracks for the reinforced seat were mounted rearward of the OEM mounting position to eliminate the rear offset of the upper versus lower tracks. The restraint anchorage positions relative to the ATDs were kept consistent for both seating positions. The seat backs were set to a recline angle of 24 degrees from vertical and angular rate sensors were positioned on both sides of

the upper seat backs in order to document the dynamic seat deflection (See Figure 7). The sled was accelerated to an impact speed of 15.8 mph (25.4 kph).

Figure 7. Sled Test 1 – Pre-test Set-up

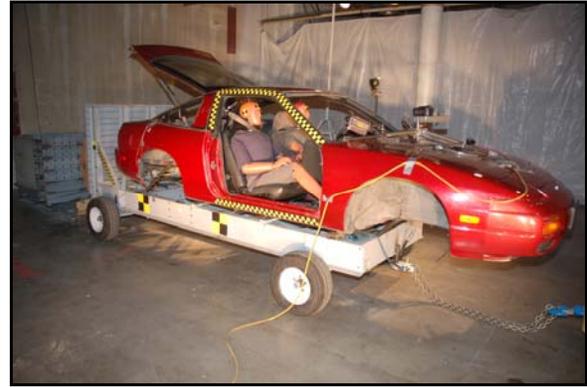
for both the ATDs. The seat backs were set to a recline angle of approximately 20 degrees from vertical. A 50th percentile Hybrid III male ATD with seated pelvis was placed in each seat and normally belted with the buck’s OEM passive restraint system (See Figure 9). The sled was accelerated to an impact speed of 16.2 mph (26.1 kph).

Figure 9. Sled Test 2 – Pre-test Set-up

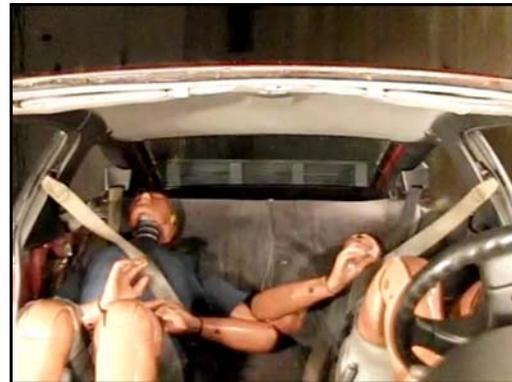
The impact resulted in a maximum longitudinal deceleration of 17.7 Gs with a delta-V of 20.1 mph (32.3 kph). The maximum seat back deflections and resulting ATD movement is depicted in Figure 10.

Figure 10. Sled Test 2 – Test Sequence
Maximum Deflection (from Video Analysis)

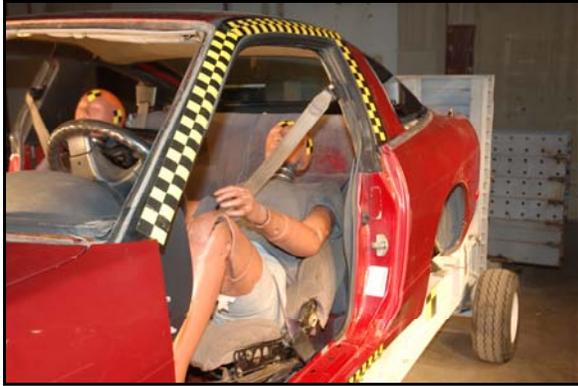
The ATDs’ heads were painted in order to identify head impact locations. Figure 11 shows the post-test residual positions of the seat backs and ATDs. The driver’s single recliner seat deformed such that the driver’s ATD was seen to ramp up the seat back with its head making contact with the left rear seat back and leaving the red paint transfer seen in Figure 11. This contact was of sufficient force level to deform, or bow out, the left rear seat back structure as seen in Figure 12. In comparison, the right front, dual recliner seat prevented ATD contact with the rear seating compartment.

Figure 11. Sled Test 2 – Post-test, Red Transfer on Left Rear Seat from Driver’s Seating Position ATD Head Impact

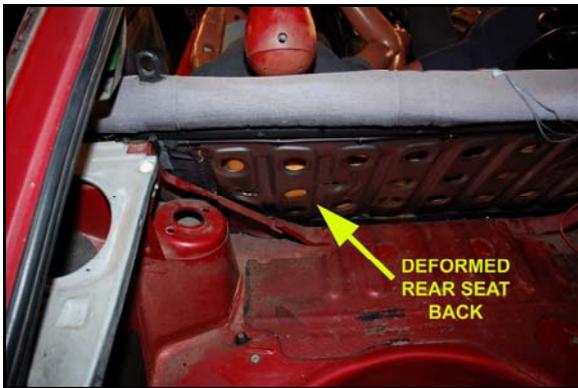
Figure 12. Rear Seat Back Deformed from Driver’s Seating Position ATD Contact

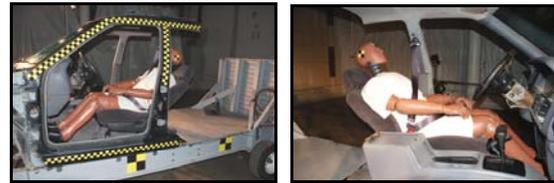
In Test 3 the ATD was restrained with the standard OEM restraint system which included a single pass-through, sliding latch plate. The seat belt was put on the ATD normally with the belt clamped at the D-ring such that approximately 62 inches (157.5 cm) of webbing was extended, consistent with the above as-found position in the real-world accident vehicle. The driver’s seat was then set to the fully reclined position. Any loose webbing was shared between the lap and shoulder portions of the restraint system prior to impact. The full recline angle of the seat was measured to be approximately 58 degrees from vertical (See Figure 13).

Figure 13. Sled Test 3 – Pre-test Set-up

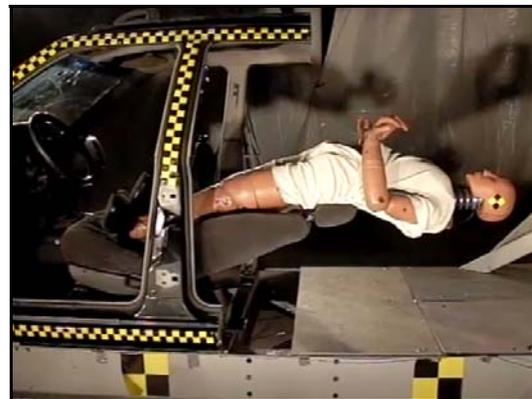
A review of high-speed film from Test 3 shows the ATD ramping up the seat back and moving fully into the rear compartment. A high-speed camera focused on the pass-through latch plate showed more than 3 inches (76.2 mm) of webbing passing through the latch plate and into the lap belt as the ATD ramped up the seat back (See Figure 14). The ATD moved rearward, effectively unrestrained, until his feet caught the lap portion of the belt webbing (See Figure 15).

Figure 14. Sled Test 3 – ATD Ramping During Test

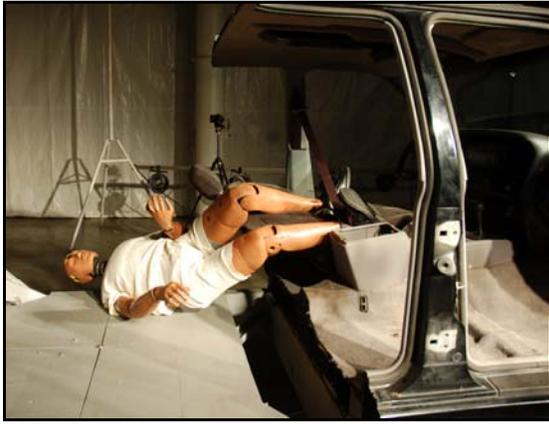
Figure 15. Sled Test 3 – ATD Post-Test

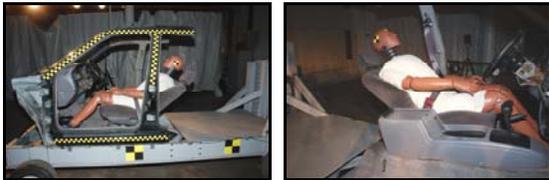
In Test 4, the configuration was similar to that of Test 3, however, a locking latch plate replaced the OEM single pass-through, falling latch plate. The shoulder belt was again clamped at the approximate 62 inch (157.5 cm) position. The lap belt was adjusted on the ATD in a normally tight configuration with the seat in a normal and upright position. The seat back was then again set to its fully recline position at an angle of approximately 58 degrees from vertical (See Figure 16).

Figure 16. Sled Test 4 – Pre-test Set-up

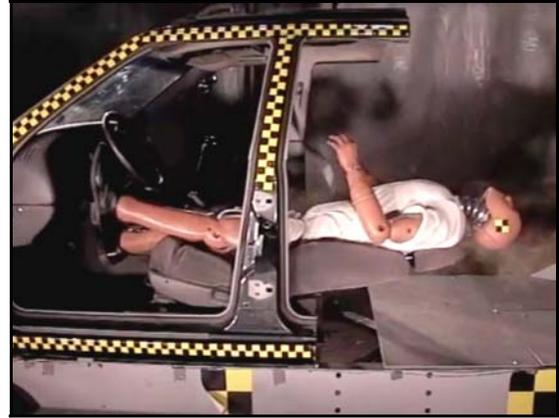
A film analysis of Test 4 demonstrates the locking latch plate was effective at maintaining the tight lap belt condition. The tight lap belt was seen to limit the amount of ATD excursion and velocity into the rear occupant compartment (See Figure 17). Figure 18 depicts the ATD's post-test position.

Figure 17. Sled Test 4 – ATD Ramping During Test

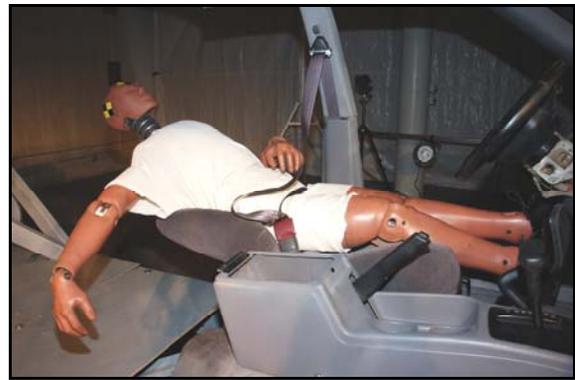
Figure 18. Sled Test 4 – ATD Post-Test

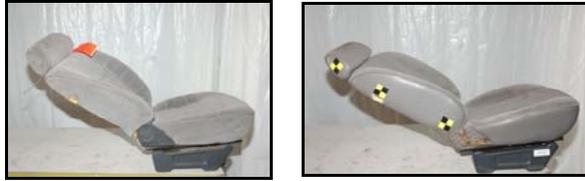
Consistent with previous work [3, 4], good correlation was seen between the seat back deflection recorded in the QST tested Chevrolet Lumina seat and its sled tested equivalent (Sled Test 2) (See Figure 19).

Figure 19: Chevrolet Lumina QST and Sled Tested Seat Comparison
