INFLUENCE OF DRIVER ASSISTANCE SYSTEMS ON REPAIR COSTS

Paper Number 11-0350

In the following article, based on a crash test (following Euro NCAP with a frontal impact) the influence of driver assistance systems on repair costs after an accident are described and discussed. Particularly, the potential of an integrated safety approach regarding repair cost reduction is described, focusing on an autonomous emergency braking system. The system of an actual BMW 5 Series model will serve as an example.

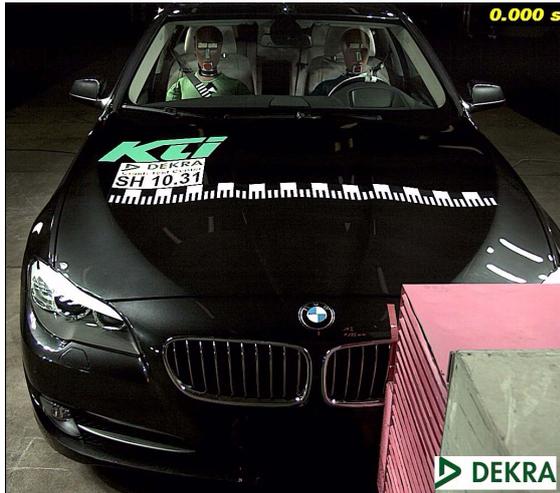
Figure 1. Impact position with 40% overlap.

The tested vehicle was a BMW 530d, type F10, equipped with a prototypic collision imminent braking system. The test set up followed the Euro NCAP frontal impact configuration. This is an offset crash test with 40% overlap against a deformable barrier and Hybrid III 50th percentile male dummies on the driver's and passenger's seats. The collision speed is given at 64 km/h. This speed was chosen as the initial speed for the autonomous braking. For comparison, a similar car was crashed without the activation of an active safety system. The test set-up is shown in Figure 1.

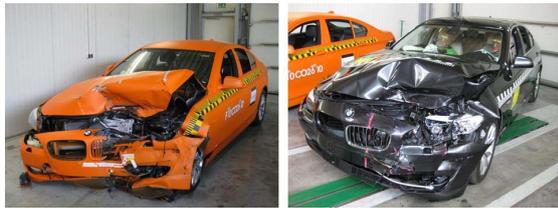
Figure 2. Different deformations resulting from the 64 km/h impact (orange) and the 40 km/h impact (black).

Approaching the barrier the sensor detected the obstacle and the full braking power was automatically triggered 0.9 seconds before the impact. The collision speed was reduced to 40km/h. The collision energy was, thus, reduced far more than 50% from 343kJ to 133kJ. The different deformation patterns are shown in Figure 2.
