REPORT NUMBER TR-P25001-18-NC

**NEW CAR ASSESSMENT PROGRAM
FRONTAL BARRIER IMPACT TEST**

**HYUNDAI MOTOR COMPANY
2005 HYUNDAI TUCSON
5-DOOR MPV**

NHTSA NUMBER: M50508

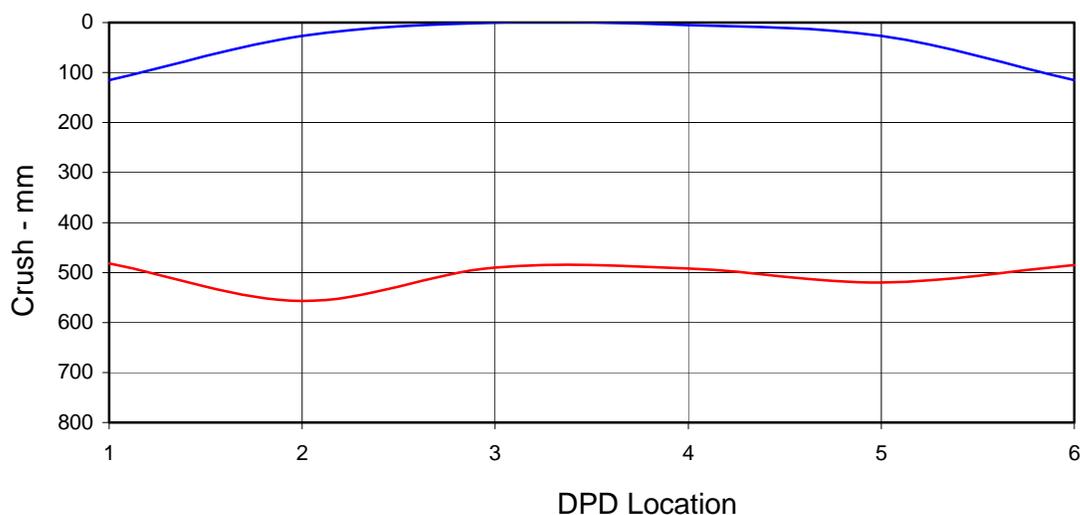
Collision Deformation Classification: 12FDEW6
 Damage Region Length (mm): 1374

No.	Measurement Description	Units	Pre-Test	Post-Test	Difference
C1	Crush zone 1 at left side	mm	115	482	-367
C2	Crush zone 2 on left side	mm	27	557	-530
C3	Crush zone 3 on left side	mm	0	490	-490
C4	Crush zone 4 on right side	mm	5	492	-487
C5	Crush zone 5 on right side	mm	27	520	-493
C6	Crush zone 6 at right side	mm	115	485	-370

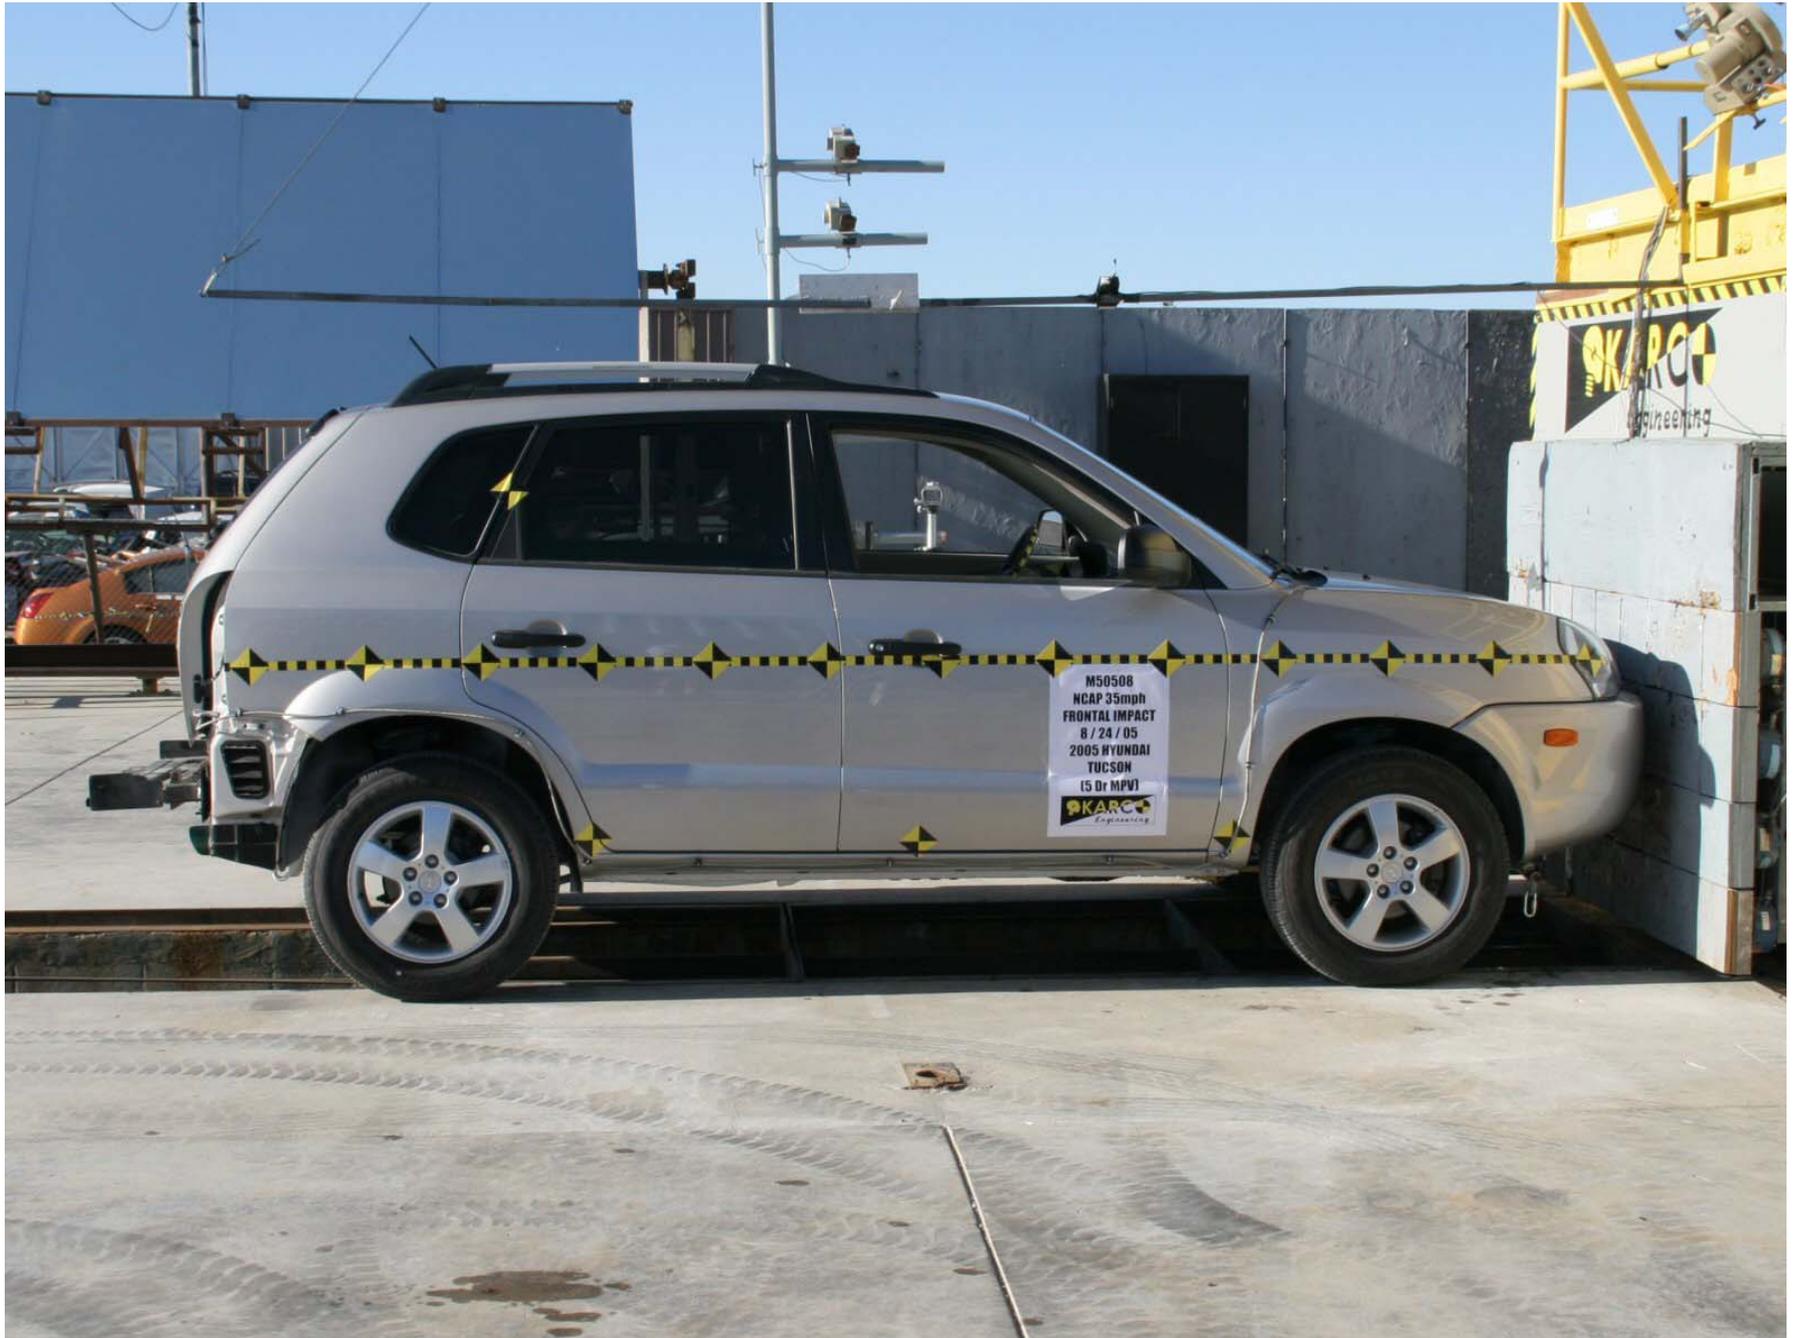
Figure A-9: Post-Test Left Side View

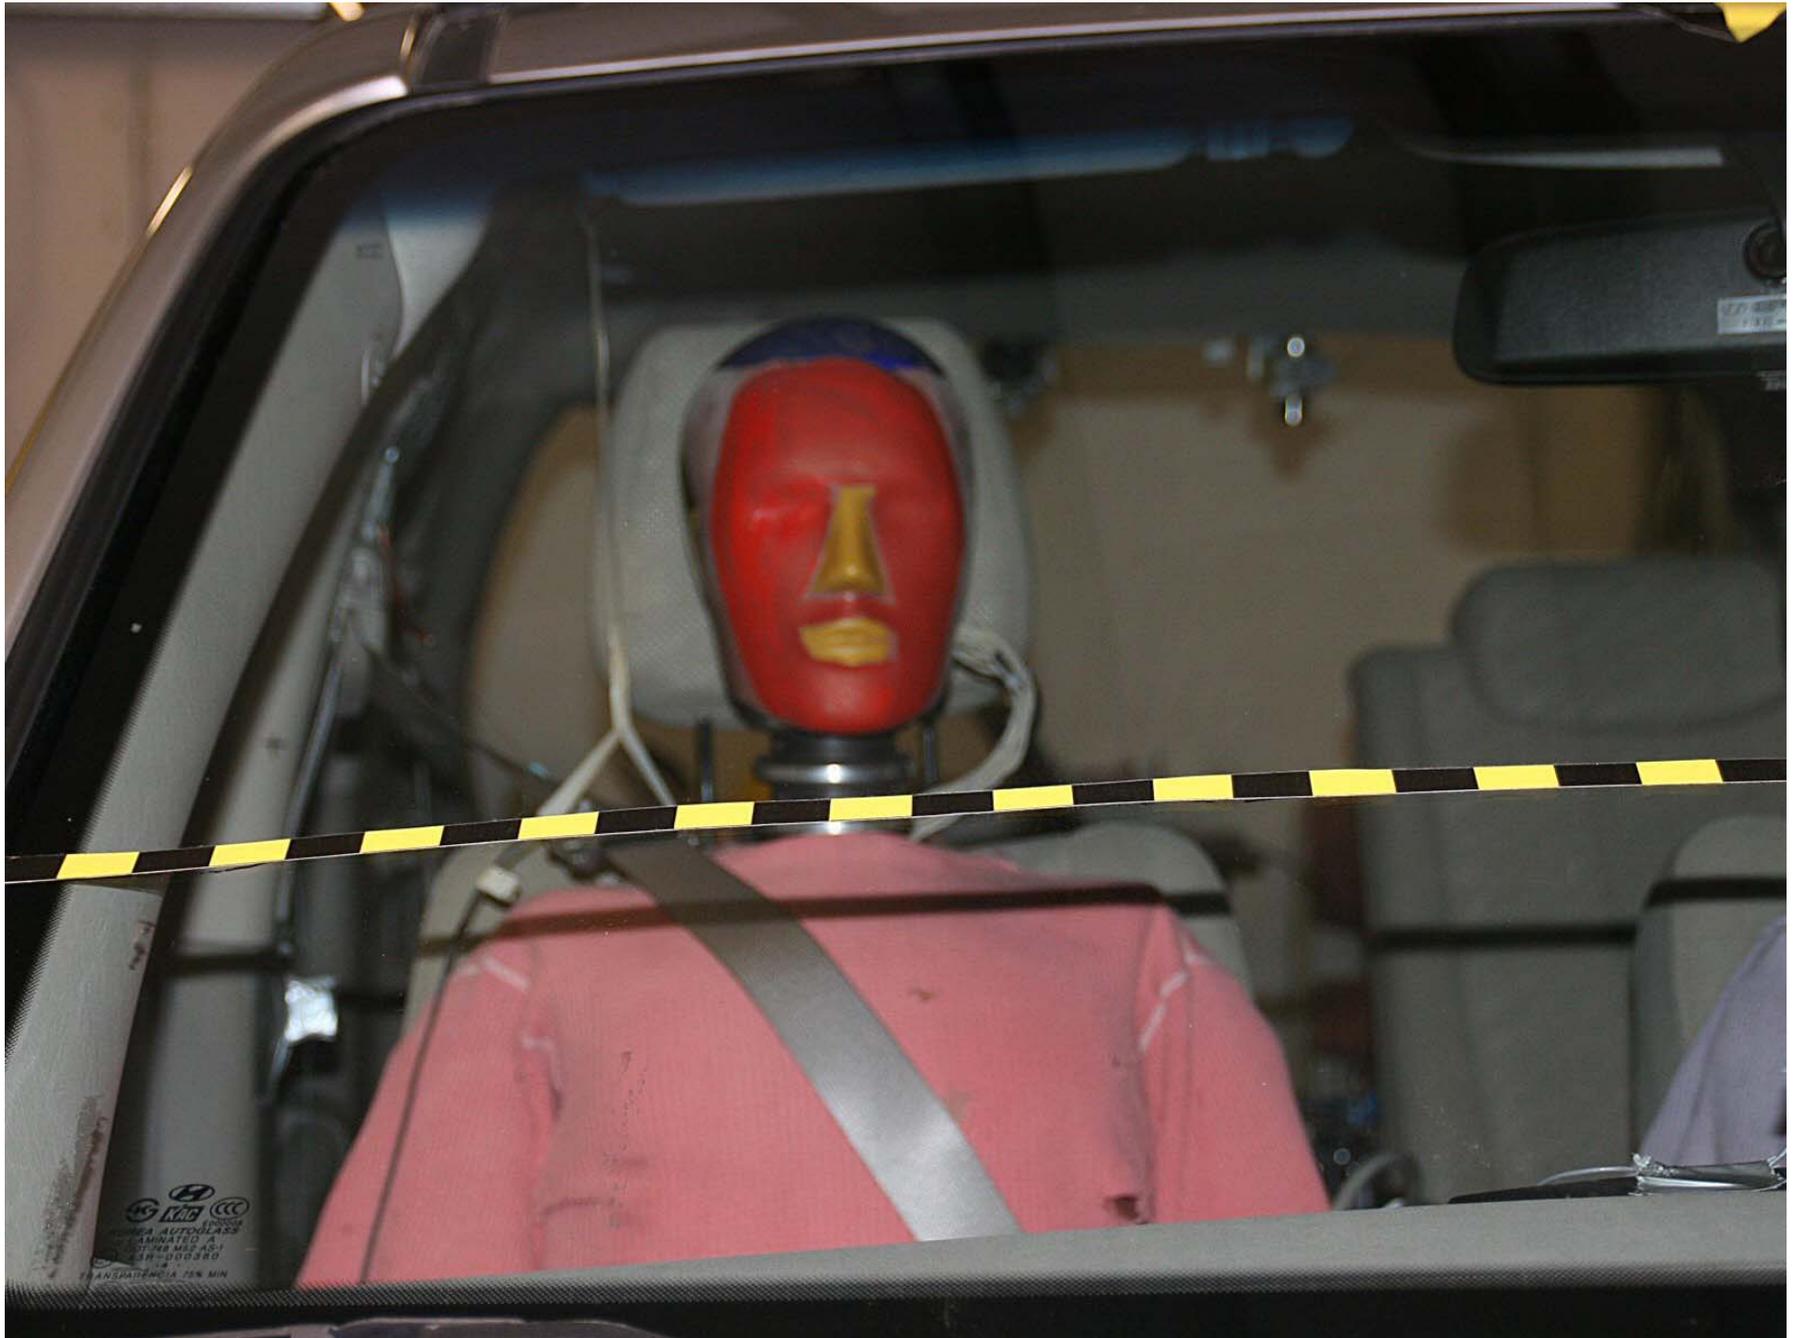
Figure A-43: Post-Test Driver Dummy Airbag Contact

The driver's visible contact points were as follows: The driver ATD's head contacted the airbag, its chest and abdomen had no contact. Both knees contacted the knee bolster.

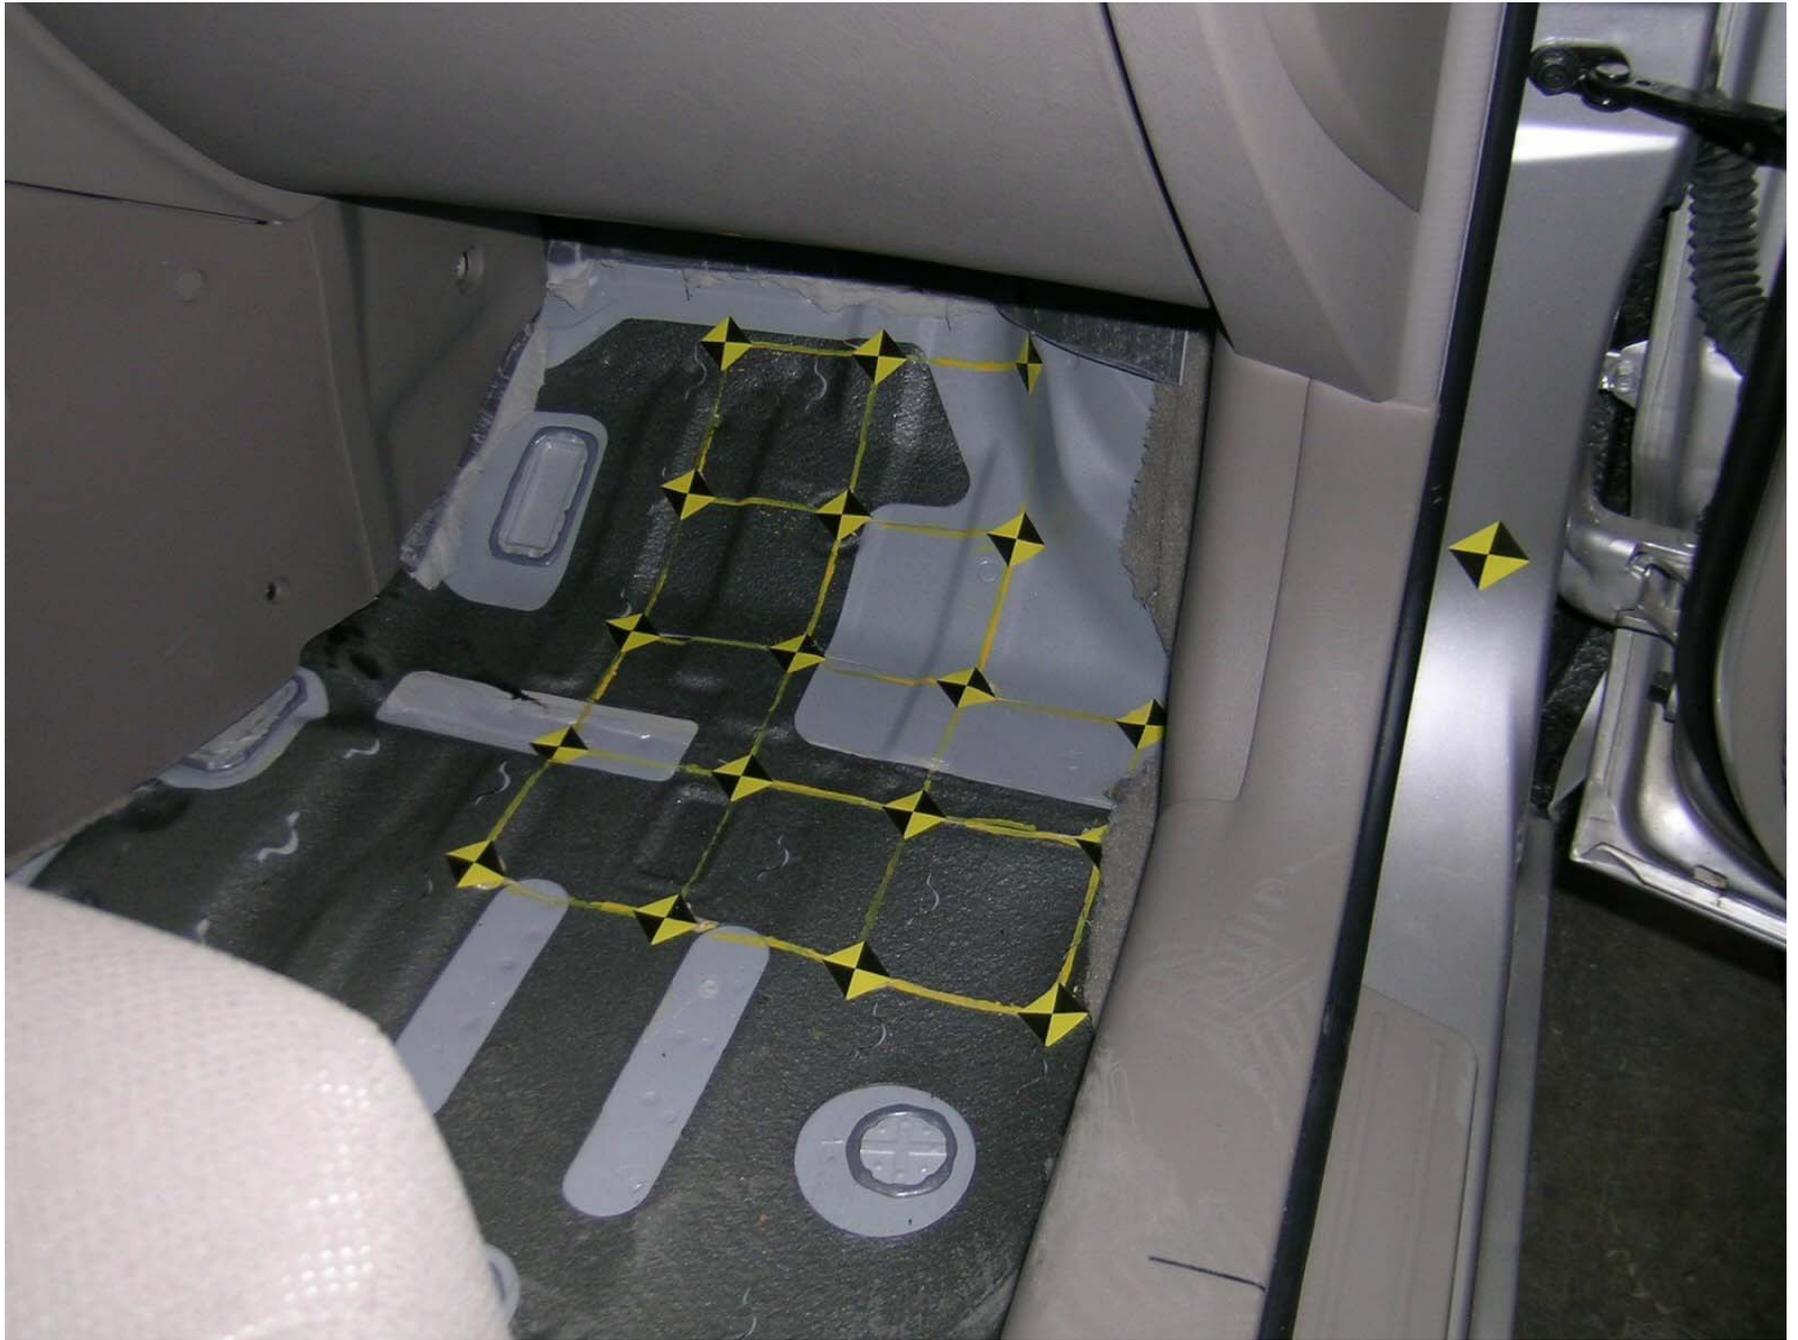
Figure A-53: Post-Test Passenger Side Glove Box

The passenger's visible contact points were as follows: The passenger ATD's head, chest and abdomen contacted the airbag. Both knees contacted the glove box.

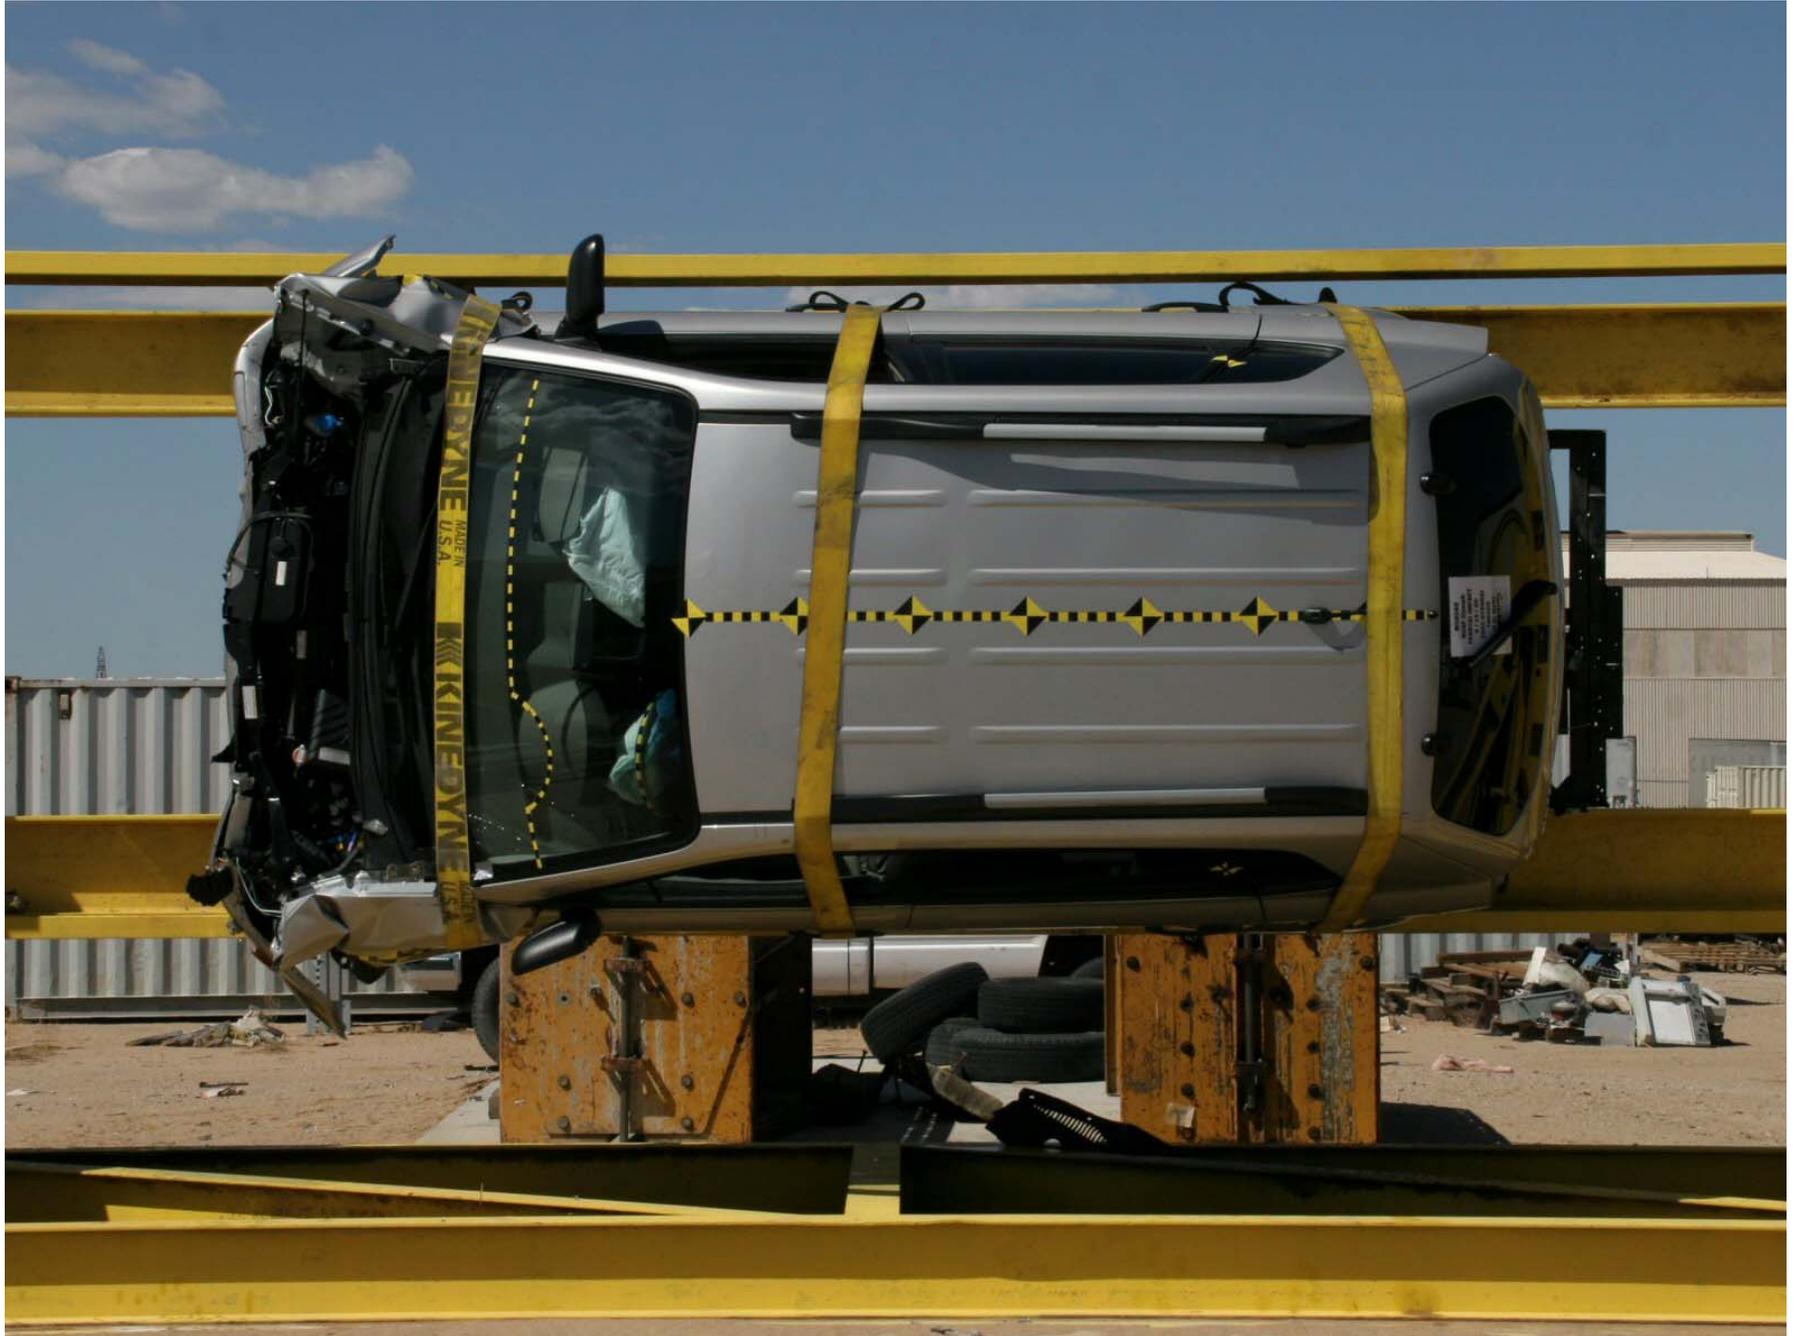
Figure A-58: Vehicle on Rollover Device (0°)

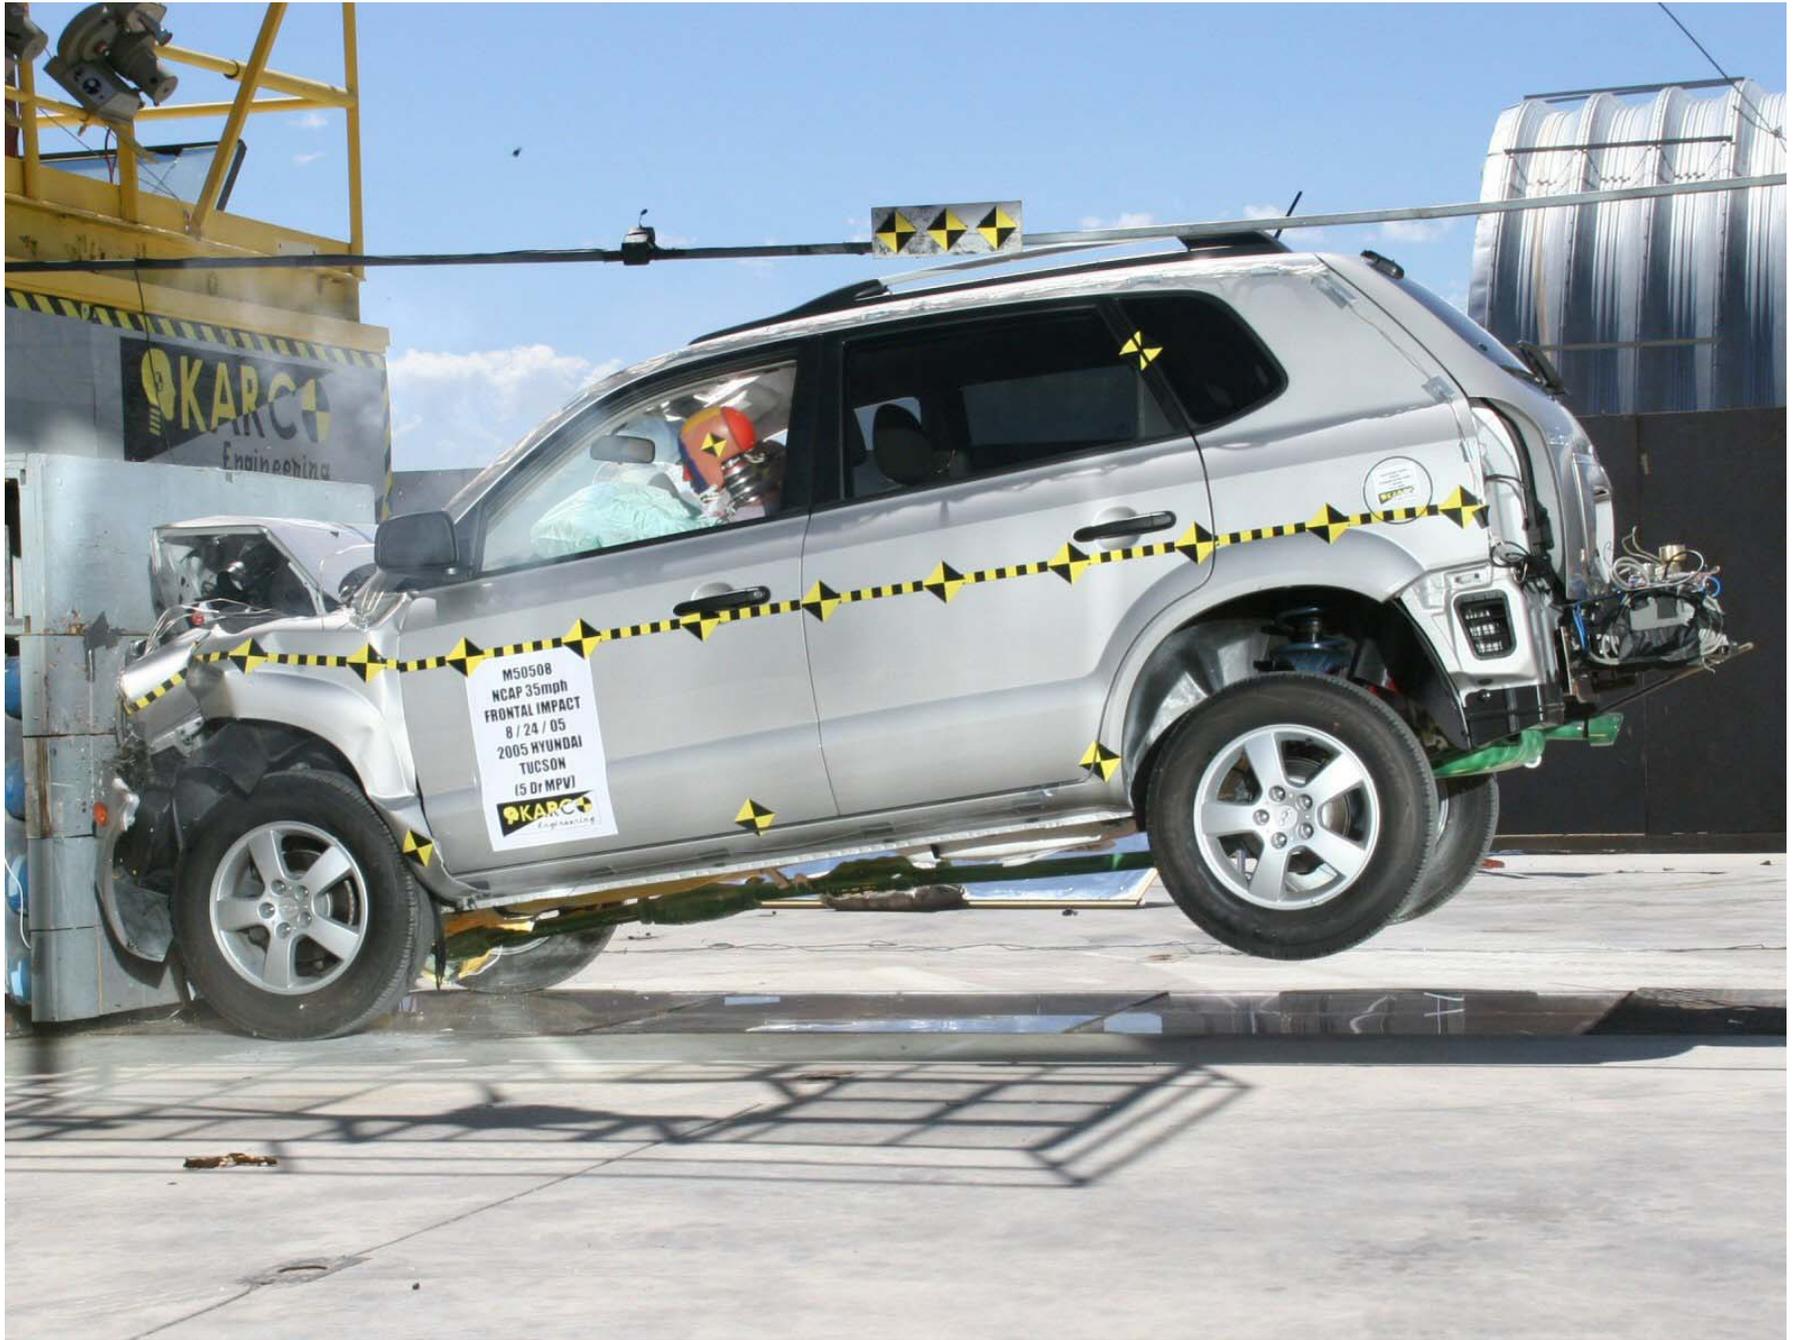
Figure A-62: Vehicle Impact

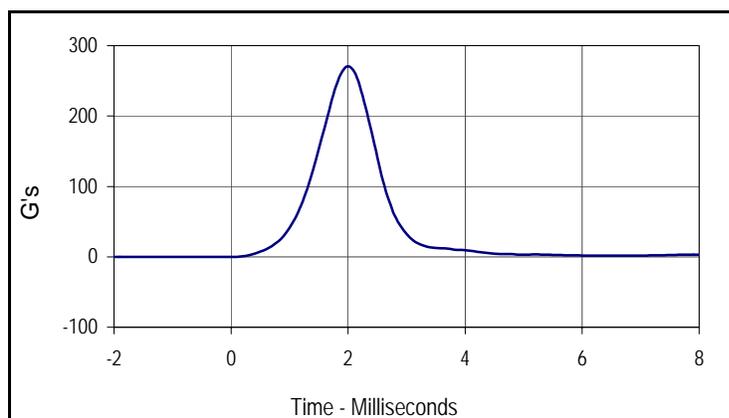
Tested Parameter	Units	Specification	Result	Pass/Fail
Laboratory Temperature	°C	18.9 to 25.6	21.1	Pass
Laboratory Relative Humidity	%	10 to 70	30	Pass
Peak Resultant Acceleration	G's	225.0 to 275.0	270.6	Pass
Peak Lateral Acceleration	G's	≤15.0	10.3	Pass
Is Acceleration Unimodal?	Yes/No	Yes	Yes	Pass
Overall Test Results			Pass

Curve Description			
Head Resultant			
CURNO	Type	SAE Class	Units
001	RES	1000	G's
Max	Time	Min	Time
270.6	2.0	0.0	-0.2

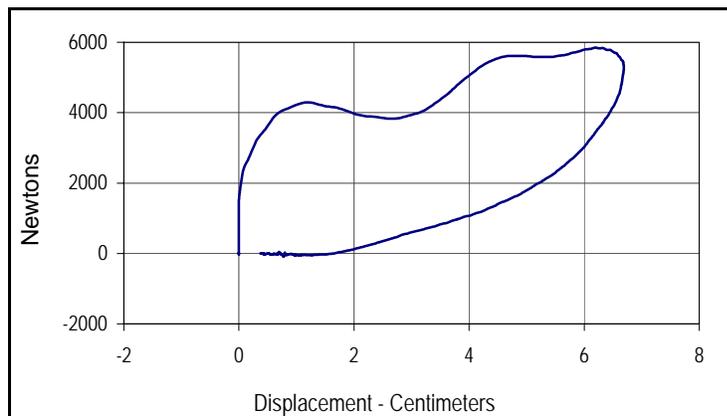
Tested Parameter	Units	Specification	Result	Pass/Fail
Laboratory Temperature	°C	20.6 to 22.2	21.1	Pass
Laboratory Relative Humidity	%	10 to 70	30	Pass
Probe Velocity	m/s	6.58 to 6.82	6.75	Pass
Peak Probe Force	Newtons	5159 to 5893	5846	Pass
Peak Sternum Deflection	CM	6.35 to 7.26	6.69	Pass
Internal Hysteresis	%	69 to 85	75.5	Pass
Overall Test Results				Pass

Curve Description			
Probe Force vs. Chest Deflection			
CURNO	Type	SAE Class	Hysteresis
001	FIL	180	75.5
Peak Probe Force		Peak Chest Deflection	
5846		6.69
