**REPORT NUMBER TR-P26001-08-NC**

**NEW CAR ASSESSMENT PROGRAM  
FRONTAL BARRIER IMPACT TEST**

**GENERAL MOTORS CORPORATION  
2006 BUICK LUCERNE CX  
4-DOOR SEDAN**

**FINAL REPORT**

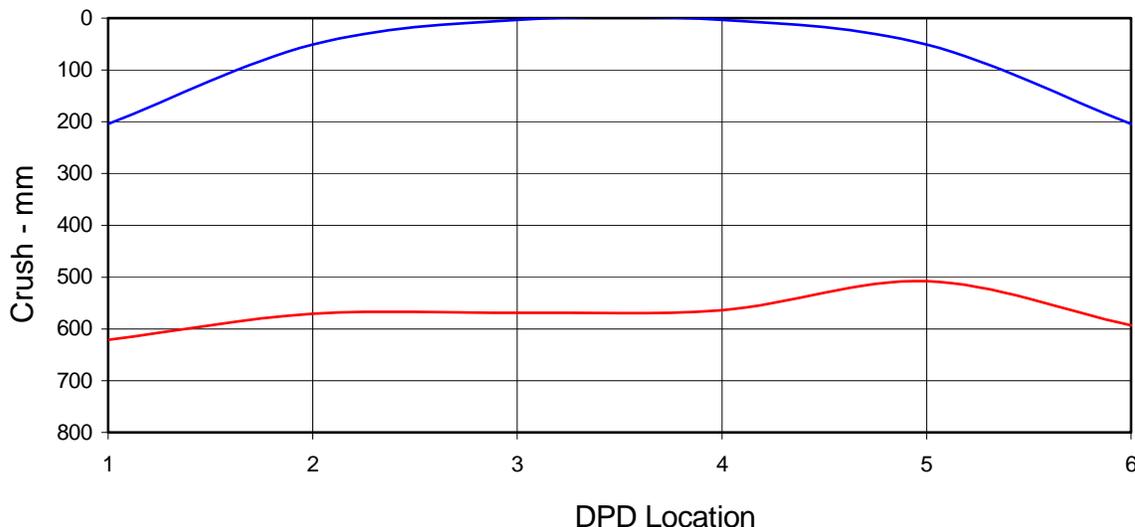
Collision Deformation Classification: 12FDEW6 Midpoint of Damage: Vehicle Centerline  
 Damage Region Length (mm): 1550 Impact Mode: Full Frontal

No.	Measurement Description	Units	Pre-Test	Post-Test	Difference
C1	Crush zone 1 at left side	mm	204	621	-417
C2	Crush zone 2 on left side	mm	51	571	-520
C3	Crush zone 3 on left side	mm	3	569	-566
C4	Crush zone 4 on right side	mm	3	564	-561
C5	Crush zone 5 on right side	mm	51	508	-457
C6	Crush zone 6 at right side	mm	204	593	-389

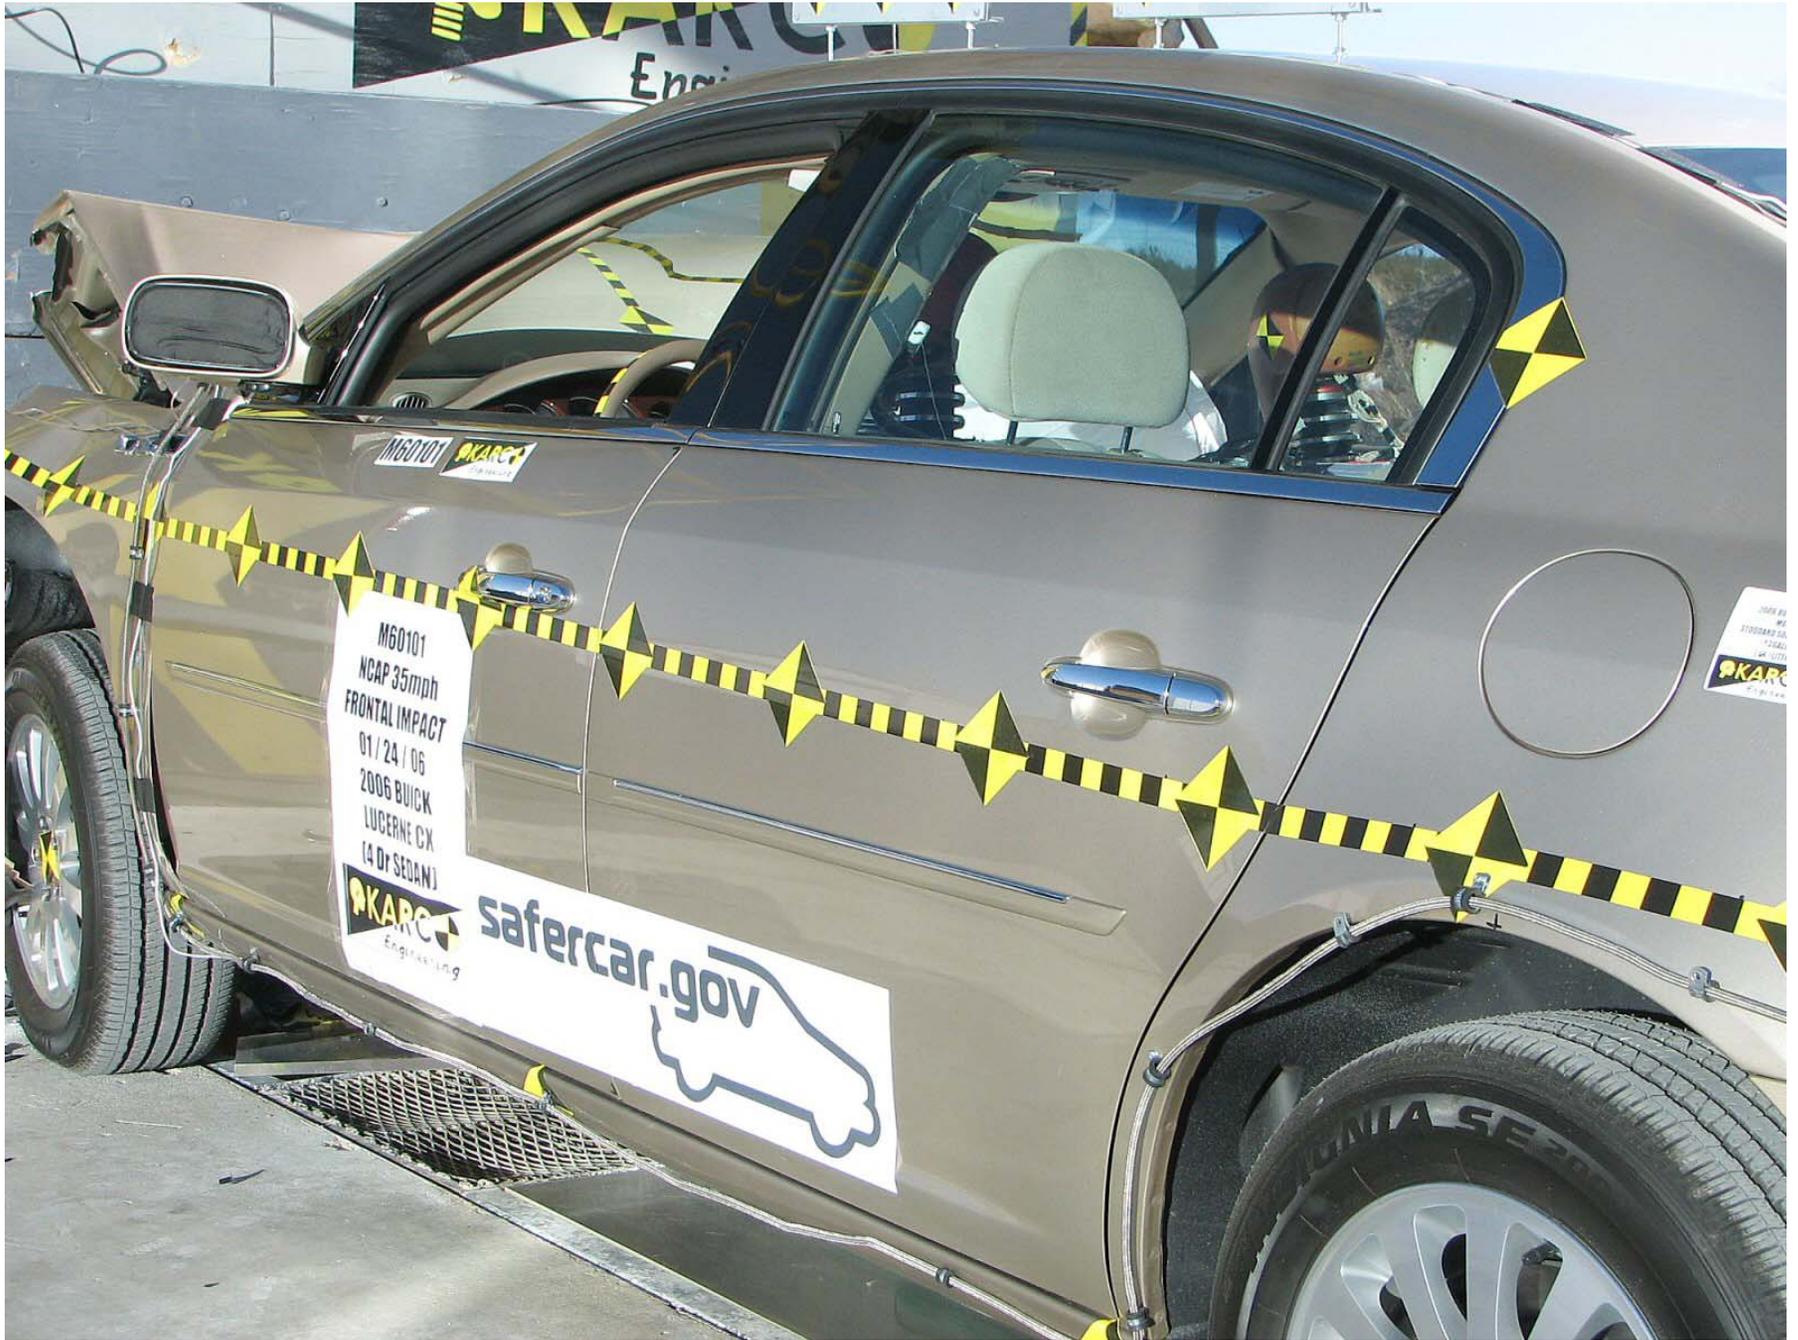
Figure A-16: Post-Test Left Side 3/4 View of Doors After Impact

The maximum static crush of the vehicle was 571 at the vehicle's centerline and both the driver and the passenger side doors remained closed and latched during the impact event and were operable after the impact.

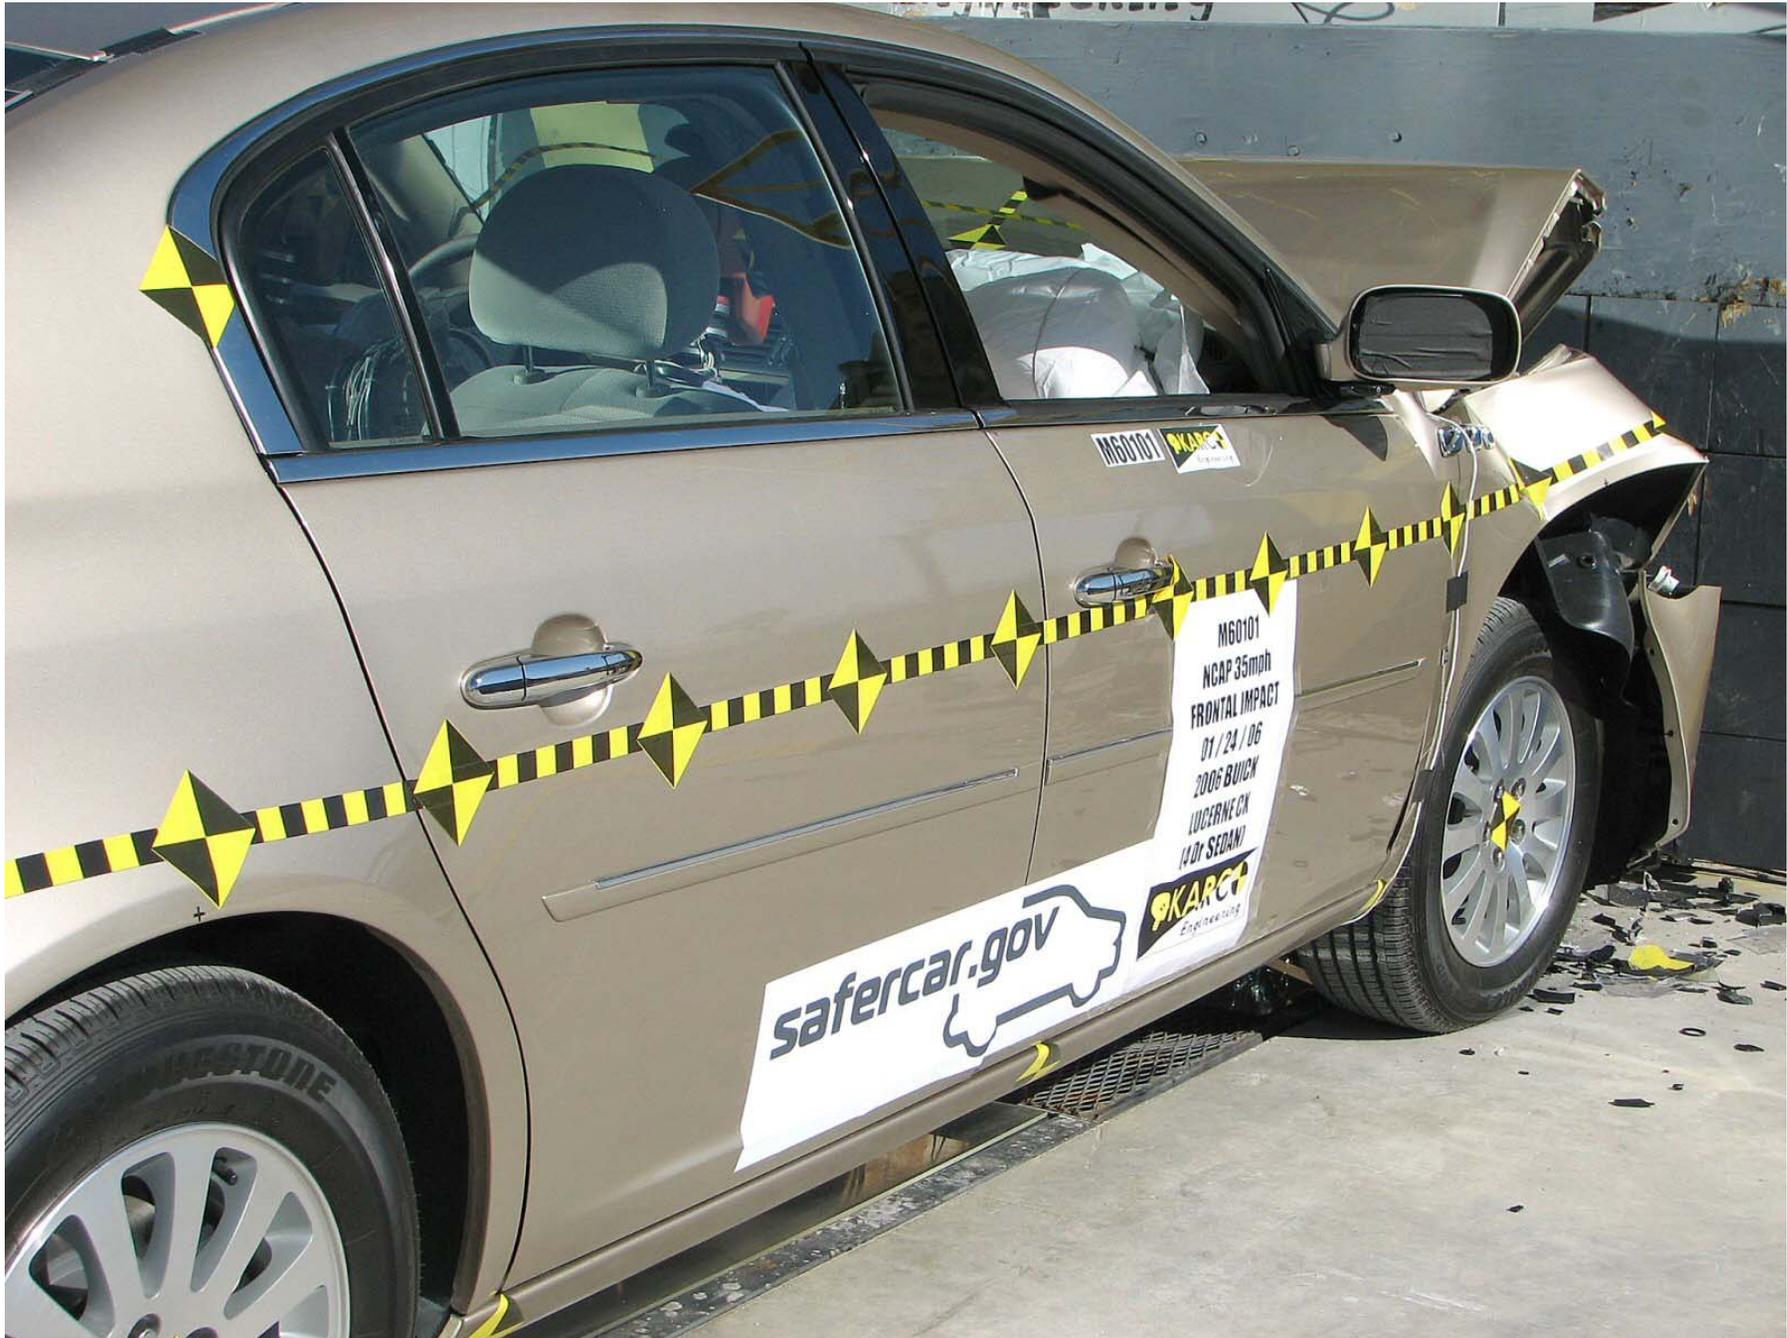
Figure A-17: Post-Test Right Side ¾ View of Doors After Impact

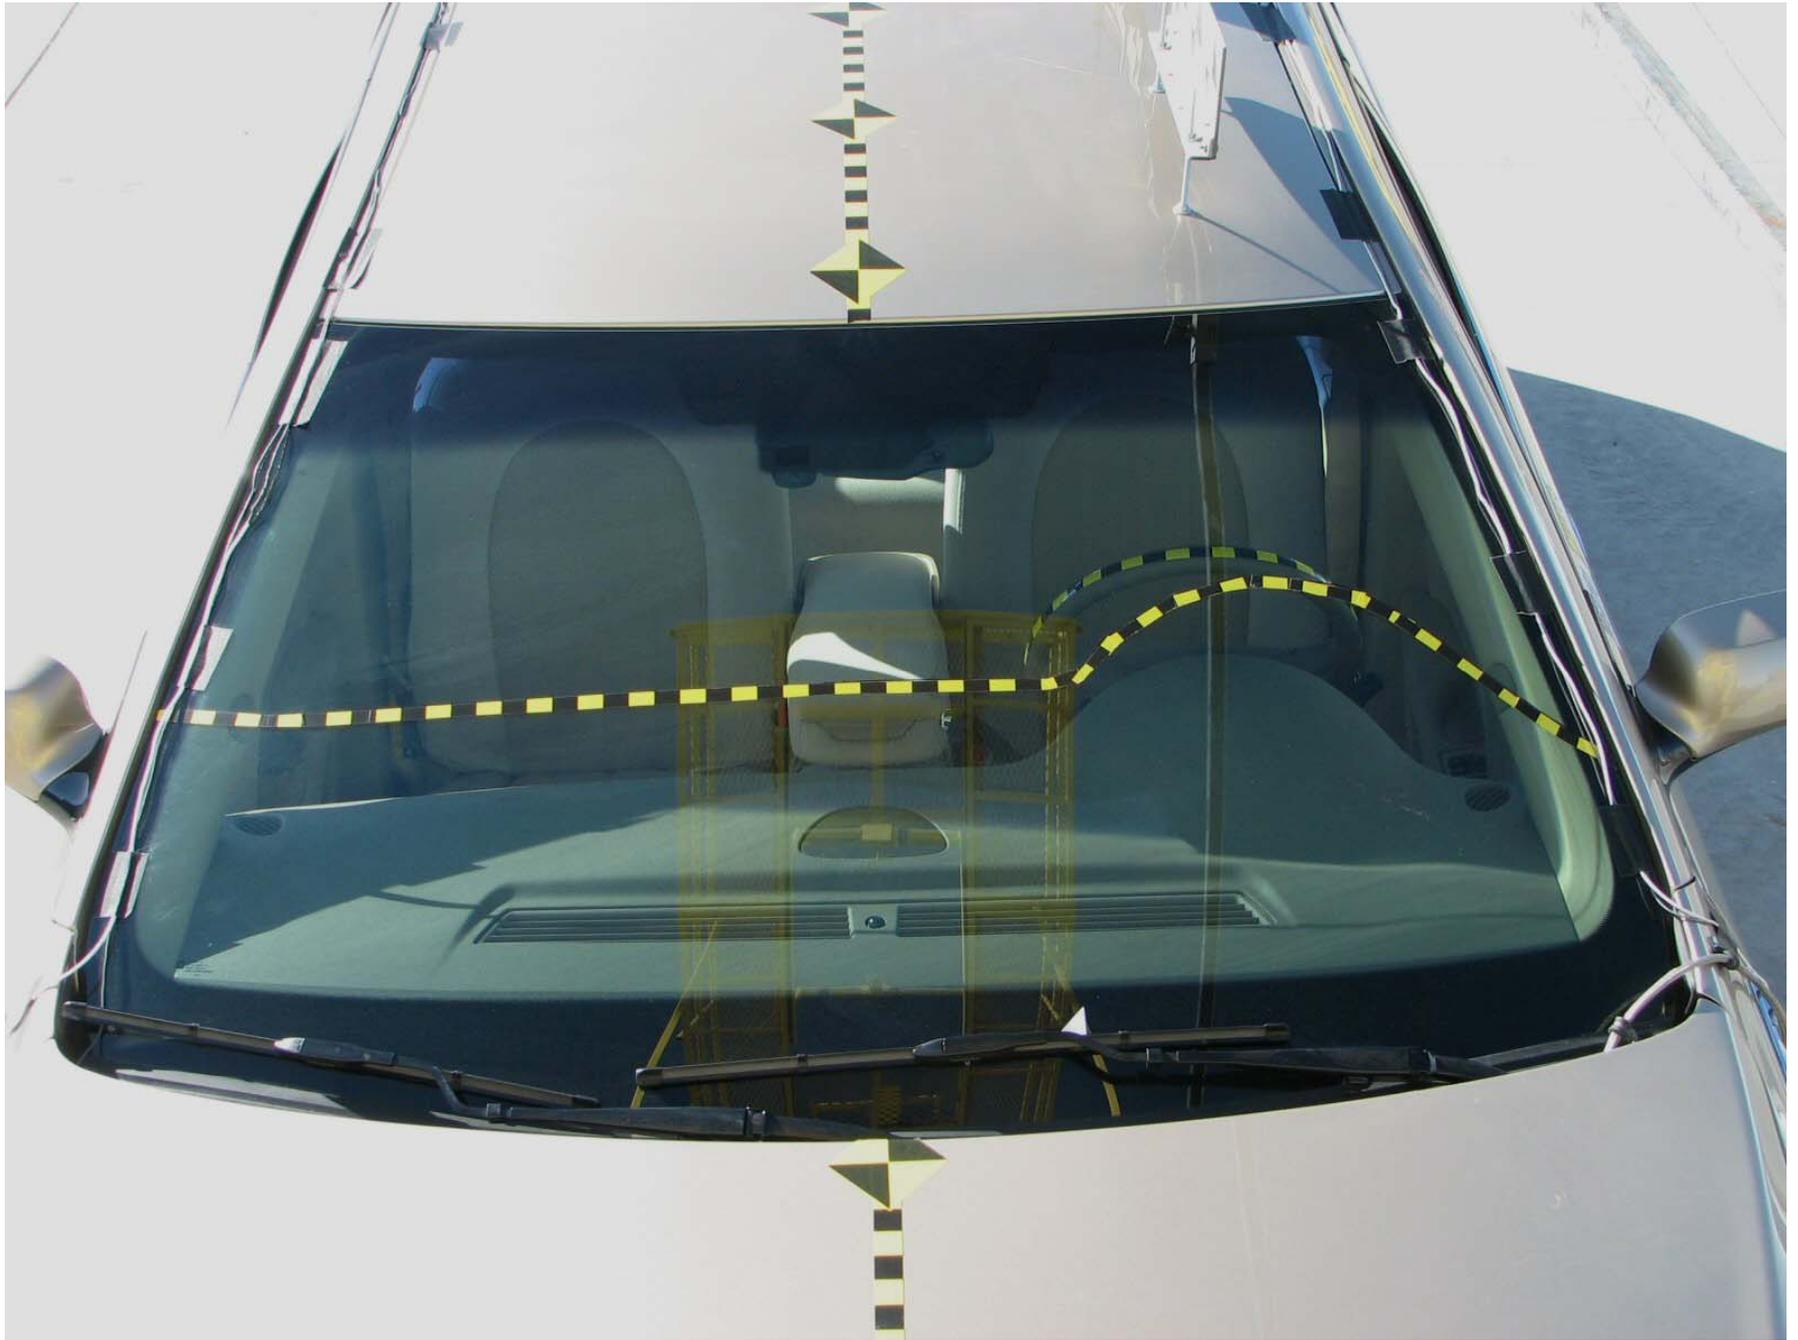
Figure A-18: Pre-Test Windshield

There was 100 percent windshield retention and there was no intrusion into the protected zone of the windshield during the impact event. There was no stoddard solvent leakage after the event or during any phase of the static rollover.

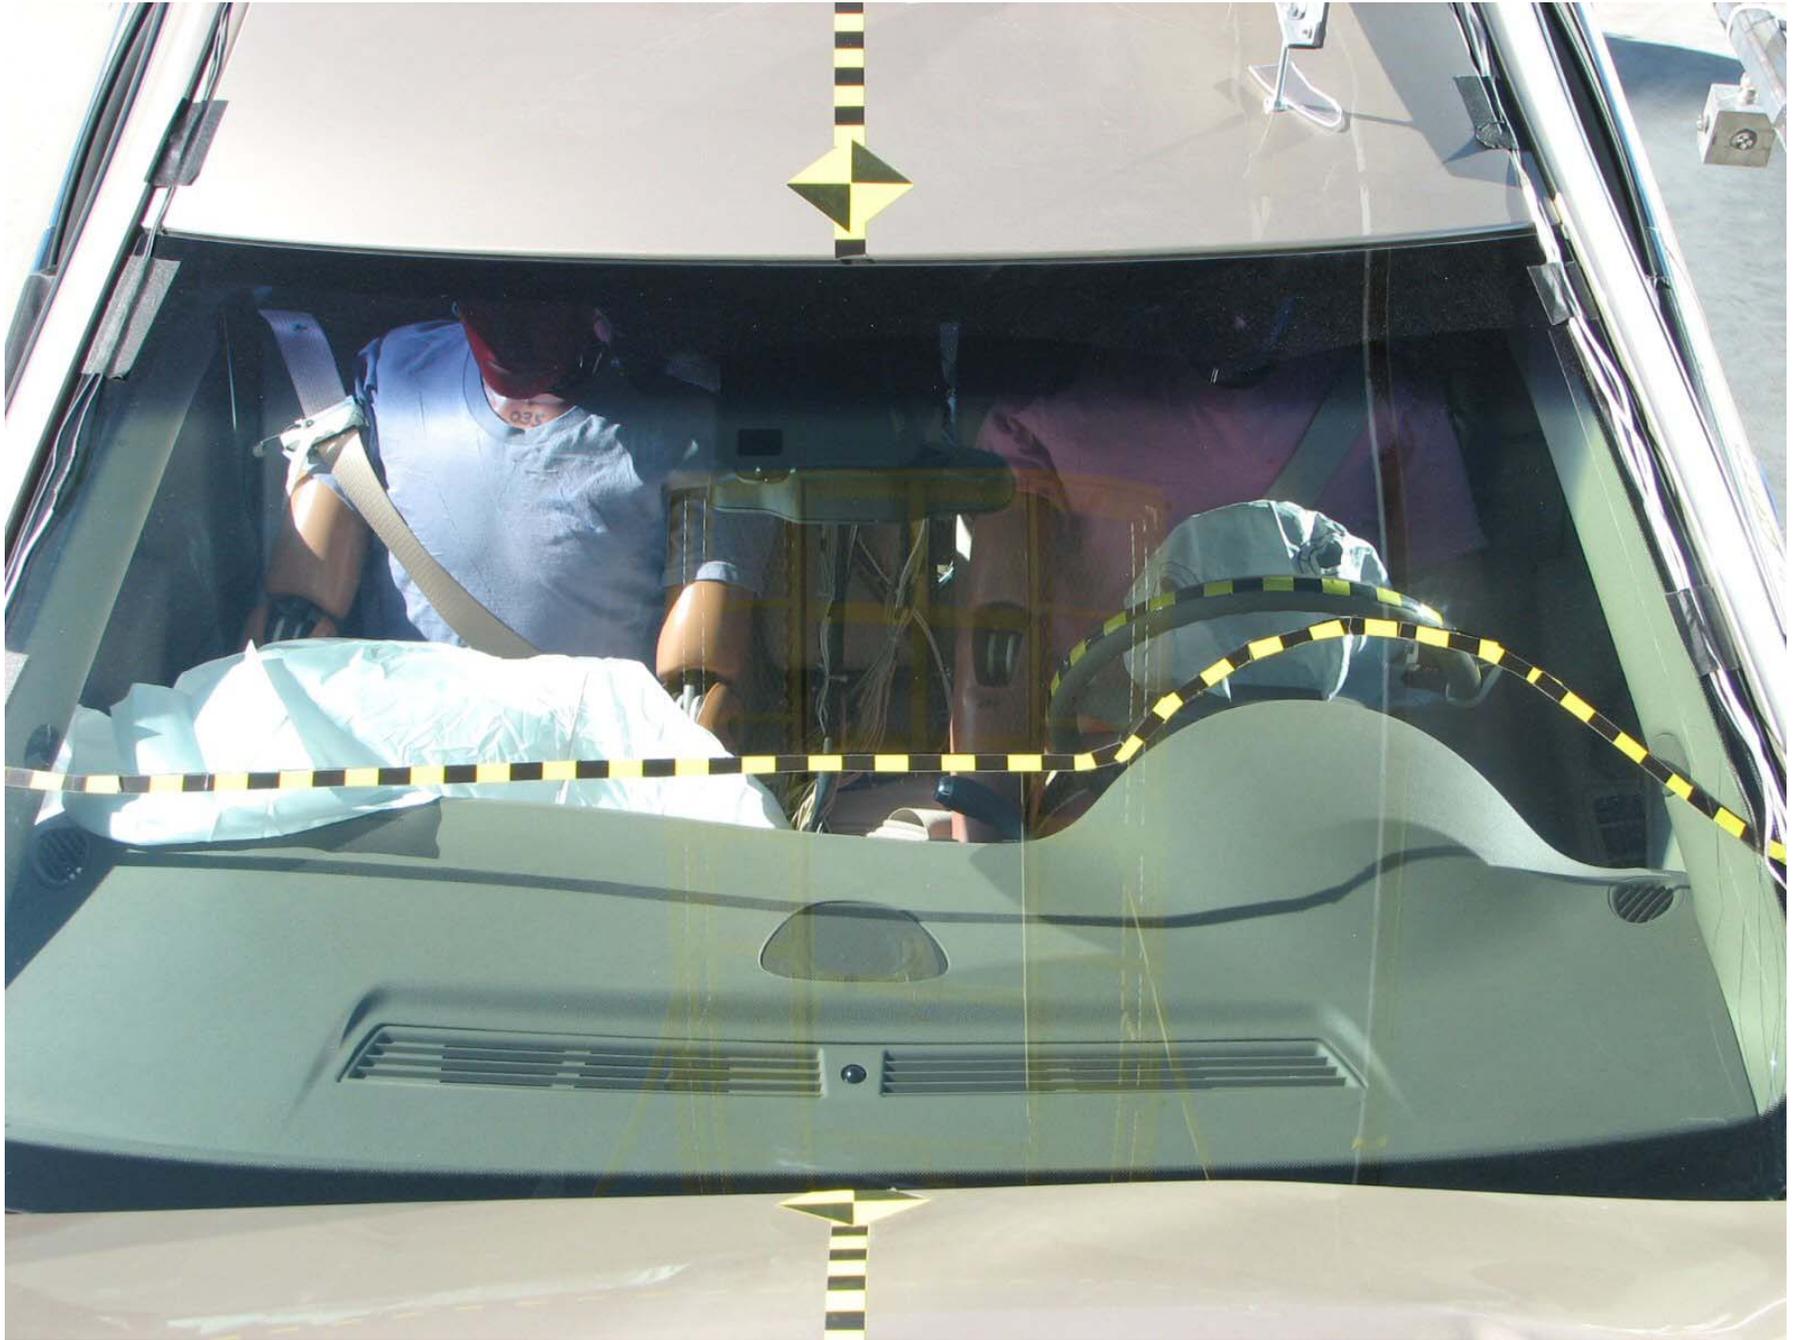
Figure A-19: Post-Test Windshield

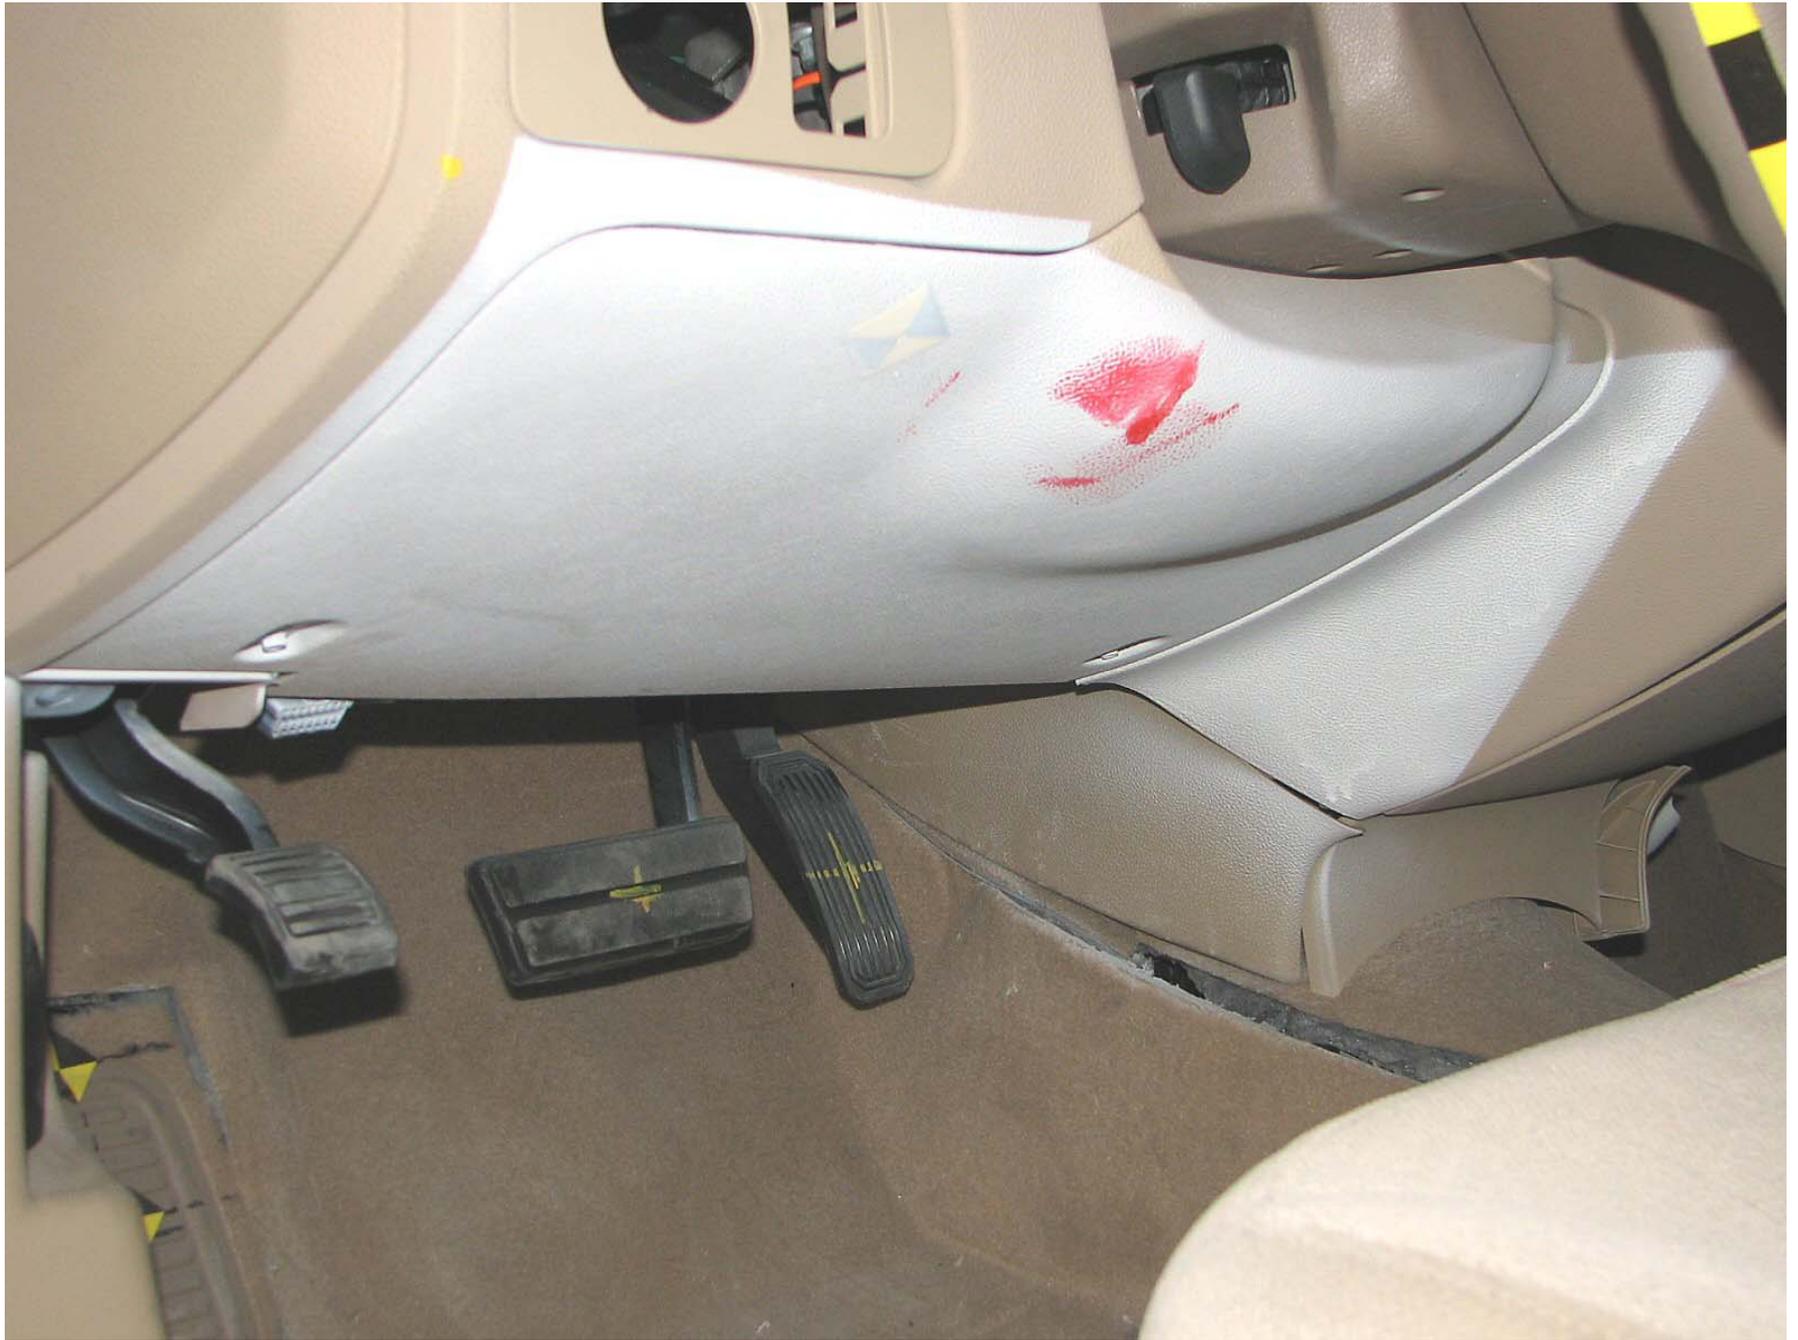
Figure A-39: Post-Test Driver Side Knee Bolster

The driver's visible contact points were as follows: The driver ATD's head and chest contacted the airbag and the abdomen had no contact. Both knees contacted the knee bolster.

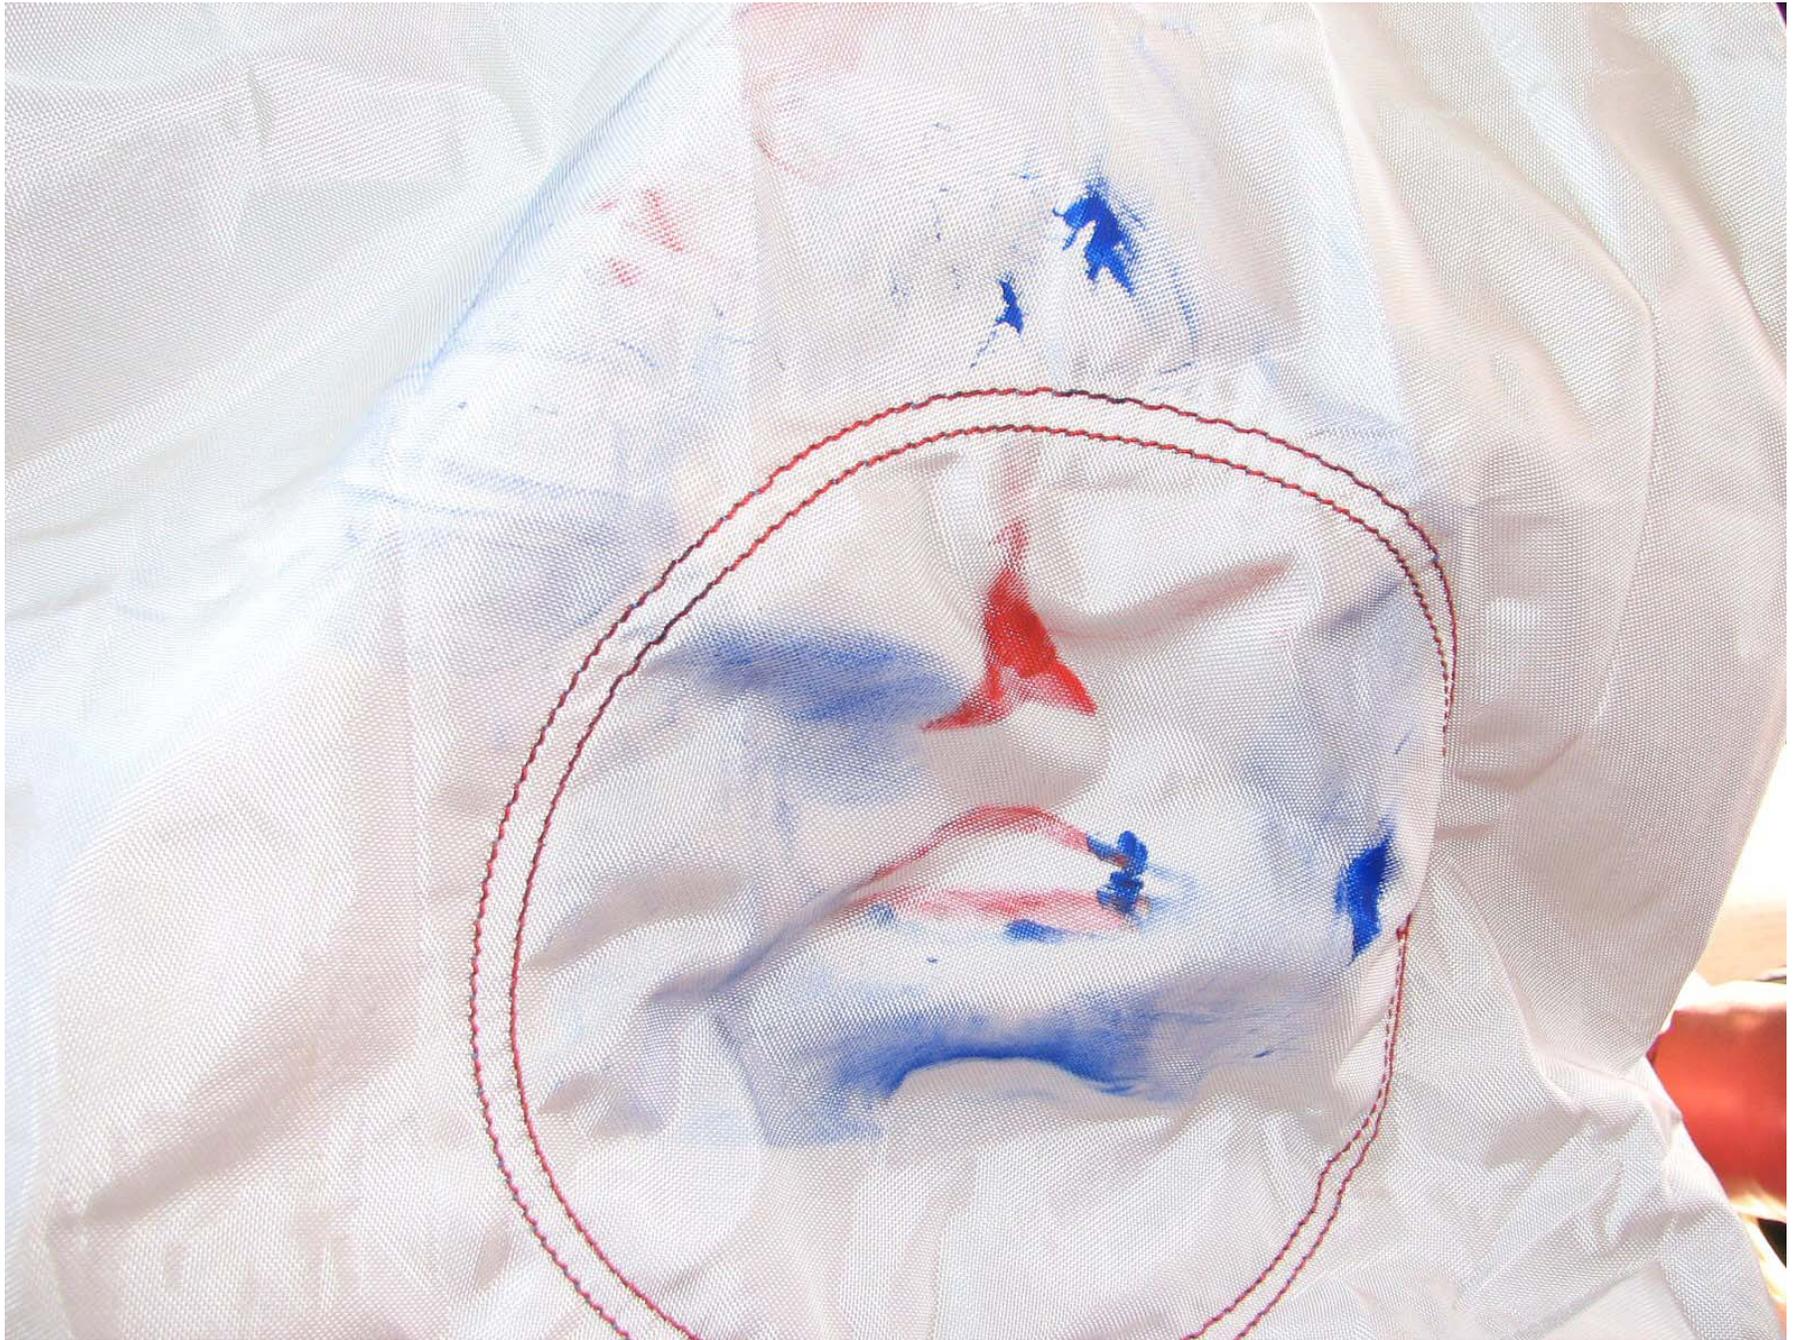
Figure A-43: Post-Test Driver Dummy Airbag Contact

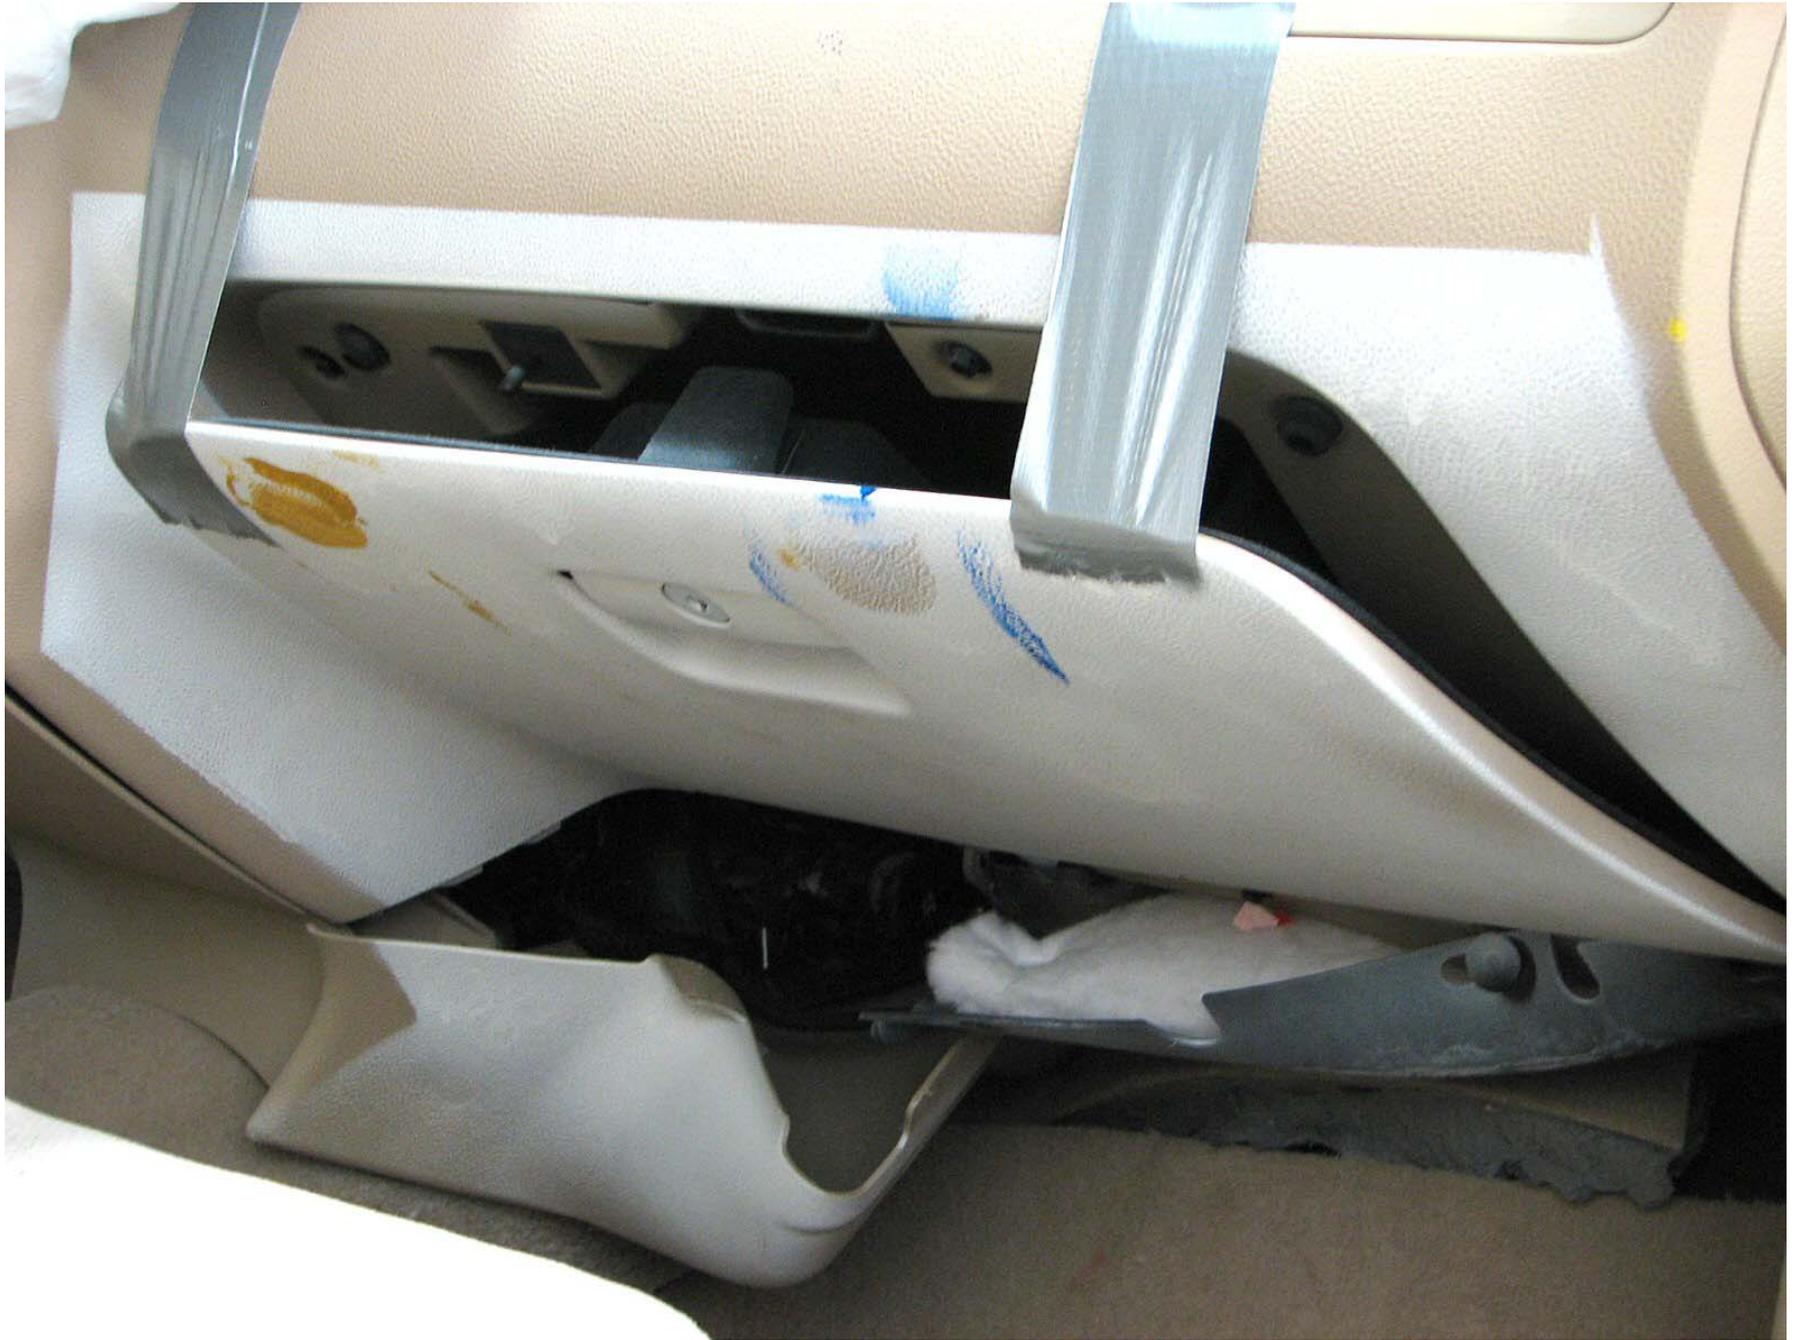
Figure A-53: Post-Test Passenger Side Glove Box

The passenger's visible contact points were as follows: The passenger ATD's head, chest contacted the airbag and the abdomen had no contact. Both knees contacted the glove box.

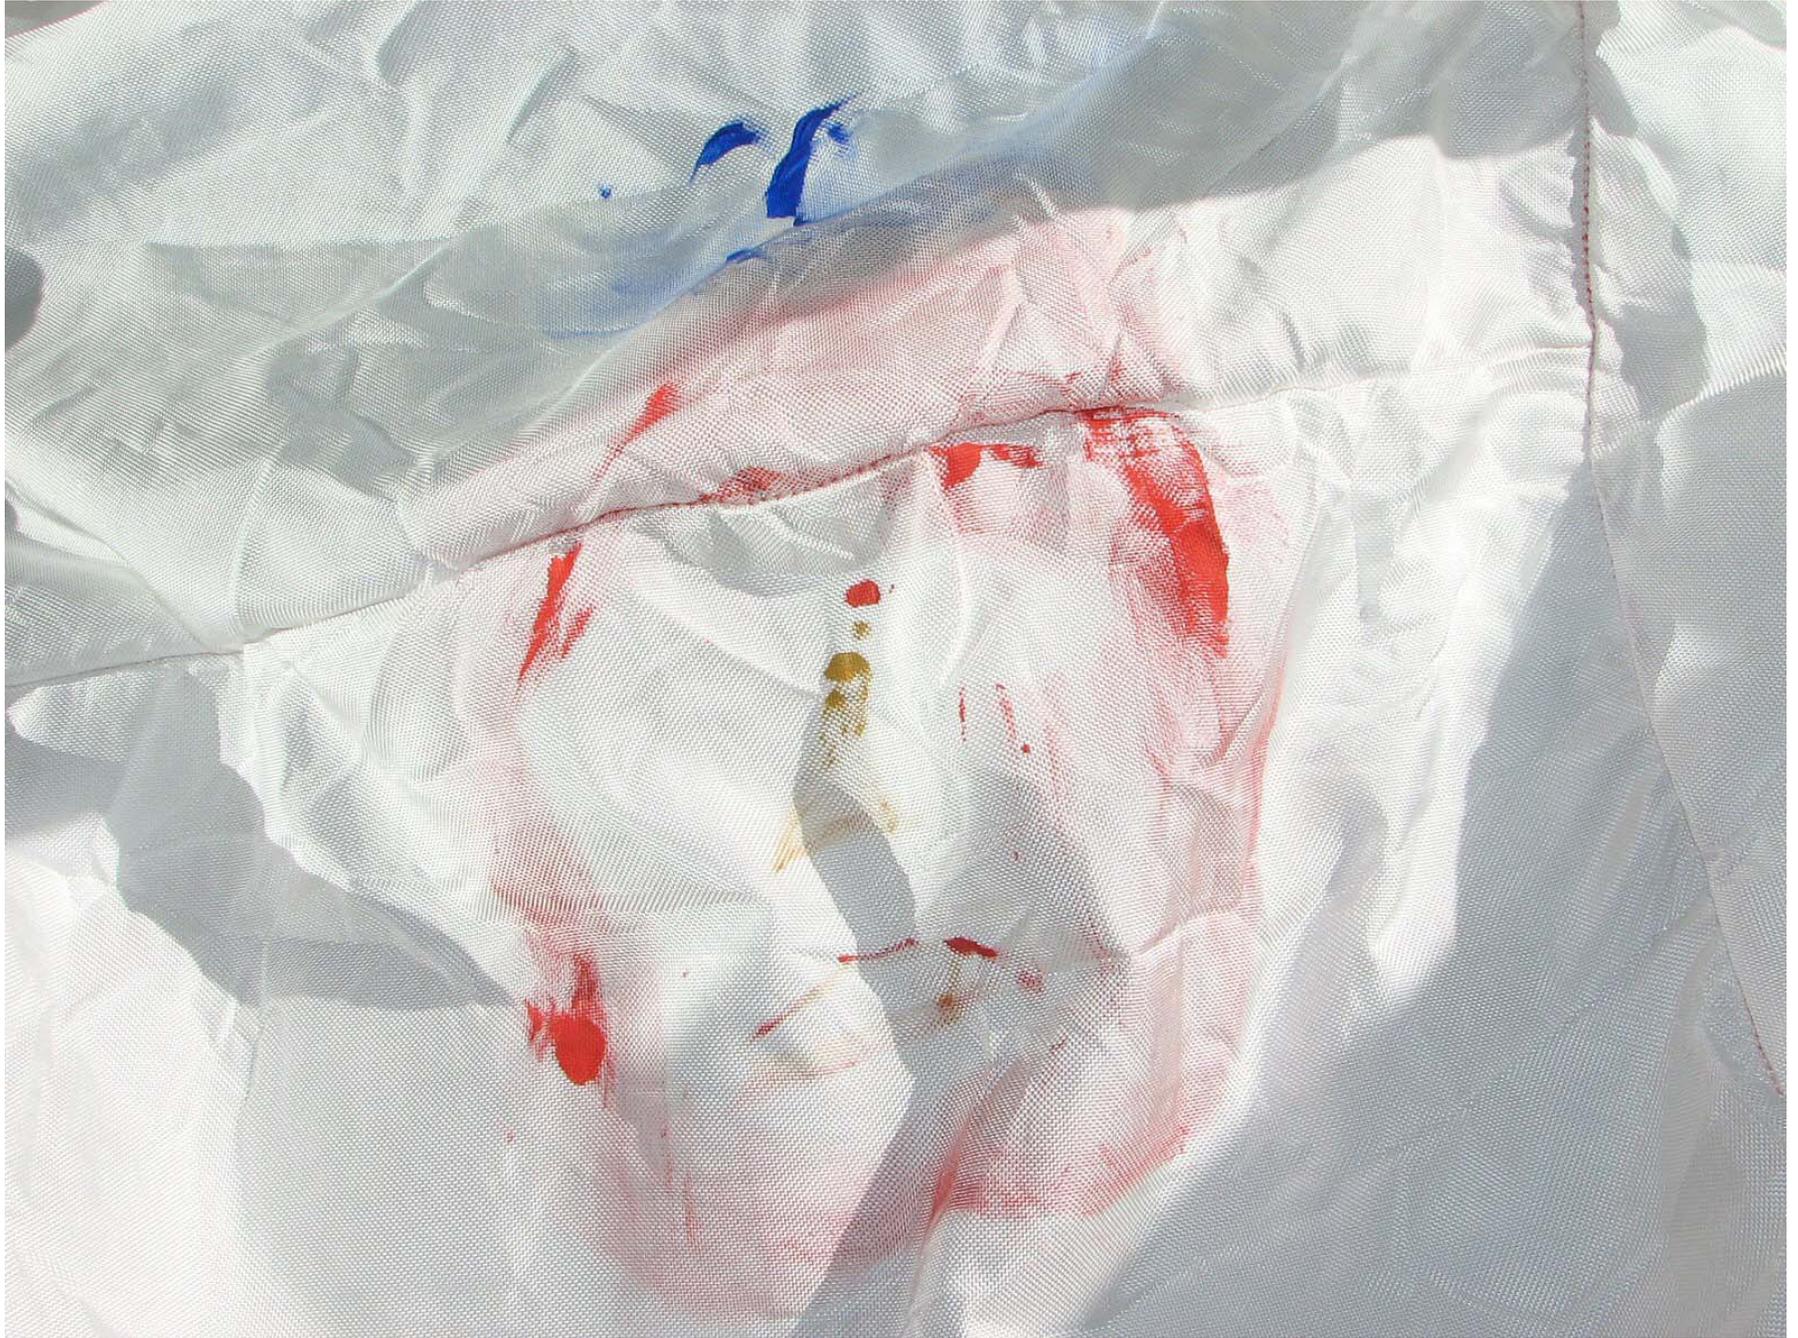
Figure A-57: Post-Test Passenger Dummy Airbag Contact
