**REPORT NUMBER TR-P26001-08-NC**

**NEW CAR ASSESSMENT PROGRAM  
FRONTAL BARRIER IMPACT TEST**

**GENERAL MOTORS CORPORATION  
2006 BUICK LUCERNE CX  
4-DOOR SEDAN**

**FINAL REPORT**

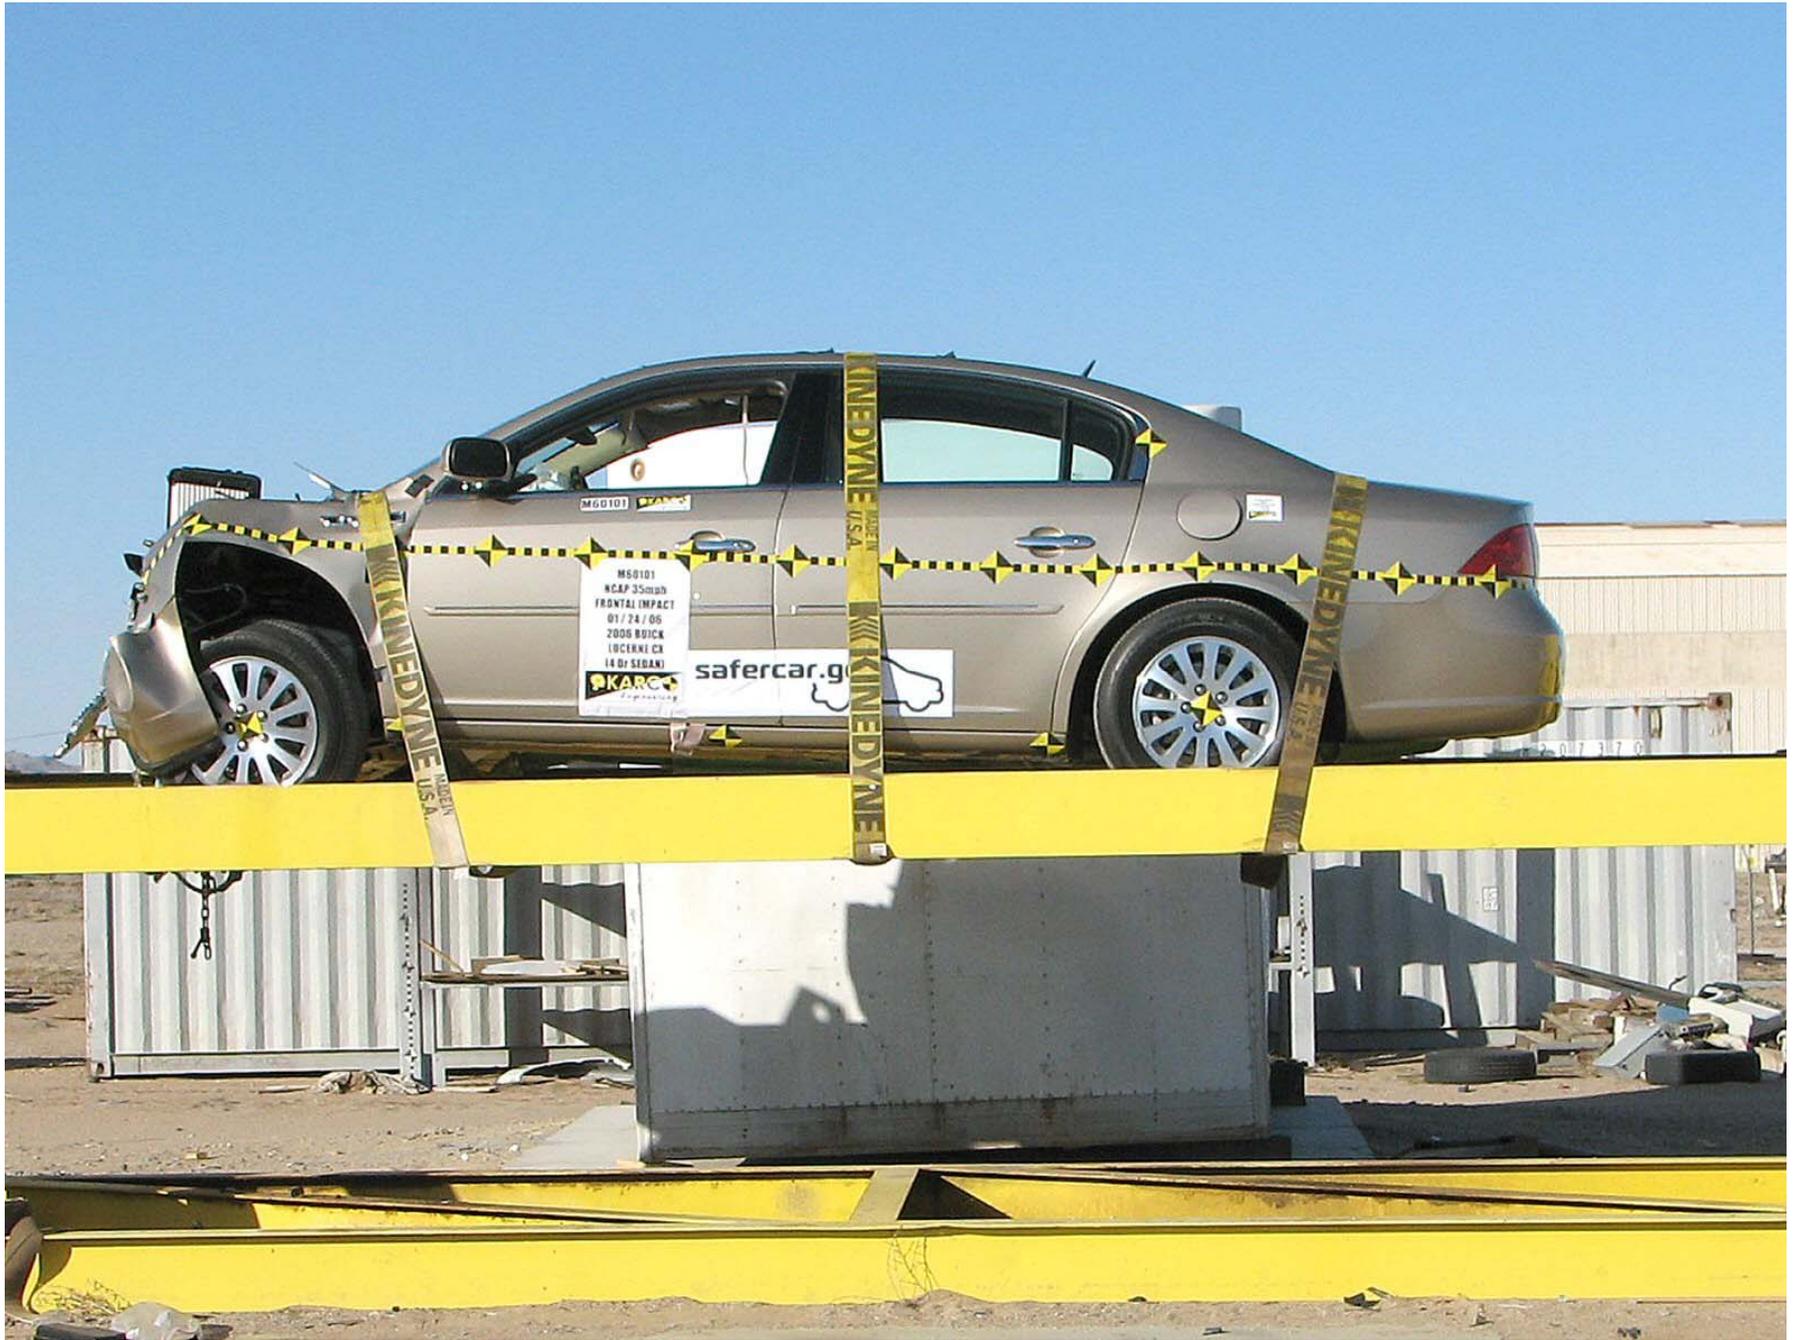
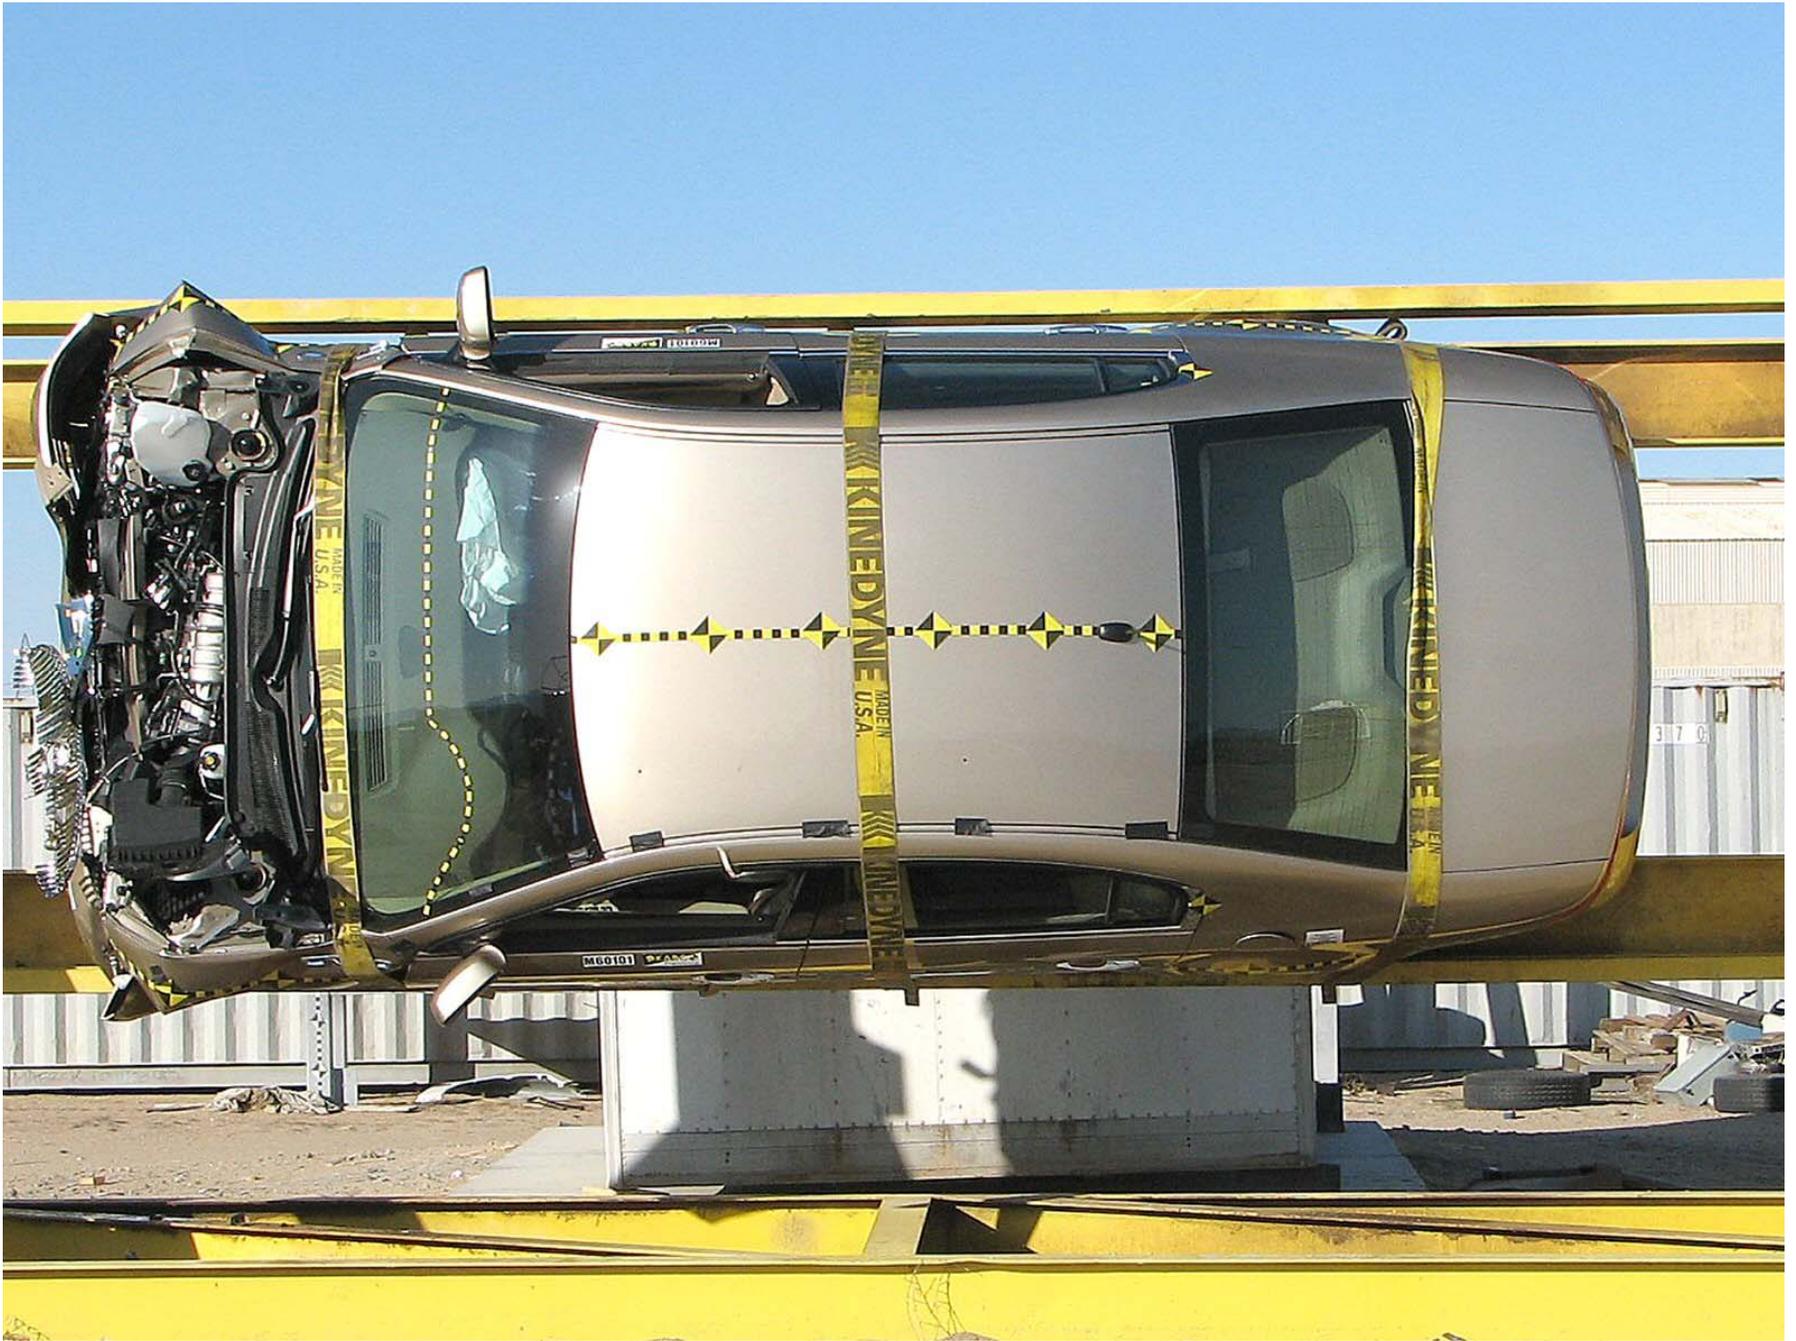
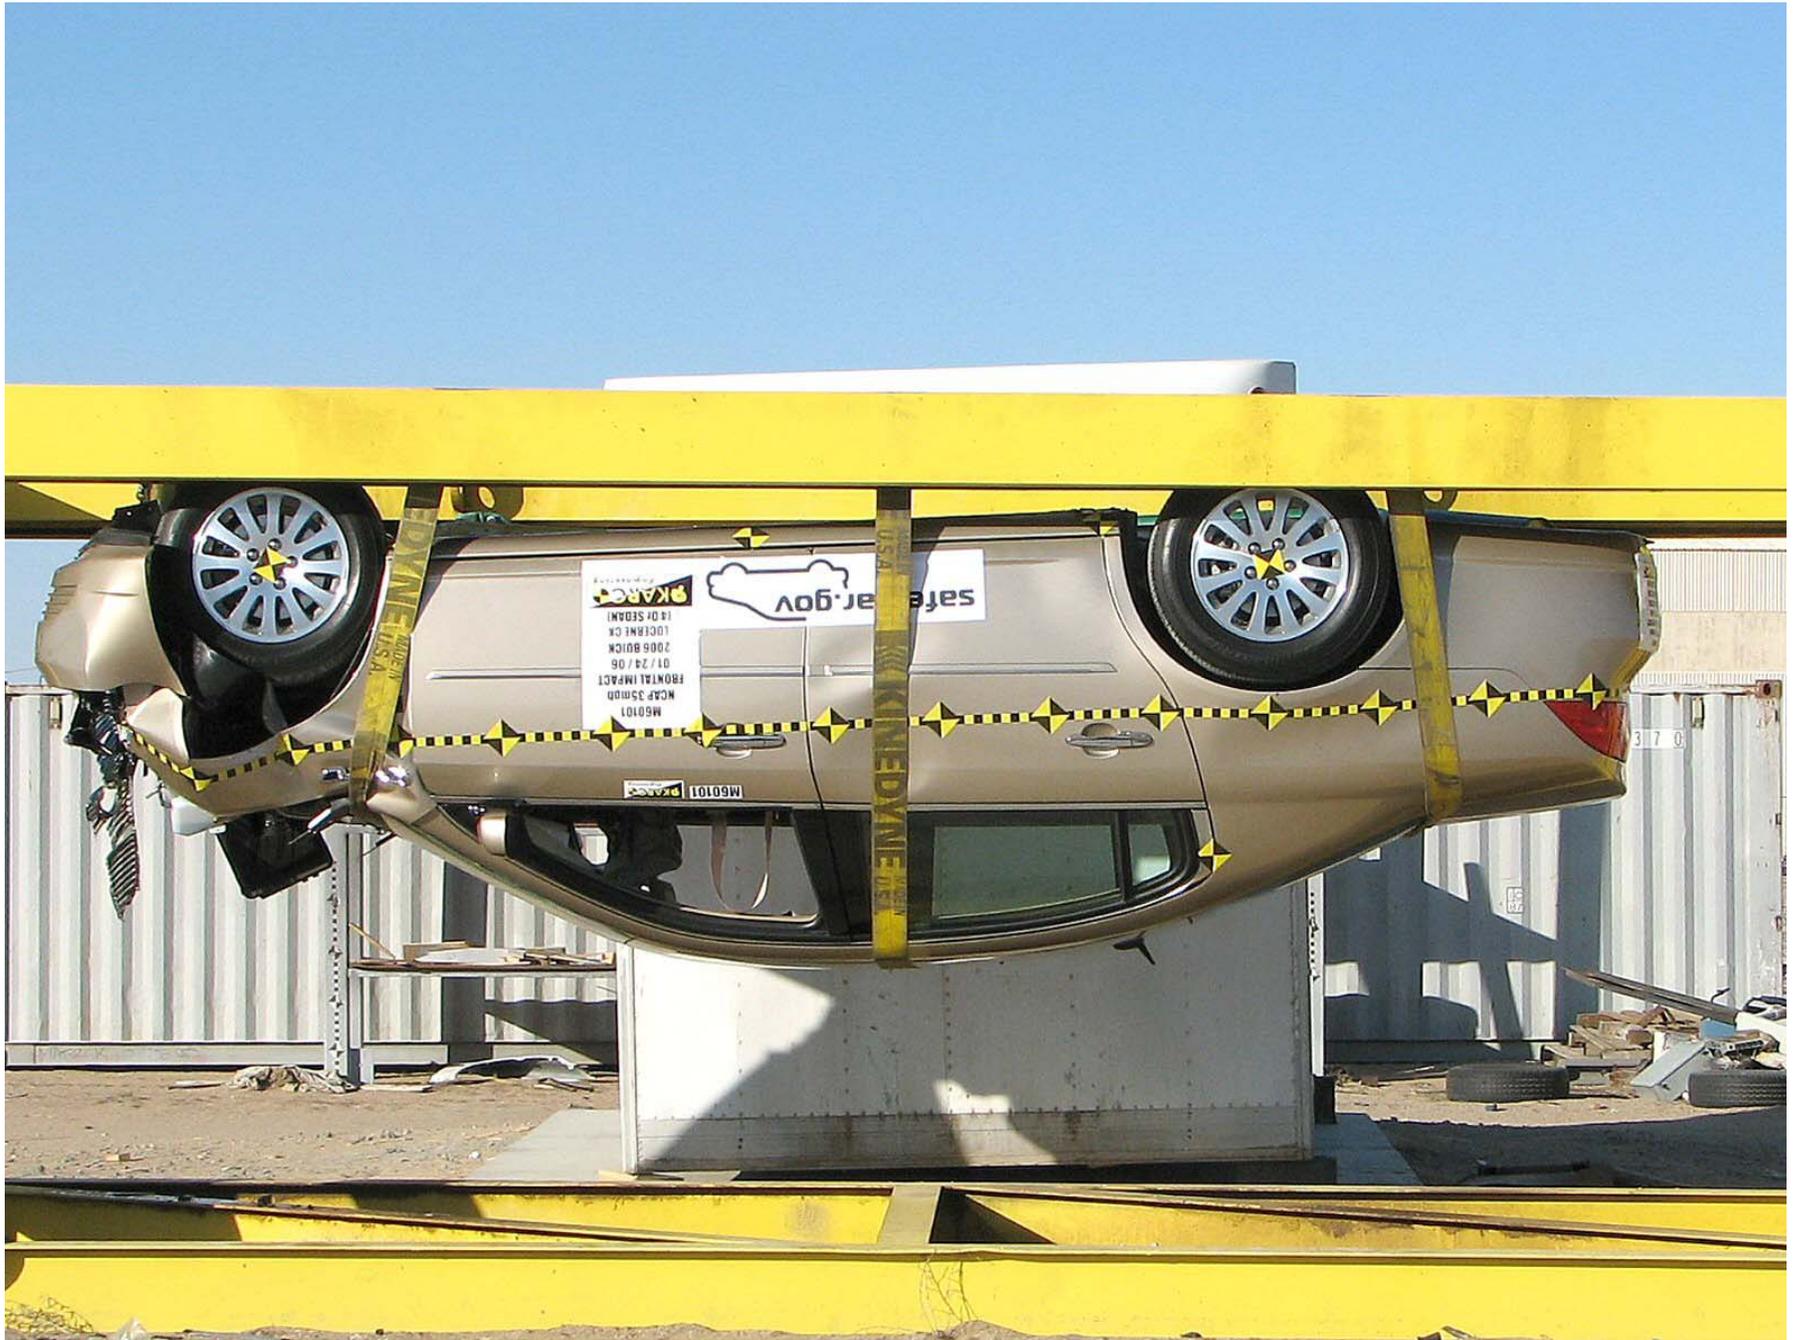
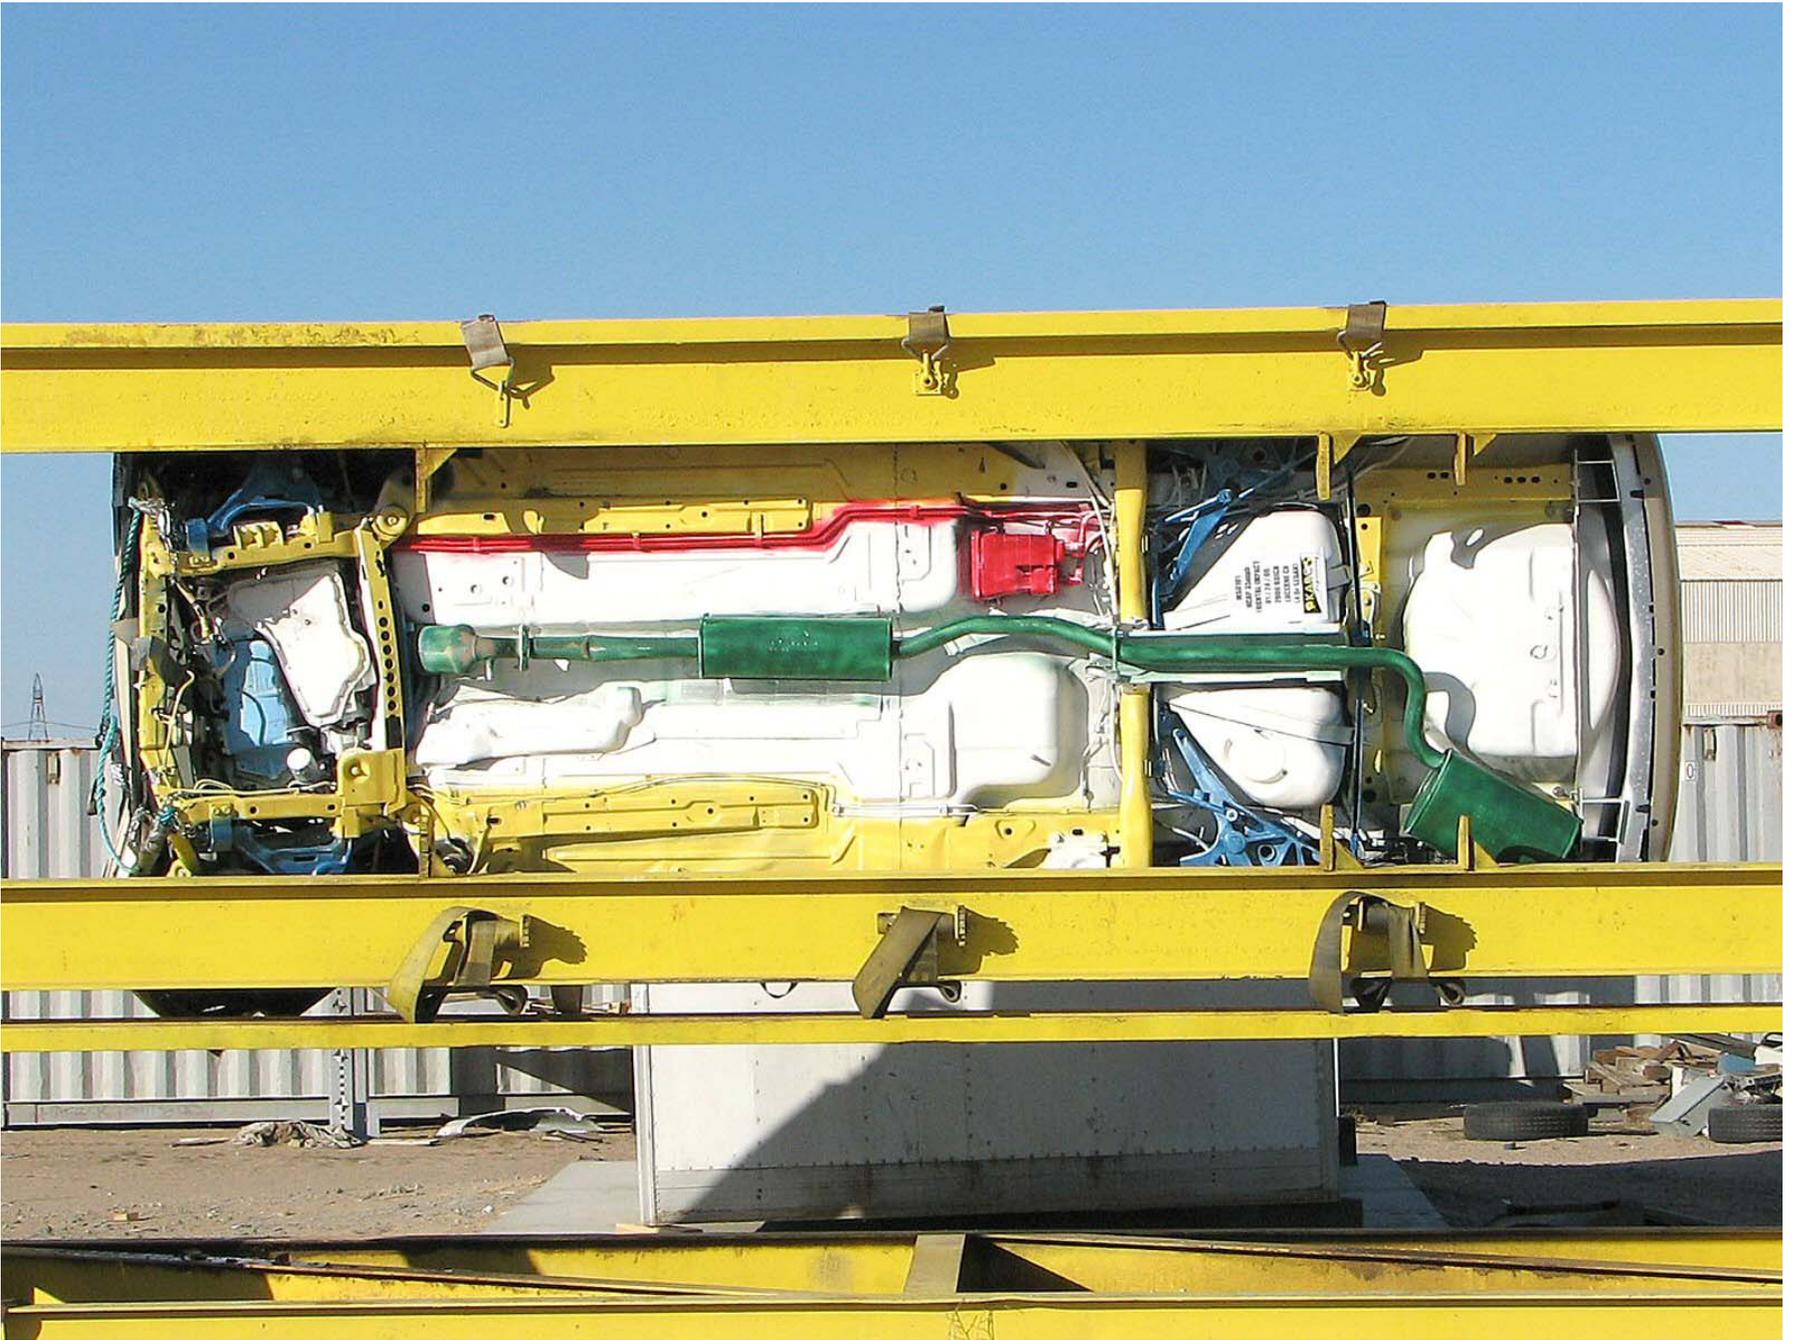
Figure A-58: Vehicle on Rollover Device (0°)

Figure A-59: Vehicle on Rollover Device (90°)

Figure A-60: Vehicle on Rollover Device (180°)

Figure A-61: Vehicle on Rollover Device (270°)

1. The specified fixture rollover rate for each 90° of rotation is 60 to 120 seconds.
2. The position hold time at each position is 300 seconds (minimum).
3. No solvent leakage occurred during rollover.

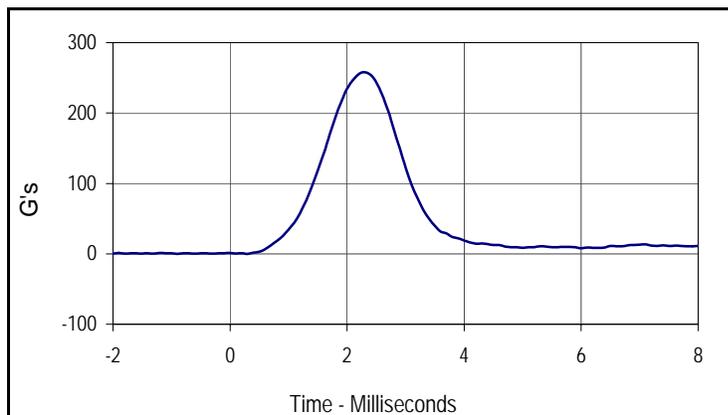
Tested Parameter	Units	Specification	Result	Pass/Fail
Laboratory Temperature	°C	18.9 to 25.6	21.1	Pass
Laboratory Relative Humidity	%	10 to 70	30	Pass
Peak Resultant Acceleration	G's	225.0 to 275.0	258.0	Pass
Peak Lateral Acceleration	G's	≤15.0	3.0	Pass
Is Acceleration Unimodal?	Yes/No	Yes	Yes	Pass
Overall Test Results				Pass

Curve Description			
Head Resultant			
CURNO	Type	SAE Class	Units
001	RES	1000	G's
Max	Time	Min	Time
258.0	2.3	0.1	-0.9

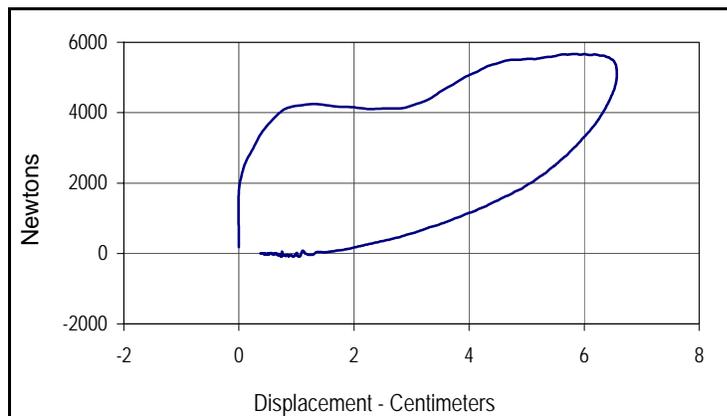
Tested Parameter	Units	Specification	Result	Pass/Fail
Laboratory Temperature	°C	20.6 to 22.2	21.1	Pass
Laboratory Relative Humidity	%	10 to 70	30	Pass
Probe Velocity	m/s	6.58 to 6.82	6.64	Pass
Peak Probe Force	Newtons	5159 to 5893	5670	Pass
Peak Sternum Deflection	CM	6.35 to 7.26	6.57	Pass
Internal Hysteresis	%	69 to 85	75.1	Pass
Overall Test Results				Pass

Curve Description			
Probe Force vs. Chest Deflection			
CURNO	Type	SAE Class	Hysteresis
001	FIL	180	75.1
Peak Probe Force		Peak Chest Deflection	
5670		6.57

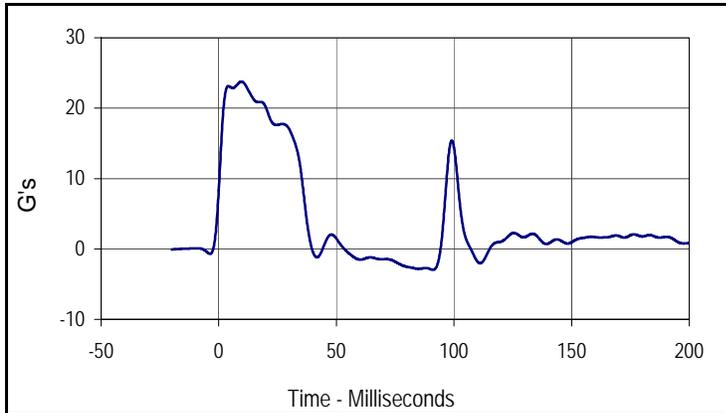
Tested Parameter	Units	Specification	Result	Pass/Fail	
Laboratory Temperature	°C	20.6 to 22.2	21.1	Pass	
Laboratory Relative Humidity	%	10 to 70	30	Pass	
Pendulum Velocity	m/s	6.89 to 7.13	6.98	Pass	
Pendulum Deceleration	10 Msec.	G's	22.5 to 27.5	23.8	Pass
	20 Msec.	G's	17.6 to 22.6	20.1	Pass
	30 Msec.	G's	12.5 to 18.5	17.0	Pass
Peak Pendulum Decel. after 30 Msec.	G's	≤ 29.0	17.0	Pass	
Deceleration Decay, Time to Cross 5 G's	Msec.	34.0 to 42.0	37.1	Pass	
Maximum "D" Plane Rotation	Max	Degrees	64.0 to 78.0	70.4	Pass
	Time	Msec.	57.0 to 64.0	60.9	Pass
"D" Plane Rotation Decay, Time To Zero Crossing	Msec.	113.0 to 128.0	118.6	Pass	
Moment About Occ. Condyle	Max	Nm	84.1 to 108.5	88.1	Pass
	Time	Msec.	47.0 to 58.0	53.6	Pass
Positive Moment Decay, Time To Zero Crossing	Msec.	97.0 to 107.0	99.8	Pass	
<b>Overall Test Results</b>				<b>Pass</b>

Curve Description			
Pendulum Deceleration			
CURNO	Type	SAE Class	Units
001	FIL	60	G's
Max	Time	Min	Time
23.8	9.6	-3.0	91.0

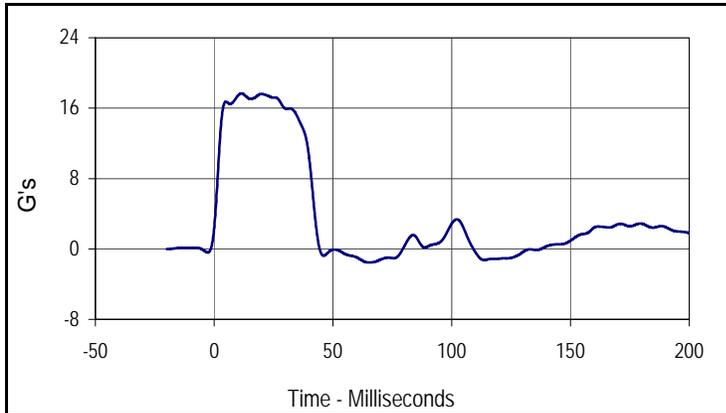
Tested Parameter	Units	Specification	Result	Pass/Fail	
Laboratory Temperature	°C	20.6 to 22.2	21.1	Pass	
Laboratory Relative Humidity	%	10 to 70	30	Pass	
Pendulum Velocity	m/s	5.94 to 6.19	6.00	Pass	
Pendulum Deceleration	10 Msec.	G's	17.2 to 21.2	17.4	Pass
	20 Msec.	G's	14.0 to 19.0	17.6	Pass
	30 Msec.	G's	11.0 to 16.0	15.9	Pass
Peak Pendulum Decel. after 30 Msec.	G's	≤ 22.0	16.0	Pass	
Deceleration Decay, Time to Cross 5 G's	Msec.	38.0 to 46.0	42.0	Pass	
Maximum "D" Plane Rotation	Max	Degrees	81.0 to 106.0	98.8	Pass
	Time	Msec.	72.0 to 82.0	76.8	Pass
"D" Plane Rotation Decay, Time To Zero Crossing	Msec.	147.0 to 174.0	151.9	Pass	
Moment About Occ. Condyle	Max	Nm	-52.9 to- 79.9	-72.1	Pass
	Time	Msec.	65.0 to 79.0	68.1	Pass
Positive Moment Decay, Time To Zero Crossing	Msec.	120.0 to 148.0	137.8	Pass	
<b>Overall Test Results</b>				<b>Pass</b>

Curve Description			
Pendulum Deceleration			
CURNO	Type	SAE Class	Units
001	FIL	60	G's
Max	Time	Min	Time
17.7	11.5	-1.5	65.2

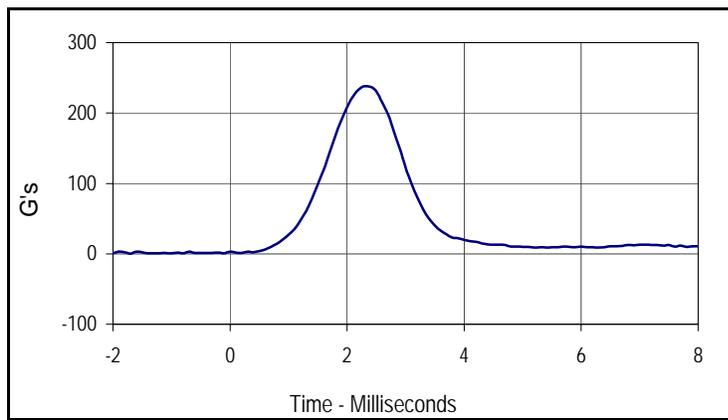
Tested Parameter	Units	Specification	Result	Pass/Fail
Laboratory Temperature	°C	18.9 to 25.6	21.1	Pass
Laboratory Relative Humidity	%	10 to 70	30	Pass
Peak Resultant Acceleration	G's	225.0 to 275.0	237.9	Pass
Peak Lateral Acceleration	G's	≤15.0	5.0	Pass
Is Acceleration Unimodal?	Yes/No	Yes	Yes	Pass
Overall Test Results				Pass

Curve Description			
Head Resultant			
CURNO	Type	SAE Class	Units
001	RES	1000	G's
Max	Time	Min	Time
237.9	2.3	0.4	-1.7

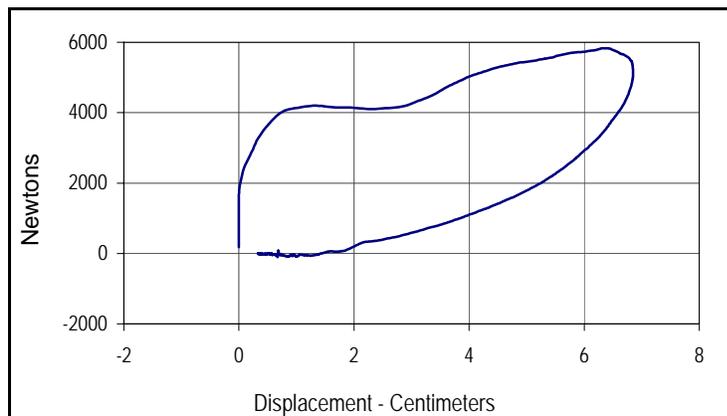
Tested Parameter	Units	Specification	Result	Pass/Fail
Laboratory Temperature	°C	20.6 to 22.2	21.1	Pass
Laboratory Relative Humidity	%	10 to 70	30	Pass
Probe Velocity	m/s	6.58 to 6.82	6.70	Pass
Peak Probe Force	Newtons	5159 to 5893	5829	Pass
Peak Sternum Deflection	CM	6.35 to 7.26	6.85	Pass
Internal Hysteresis	%	69 to 85	74.5	Pass
Overall Test Results				Pass

Curve Description			
Probe Force vs. Chest Deflection			
CURNO	Type	SAE Class	Hysteresis
001	FIL	180	74.5
Peak Probe Force		Peak Chest Deflection	
5829		6.85

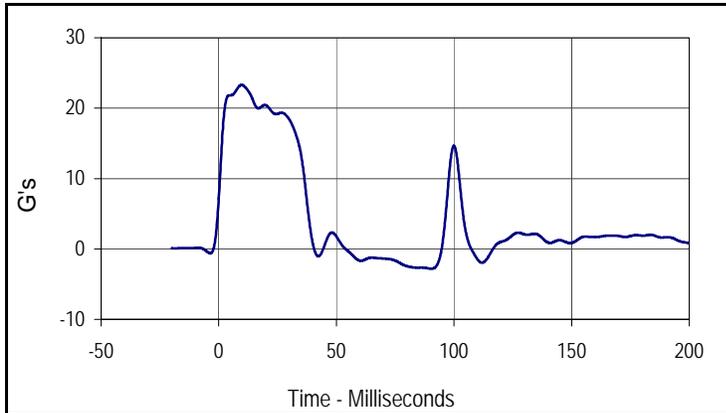
Tested Parameter	Units	Specification	Result	Pass/Fail	
Laboratory Temperature	°C	20.6 to 22.2	21.1	Pass	
Laboratory Relative Humidity	%	10 to 70	30	Pass	
Pendulum Velocity	m/s	6.89 to 7.13	7.11	Pass	
Pendulum Deceleration	10 Msec.	G's	22.5 to 27.5	23.3	Pass
	20 Msec.	G's	17.6 to 22.6	20.4	Pass
	30 Msec.	G's	12.5 to 18.5	18.4	Pass
Peak Pendulum Decel. after 30 Msec.	G's	≤ 29.0	18.4	Pass	
Deceleration Decay, Time to Cross 5 G's	Msec.	34.0 to 42.0	38.1	Pass	
Maximum "D" Plane Rotation	Max	Degrees	64.0 to 78.0	71.8	Pass
	Time	Msec.	57.0 to 64.0	63.7	Pass
"D" Plane Rotation Decay, Time To Zero Crossing	Msec.	113.0 to 128.0	119.6	Pass	
Moment About Occ. Condyle	Max	Nm	84.1 to 108.5	89.0	Pass
	Time	Msec.	47.0 to 58.0	55.1	Pass
Positive Moment Decay, Time To Zero Crossing	Msec.	97.0 to 107.0	101.3	Pass	
<b>Overall Test Results</b>				<b>Pass</b>

Curve Description			
Pendulum Deceleration			
CURNO	Type	SAE Class	Units
001	FIL	60	G's
Max	Time	Min	Time
23.3	9.7	-2.8	90.4

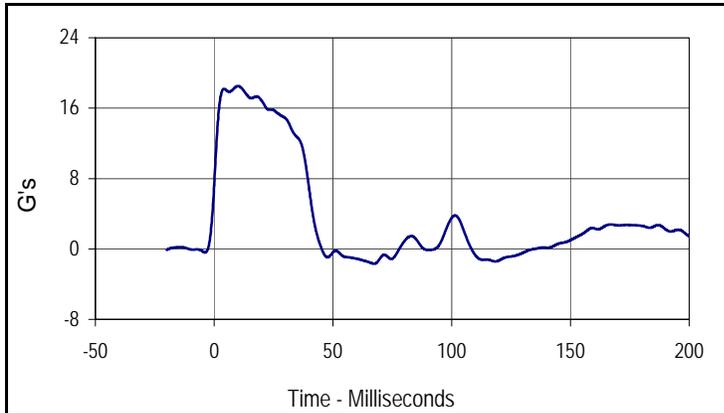
Tested Parameter	Units	Specification	Result	Pass/Fail	
Laboratory Temperature	°C	20.6 to 22.2	21.1	Pass	
Laboratory Relative Humidity	%	10 to 70	30	Pass	
Pendulum Velocity	m/s	5.94 to 6.19	6.11	Pass	
Pendulum Deceleration	10 Msec.	G's	17.2 to 21.2	18.5	Pass
	20 Msec.	G's	14.0 to 19.0	16.9	Pass
	30 Msec.	G's	11.0 to 16.0	14.9	Pass
Peak Pendulum Decel. after 30 Msec.	G's	≤ 22.0	14.9	Pass	
Deceleration Decay, Time to Cross 5 G's	Msec.	38.0 to 46.0	41.0	Pass	
Maximum "D" Plane Rotation	Max	Degrees	81.0 to 106.0	97.9	Pass
	Time	Msec.	72.0 to 82.0	78.0	Pass
"D" Plane Rotation Decay, Time To Zero Crossing	Msec.	147.0 to 174.0	152.5	Pass	
Moment About Occ. Condyle	Max	Nm	-52.9 to- 79.9	-68.3	Pass
	Time	Msec.	65.0 to 79.0	68.0	Pass
Positive Moment Decay, Time To Zero Crossing	Msec.	120.0 to 148.0	139.2	Pass	
<b>Overall Test Results</b>				<b>Pass</b>

Curve Description			
Pendulum Deceleration			
CURNO	Type	SAE Class	Units
001	FIL	60	G's
Max	Time	Min	Time
18.5	10.0	-1.7	67.4
