REPORT NUMBER TR-P26001-12-NC

**NEW CAR ASSESSMENT PROGRAM
FRONTAL BARRIER IMPACT TEST**

**GENERAL MOTORS CORPORATION
2006 CHEVROLET HHR LT
5-DOOR MPV**

NHTSA NUMBER: M60108

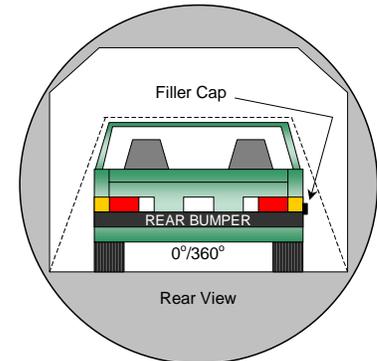
270° to 360°

1. The specified fixture rollover rate for each 90° of rotation is 60 to 120 seconds.
2. The position hold time at each position is 300 seconds (minimum).
3. No solvent leakage occurred during rollover.

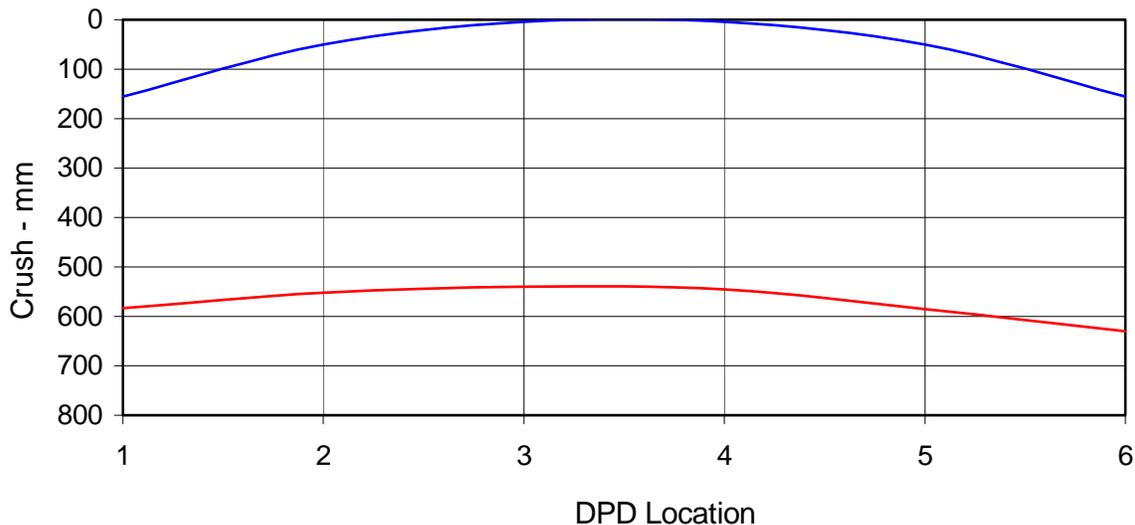
Collision Deformation Classification: 12FDEW6
 Damage Region Length (mm): 1234

Midpoint of Damage: Vehicle Centerline
 Impact Mode: Full Frontal

No.	Measurement Description	Units	Pre-Test	Post-Test	Difference
C1	Crush zone 1 at left side	mm	155	583	428
C2	Crush zone 2 on left side	mm	50	552	502
C3	Crush zone 3 on left side	mm	4	540	536
C4	Crush zone 4 on right side	mm	4	545	541
C5	Crush zone 5 on right side	mm	50	585	535
C6	Crush zone 6 at right side	mm	155	630	475

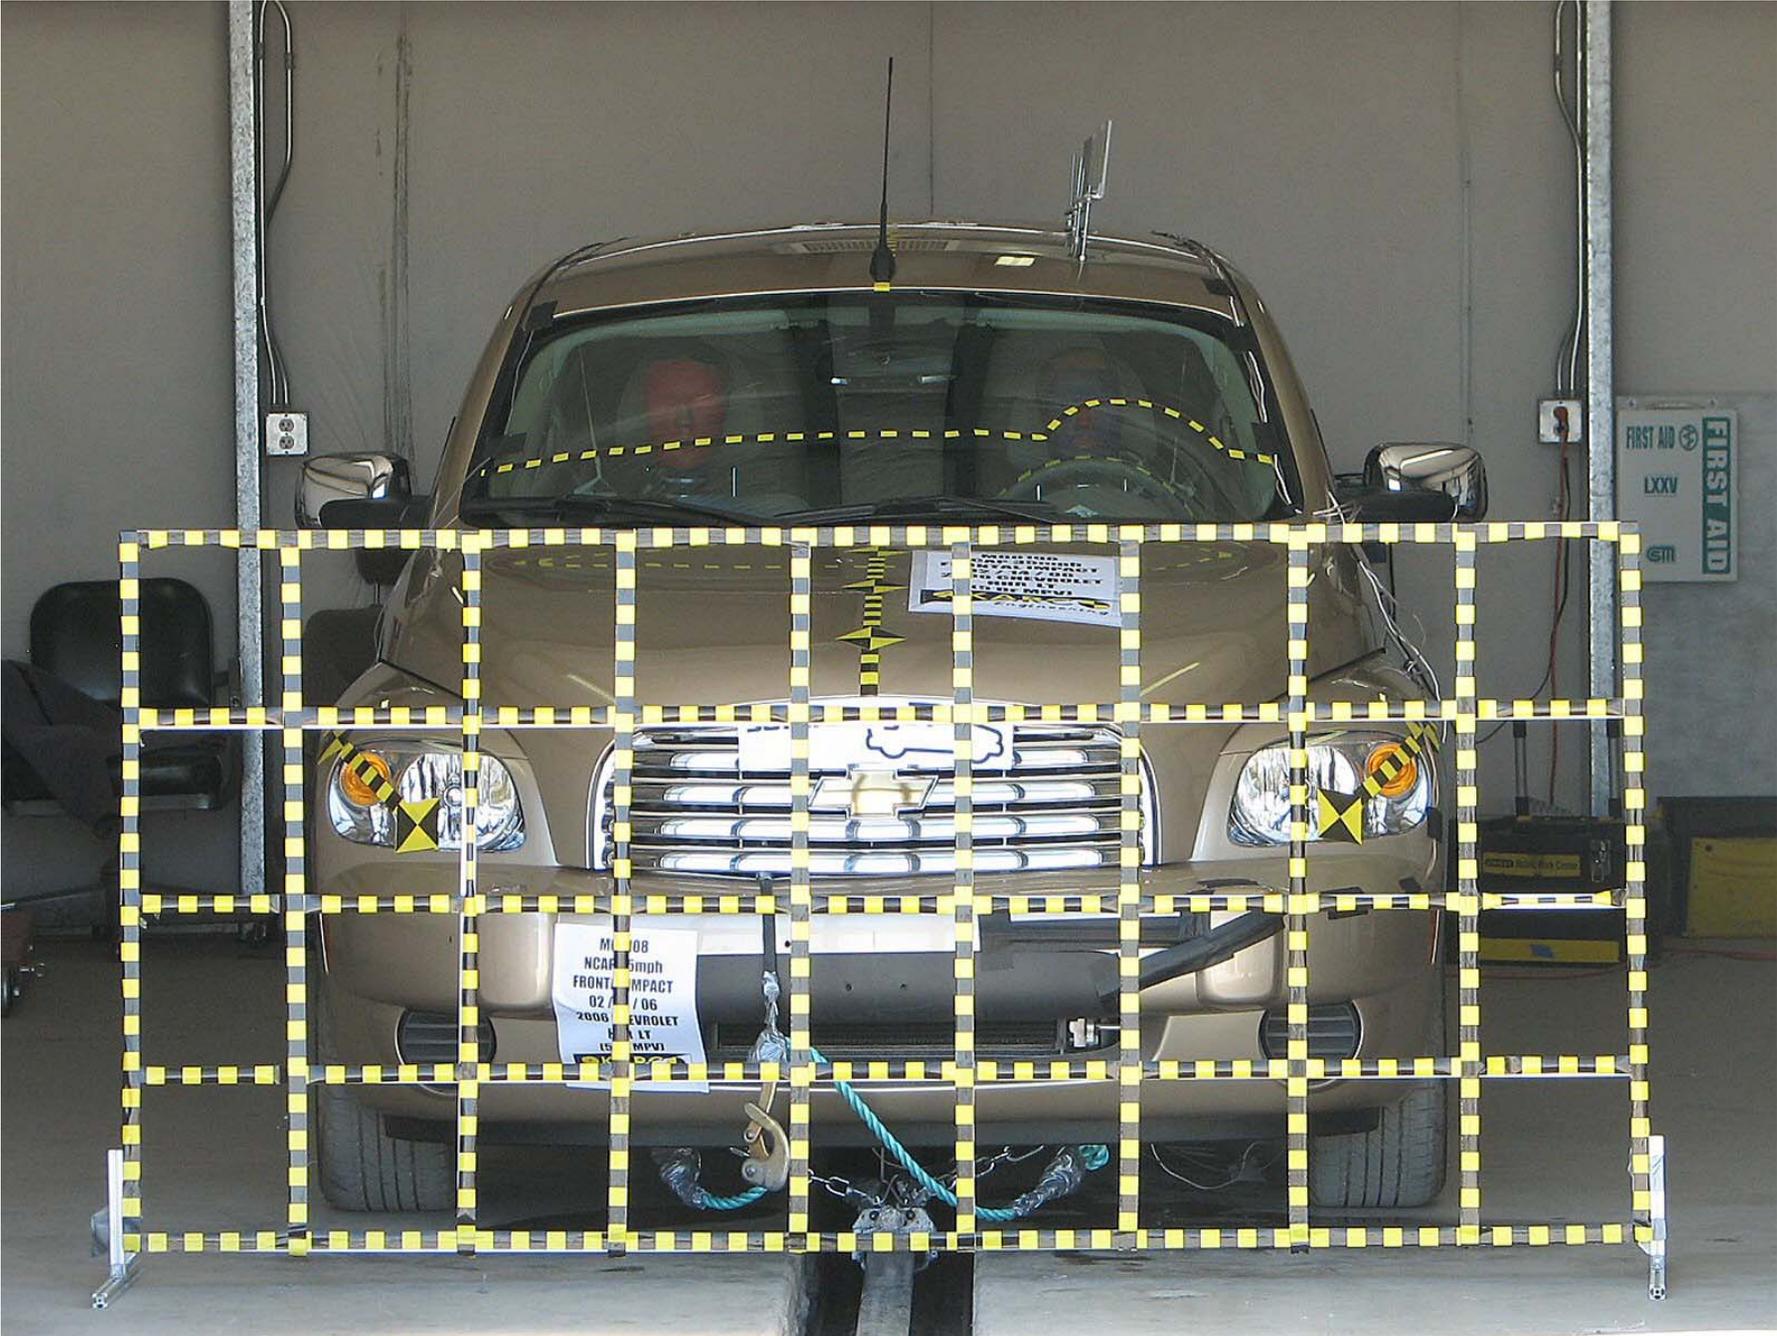
Figure A-1: Load Cell Location

A load cell barrier consisting of 36 load cells was impacted by a 2006 Chevrolet HHR LT 5-Door MPV at a velocity of 56.20 km/h. The test was performed at Karco Engineering, LLC on February 14, 2006.

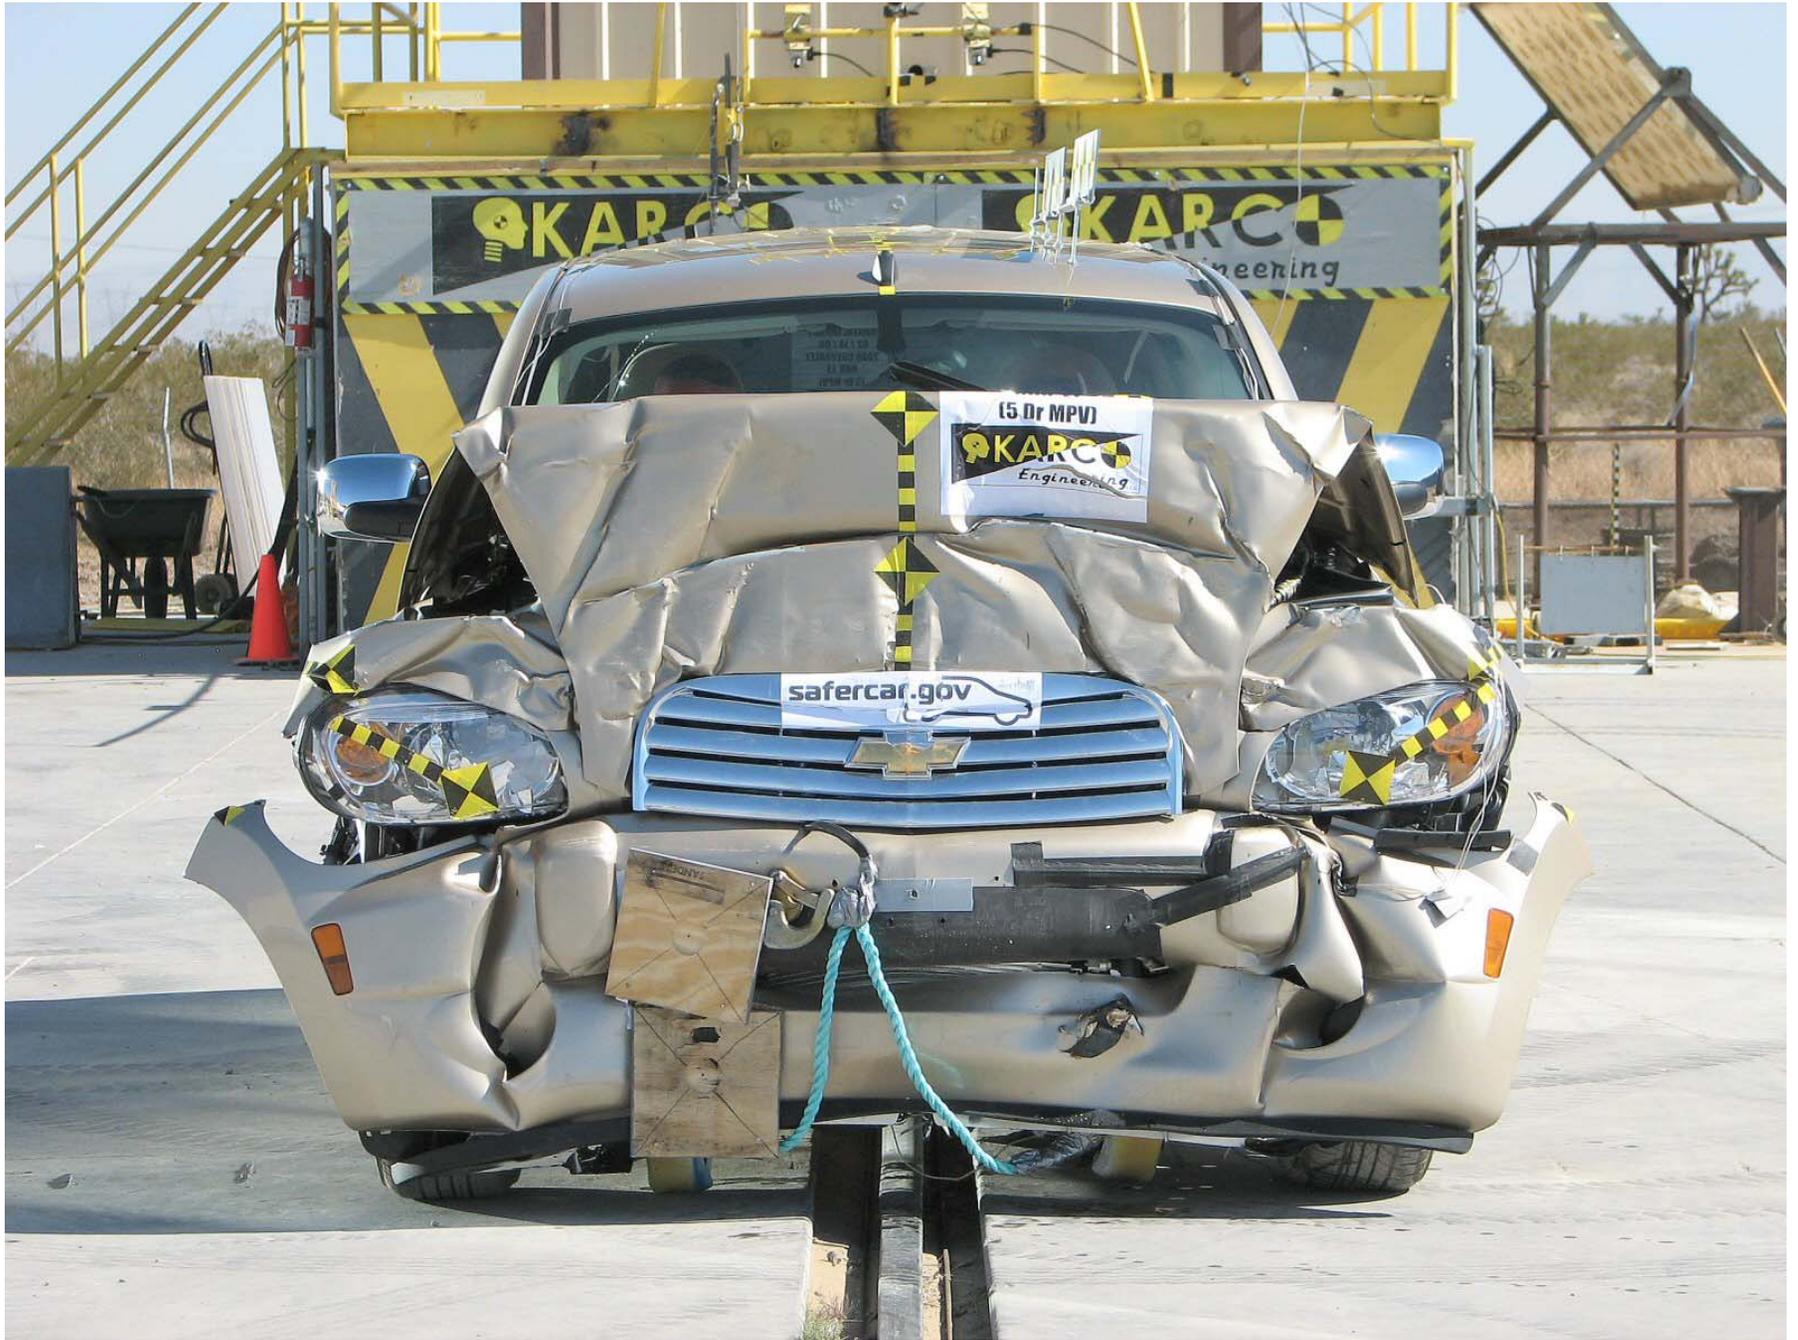
Figure A-7: Post-Test Front View (Vehicle Moved)

The maximum static crush of the vehicle was 667 mm at the vehicle's centerline and both the driver and the passenger side doors remained closed and latched during the impact event and were operable after the impact.

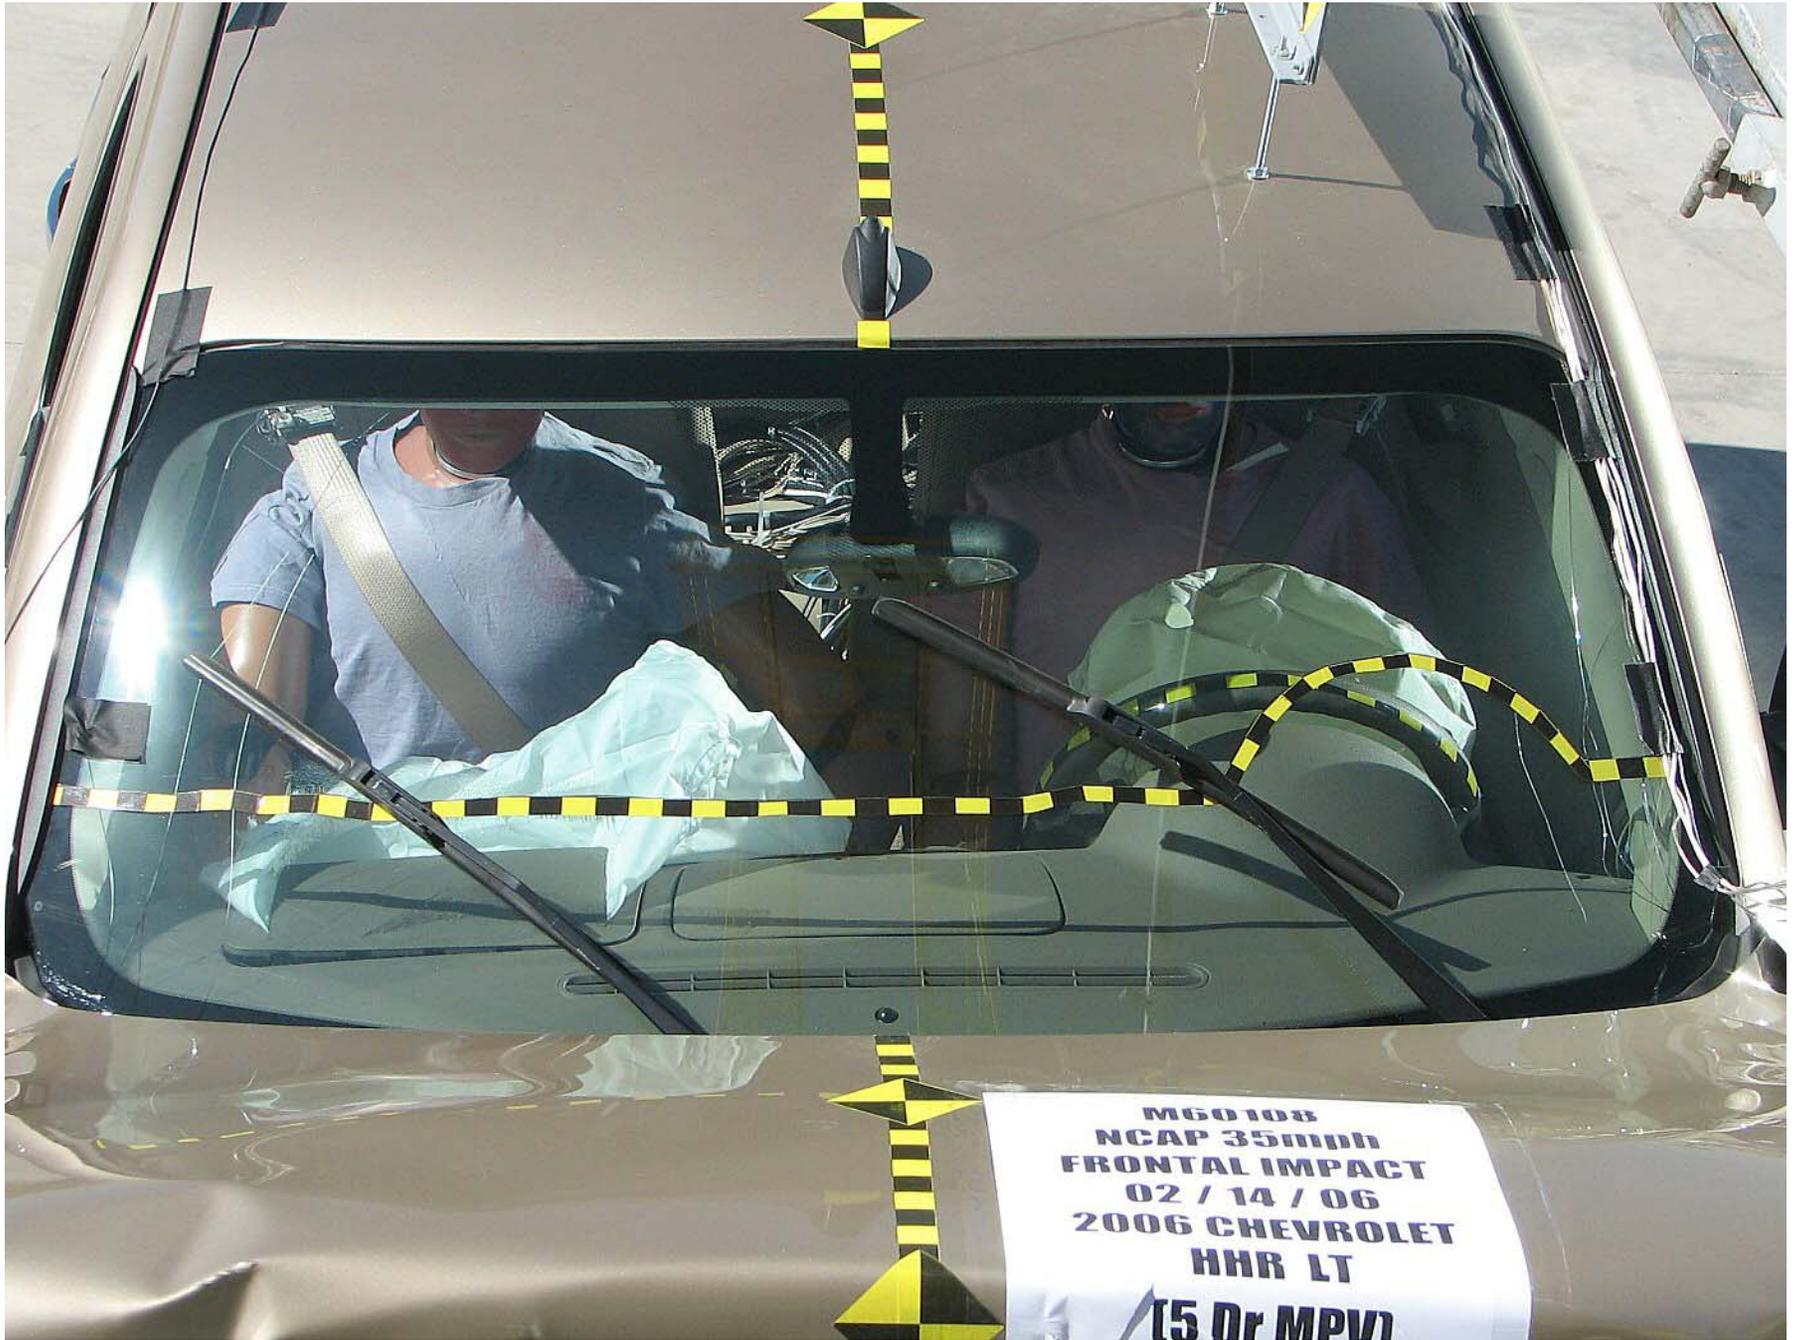
Figure A-19: Post-Test Windshield

There was 100 percent windshield retention and there was no intrusion into the protected zone of the windshield during the impact event. There was no stoddard solvent leakage after the event or during any phase of the static rollover.

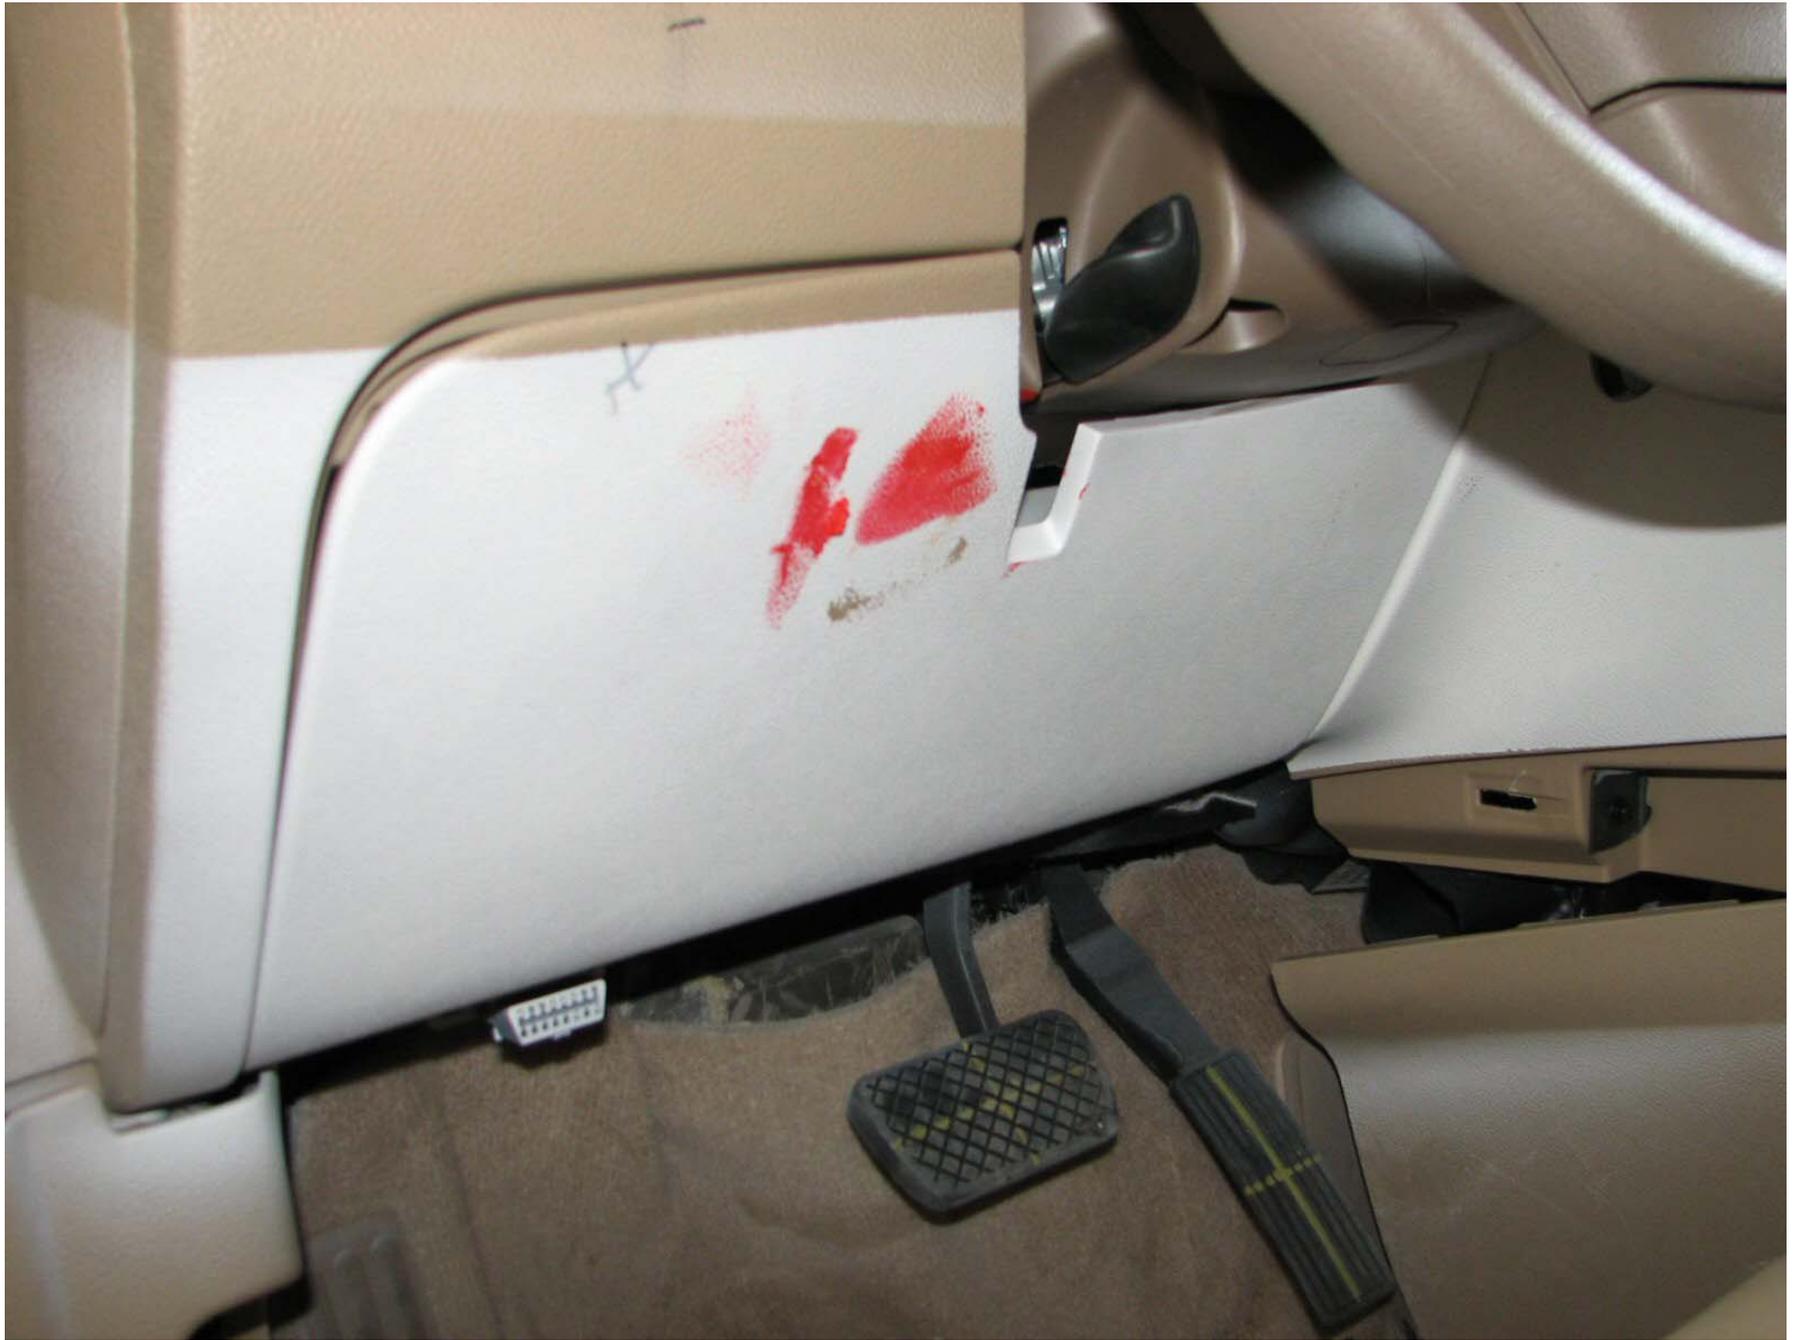
Figure A-39: Post-Test Driver Side Knee Bolster

The driver's visible contact points were as follows: The driver ATD's head and chest contacted the airbag and the abdomen had no contact. Both knees contacted the knee bolster.

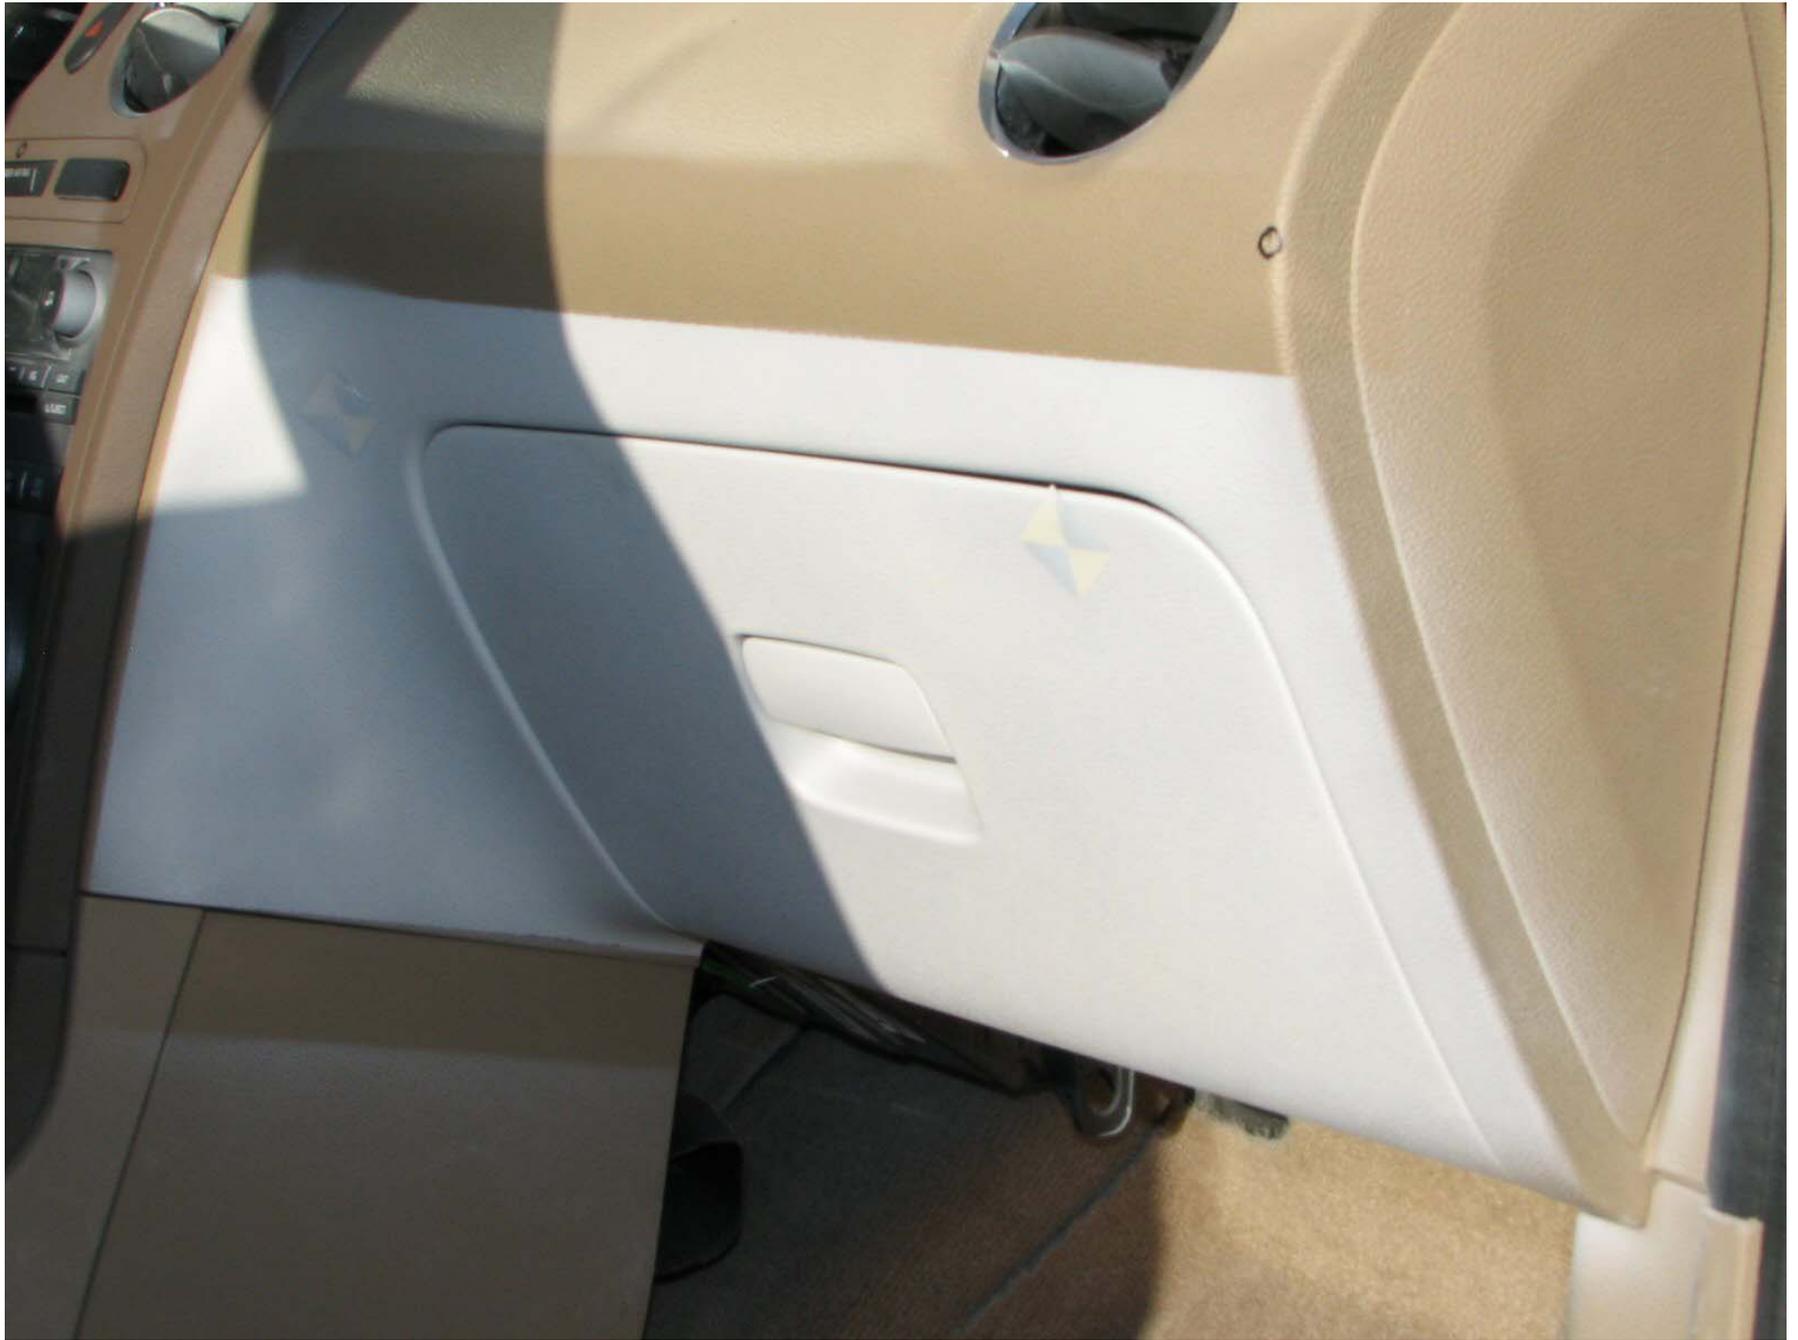
Figure A-53: Post-Test Passenger Side Glove Box

The passenger's visible contact points were as follows: The passenger ATD's head, chest and abdomen contacted the airbag. Both knees contacted the glove box.

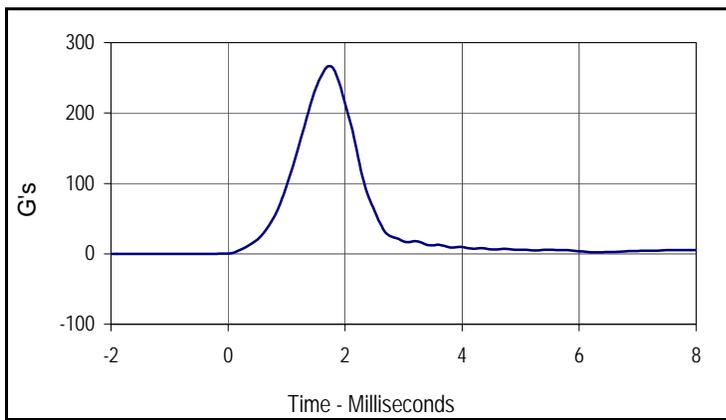
Tested Parameter	Units	Specification	Result	Pass/Fail
Laboratory Temperature	°C	18.9 to 25.6	21.1	Pass
Laboratory Relative Humidity	%	10 to 70	30	Pass
Peak Resultant Acceleration	G's	225.0 to 275.0	266.2	Pass
Peak Lateral Acceleration	G's	≤15.0	8.2	Pass
Is Acceleration Unimodal?	Yes/No	Yes	Yes	Pass
Overall Test Results			Pass

Curve Description			
Head Resultant			
CURNO	Type	SAE Class	Units
001	RES	1000	G's
Max	Time	Min	Time
266.2	1.7	0.0	-0.8

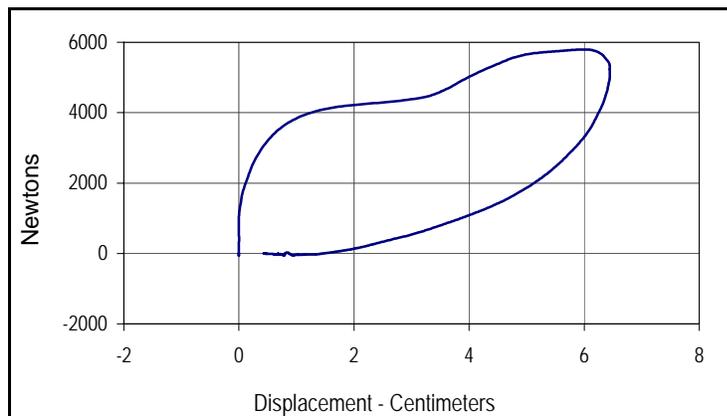
Tested Parameter	Units	Specification	Result	Pass/Fail
Laboratory Temperature	°C	20.6 to 22.2	21.3	Pass
Laboratory Relative Humidity	%	10 to 70	30	Pass
Probe Velocity	m/s	6.58 to 6.82	6.75	Pass
Peak Probe Force	Newtons	5159 to 5893	5796	Pass
Peak Sternum Deflection	CM	6.35 to 7.26	6.45	Pass
Internal Hysteresis	%	69 to 85	76.8	Pass
Overall Test Results				Pass

Curve Description			
Probe Force vs. Chest Deflection			
CURNO	Type	SAE Class	Hysteresis
001	FIL	600	76.8
Peak Probe Force		Peak Chest Deflection	
5796		6.45

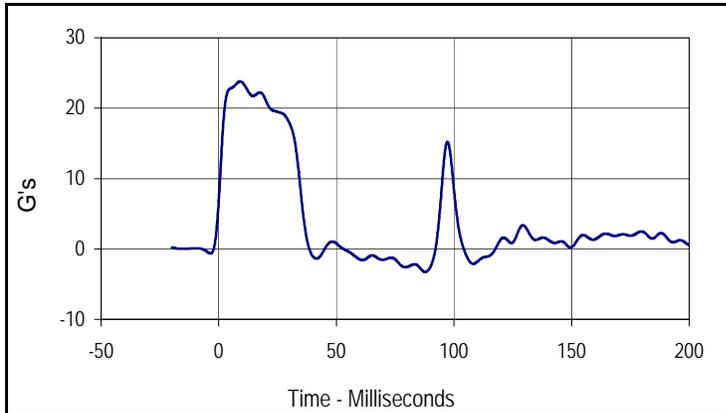
Tested Parameter	Units	Specification	Result	Pass/Fail	
Laboratory Temperature	°C	20.6 to 22.2	21.1	Pass	
Laboratory Relative Humidity	%	10 to 70	30	Pass	
Pendulum Velocity	m/s	6.89 to 7.13	6.98	Pass	
Pendulum Deceleration	10 Msec.	G's	22.5 to 27.5	23.6	Pass
	20 Msec.	G's	17.6 to 22.6	21.1	Pass
	30 Msec.	G's	12.5 to 18.5	17.9	Pass
Peak Pendulum Decel. after 30 Msec.	G's	≤ 29.0	17.9	Pass	
Deceleration Decay, Time to Cross 5 G's	Msec.	34.0 to 42.0	35.9	Pass	
Maximum "D" Plane Rotation	Max	Degrees	64.0 to 78.0	77.2	Pass
	Time	Msec.	57.0 to 64.0	62.2	Pass
"D" Plane Rotation Decay, Time To Zero Crossing	Msec.	113.0 to 128.0	122.7	Pass	
Moment About Occ. Condyle	Max	Nm	84.1 to 108.5	100.4	Pass
	Time	Msec.	47.0 to 58.0	54.9	Pass
Positive Moment Decay, Time To Zero Crossing	Msec.	97.0 to 107.0	100.7	Pass	
Overall Test Results				Pass

Curve Description			
Pendulum Deceleration			
CURNO	Type	SAE Class	Units
001	FIL	60	G's
Max	Time	Min	Time
23.8	9.1	-3.3	87.7

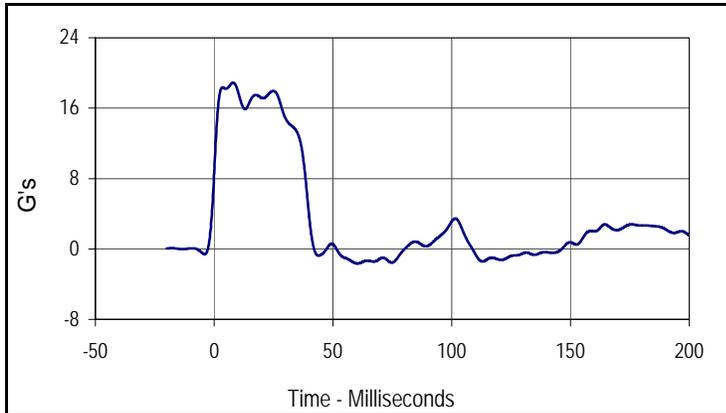
Tested Parameter	Units	Specification	Result	Pass/Fail	
Laboratory Temperature	°C	20.6 to 22.2	21.1	Pass	
Laboratory Relative Humidity	%	10 to 70	30	Pass	
Pendulum Velocity	m/s	5.94 to 6.19	6.11	Pass	
Pendulum Deceleration	10 Msec.	G's	17.2 to 21.2	17.9	Pass
	20 Msec.	G's	14.0 to 19.0	17.2	Pass
	30 Msec.	G's	11.0 to 16.0	14.8	Pass
Peak Pendulum Decel. after 30 Msec.	G's	≤ 22.0	14.8	Pass	
Deceleration Decay, Time to Cross 5 G's	Msec.	38.0 to 46.0	39.6	Pass	
Maximum "D" Plane Rotation	Max	Degrees	81.0 to 106.0	92.7	Pass
	Time	Msec.	72.0 to 82.0	73.7	Pass
"D" Plane Rotation Decay, Time To Zero Crossing	Msec.	147.0 to 174.0	154.3	Pass	
Moment About Occ. Condyle	Max	Nm	-52.9 to- 79.9	-63.8	Pass
	Time	Msec.	65.0 to 79.0	66.4	Pass
Positive Moment Decay, Time To Zero Crossing	Msec.	120.0 to 148.0	135.0	Pass	
Overall Test Results				Pass

Curve Description			
Pendulum Deceleration			
CURNO	Type	SAE Class	Units
001	FIL	60	G's
Max	Time	Min	Time
18.9	8.0	-1.7	60.3

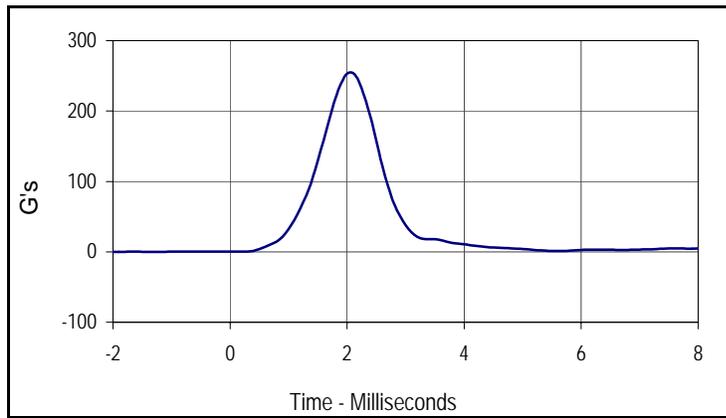
Tested Parameter	Units	Specification	Result	Pass/Fail
Laboratory Temperature	°C	18.9 to 25.6	21.1	Pass
Laboratory Relative Humidity	%	10 to 70	30	Pass
Peak Resultant Acceleration	G's	225.0 to 275.0	254.0	Pass
Peak Lateral Acceleration	G's	≤15.0	2.6	Pass
Is Acceleration Unimodal?	Yes/No	Yes	Yes	Pass
Overall Test Results				Pass

Curve Description			
Head Resultant			
CURNO	Type	SAE Class	Units
001	RES	1000	G's
Max	Time	Min	Time
254.0	2.1	0.1	-1.3

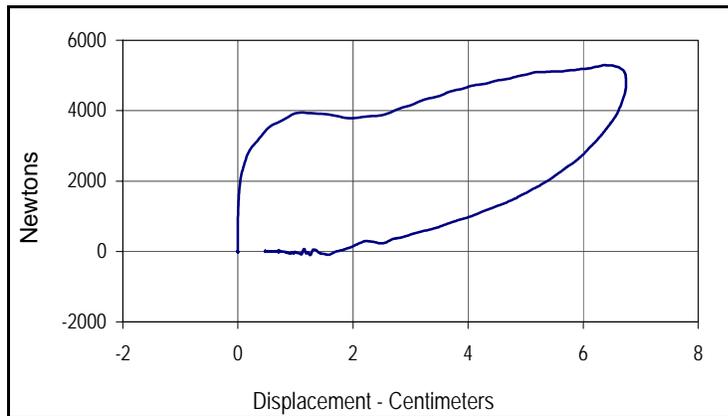
Tested Parameter	Units	Specification	Result	Pass/Fail
Laboratory Temperature	°C	20.6 to 22.2	21.1	Pass
Laboratory Relative Humidity	%	10 to 70	30	Pass
Probe Velocity	m/s	6.58 to 6.82	6.64	Pass
Peak Probe Force	Newtons	5159 to 5893	5293	Pass
Peak Sternum Deflection	CM	6.35 to 7.26	6.75	Pass
Internal Hysteresis	%	69 to 85	75.9	Pass
Overall Test Results				Pass

Curve Description			
Probe Force vs. Chest Deflection			
CURNO	Type	SAE Class	Hysteresis
001	FIL	180	75.9
Peak Probe Force		Peak Chest Deflection	
5293		6.75

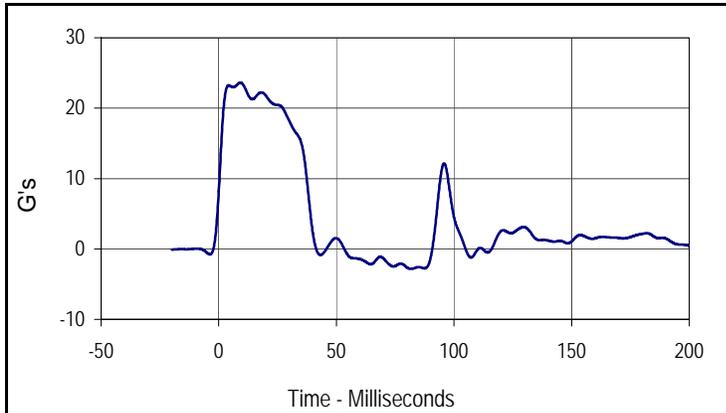
Tested Parameter	Units	Specification	Result	Pass/Fail	
Laboratory Temperature	°C	20.6 to 22.2	21.1	Pass	
Laboratory Relative Humidity	%	10 to 70	30	Pass	
Pendulum Velocity	m/s	6.89 to 7.13	6.98	Pass	
Pendulum Deceleration	10 Msec.	G's	22.5 to 27.5	23.5	Pass
	20 Msec.	G's	17.6 to 22.6	21.8	Pass
	30 Msec.	G's	12.5 to 18.5	18.2	Pass
Peak Pendulum Decel. after 30 Msec.	G's	≤ 29.0	18.2	Pass	
Deceleration Decay, Time to Cross 5 G's	Msec.	34.0 to 42.0	39	Pass	
Maximum "D" Plane Rotation	Max	Degrees	64.0 to 78.0	68.9	Pass
	Time	Msec.	57.0 to 64.0	61.1	Pass
"D" Plane Rotation Decay, Time To Zero Crossing	Msec.	113.0 to 128.0	116.1	Pass	
Moment About Occ. Condyle	Max	Nm	84.1 to 108.5	90.6	Pass
	Time	Msec.	47.0 to 58.0	50.7	Pass
Positive Moment Decay, Time To Zero Crossing	Msec.	97.0 to 107.0	97.8	Pass	
Overall Test Results				Pass

Curve Description			
Pendulum Deceleration			
CURNO	Type	SAE Class	Units
001	FIL	60	G's
Max	Time	Min	Time
23.6	9.3	-2.8	81.6

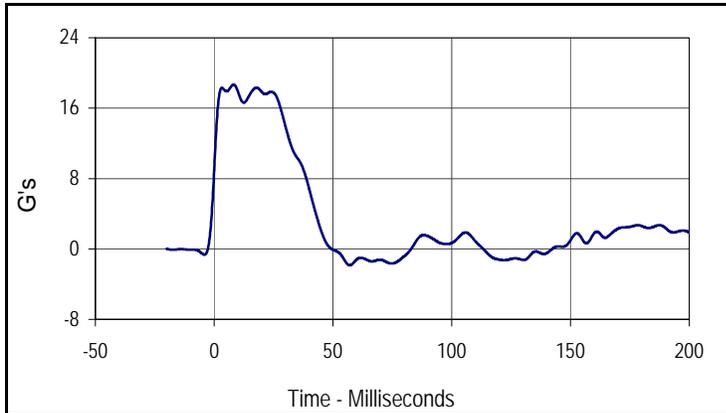
Tested Parameter	Units	Specification	Result	Pass/Fail	
Laboratory Temperature	°C	20.6 to 22.2	21.1	Pass	
Laboratory Relative Humidity	%	10 to 70	30	Pass	
Pendulum Velocity	m/s	5.94 to 6.19	6.11	Pass	
Pendulum Deceleration	10 Msec.	G's	17.2 to 21.2	17.9	Pass
	20 Msec.	G's	14.0 to 19.0	17.9	Pass
	30 Msec.	G's	11.0 to 16.0	13.9	Pass
Peak Pendulum Decel. after 30 Msec.	G's	≤ 22.0	13.9	Pass	
Deceleration Decay, Time to Cross 5 G's	Msec.	38.0 to 46.0	41.8	Pass	
Maximum "D" Plane Rotation	Max	Degrees	81.0 to 106.0	101.0	Pass
	Time	Msec.	72.0 to 82.0	78.1	Pass
"D" Plane Rotation Decay, Time To Zero Crossing	Msec.	147.0 to 174.0	159.3	Pass	
Moment About Occ. Condyle	Max	Nm	-52.9 to- 79.9	-64.8	Pass
	Time	Msec.	65.0 to 79.0	68.3	Pass
Positive Moment Decay, Time To Zero Crossing	Msec.	120.0 to 148.0	137.5	Pass	
Overall Test Results				Pass

Curve Description			
Pendulum Deceleration			
CURNO	Type	SAE Class	Units
001	FIL	60	G's
Max	Time	Min	Time
18.7	8.1	-1.9	57.1
