REPORT NUMBER: MCW-DOT-06SN03

NEW CAR ASSESSMENT PROGRAM
SIDE IMPACT TEST

GENERAL MOTORS
2006 BUICK LUCERNE 4 DOOR SEDAN
NHTSA NUMBER: M60100

FINAL REPORT

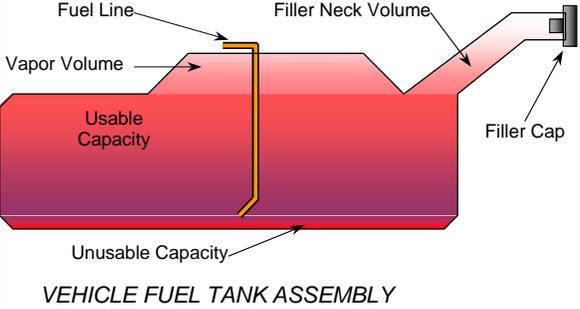
The diagram illustrates the internal structure of a vehicle fuel tank assembly. It shows a fuel line entering the tank, a filler neck with a filler cap, and a fuel line exiting. The tank is divided into sections: Usable Capacity (the main volume), Vapor Volume (the space above the fuel), and Unusable Capacity (the space at the bottom of the tank). The Filler Neck Volume is the space within the neck above the fuel level. The diagram is labeled 'VEHICLE FUEL TANK ASSEMBLY'.

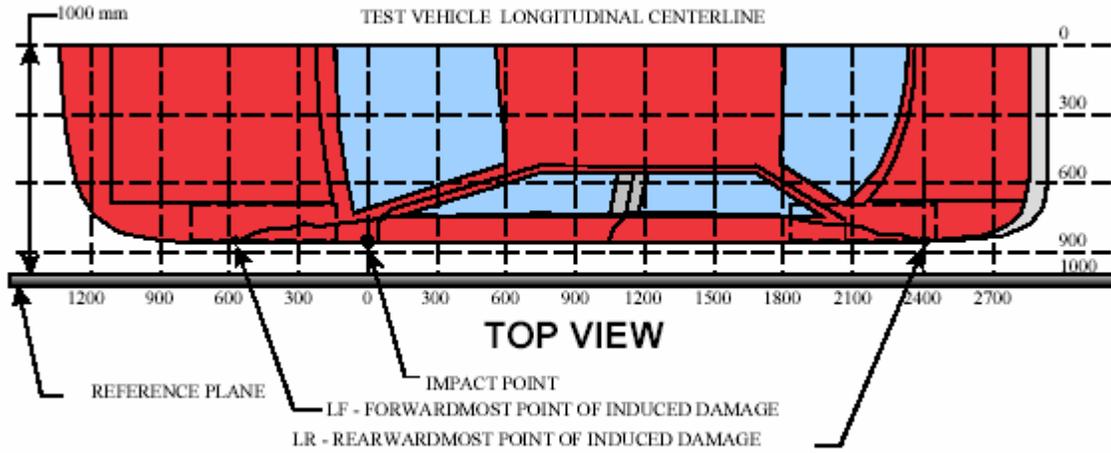
DATA SHEET 11
VEHICLE DAMAGE PROFILE DISTANCES (DPD)

DPD MEASUREMENTS				
	DPD measurement (mm)	Pre test (mm)	Post test (mm)	Crush (mm)
1	-450	164	164	0
2	180	164	311	147
3	810	164	395	231
4	1440	164	441	277
5	2070	164	233	69
6	2700	164	169	0

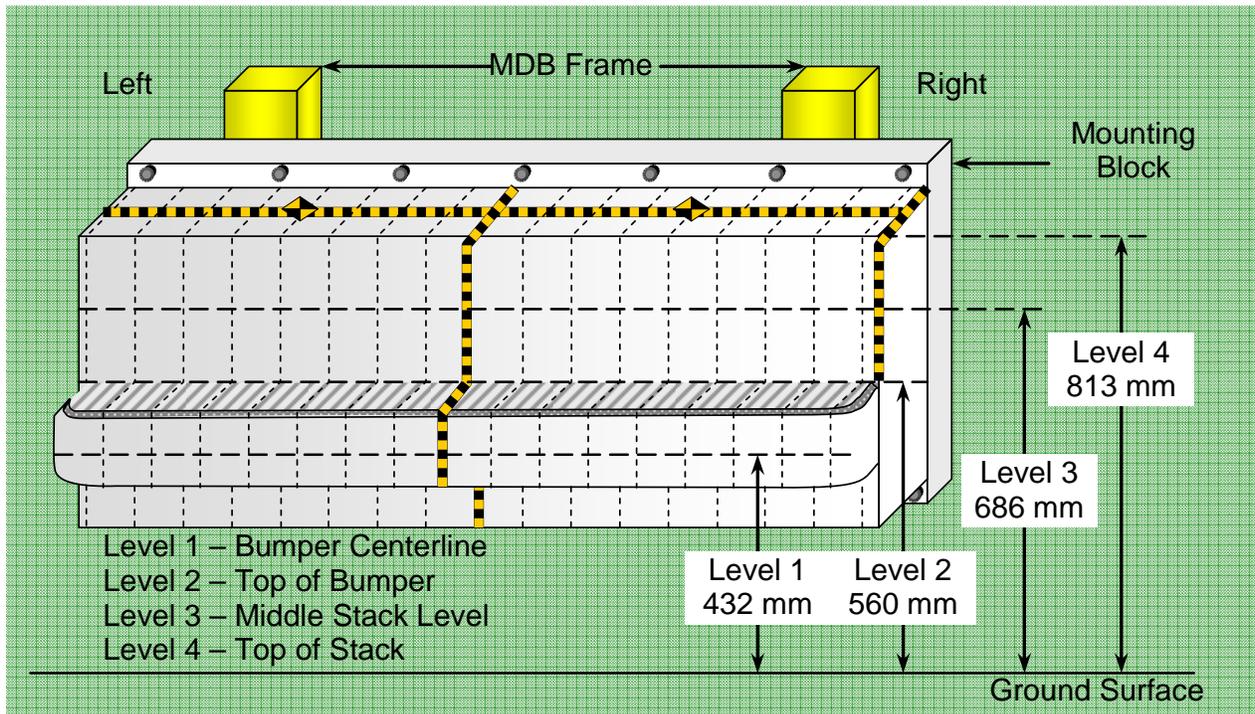
**DATA SHEET 12
DEFORMABLE BARRIER STATIC CRUSH**

DEFORMABLE BARRIER FACE SUMMARY		
Barrier face manufacturer		Plascore
Serial number		206A1105 185B1205
Level	Description	Maximum crush
1	Center of bumper	163
2	Top of bumper	93
3	Middle of stack	75
4	Top of stack	76
Maximum post test intrusion is 163 mm at level 1
