**REPORT NUMBER TR-P27003-05-NC**

**NEW CAR ASSESSMENT PROGRAM  
SIDE IMPACT TEST**

**TOYOTA MOTOR CORPORATION  
2007 TOYOTA PRIUS  
5-DOOR HATCHBACK**

**FINAL REPORT**

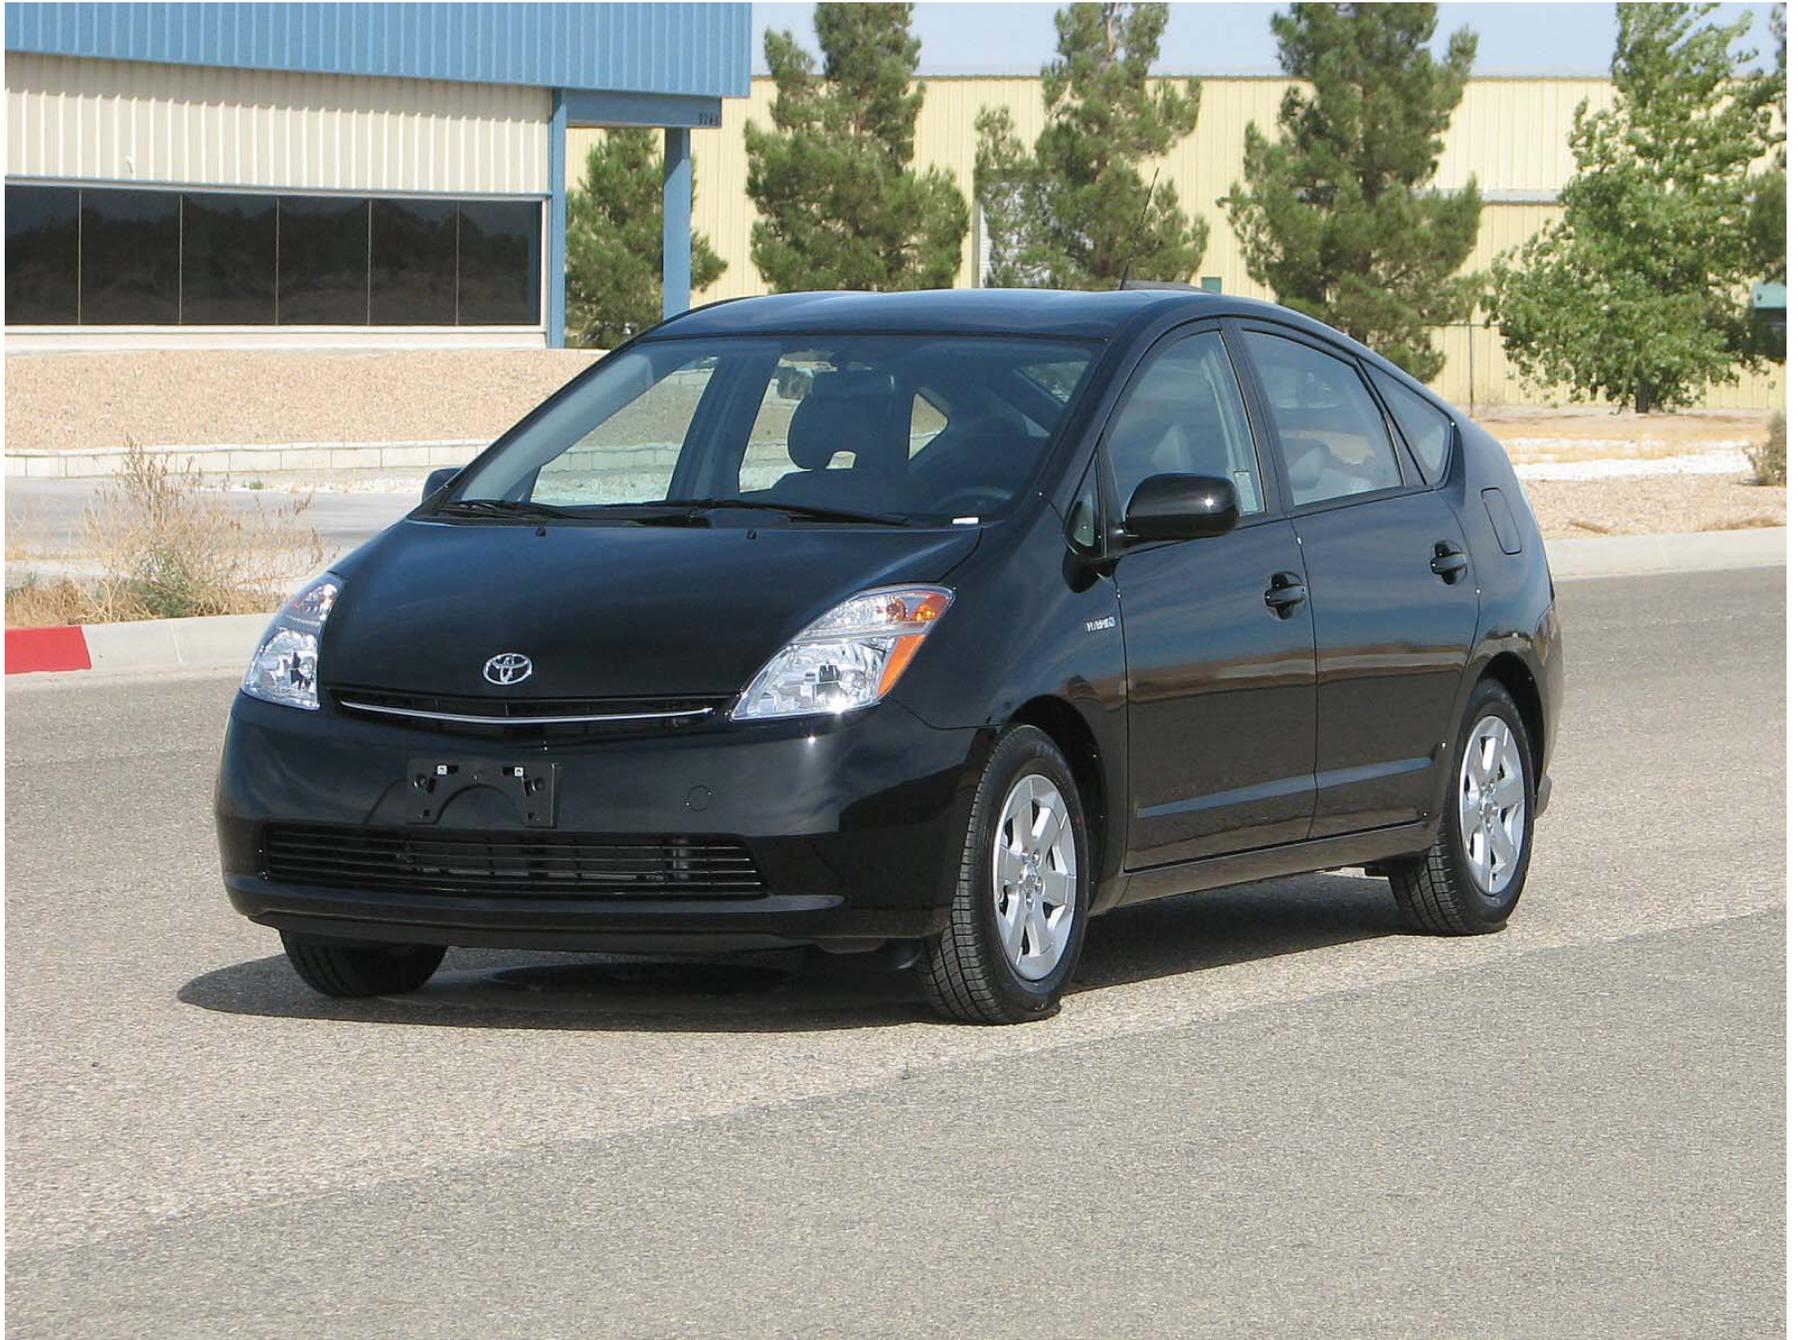
Figure A-1: Left Front  $\frac{3}{4}$  View, as Received

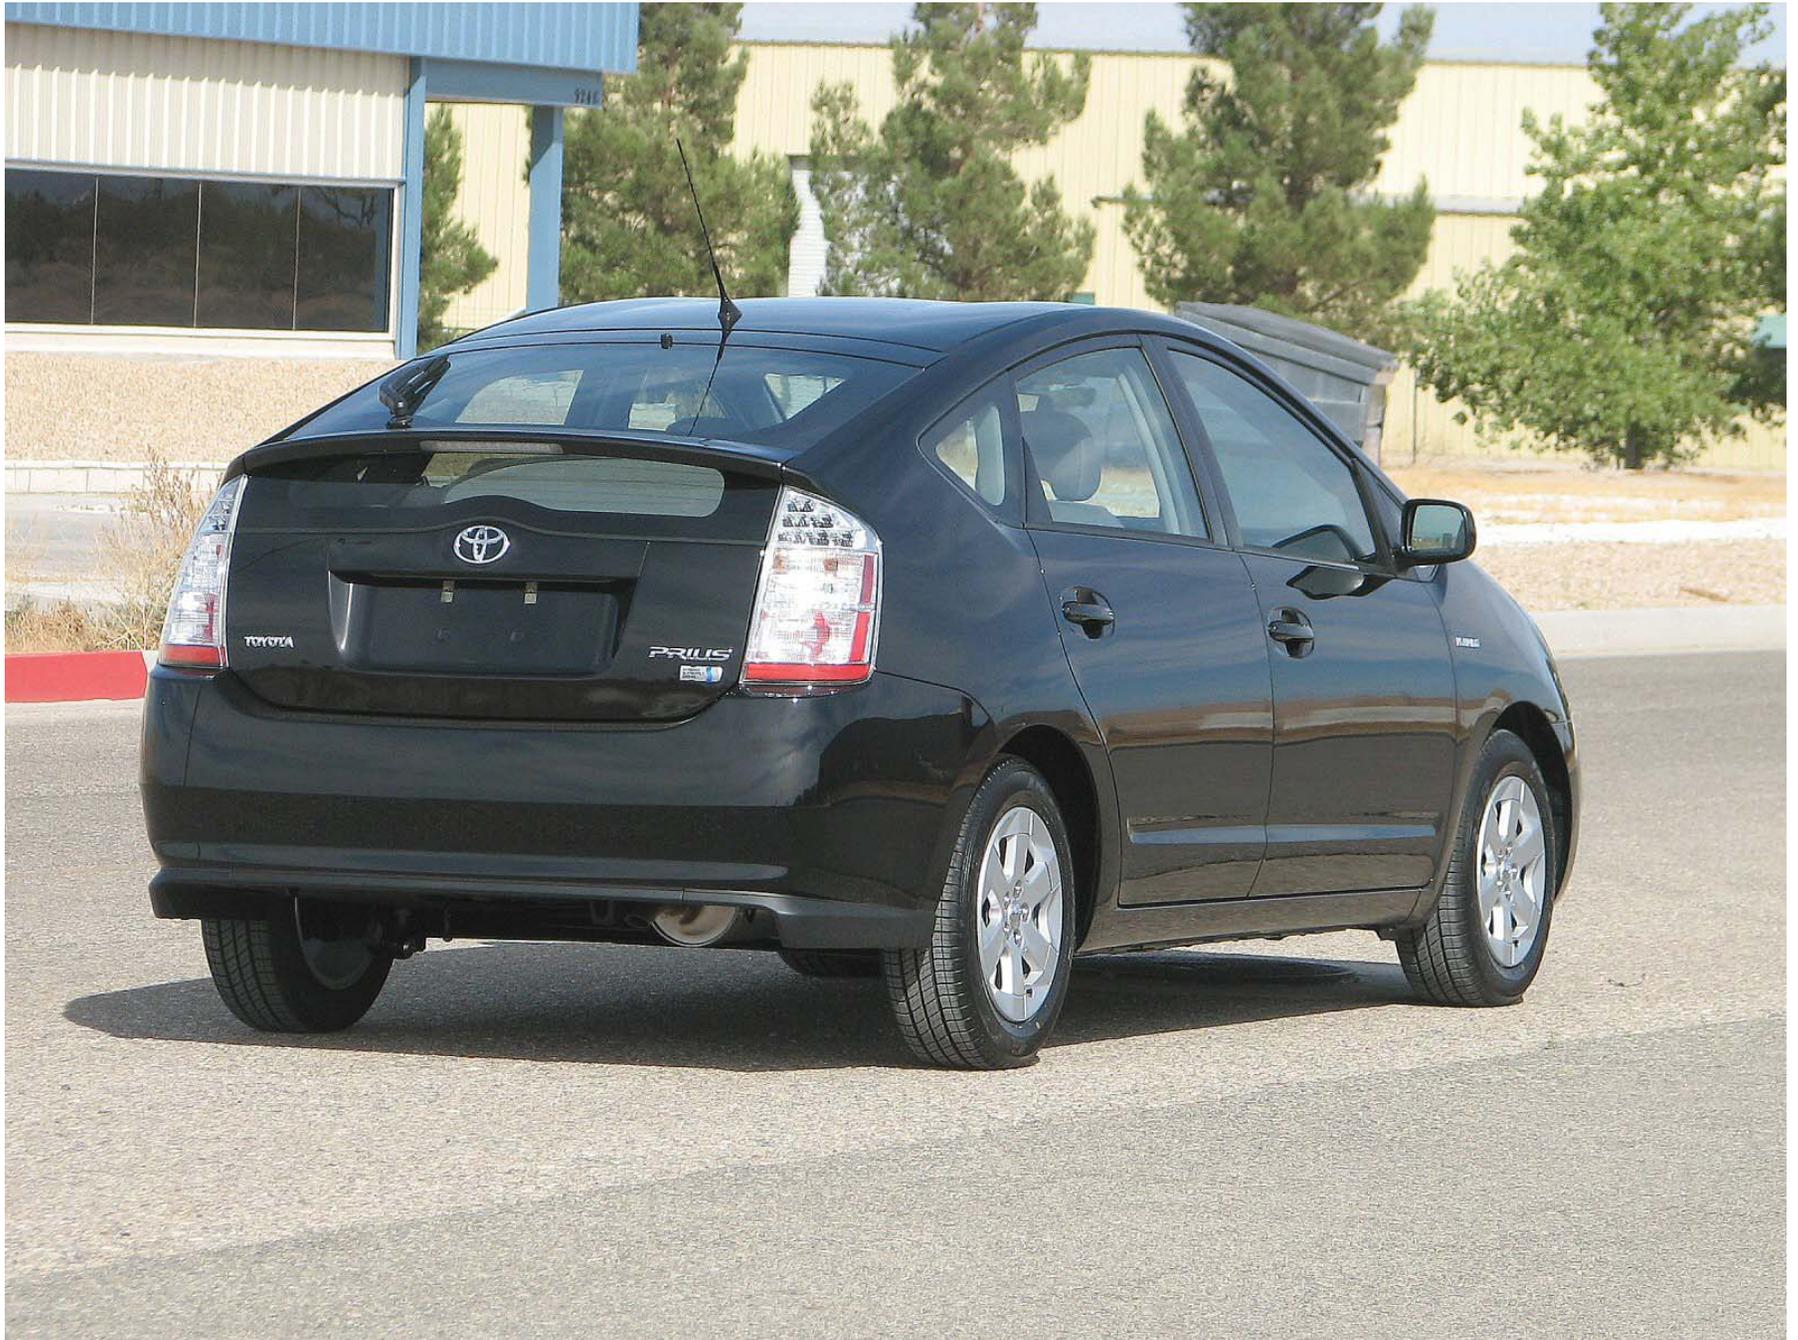
Figure A-2: Right Rear ¾ View, as Received

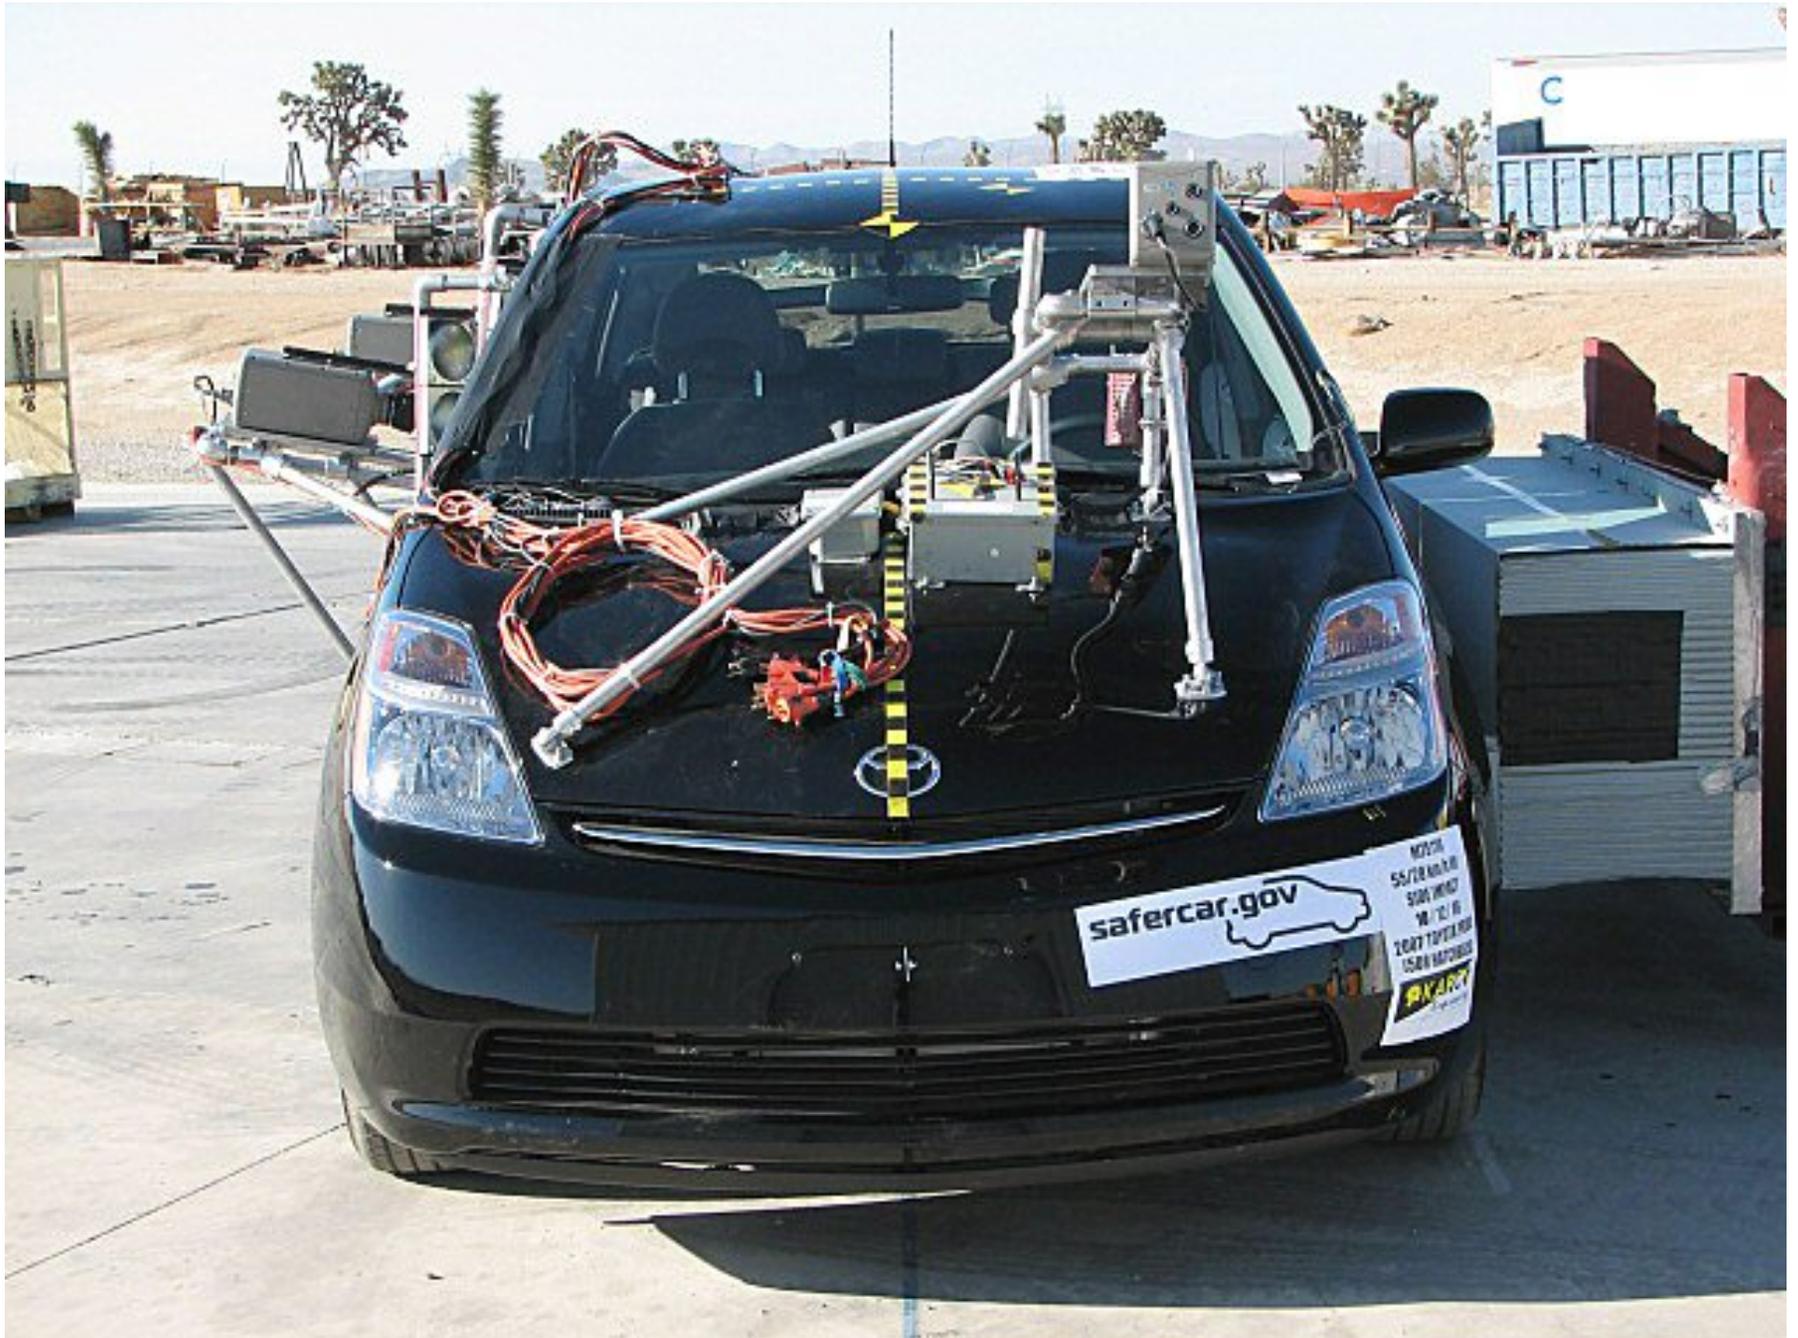
Figure A-5: Pre-Test Front View

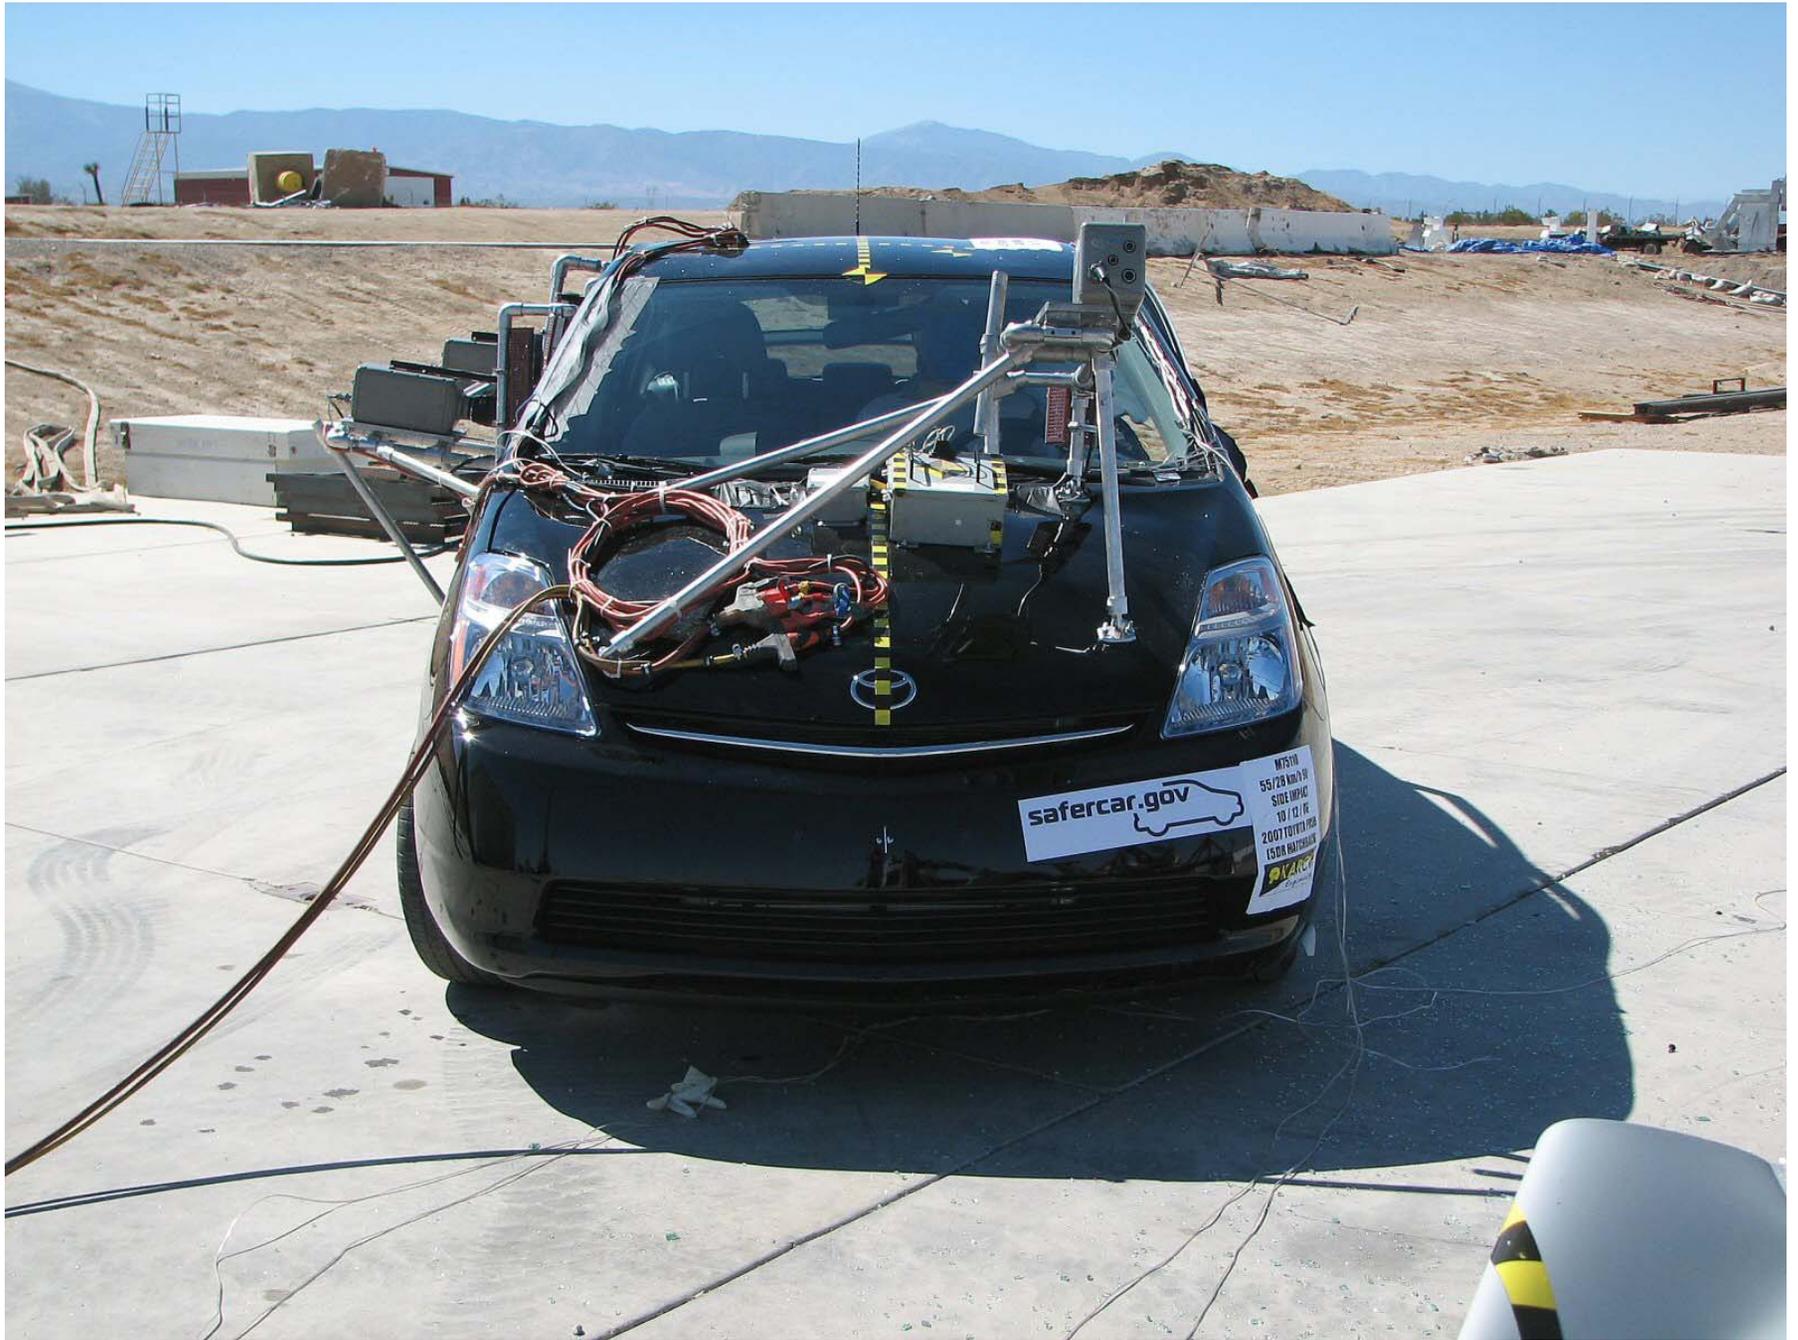
Figure A-6: Post-Test Front View

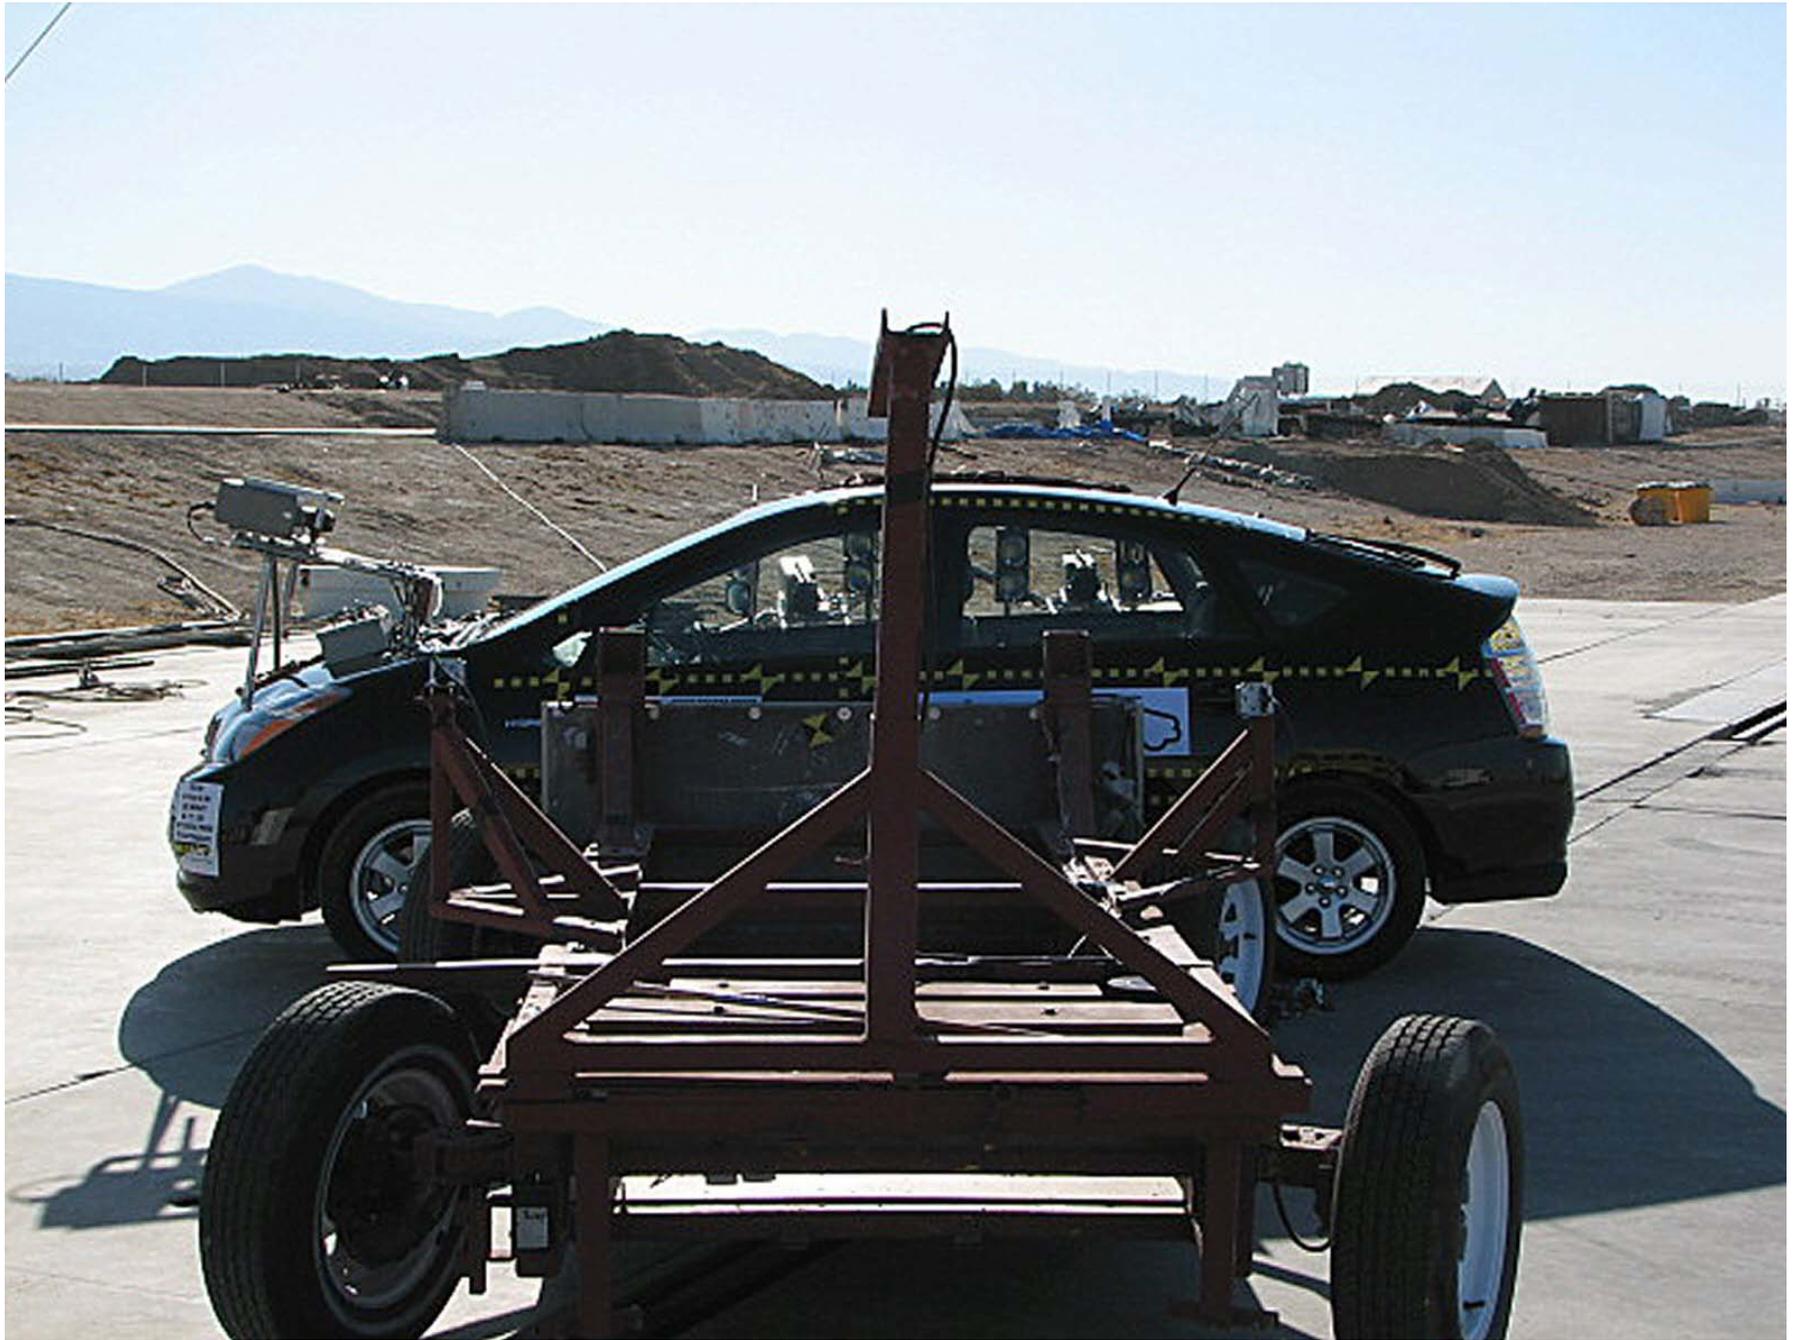
Figure A-9: Pre-Test Left Side View

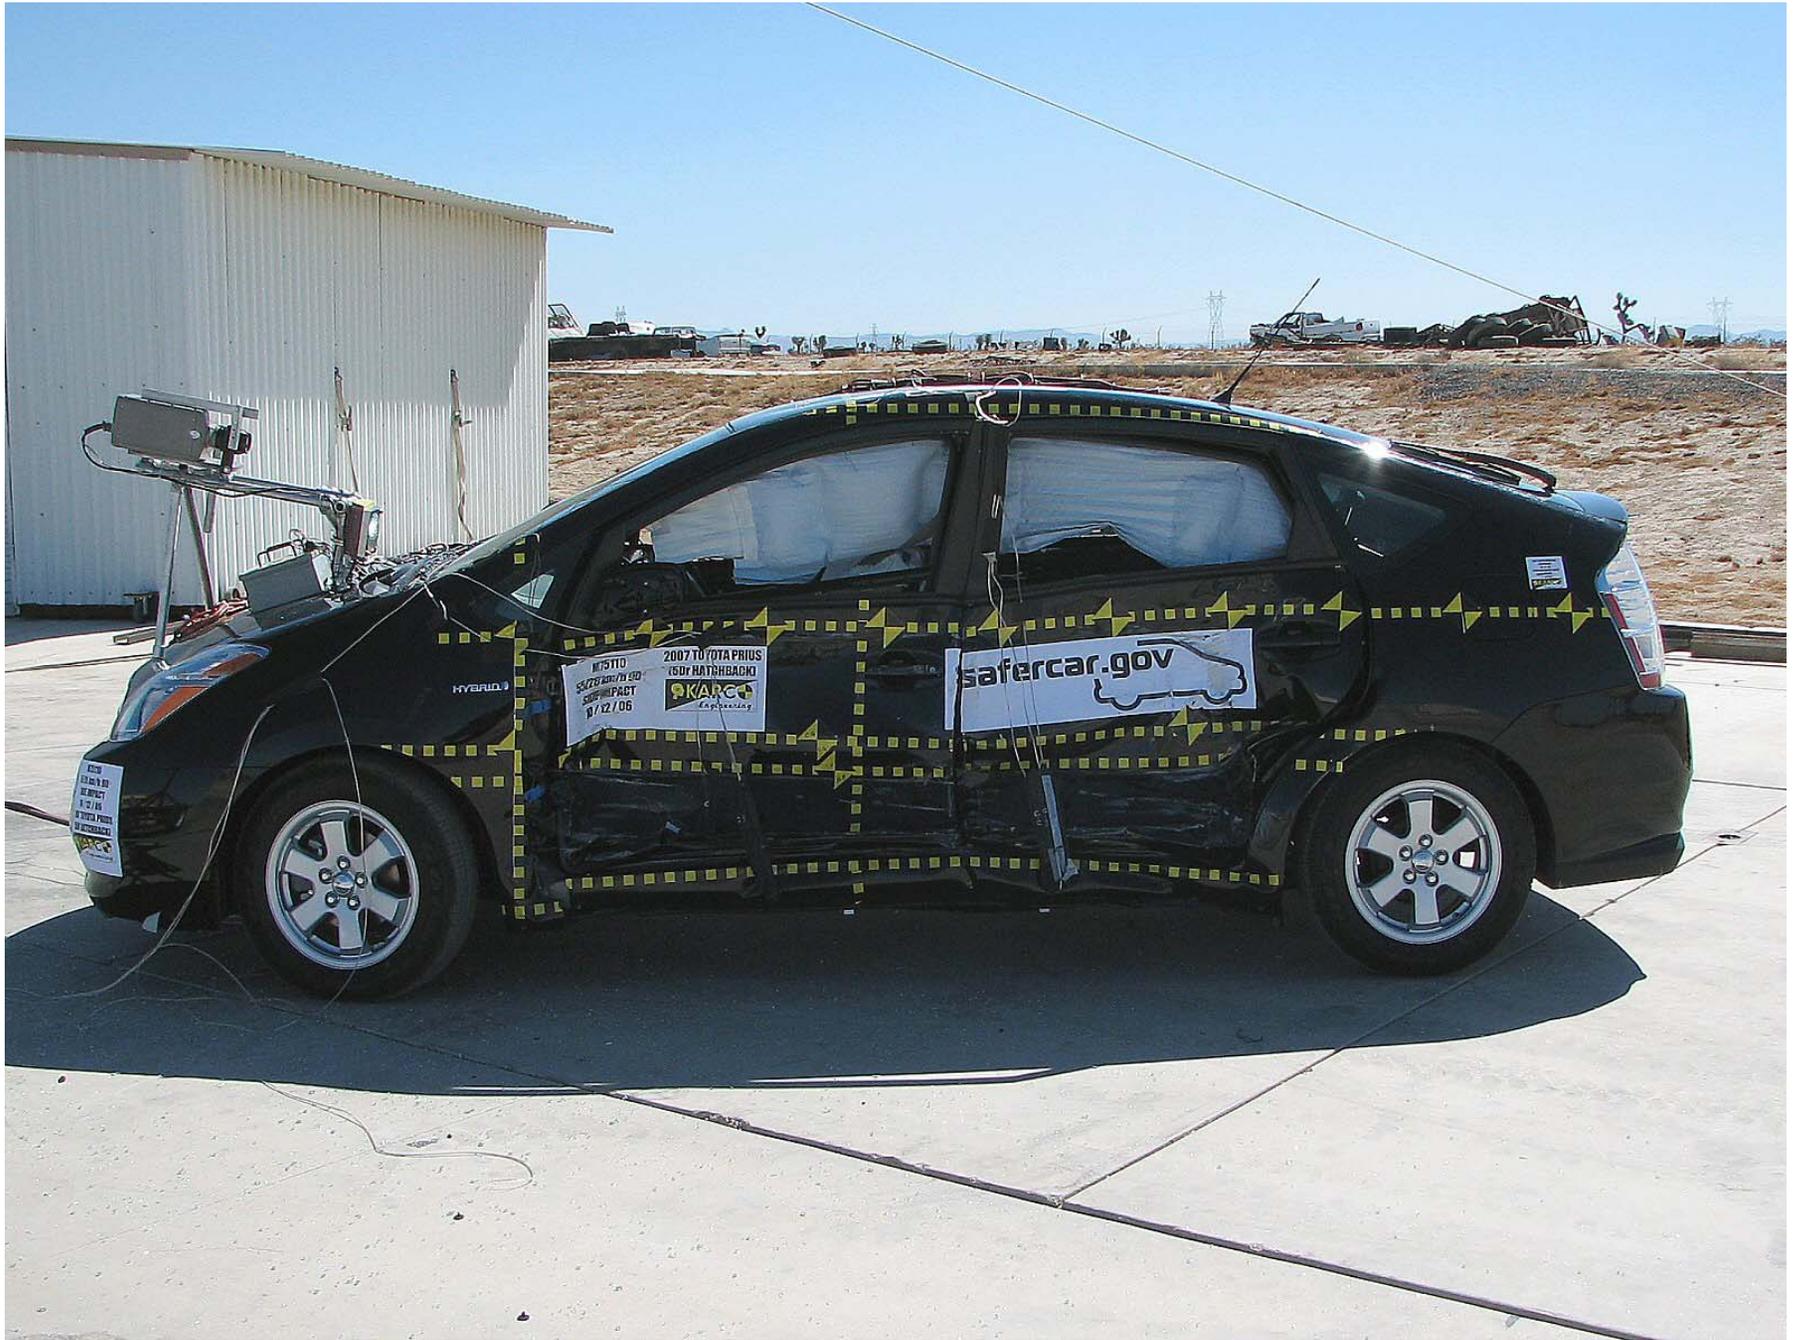
Figure A-10: Post-Test Left Side View

The driver and passenger doors remained closed during impact. The test vehicle sustained a maximum static crush of 331 mm at level 3, 1500 mm rearward of the left vertical impact point. The driver SID/Hybrid III, Serial No. 274 and the passenger SID/Hybrid III, Serial No. 275 were calibrated prior to this test. The SID/Hybrid III injury criteria is summarized as follows:

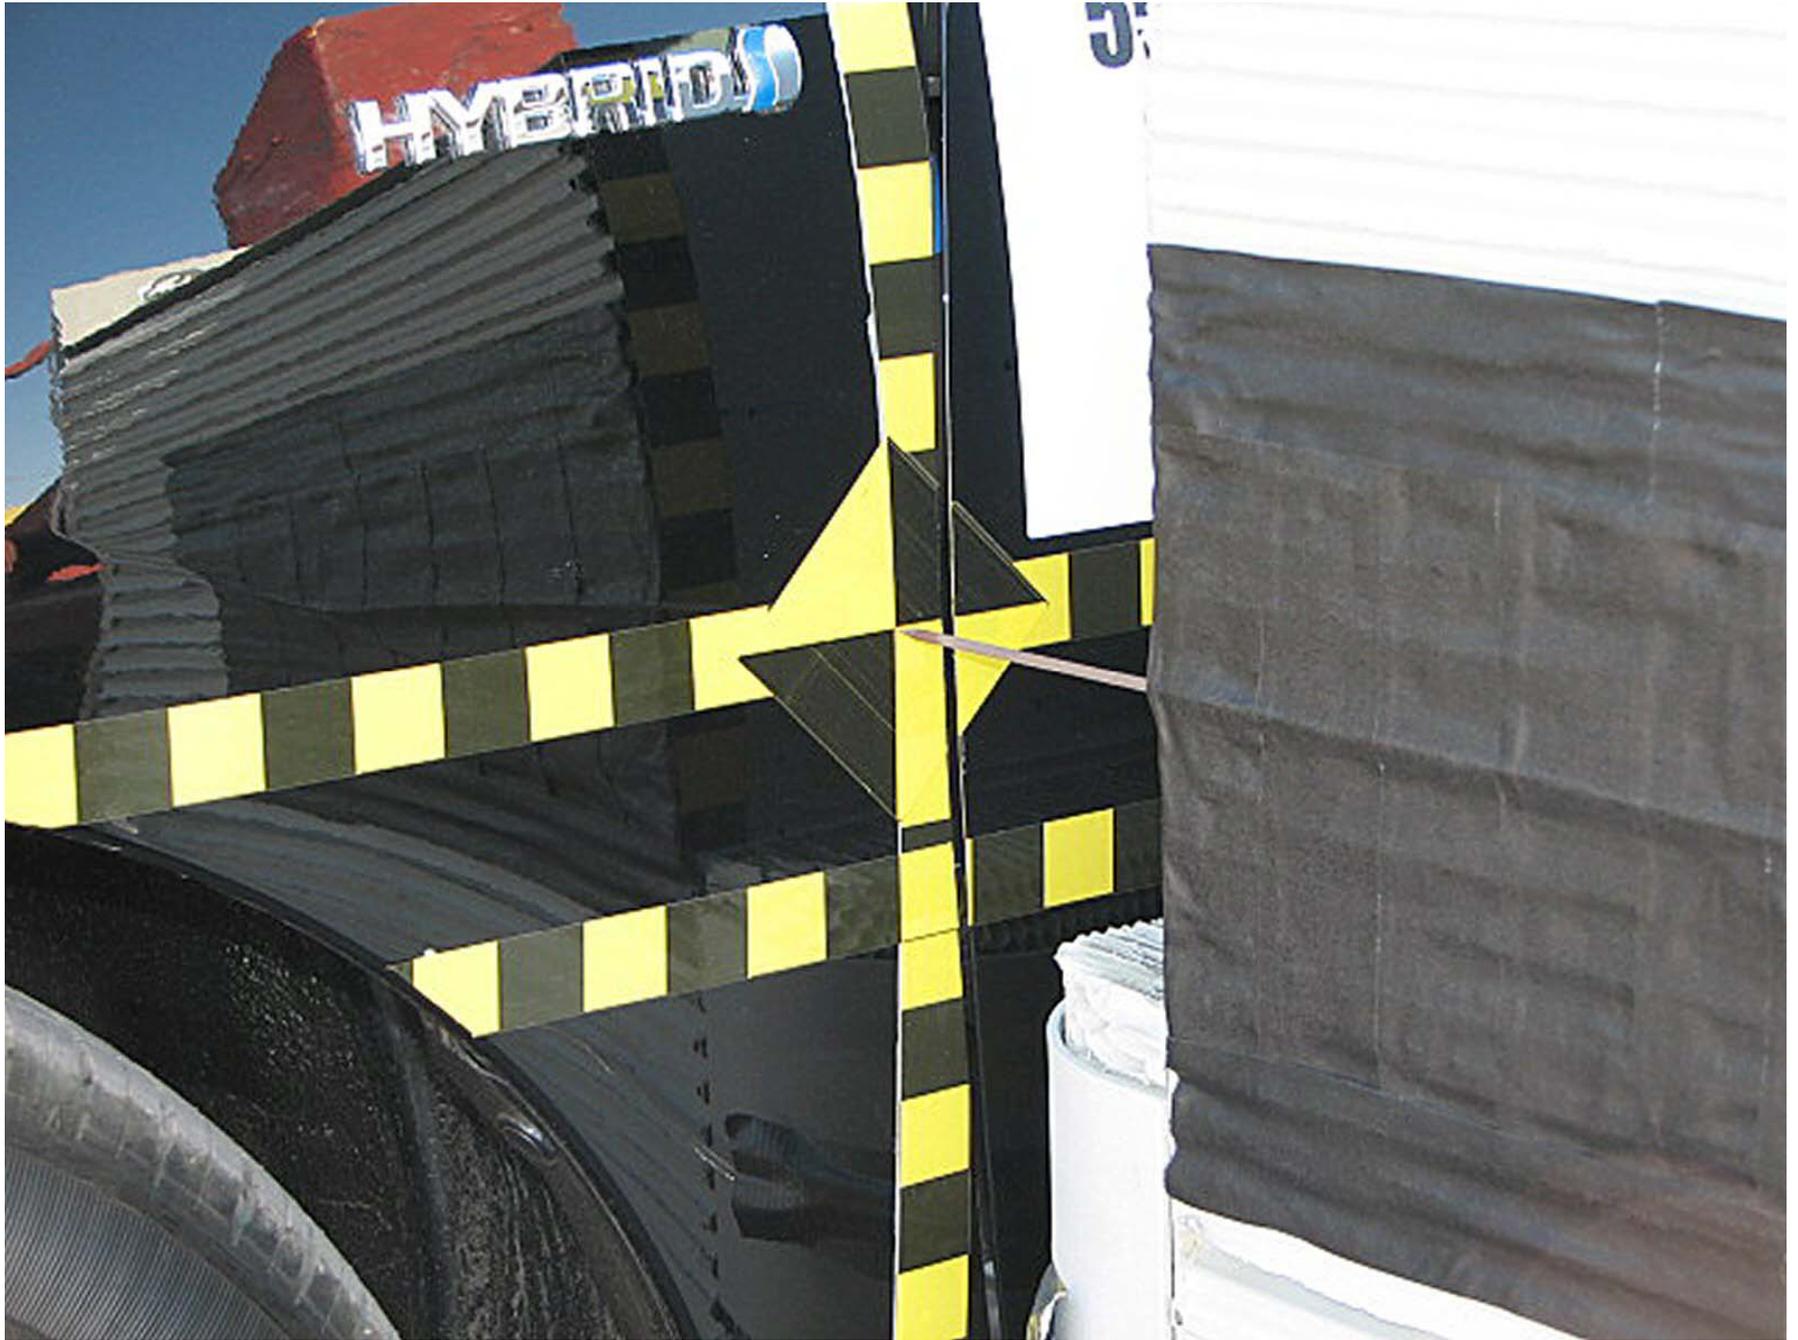
Figure A-25: Pre-Test Left Impact Point

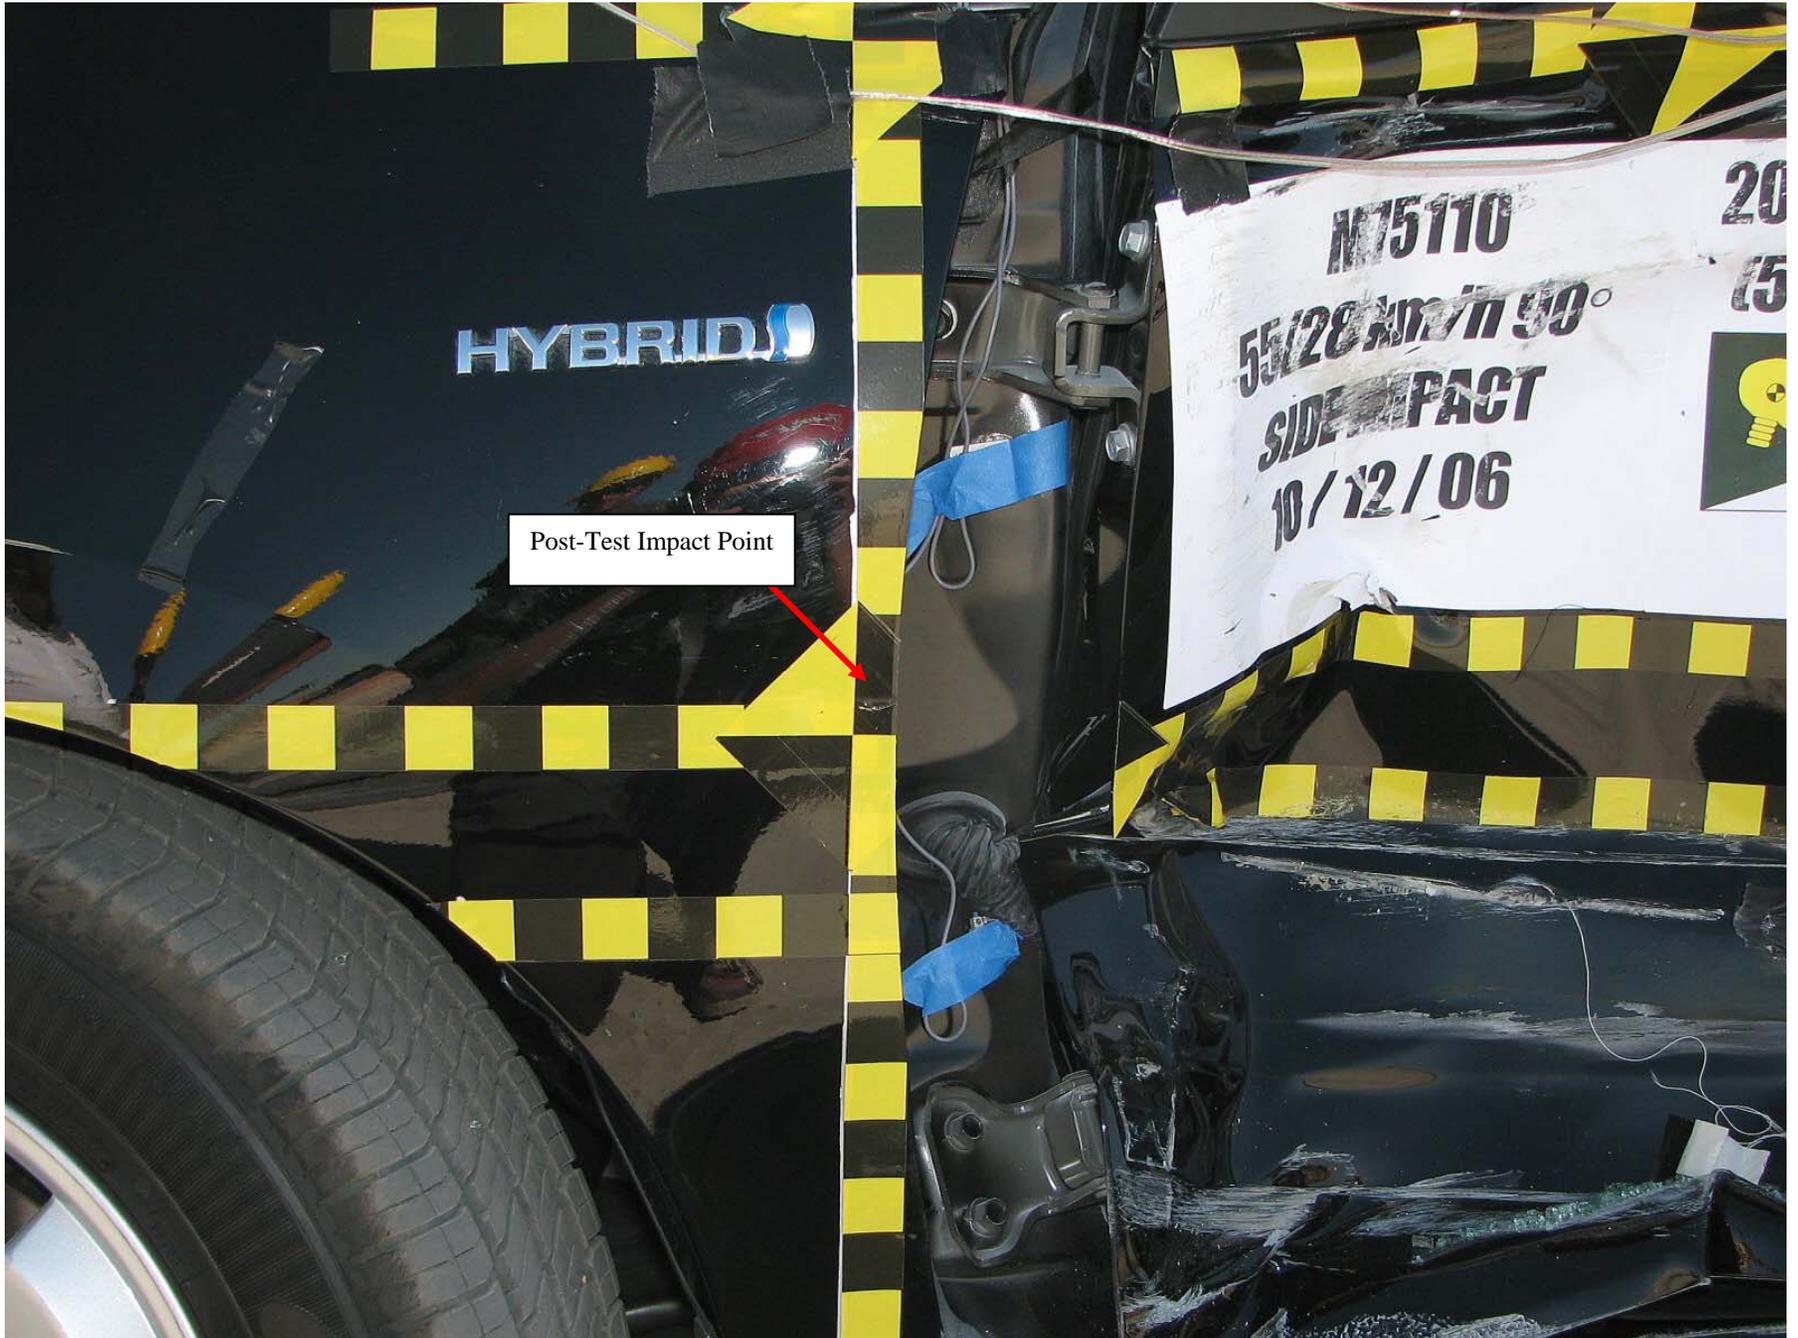
Figure A-26: Post-Test Left Impact Point

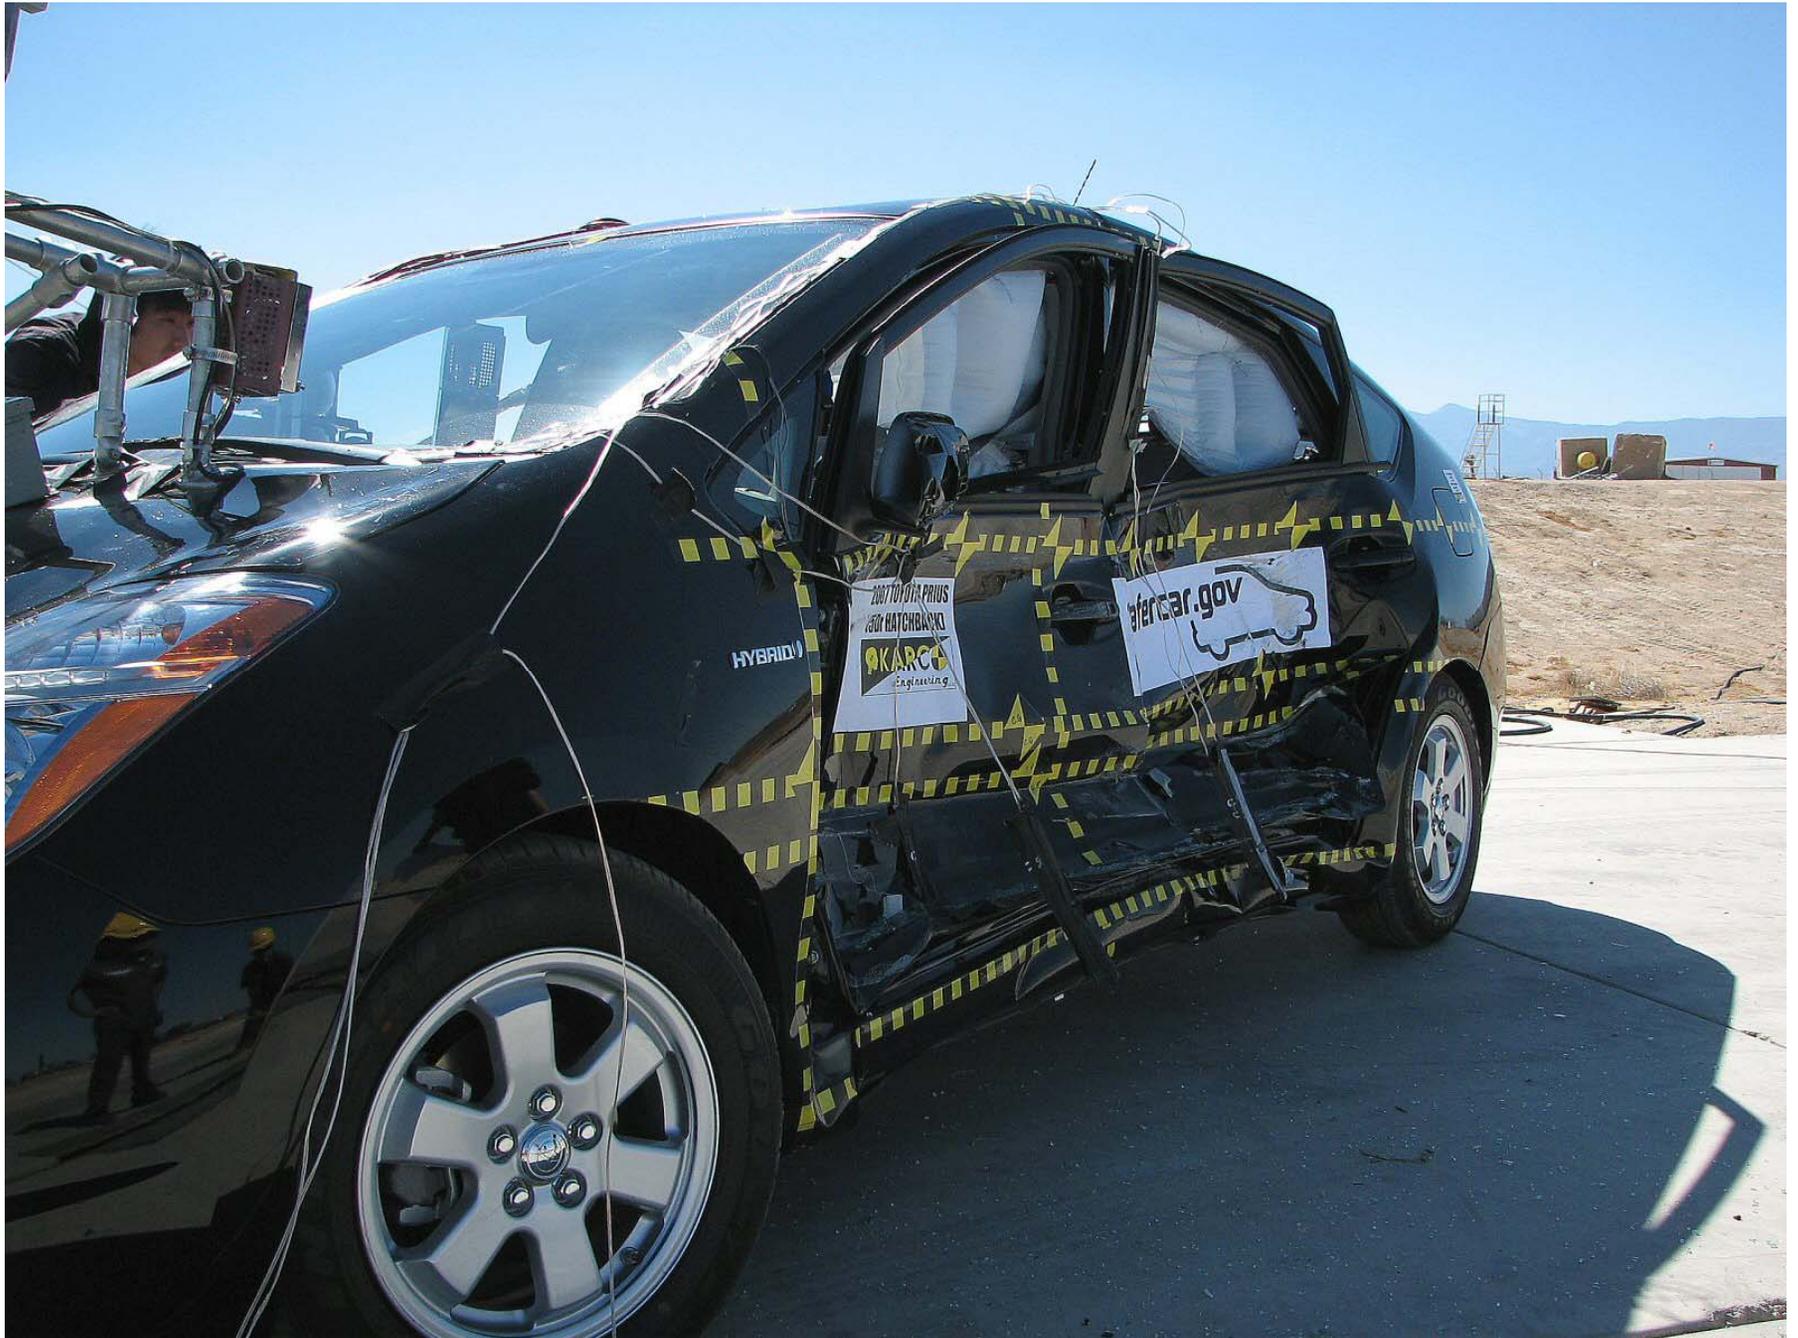
Figure A-28: Post-Test Front  $\frac{3}{4}$  View of Left Side Door

Description	Front	Rear
Left Side Door Opening	Door remained closed and latched, jammed	Door remained closed and latched, jammed
Right Side Door Opening	Remained closed and latched, operational	Remained closed and latched, operational
Seat Movement	None	None
Seat Back Failure	None	None
