**REPORT NUMBER TR-P27003-05-NC**

**NEW CAR ASSESSMENT PROGRAM  
SIDE IMPACT TEST**

**TOYOTA MOTOR CORPORATION  
2007 TOYOTA PRIUS  
5-DOOR HATCHBACK**

**FINAL REPORT**

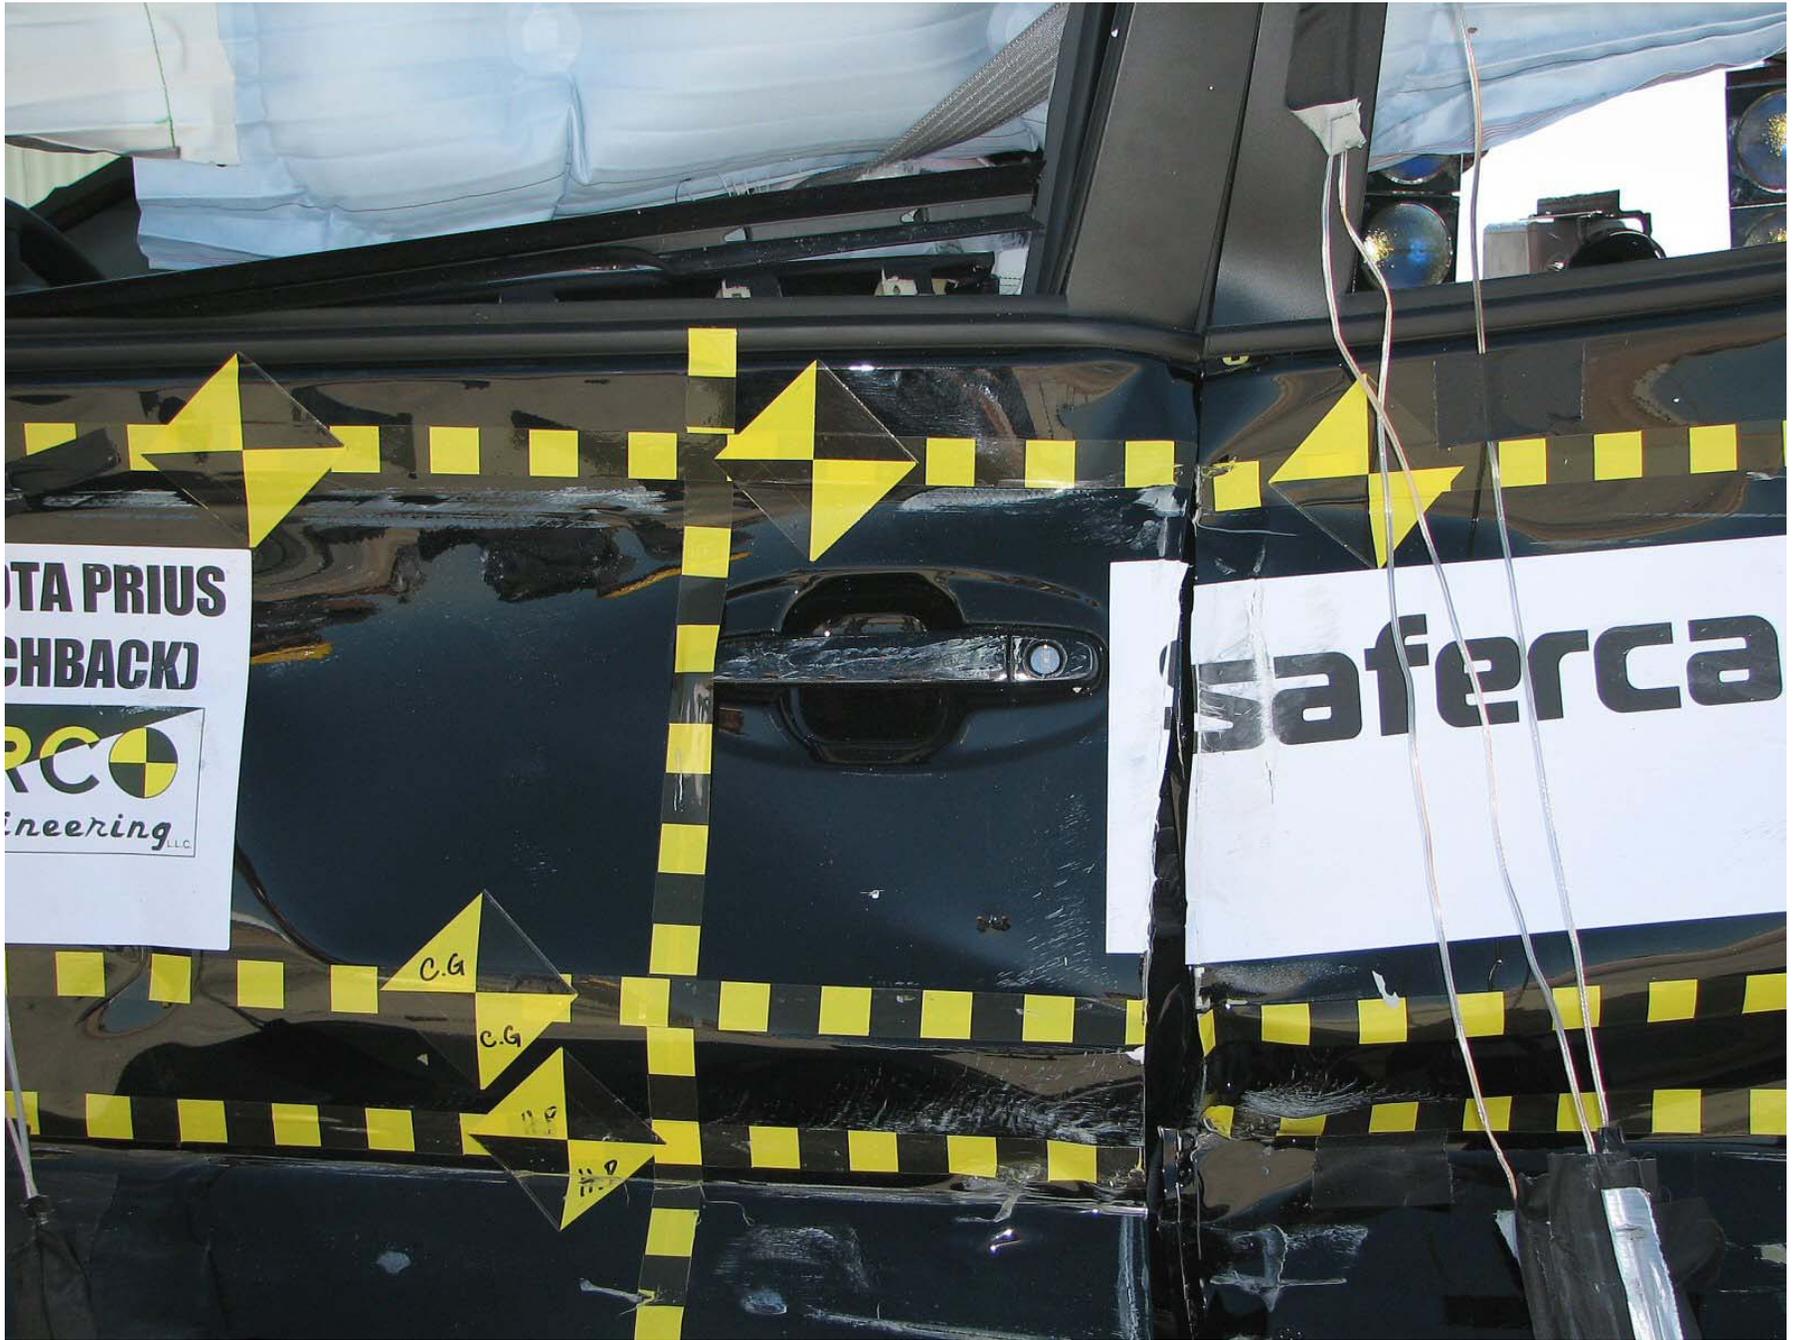
Figure A-32: Post-Test Left Front Door

Description	Front	Rear
Left Side Door Opening	Door remained closed and latched, jammed	Door remained closed and latched, jammed
Right Side Door Opening	Remained closed and latched, operational	Remained closed and latched, operational
Seat Movement	None	None
Seat Back Failure	None	None

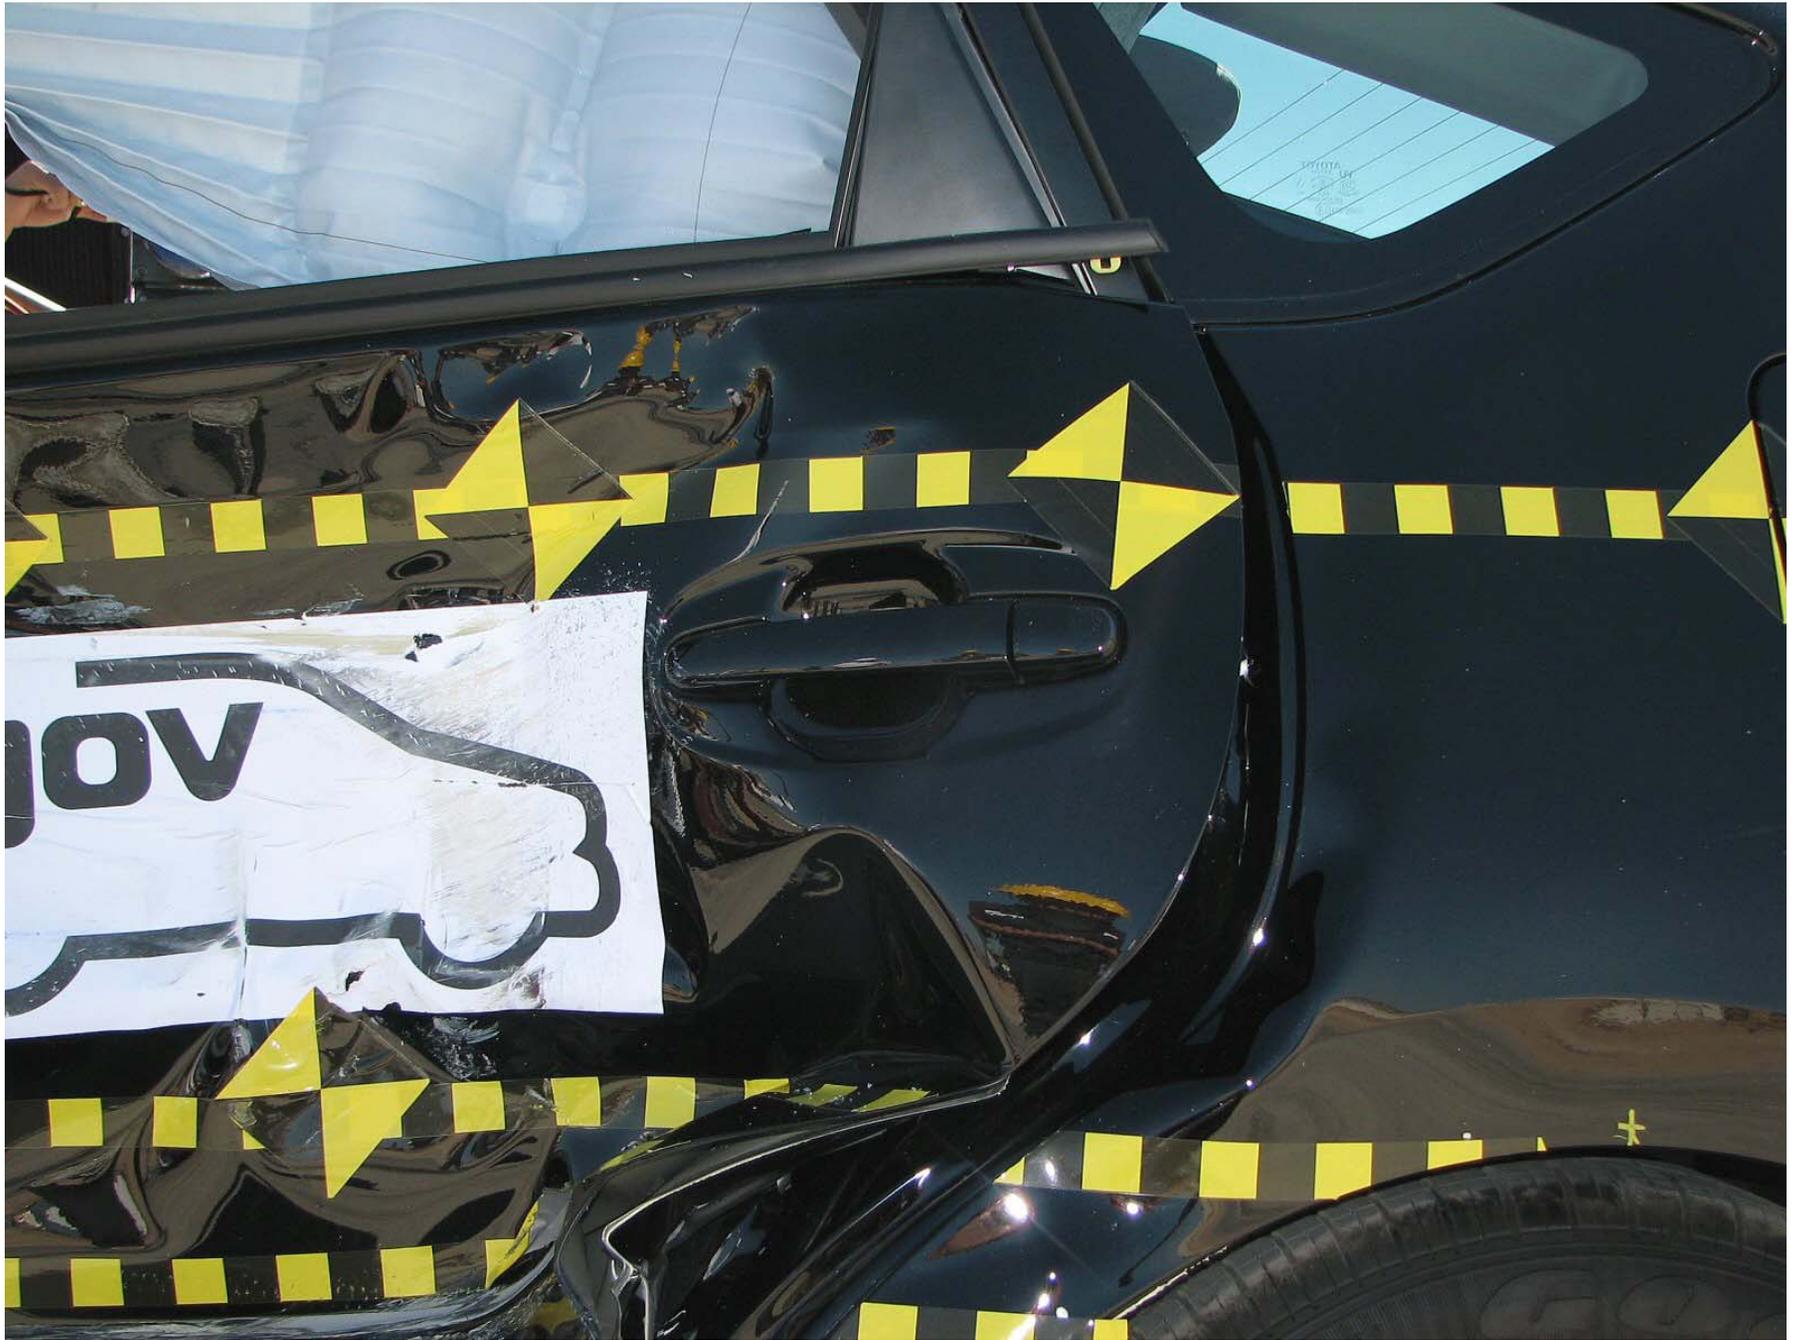
Figure A-34: Post-Test Left Rear Door

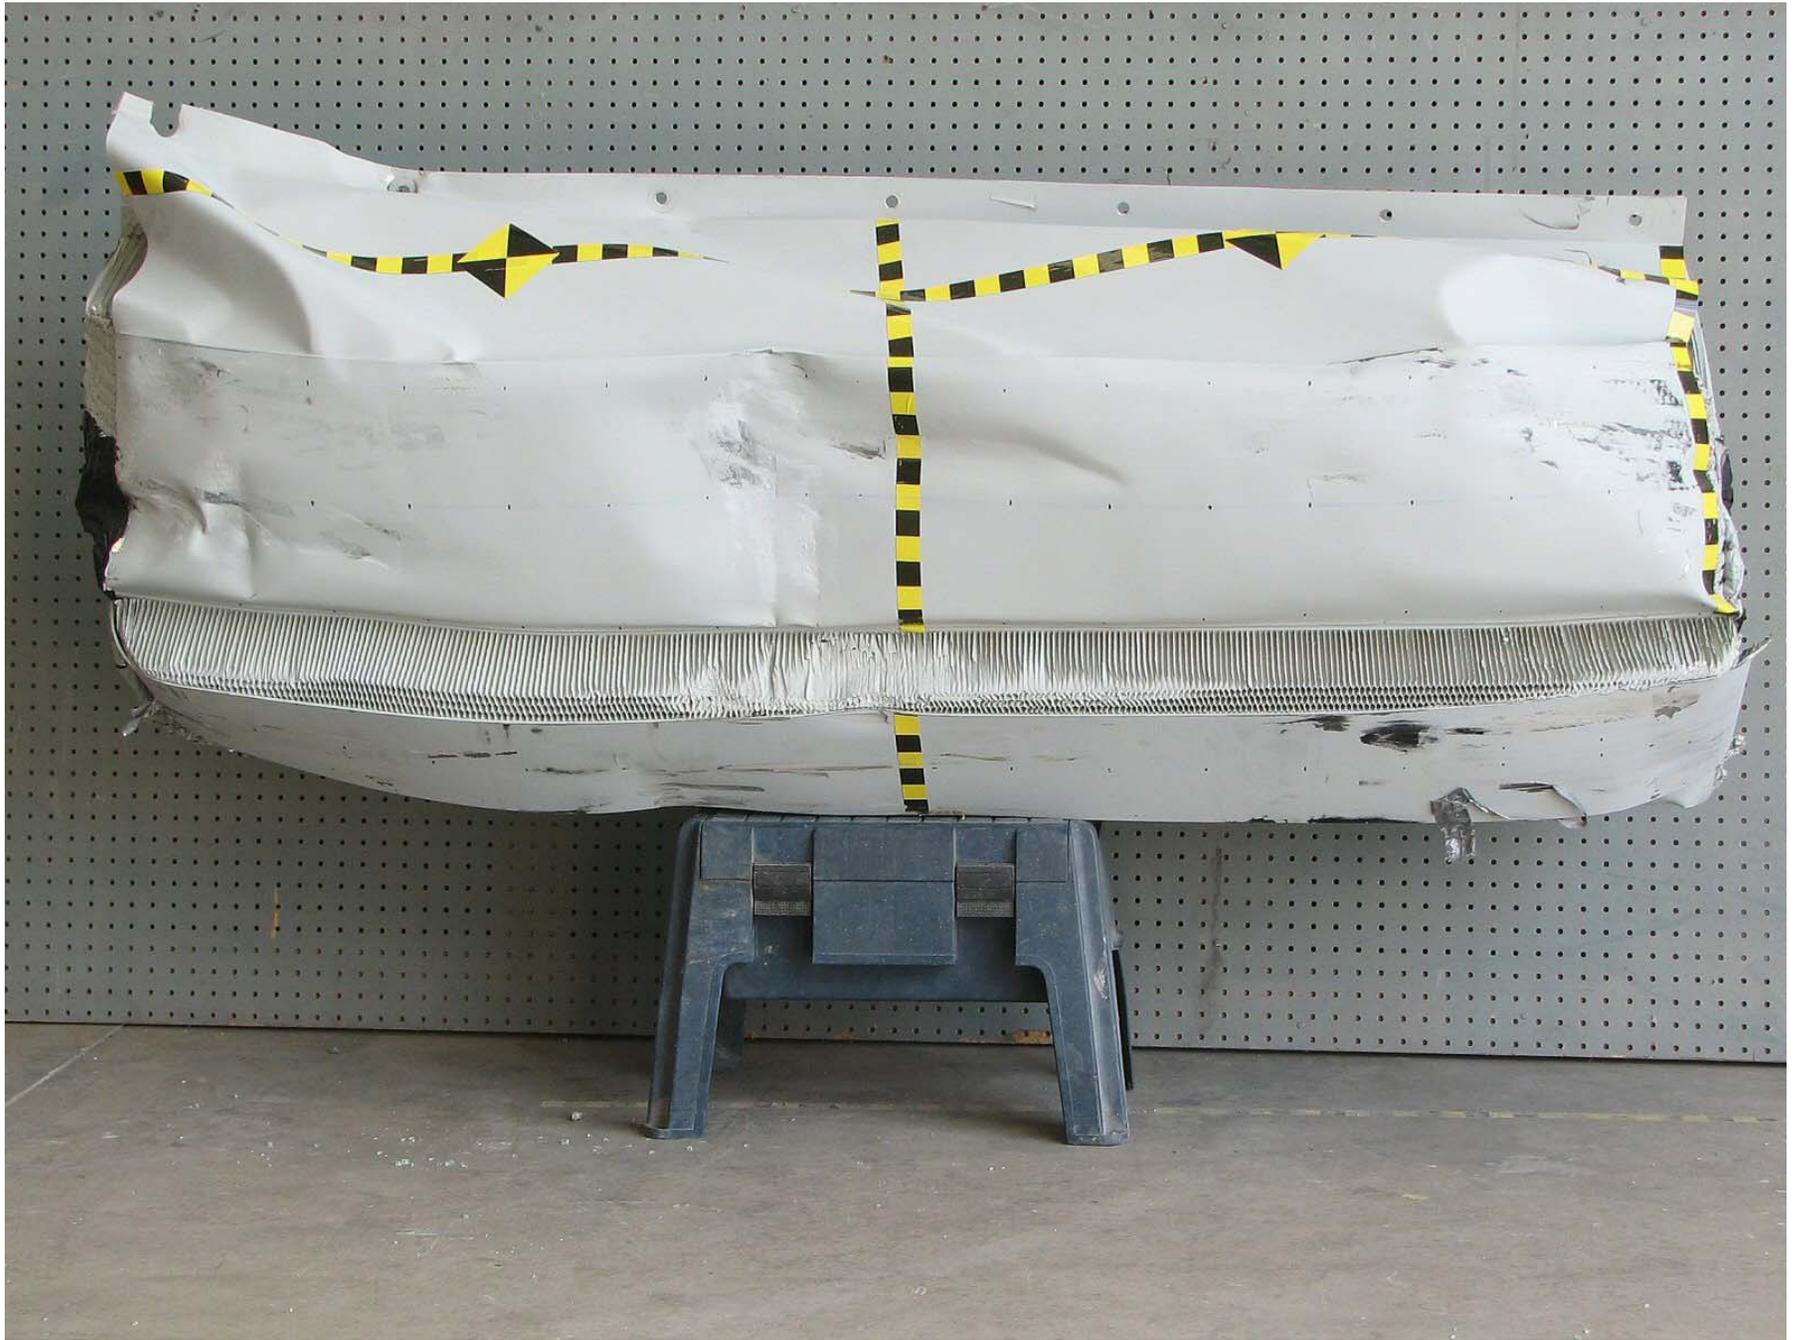
Figure A-54: Post-Test Front View of Deformable Barrier

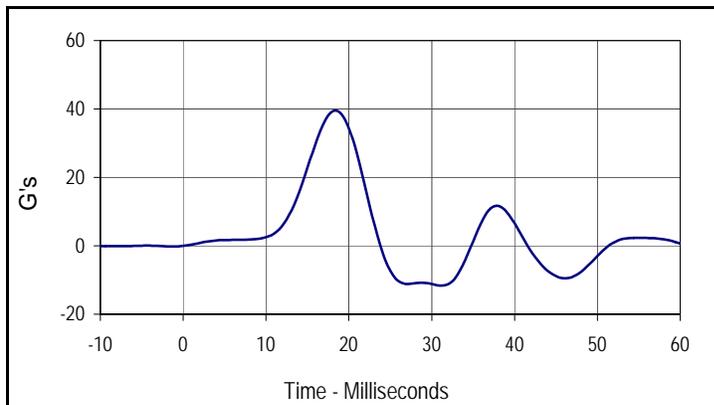
Curve Description			
Upper Rib Primary Y			
CURNO	Type	SAE Class	Units
001	FIL	FIR100	G's
Max	Time	Min	Time
39.4	18.1	-11.7	31.3

Tested Parameter	Units	Specification	Result	Pass/Fail
Laboratory Temperature	°C	18.9 to 25.6	22.2	Pass
Laboratory Relative Humidity	%	10 to 70	31	Pass
Probe Velocity	m/s	4.21 to 4.33	4.27	Pass
Upper Rib Acceleration	G's	37.0 to 46.0	39.4	Pass
Lower Rib Acceleration	G's	37.0 to 46.0	38.3	Pass
Thoracic Spine Acceleration	G's	15.0 to 22.0	16.9	Pass
Overall Test Results				Pass

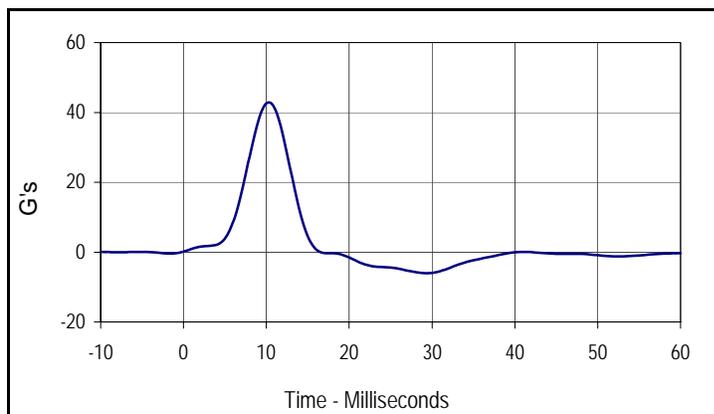
Curve Description			
Pelvis Primary Y			
CURNO	Type	SAE Class	Units
001	FIL	FIR100	G's
Max	Time	Min	Time
42.6	10.0	-6.1	29.4

Tested Parameter	Units	Specification	Result	Pass/Fail
Laboratory Temperature	°C	18.9 to 25.6	21.1	Pass
Laboratory Relative Humidity	%	10 to 70	30	Pass
Probe Velocity	m/s	4.21 to 4.33	4.29	Pass
Peak Pelvis Acceleration	G's	40.0 to 60.0	42.6	Pass
Acceleration Time Above 20 G's	Msec.	3.0 to 7.0	6.25	Pass
Overall Test Results				Pass

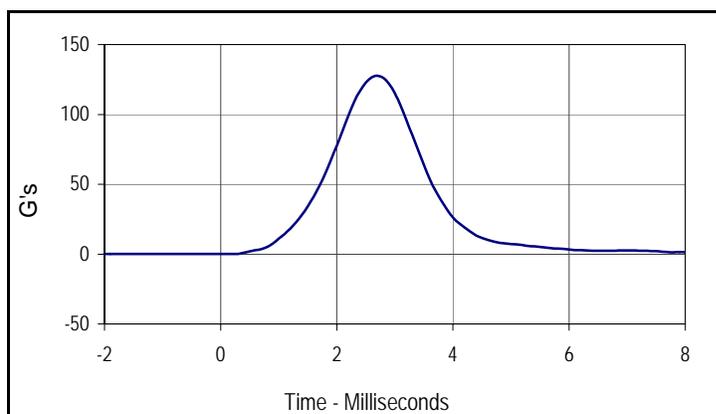
Curve Description			
Head Resultant			
CURNO	Type	SAE Class	Units
001	RES	1000	G's
Max	Time	Min	Time
127.8	2.7	0.0	-1.2

Tested Parameter	Units	Specification	Result	Pass/Fail
Laboratory Temperature	°C	18.9 to 25.6	22.2	Pass
Laboratory Relative Humidity	%	10 to 70	30	Pass
Peak Resultant Acceleration	G's	120.0 to 150.0	127.8	Pass
Peak Longitudinal Acceleration	G's	≤15.0	5.8	Pass
Is Acceleration Unimodal?	Yes/No	Yes	Yes	Pass
Oscillations After Main Pulse	%	<15	5.7	Pass
Overall Test Results				Pass

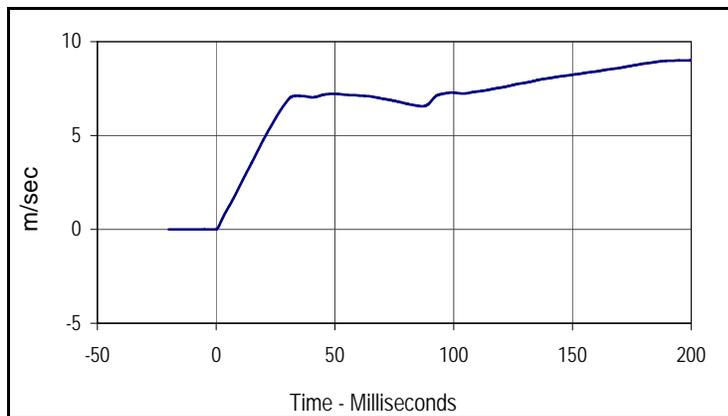
Curve Description			
Pendulum Velocity			
CURNO	Type	SAE Class	Units
001	FIL	180	m/sec
Max	Time	Min	Time
9.0	196.0	0.0	-0.5

Tested Parameter	Units	Specification	Result	Pass/Fail	
Laboratory Temperature	°C	20.6 to 22.2	21.1	Pass	
Laboratory Relative Humidity	%	10 to 70	31	Pass	
Pendulum Velocity	m/sec	6.89 to 7.13	7.08	Pass	
Pendulum Deceleration	10 Msec.	m/sec	1.96 to 2.55	2.34	Pass
	20 Msec.	m/sec	4.12 to 5.10	4.80	Pass
	30 Msec.	m/sec	5.73 to 7.01	6.86	Pass
	40 to 70	m/sec	6.27 to 7.64	7.22	Pass
"D" Plane Rotation	Max	Degrees	66.0 to 82.0	78.1	Pass
Max Rotation Time After Peak Moment	Msec.	2.0 to 16.0	9.8	Pass	
Rotation Time From Peak to Zero Angle	Msec.	58.0 to 67.0	61.0	Pass	
Moment About Occipital Condyle	Nm	73.0 to 88.0	82.5	Pass	
Positive Moment Decay, Time To 0 Nm	Msec.	49.0 to 64.0	50.1	Pass	
Overall Test Results				Pass

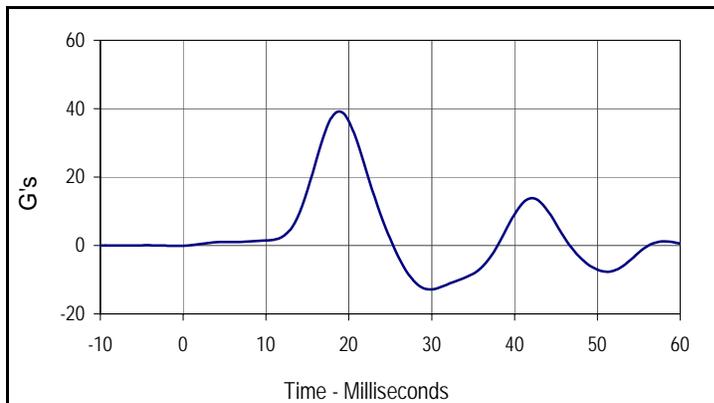
Curve Description			
Upper Rib Primary Y			
CURNO	Type	SAE Class	Units
001	FIL	FIR100	G's
Max	Time	Min	Time
39.2	18.8	-12.8	30.0

Tested Parameter	Units	Specification	Result	Pass/Fail
Laboratory Temperature	°C	18.9 to 25.6	21.1	Pass
Laboratory Relative Humidity	%	10 to 70	30	Pass
Probe Velocity	m/s	4.21 to 4.33	4.27	Pass
Upper Rib Acceleration	G's	37.0 to 46.0	39.2	Pass
Lower Rib Acceleration	G's	37.0 to 46.0	37.6	Pass
Thoracic Spine Acceleration	G's	15.0 to 22.0	19.2	Pass
Overall Test Results				Pass

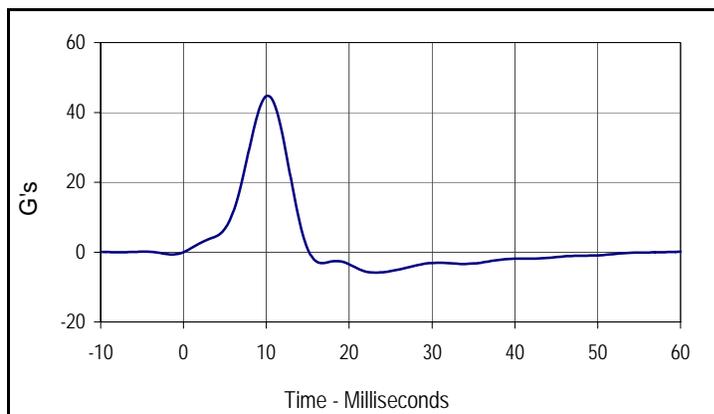
Curve Description			
Pelvis Primary Y			
CURNO	Type	SAE Class	Units
001	FIL	FIR100	G's
Max	Time	Min	Time
44.7	10.0	-5.9	23.1

Tested Parameter	Units	Specification	Result	Pass/Fail
Laboratory Temperature	°C	18.9 to 25.6	21.7	Pass
Laboratory Relative Humidity	%	10 to 70	30	Pass
Probe Velocity	m/s	4.21 to 4.33	4.33	Pass
Peak Pelvis Acceleration	G's	40.0 to 60.0	44.7	Pass
Acceleration Time Above 20 G's	Msec.	3.0 to 7.0	5.63	Pass
Overall Test Results				Pass

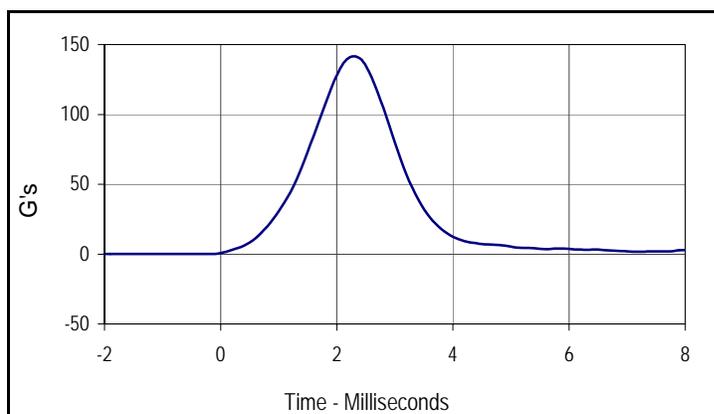
Curve Description			
Head Resultant			
CURNO	Type	SAE Class	Units
001	RES	1000	G's
Max	Time	Min	Time
141.6	2.3	0.1	-0.2

Tested Parameter	Units	Specification	Result	Pass/Fail
Laboratory Temperature	°C	18.9 to 25.6	21.1	Pass
Laboratory Relative Humidity	%	10 to 70	30	Pass
Peak Resultant Acceleration	G's	120.0 to 150.0	141.6	Pass
Peak Longitudinal Acceleration	G's	≤15.0	7.4	Pass
Is Acceleration Unimodal?	Yes/No	Yes	Yes	Pass
Oscillations After Main Pulse	%	<15	3.7	Pass
Overall Test Results				Pass

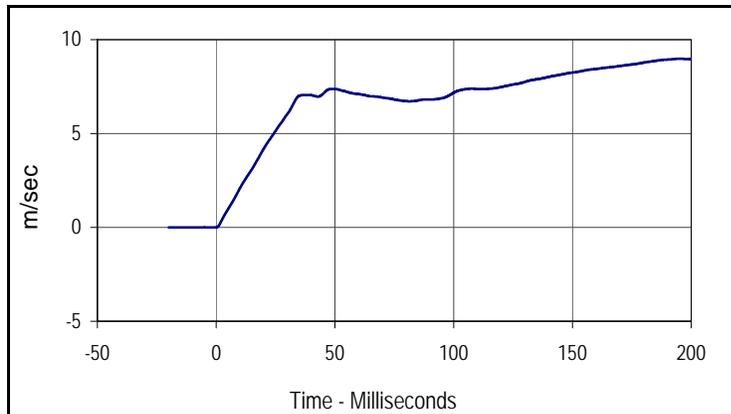
Curve Description			
Pendulum Velocity			
CURNO	Type	SAE Class	Units
001	FIL	180	m/sec
Max	Time	Min	Time
9.0	194.7	0.0	-0.3

Tested Parameter	Units	Specification	Result	Pass/Fail	
Laboratory Temperature	°C	20.6 to 22.2	21.7	Pass	
Laboratory Relative Humidity	%	10 to 70	31	Pass	
Pendulum Velocity	m/sec	6.89 to 7.13	7.12	Pass	
Pendulum Deceleration	10 Msec.	m/sec	1.96 to 2.55	2.09	Pass
	20 Msec.	m/sec	4.12 to 5.10	4.19	Pass
	30 Msec.	m/sec	5.73 to 7.01	6.04	Pass
	40 to 70	m/sec	6.27 to 7.64	7.38	Pass
"D" Plane Rotation	Max	Degrees	66.0 to 82.0	74.2	Pass
Max Rotation Time After Peak Moment	Msec.	2.0 to 16.0	3.7	Pass	
Rotation Time From Peak to Zero Angle	Msec.	58.0 to 67.0	59.2	Pass	
Moment About Occipital Condyle	Nm	73.0 to 88.0	85.8	Pass	
Positive Moment Decay, Time To 0 Nm	Msec.	49.0 to 64.0	62.4	Pass	
Overall Test Results				Pass

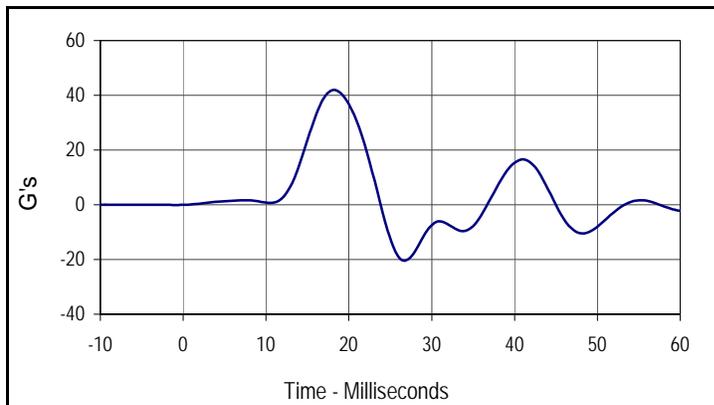
Curve Description			
Upper Rib Primary			
CURNO	Type	SAE Class	Units
001	FIL	FIR100	G's
Max	Time	Min	Time
41.9	18.1	-20.4	26.9

Tested Parameter	Units	Specification	Result	Pass/Fail
Laboratory Temperature	°C	18.9 to 25.6	21.1	Pass
Laboratory Relative Humidity	%	10 to 70	30	Pass
Probe Velocity	m/s	4.21 to 4.33	4.27	Pass
Upper Rib Acceleration	G's	37.0 to 46.0	41.9	Pass
Lower Rib Acceleration	G's	37.0 to 46.0	39.1	Pass
Thoracic Spine Acceleration	G's	15.0 to 22.0	21.9	Pass
Overall Test Results				Pass

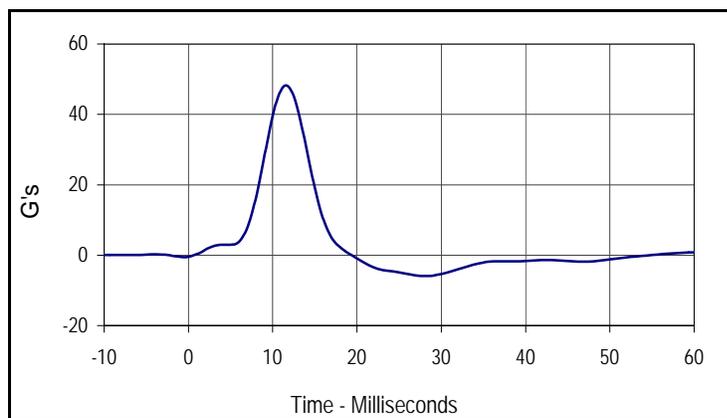
Curve Description			
Pelvis Primary Y			
CURNO	Type	SAE Class	Units
001	FIL	FIR100	G's
Max	Time	Min	Time
47.9	11.9	-5.9	28.1

Tested Parameter	Units	Specification	Result	Pass/Fail
Laboratory Temperature	°C	18.9 to 25.6	21.1	Pass
Laboratory Relative Humidity	%	10 to 70	30	Pass
Probe Velocity	m/s	4.21 to 4.33	4.29	Pass
Peak Pelvis Acceleration	G's	40.0 to 60.0	47.9	Pass
Acceleration Time Above 20 G's	Msec.	3.0 to 7.0	6.25	Pass
Overall Test Results				Pass

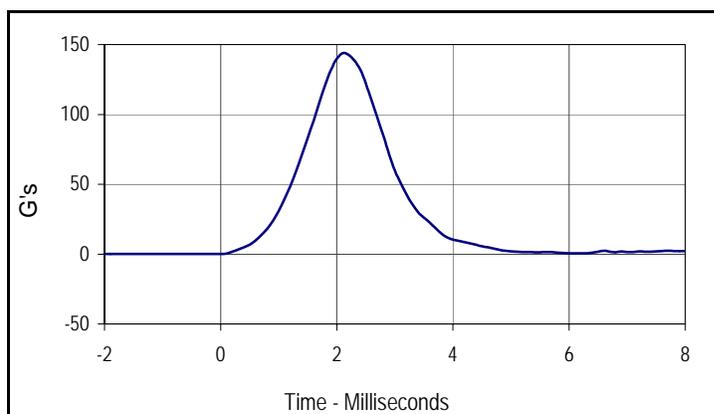
Curve Description			
Head Resultant			
CURNO	Type	SAE Class	Units
001	RES	1000	G's
Max	Time	Min	Time
143.8	2.1	0.0	-1.6

Tested Parameter	Units	Specification	Result	Pass/Fail
Laboratory Temperature	°C	18.9 to 25.6	21.1	Pass
Laboratory Relative Humidity	%	10 to 70	30	Pass
Peak Resultant Acceleration	G's	120.0 to 150.0	143.8	Pass
Peak Longitudinal Acceleration	G's	≤15.0	1.9	Pass
Is Acceleration Unimodal?	Yes/No	Yes	Yes	Pass
Oscillations After Main Pulse	%	<15	1.7	Pass
Overall Test Results				Pass

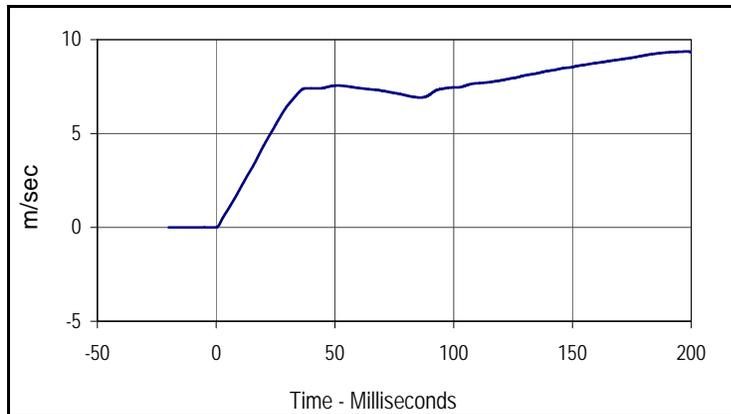
Curve Description			
Pendulum Velocity			
CURNO	Type	SAE Class	Units
001	FIL	180	m/sec
Max	Time	Min	Time
9.4	197.9	0.0	-0.3

Tested Parameter	Units	Specification	Result	Pass/Fail	
Laboratory Temperature	°C	20.6 to 22.2	21.1	Pass	
Laboratory Relative Humidity	%	10 to 70	30	Pass	
Pendulum Velocity	m/sec	6.89 to 7.13	6.95	Pass	
Pendulum Deceleration	10 Msec.	m/sec	1.96 to 2.55	2.05	Pass
	20 Msec.	m/sec	4.12 to 5.10	4.35	Pass
	30 Msec.	m/sec	5.73 to 7.01	6.48	Pass
	40 to 70	m/sec	6.27 to 7.64	7.55	Pass
"D" Plane Rotation	Max Degrees	66.0 to 82.0	74.6	Pass	
Max Rotation Time After Peak Moment	Msec.	2.0 to 16.0	8.6	Pass	
Rotation Time From Peak to Zero Angle	Msec.	58.0 to 67.0	60.4	Pass	
Moment About Occipital Condyle	Nm	73.0 to 88.0	81.7	Pass	
Positive Moment Decay, Time To 0 Nm	Msec.	49.0 to 64.0	49.7	Pass	
Overall Test Results				Pass

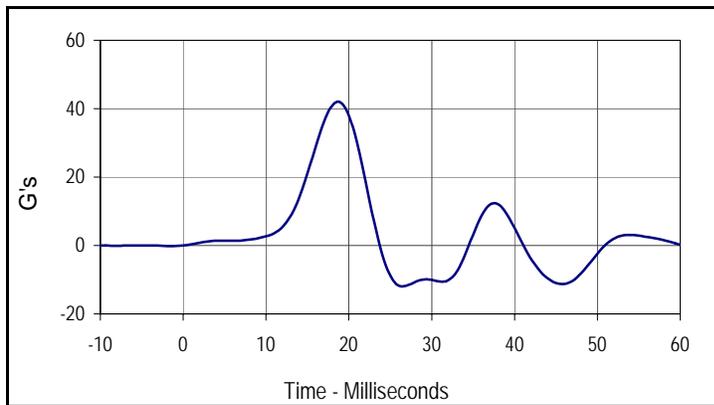
Curve Description			
Upper Rib Primary Y			
CURNO	Type	SAE Class	Units
001	FIL	FIR100	G's
Max	Time	Min	Time
42.1	18.8	-11.9	26.3

Tested Parameter	Units	Specification	Result	Pass/Fail
Laboratory Temperature	°C	18.9 to 25.6	21.1	Pass
Laboratory Relative Humidity	%	10 to 70	30	Pass
Probe Velocity	m/s	4.21 to 4.33	4.30	Pass
Upper Rib Acceleration	G's	37.0 to 46.0	42.1	Pass
Lower Rib Acceleration	G's	37.0 to 46.0	39.2	Pass
Thoracic Spine Acceleration	G's	15.0 to 22.0	18.5	Pass
Overall Test Results				Pass

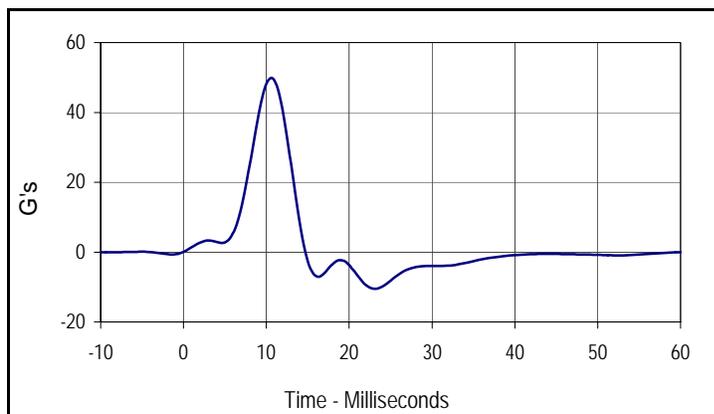
Curve Description			
Pelvis Primary Y			
CURNO	Type	SAE Class	Units
001	FIL	FIR100	G's
Max	Time	Min	Time
49.9	10.6	-10.5	23.1

Tested Parameter	Units	Specification	Result	Pass/Fail
Laboratory Temperature	°C	18.9 to 25.6	21.7	Pass
Laboratory Relative Humidity	%	10 to 70	30	Pass
Probe Velocity	m/s	4.21 to 4.33	4.30	Pass
Peak Pelvis Acceleration	G's	40.0 to 60.0	49.9	Pass
Acceleration Time Above 20 G's	Msec.	3.0 to 7.0	5.63	Pass
Overall Test Results				Pass

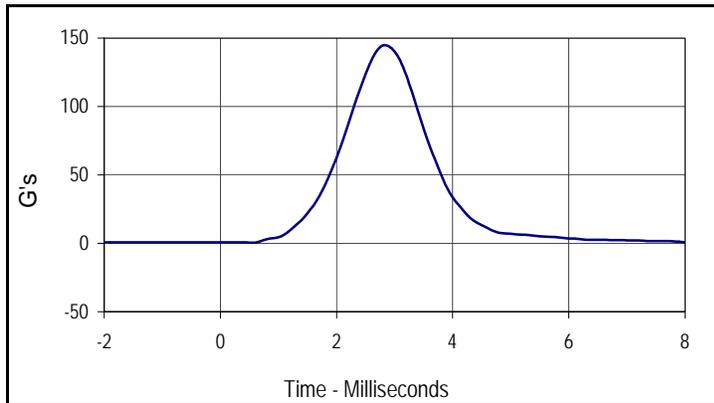
Curve Description			
Head Resultant			
CURNO	Type	SAE Class	Units
001	RES	1000	G's
Max	Time	Min	Time
144.6	2.8	0.5	0.5

Tested Parameter	Units	Specification	Result	Pass/Fail
Laboratory Temperature	°C	18.9 to 25.6	21.1	Pass
Laboratory Relative Humidity	%	10 to 70	30	Pass
Peak Resultant Acceleration	G's	120.0 to 150.0	144.6	Pass
Peak Longitudinal Acceleration	G's	≤15.0	5.3	Pass
Is Acceleration Unimodal?	Yes/No	Yes	Yes	Pass
Oscillations After Main Pulse	%	<15	4.8	Pass
<b>Overall Test Results</b>				<b>Pass</b>

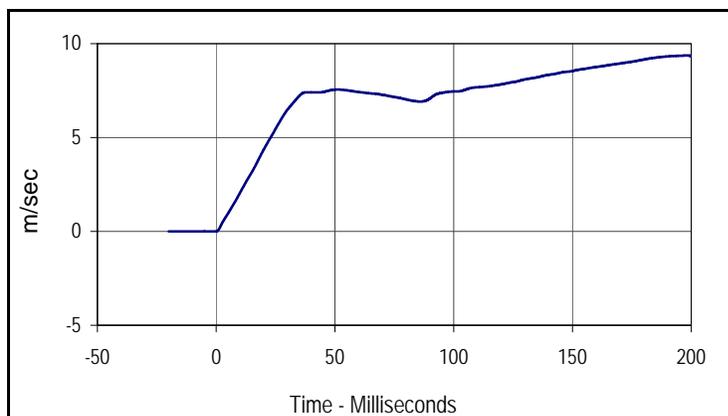
Curve Description			
Pendulum Velocity			
CURNO	Type	SAE Class	Units
001	FIL	180	m/sec
Max	Time	Min	Time
9.4	197.9	0.0	-0.3

Tested Parameter	Units	Specification	Result	Pass/Fail	
Laboratory Temperature	°C	20.6 to 22.2	21.7	Pass	
Laboratory Relative Humidity	%	10 to 70	31	Pass	
Pendulum Velocity	m/sec	6.89 to 7.13	7.12	Pass	
Pendulum Deceleration	10 Msec.	m/sec	1.96 to 2.55	2.05	Pass
	20 Msec.	m/sec	4.12 to 5.10	4.35	Pass
	30 Msec.	m/sec	5.73 to 7.01	6.48	Pass
	40 to 70	m/sec	6.27 to 7.64	7.55	Pass
"D" Plane Rotation	Max	Degrees	66.0 to 82.0	76.1	Pass
Max Rotation Time After Peak Moment	Msec.	2.0 to 16.0	8.6	Pass	
Rotation Time From Peak to Zero Angle	Msec.	58.0 to 67.0	60.4	Pass	
Moment About Occipital Condyle	Nm	73.0 to 88.0	82.5	Pass	
Positive Moment Decay, Time To 0 Nm	Msec.	49.0 to 64.0	49.7	Pass	
Overall Test Results				Pass
