REPORT NUMBER: MCW-DOT-07SN02

NEW CAR ASSESSMENT PROGRAM
SIDE IMPACT TEST

2006 TOYOTA SIENNA 4-DOOR MPV

FINAL REPORT

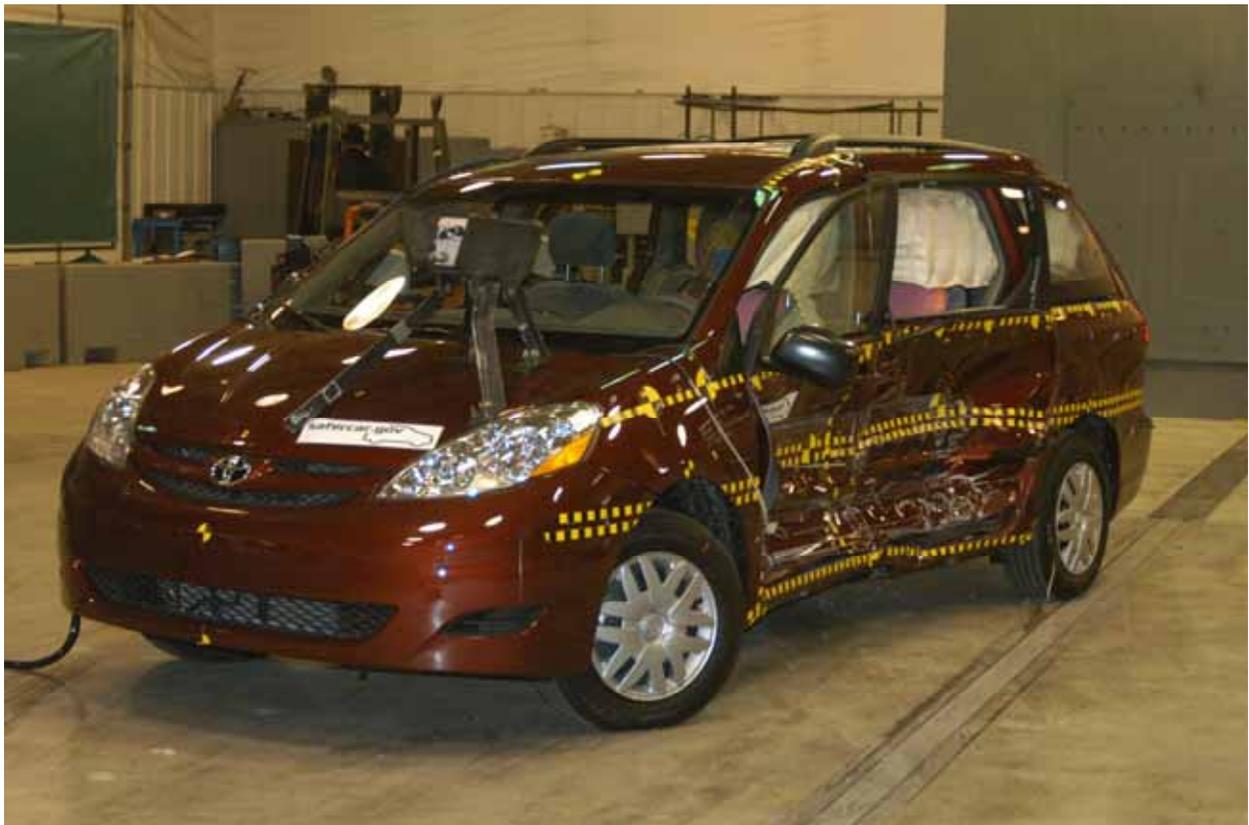
Figure A-8: Post test left front 3/4 view of test vehicle

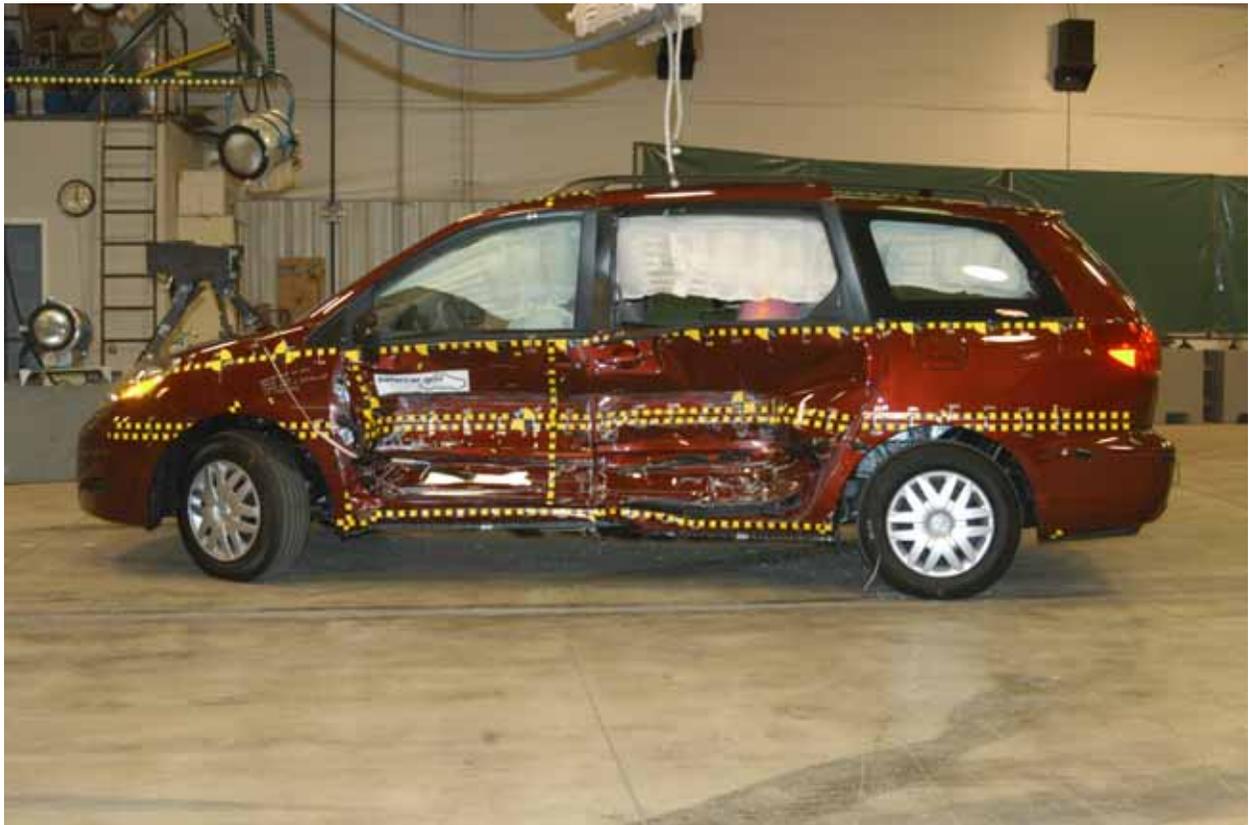
Figure A-10: Post test left side view of test vehicle

POST TEST STRUCTURAL OBSERVATIONS	
Critical areas of performance	Observations/conclusions
Pillar performance	None
Sill separation	Sill separation 240 mm rearward of b-pillar
Windshield damage	Slight crack at the top of the driver's a-pillar
Window damage	Rear struck side door window shattered on impact
Other notable effects	90 mm gap between b-pillar and top of front door; 158 mm gap between c-pillar and top of rear door

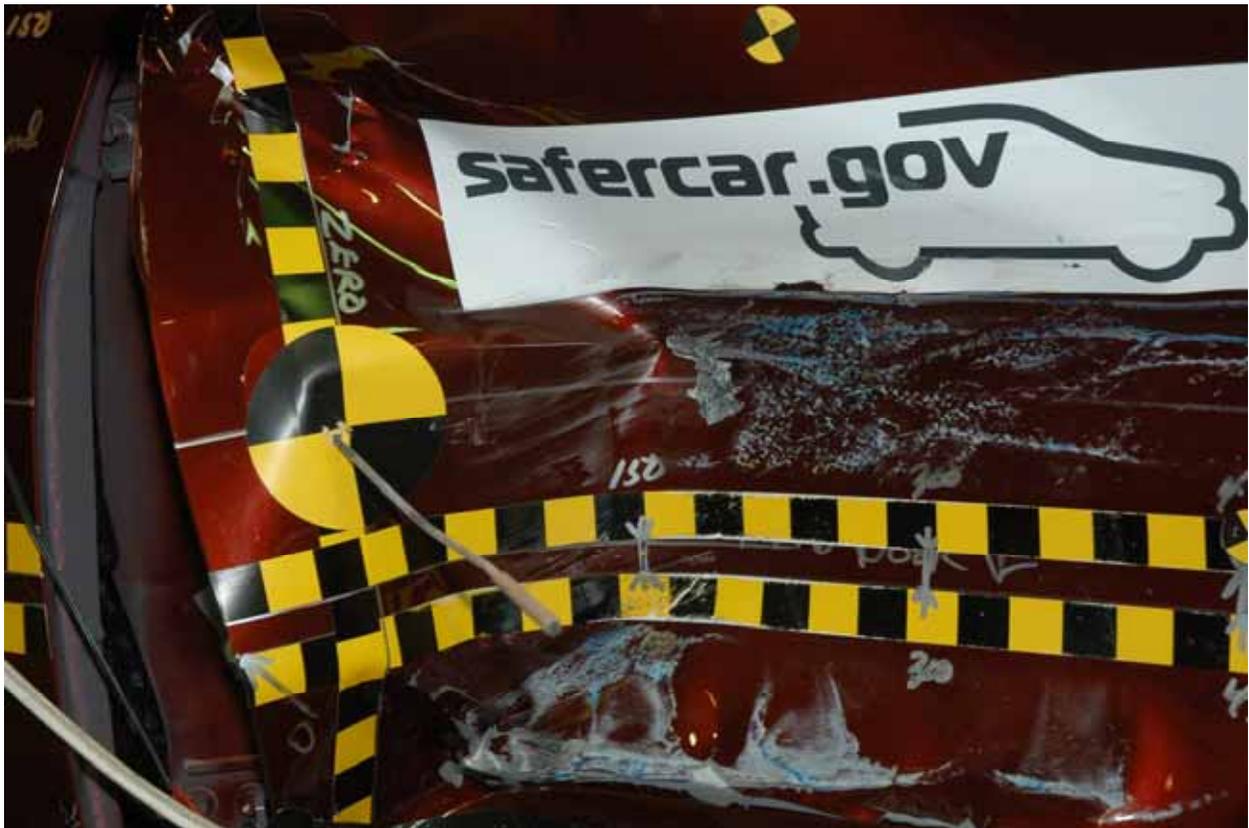
Figure A-26: Post test impact point

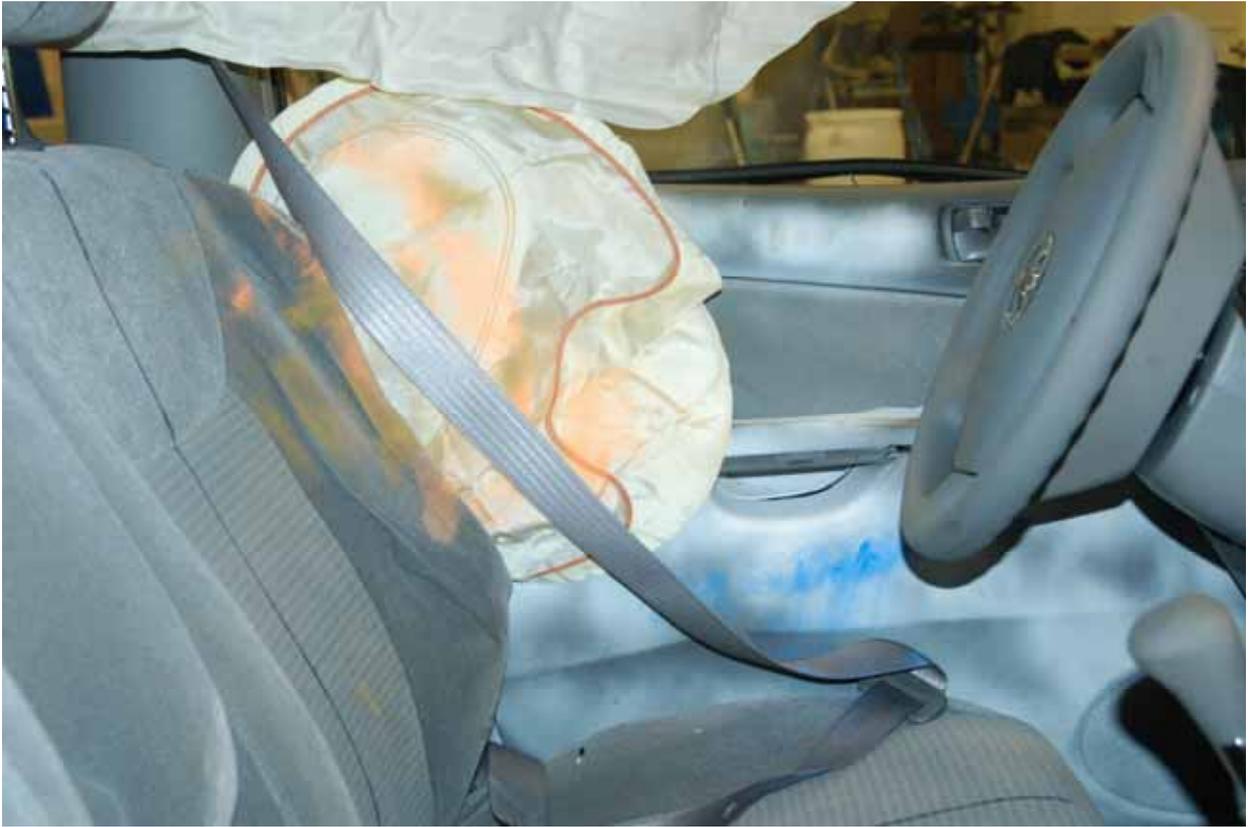
Figure A-41: Post test driver contact locations (1)

TEST DUMMY INFORMATION AND CONTACT POINTS		
Description	Left front seat	Left rear seat
Dummy type / serial no.	SID HIII/056	SID HIII/058
Head contact	To side curtain air bag	To side curtain air bag and c-pillar
Upper torso contact	To seat mounted side air bag	To left rear door panel at window sill
Lower torso contact	To seat mounted side air bag	To left rear door panel 160 mm below window sill
Left leg contact	To left front door panel 120 mm below arm rest	To left rear door panel 315 mm below window sill
Left knee contact	To left front door panel 30 mm below arm rest	To left rear door panel 220 mm below window sill

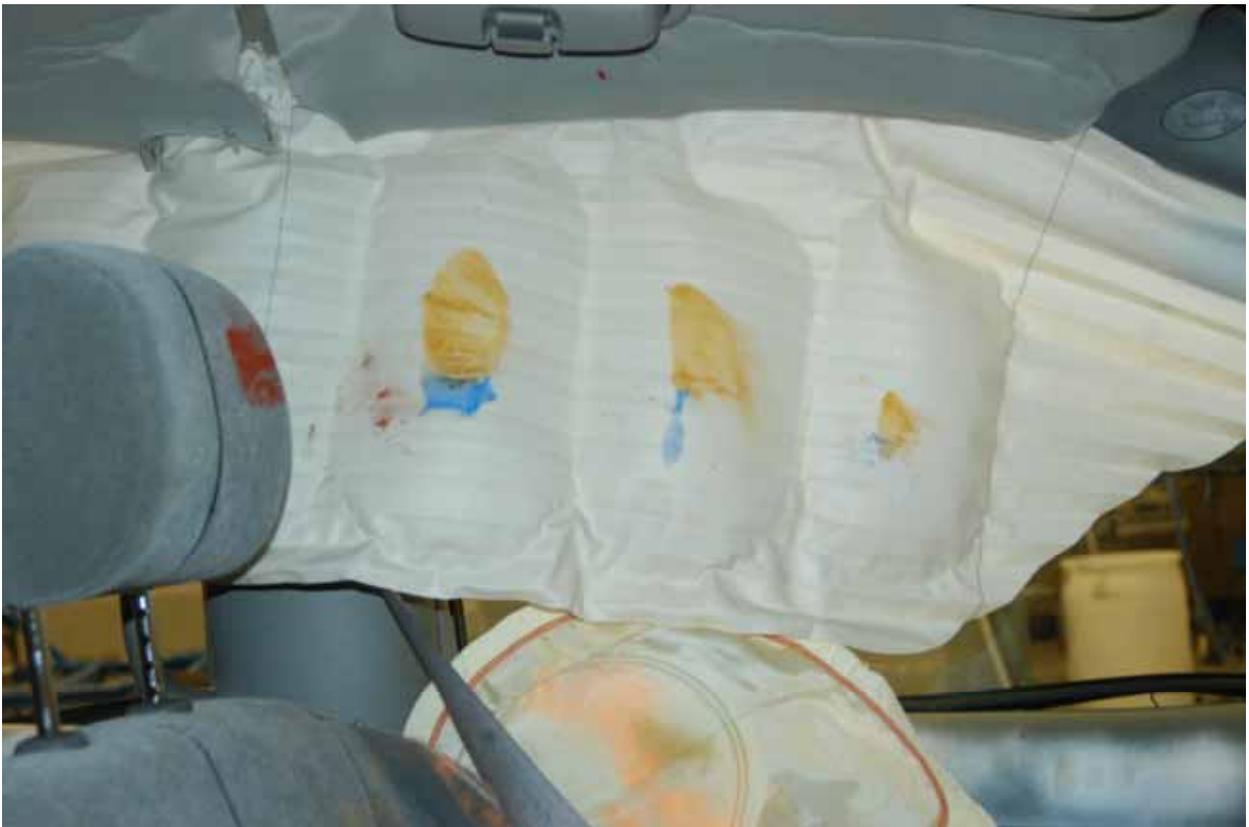
Figure A-42: Post test driver contact locations (2)

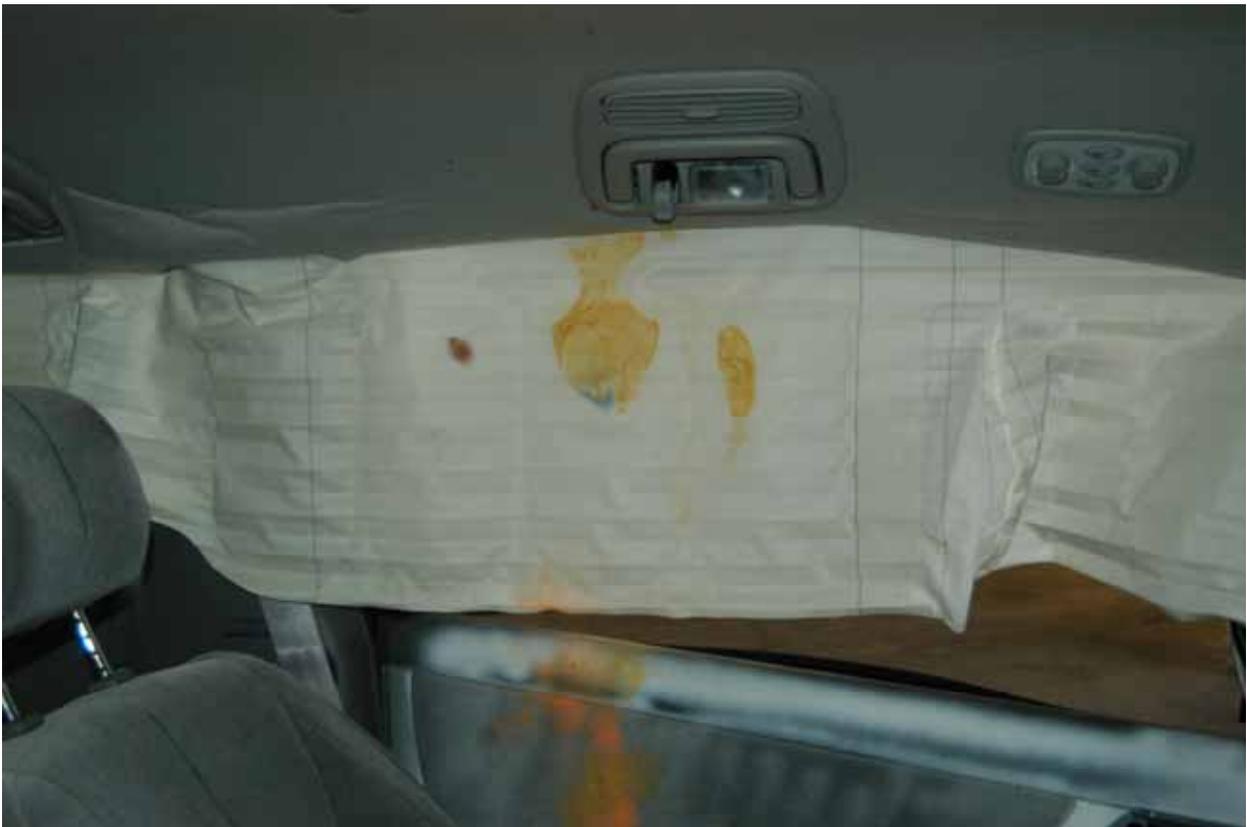
Figure A-50: Post test passenger contact locations (2)
