REPORT NUMBER TR-P27001-04-NC

**NEW CAR ASSESSMENT PROGRAM
FRONTAL BARRIER IMPACT TEST**

**GENERAL MOTORS OF CANADA LTD.
2007 CHEVROLET SILVERADO LT1
4-DOOR TRUCK**

NHTSA NUMBER: M70109

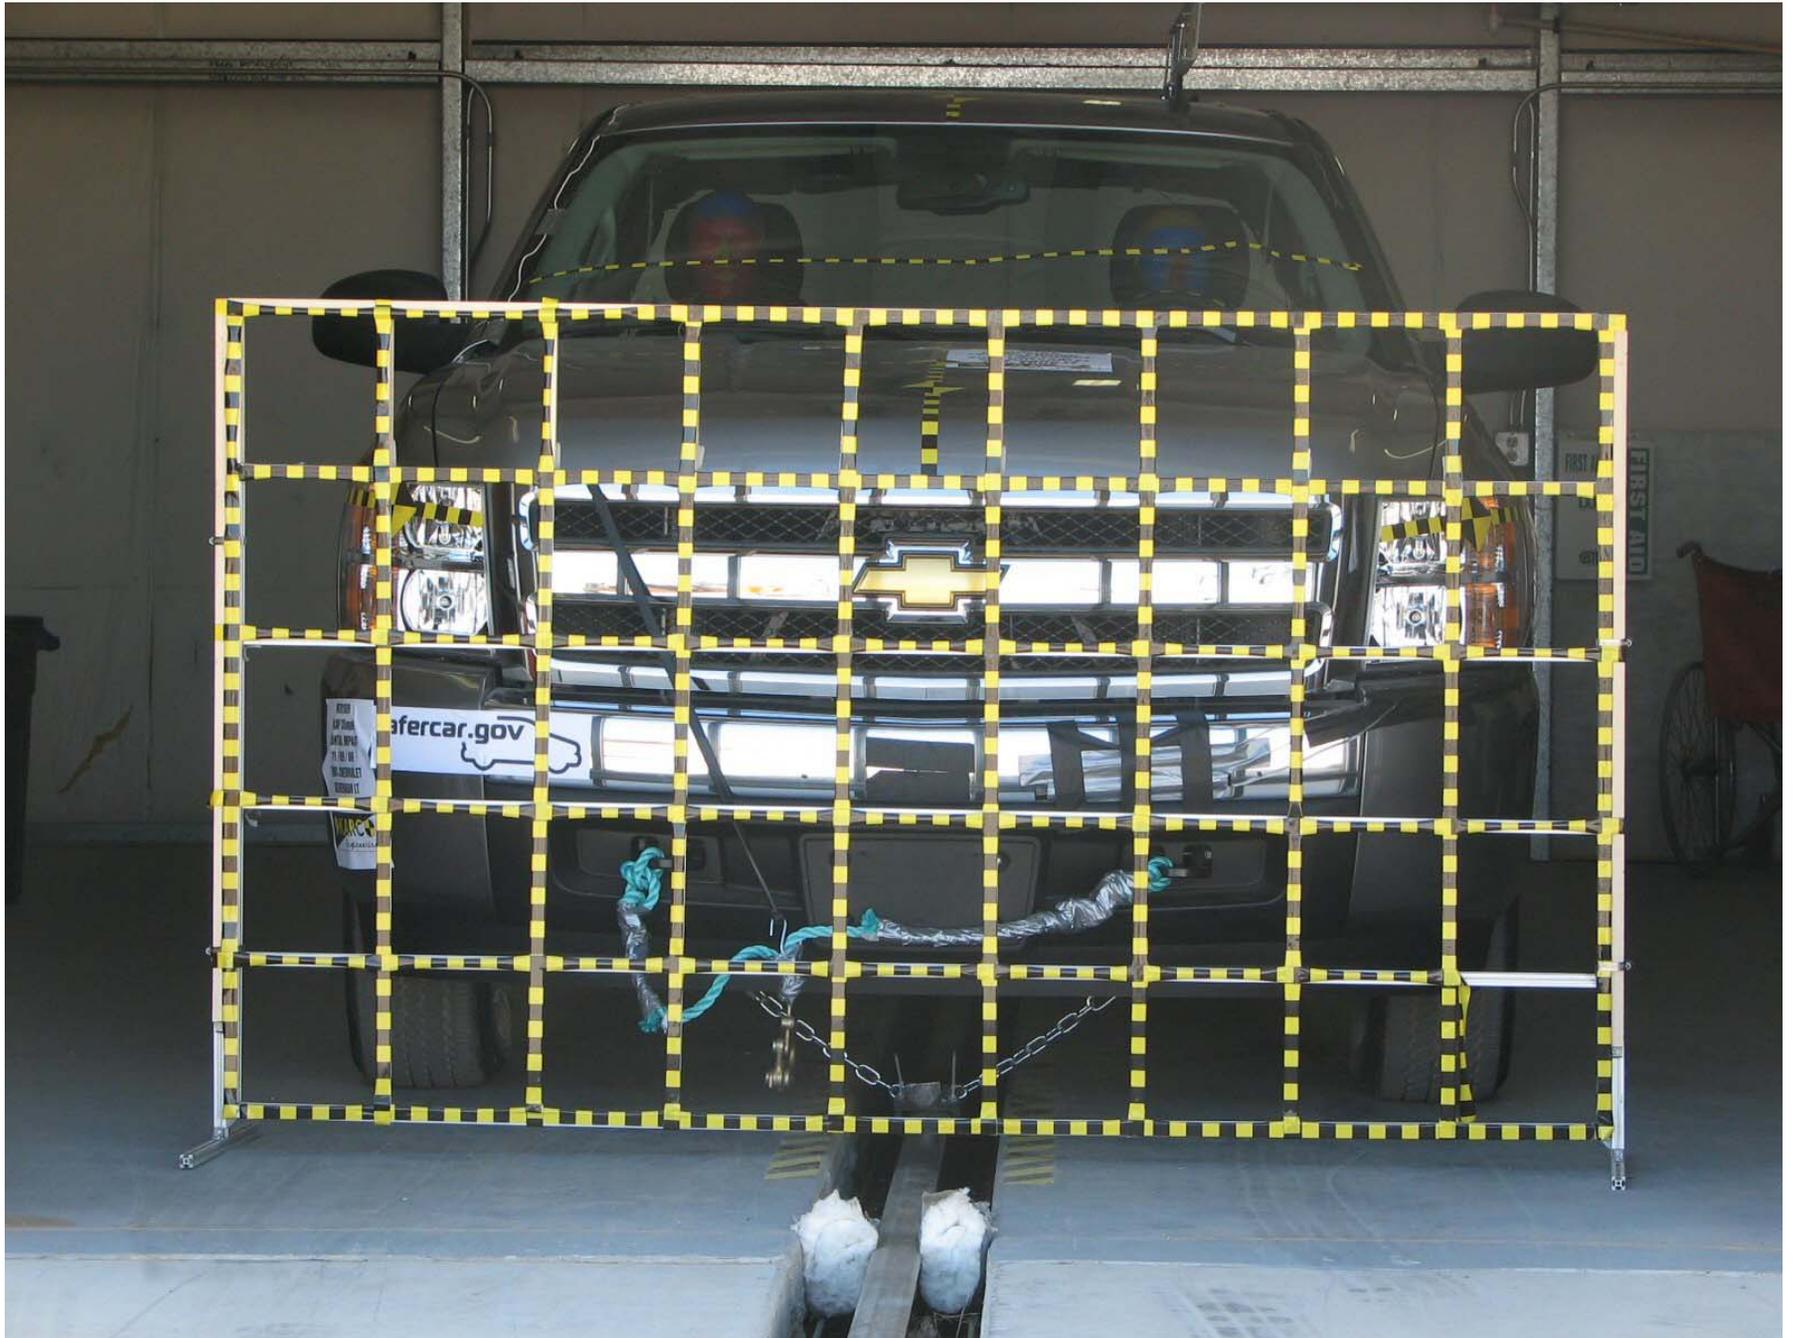
Figure A-1: Load Cell Location

A load cell barrier consisting of 45 load cells was impacted by a 2007 Chevrolet Silverado LT1 4-Door Truck at a velocity of 56.15 km/h. The test was performed at Karco Engineering, LLC on November 09, 2006.

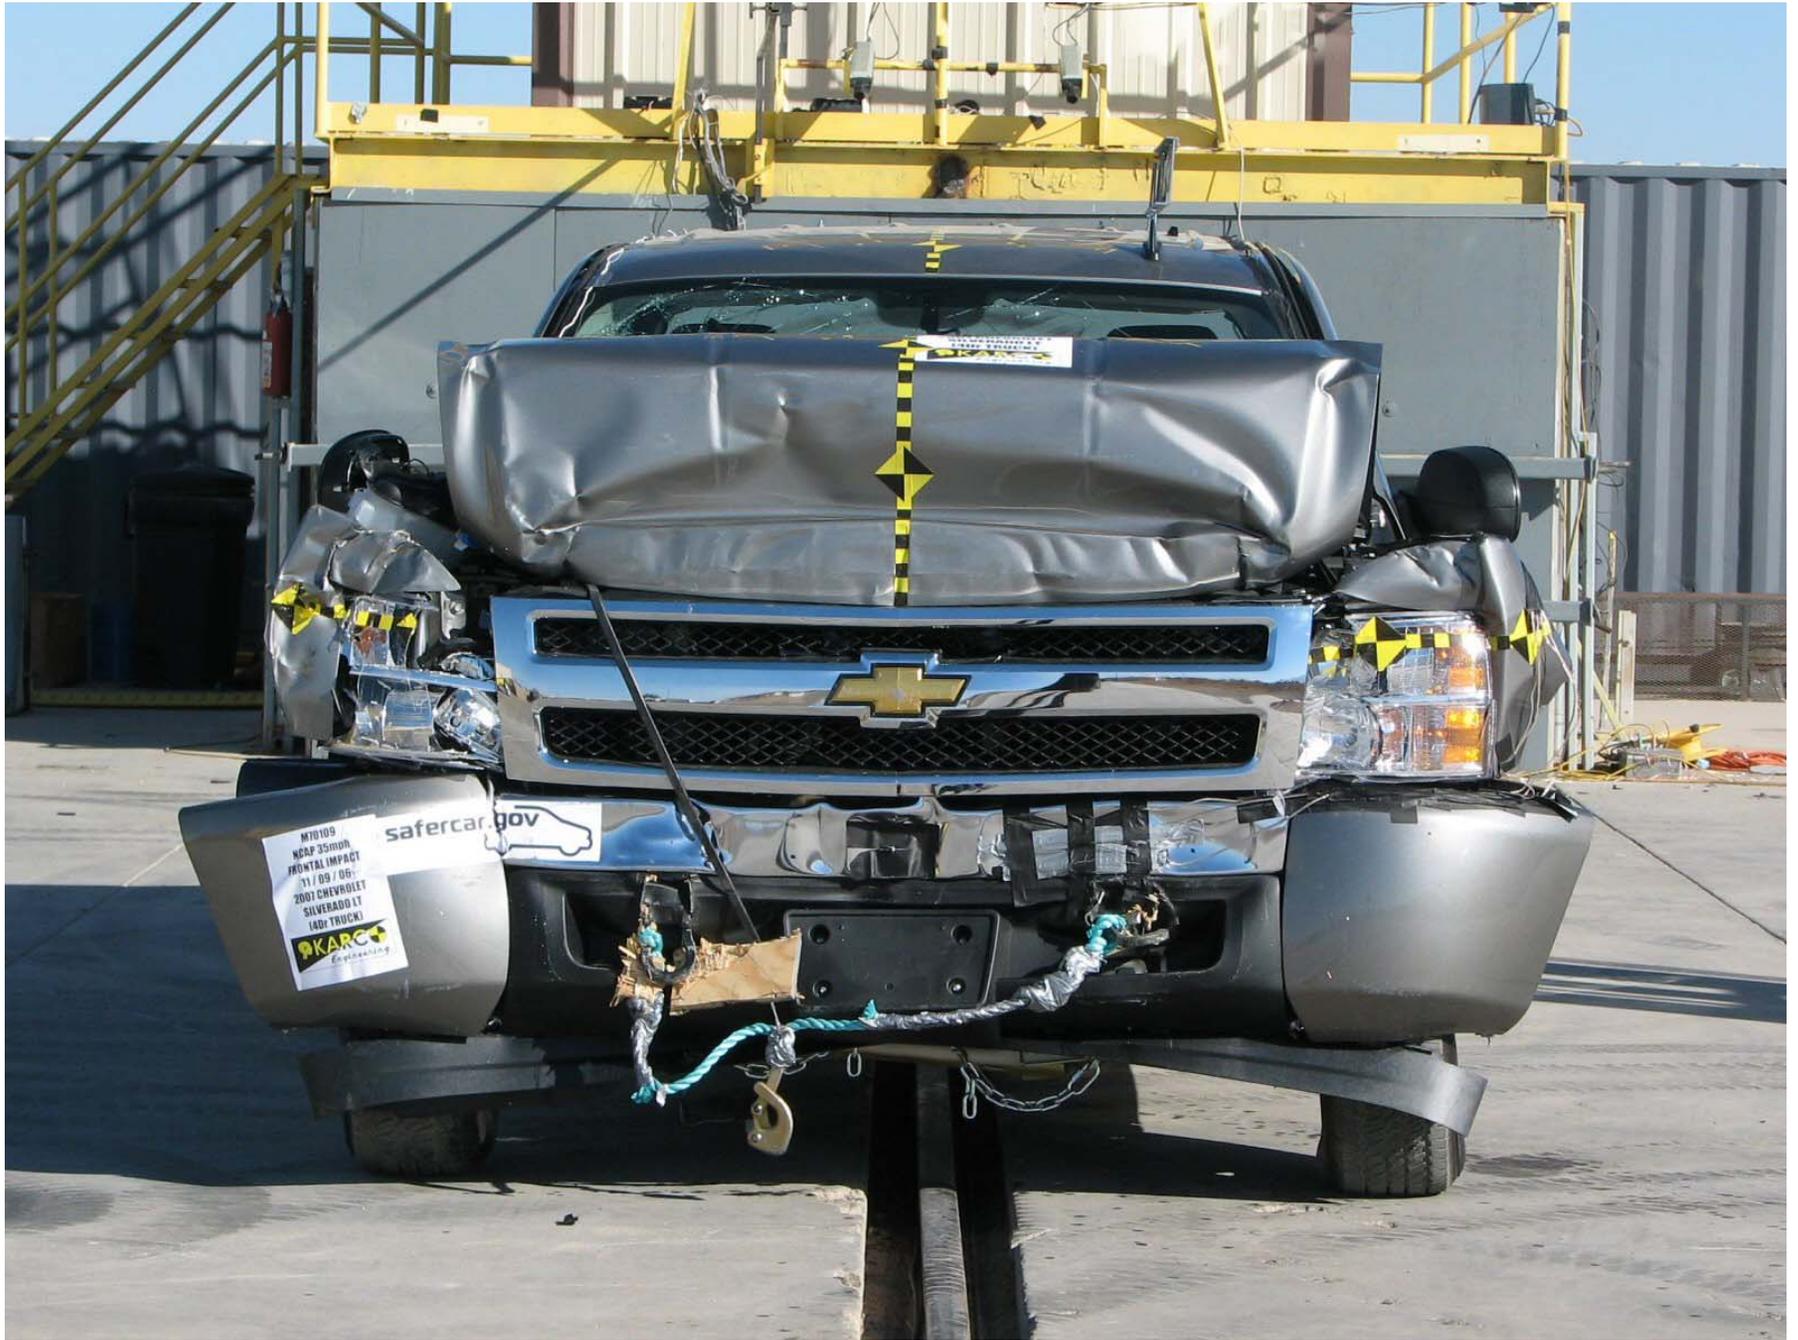
Figure A-7: Post-Test Front View (Vehicle Moved)

The maximum static crush of the vehicle was 653 mm at the vehicle's centerline and both the driver and the passenger side doors remained closed and latched during the impact event and were operable after the impact.

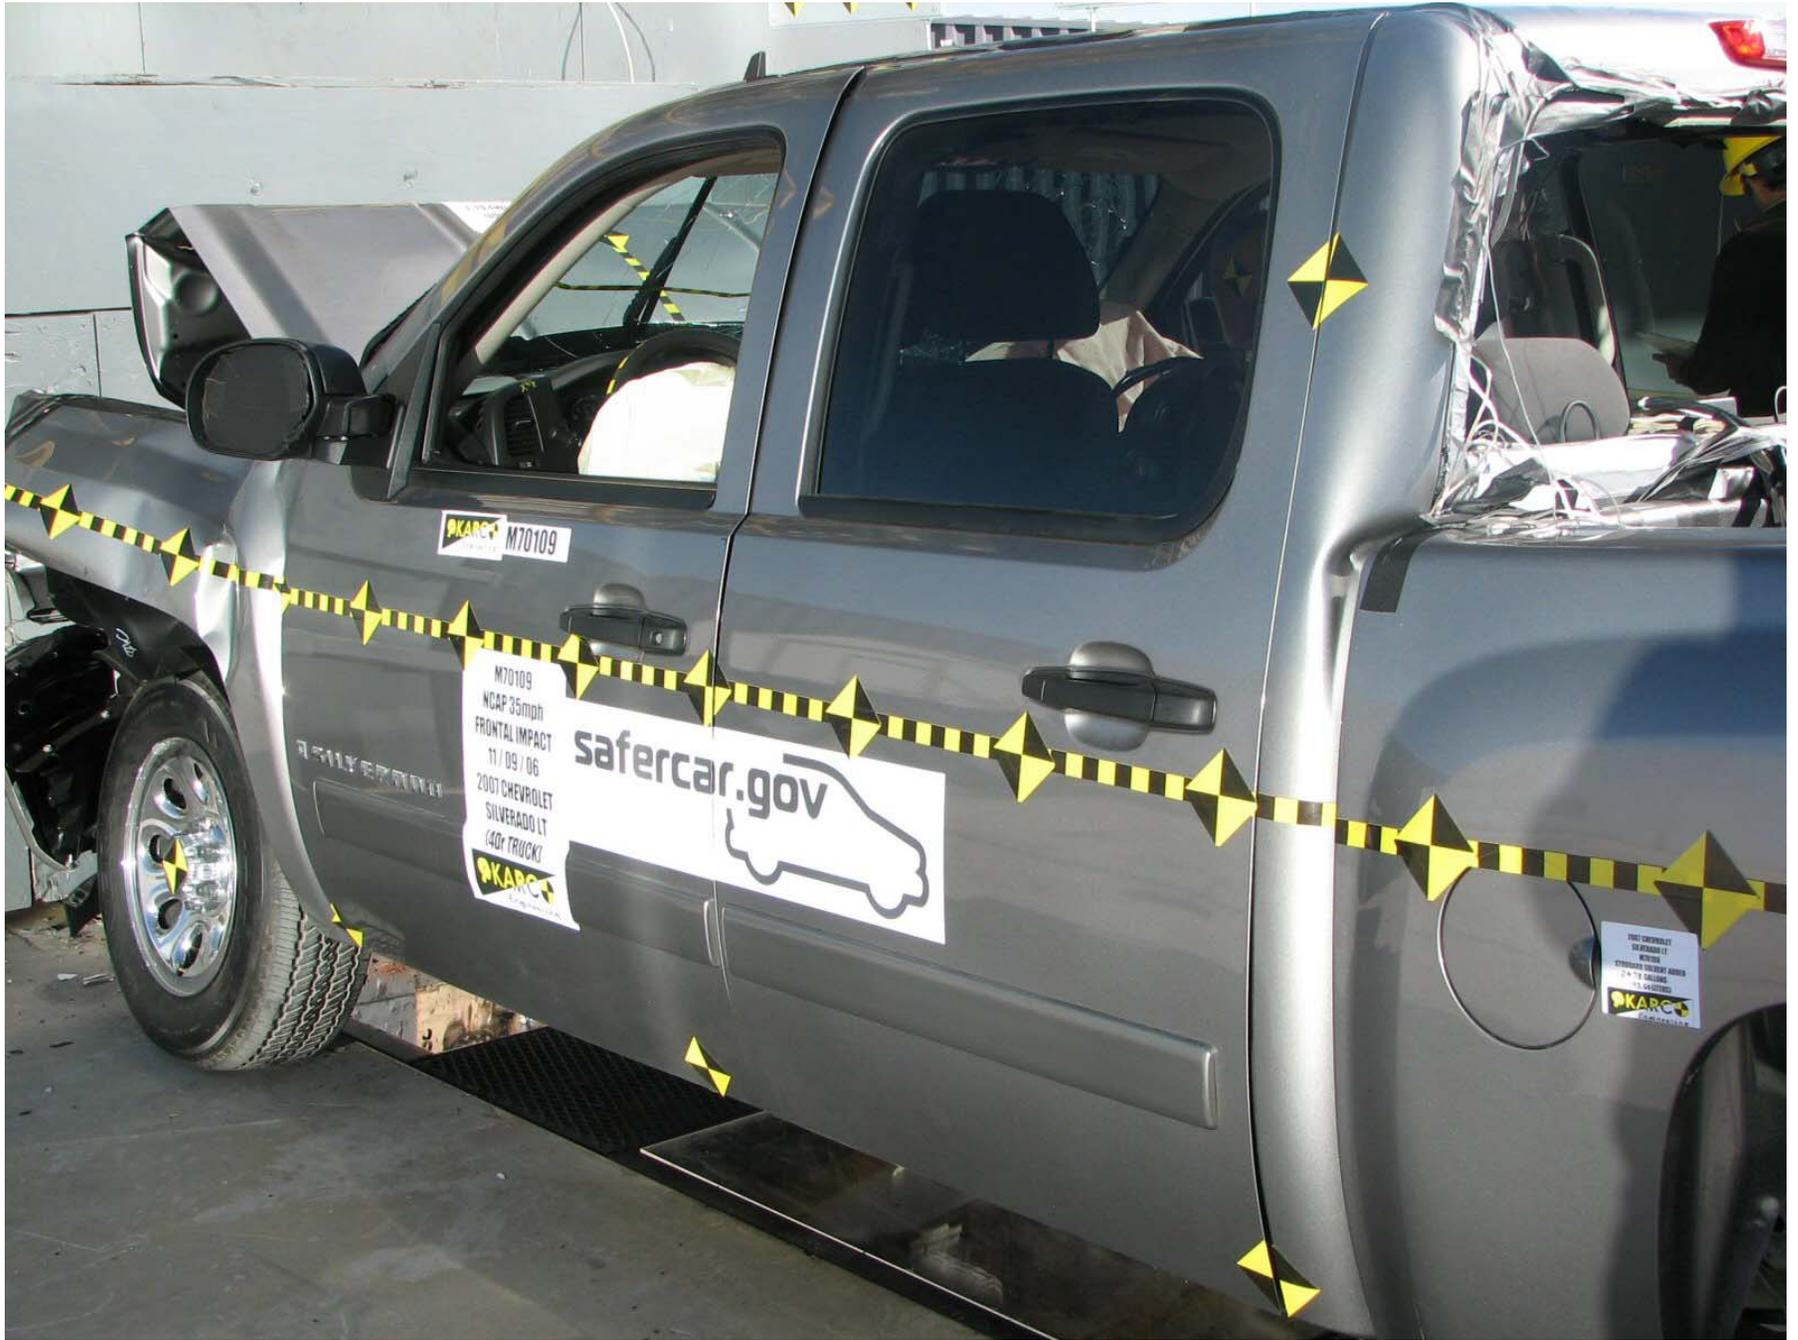
Figure A-16: Post-Test Left Side 3/4 View of Doors After Impact

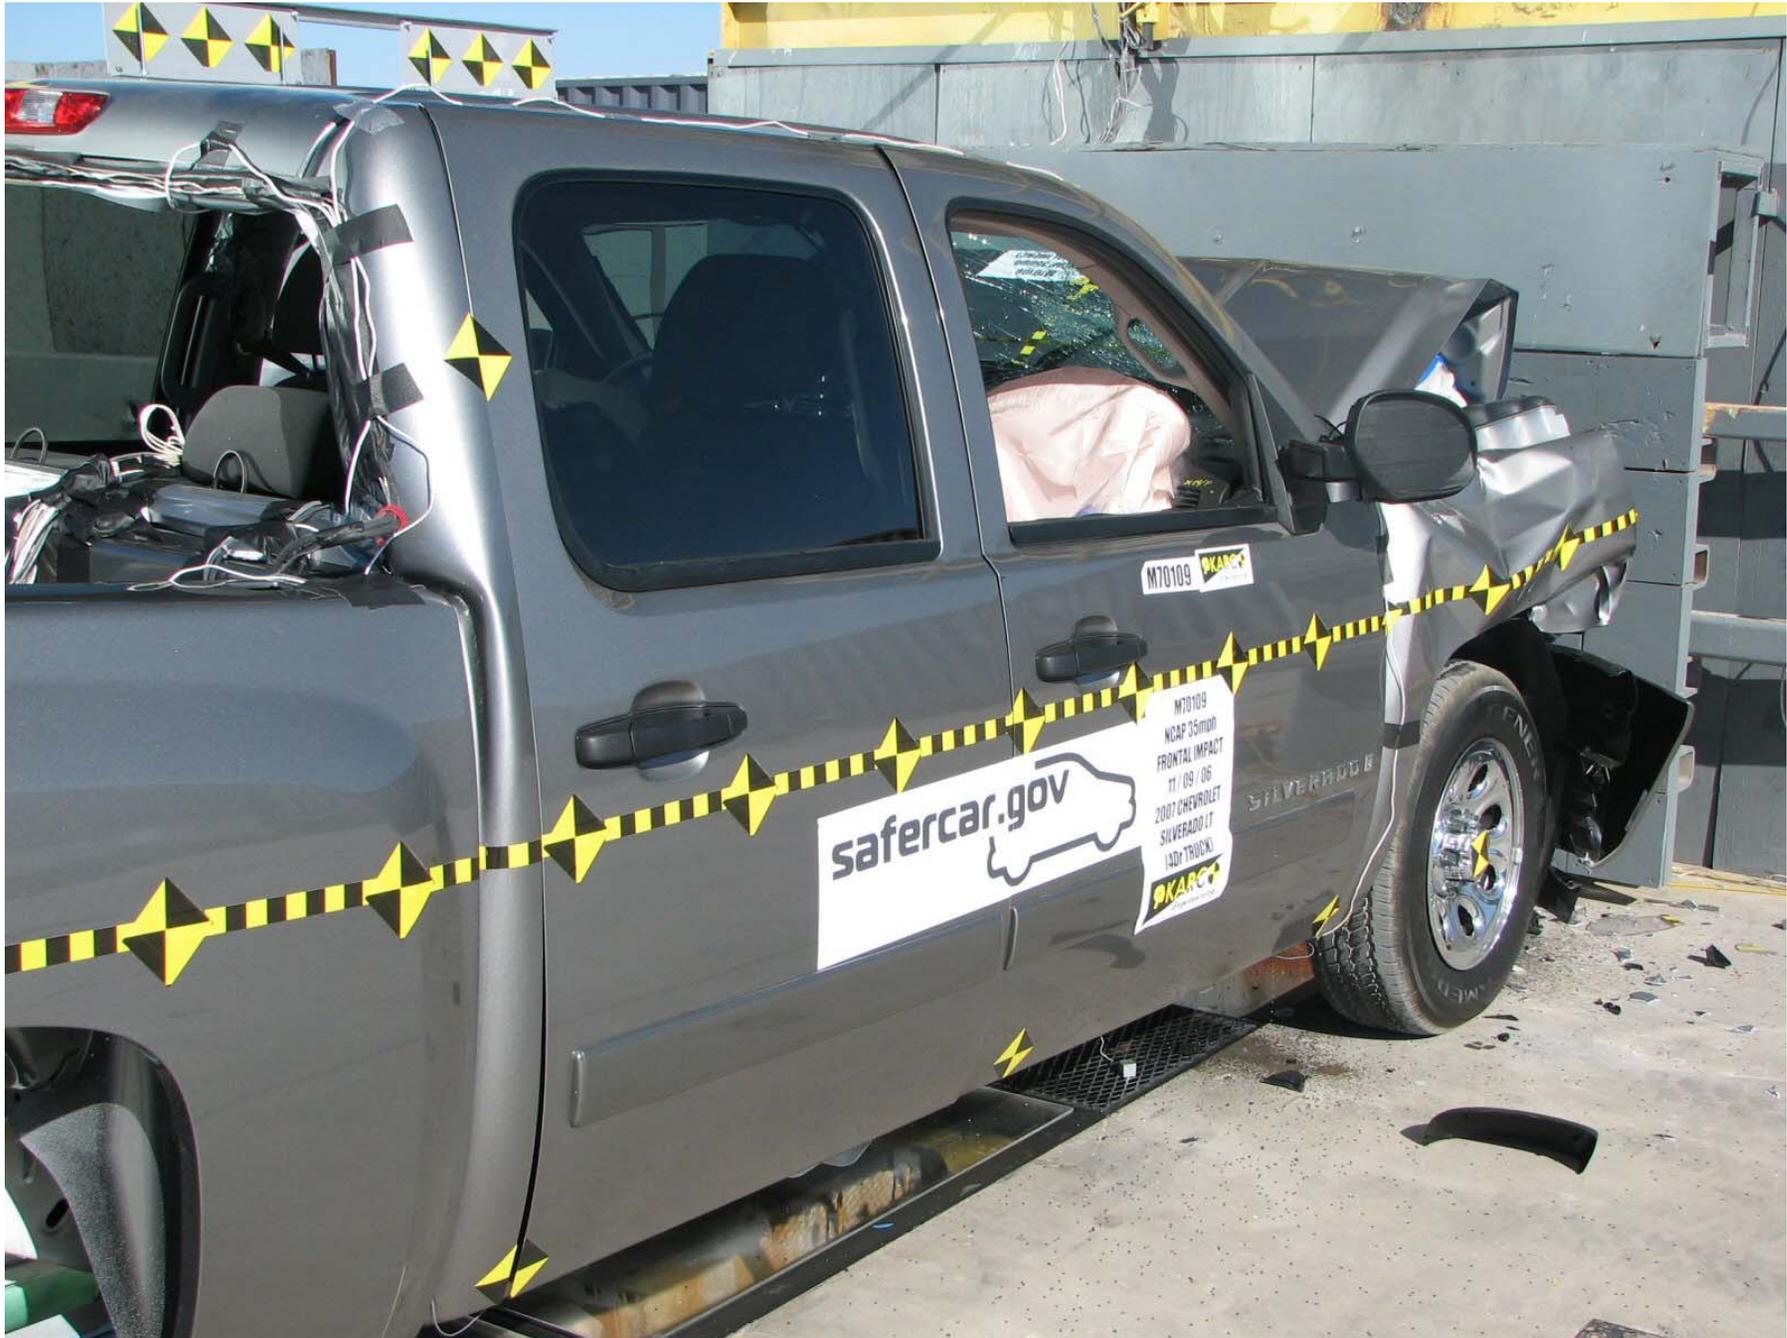
Figure A-17: Post-Test Right Side ¾ View of Doors After Impact

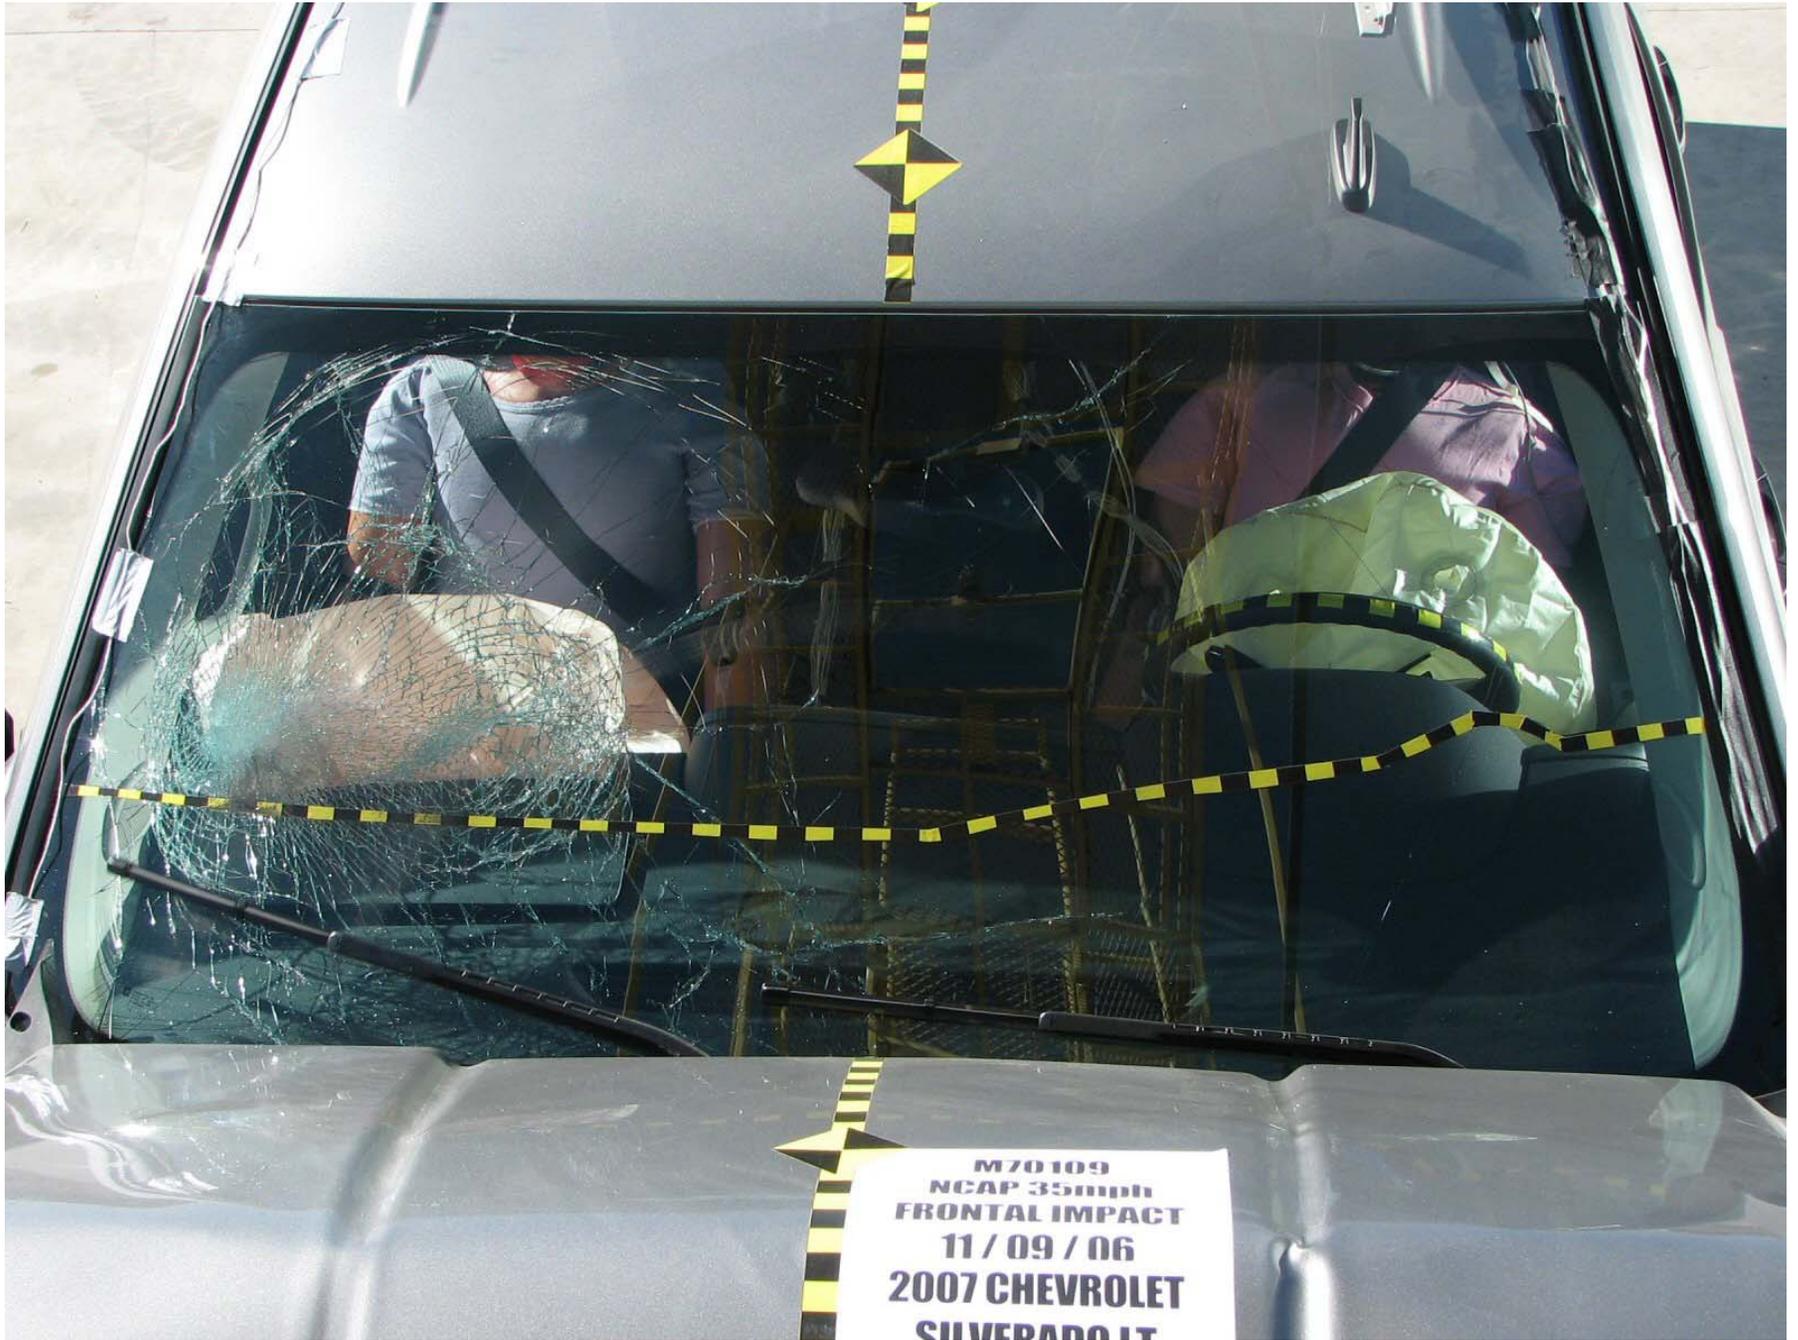
Figure A-19: Post-Test Windshield

There was 100 percent windshield retention and there was no intrusion into the protected zone of the windshield during the impact event. There was no stoddard solvent leakage after the event or during any phase of the static rollover.

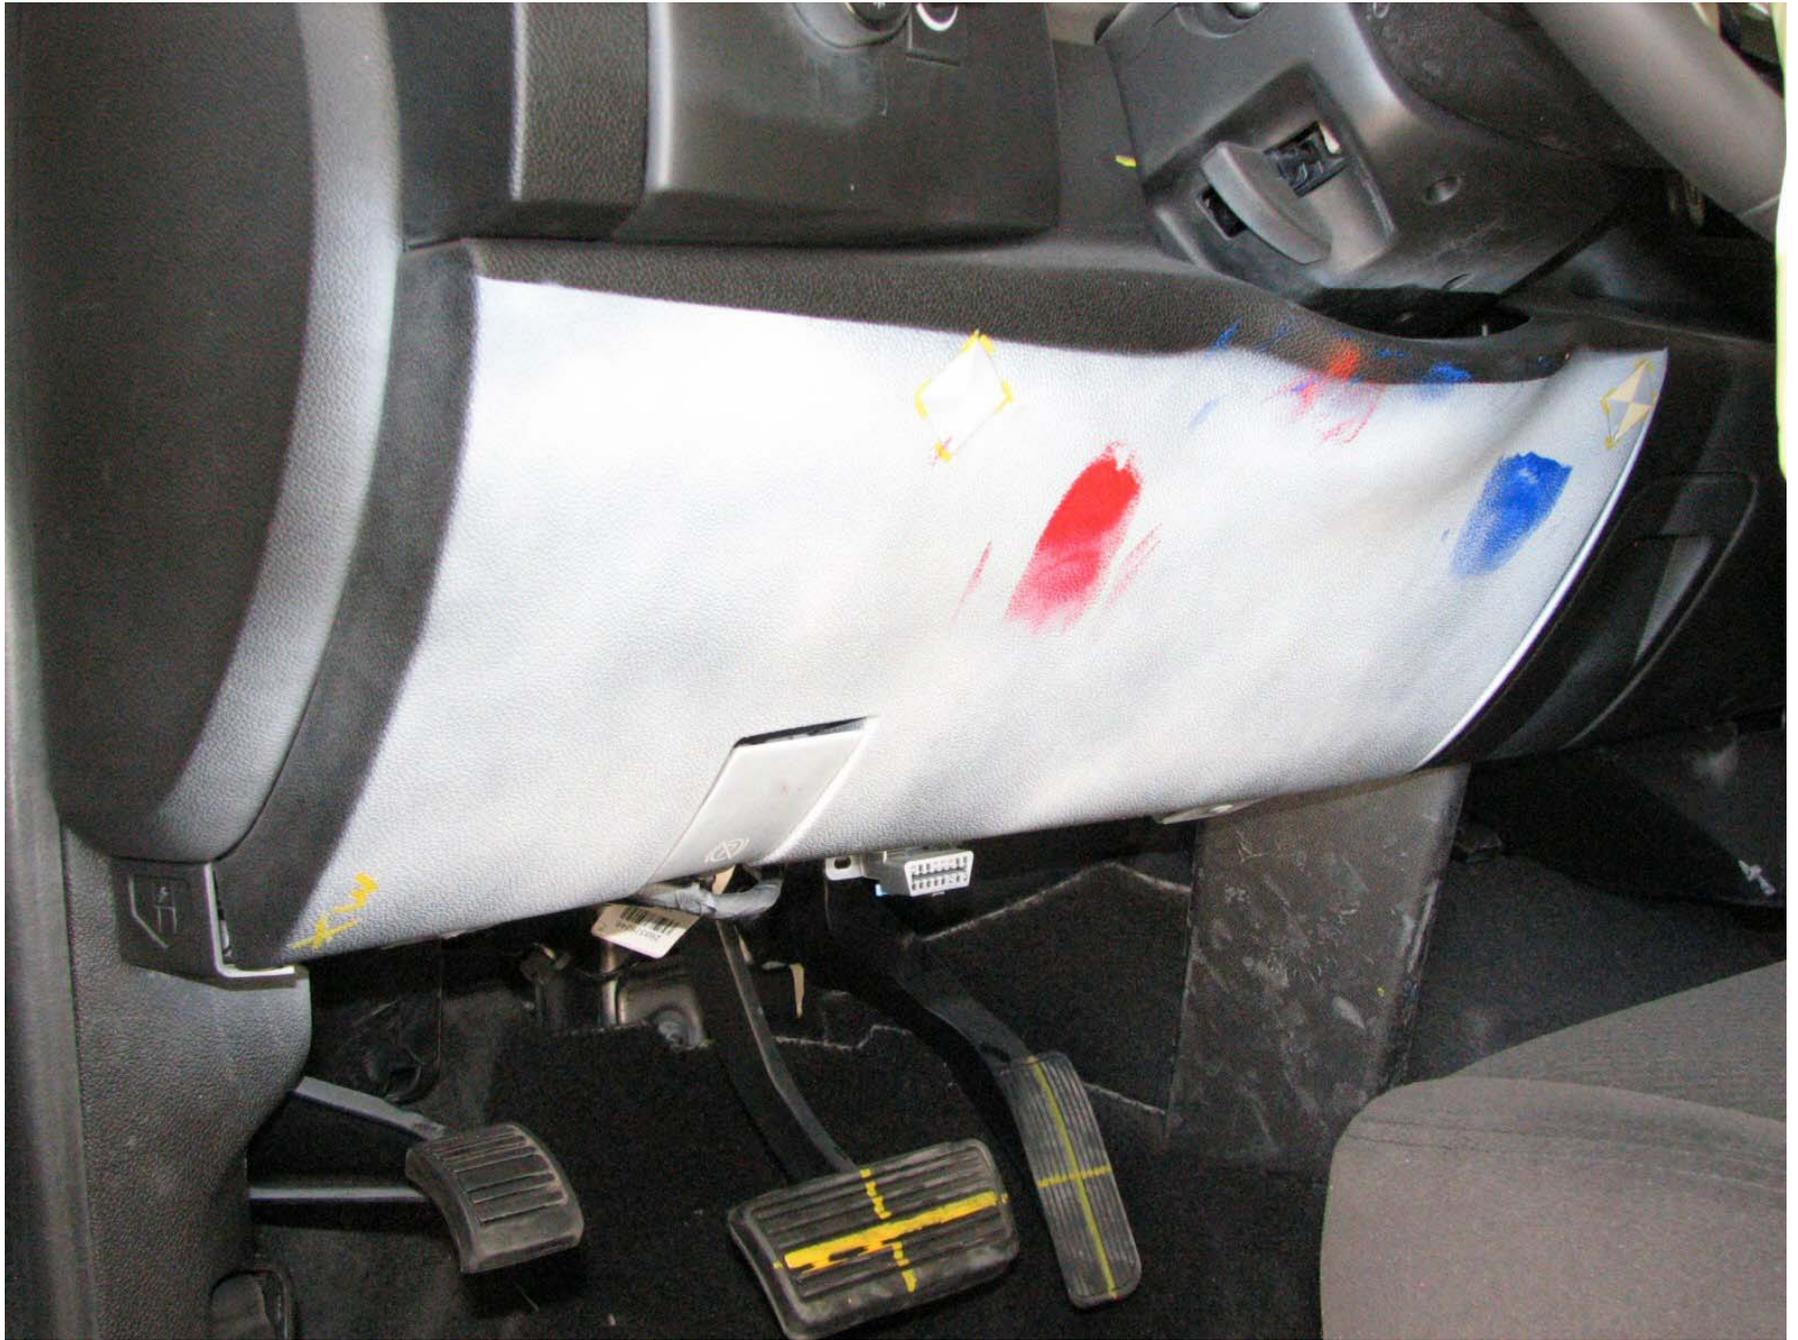
Figure A-39: Post-Test Driver Side Knee Bolster

The driver's visible contact points were as follows: The driver ATD's head and chest contacted the airbag and the abdomen had no contact. Both knees contacted the knee bolster.

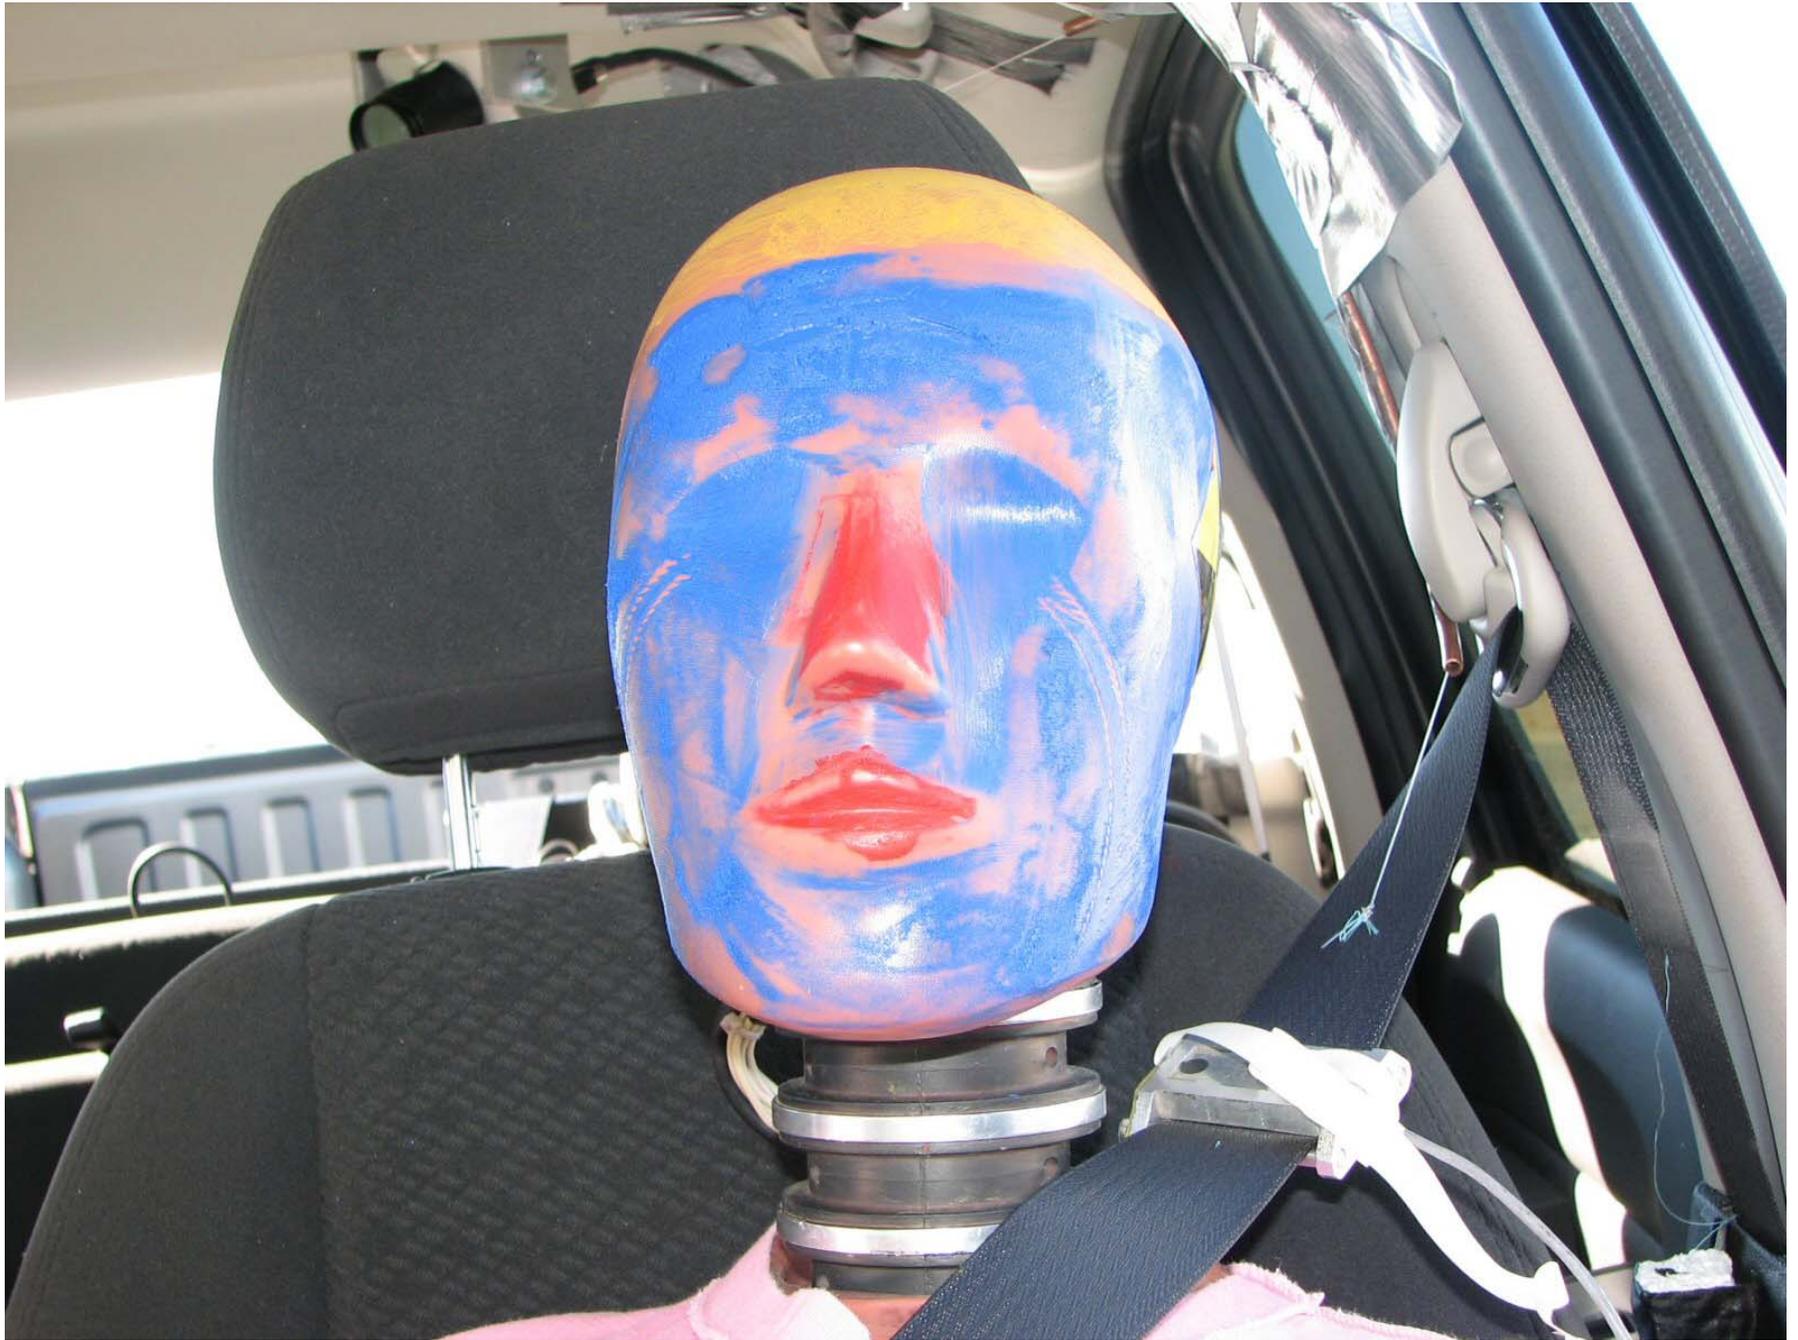
Figure A-43: Post-Test Driver Dummy Airbag Contact

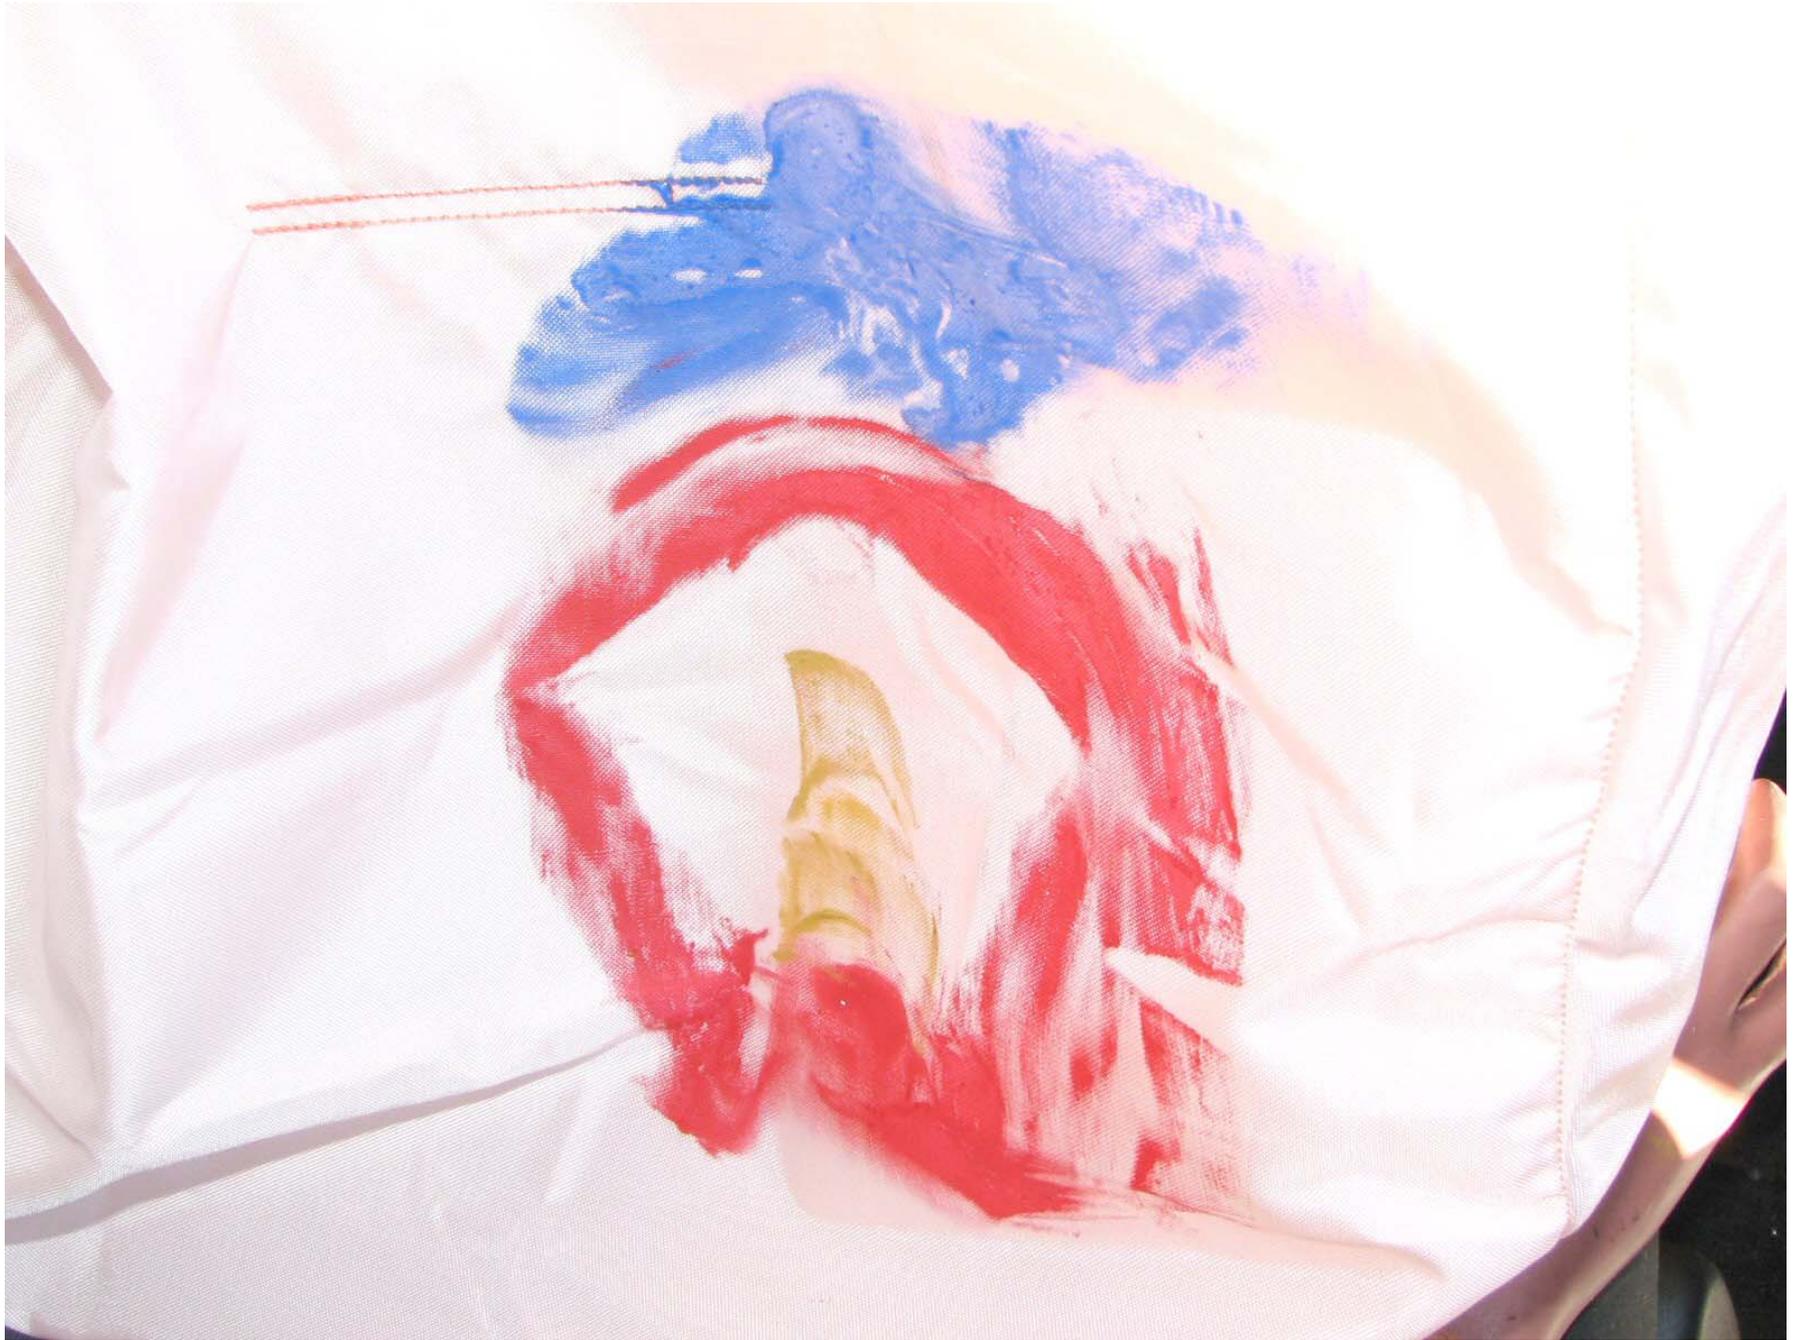
Figure A-57: Post-Test Passenger Dummy Airbag Contact

The passenger's visible contact points were as follows: The passenger ATD's head, chest and abdomen contacted the airbag. Both knees contacted the knee bolster.

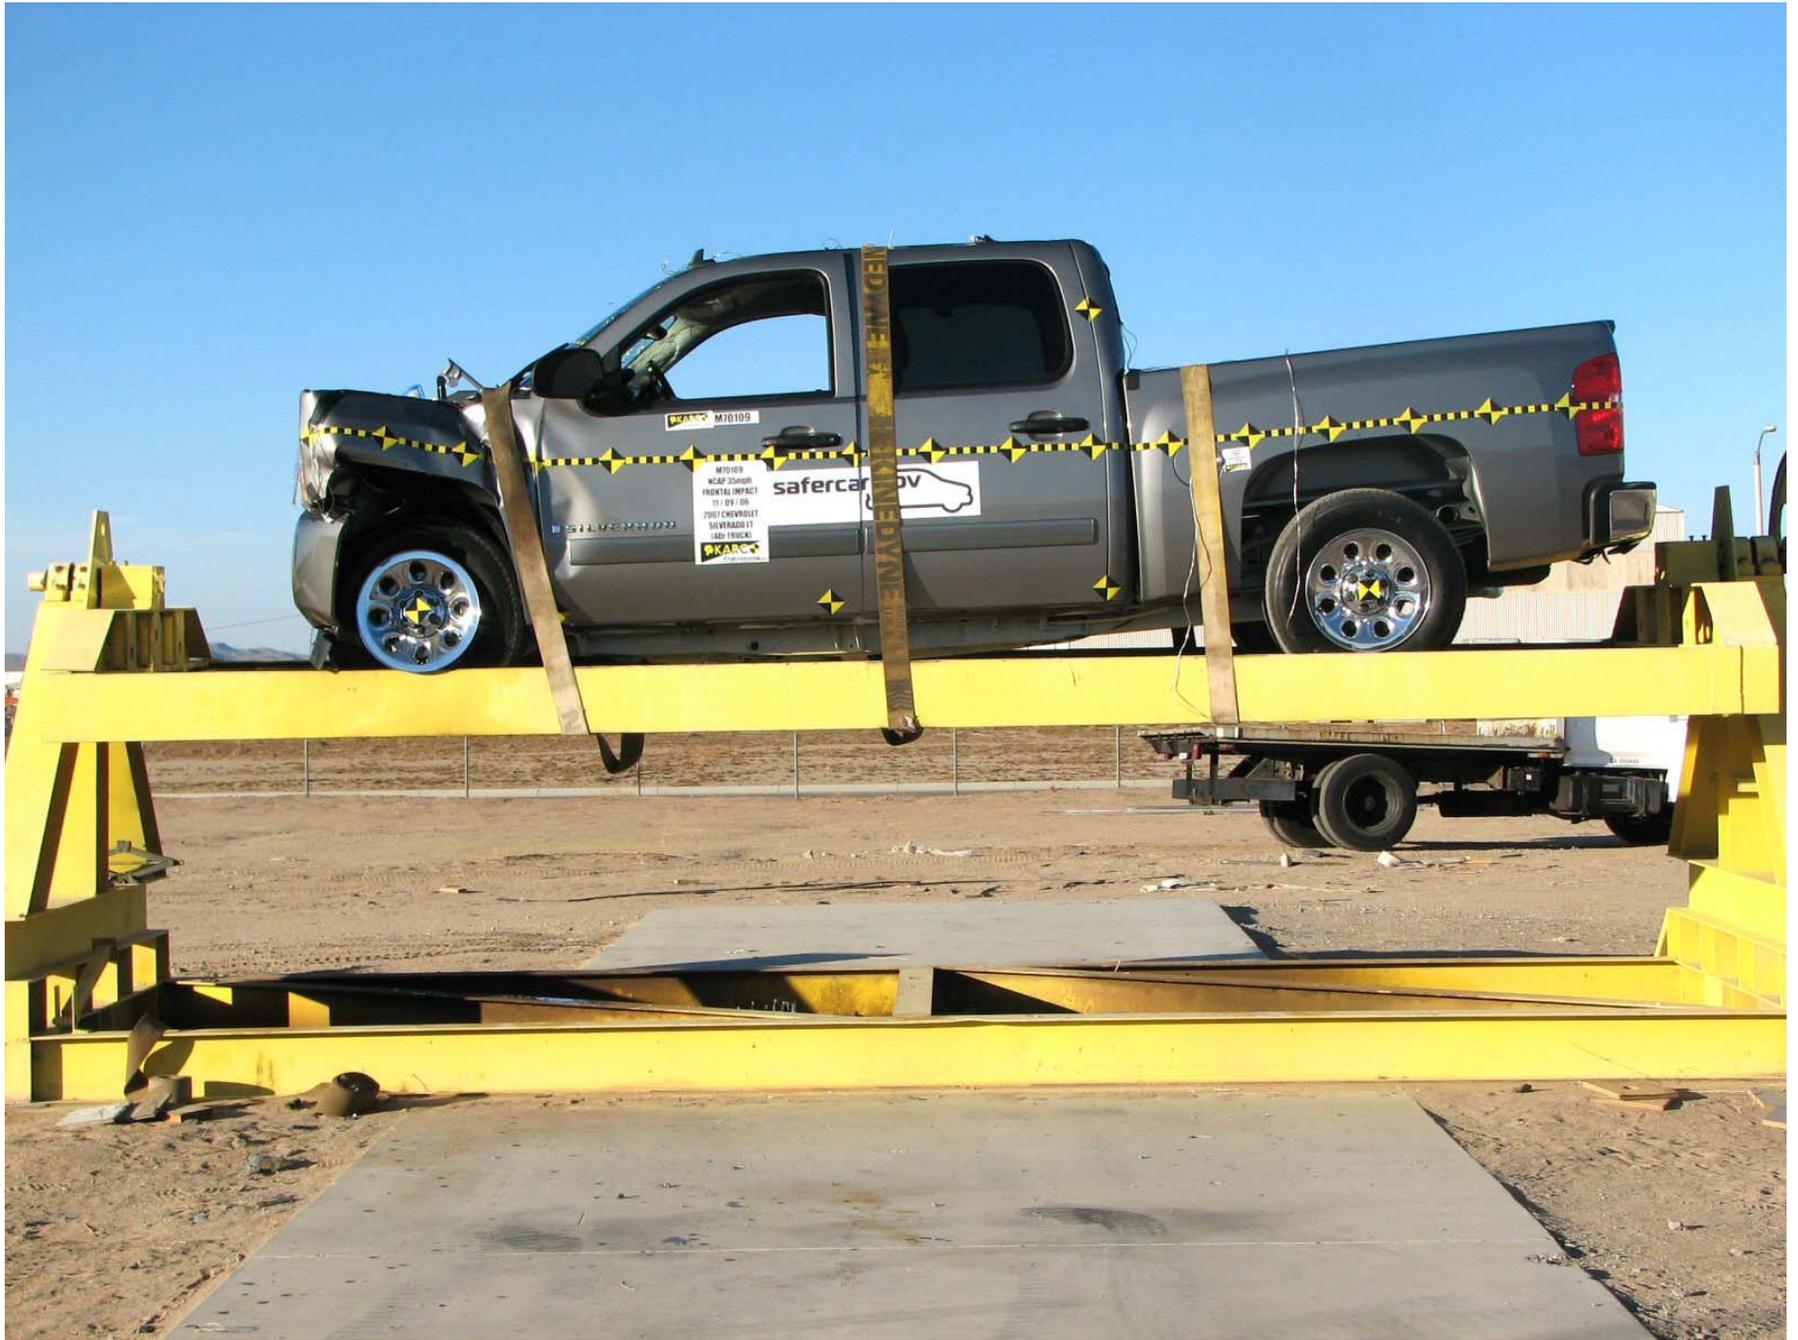
Figure A-58: Vehicle on Rollover Device (0°)

1. The specified fixture rollover rate for each 90° of rotation is 60 to 120 seconds.
2. The position hold time at each position is 300 seconds (minimum).
3. No solvent leakage occurred during rollover.
