REPORT NUMBER TR-P27001-04-NC

**NEW CAR ASSESSMENT PROGRAM
FRONTAL BARRIER IMPACT TEST**

**GENERAL MOTORS OF CANADA LTD.
2007 CHEVROLET SILVERADO LT1
4-DOOR TRUCK**

NHTSA NUMBER: M70109

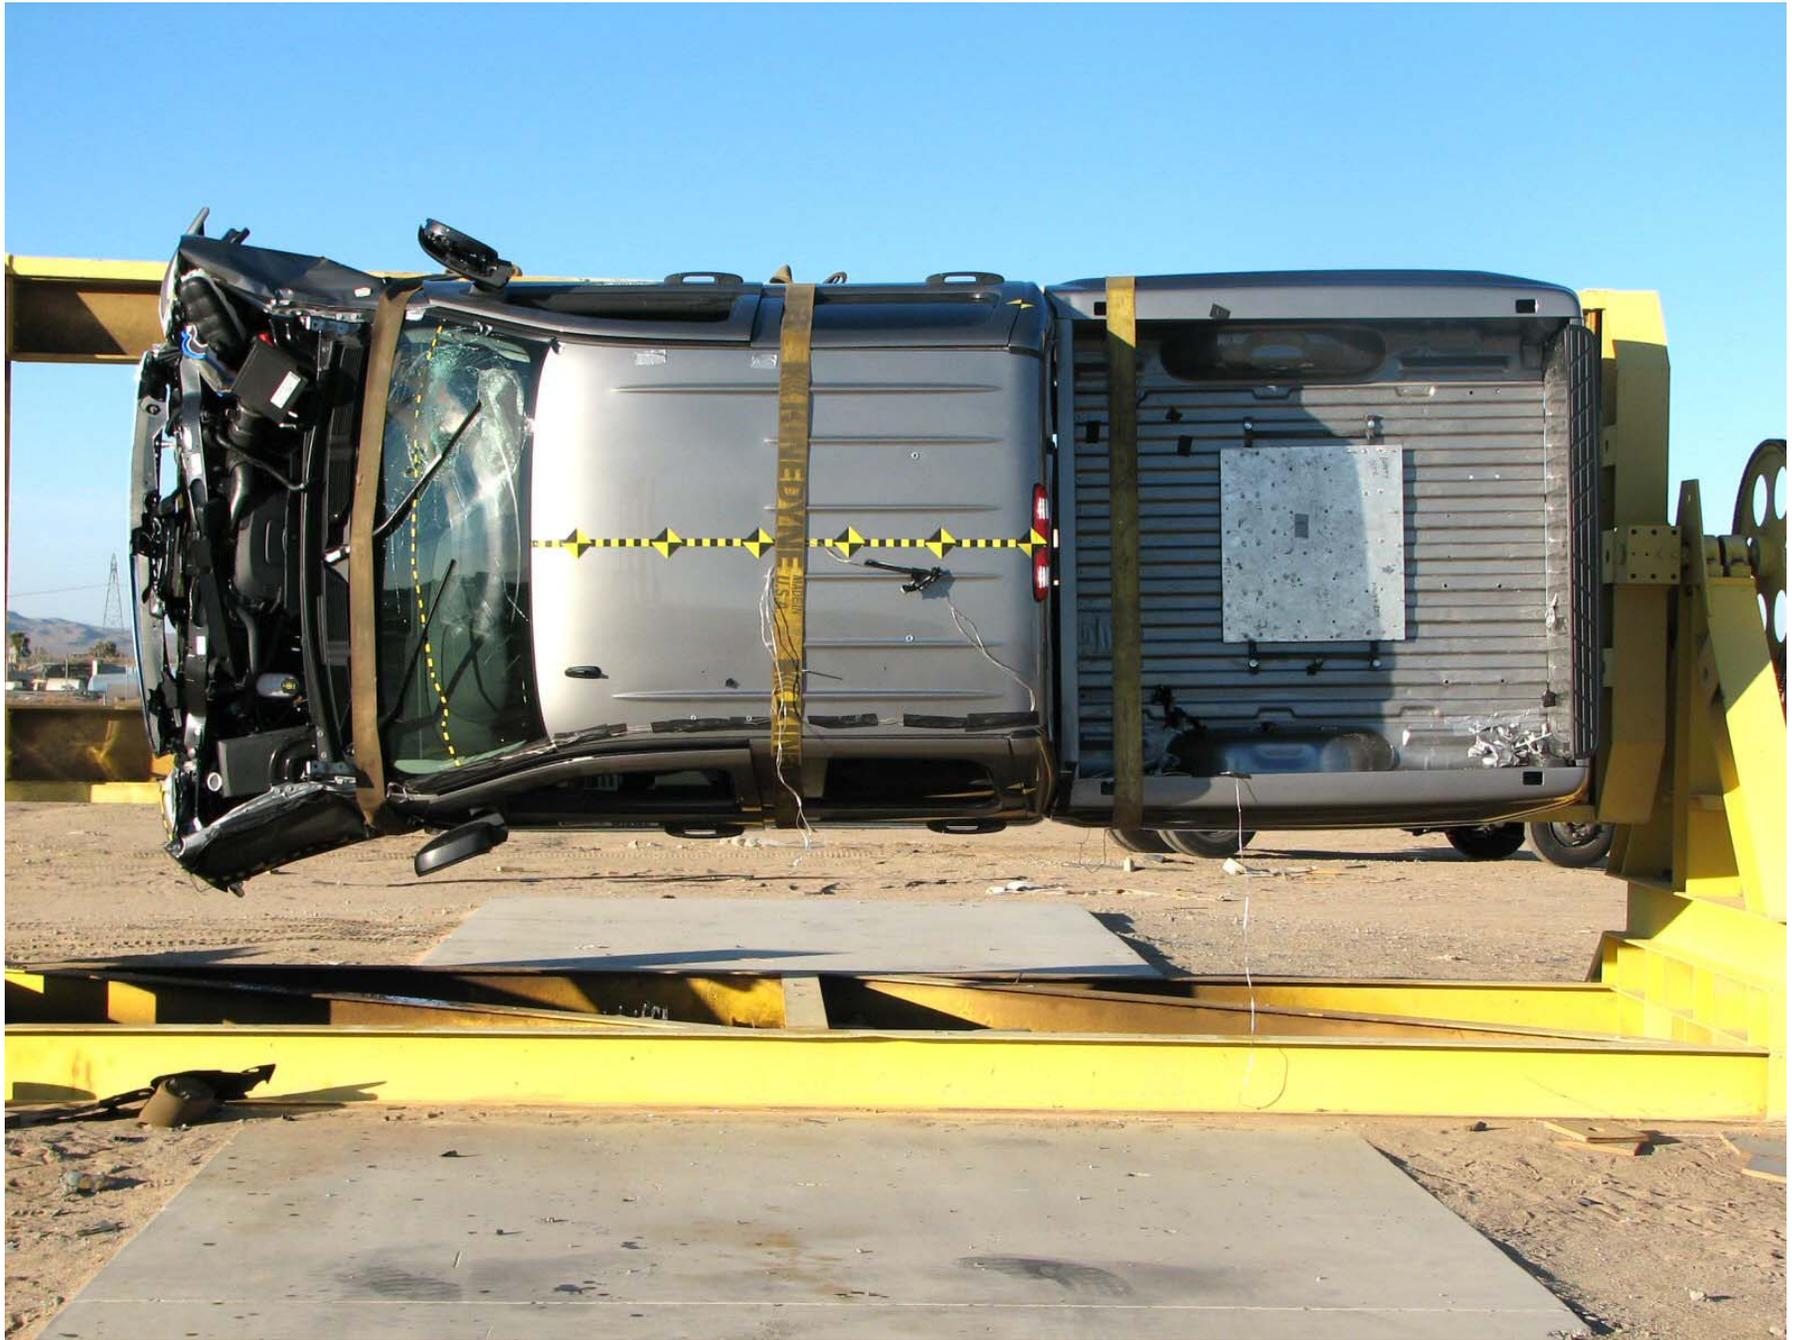
Figure A-59: Vehicle on Rollover Device (90°)

1. The specified fixture rollover rate for each 90° of rotation is 60 to 120 seconds.
2. The position hold time at each position is 300 seconds (minimum).
3. No solvent leakage occurred during rollover.

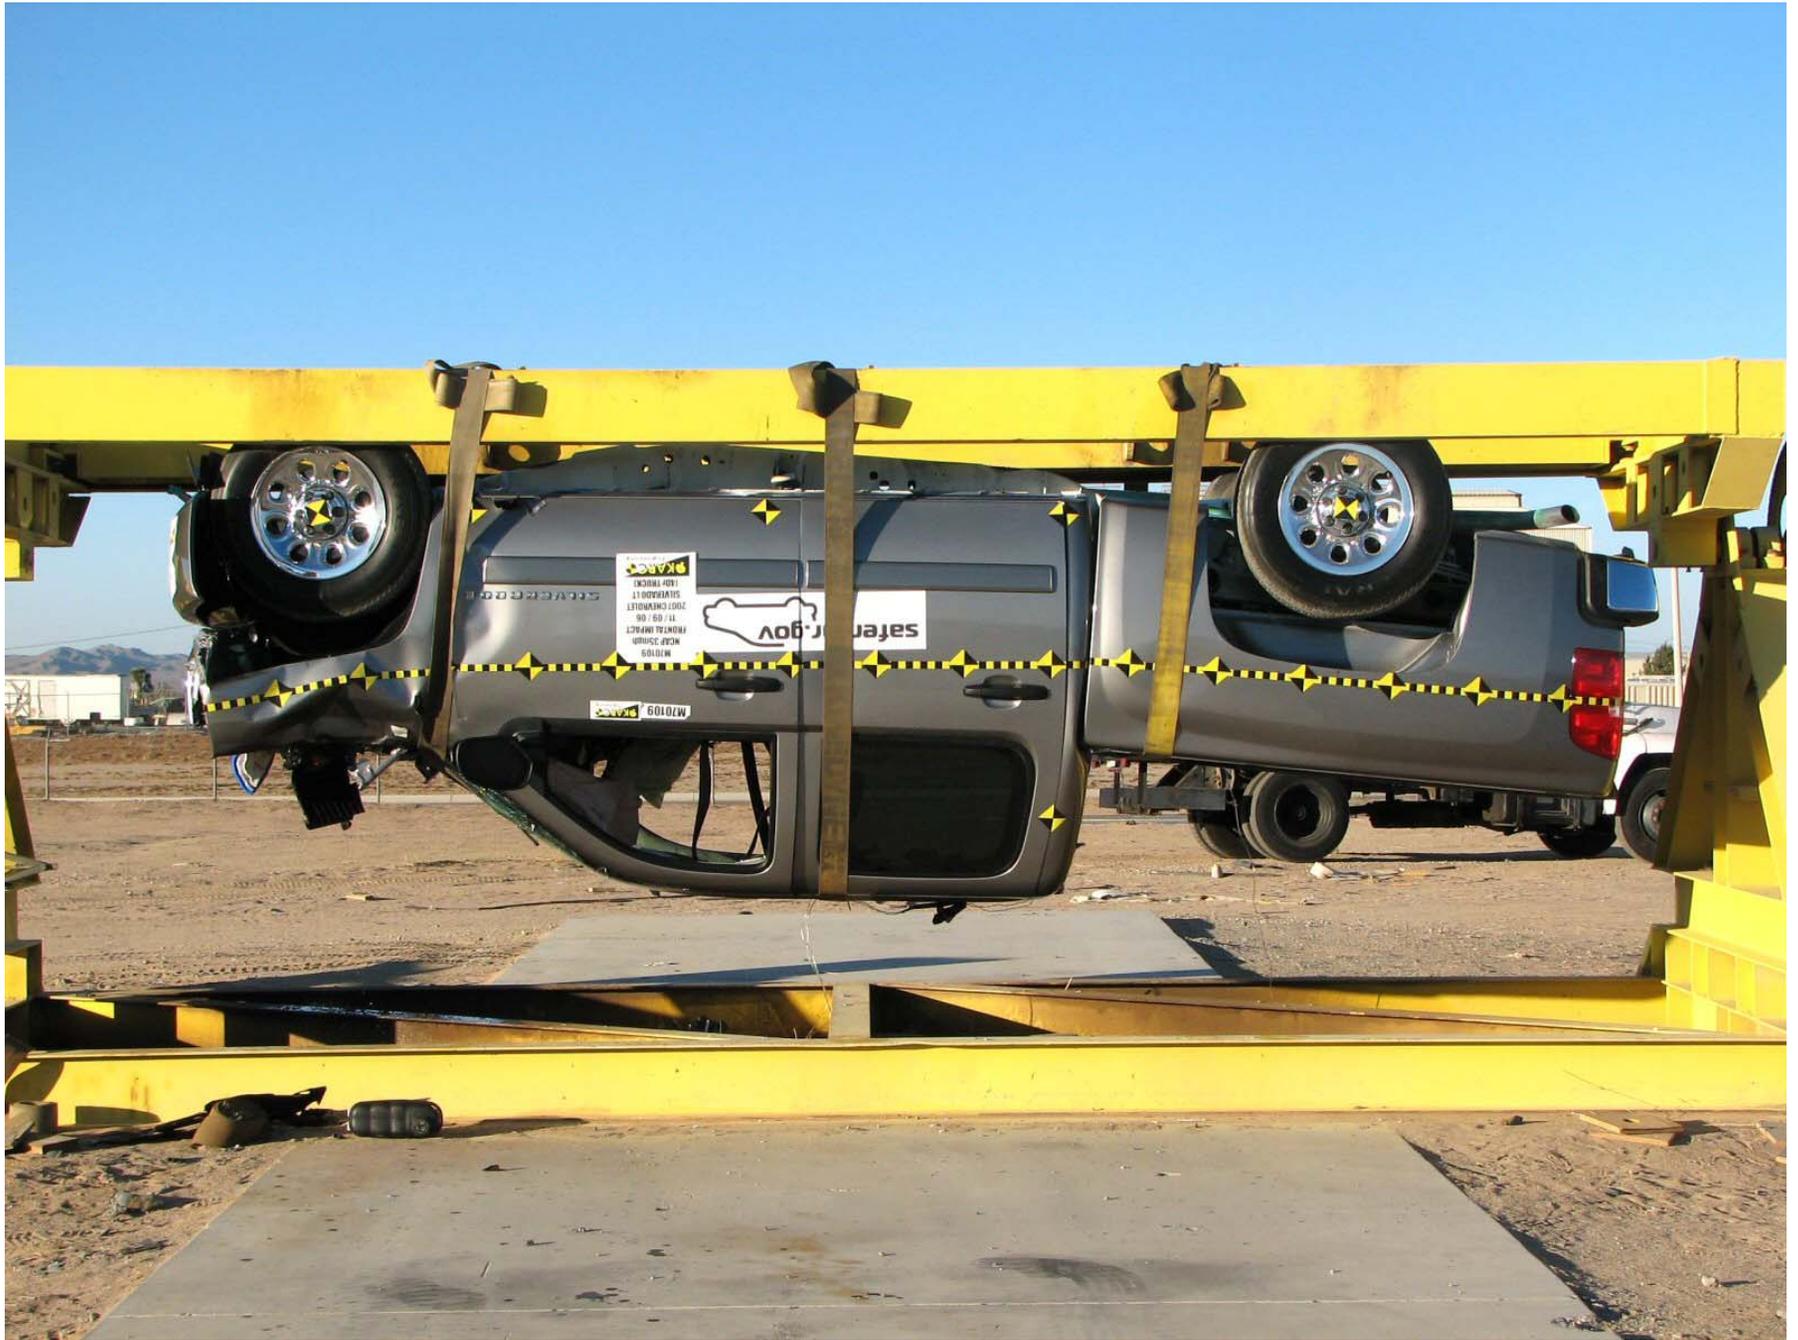
Figure A-60: Vehicle on Rollover Device (180°)

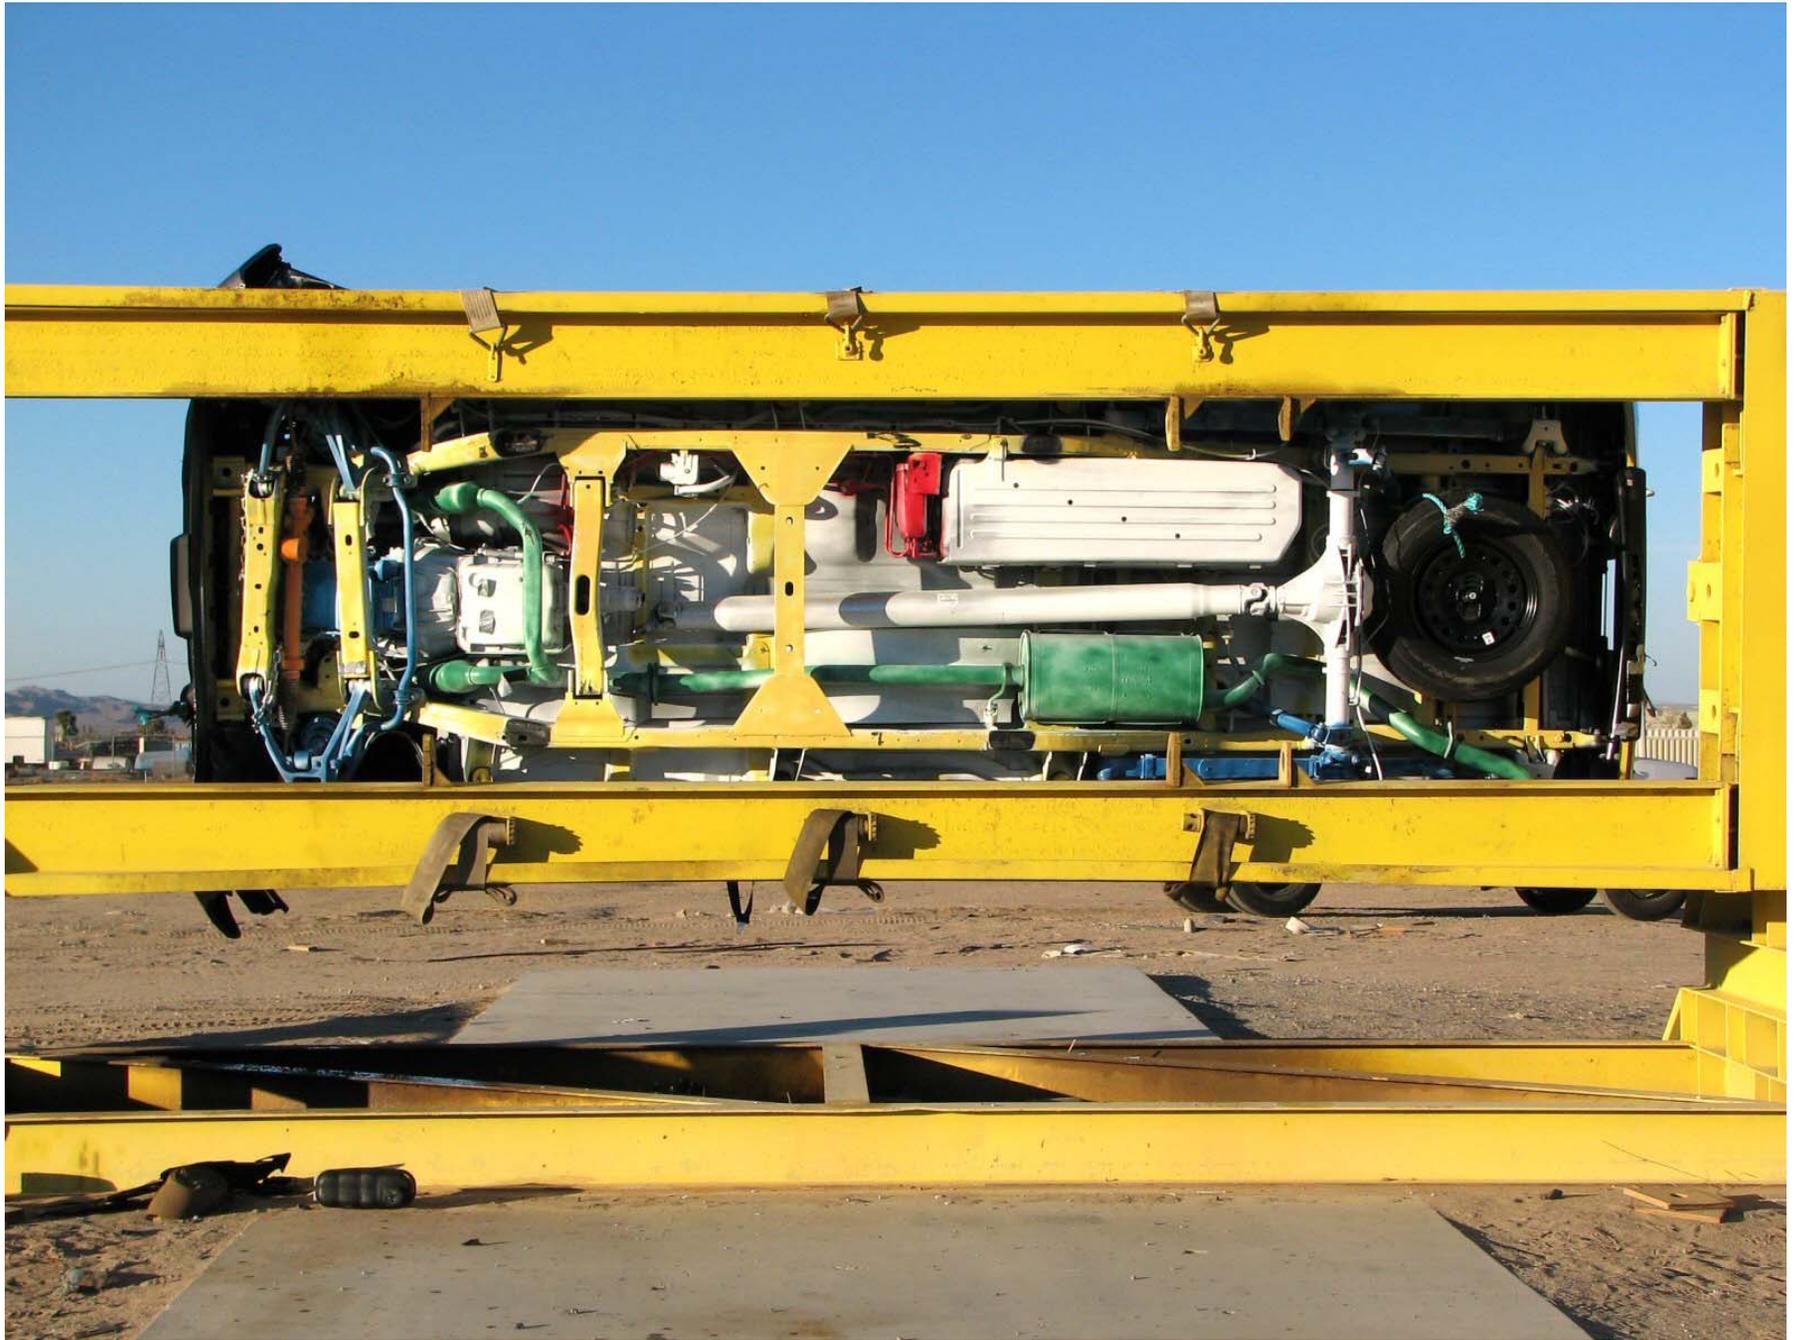
Figure A-61: Vehicle on Rollover Device (270°)

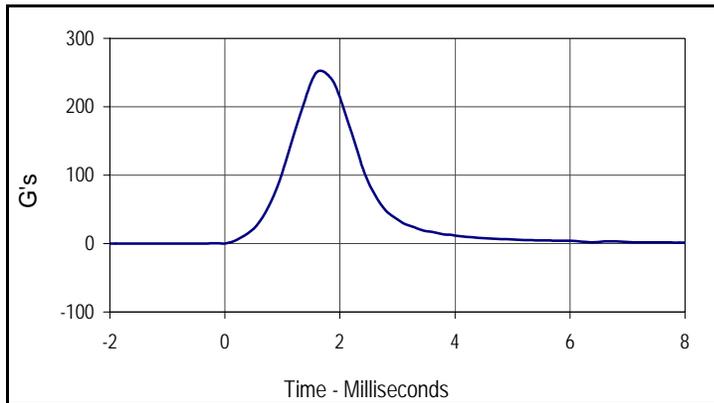
Tested Parameter	Units	Specification	Result	Pass/Fail
Laboratory Temperature	°C	18.9 to 25.6	21.7	Pass
Laboratory Relative Humidity	%	10 to 70	30	Pass
Peak Resultant Acceleration	G's	225.0 to 275.0	251.9	Pass
Peak Lateral Acceleration	G's	≤15.0	4.1	Pass
Is Acceleration Unimodal?	Yes/No	Yes	Yes	Pass
Overall Test Results				Pass

Curve Description			
Head Resultant			
CURNO	Type	SAE Class	Units
001	RES	1000	G's
Max	Time	Min	Time
251.9	1.7	0.1	-0.6

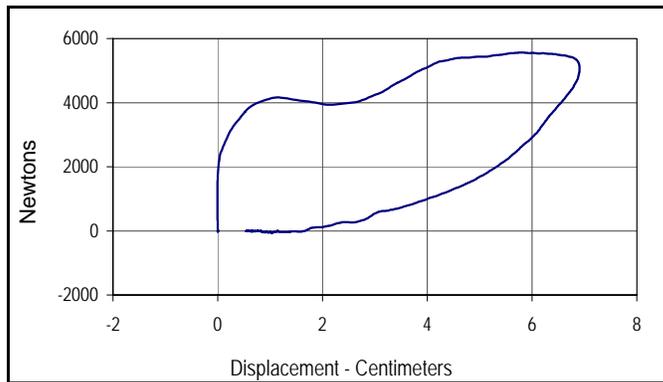
Tested Parameter	Units	Specification	Result	Pass/Fail
Laboratory Temperature	°C	20.6 to 22.2	21.1	Pass
Laboratory Relative Humidity	%	10 to 70	30	Pass
Probe Velocity	m/s	6.58 to 6.82	6.78	Pass
Peak Probe Force	Newtons	5159 to 5893	5563	Pass
Peak Sternum Deflection	CM	6.35 to 7.26	6.91	Pass
Internal Hysteresis	%	69 to 85	74.9	Pass
Overall Test Results				Pass

Curve Description			
Probe Force vs. Chest Deflection			
CURNO	Type	SAE Class	Hysteresis
001	FIL	180	74.9
Peak Probe Force		Peak Chest Deflection	
5563		6.91

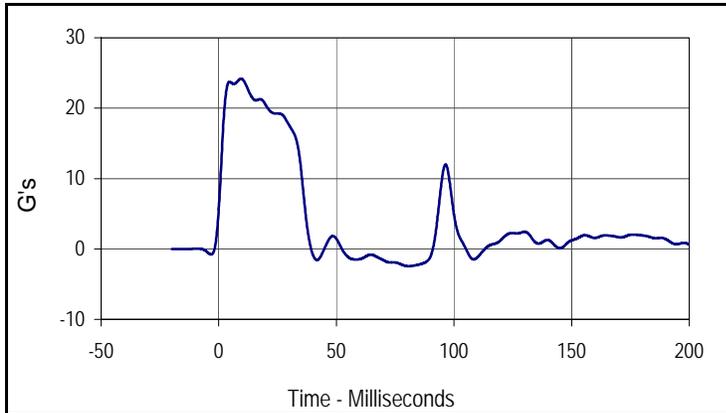
Tested Parameter	Units	Specification	Result	Pass/Fail	
Laboratory Temperature	°C	20.6 to 22.2	20.6	Pass	
Laboratory Relative Humidity	%	10 to 70	30	Pass	
Pendulum Velocity	m/s	6.89 to 7.13	6.96	Pass	
Pendulum Deceleration	10 Msec.	G's	22.5 to 27.5	24.1	Pass
	20 Msec.	G's	17.6 to 22.6	20.4	Pass
	30 Msec.	G's	12.5 to 18.5	17.5	Pass
Peak Pendulum Decel. after 30 Msec.	G's	≤ 29.0	17.5	Pass	
Deceleration Decay, Time to Cross 5 G's	Msec.	34.0 to 42.0	37	Pass	
Maximum "D" Plane Rotation	Max	Degrees	64.0 to 78.0	71.9	Pass
	Time	Msec.	57.0 to 64.0	60.9	Pass
"D" Plane Rotation Decay, Time To Zero Crossing	Msec.	113.0 to 128.0	123.3	Pass	
Moment About Occ. Condyle	Max	Nm	84.1 to 108.5	88.1	Pass
	Time	Msec.	47.0 to 58.0	47.7	Pass
Positive Moment Decay, Time To Zero Crossing	Msec.	97.0 to 107.0	97.8	Pass	
Overall Test Results				Pass

Curve Description			
Pendulum Deceleration			
CURNO	Type	SAE Class	Units
001	FIL	60	G's
Max	Time	Min	Time
24.2	9.5	-2.4	80.8

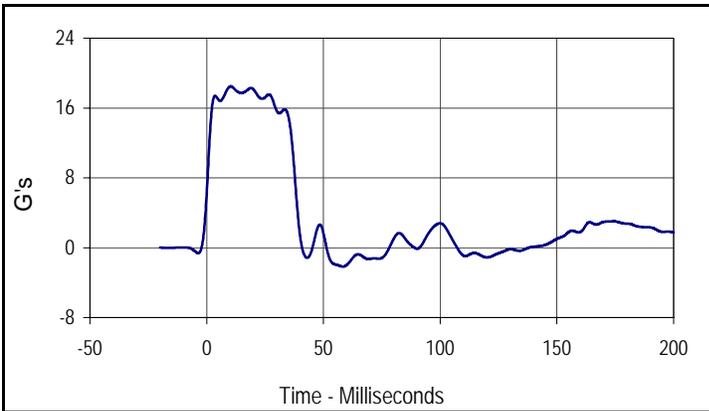
Tested Parameter	Units	Specification	Result	Pass/Fail	
Laboratory Temperature	°C	20.6 to 22.2	21.1	Pass	
Laboratory Relative Humidity	%	10 to 70	30	Pass	
Pendulum Velocity	m/s	5.94 to 6.19	6.13	Pass	
Pendulum Deceleration	10 Msec.	G's	17.2 to 21.2	18.5	Pass
	20 Msec.	G's	14.0 to 19.0	18.1	Pass
	30 Msec.	G's	11.0 to 16.0	15.7	Pass
Peak Pendulum Decel. after 30 Msec.	G's	≤ 22.0	15.9	Pass	
Deceleration Decay, Time to Cross 5 G's	Msec.	38.0 to 46.0	38.7	Pass	
Maximum "D" Plane Rotation	Max	Degrees	81.0 to 106.0	95.4	Pass
	Time	Msec.	72.0 to 82.0	74.4	Pass
"D" Plane Rotation Decay, Time To Zero Crossing	Msec.	147.0 to 174.0	151	Pass	
Moment About Occ. Condyle	Max	Nm	-52.9 to- 79.9	-79.3	Pass
	Time	Msec.	65.0 to 79.0	65.9	Pass
Positive Moment Decay, Time To Zero Crossing	Msec.	120.0 to 148.0	137.5	Pass	
Overall Test Results				Pass

Curve Description			
Pendulum Deceleration			
CURNO	Type	SAE Class	Units
001	FIL	60	G's
Max	Time	Min	Time
18.5	10.3	-2.2	58.4

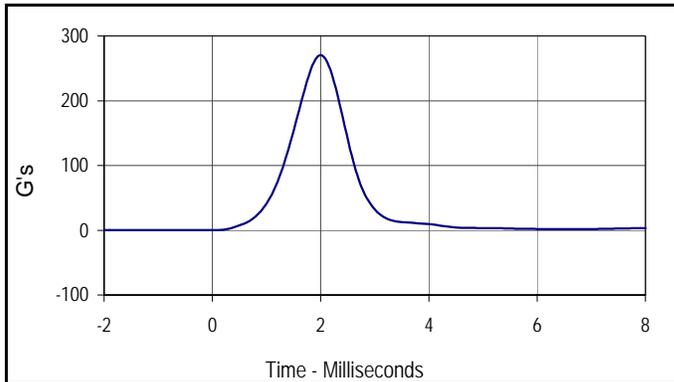
Tested Parameter	Units	Specification	Result	Pass/Fail
Laboratory Temperature	°C	18.9 to 25.6	21.1	Pass
Laboratory Relative Humidity	%	10 to 70	30	Pass
Peak Resultant Acceleration	G's	225.0 to 275.0	270.6	Pass
Peak Lateral Acceleration	G's	≤15.0	8.6	Pass
Is Acceleration Unimodal?	Yes/No	Yes	Yes	Pass
Overall Test Results				Pass

Curve Description			
Head Resultant			
CURNO	Type	SAE Class	Units
001	RES	1000	G's
Max	Time	Min	Time
270.6	2.0	0.0	-0.2

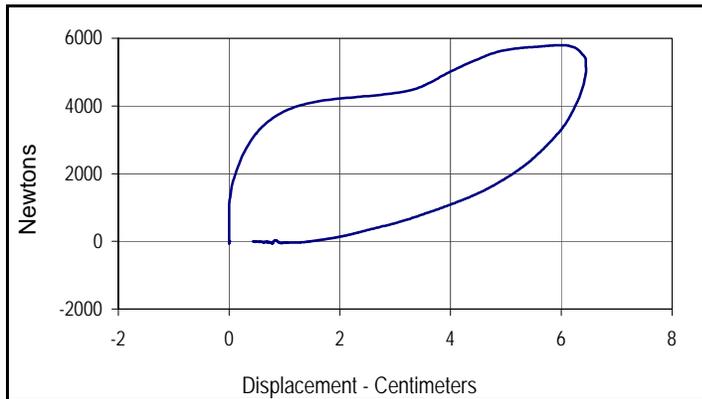
Tested Parameter	Units	Specification	Result	Pass/Fail
Laboratory Temperature	°C	20.6 to 22.2	21.1	Pass
Laboratory Relative Humidity	%	10 to 70	30	Pass
Probe Velocity	m/s	6.58 to 6.82	6.75	Pass
Peak Probe Force	Newtons	5159 to 5893	5796	Pass
Peak Sternum Deflection	CM	6.35 to 7.26	6.45	Pass
Internal Hysteresis	%	69 to 85	76.8	Pass
Overall Test Results			Pass

Curve Description			
Probe Force vs. Chest Deflection			
CURNO	Type	SAE Class	Hysteresis
001	FIL	600	76.8
Peak Probe Force		Peak Chest Deflection	
5796		6.45

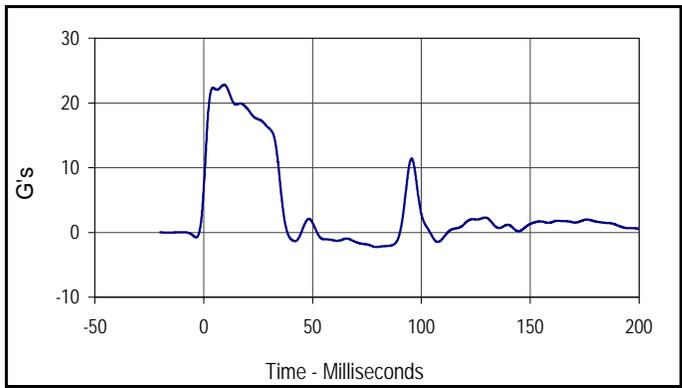
Tested Parameter	Units	Specification	Result	Pass/Fail	
Laboratory Temperature	°C	20.6 to 22.2	21.9	Pass	
Laboratory Relative Humidity	%	10 to 70	30	Pass	
Pendulum Velocity	m/s	6.89 to 7.13	7.04	Pass	
Pendulum Deceleration	10 Msec.	G's	22.5 to 27.5	22.7	Pass
	20 Msec.	G's	17.6 to 22.6	19.1	Pass
	30 Msec.	G's	12.5 to 18.5	16.1	Pass
Peak Pendulum Decel. after 30 Msec.	G's	≤ 29.0	16.1	Pass	
Deceleration Decay, Time to Cross 5 G's	Msec.	34.0 to 42.0	36	Pass	
Maximum "D" Plane Rotation	Max	Degrees	64.0 to 78.0	70.6	Pass
	Time	Msec.	57.0 to 64.0	59.4	Pass
"D" Plane Rotation Decay, Time To Zero Crossing	Msec.	113.0 to 128.0	122.8	Pass	
Moment About Occ. Condyle	Max	Nm	84.1 to 108.5	85.1	Pass
	Time	Msec.	47.0 to 58.0	48.0	Pass
Positive Moment Decay, Time To Zero Crossing	Msec.	97.0 to 107.0	97.6	Pass	
Overall Test Results				Pass

Curve Description			
Pendulum Deceleration			
CURNO	Type	SAE Class	Units
001	FIL	60	G's
Max	Time	Min	Time
22.8	9.3	-2.3	79.4

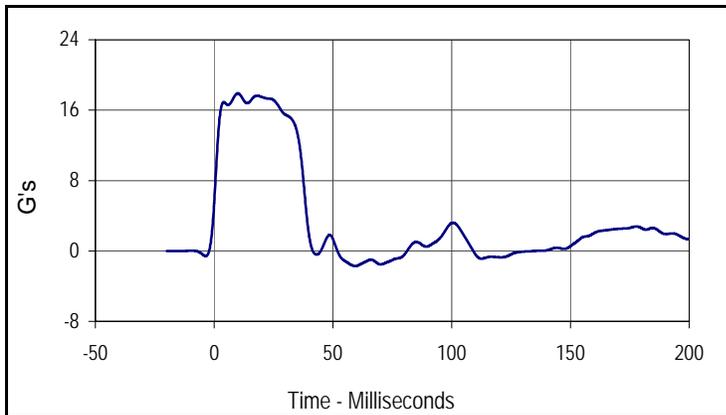
Tested Parameter	Units	Specification	Result	Pass/Fail	
Laboratory Temperature	°C	20.6 to 22.2	21.1	Pass	
Laboratory Relative Humidity	%	10 to 70	30	Pass	
Pendulum Velocity	m/s	5.94 to 6.19	6.13	Pass	
Pendulum Deceleration	10 Msec.	G's	17.2 to 21.2	17.9	Pass
	20 Msec.	G's	14.0 to 19.0	17.5	Pass
	30 Msec.	G's	11.0 to 16.0	15.5	Pass
Peak Pendulum Decel. after 30 Msec.	G's	≤ 22.0	15.5	Pass	
Deceleration Decay, Time to Cross 5 G's	Msec.	38.0 to 46.0	38.6	Pass	
Maximum "D" Plane Rotation	Max	Degrees	81.0 to 106.0	95.0	Pass
	Time	Msec.	72.0 to 82.0	73.5	Pass
"D" Plane Rotation Decay, Time To Zero Crossing	Msec.	147.0 to 174.0	149.7	Pass	
Moment About Occ. Condyle	Max	Nm	-52.9 to- 79.9	-71.6	Pass
	Time	Msec.	65.0 to 79.0	65.0	Pass
Positive Moment Decay, Time To Zero Crossing	Msec.	120.0 to 148.0	133.1	Pass	
Overall Test Results				Pass

Curve Description			
Pendulum Deceleration			
CURNO	Type	SAE Class	Units
001	FIL	60	G's
Max	Time	Min	Time
17.9	10.0	-1.7	59.3
