REPORT NUMBER: CAL-07-07

**NEW CAR ASSESSMENT PROGRAM (NCAP)  
FRONTAL BARRIER IMPACT TEST**

KIA MOTORS CORPORATION  
2007 KIA RONDO  
FIVE DOOR WAGON

CALSPAN TEST NUMBER: 8806-NCAP-07

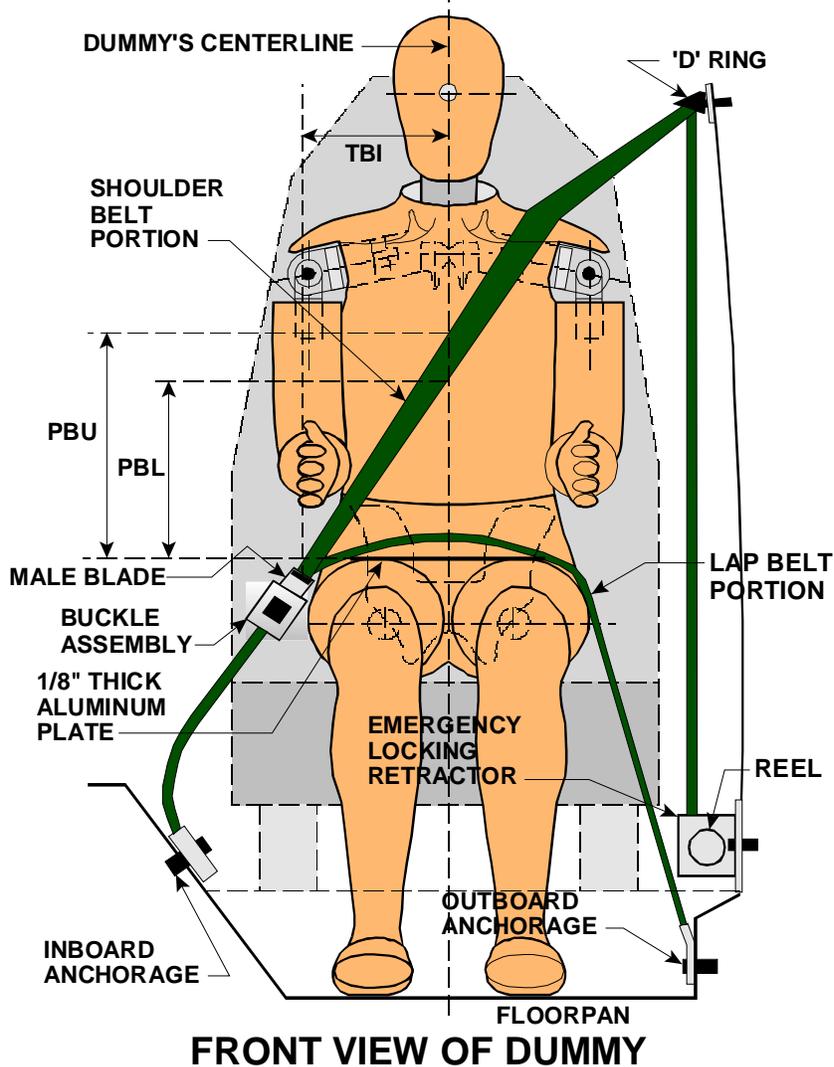
**SEAT BELT POSITIONING DATA**

DRIVER DUMMY (mm)	PASSENGER DUMMY (mm)
PBU -- Top surface of alum. plate to upper edge	320	330
PBL-- Top surface of alum. plate to belt lower edge	240	250
LAP BELT TENSION	10 N	10 N
SHOULDER BELT TENSION	Retractor	Retractor

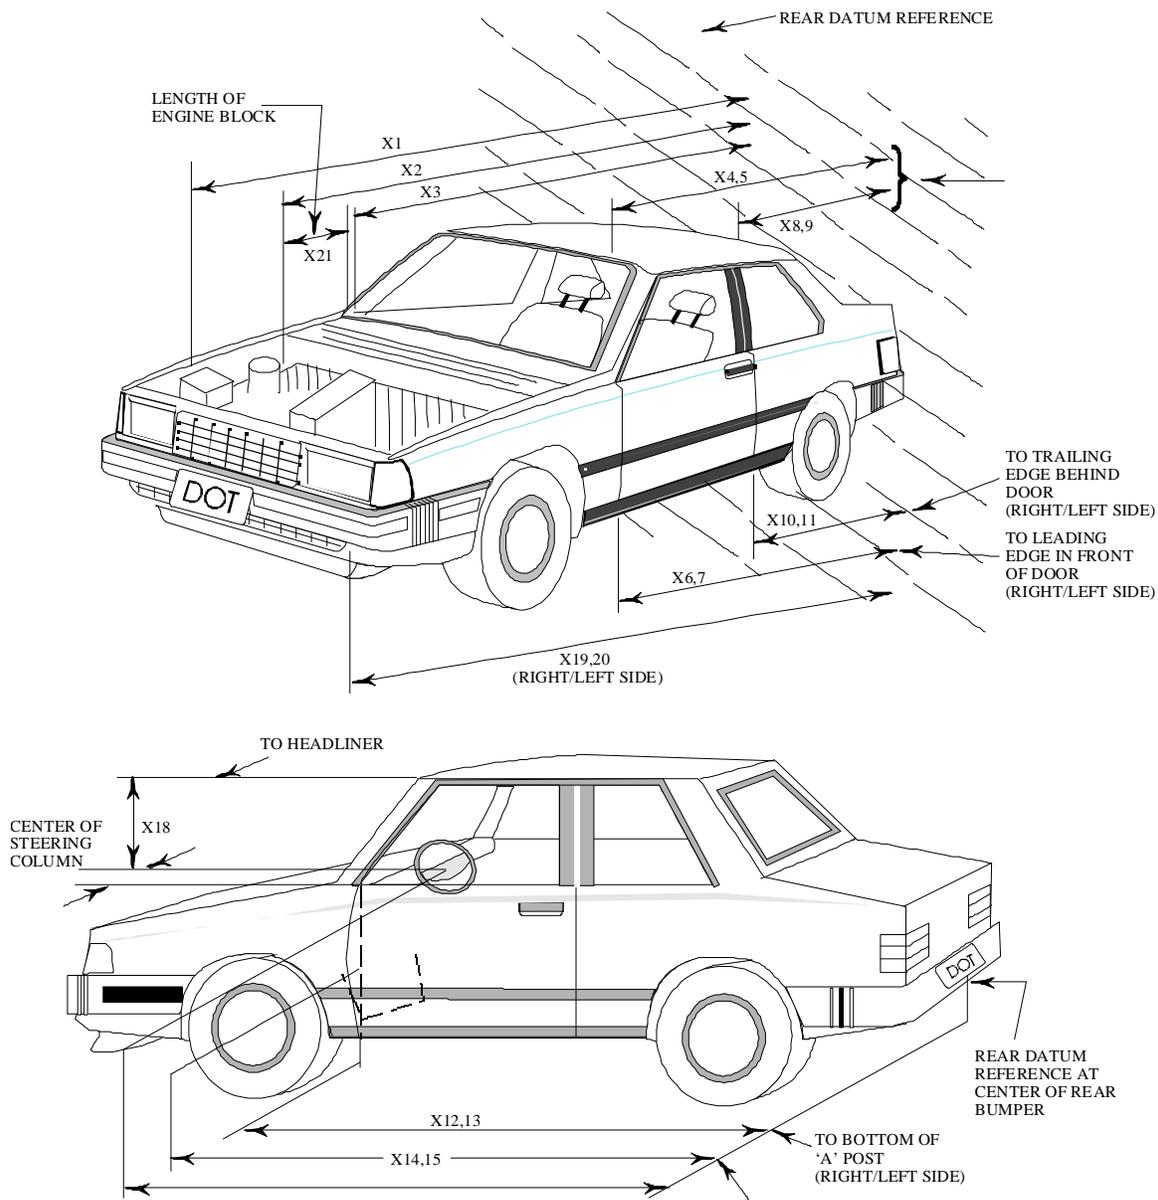
**DATA SHEET NO. 10**  
**TEST VEHICLE MEASUREMENTS**

Elements	Pre-Test (mm)
1	Total length	4549
2	Total Width	1805
3	Bumper Top Height	584
4	Bumper Bottom Height	420
5	Longitudinal Member Top Height	536
6	Distance Between Longitudinal Members	1090
7	Longitudinal Member Width	77
8	Engine top height	867
9	Engine bottom height	175
10	Engine and gearbox width	685
11	Front bumper-engine distance	449
12	Front shock absorber fixing height	878
13	Bonnet leading edge height	792
14	Front shock absorber fixing width	1178
15	Front bumper – front axle distance	933
16	Front axle – A pillar distance	1023
17	A-pillar – B pillar distance	425
18	B-pillar – rear axle distance	1261
19	B-pillar – C Pillar distance	1089
20	Roof sill bottom height	1503
21	Roof sill top height	1599
22	Floor sill bottom height	208
23	Floor sill top height	333

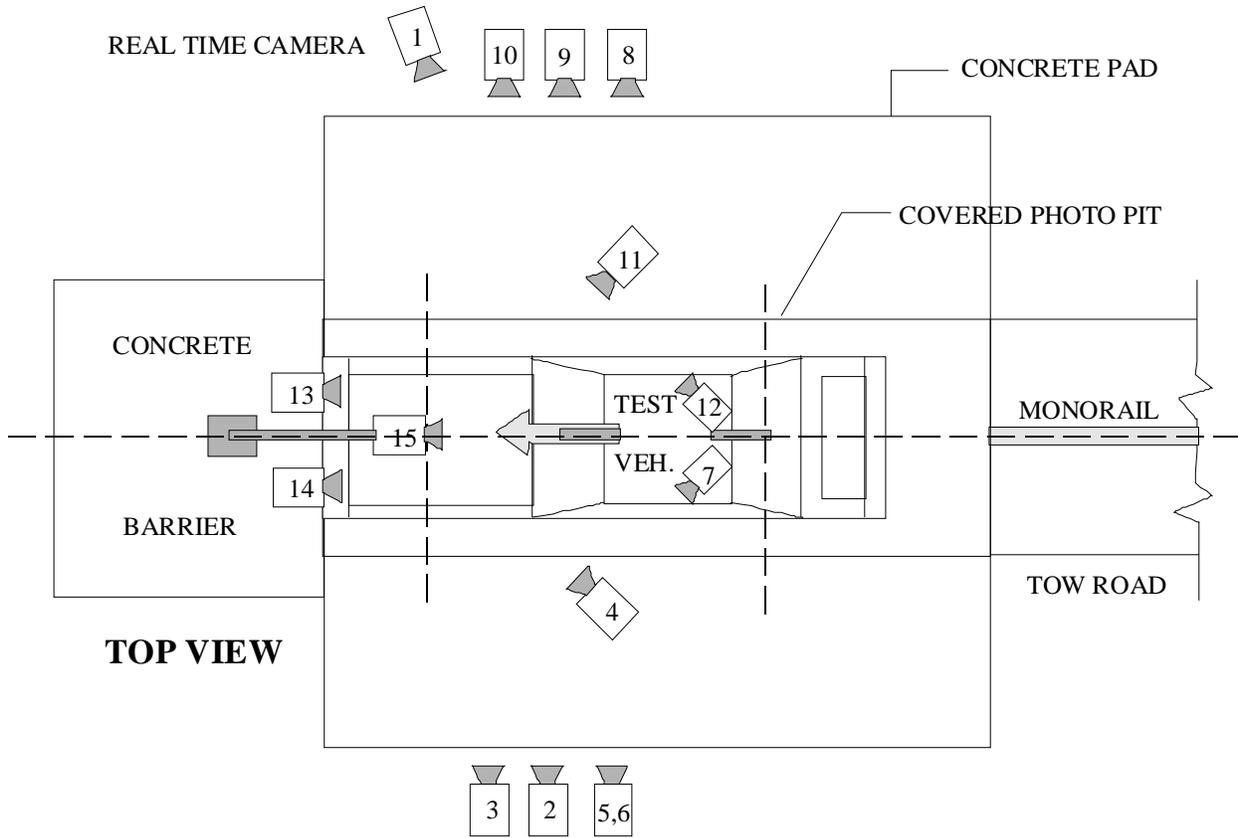
DATA SHEET NO.11  
HIGH-SPEED CAMERA LOCATIONS

CAMERA FRAME RATES:  
#1 - 24 FPS  
All Others - 1000 fps

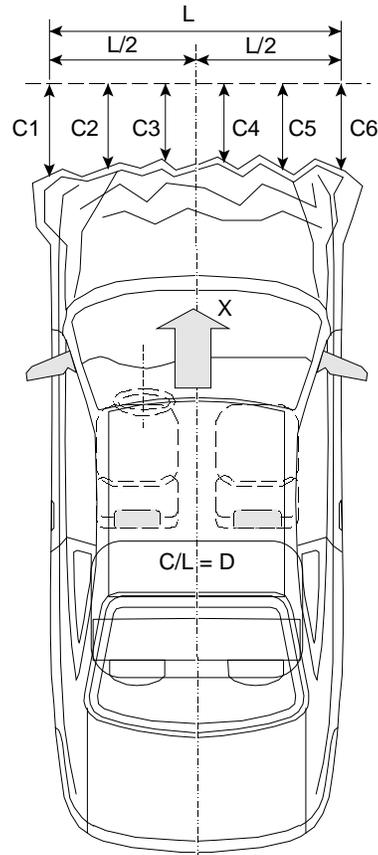
Crush Depth Dimensions

PRE (mm)	POST (mm)	DIFF (mm)
C1 =	4409	4076	333
C2 =	4501	4112	389
C3 =	4548	4130	418
C4 =	4548	4115	433
C5 =	4501	4067	434
C6 =	4409	3981	428

Midpoint of Damage: D = Vehicle Centerline (Longitudinal)

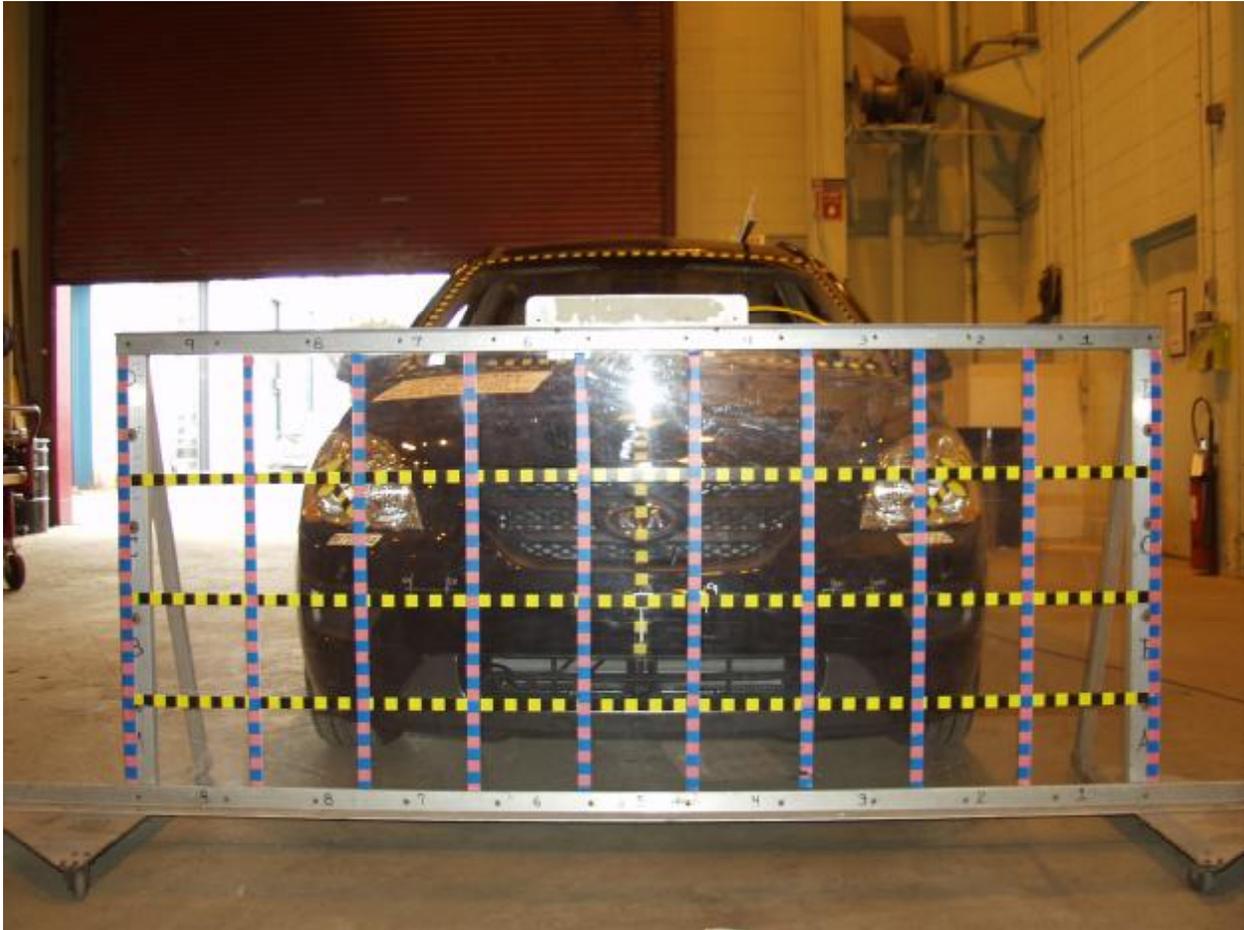
**Figure A-1: Load Cell Locations**

A load cell barrier consisting of 36 load cells was impacted by a 2007 Kia Rondo Five Door Wagon at a velocity of 55.84 kph. The test was performed at Calspan on December 19, 2006. Pre- and post-test photographs of the vehicle and dummies can be found in Appendix A.

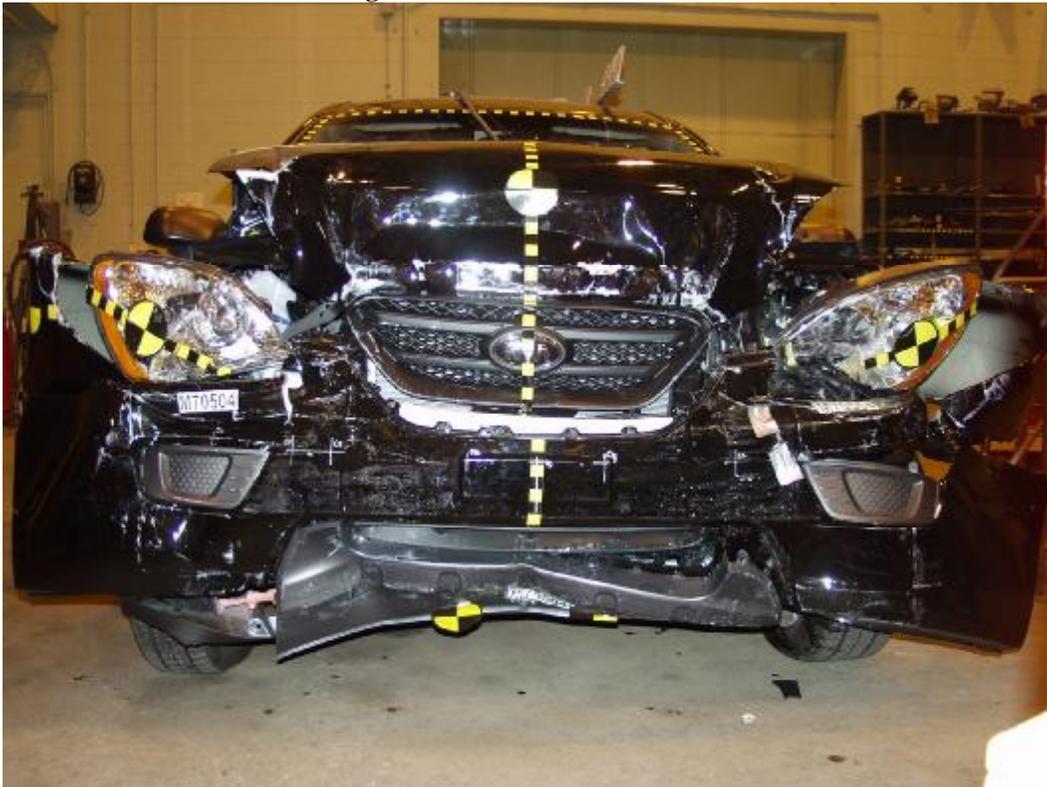
**Figure A-7: Post-Test Front View**

Vehicle NHTSA No.:                   M70504                   Test Mode:                   56.3 kph Frontal Barrier                    
 Test Date:                   December 19, 2006                   Time:                   13:10                   Temperature:                   20                   °C  
 Vehicle Make/Model/Body Style:                   2007 Kia Rondo Five Door Wagon                    
 Vehicle Test Weight:                   1751.0                   kg Impact Velocity:                   55.84                   kph (55.5 – 57.1 kph)  
 Vehicle/Barrier Impact Angle:                   0                   ° Max Static Crush:                   436                   mm

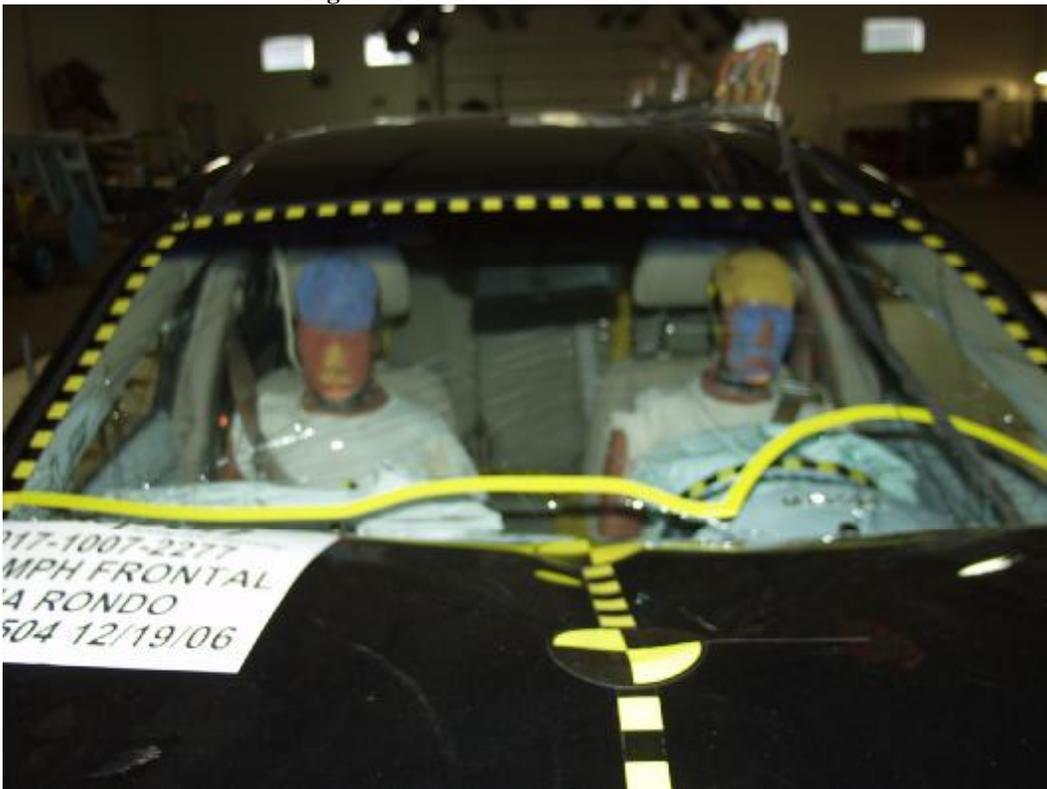
**Figure A-19: Post-Test Windshield View**

Description	Driver Side	Passenger Side
Door Lock Status	Unlocked	Unlocked
Front Door Opening	Closed, latched and operable without tools	Closed, latched and operable without tools
Rear Door Opening	Closed, latched and operable without tools	Closed, latched and operable without tools
Hatch/Other Door Opening	-	Closed, latched and operable without tools
Front Seat Track Shift (mm)	0	0
Front Seat Back Failure	None	None
Glazing Damage	The windshield cracked during contact from the passenger airbag cover.

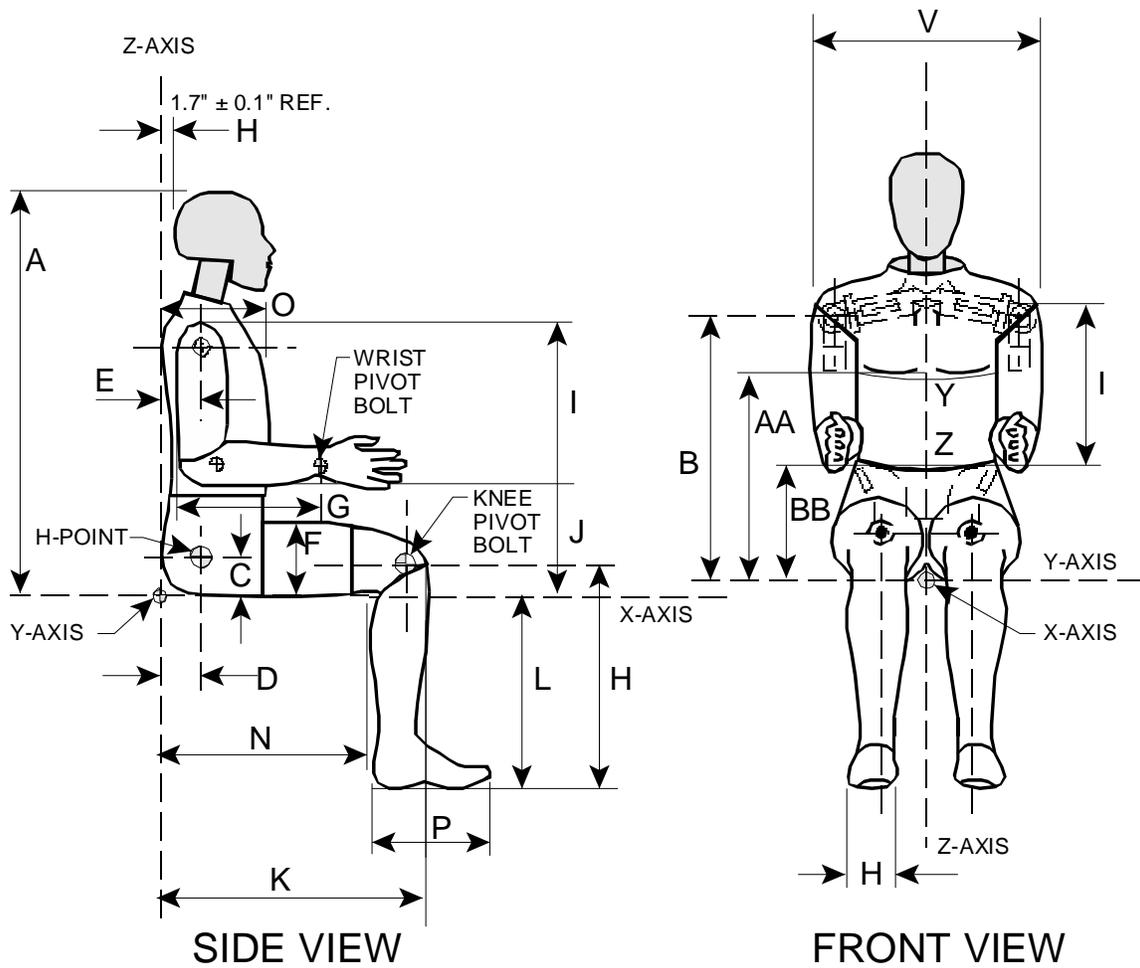
# EXTERNAL DIMENSIONS SPECIFICATIONS

NOTE: Figure is referenced to the erect seated position. The curved lumbar does not allow the Hybrid III to be positioned in a perfect erect attitude. (REF: S572.31(A)(6))

TEST PARAMETER		SPECIFICATION	TEST RESULTS
Temperature			21.1
Relative Humidity			50
Location for Chest Circumference	AA	16.9 - 17.1 in	17.0
Location for Waist Circumference	BB	8.9 - 9.1 in	9.0
Total Sitting Height	A	34.6 - 35.0 in	34.7
Shoulder Pivot Height	B	19.9 - 20.5 in	20.1
H-Point Height	C	3.3 - 3.5 in	3.4
H-Point from Backline	D	5.3 - 5.5 in	5.4
Shoulder Pivot from Backline	E	3.3 - 3.7 in	3.4
Thigh Clearance	F	5.5 - 6.1 in	5.9
Back of Elbow to Wrist Pivot	G	11.4 - 12.0 in	11.8
Skull Cap to Backline	H	1.6 - 1.8 in	1.7
Shoulder - Elbow Length	I	13.0 - 13.6 in	13.3
Elbow Rest Height	J	7.5 - 8.3 in	7.7
Buttock Knee Length	K	22.8 - 23.8 in	22.9
Popliteal Height	L	16.9 - 17.9 in	17.5
Knee Pivot Height	M	19.1 - 19.7 in	19.4
Buttock Popliteal Length	N	17.8 - 18.8 in	18.6
Chest Depth	O	8.4 - 9.0 in	8.6
Foot Length	P	9.9 - 10.5 in	10.0
Shoulder Breadth	V	16.6 - 17.2 in	16.8
Foot Breadth	W	3.6 - 4.2 in	3.9
Chest Circumference (With Jacket)	Y	38.2 - 39.4 in	39.0
