REPORT NUMBER: NCAP-MGA-2007-012

**NEW CAR ASSESSMENT PROGRAM
FRONTAL BARRIER IMPACT TEST**

**CAMI AUTOMOTIVE, INC.
2008 SUZUKI XL7
NHTSA NUMBER: X80500**

**PREPARED BY:
MGA RESEARCH CORPORATION
5000 WARREN ROAD
BURLINGTON, WI 53105**

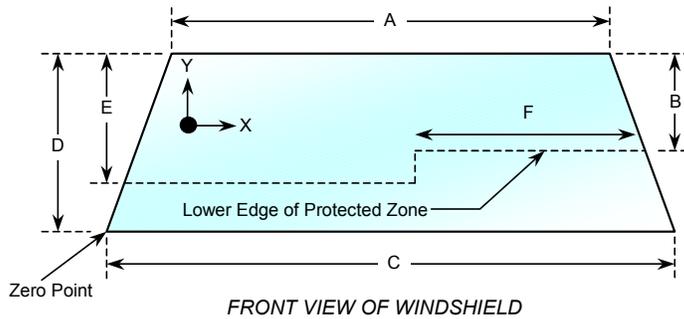
WINDSHIELD PERIPHERY MEASUREMENTS

Measurement	Pre-Test (mm)	Post-Test (mm)	% of Retention
Left Side	2194	2136	97.4
Right Side	2194	1932	88.1
Total	4388	4068	92.7

Item	Units	Value
A	mm	1190
B	mm	591
C	mm	1478
D	mm	860
E	mm	603
F	mm	386

There was 92.7 percent windshield retention and no intrusion into the protected zone of the windshield during the event. There was no Stoddard Solvent leakage after the event or during any phase of the static rollover.

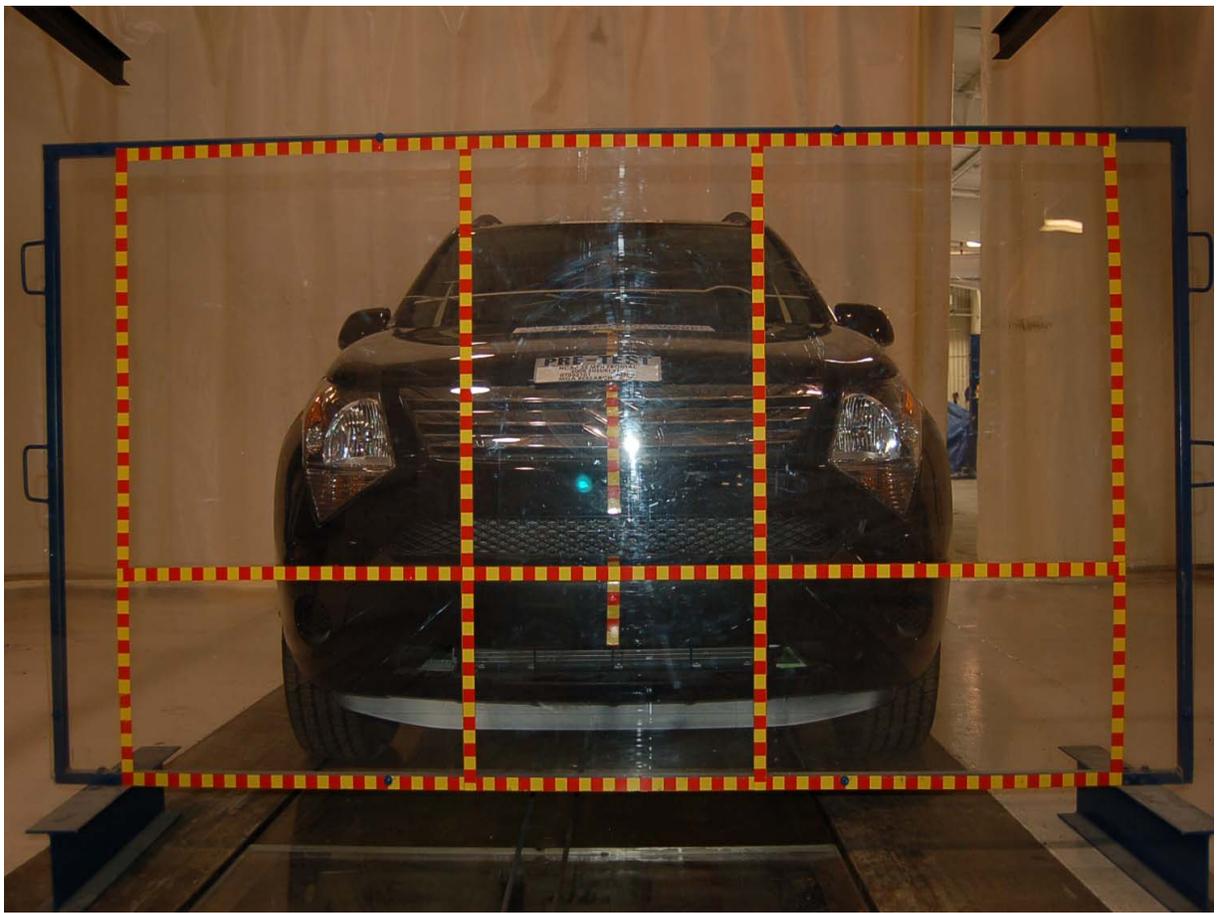
Load Cell Location

A load cell barrier was impacted by a 2008 Suzuki XL7 at a velocity of 56.3 kph. The test was performed at MGA Research Corporation on May 21, 2007. Pre-and post-test photographs of the vehicle and dummies can be found in Appendix A.

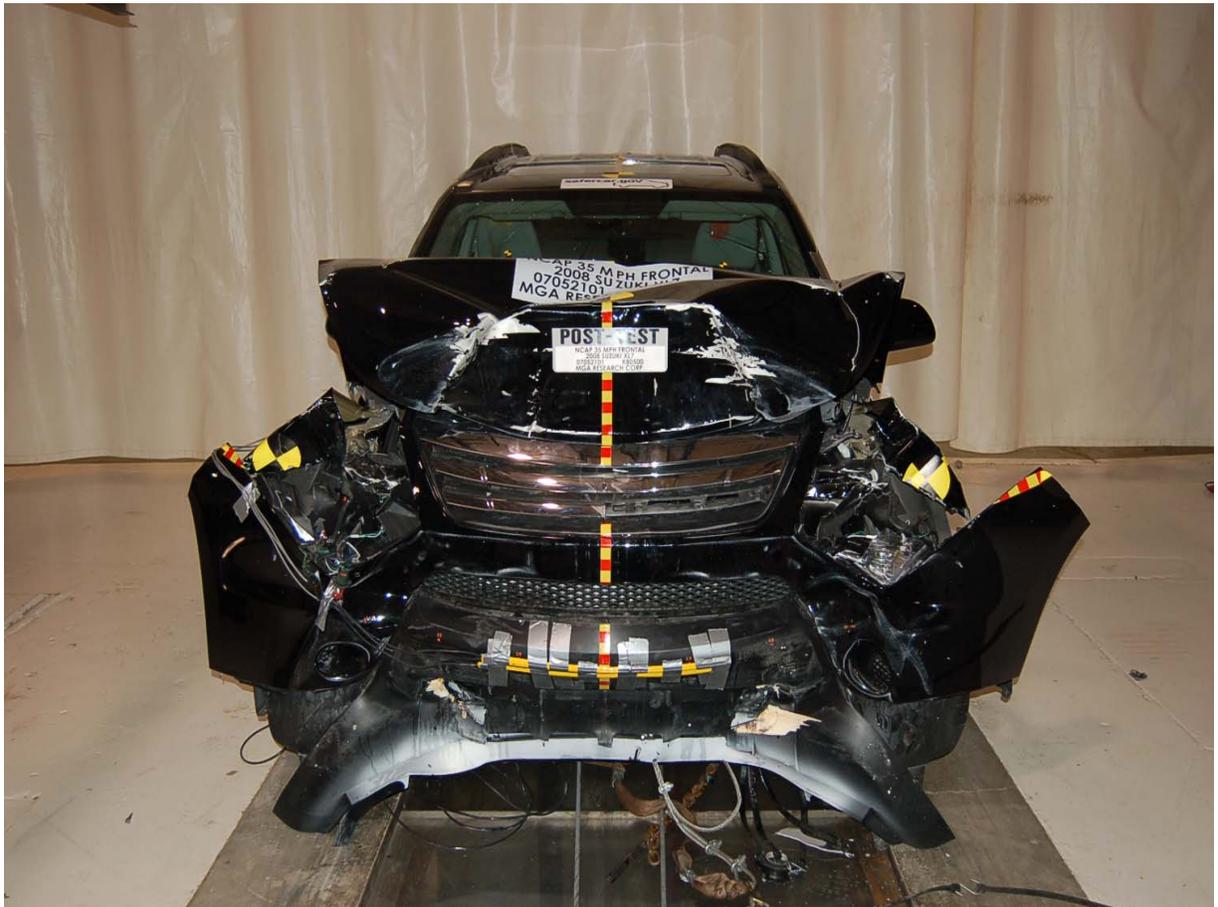
Post-Test Front View

The maximum static crush of the vehicle was 527 mm and both the driver and passenger side doors remained closed and latched during the impact event and were operable after the impact.

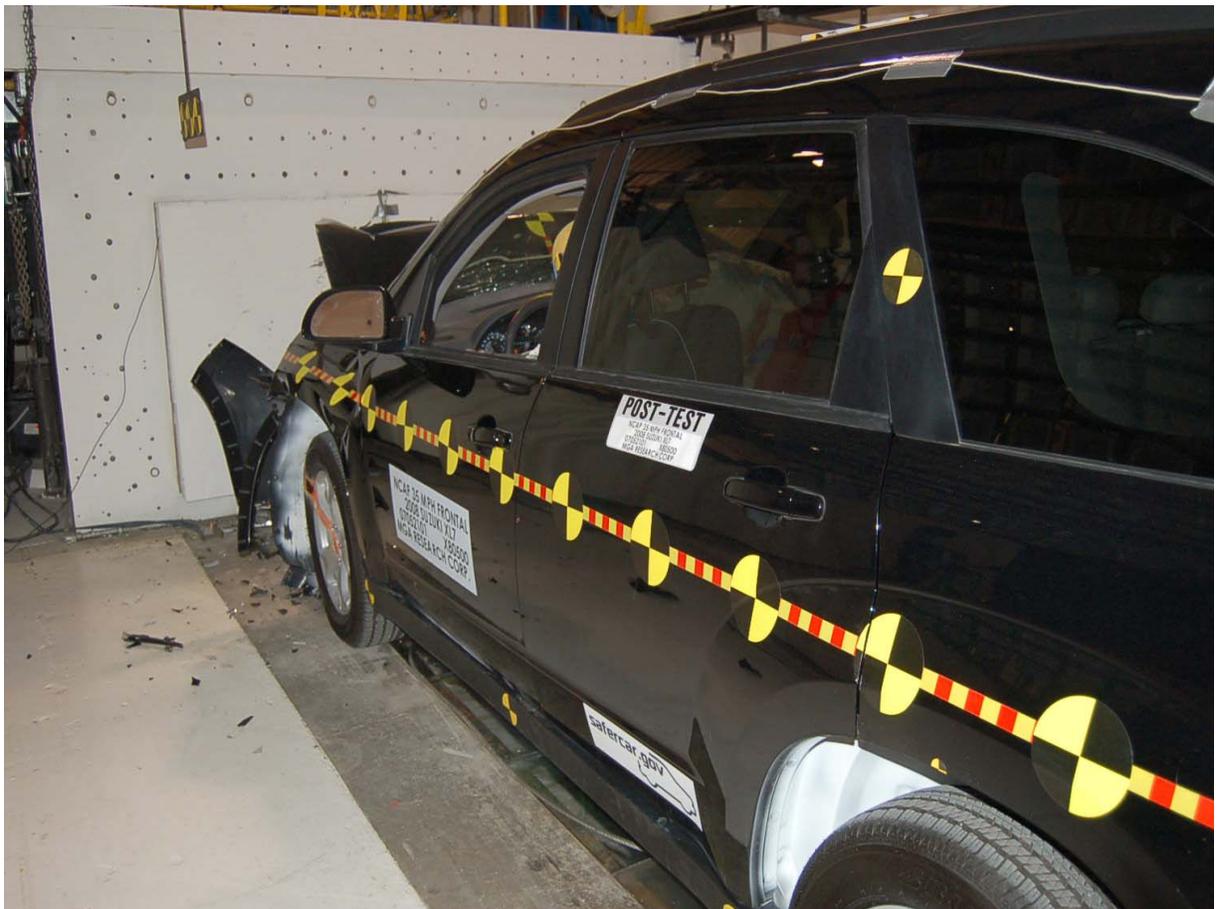
Post-Test Left Side 3/4 View of Doors After Impact

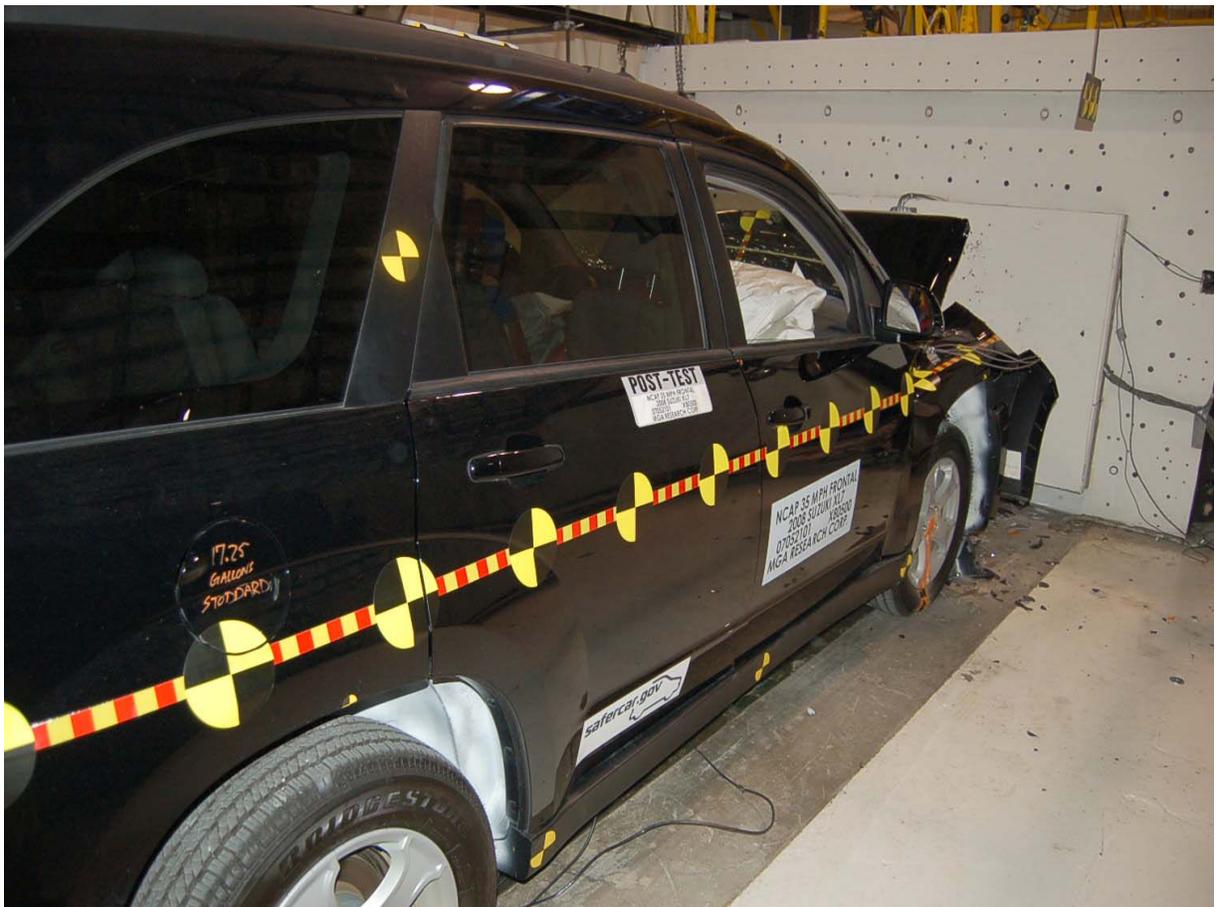
Post-Test Right Side ¾ View of Doors After Impact

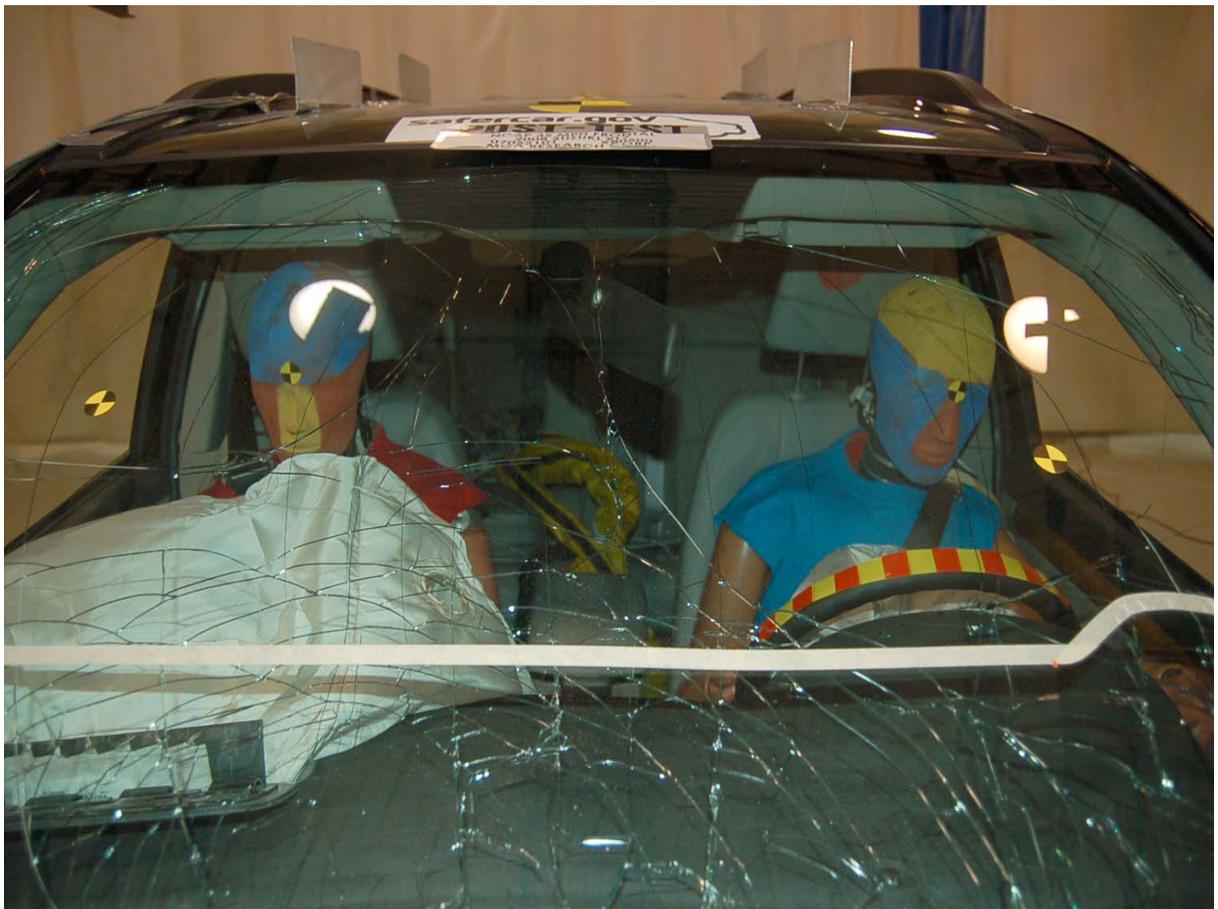
Post-Test Windshield View

Description	Driver	Passenger
Locked/Unlocked Doors	Doors were locked	Doors were locked
Front Door Opening	Door remained closed and latched; Door opened without tools	Door remained closed and latched; Door opened without tools
Rear Door Opening	Door remained closed and latched; Door opened without tools	Door remained closed and latched; Door opened without tools
Seat Track Shift (mm)	0	0
Seat Back Failure	None	None
Glazing Damage	The windshield cracked.

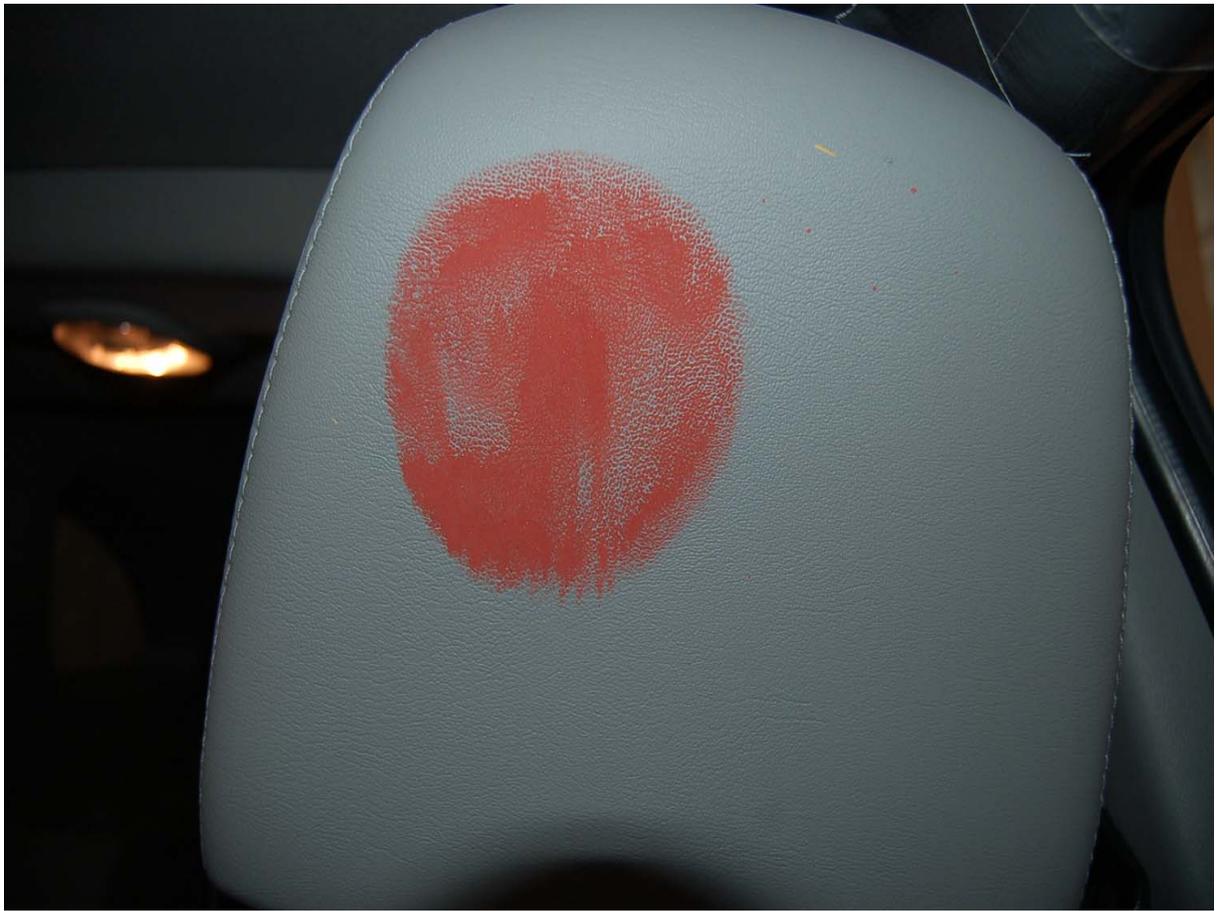
Post-Test Driver Dummy Head Contact (headrest)

The driver's head and chest contacted the airbag. The driver's head also contacted the headrest. The driver's knees contacted the knee bolster. The passenger's head and chest contacted the airbag. The passenger's head also contacted the headrest and side header. The passenger's knees contacted the glove box.

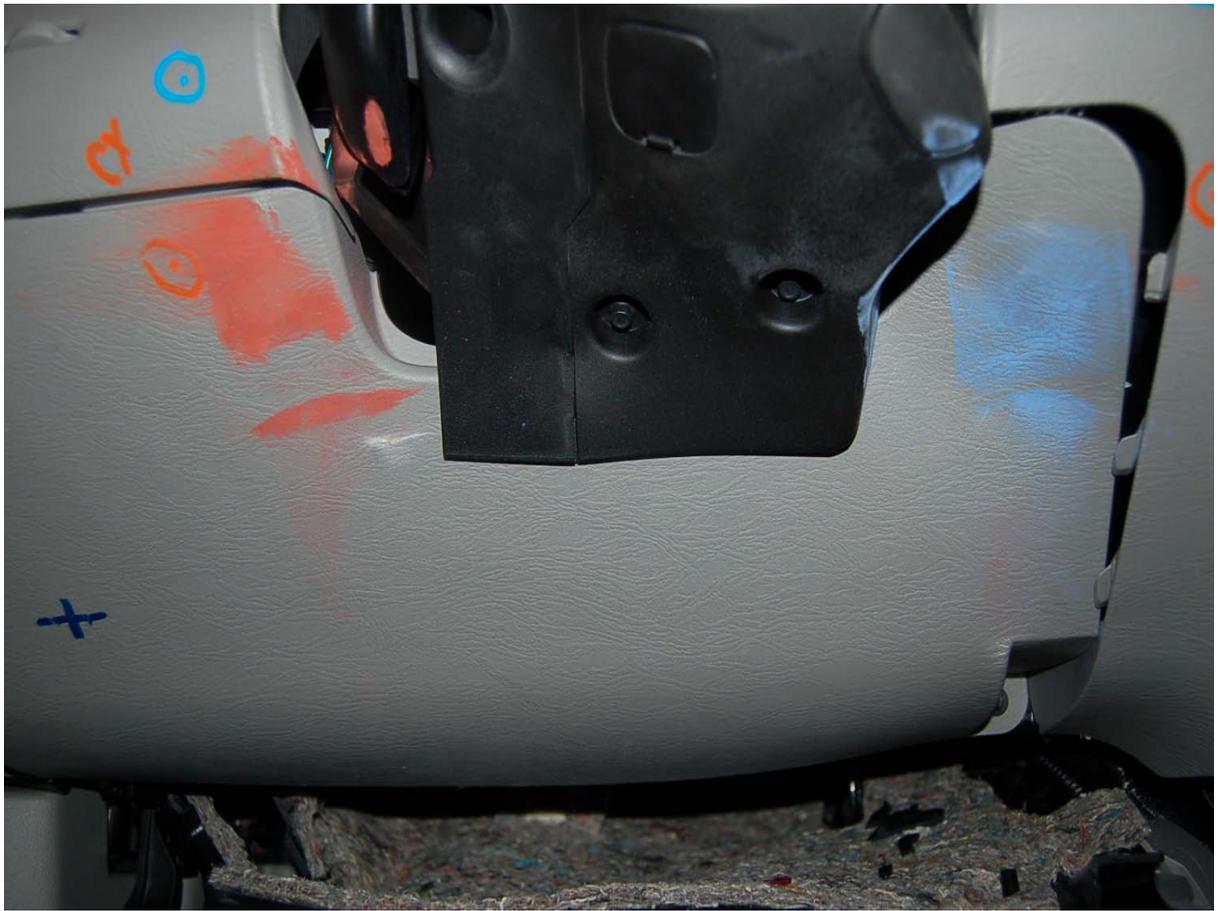
Post-Test Driver Dummy Knee Contact

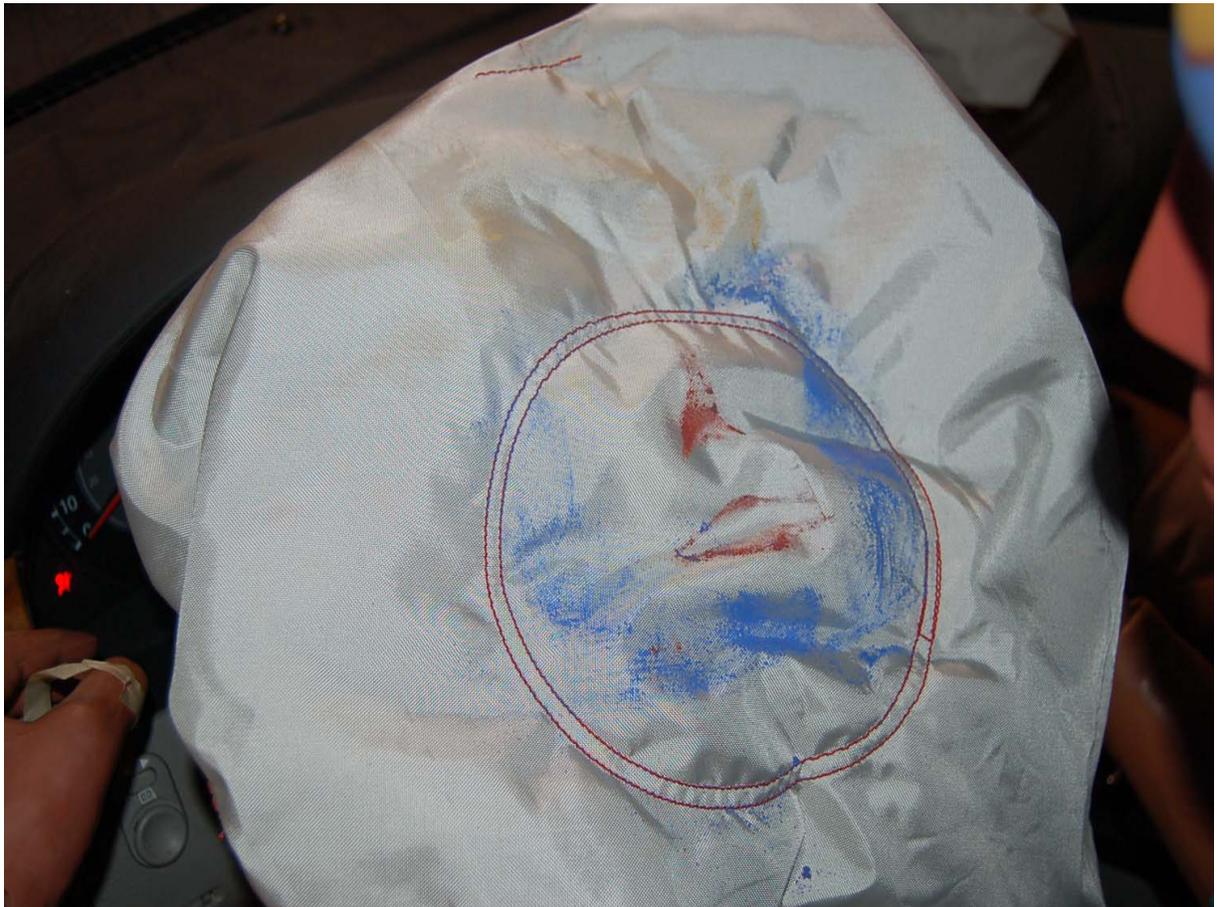
Post-Test Driver Dummy Airbag Contact

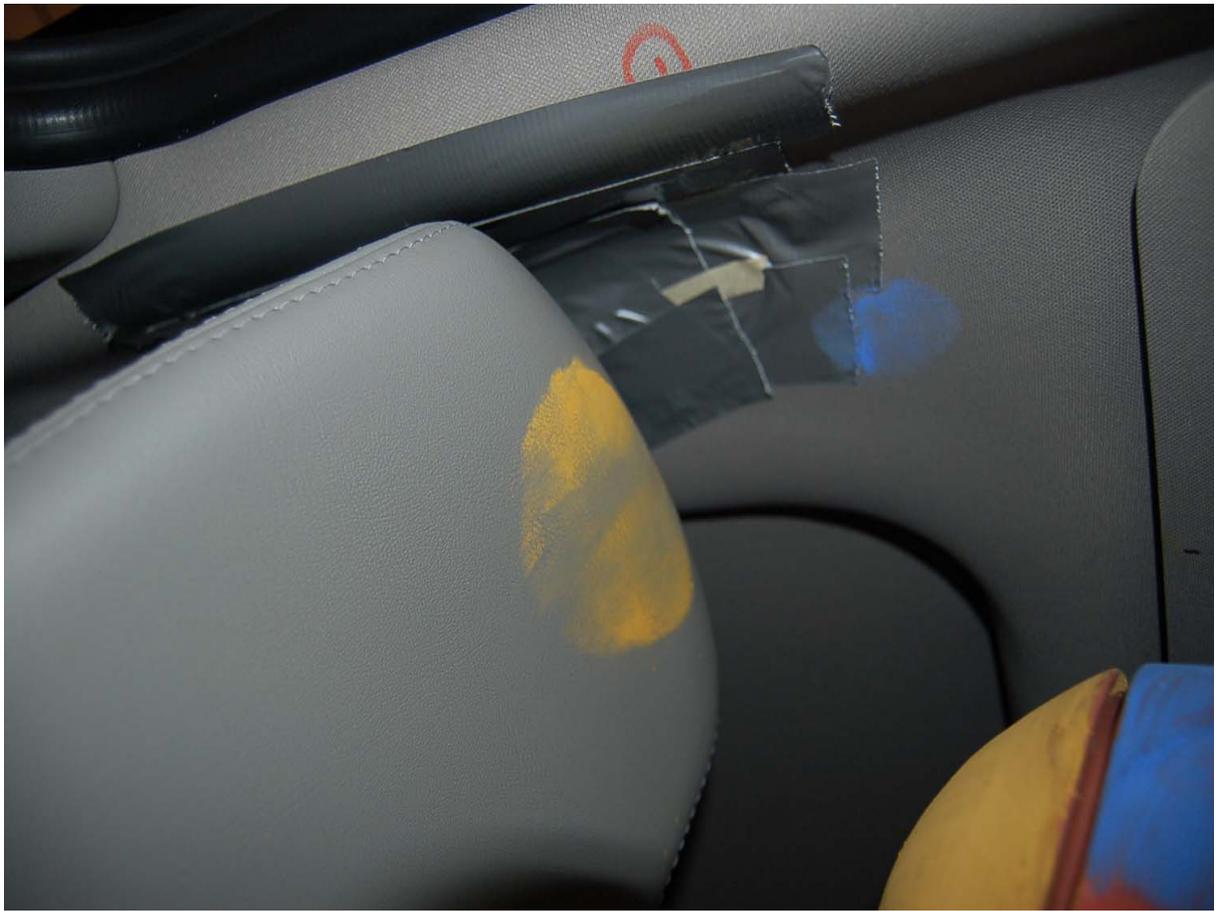
Post-Test Passenger Dummy Head Contact (headrest & side header)

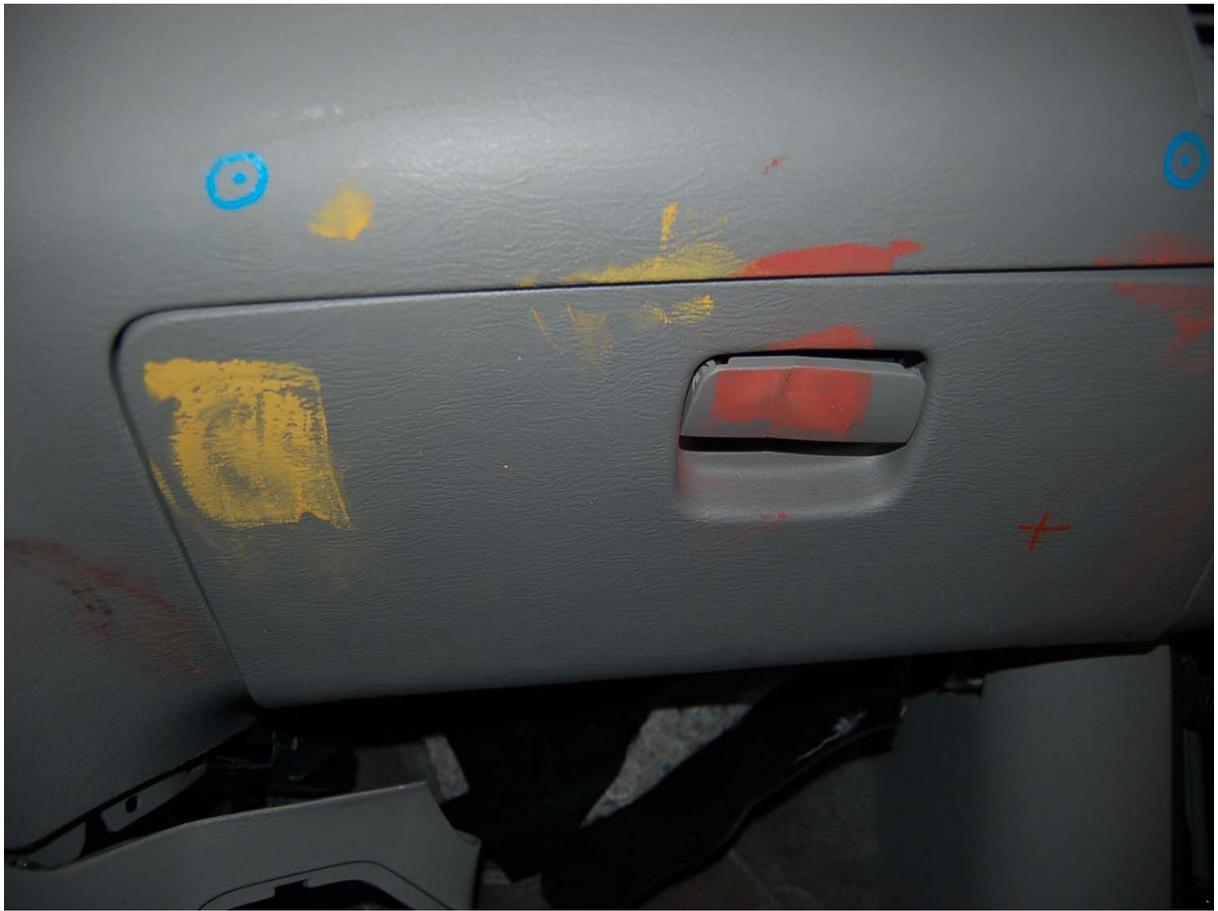
Post-Test Passenger Dummy Knee Contact

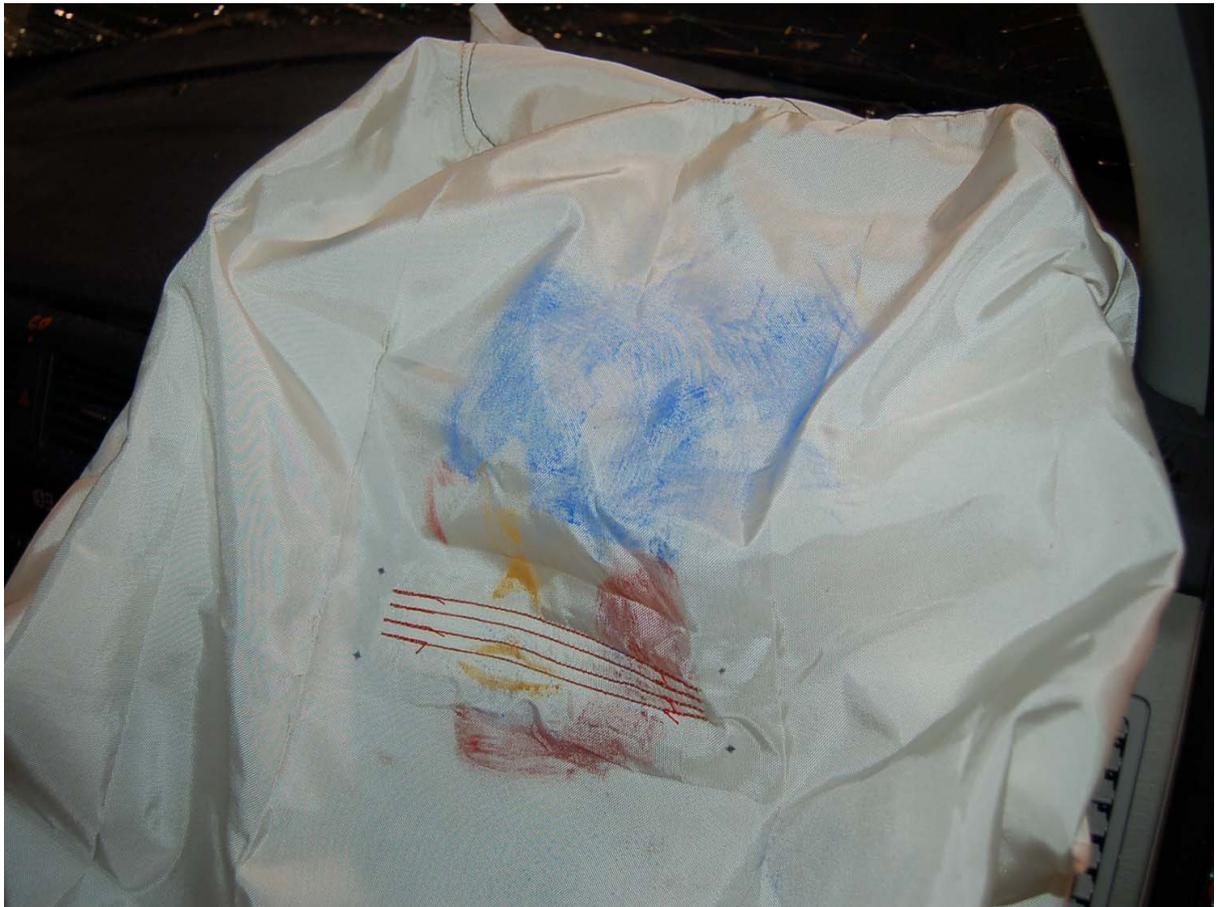
Post-Test Passenger Dummy Airbag Contact

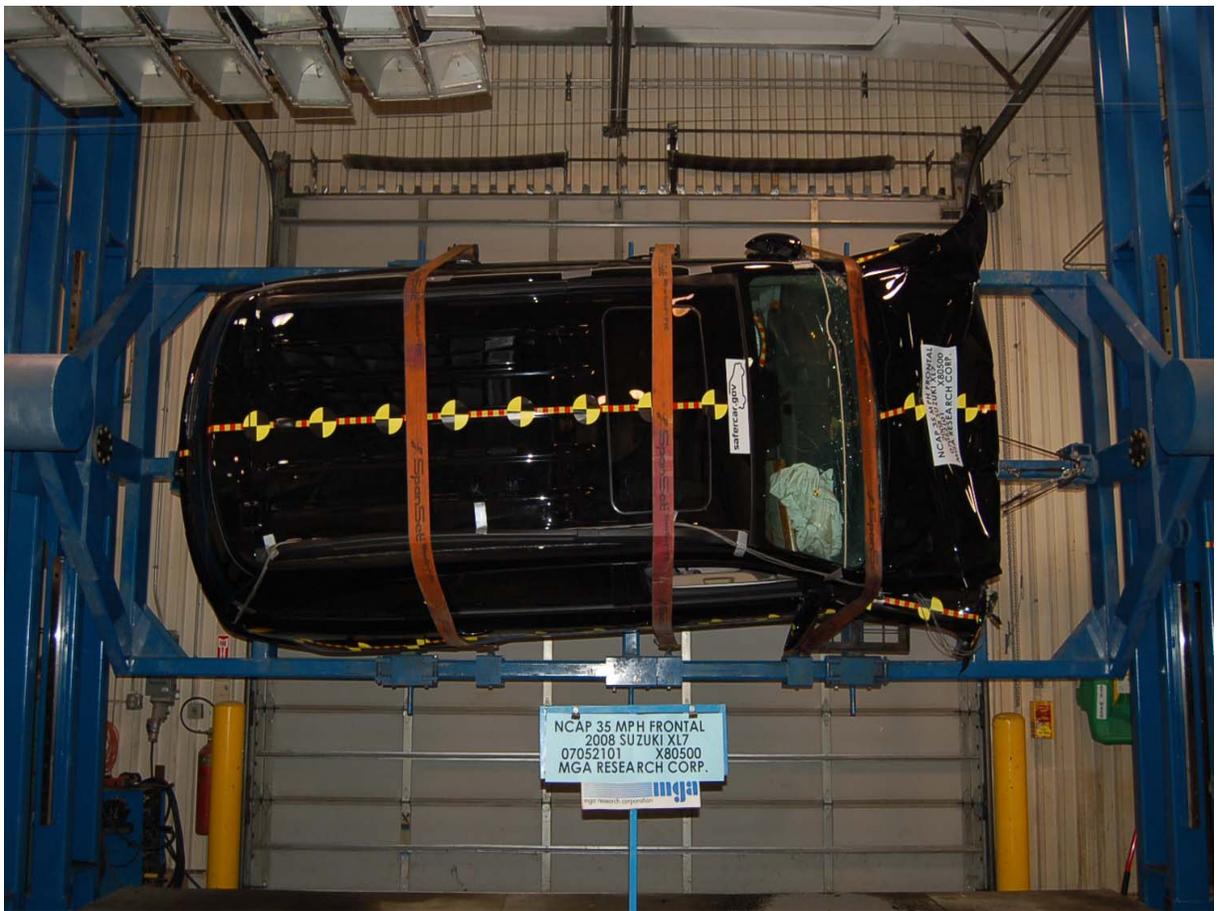
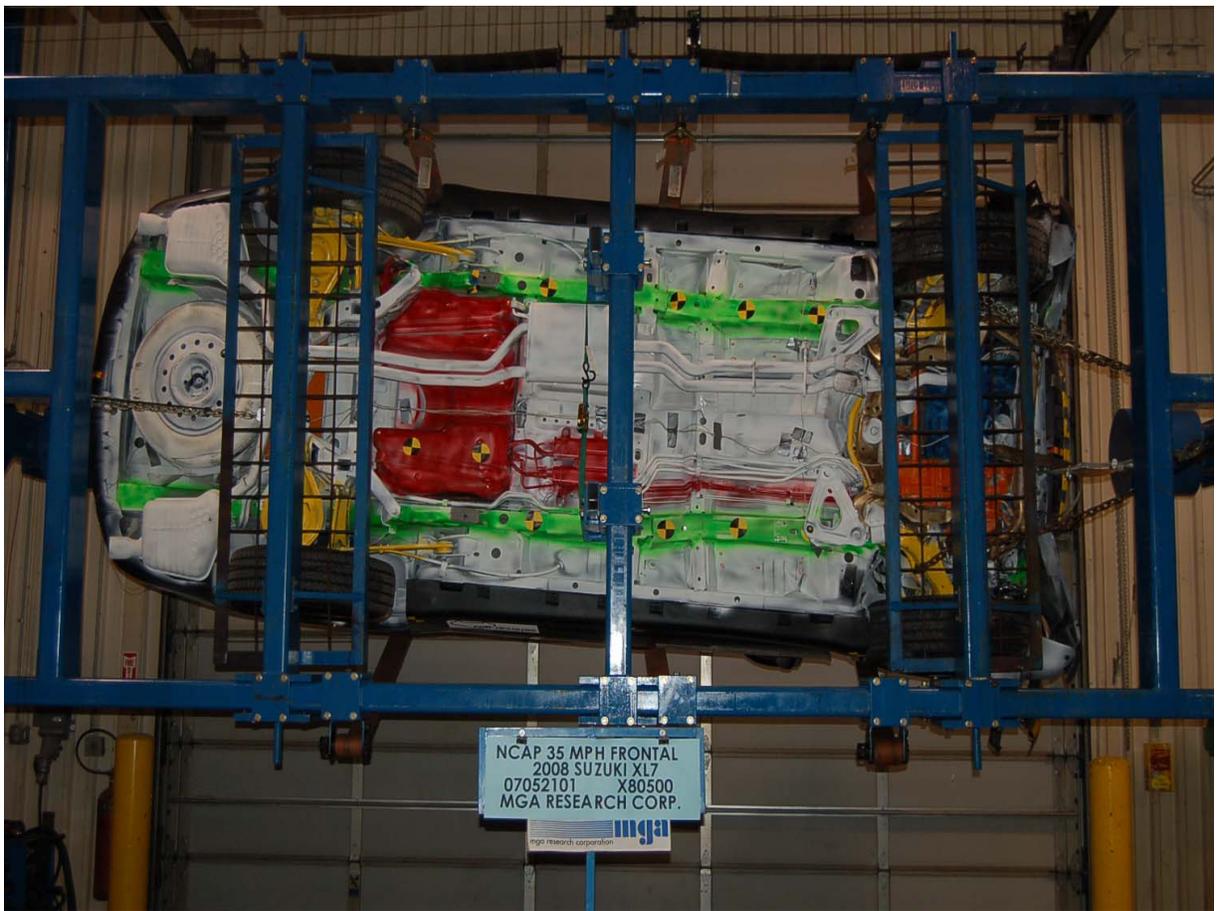
Rollover 90 Degrees

Rollover 180 Degrees

Rollover 270 Degrees

None

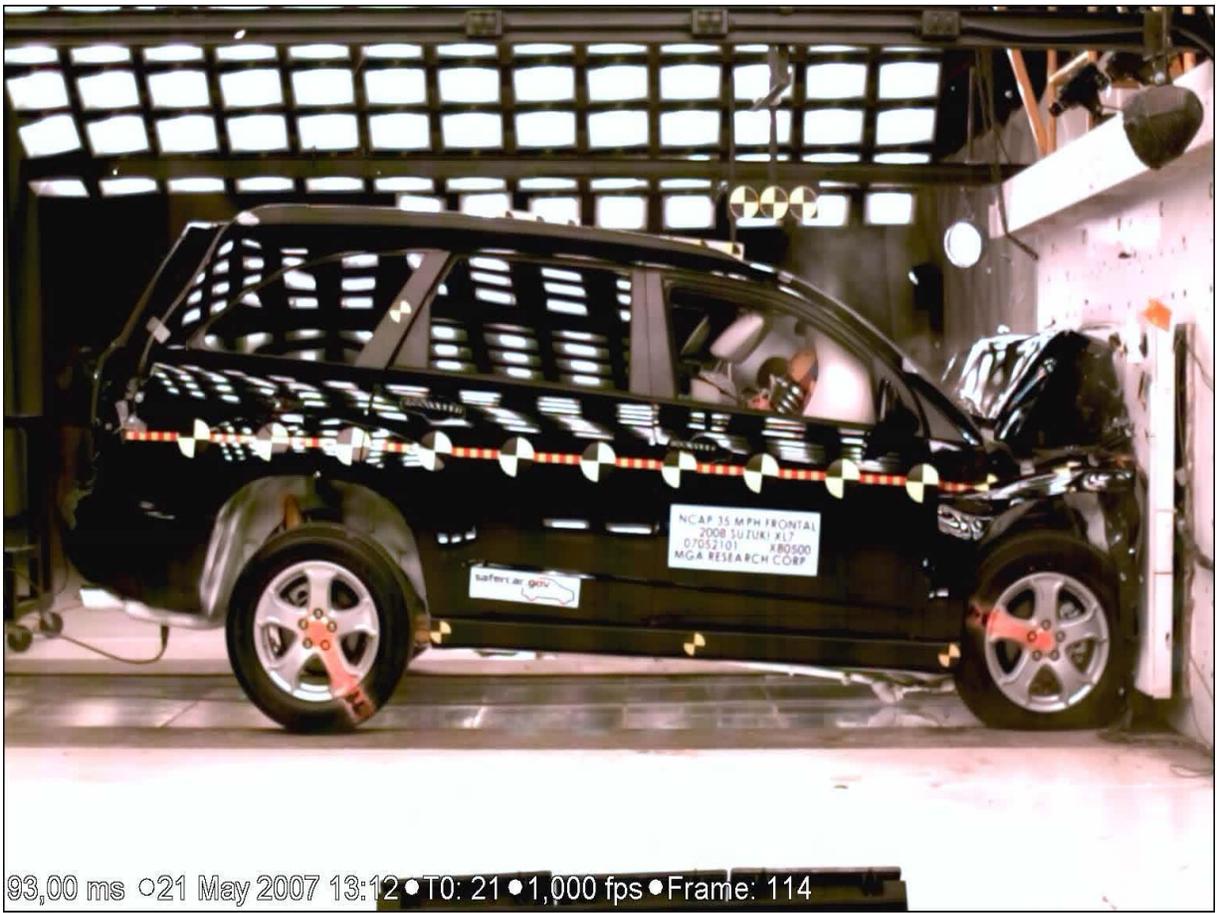
93,00 ms 21 May 2007 13:12 • T0: 21 • 1,000 fps • Frame: 114

Vehicle Impact
