**REPORT NUMBER TR-P28001-04-NC**

**NEW CAR ASSESSMENT PROGRAM  
FRONTAL BARRIER IMPACT TEST**

**TOYOTA MOTOR CORPORATION  
2008 LEXUS IS 250  
4-DOOR SEDAN**

**FINAL REPORT**

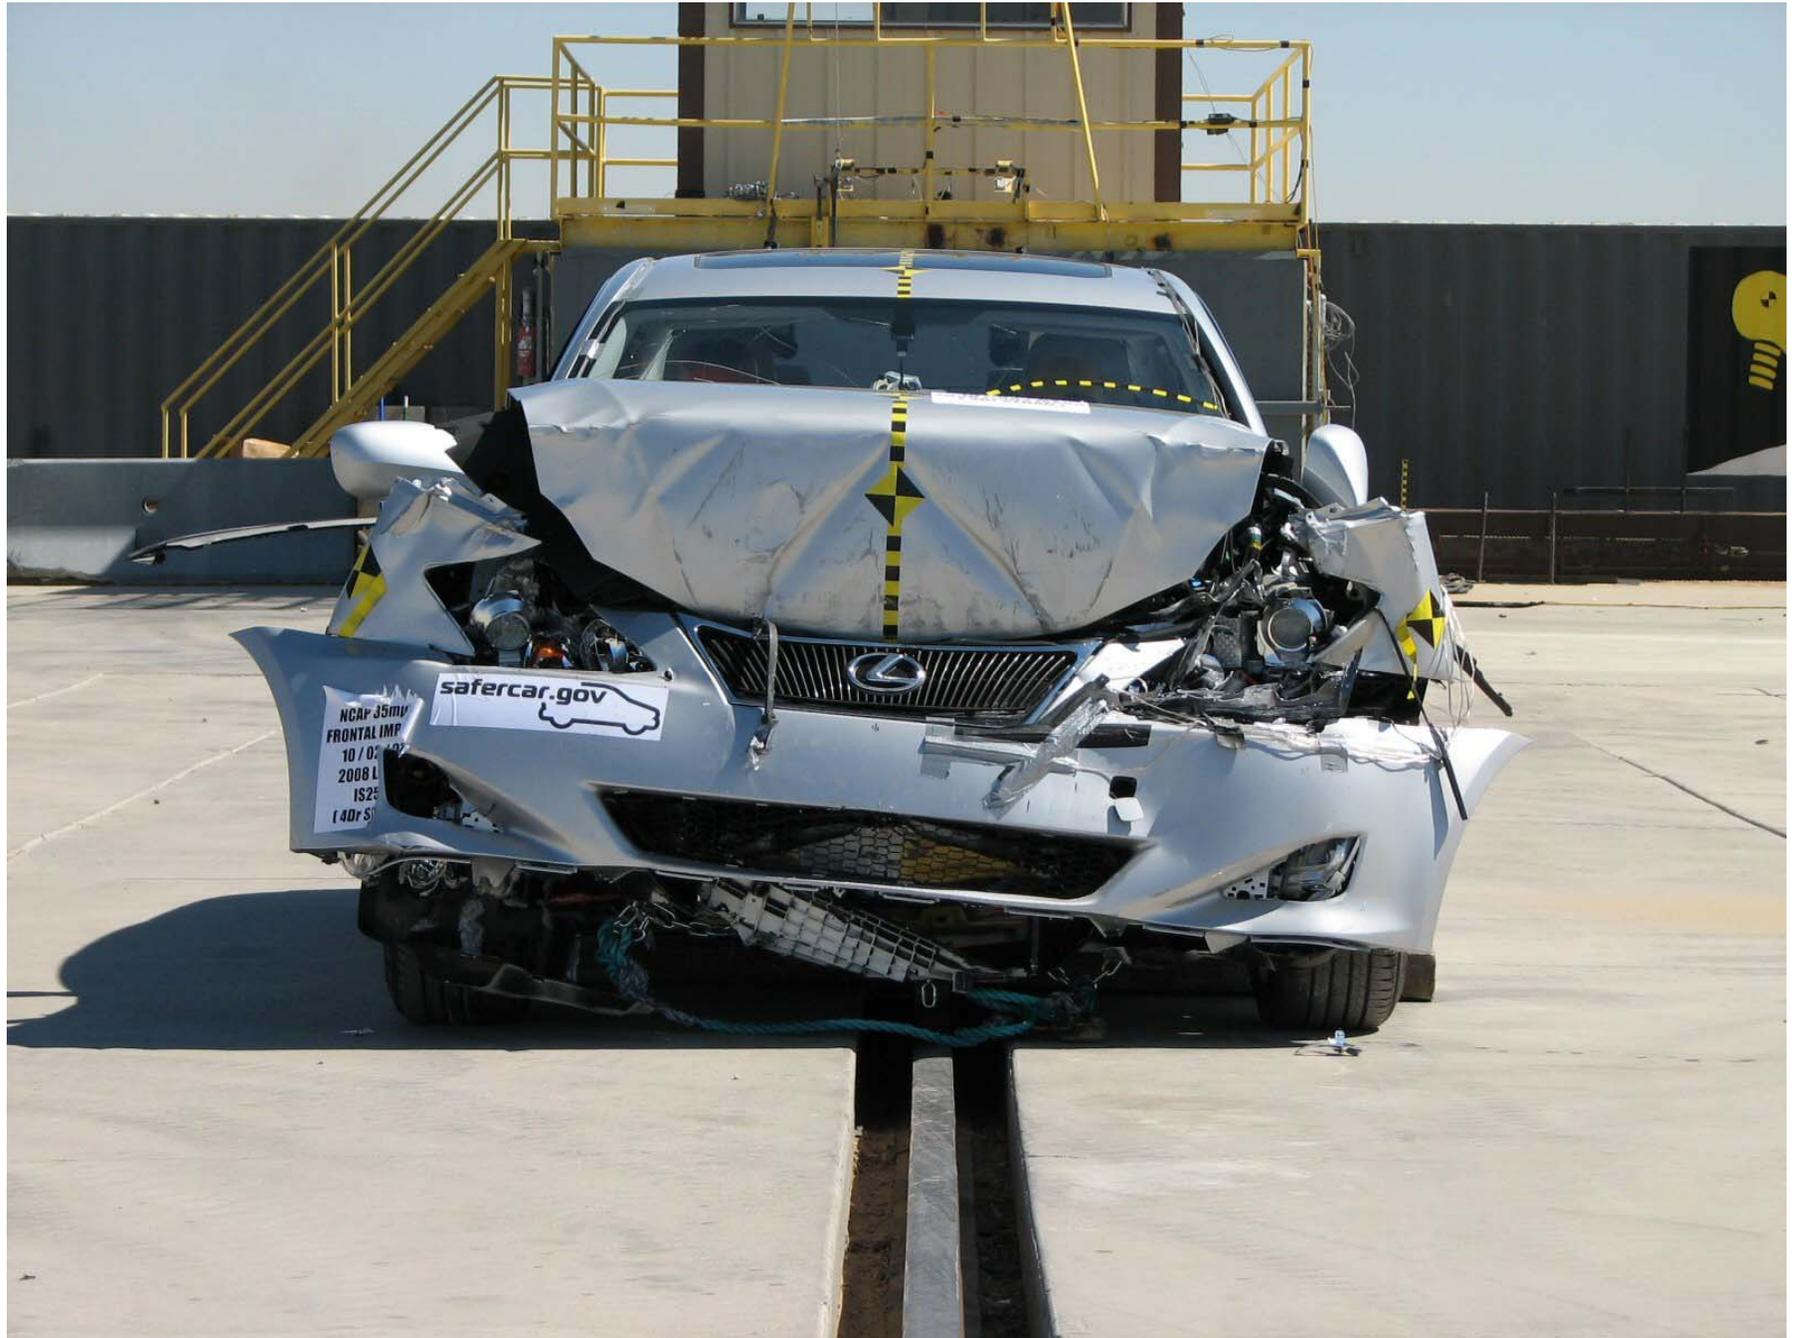
Figure A-7: Post-Test Front View (Vehicle Moved)

The maximum static crush of the vehicle was 473 mm at the vehicle's centerline. Both the driver and the passenger side doors remained closed and latched during the impact event, and were operable after the impact.

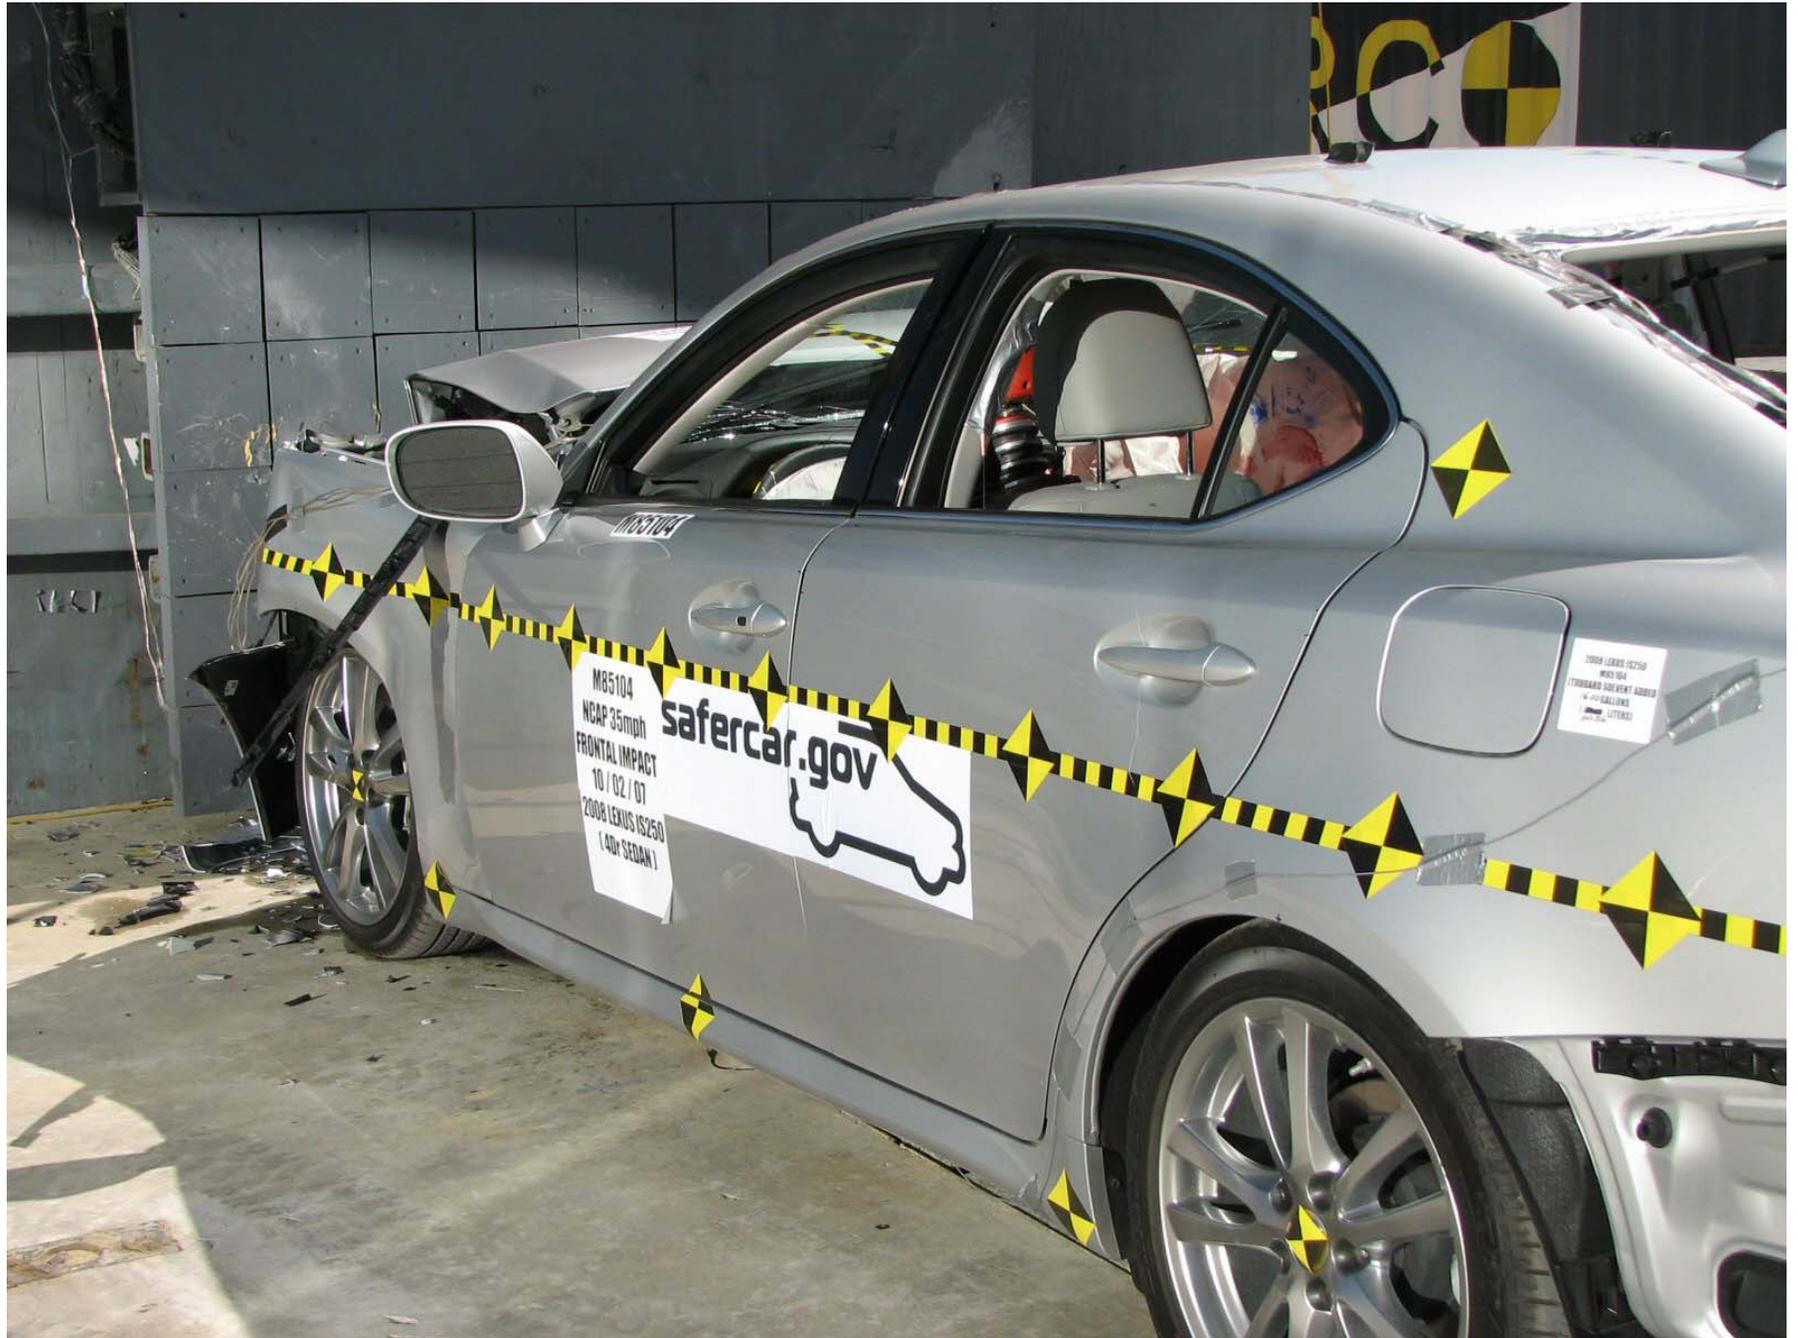
Figure A-16: Post-Test Left Side 3/4 View of Doors After Impact

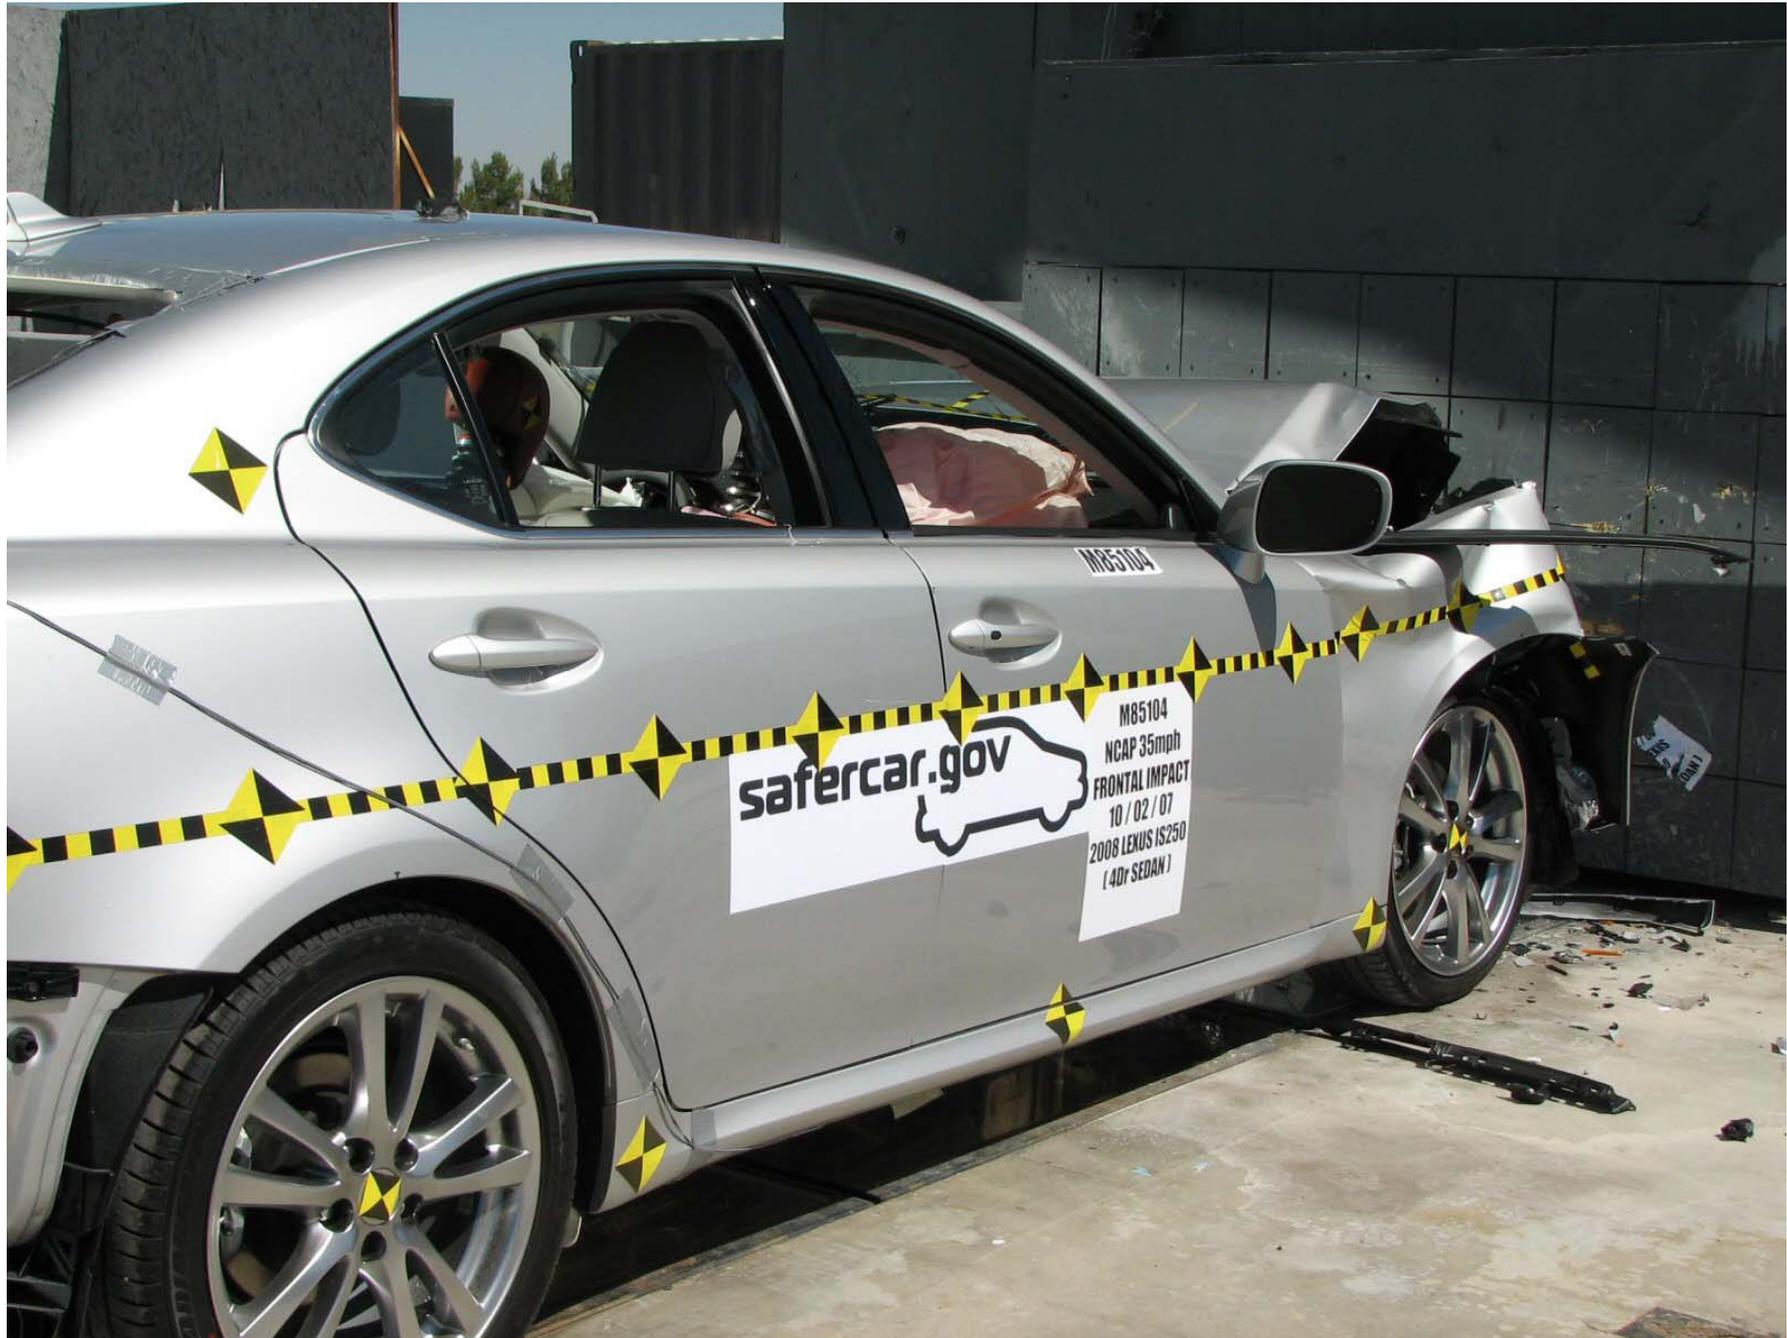
Figure A-17: Post-Test Right Side ¾ View of Doors After Impact

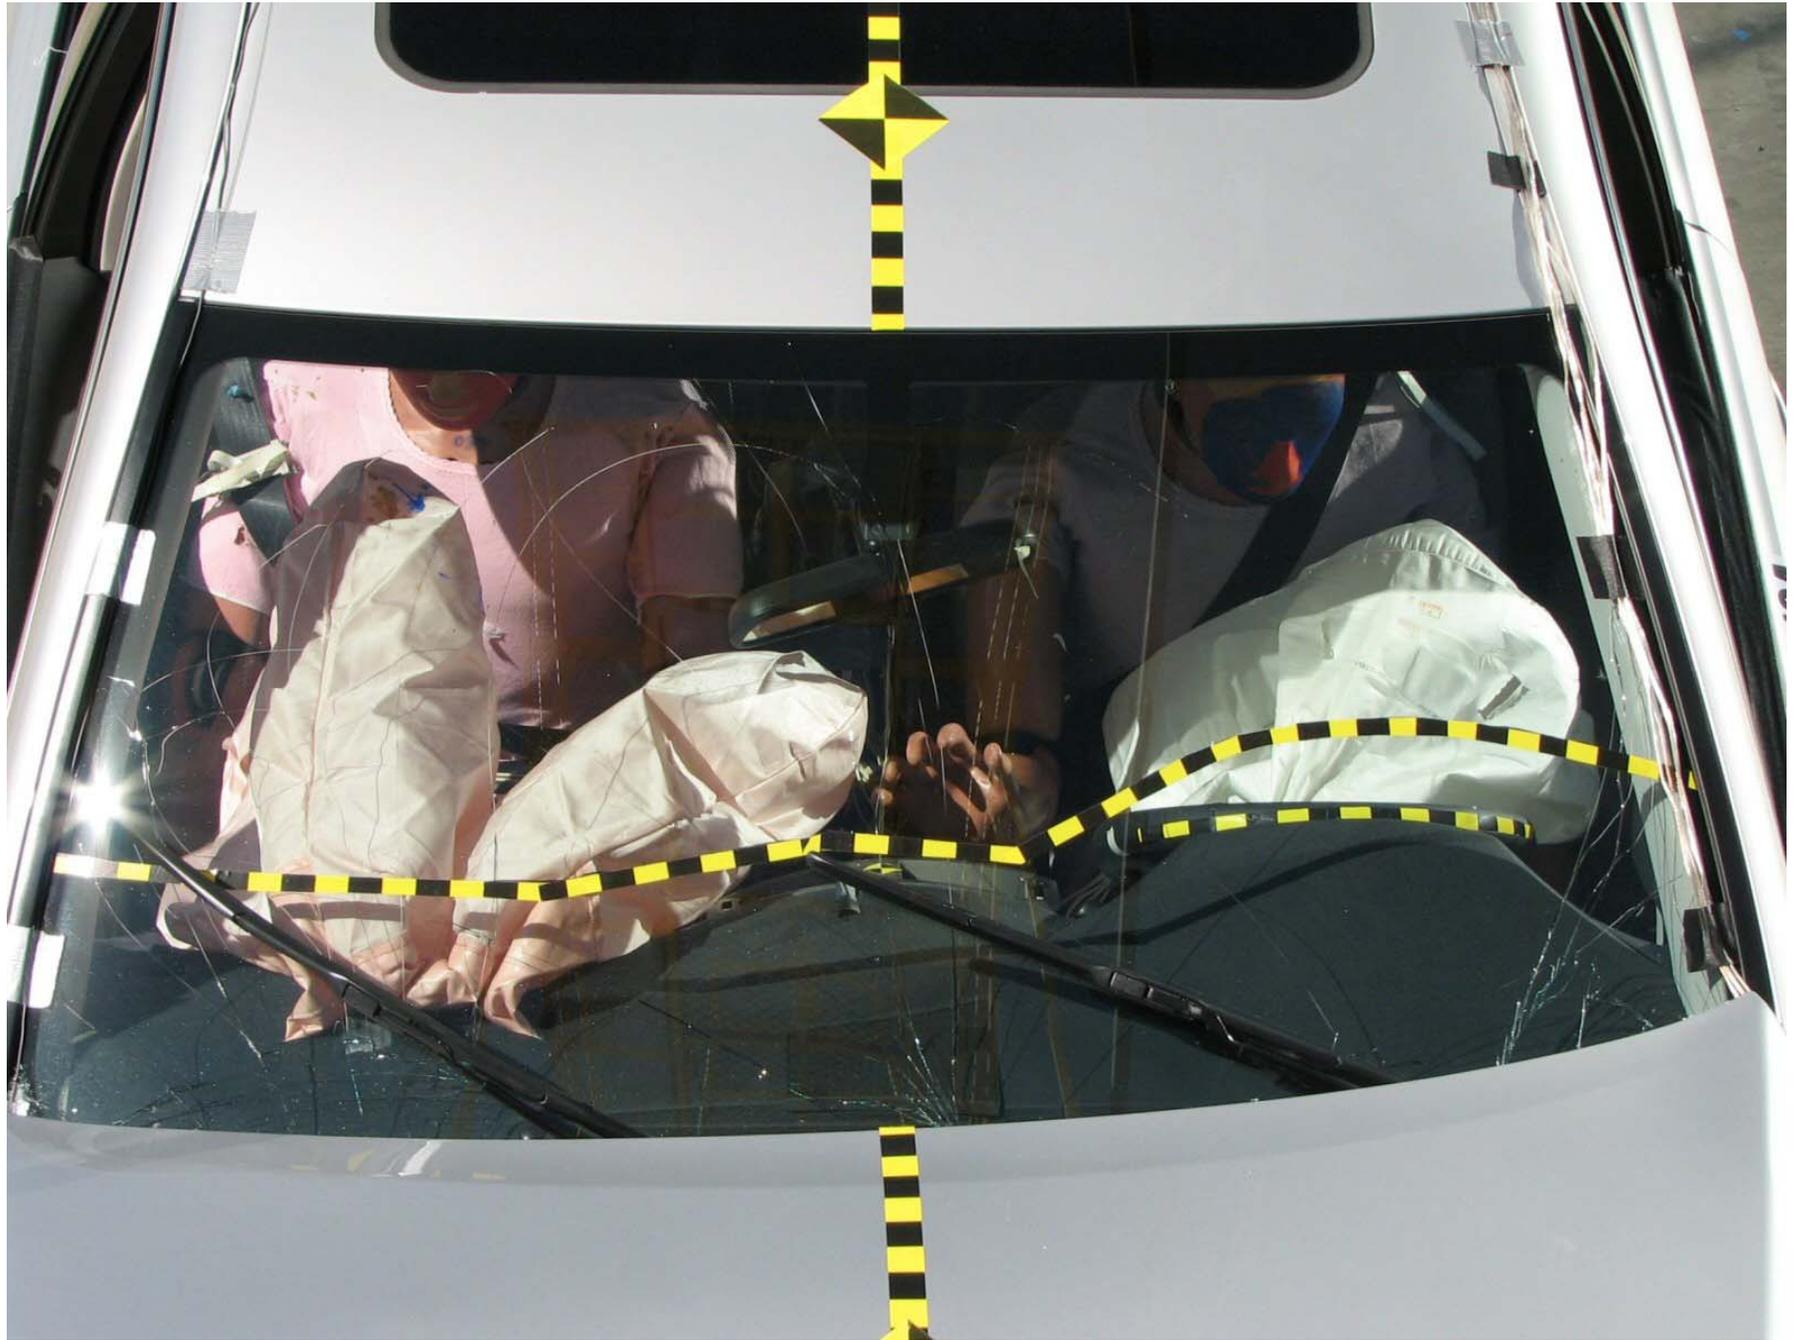
Figure A-19: Post-Test Windshield

There was 100 percent windshield retention and there was no intrusion into the protected zone of the windshield during the impact event. There was no stoddard solvent leakage after the event or during any phase of the static rollover.

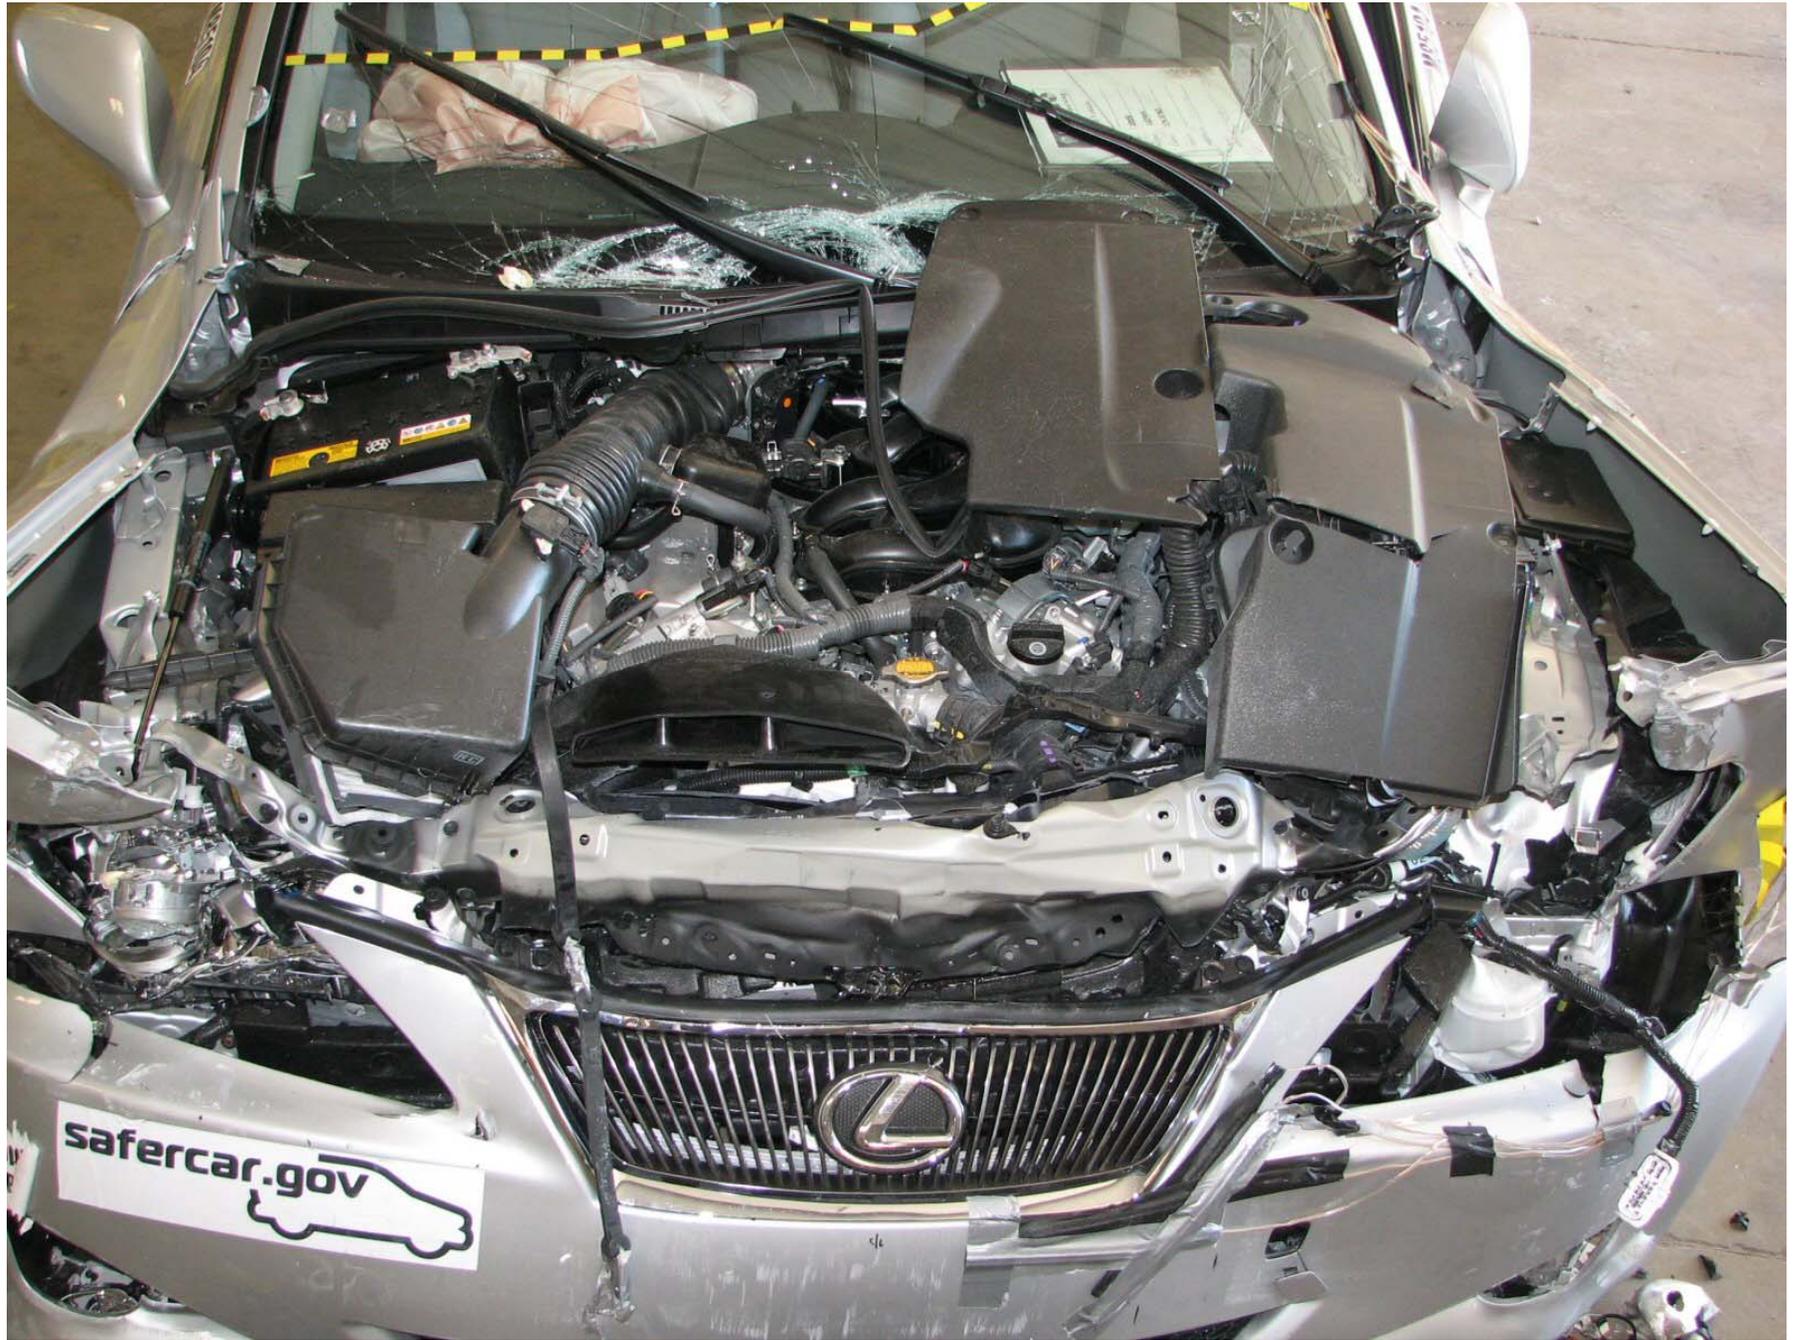
Figure A-21: Post-Test Engine Compartment (Vehicle Moved)

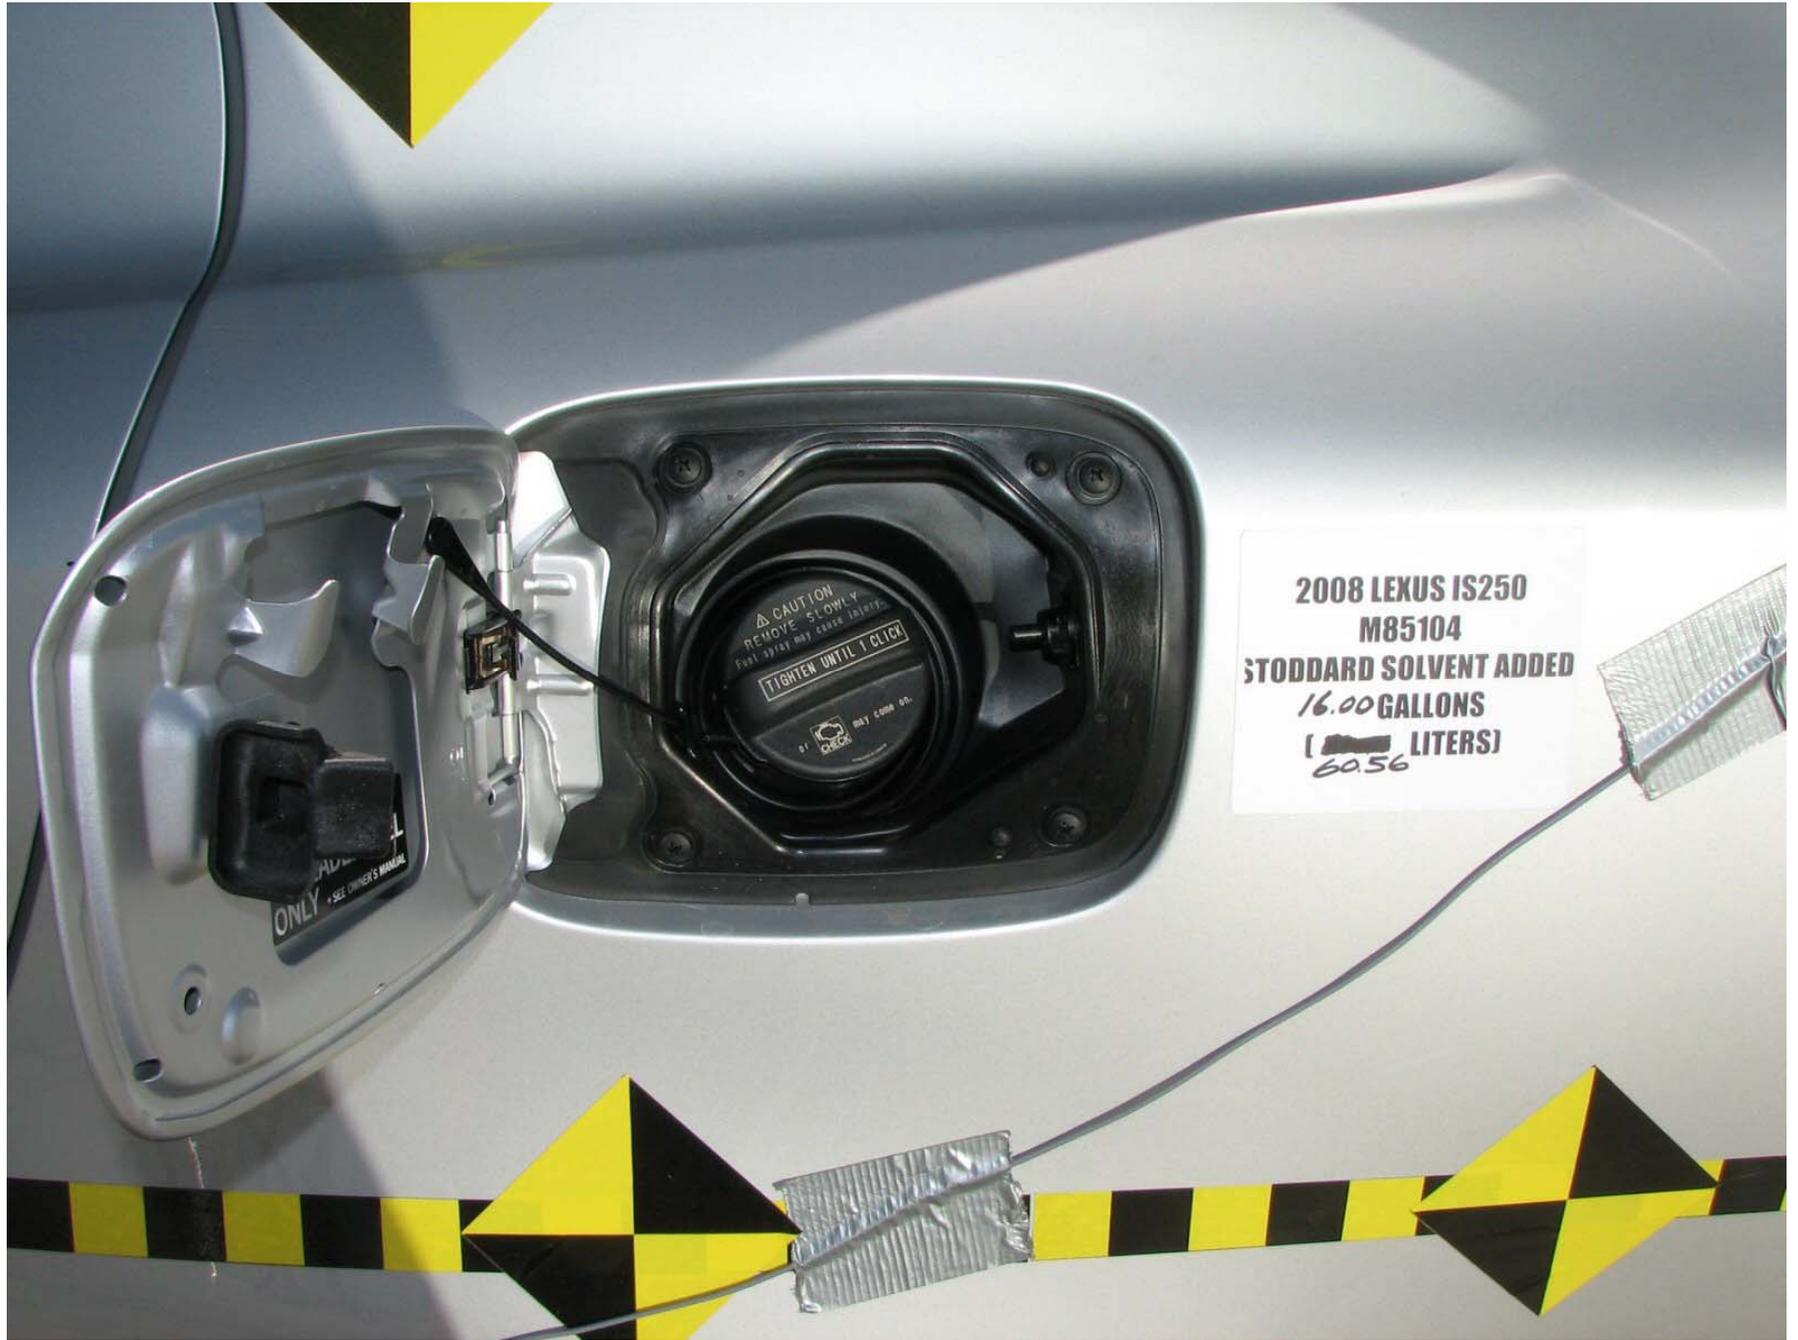
Figure A-22: Pre-Test Fuel Cap

2008 LEXUS IS250  
M85104  
STODDARD SOLVENT ADDED  
16.00 GALLONS  
(60.56 LITERS)

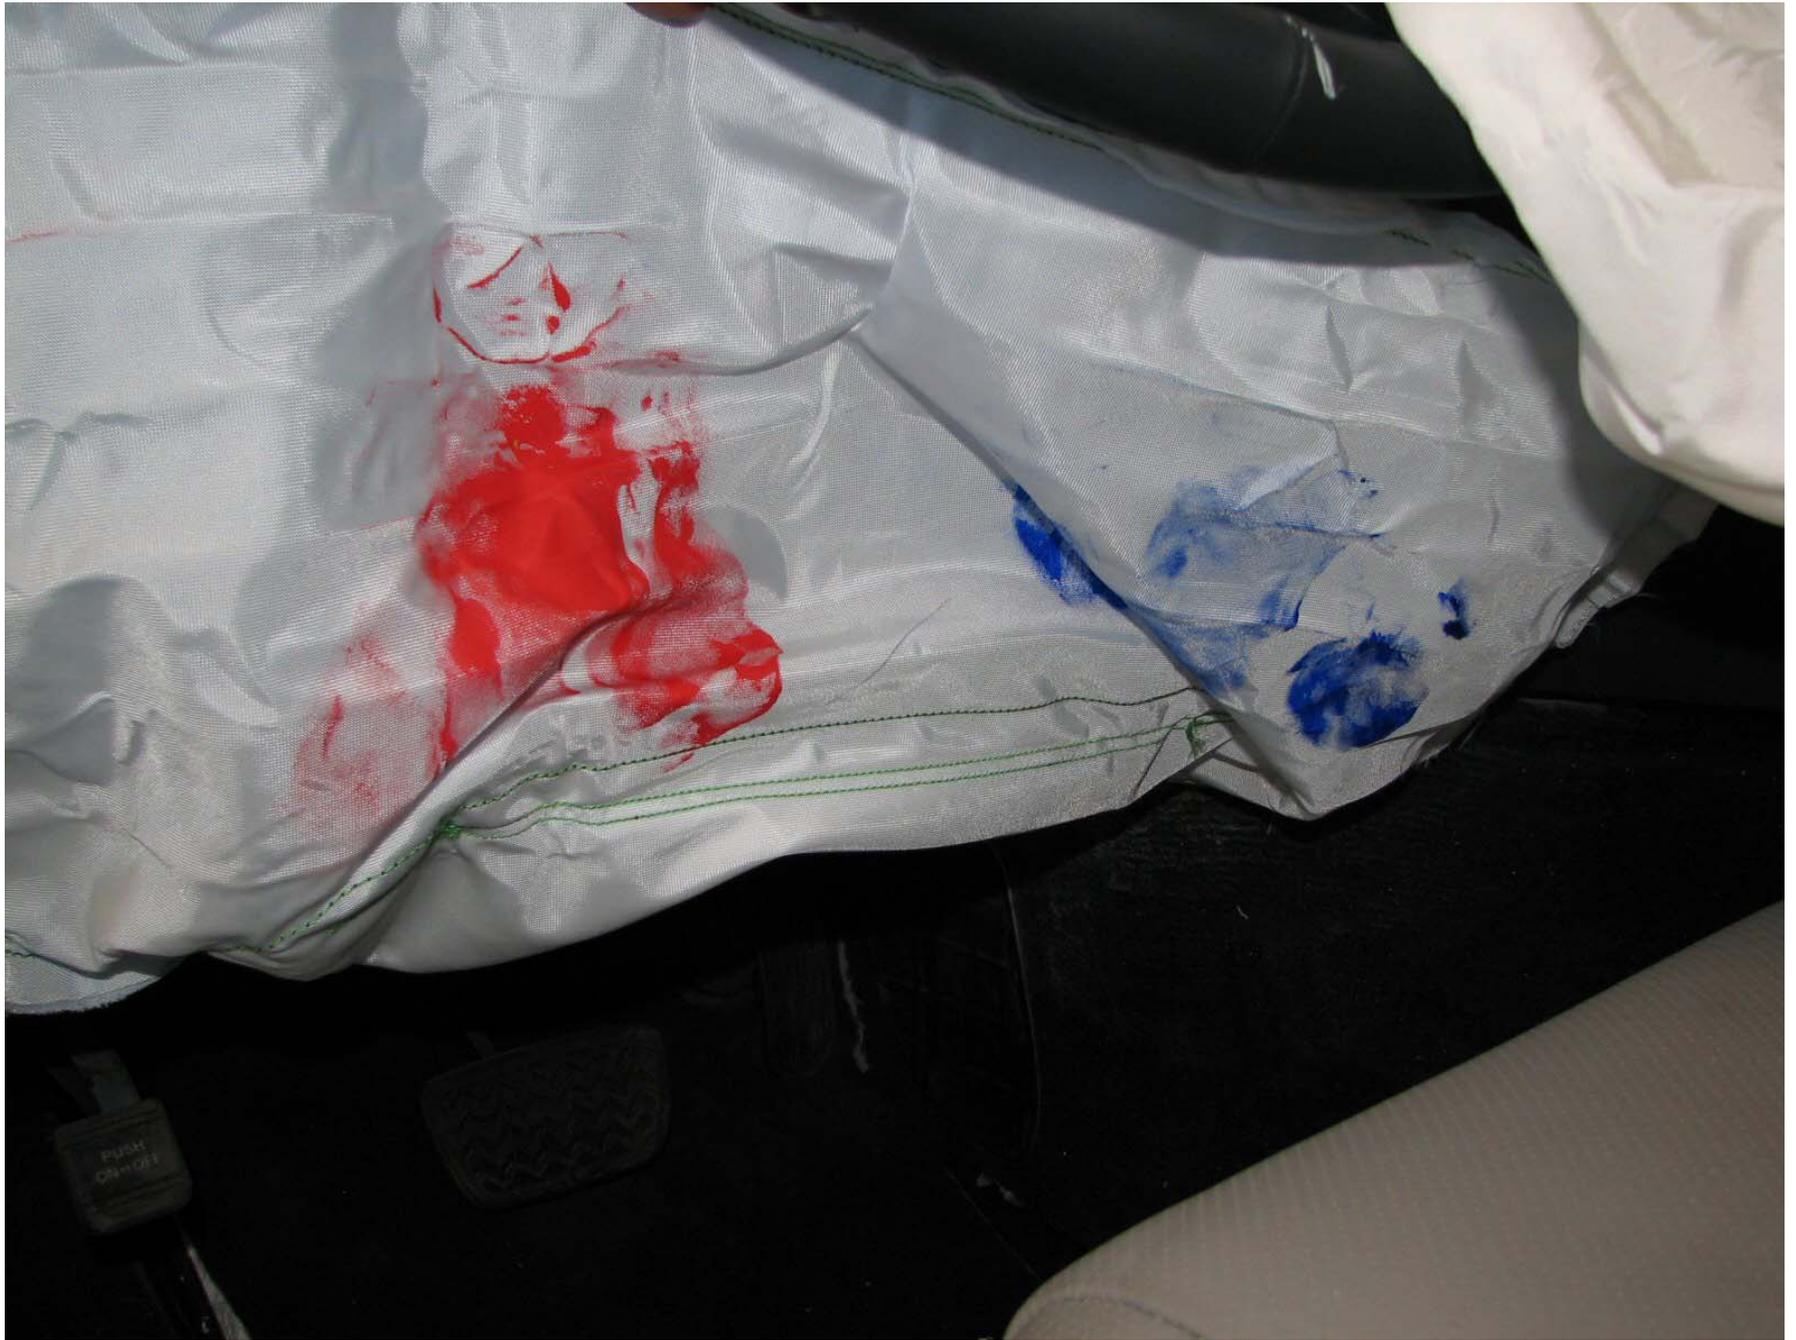
Figure A-39: Post-Test Driver Side Knee Bolster

The driver's visible contact points were as follows: The driver ATD's head and chest contacted the airbag. The head also contacted the headrest. The abdomen had no contact. Both the left and right knees contacted the knee airbag.

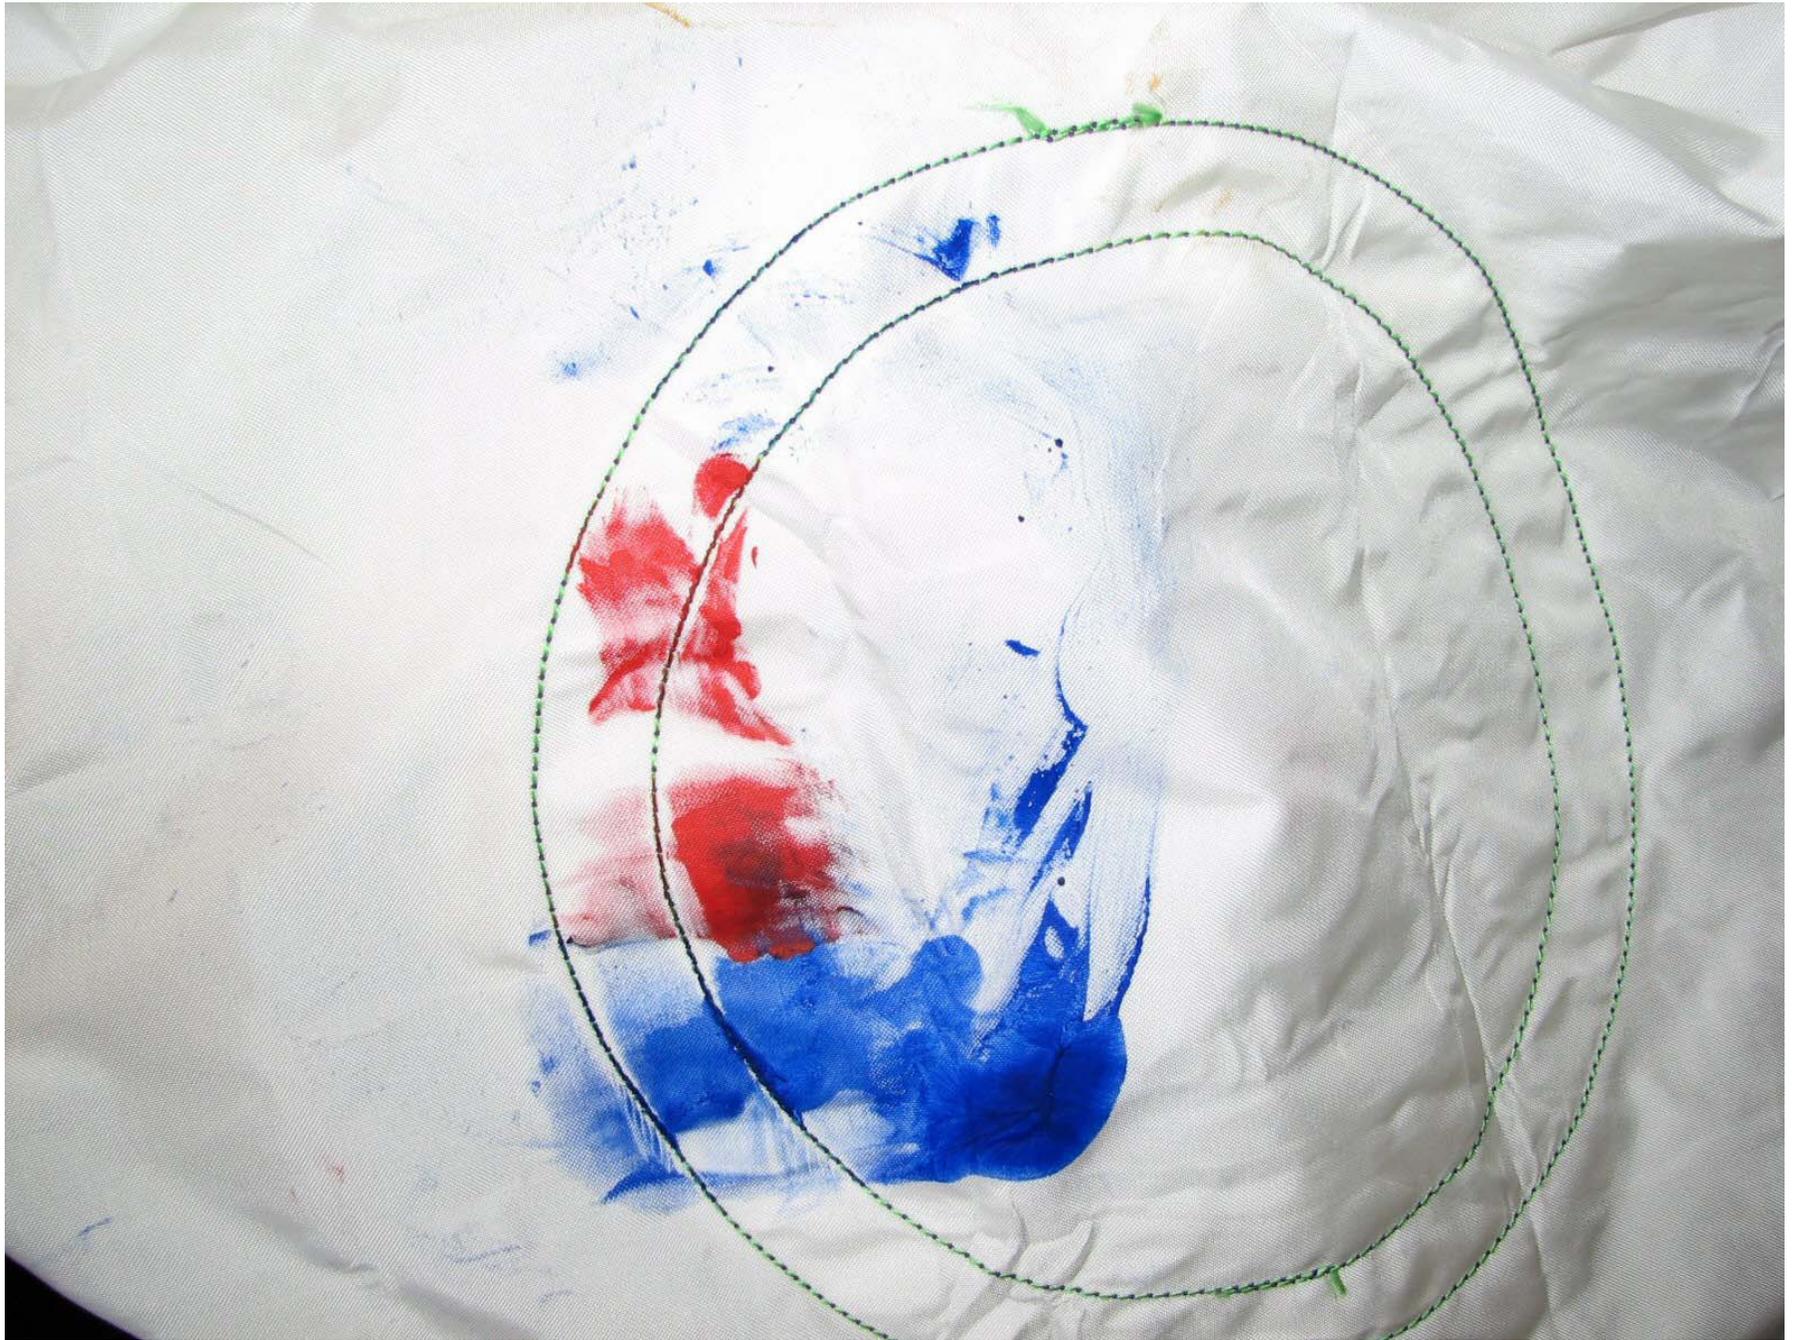
Figure A-43: Post-Test Driver Dummy Airbag Contact

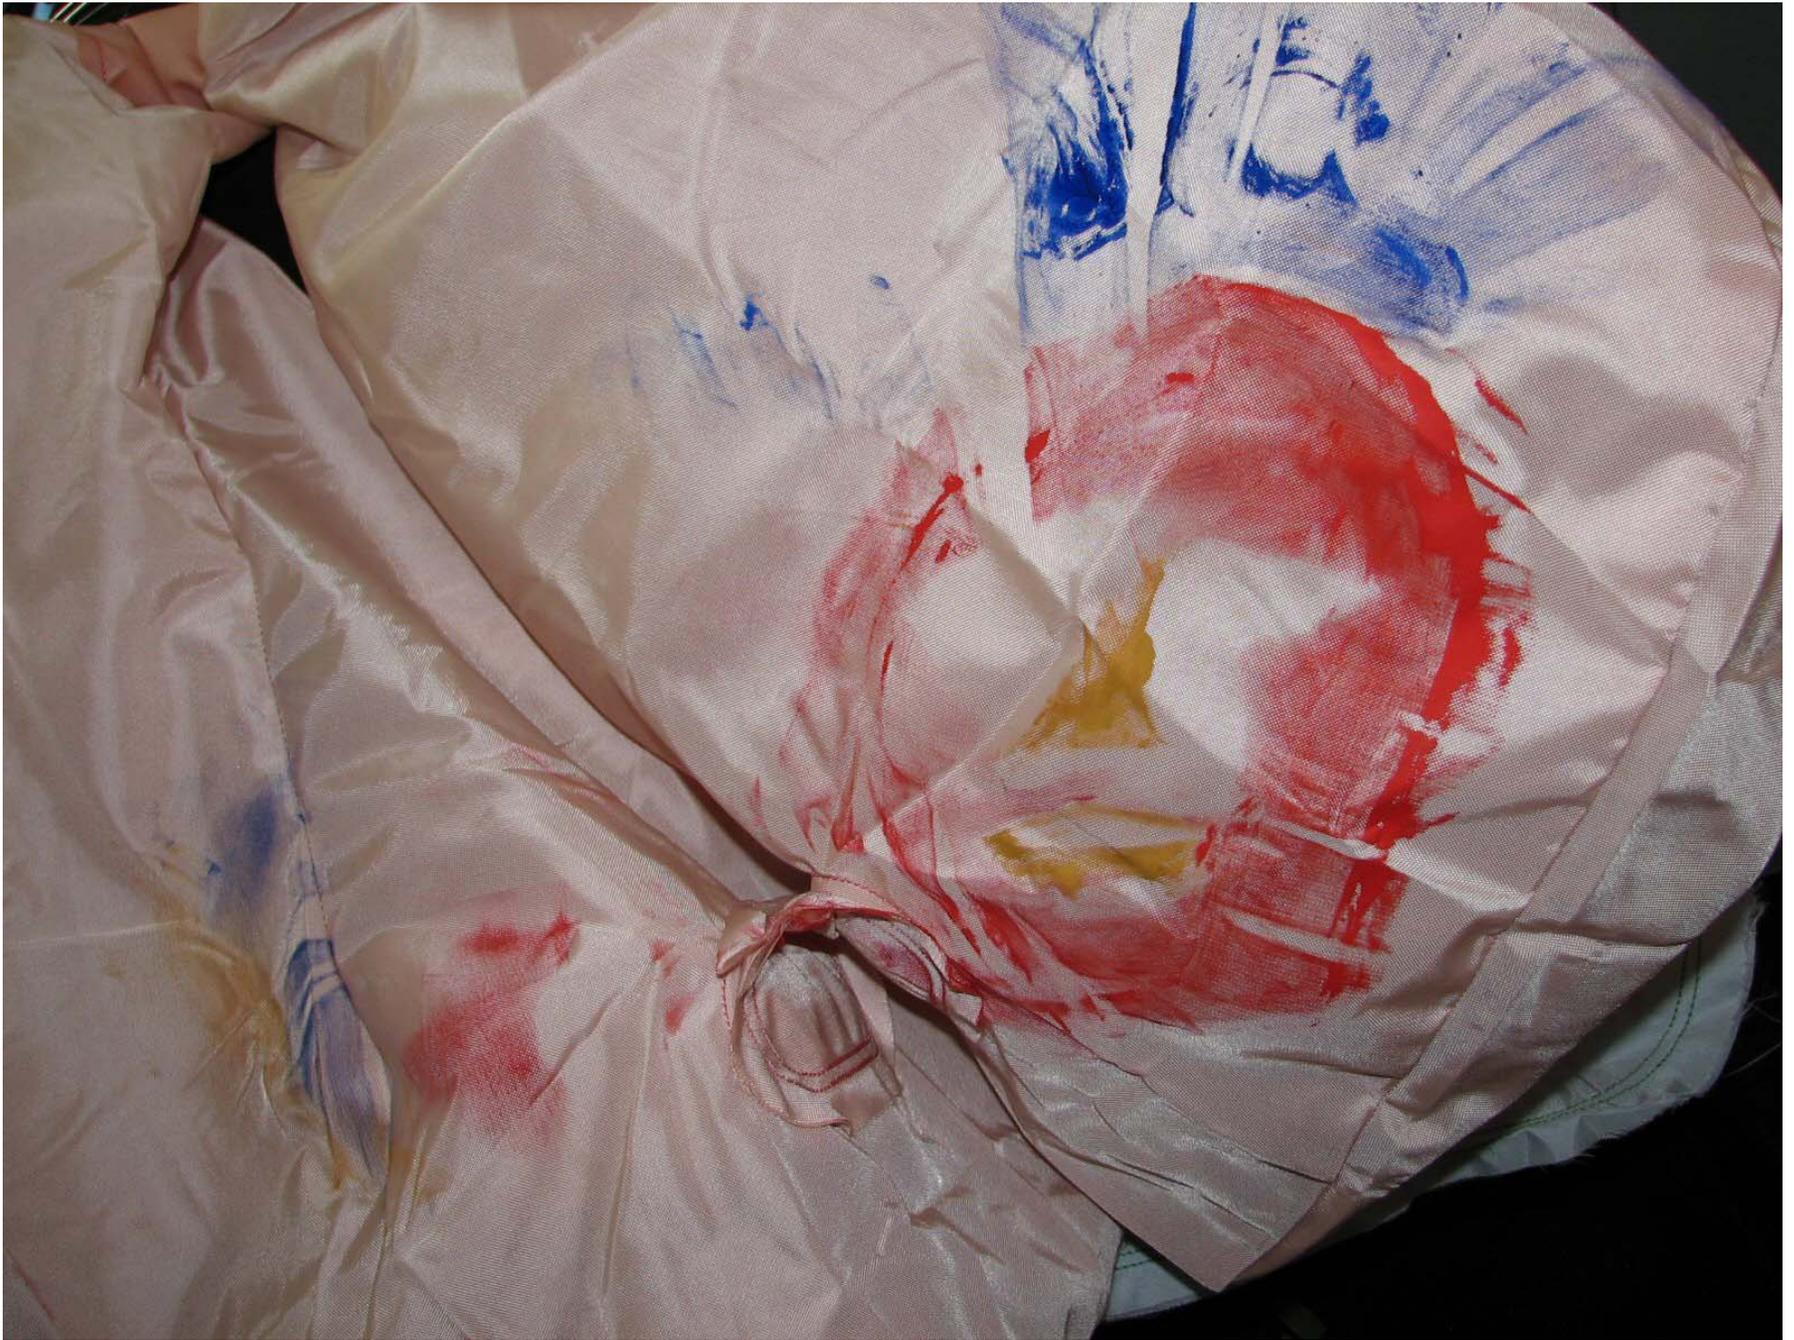
Figure A-57: Post-Test Passenger Dummy Airbag Contact

The passenger's visible contact points were as follows: The passenger ATD's head and chest contacted the airbag. The abdomen had no contact. Both knees contacted the knee airbag.
