**REPORT NUMBER TR-P28001-04-NC**

**NEW CAR ASSESSMENT PROGRAM  
FRONTAL BARRIER IMPACT TEST**

**TOYOTA MOTOR CORPORATION  
2008 LEXUS IS 250  
4-DOOR SEDAN**

**FINAL REPORT**

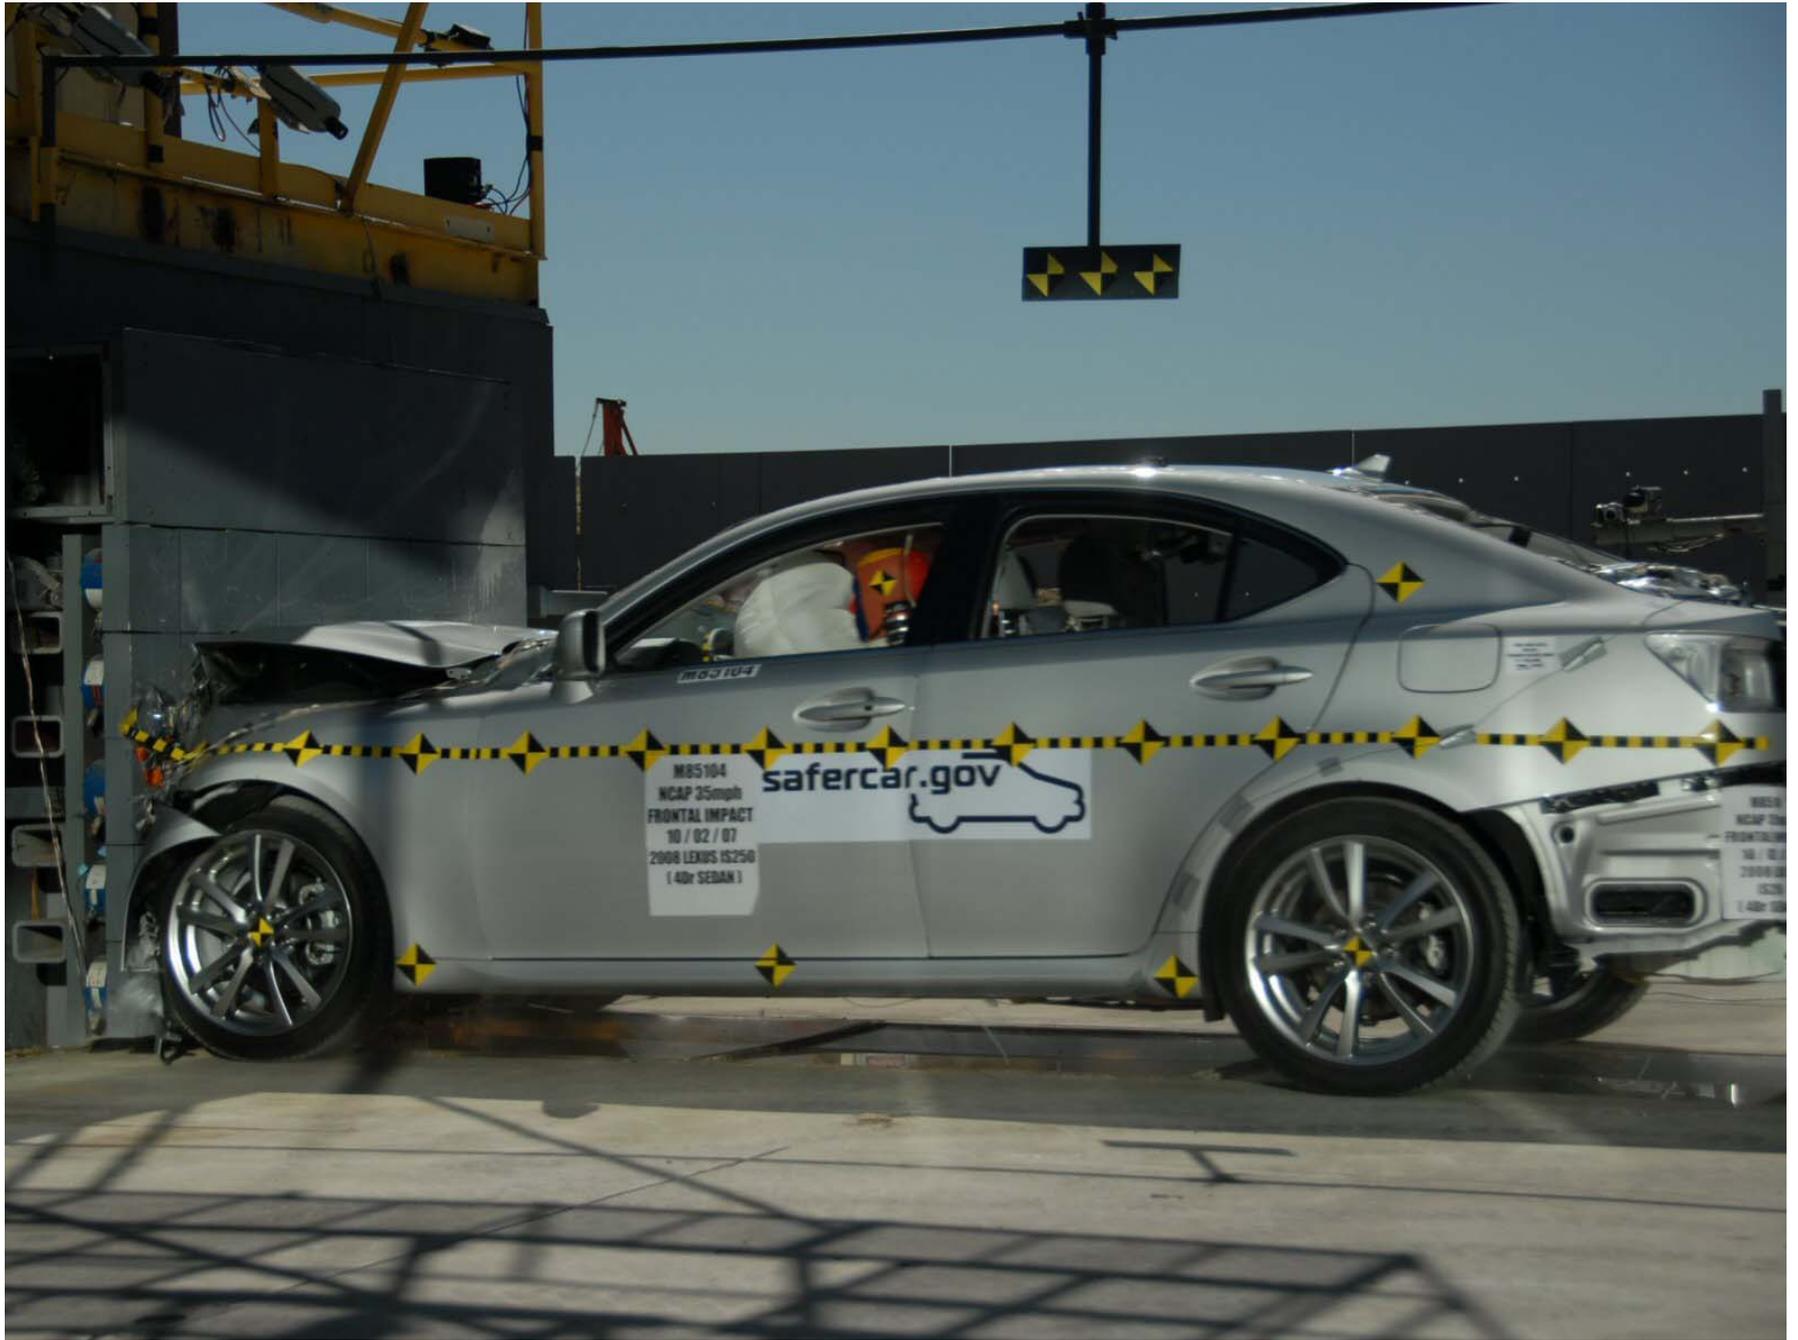
Figure A-62: Vehicle Impact

A load cell barrier consisting of 36 load cells was impacted by a 2008 Lexus IS 250 4-Door Sedan at a velocity of 56.29 km/h. The test was performed at Karco Engineering, LLC on October 2, 2007.

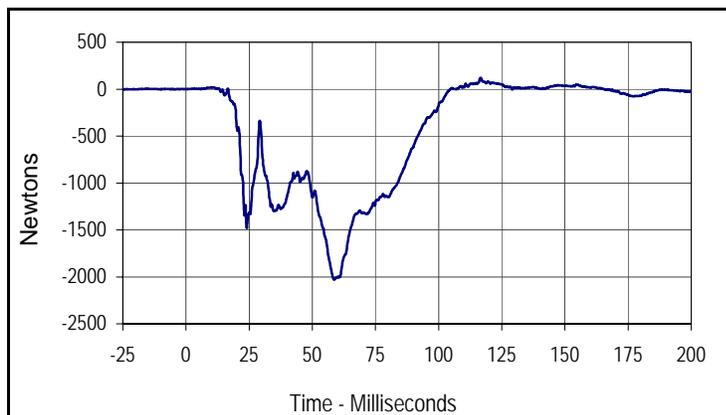
Curve Description			
Driver Left Femur Force Z			
CURNO	Type	SAE Class	Units
007	FIL	600	Newtons
Max	Time	Min	Time
122.0	116.6	-2030.3	58.6

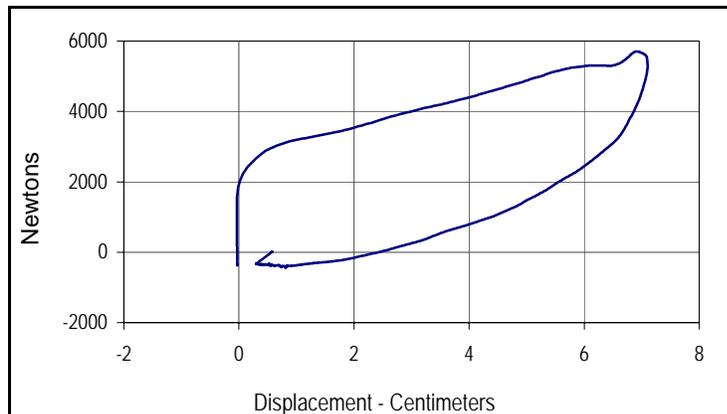
Curve Description			
Probe Force vs. Chest Deflection			
CURNO	Type	SAE Class	Hysteresis
001	FIL	180	75.7
Peak Probe Force		Peak Chest Deflection	
5704		7.10

Tested Parameter	Units	Specification	Result	Pass/Fail
Laboratory Temperature	°C	20.6 to 22.2	21.1	Pass
Laboratory Relative Humidity	%	10 to 70	30	Pass
Probe Velocity	m/s	6.58 to 6.82	6.66	Pass
Peak Probe Force	Newtons	5159 to 5893	5704	Pass
Peak Sternum Deflection	CM	6.35 to 7.26	7.10	Pass
Internal Hysteresis	%	69 to 85	75.7	Pass
Overall Test Results				Pass

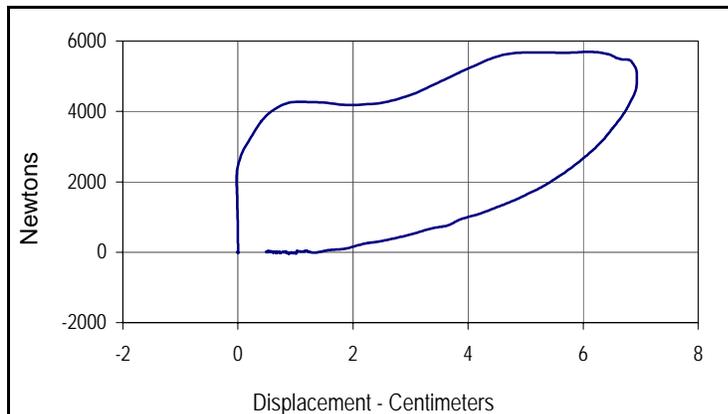
Curve Description			
Probe Force vs. Chest Deflection			
CURNO	Type	SAE Class	Hysteresis
001	FIL	180	76.8
Peak Probe Force		Peak Chest Deflection	
5694		6.93

Tested Parameter	Units	Specification	Result	Pass/Fail
Laboratory Temperature	°C	20.6 to 22.2	21.1	Pass
Laboratory Relative Humidity	%	10 to 70	30	Pass
Probe Velocity	m/s	6.58 to 6.82	6.63	Pass
Peak Probe Force	Newtons	5159 to 5893	5694	Pass
Peak Sternum Deflection	CM	6.35 to 7.26	6.93	Pass
Internal Hysteresis	%	69 to 85	76.8	Pass
Overall Test Results				Pass
