**REPORT NUMBER TR-P28001-07-NC**

**NEW CAR ASSESSMENT PROGRAM  
FRONTAL BARRIER IMPACT TEST**

**SUZUKI MOTOR CORPORATION JAPAN  
2008 SUZUKI SX4  
4-DOOR**

**NHTSA NUMBER: M80512**

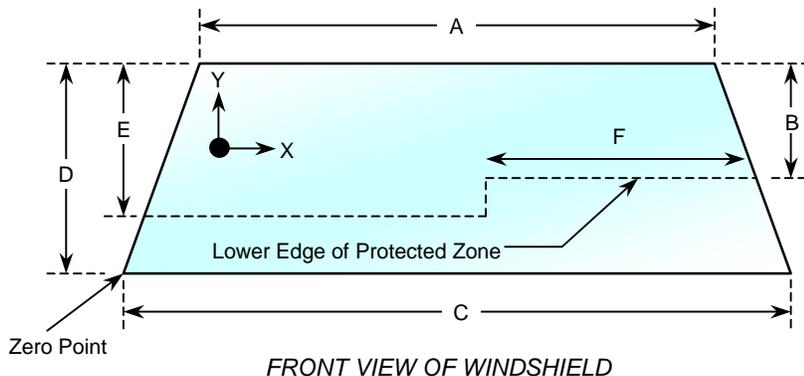
WINDSHIELD AND PROTECTED ZONE

Item	Units	Value
A	mm	1095
B	mm	575
C	mm	1405
D	mm	930
E	mm	580
F	mm	880

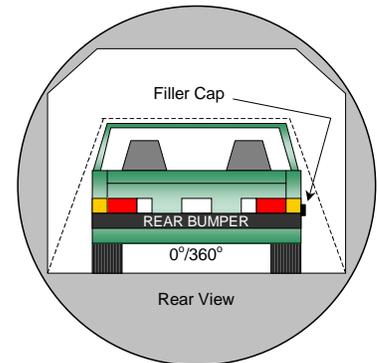
270° to 360°

1. The specified fixture rollover rate for each 90° of rotation is 60 to 120 seconds.
2. The position hold time at each position is 300 seconds (minimum).
3. No solvent leakage occurred during rollover.

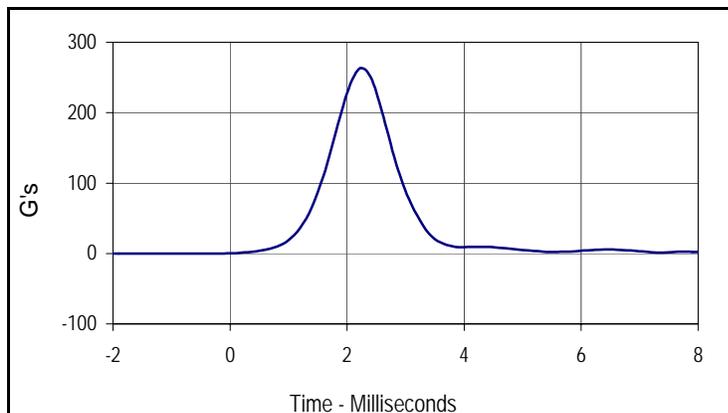
Curve Description			
Head Resultant			
CURNO	Type	SAE Class	Units
001	RES	1000	G's
Max	Time	Min	Time
262.3	2.3	0.0	-0.1

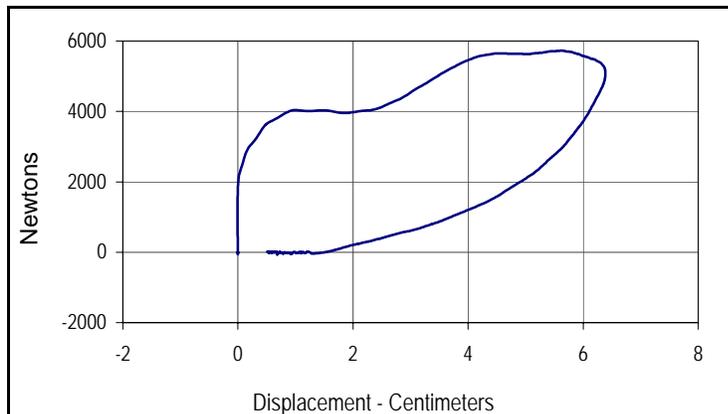
Curve Description			
Probe Force vs. Chest Deflection			
CURNO	Type	SAE Class	Hysteresis
001	FIL	180	75.4
Peak Probe Force		Peak Chest Deflection	
5725		6.39

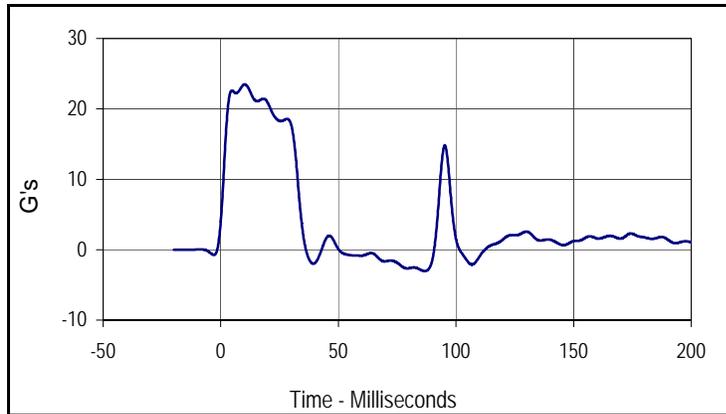
Curve Description			
Pendulum Deceleration			
CURNO	Type	SAE Class	Units
001	FIL	60	G's
Max	Time	Min	Time
23.5	10.1	-3.0	86.7

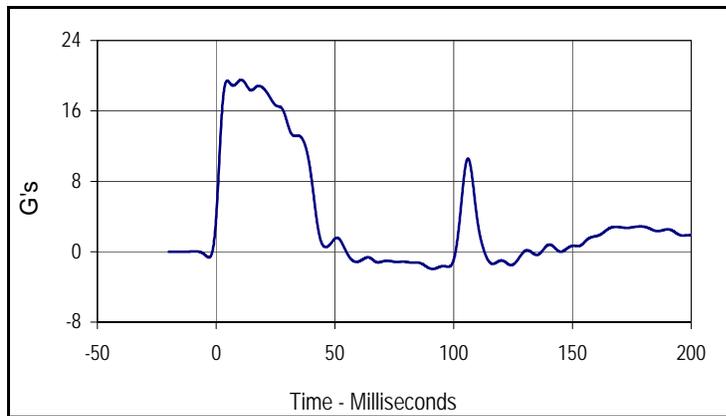
Curve Description			
Pendulum Deceleration			
CURNO	Type	SAE Class	Units
001	FIL	60	G's
Max	Time	Min	Time
19.5	10.5	-2.0	91.2

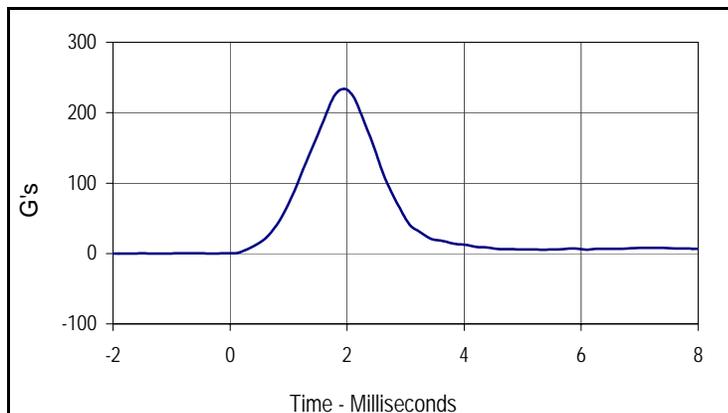
Curve Description			
Head Resultant			
CURNO	Type	SAE Class	Units
001	RES	1000	G's
Max	Time	Min	Time
233.1	1.9	0.0	-1.3

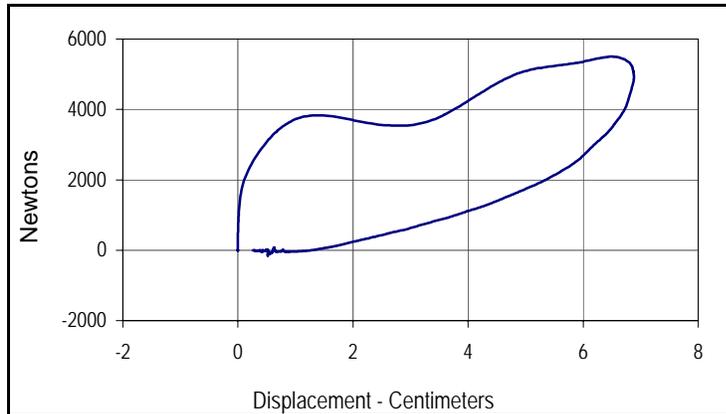
Curve Description			
Probe Force vs. Chest Deflection			
CURNO	Type	SAE Class	Hysteresis
001	FIL	180	72.2
Peak Probe Force		Peak Chest Deflection	
5500		6.88

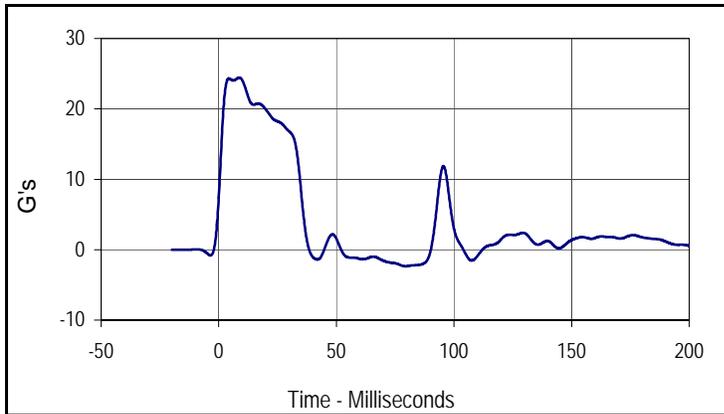
Curve Description			
Pendulum Deceleration			
CURNO	Type	SAE Class	Units
001	FIL	60	G's
Max	Time	Min	Time
24.4	8.7	-2.4	79.4

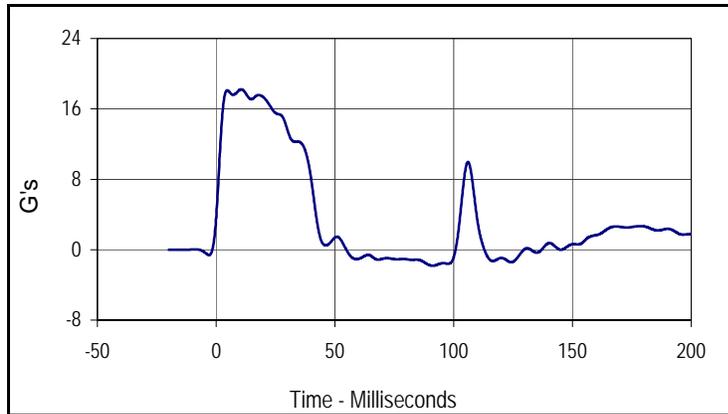
Curve Description			
Pendulum Deceleration			
CURNO	Type	SAE Class	Units
001	FIL	60	G's
Max	Time	Min	Time
18.2	10.5	-1.8	91.2
