REPORT NUMBER TR-P28001-11-NC

**NEW CAR ASSESSMENT PROGRAM
FRONTAL BARRIER IMPACT TEST**

**HONDA OF AMERICA MFG., INC
2008 HONDA ACCORD
2-DOOR COUPE**

NHTSA NUMBER: M85300

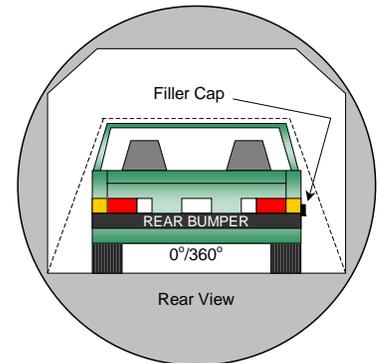
270° to 360°

1. The specified fixture rollover rate for each 90° of rotation is 60 to 120 seconds.
2. The position hold time at each position is 300 seconds (minimum).
3. No solvent leakage occurred during rollover.

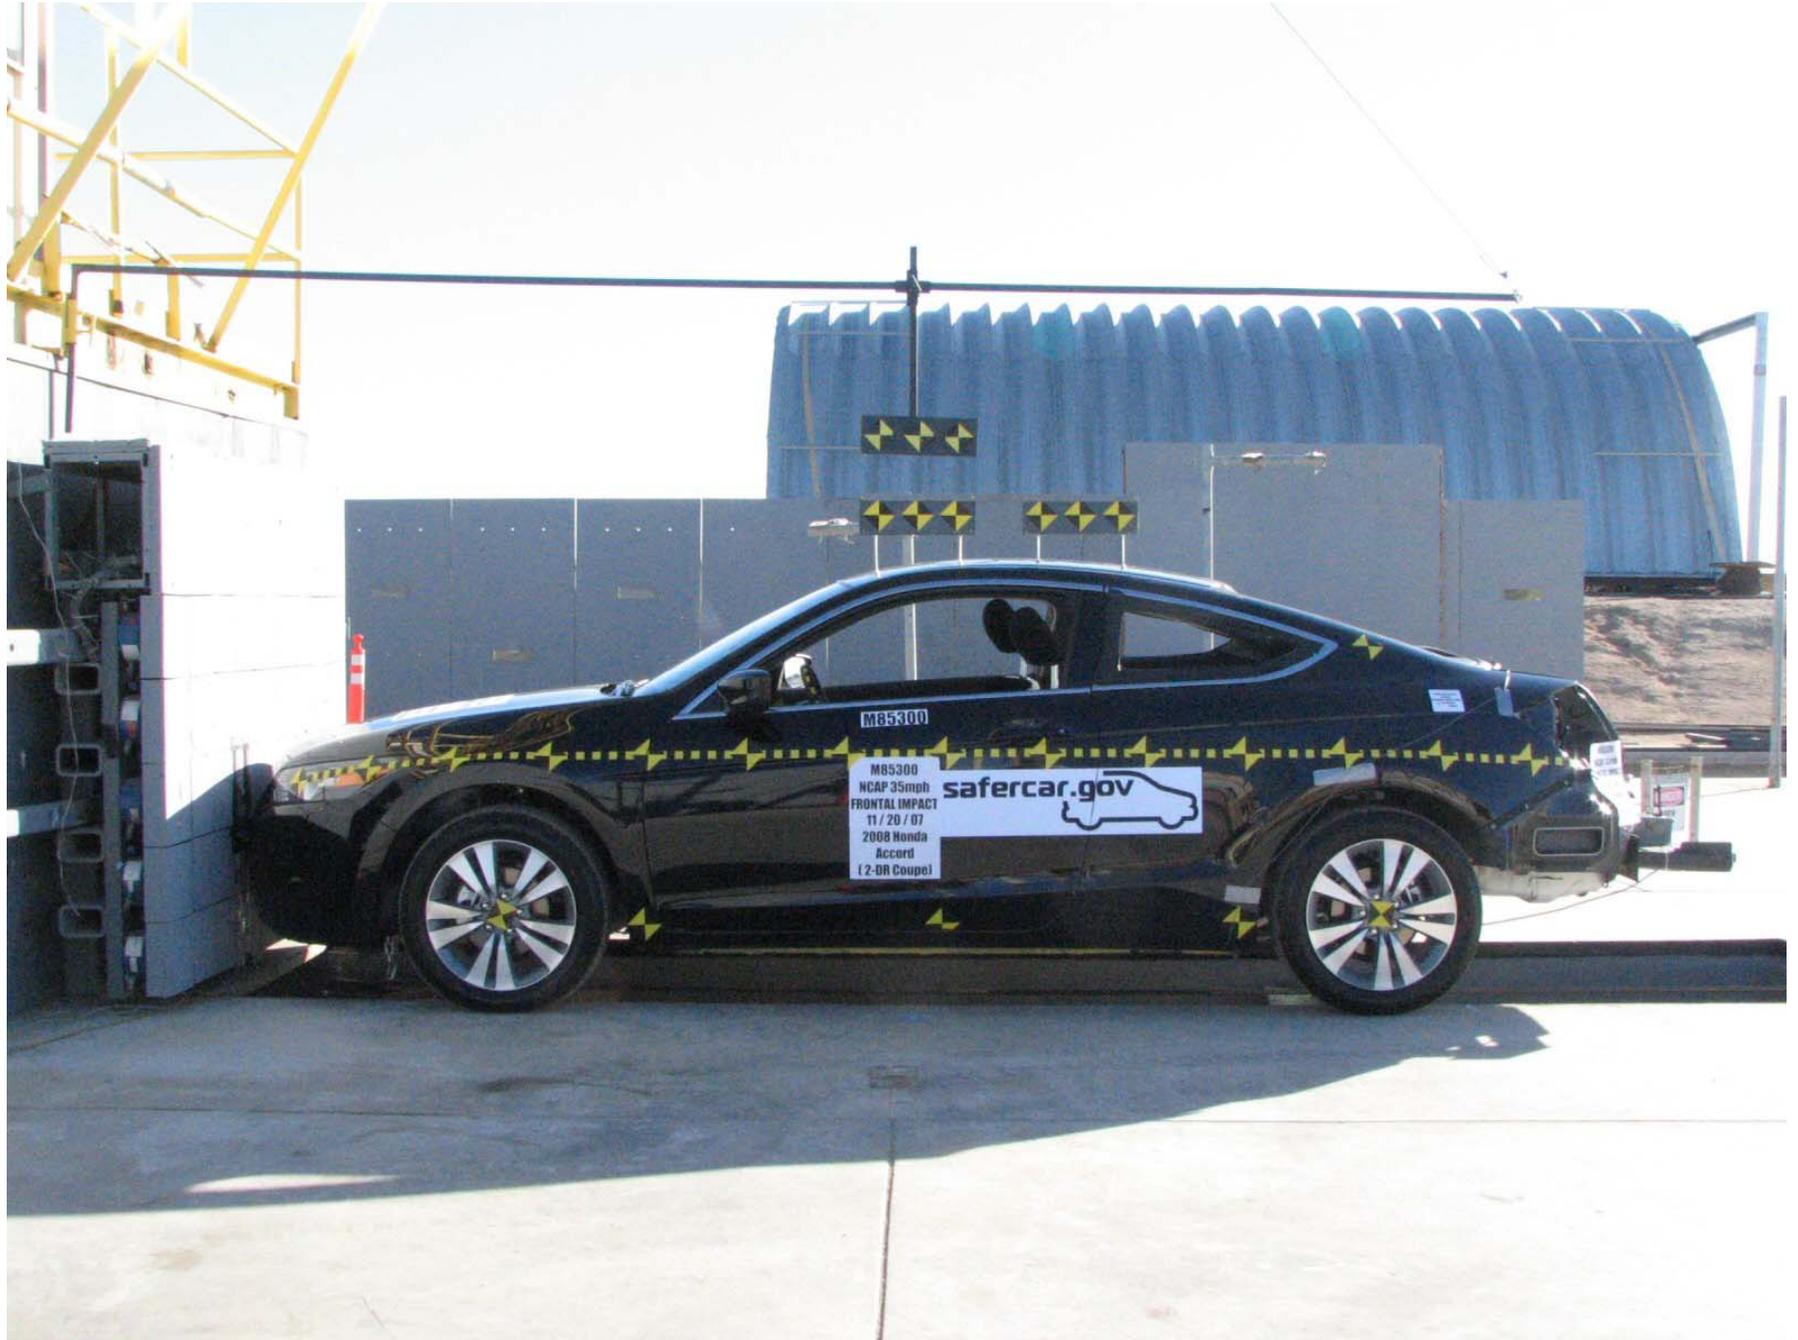
Figure A-7: Post-Test Front View (Vehicle Moved)

The maximum static crush of the vehicle was 596 mm to the right of the vehicle's centerline at DPD 4. Both the driver and the passenger side doors remained closed and latched during the impact event, and were operable after the impact.

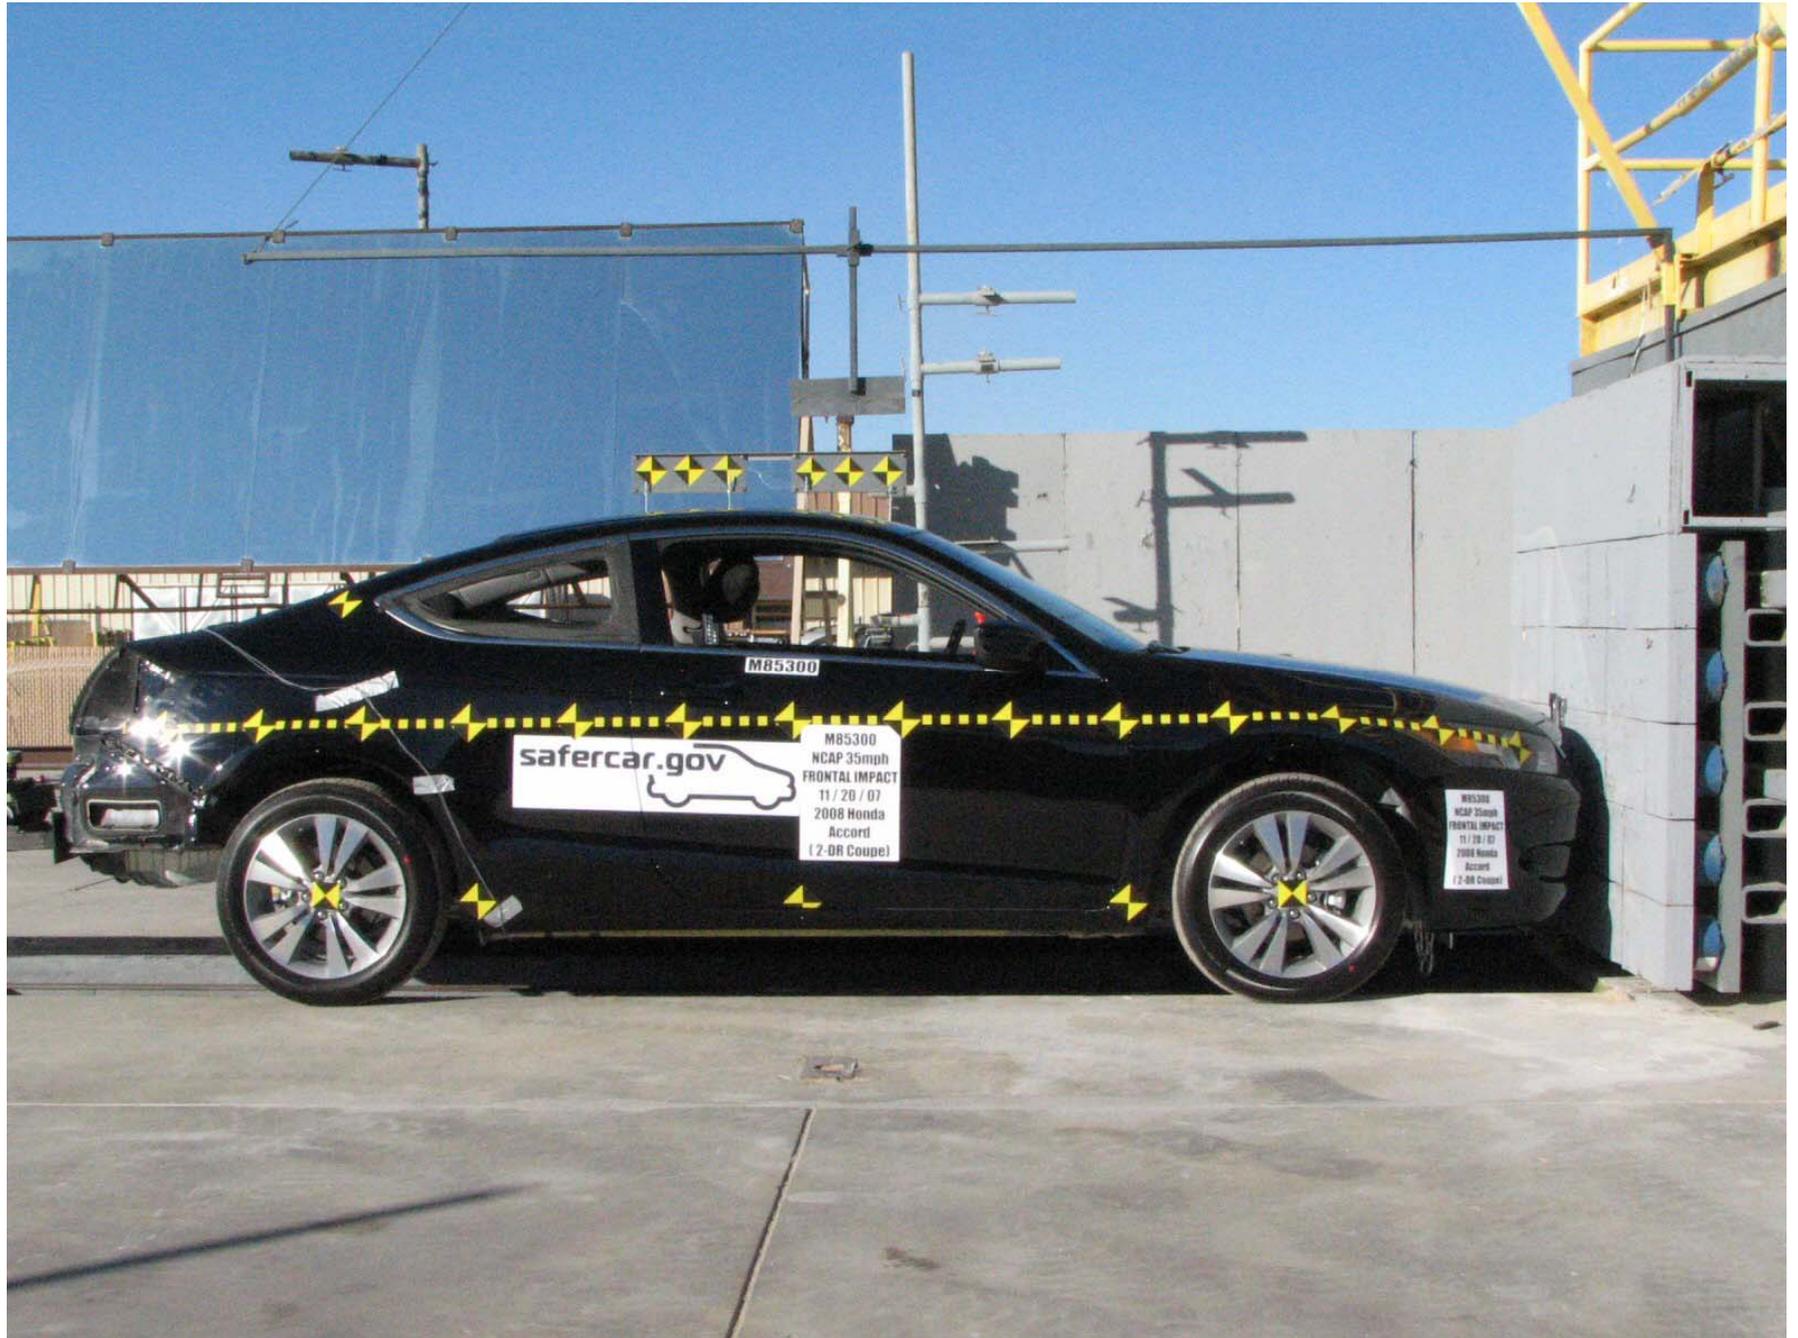
Figure A-9: Post-Test Left Side View

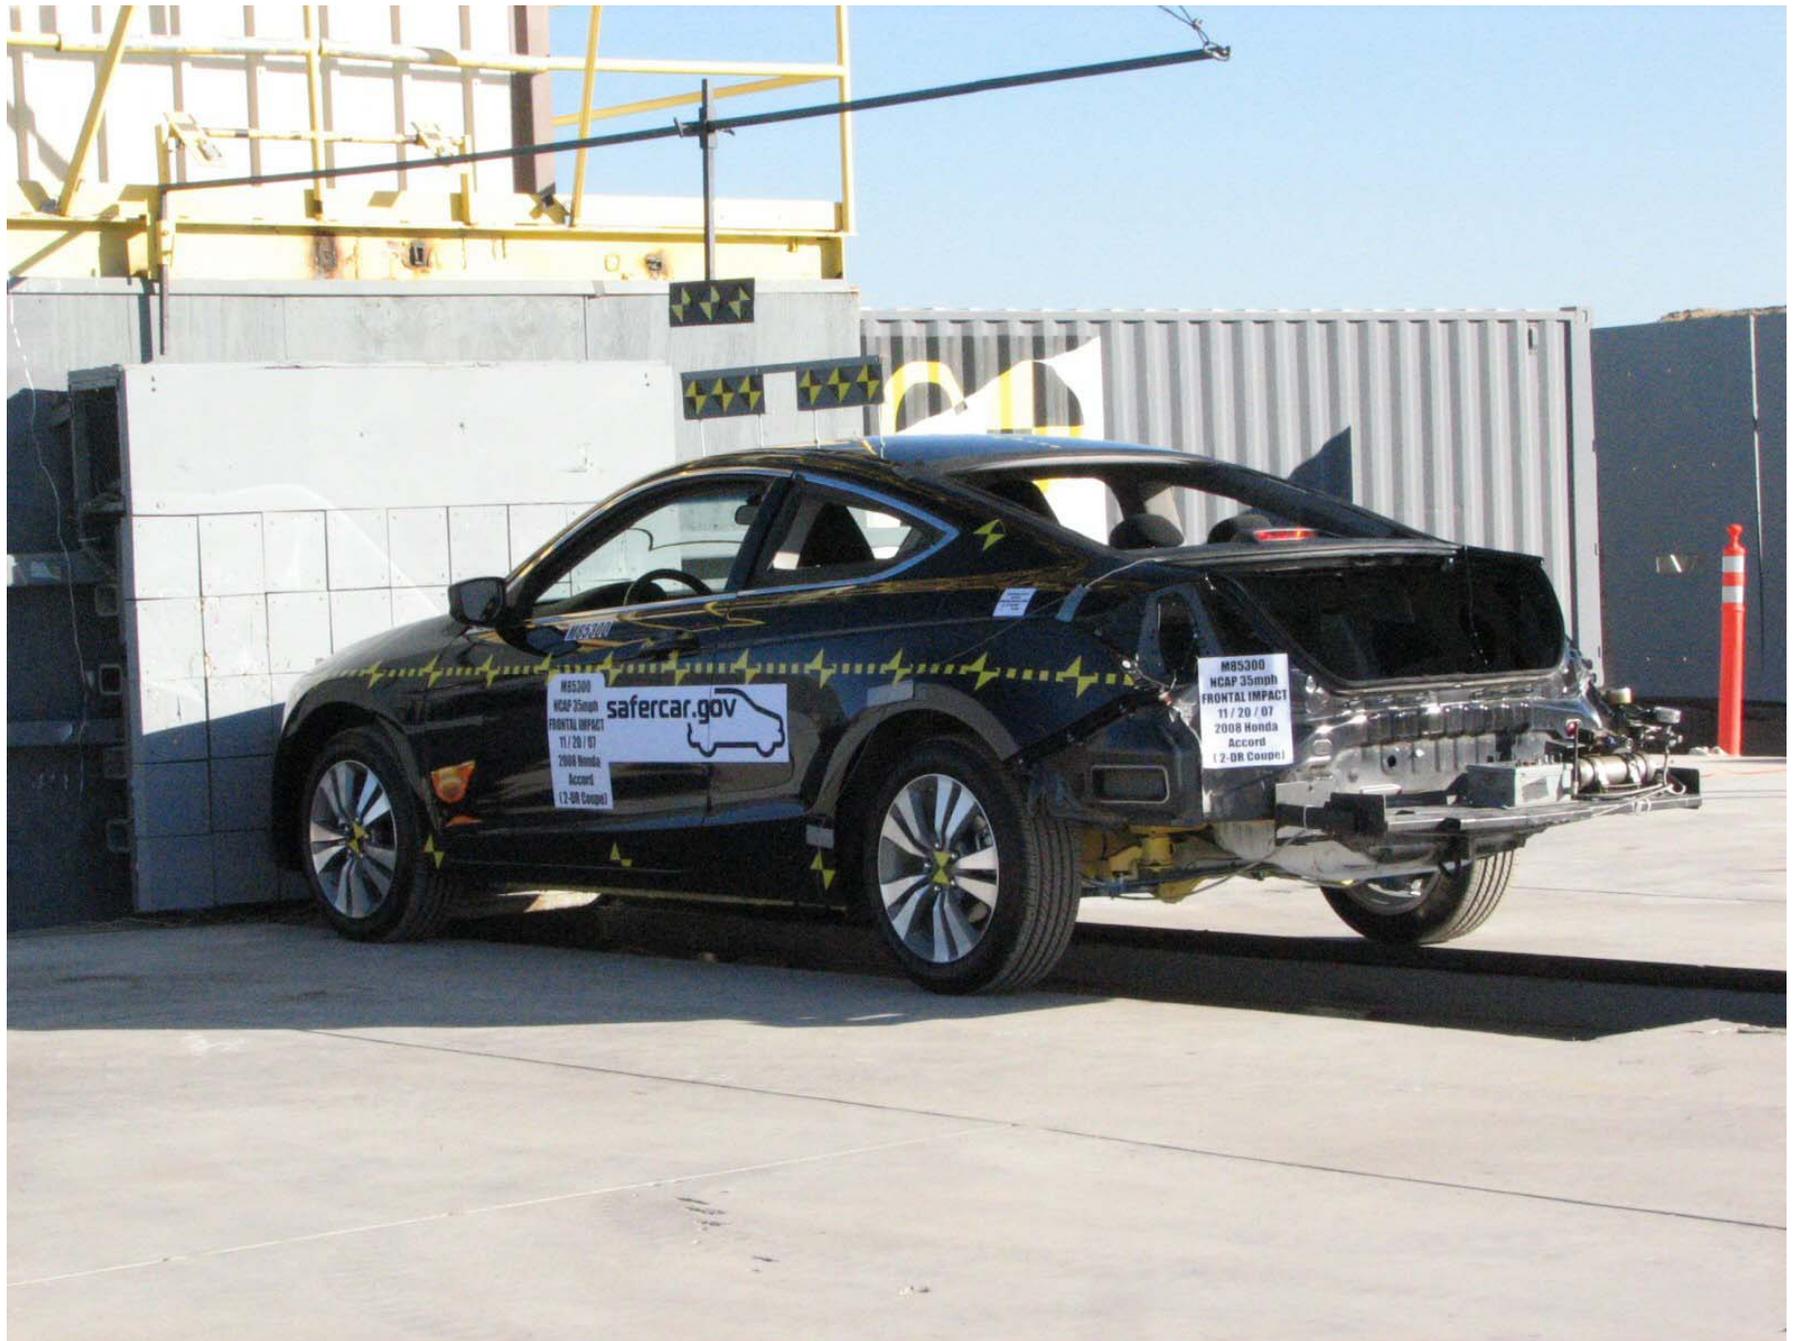
Figure A-13: Post-Test Right Front ¾ View (Vehicle Moved)

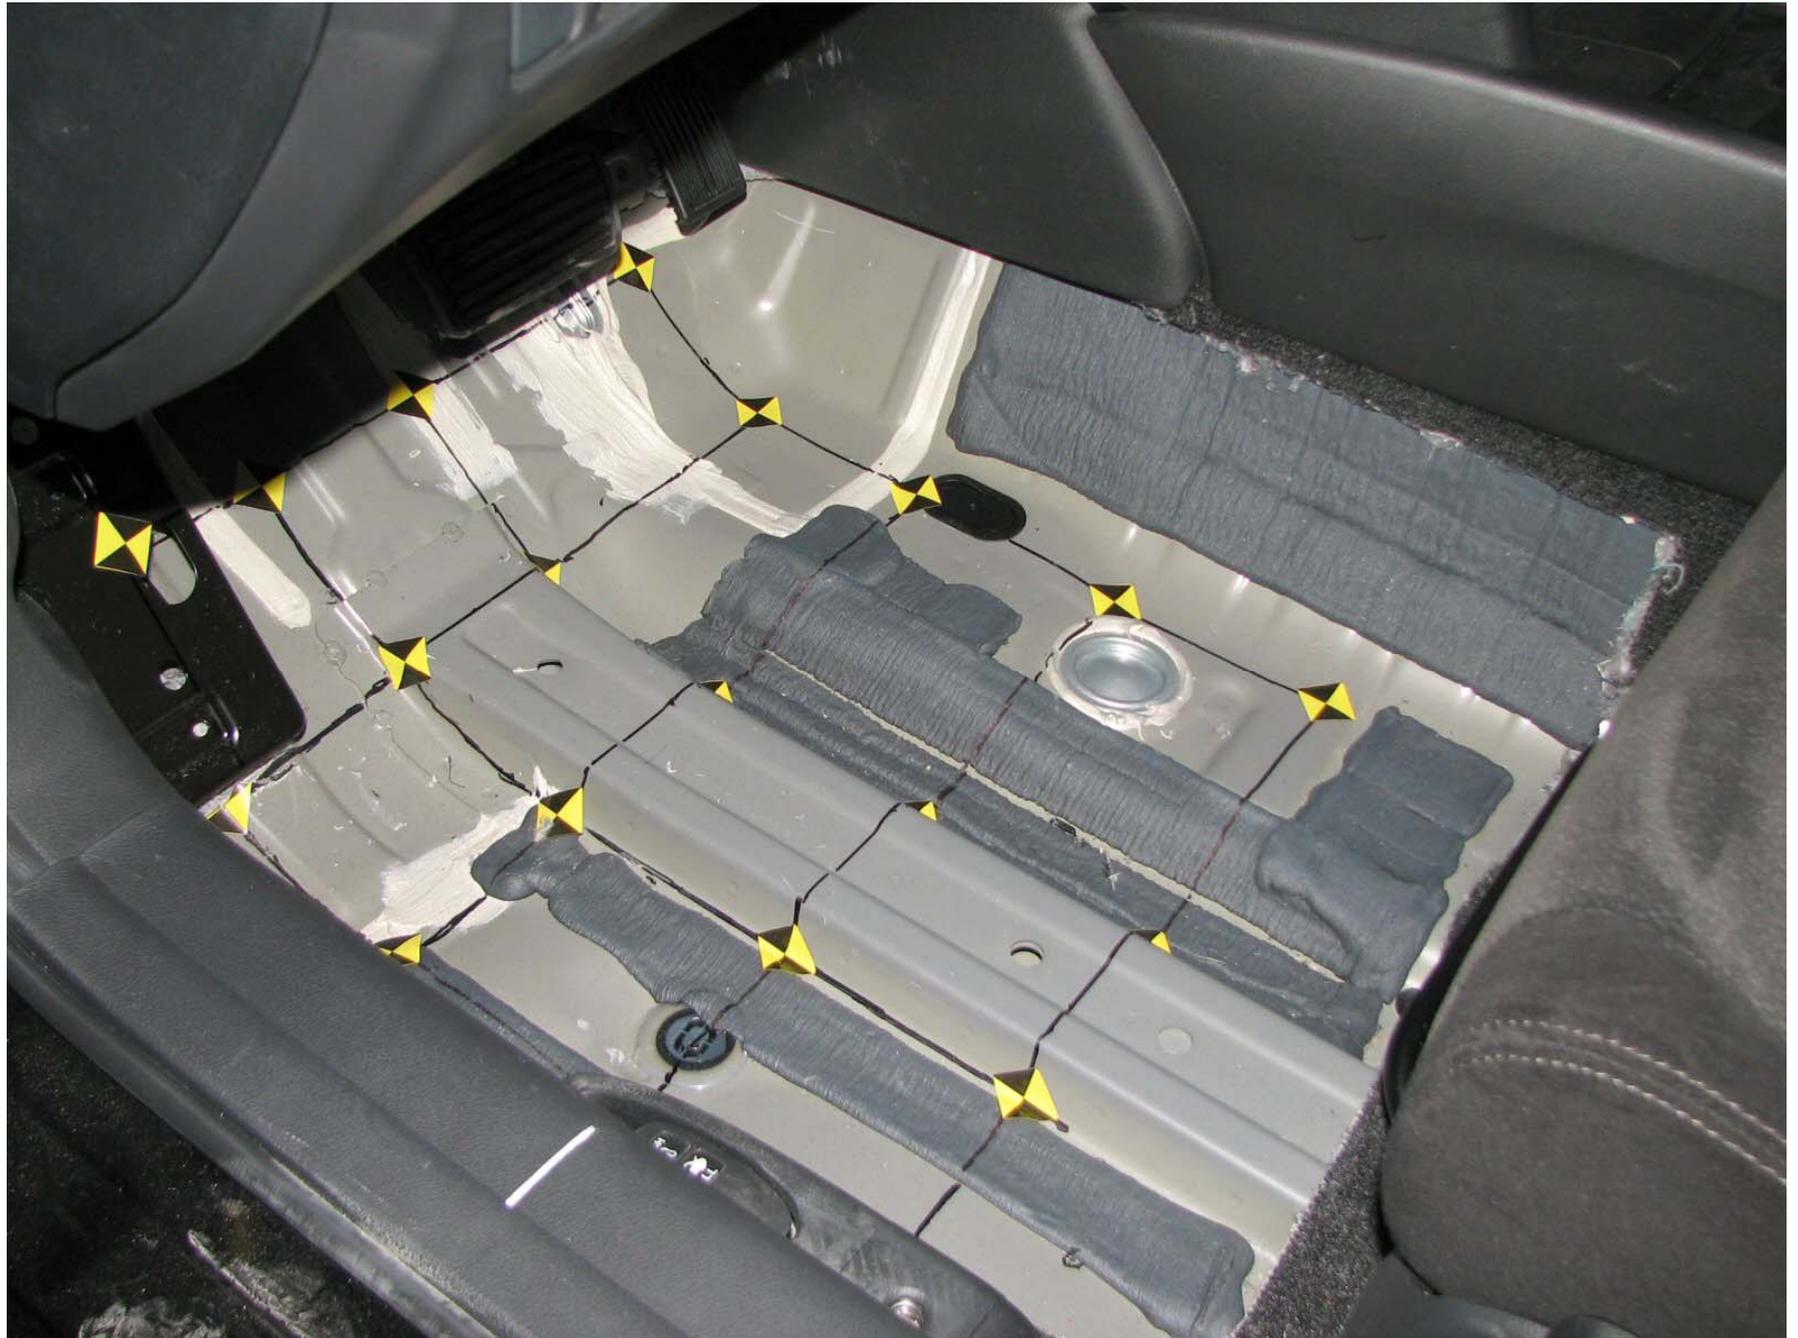
Figure A-39: Post-Test Driver Side Knee Bolster

The driver's visible contact points were as follows: The driver ATD's head and chest contacted the airbag. The head also contacted the headrest. Both the left and right knees contacted the knee bolster.

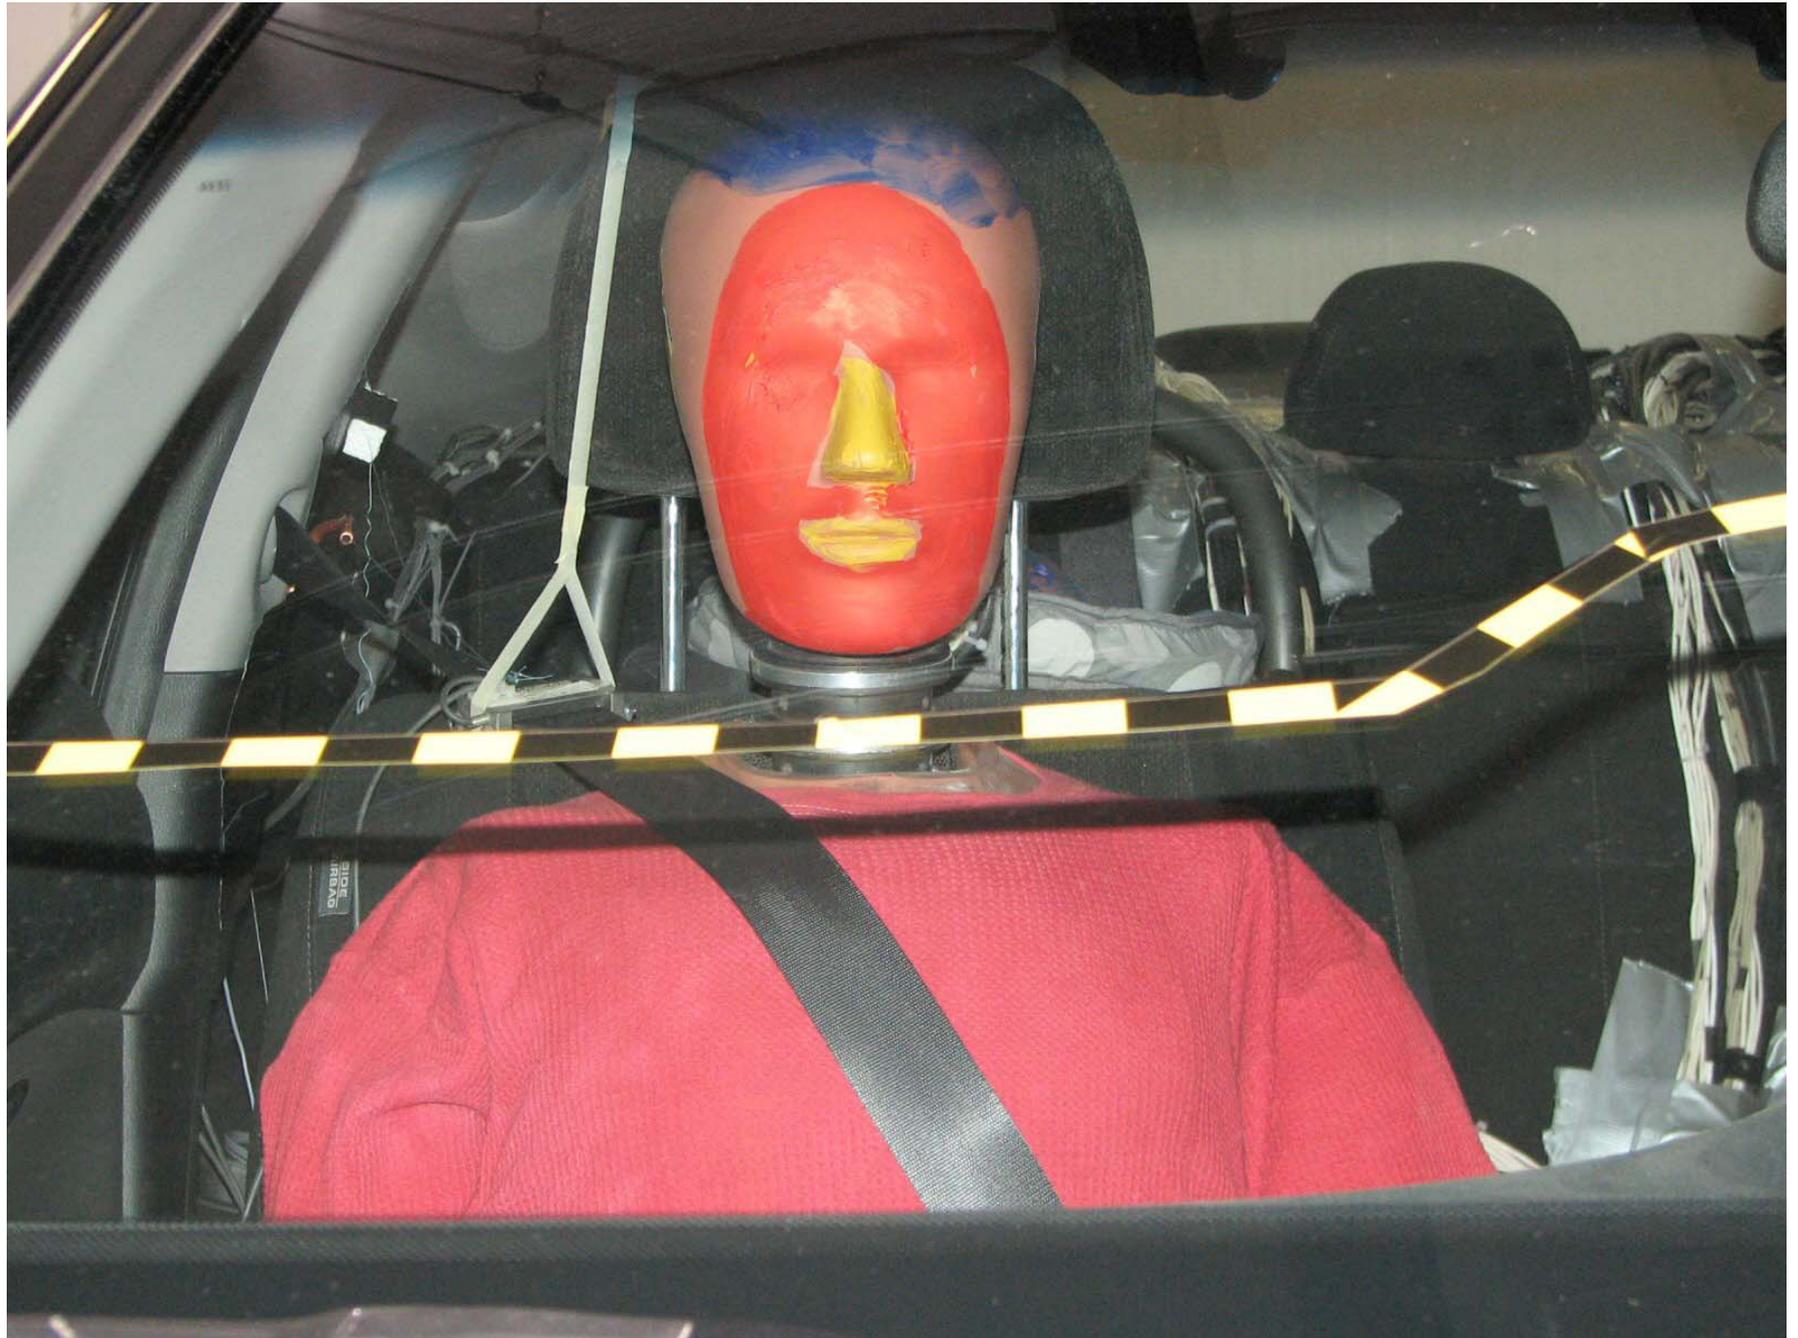
Figure A-43: Post-Test Driver Dummy Airbag Contact

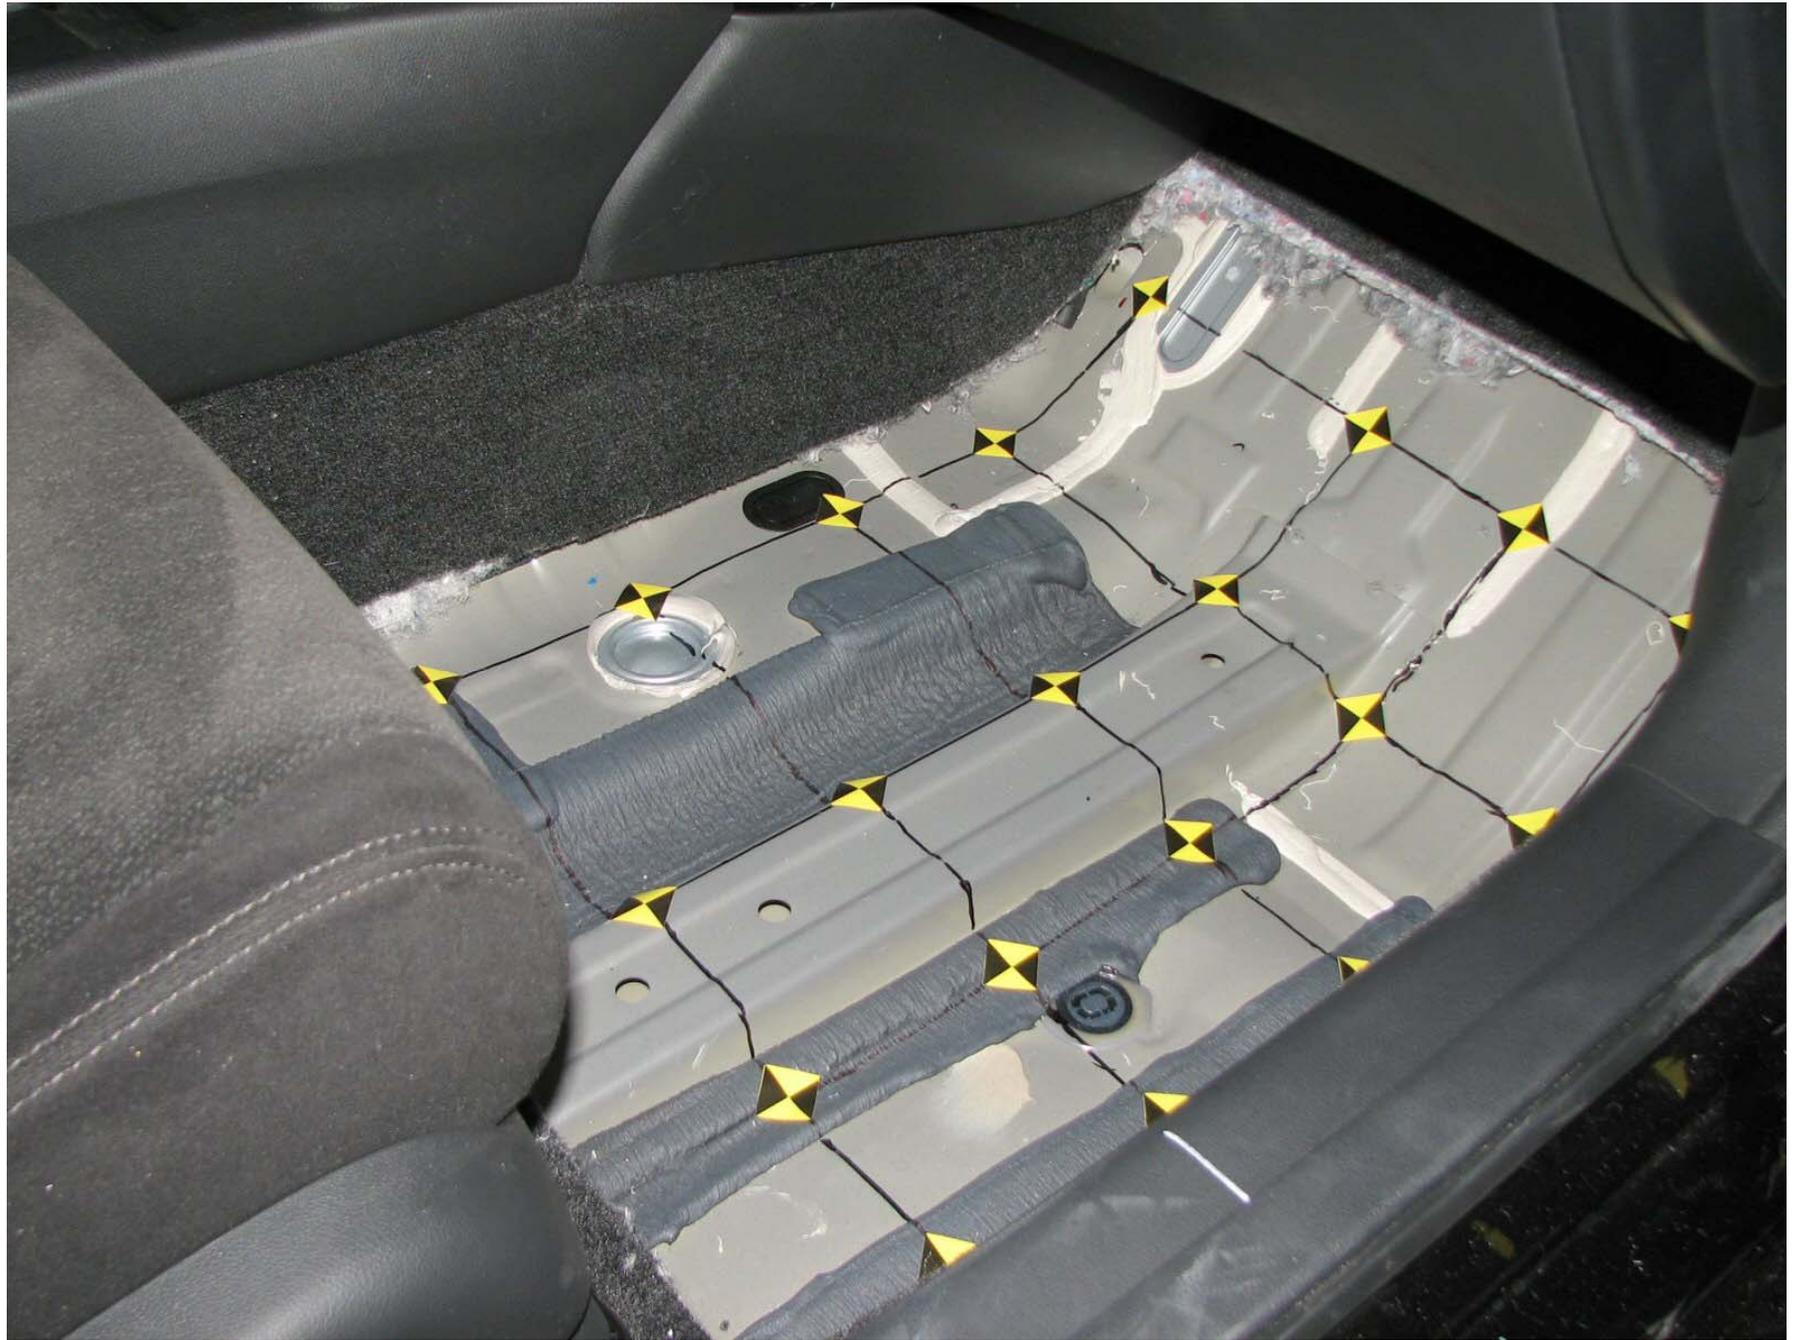
Figure A-53: Post-Test Passenger Side Glove Box

The passenger's visible contact points were as follows: The passenger ATD's head contacted the airbag and headrest. The chest also contacted the airbag. Both knees contacted the glove box.

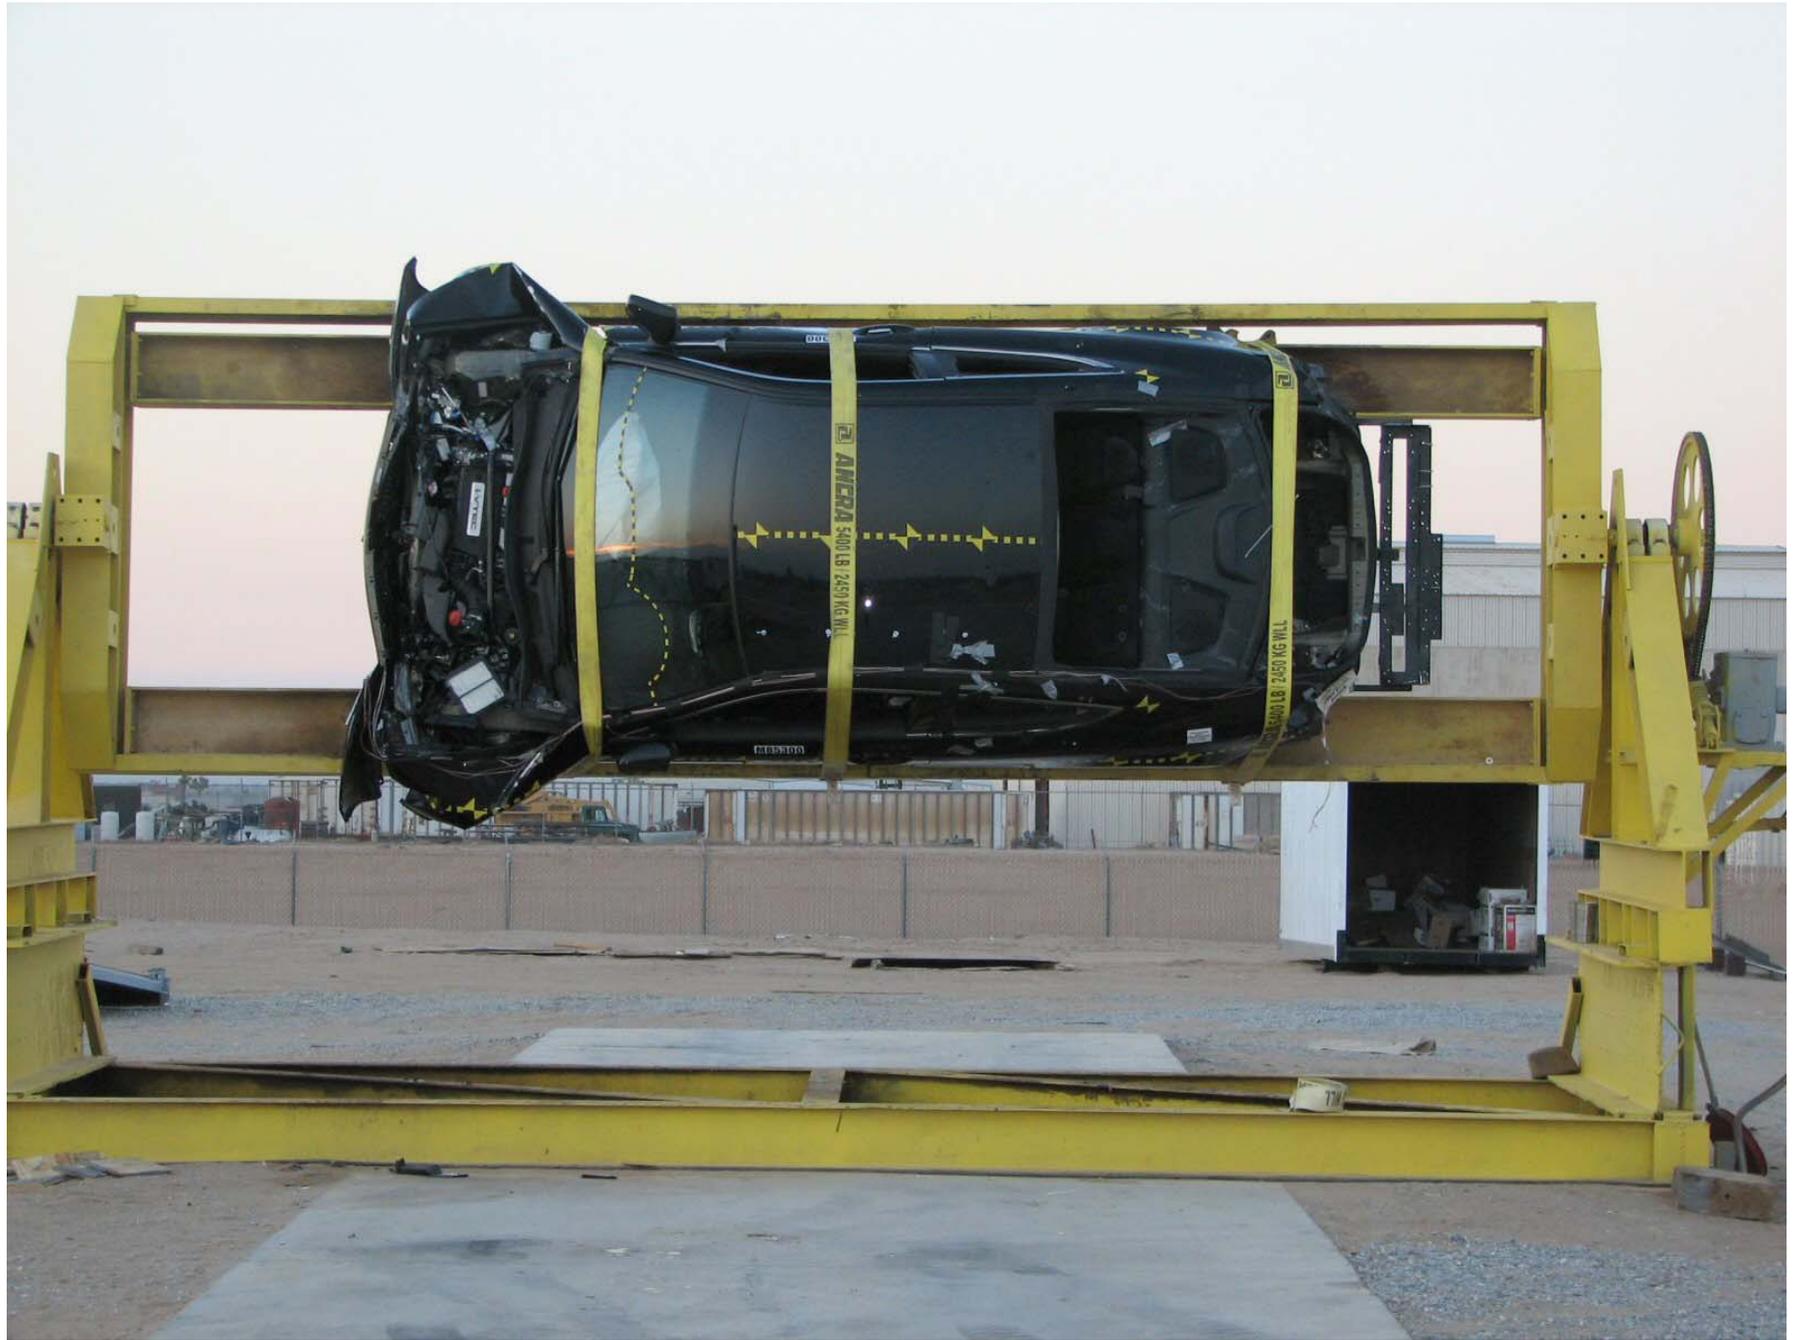
Figure A-58: Vehicle on Rollover Device (0°)

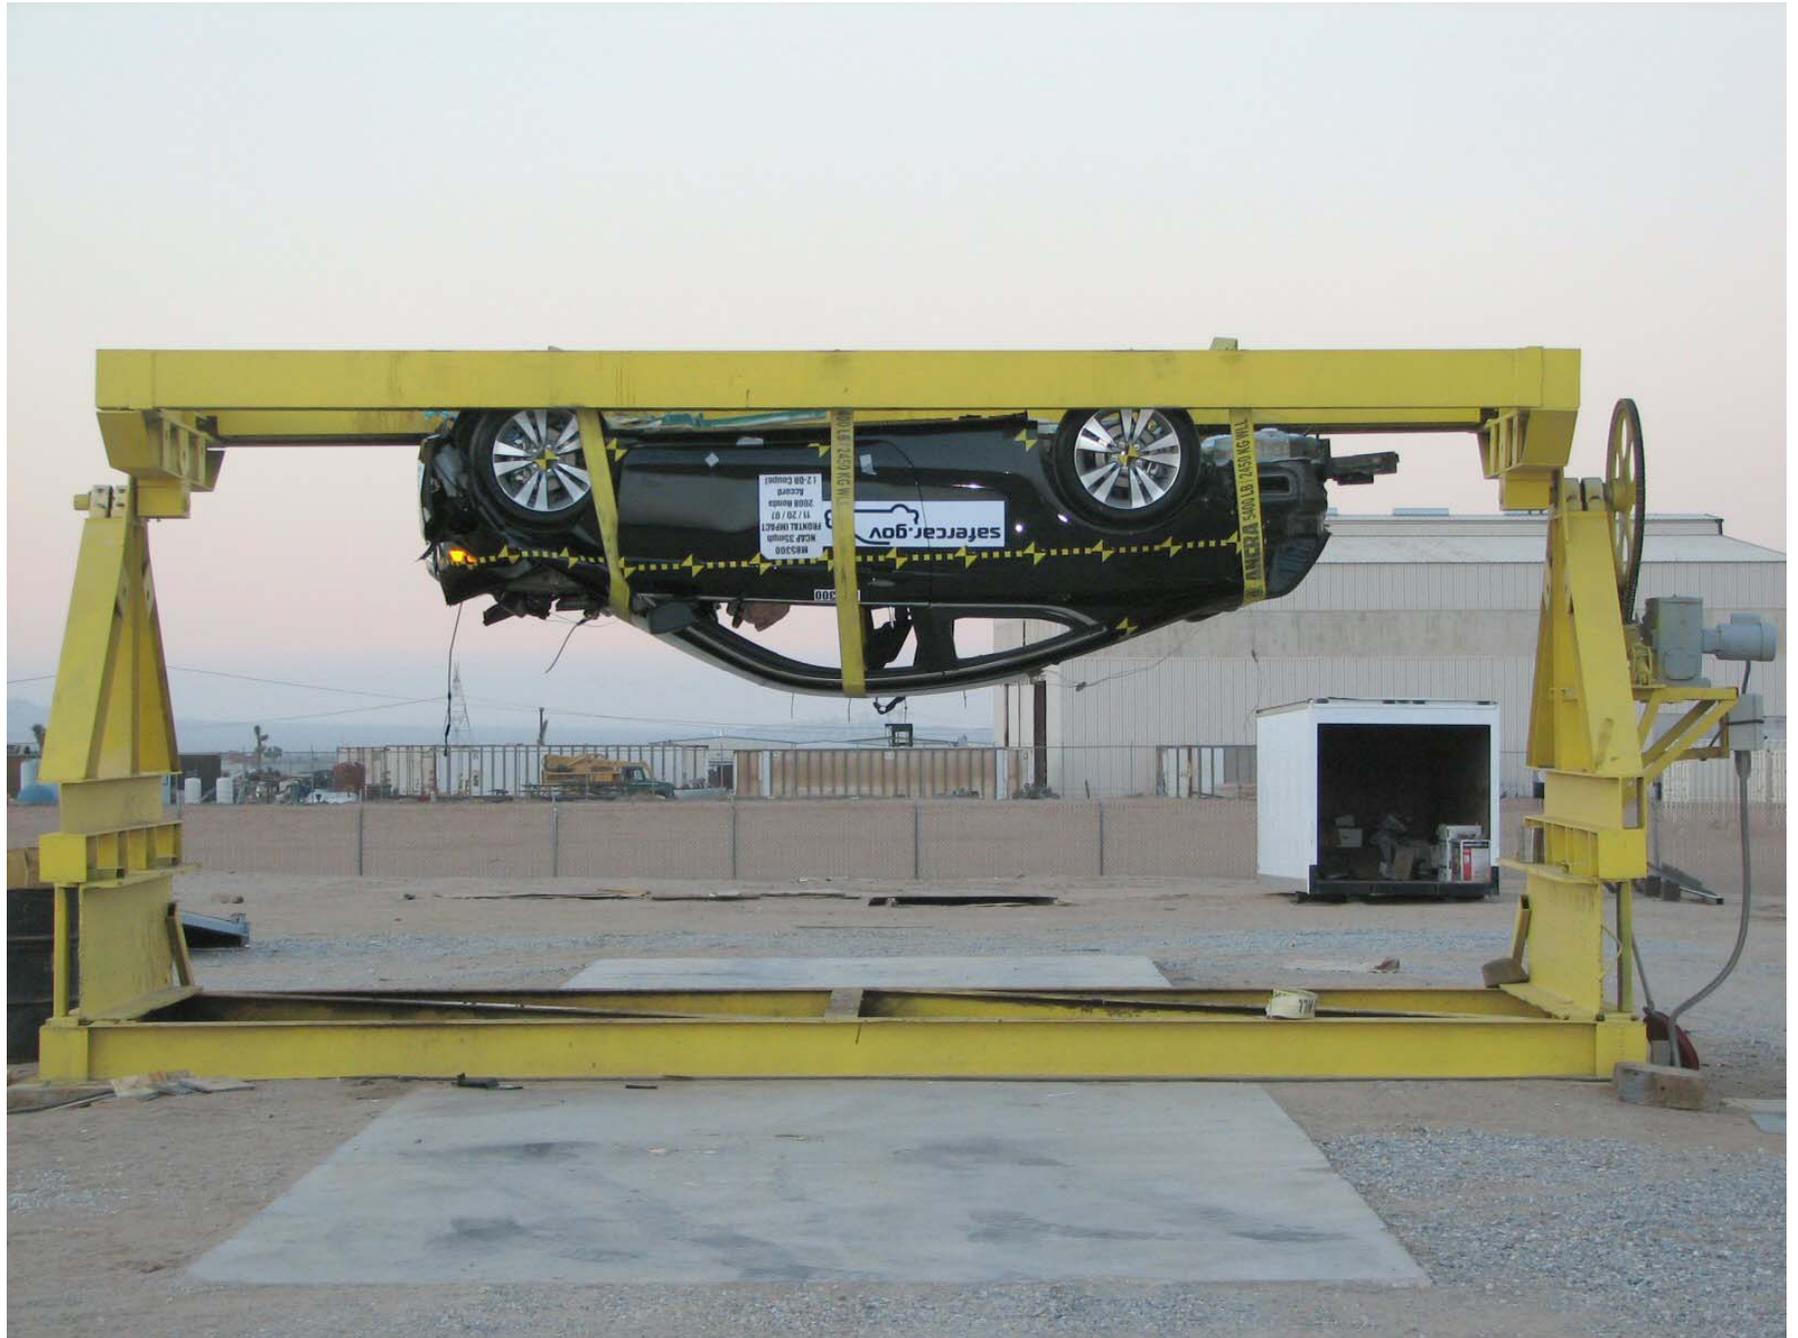
Figure A-59: Vehicle on Rollover Device (90°)

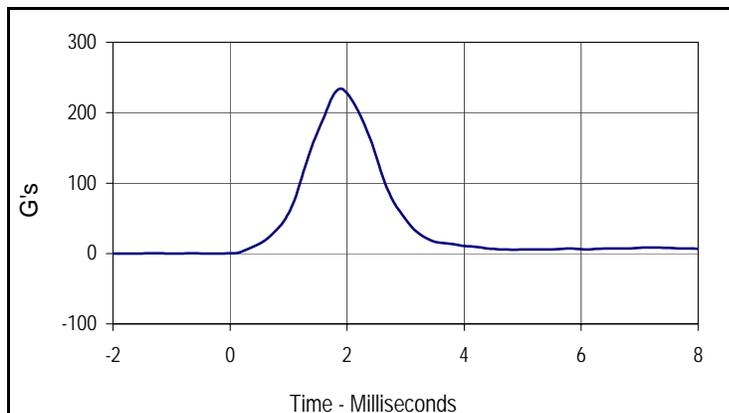
Tested Parameter	Units	Specification	Result	Pass/Fail
Laboratory Temperature	°C	18.9 to 25.6	21.1	Pass
Laboratory Relative Humidity	%	10 to 70	30	Pass
Peak Resultant Acceleration	G's	225.0 to 275.0	233.9	Pass
Peak Lateral Acceleration	G's	≤15.0	10.3	Pass
Is Acceleration Unimodal?	Yes/No	Yes	Yes	Pass
Overall Test Results			Pass

Curve Description			
Head Resultant			
CURNO	Type	SAE Class	Units
001	RES	1000	G's
Max	Time	Min	Time
233.9	1.9	0.0	-0.2

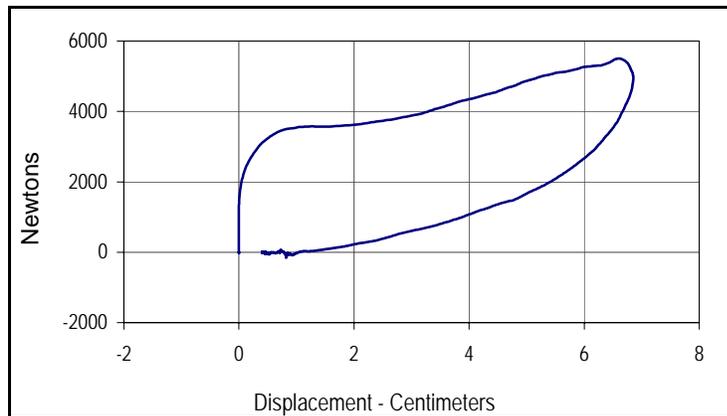
Tested Parameter	Units	Specification	Result	Pass/Fail
Laboratory Temperature	°C	20.6 to 22.2	21.1	Pass
Laboratory Relative Humidity	%	10 to 70	30	Pass
Probe Velocity	m/s	6.58 to 6.82	6.62	Pass
Peak Probe Force	Newtons	5159 to 5893	5503	Pass
Peak Sternum Deflection	CM	6.35 to 7.26	6.85	Pass
Internal Hysteresis	%	69 to 85	73.0	Pass
Overall Test Results				Pass

Curve Description			
Probe Force vs. Chest Deflection			
CURNO	Type	SAE Class	Hysteresis
001	FIL	180	73.0
Peak Probe Force		Peak Chest Deflection	
5503		6.85

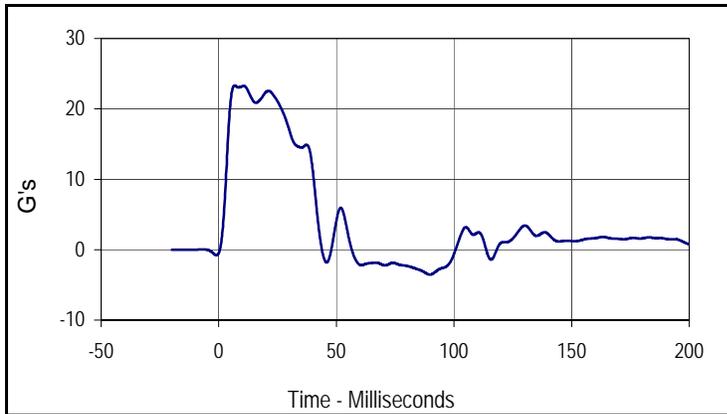
Tested Parameter	Units	Specification	Result	Pass/Fail	
Laboratory Temperature	°C	20.6 to 22.2	21.1	Pass	
Laboratory Relative Humidity	%	10 to 70	30	Pass	
Pendulum Velocity	m/s	6.89 to 7.13	6.92	Pass	
Pendulum Deceleration	10 Msec.	G's	22.5 to 27.5	23.2	Pass
	20 Msec.	G's	17.6 to 22.6	22.4	Pass
	30 Msec.	G's	12.5 to 18.5	17.0	Pass
Peak Pendulum Decel. after 30 Msec.	G's	≤ 29.0	17.0	Pass	
Deceleration Decay, Time to Cross 5 G's	Msec.	34.0 to 42.0	41.9	Pass	
Maximum "D" Plane Rotation	Max	Degrees	64.0 to 78.0	71.6	Pass
	Time	Msec.	57.0 to 64.0	62.8	Pass
"D" Plane Rotation Decay, Time To Zero Crossing	Msec.	113.0 to 128.0	115.3	Pass	
Moment About Occ. Condyle	Max	Nm	84.1 to 108.5	98.1	Pass
	Time	Msec.	47.0 to 58.0	52.1	Pass
Positive Moment Decay, Time To Zero Crossing	Msec.	97.0 to 107.0	97.0	Pass	
Overall Test Results				Pass

Curve Description			
Pendulum Deceleration			
CURNO	Type	SAE Class	Units
001	FIL	60	G's
Max	Time	Min	Time
23.3	6.7	-3.5	89.8

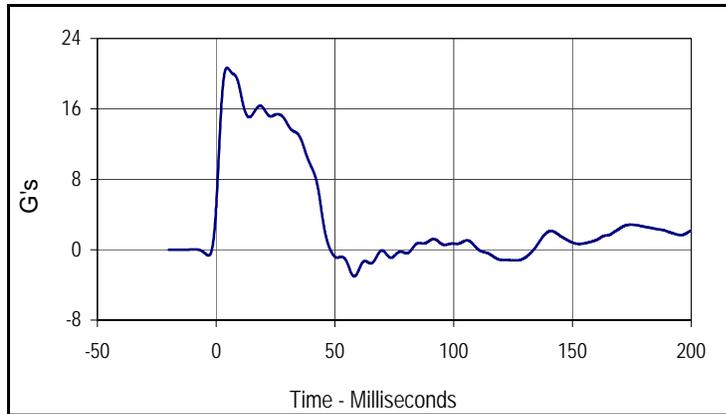
Tested Parameter	Units	Specification	Result	Pass/Fail	
Laboratory Temperature	°C	20.6 to 22.2	21.1	Pass	
Laboratory Relative Humidity	%	10 to 70	30	Pass	
Pendulum Velocity	m/s	5.94 to 6.19	6.09	Pass	
Pendulum Deceleration	10 Msec.	G's	17.2 to 21.2	18.2	Pass
	20 Msec.	G's	14.0 to 19.0	16.0	Pass
	30 Msec.	G's	11.0 to 16.0	14.3	Pass
Peak Pendulum Decel. after 30 Msec.	G's	≤ 22.0	14.3	Pass	
Deceleration Decay, Time to Cross 5 G's	Msec.	38.0 to 46.0	44.1	Pass	
Maximum "D" Plane Rotation	Max	Degrees	81.0 to 106.0	104.9	Pass
	Time	Msec.	72.0 to 82.0	76.9	Pass
"D" Plane Rotation Decay, Time To Zero Crossing	Msec.	147.0 to 174.0	169.7	Pass	
Moment About Occ. Condyle	Max	Nm	-52.9 to- 79.9	-72.7	Pass
	Time	Msec.	65.0 to 79.0	65.5	Pass
Positive Moment Decay, Time To Zero Crossing	Msec.	120.0 to 148.0	143.2	Pass	
Overall Test Results				Pass

Curve Description			
Pendulum Deceleration			
CURNO	Type	SAE Class	Units
001	FIL	60	G's
Max	Time	Min	Time
20.7	4.6	-3.0	58.1

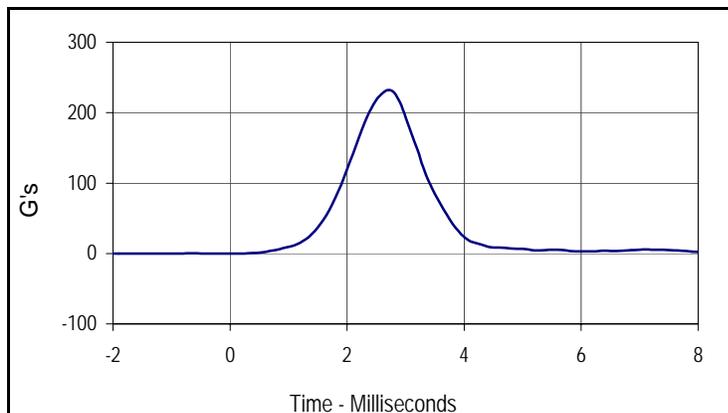
Tested Parameter	Units	Specification	Result	Pass/Fail
Laboratory Temperature	°C	18.9 to 25.6	21.1	Pass
Laboratory Relative Humidity	%	10 to 70	30	Pass
Peak Resultant Acceleration	G's	225.0 to 275.0	232.0	Pass
Peak Lateral Acceleration	G's	≤15.0	14.8	Pass
Is Acceleration Unimodal?	Yes/No	Yes	Yes	Pass
Overall Test Results			Pass	Pass

Curve Description			
Head Resultant			
CURNO	Type	SAE Class	Units
001	RES	1000	G's
Max	Time	Min	Time
232.0	2.7	0.0	0.0

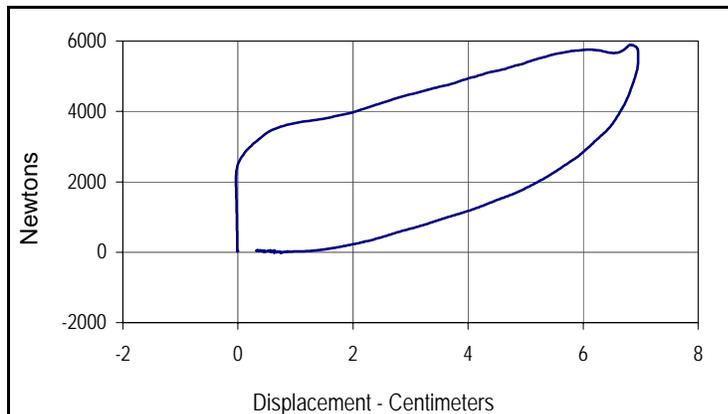
Tested Parameter	Units	Specification	Result	Pass/Fail
Laboratory Temperature	°C	20.6 to 22.2	21.1	Pass
Laboratory Relative Humidity	%	10 to 70	30	Pass
Probe Velocity	m/s	6.58 to 6.82	6.63	Pass
Peak Probe Force	Newtons	5159 to 5893	5891	Pass
Peak Sternum Deflection	CM	6.35 to 7.26	6.96	Pass
Internal Hysteresis	%	69 to 85	72.7	Pass
Overall Test Results				Pass

Curve Description			
Probe Force vs. Chest Deflection			
CURNO	Type	SAE Class	Hysteresis
001	FIL	180	72.7
Peak Probe Force		Peak Chest Deflection	
5891		6.96

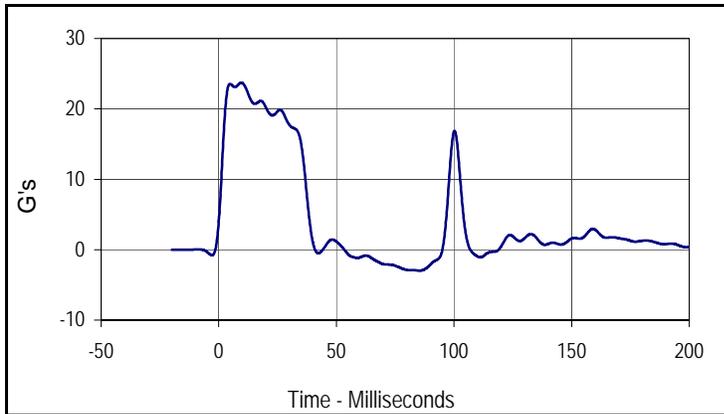
Tested Parameter	Units	Specification	Result	Pass/Fail	
Laboratory Temperature	°C	20.6 to 22.2	21.1	Pass	
Laboratory Relative Humidity	%	10 to 70	30	Pass	
Pendulum Velocity	m/s	6.89 to 7.13	6.90	Pass	
Pendulum Deceleration	10 Msec.	G's	22.5 to 27.5	23.7	Pass
	20 Msec.	G's	17.6 to 22.6	20.2	Pass
	30 Msec.	G's	12.5 to 18.5	17.7	Pass
Peak Pendulum Decel. after 30 Msec.	G's	≤ 29.0	17.7	Pass	
Deceleration Decay, Time to Cross 5 G's	Msec.	34.0 to 42.0	38.3	Pass	
Maximum "D" Plane Rotation	Max	Degrees	64.0 to 78.0	73.6	Pass
	Time	Msec.	57.0 to 64.0	59.5	Pass
"D" Plane Rotation Decay, Time To Zero Crossing	Msec.	113.0 to 128.0	116.9	Pass	
Moment About Occ. Condyle	Max	Nm	84.1 to 108.5	92.2	Pass
	Time	Msec.	47.0 to 58.0	49.6	Pass
Positive Moment Decay, Time To Zero Crossing	Msec.	97.0 to 107.0	98.5	Pass	
Overall Test Results				Pass

Curve Description			
Pendulum Deceleration			
CURNO	Type	SAE Class	Units
001	FIL	60	G's
Max	Time	Min	Time
23.7	9.6	-3.0	85.3
