REPORT NUMBER TR-P28001-11-NC

**NEW CAR ASSESSMENT PROGRAM
FRONTAL BARRIER IMPACT TEST**

**HONDA OF AMERICA MFG., INC
2008 HONDA ACCORD
2-DOOR COUPE**

NHTSA NUMBER: M85300

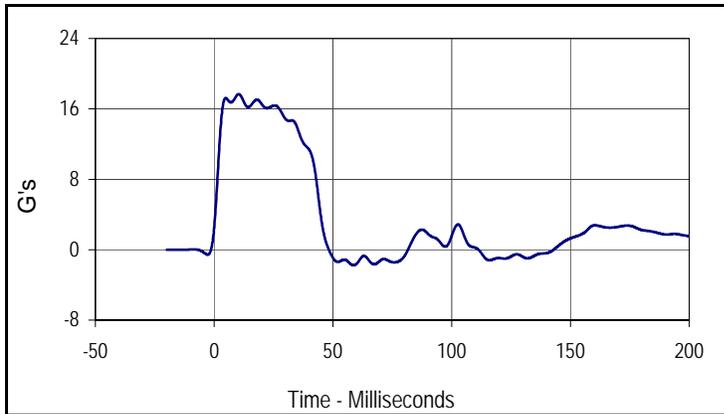
Tested Parameter	Units	Specification	Result	Pass/Fail	
Laboratory Temperature	°C	20.6 to 22.2	21.1	Pass	
Laboratory Relative Humidity	%	10 to 70	30	Pass	
Pendulum Velocity	m/s	5.94 to 6.19	6.04	Pass	
Pendulum Deceleration	10 Msec.	G's	17.2 to 21.2	17.7	Pass
	20 Msec.	G's	14.0 to 19.0	16.6	Pass
	30 Msec.	G's	11.0 to 16.0	14.8	Pass
Peak Pendulum Decel. after 30 Msec.	G's	≤ 22.0	14.8	Pass	
Deceleration Decay, Time to Cross 5 G's	Msec.	38.0 to 46.0	44.4	Pass	
Maximum "D" Plane Rotation	Max	Degrees	81.0 to 106.0	93.1	Pass
	Time	Msec.	72.0 to 82.0	79.4	Pass
"D" Plane Rotation Decay, Time To Zero Crossing	Msec.	147.0 to 174.0	151.4	Pass	
Moment About Occ. Condyle	Max	Nm	-52.9 to- 79.9	-72.6	Pass
	Time	Msec.	65.0 to 79.0	65.4	Pass
Positive Moment Decay, Time To Zero Crossing	Msec.	120.0 to 148.0	146.9	Pass	
Overall Test Results				Pass

Curve Description			
Pendulum Deceleration			
CURNO	Type	SAE Class	Units
001	FIL	60	G's
Max	Time	Min	Time
17.7	10.3	-1.8	58.7

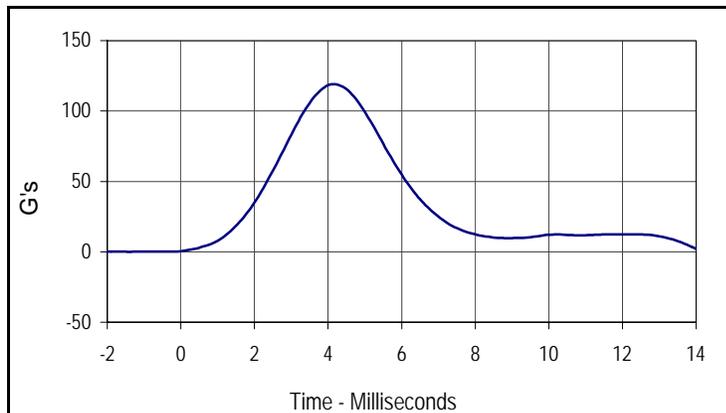
Tested Parameter	Units	Specification	Result	Pass/Fail
Laboratory Temperature	°C	18.9 to 25.6	21.1	Pass
Laboratory Relative Humidity	%	10 to 70	30	Pass
Peak Resultant Acceleration	G's	100.0 to 120.0	119.0	Pass
Peak Lateral Acceleration	G's	≤15.0	5.5	Pass
Is Acceleration Unimodal?	Yes/No	Yes	Yes	Pass
Overall Test Results				Pass

Curve Description			
Head Resultant			
CURNO	Type	SAE Class	Units
001	RES	1000	G's
Max	Time	Min	Time
119.0	4.2	0.0	-1.4

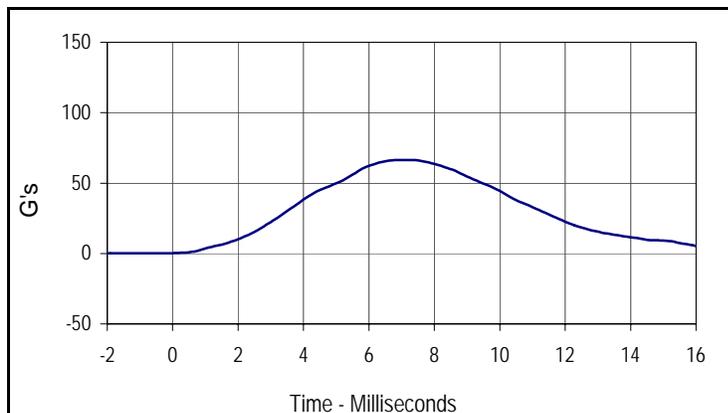
Tested Parameter	Units	Specification	Result	Pass/Fail
Laboratory Temperature	°C	18.9 to 25.6	21.1	Pass
Laboratory Relative Humidity	%	10 to 70	30	Pass
Peak Resultant Acceleration	G's	55.0 to 71.0	62.2	Pass
Peak Lateral Acceleration	G's	≤15.0	7.6	Pass
Is Acceleration Unimodal?	Yes/No	Yes	Yes	Pass
Overall Test Results			Pass

Curve Description			
Head Resultant			
CURNO	Type	SAE Class	Units
001	RES	1000	G's
Max	Time	Min	Time
62.2	6.0	0.1	-0.9

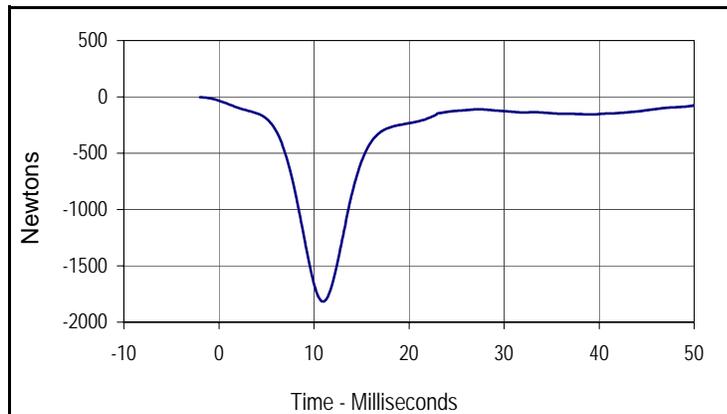
Tested Parameter	Units	Specification	Result	Pass/Fail
Laboratory Temperature	°C	20.6 to 22.2	21.1	Pass
Laboratory Relative Humidity	%	10 to 70	30	Pass
Pendulum Velocity at T=0	m/sec	4.90 to 5.10	5.04	Pass
Peak Probe Force	Newtons	-1514 to -1796	-1657	Pass
Overall Test Results				Pass

Curve Description			
Probe Force			
CURNO	Type	SAE Class	Units
001	FIL	60	Newtons
Max	Time	Min	Time
-2.3	-2.0	-1657.2	10.0

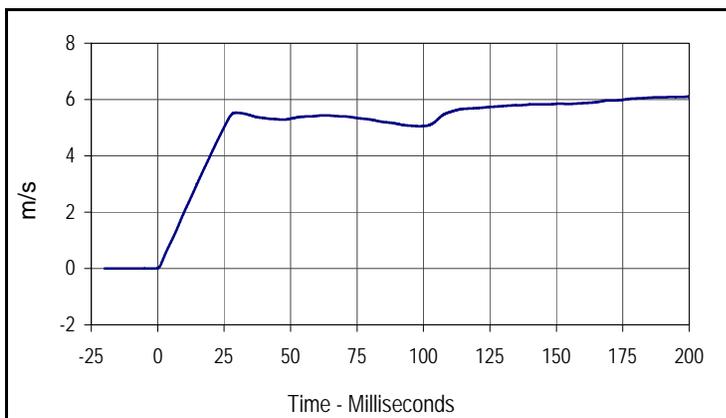
Tested Parameter	Units	Specification	Result	Pass/Fail	
Laboratory Temperature	°C	20.6 to 22.2	21.1	Pass	
Laboratory Relative Humidity	%	10 to 70	30	Pass	
Pendulum Velocity	m/s	5.10 to 5.30	5.15	Pass	
Pendulum Deceleration	10 Msec.	m/s	1.6 to 2.3	2.0	Pass
	20 Msec.	m/s	3.4 to 4.2	4.1	Pass
	25 Msec.	m/s	4.3 to 5.2	5.0	Pass
"D" Plane Rotation	Max	Degrees	75.0 to 86.0	76.1	Pass
Peak Moment in Rotation	Max	Nm	36.0 to 45.0	43.4	Pass
Positive Moment Decay, Time To 5 Nm	Msec.		60.0 to 80.0	71.5	Pass
Overall Test Results				Pass

Curve Description			
Pendulum Velocity			
CURNO	Type	SAE Class	Units
001	FIL	180	m/s
Max	Time	Min	Time
6.1	199.3	0.0	-0.7

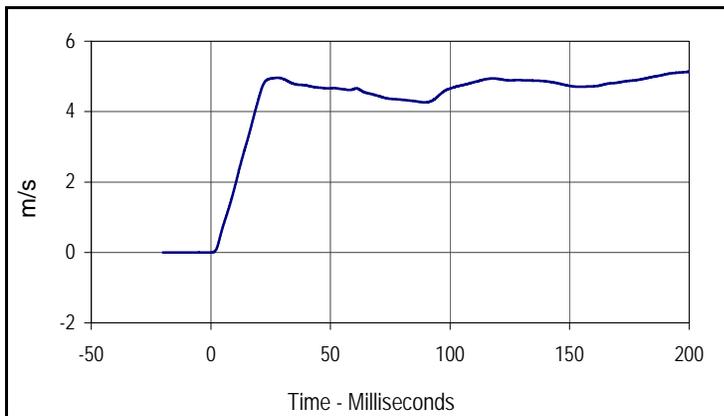
Tested Parameter	Units	Specification	Result	Pass/Fail	
Laboratory Temperature	°C	20.6 to 22.2	21.1	Pass	
Laboratory Relative Humidity	%	10 to 70	30	Pass	
Pendulum Velocity	m/s	2.4 to 2.6	2.40	Pass	
Pendulum Deceleration	6 Msec.	m/s	0.8 to 1.2	0.9	Pass
	10 Msec.	m/s	1.5 to 2.1	1.9	Pass
	14 Msec.	m/s	2.2 to 2.9	2.9	Pass
"D" Plane Rotation	Max	Degrees	80.0 to 92.0	91.5	Pass
Peak Moment in Rotation	Max	Nm	-12 to -23	-20.4	Pass
Positive Moment Decay, Time To -5 Nm	Msec.		76.0 to 90.0	77.9	Pass
Overall Test Results				Pass

Curve Description			
Pendulum Velocity			
CURNO	Type	SAE Class	Units
001	FIL	180	m/s
Max	Time	Min	Time
5.1	200.0	0.0	0.1
