REPORT NUMBER: SNCAPP-TRC-2009-001

**NEW CAR ASSESSMENT PROGRAM (NCAP)
SIDE IMPACT TEST**

**FORD MOTOR COMPANY
2010 FORD MUSTANG 2-DOOR CONVERTIBLE
NHTSA NUMBER: MA0208**

**PREPARED BY:
TRANSPORTATION RESEARCH CENTER INC.
10820 STATE ROUTE 347
P. O. BOX B-67
EAST LIBERTY, OH 43319**

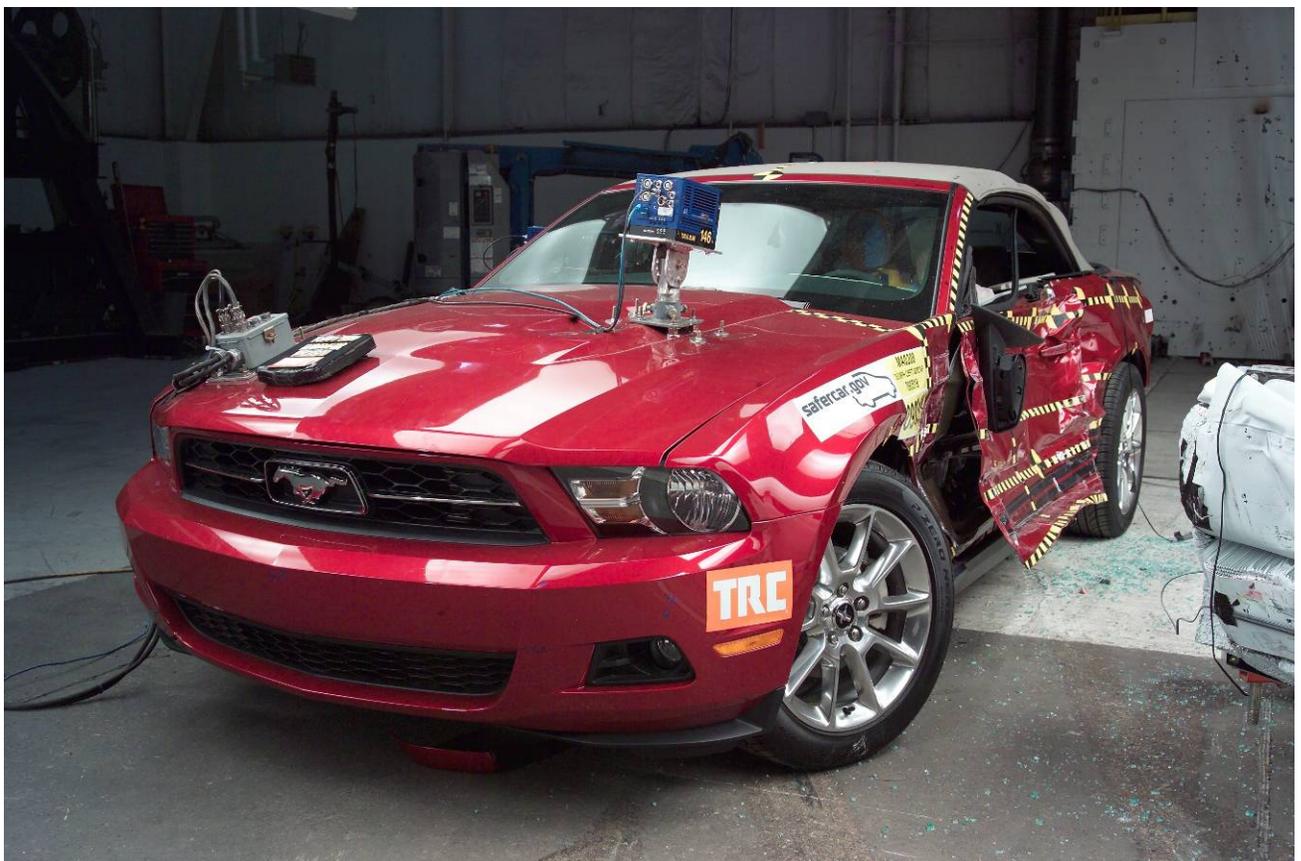
Figure A-4 Post-Test Left Front View of Test Vehicle

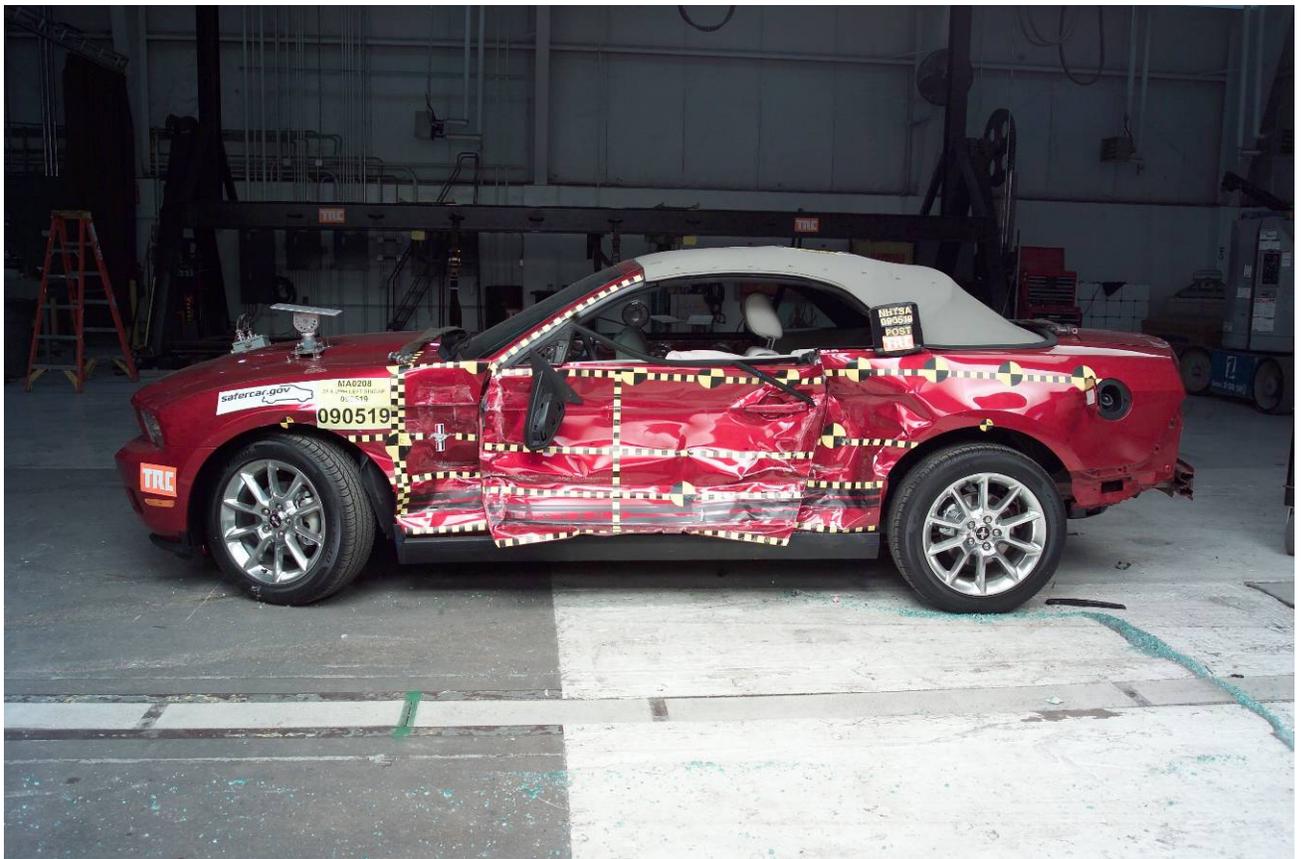
Figure A-6 Post-Test Impacted Side View of Test Vehicle

Critical Areas of Performance	Observations and Conclusions
Pillar Performance	Did not separate from vehicle
Sill Separation	Did not separate from vehicle
Windshield Damage	None
Window Damage	Left front and left rear shattered
Other Notable Effects	None

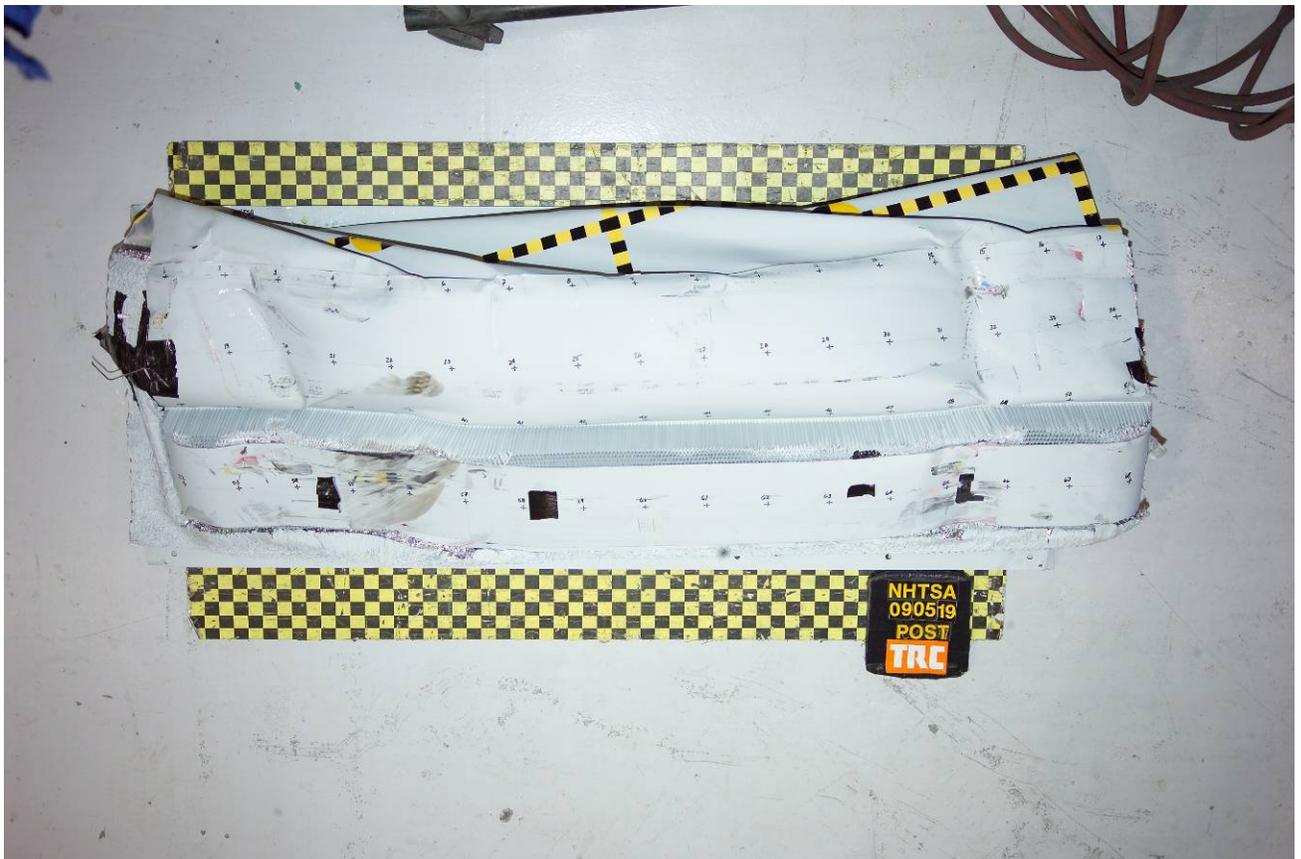
Figure A-18 Post-Test Frontal View of Impactor Face

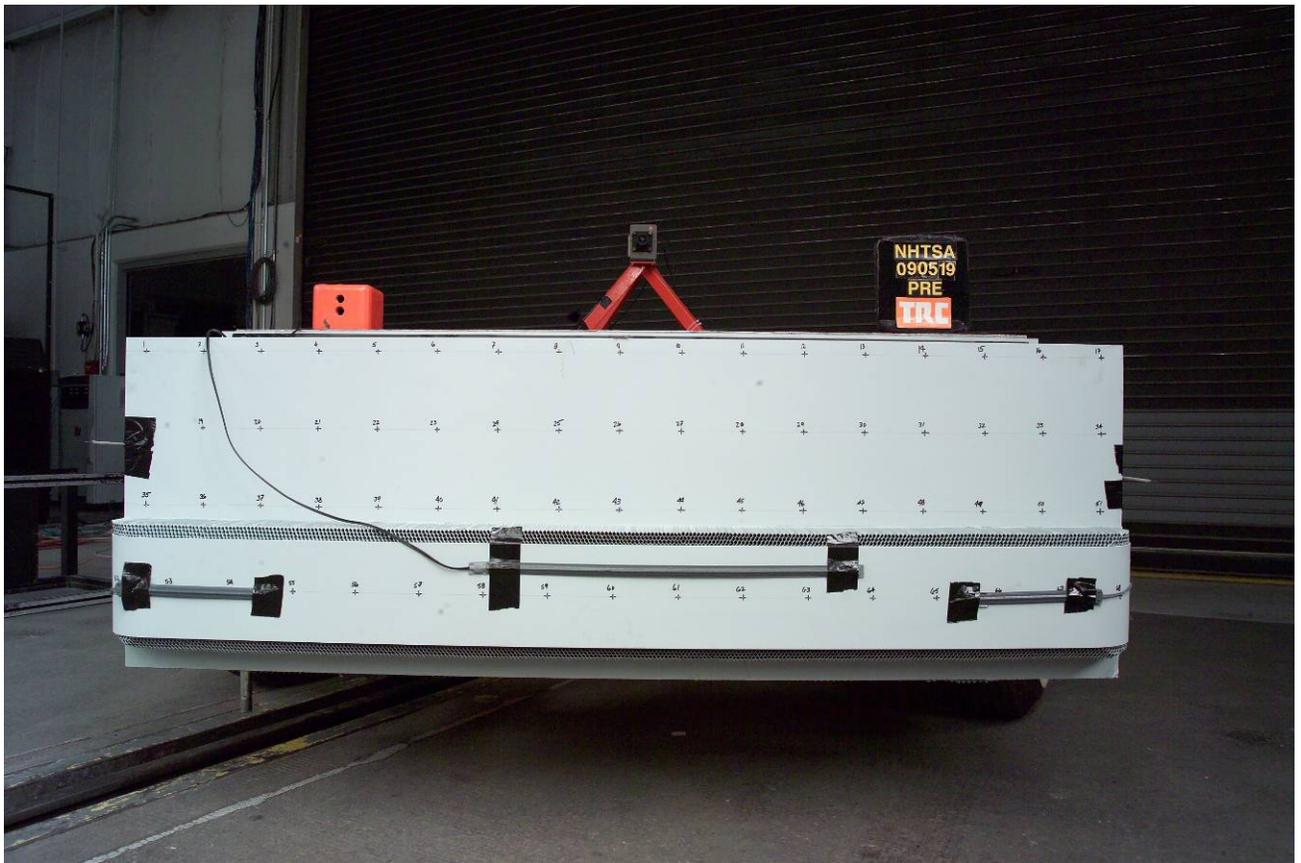
Figure A-35 Pre-Test View of MDB Showing Contact Switches in Place

The test vehicle was instrumented with twenty-one (21) structural accelerometers and the MDB was instrumented with five (5) accelerometers and two (2) contact switches on the bumper to compare left side to right side bumper impact timing. All data channels were recorded with a fully self-contained onboard Kayser Threde Data Acquisition System. The data was digitally sampled at 10,000 samples per second and processed per Appendix V of the Test Procedure.

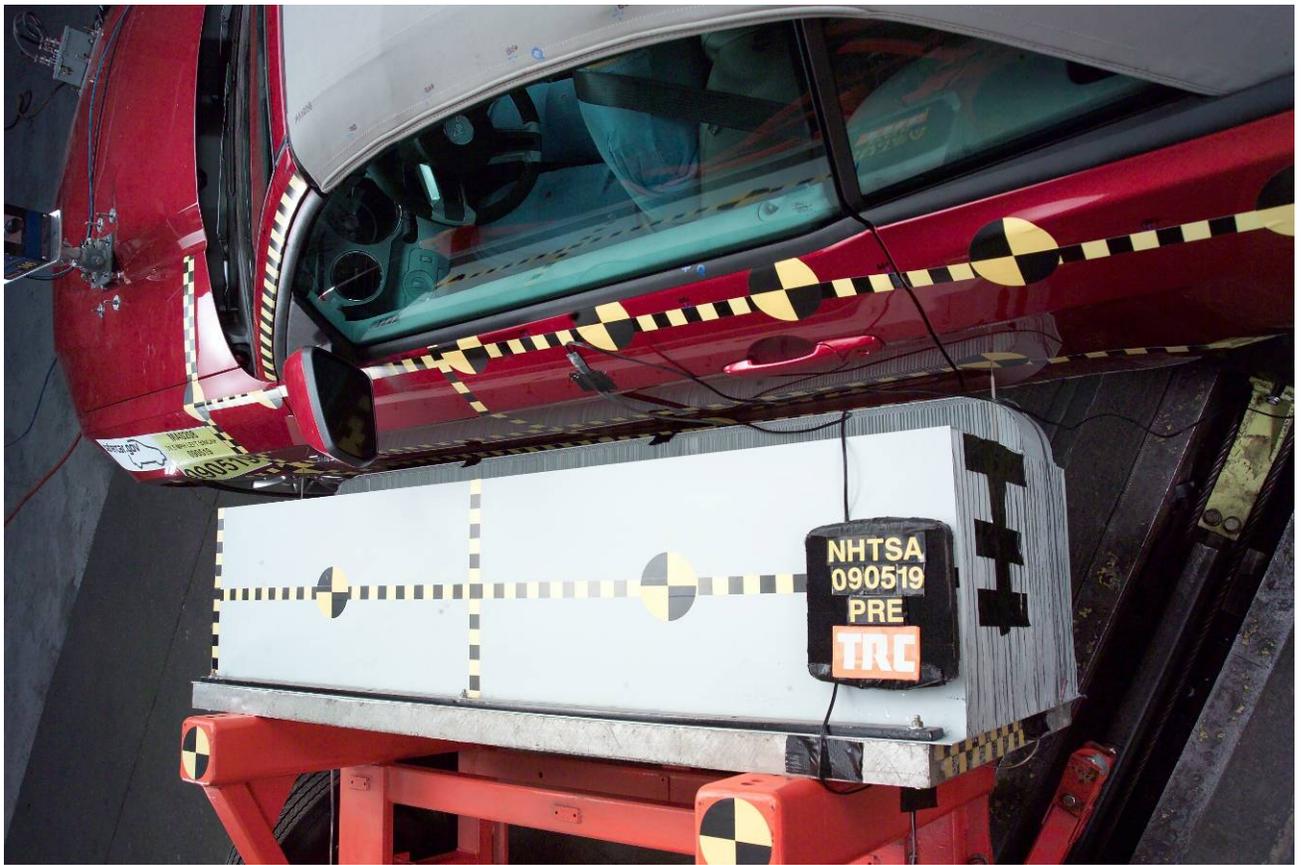
Figure A-37 Pre-Test Overhead View of MDB Aligned with Vehicle

A 2010 Ford Mustang 2-door Convertible was impacted on the left side by a Moving Deformable Barrier (MDB) which was moving forward in a 27° crabbed position to the monorail at a velocity of 62.0 km/h (38.5 mph). The target vehicle was stationary and was positioned at an angle of 63° to the line of forward motion. The side impact test was conducted by Transportation Research Center Inc. in East Liberty, Ohio on May 19, 2009. Pre-test and post-test photographs of the test vehicle, the moving deformable barrier (MDB), and the side impact dummies (SID/HIIIs) are included in Appendix A.

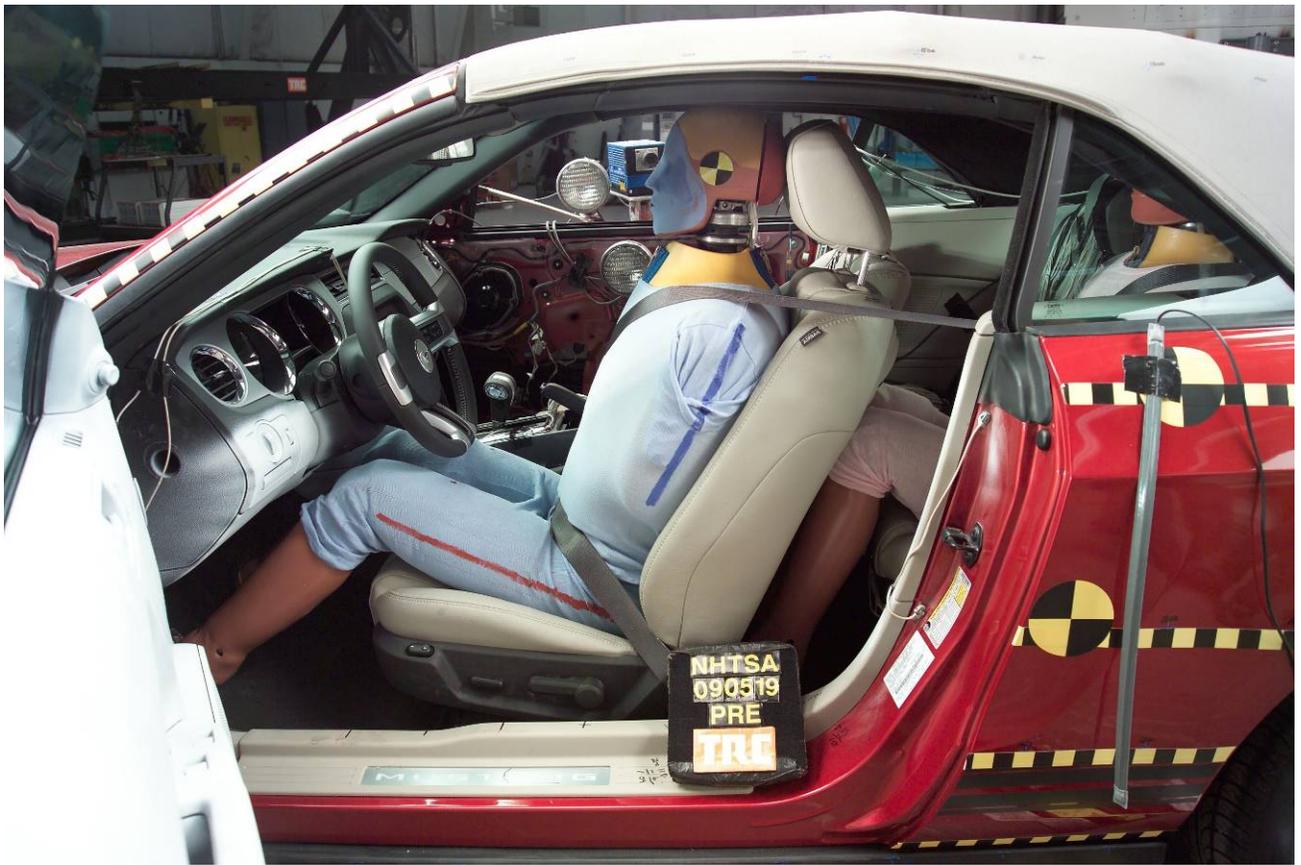
Figure A-45 Pre-Test Left View of Front SID HIII and Belt Position

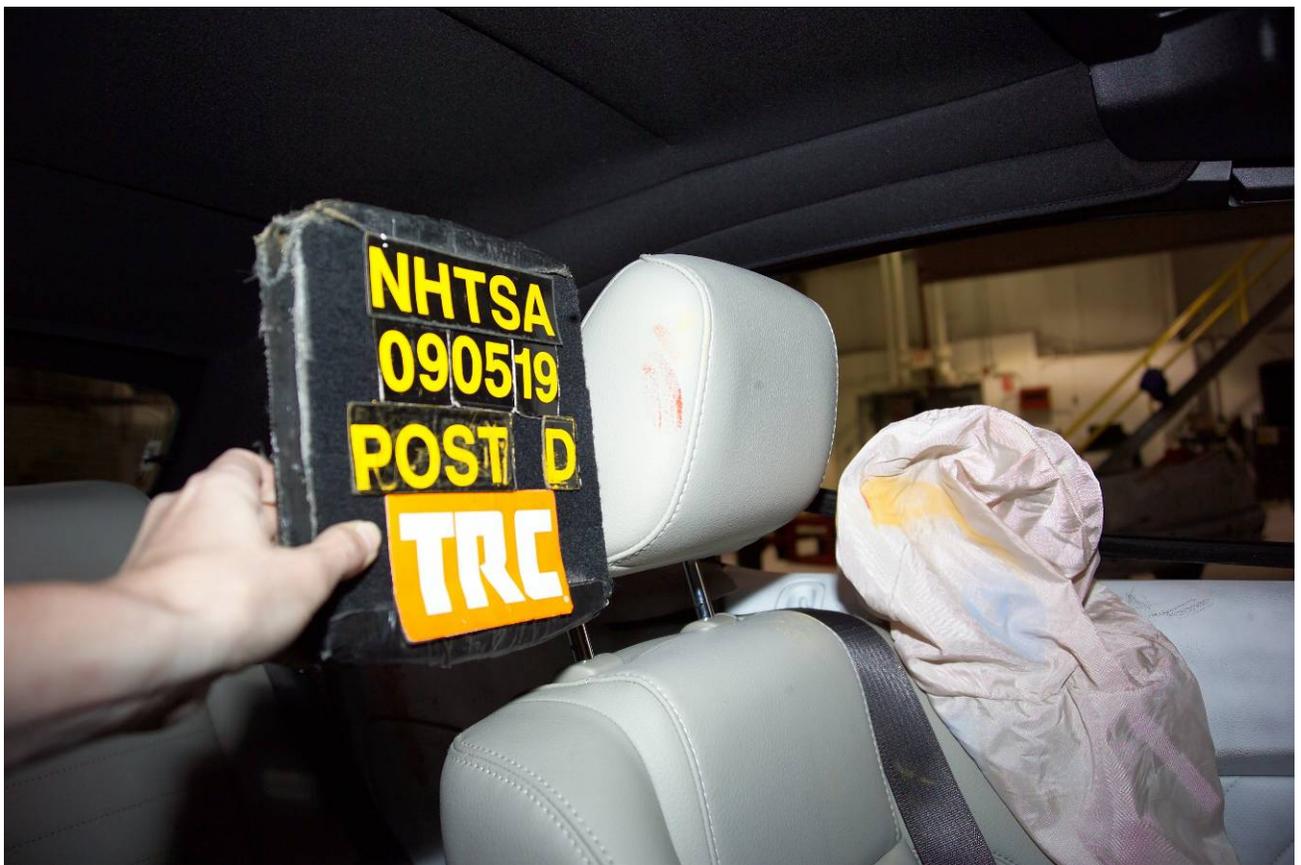
Figure A-54 Post-Test Front SID HIII Contact – View 1

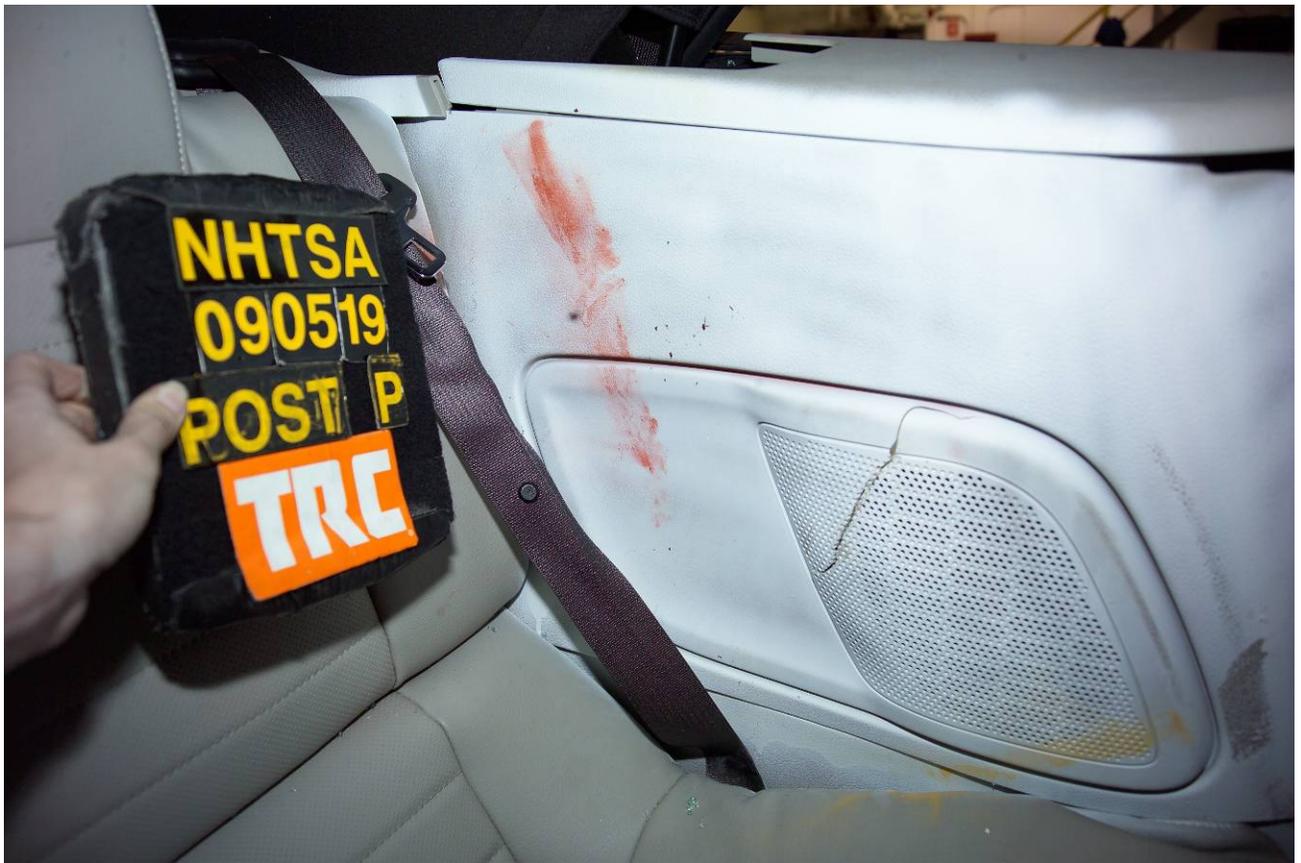
Figure A-60 Post-Test Rear SID HIII Contact – View 3

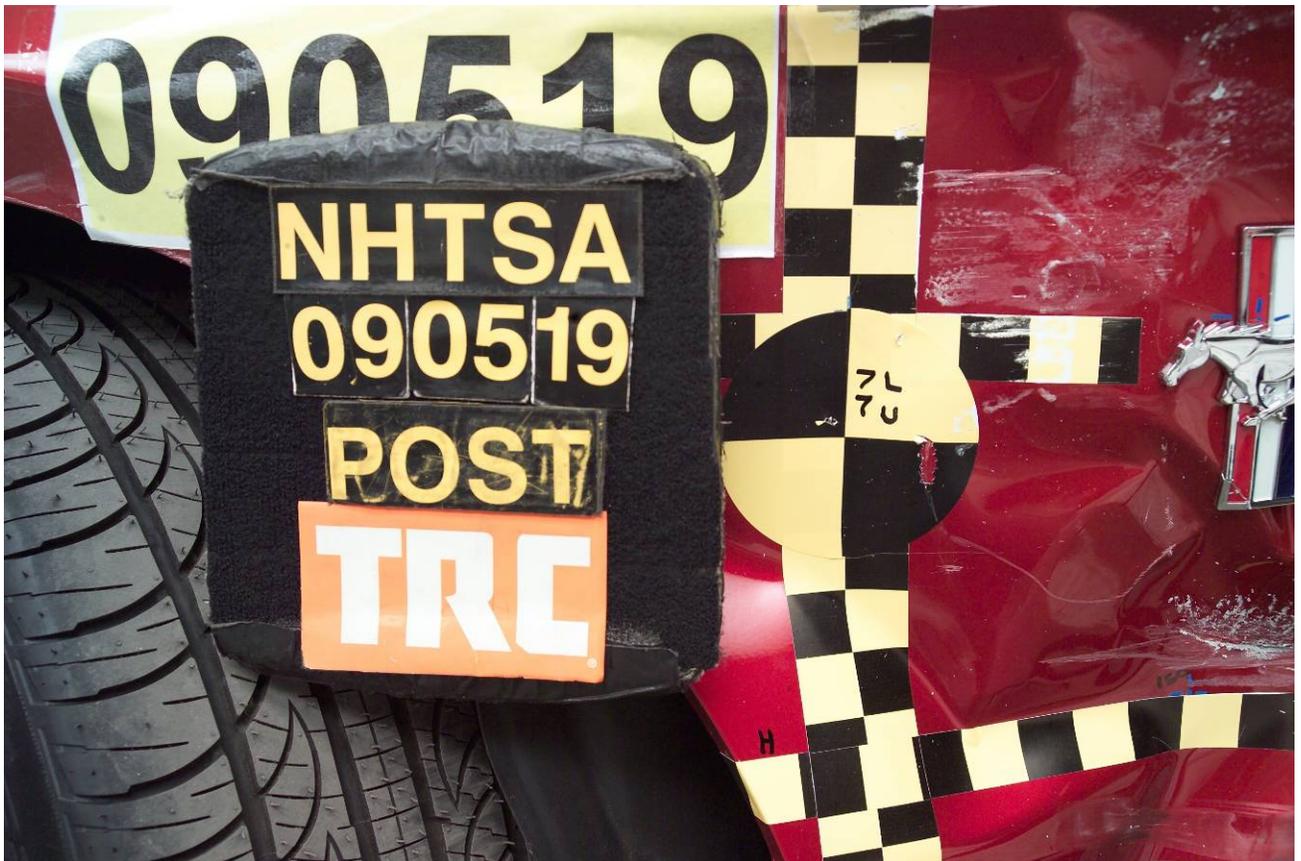
Figure A-63 Post-Test Primary Impact Point View

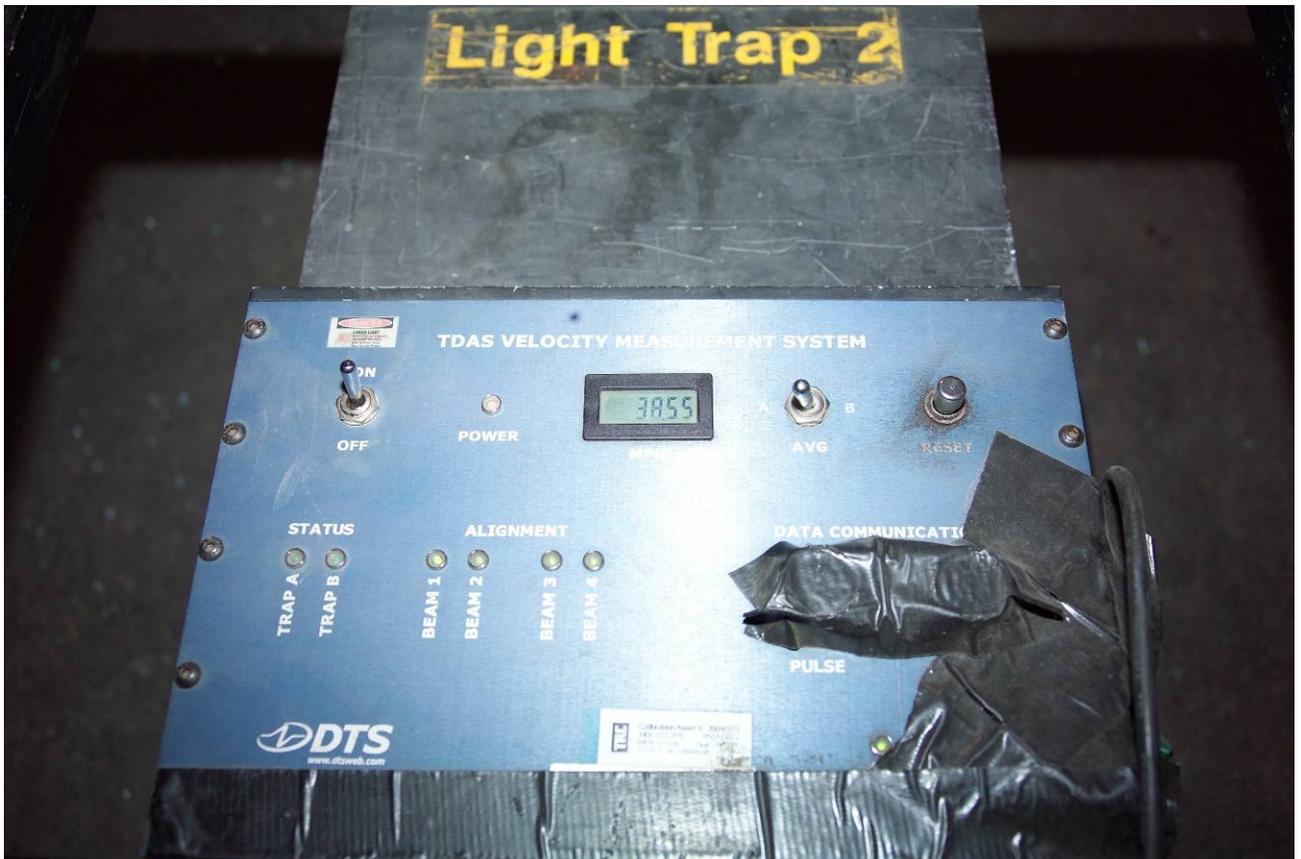
Figure A-70 Post-Test Light Trap Digital Readout – View 1

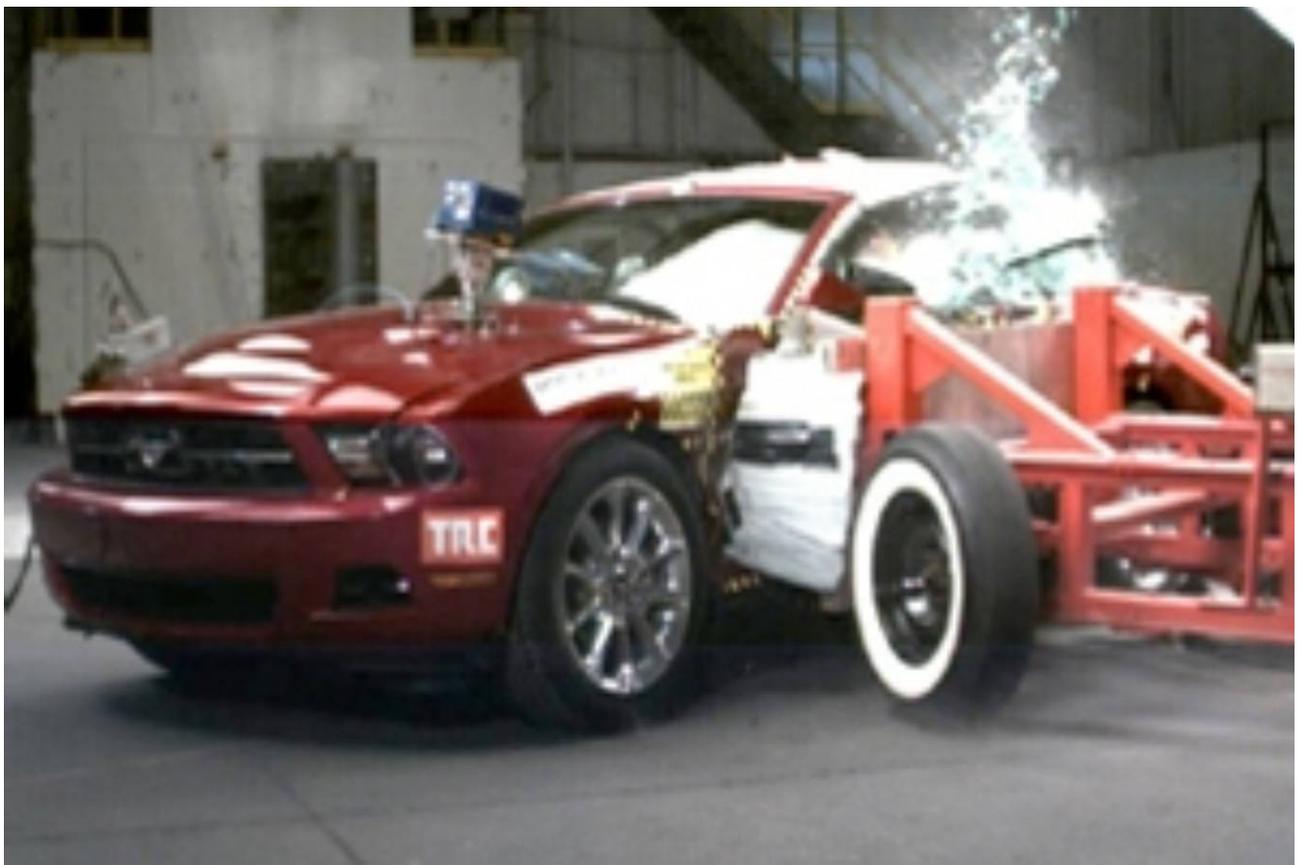
Figure A-73 Impact Event

One (1) real-time motion picture camera and nine (9) high-speed digital motion picture cameras were used to document the impact event. The pre-test and post-test conditions were recorded by one (1) real-time motion picture camera. Camera locations and pertinent camera information are documented in the data sheets. Pre-test and post-test photographs of the vehicle and Side Impact Dummy (SID/HIII) can be found in Appendix A. Two 50th percentile adult male SID/HIIIs were placed in the driver and left rear passenger designated seating positions according to instructions specified in the Laboratory Test Procedure for New Car Assessment Program Side Impact Testing dated January 2002. The SID/HIIIs were instrumented in the following locations:
