REPORT NUMBER TR-P30017-01-NC

**NEW CAR ASSESSMENT PROGRAM
FRONTAL BARRIER IMPACT TEST**

**HONDA OF CANADA MFG.
2010 ACURA ZDX ADVANCE
5-DOOR MPV**

NHTSA NUMBER: HA5300

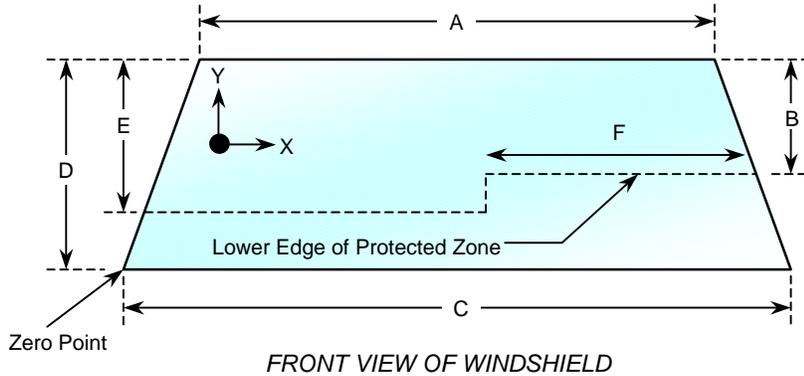
**WINDSHIELD AND
 PROTECTED ZONE**

Item	Units	Value
A	mm	1310
B	mm	477
C	mm	1573
D	mm	817
E	mm	519
F	mm	494

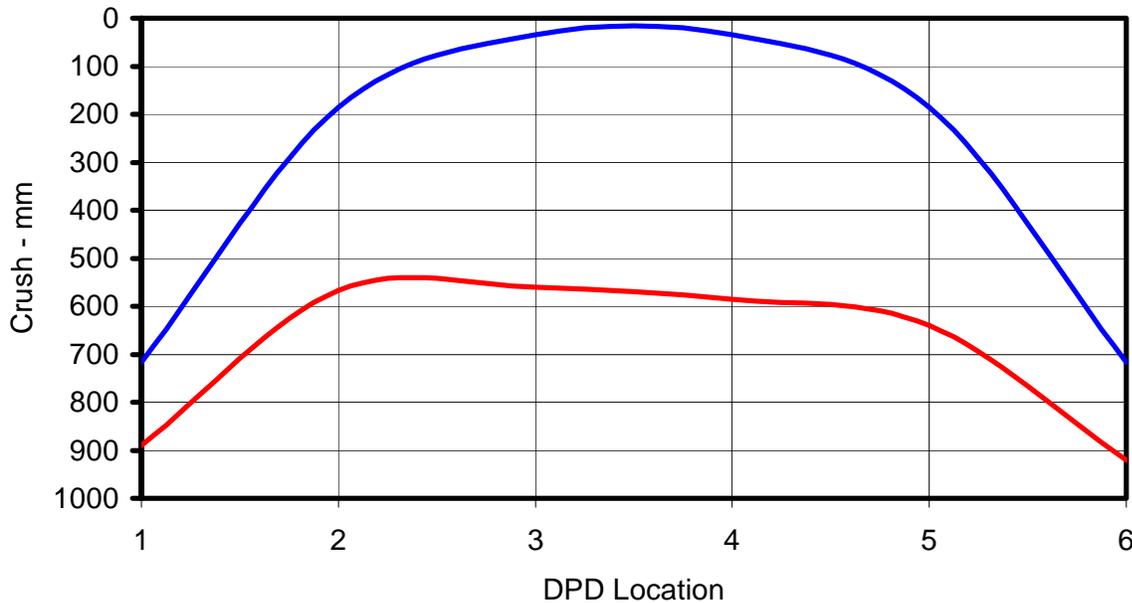
Collision Deformation Classification: 12FCEW2 Midpoint of Damage: Vehicle Centerline
 Damage Region Length: 1965 Impact Mode: Full frontal

No.	Measurement Description	Units	Pre-Test	Post-Test	Difference
C1	Crush zone 1 at left side of vehicle	mm	717	890	-173
C2	Crush zone 2 on left side of vehicle	mm	185	567	-382
C3	Crush zone 3 on left side of vehicle	mm	35	560	-525
C4	Crush zone 4 on right side of vehicle	mm	35	585	-550
C5	Crush zone 5 on right side of vehicle	mm	185	640	-455
C6	Crush zone 6 at right side of vehicle	mm	717	920	-203

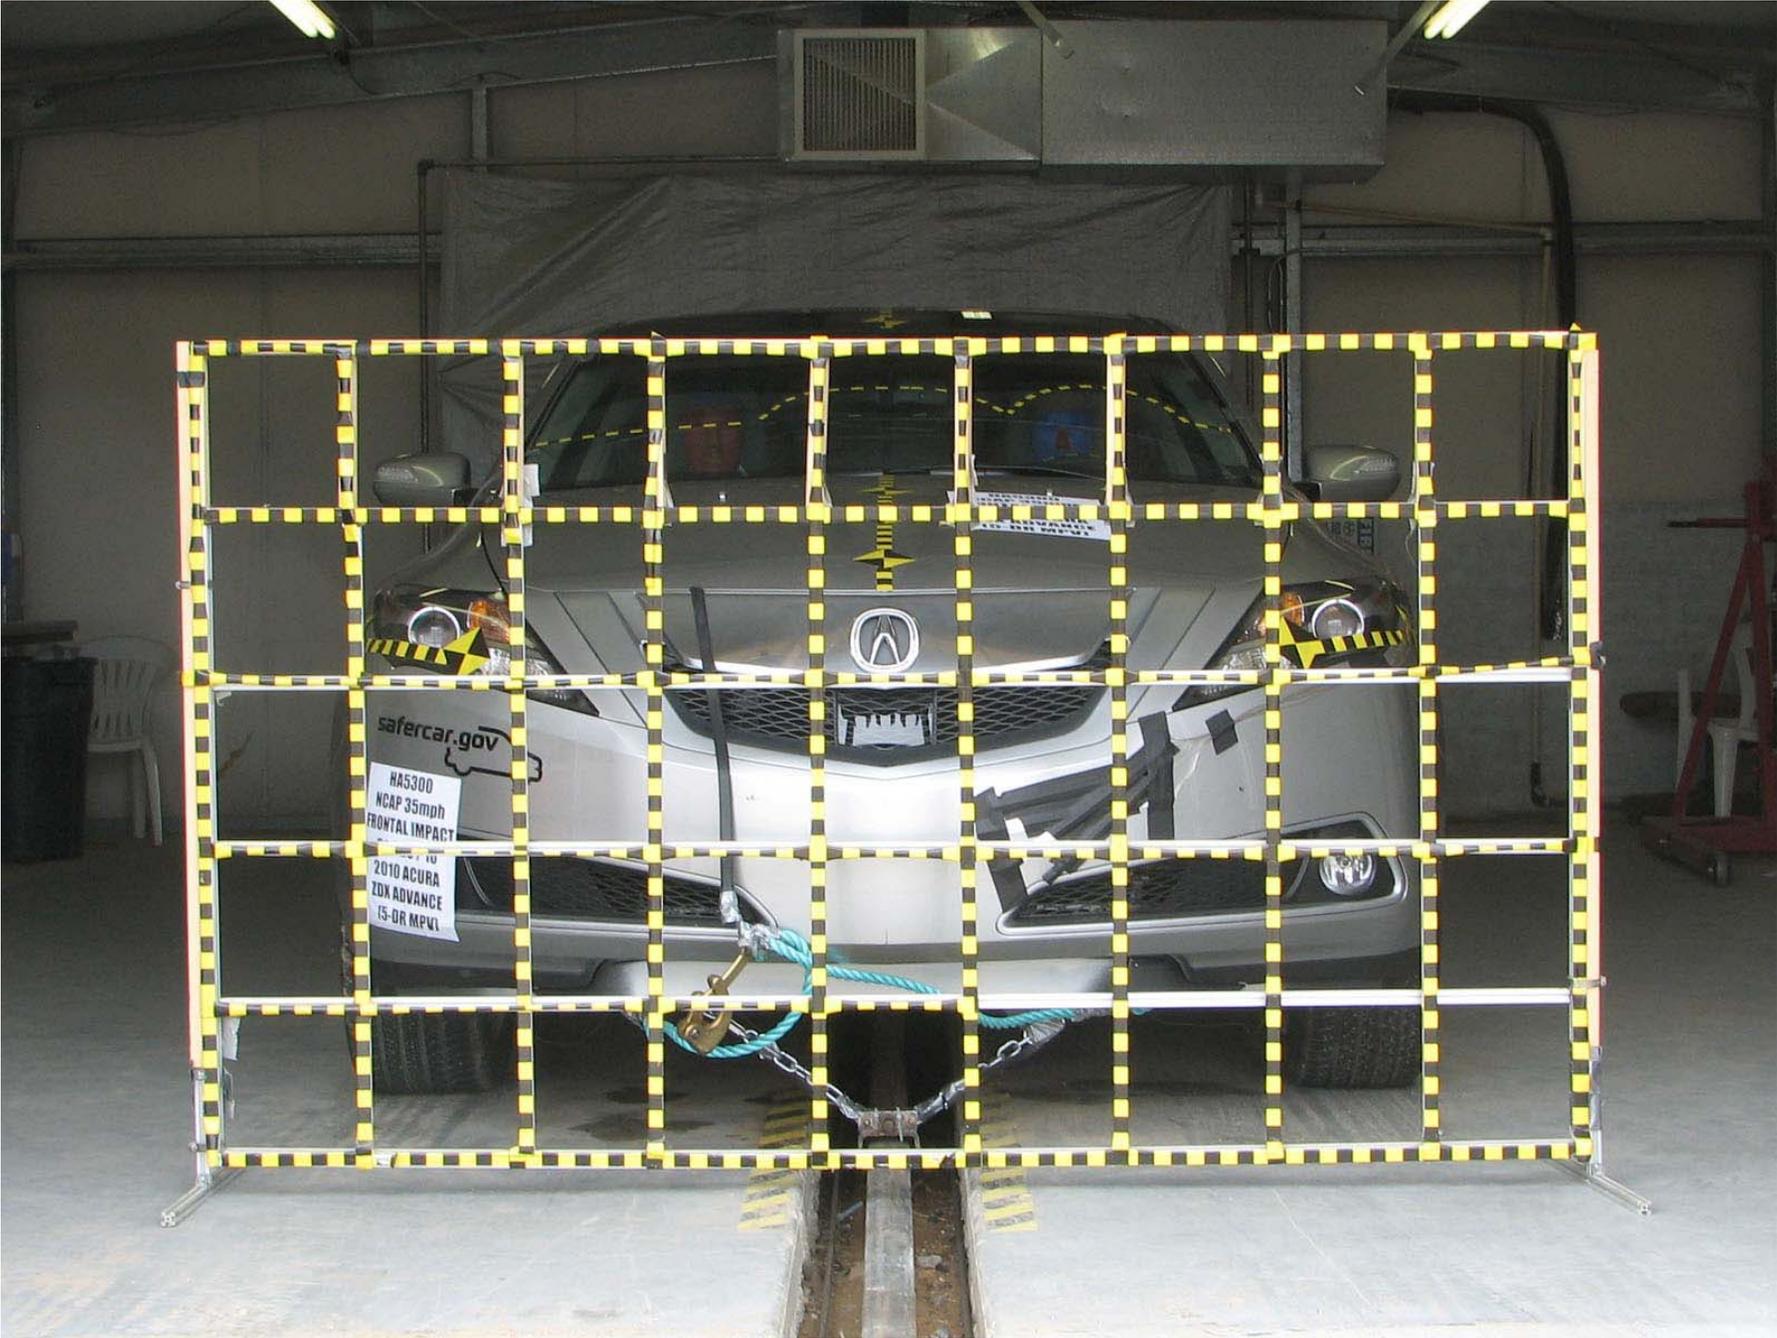
Figure A-1: Load Cell Location

A load cell barrier consisting of 36 load cells was impacted by a 2010 Acura ZDX Advance 5-Door MPV at a velocity of 56.30 km/h. The test was performed at KARCO Engineering, LLC on January 20, 2010.

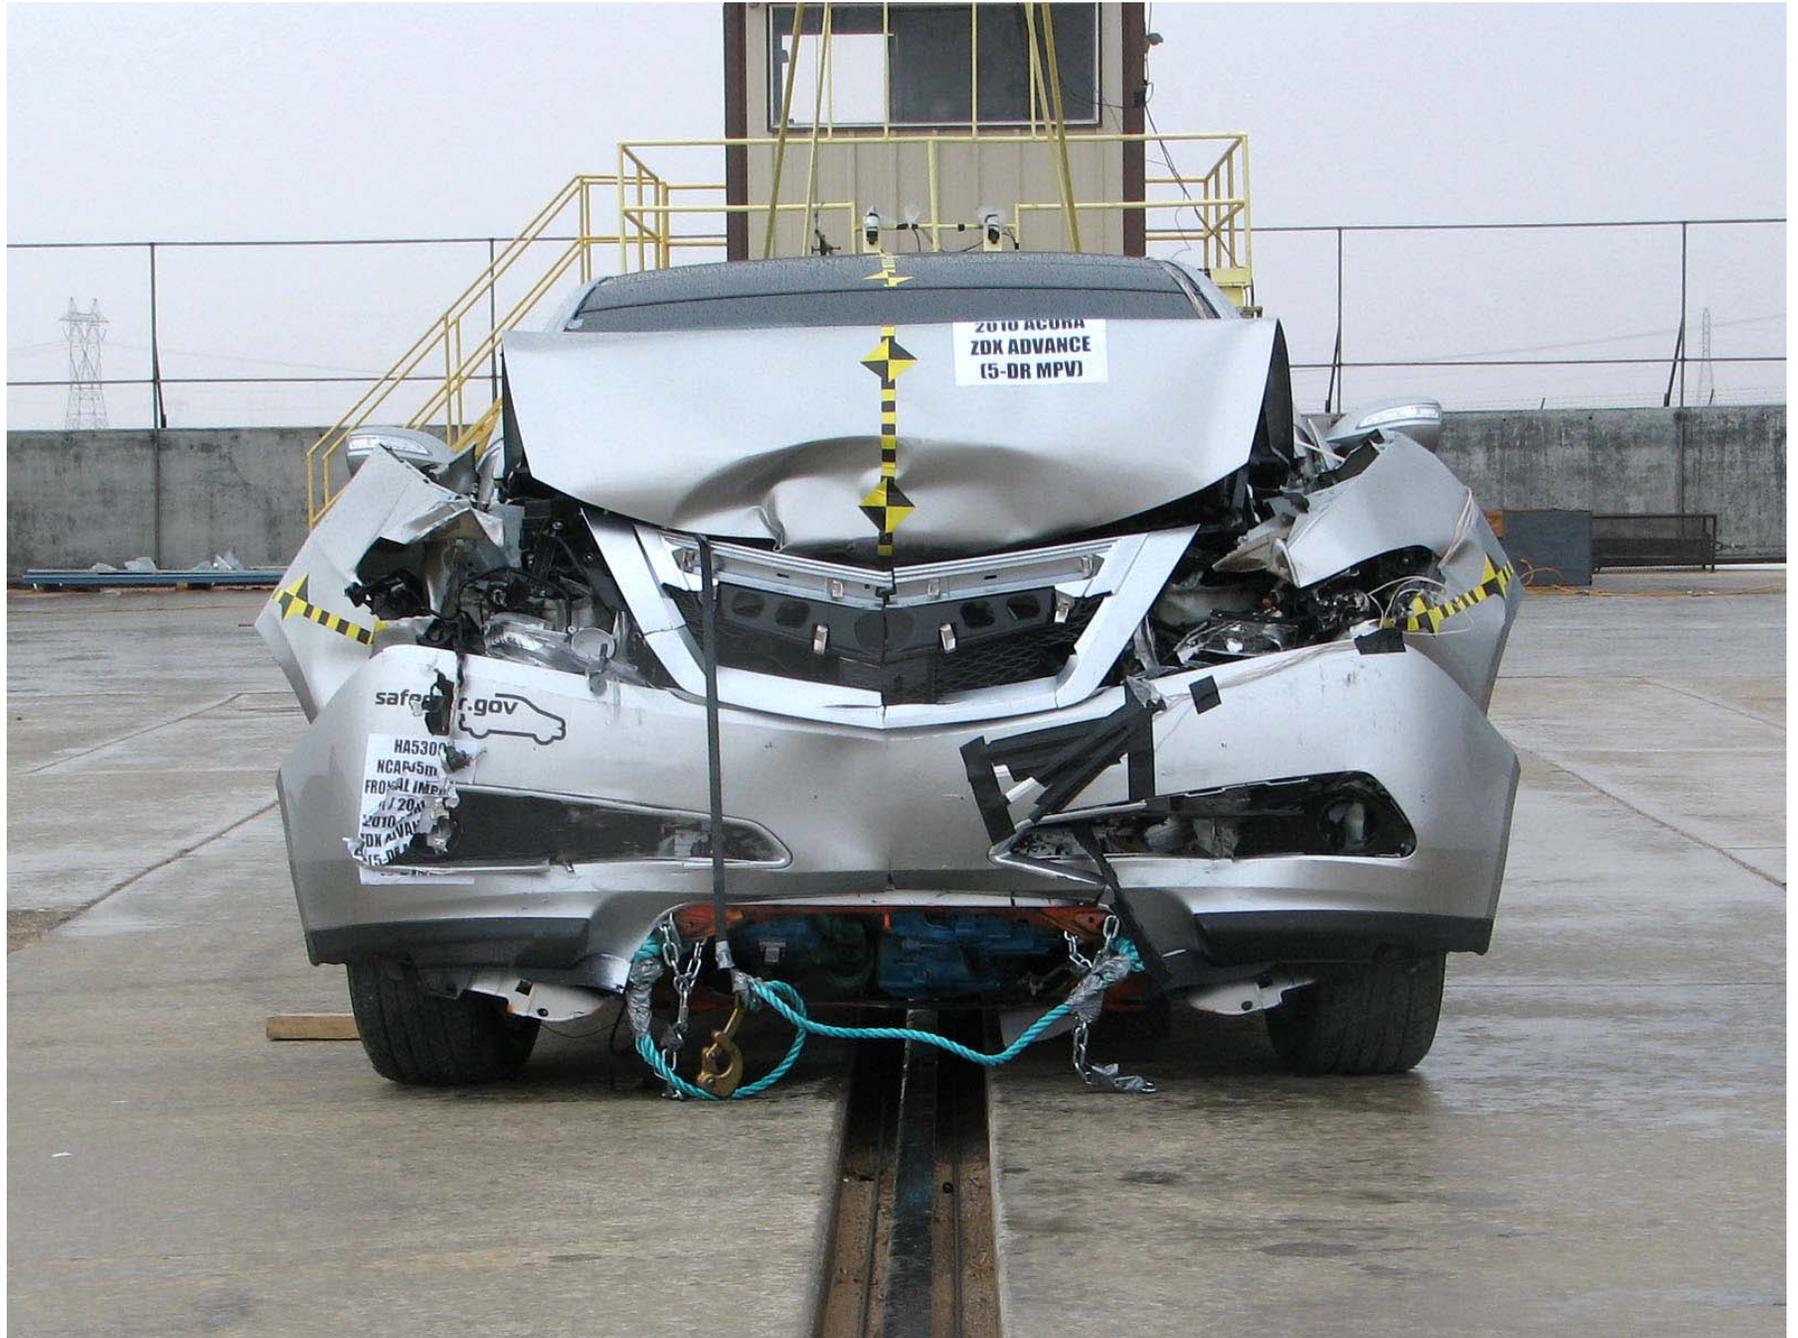
Figure A-7: Post-Test Front View (Vehicle Moved)

The maximum static crush of the vehicle was 561 mm at the vehicle's centerline. Both the driver and passenger side doors remained closed and latched during the impact event, and were operable after the impact.

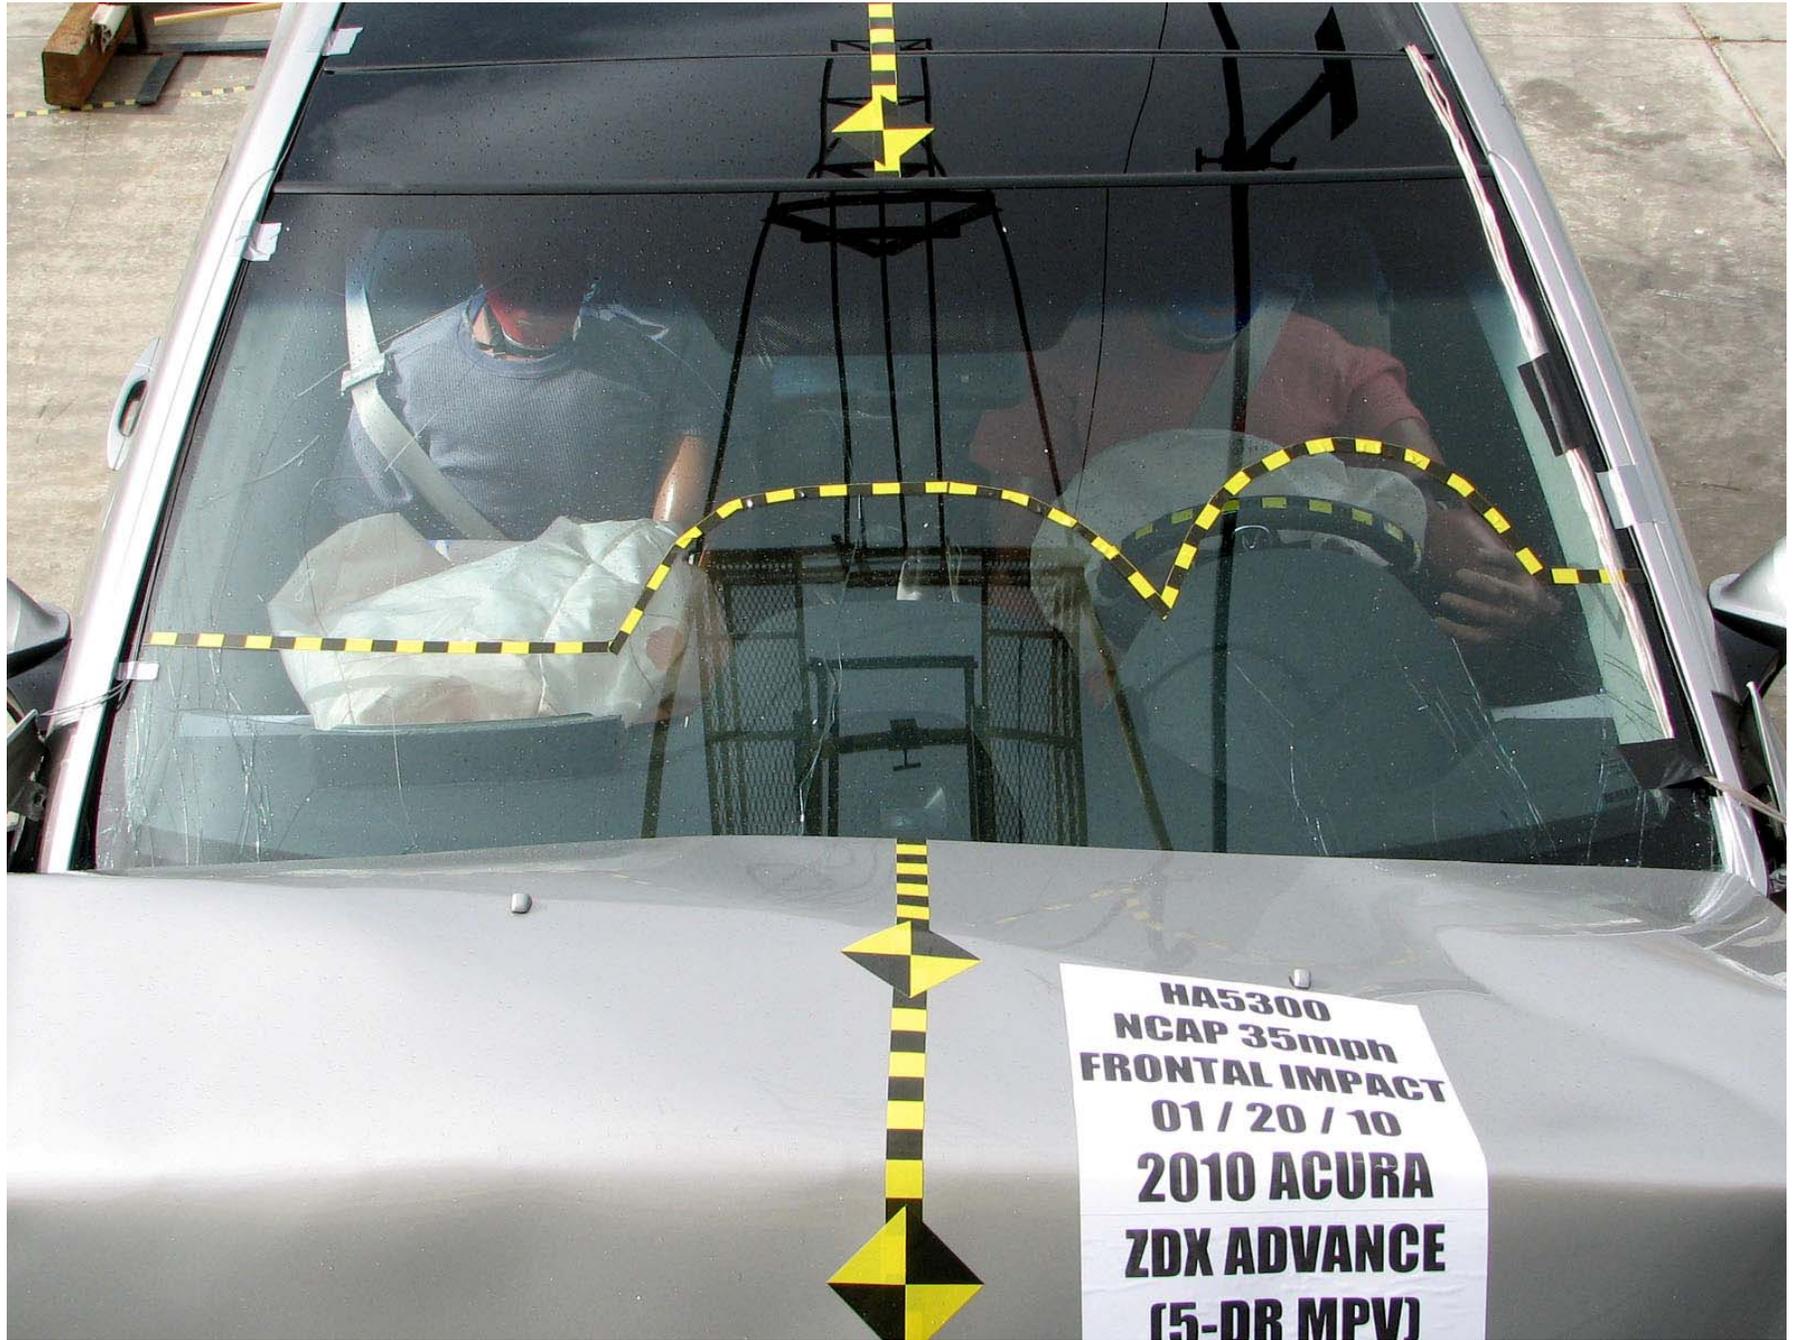
Figure A-19: Post-Test Windshield

There was 100% windshield retention and no intrusion into the protected zone of the windshield during impact. There was no Stoddard solvent leakage after the event, or during any phase of the static rollover.

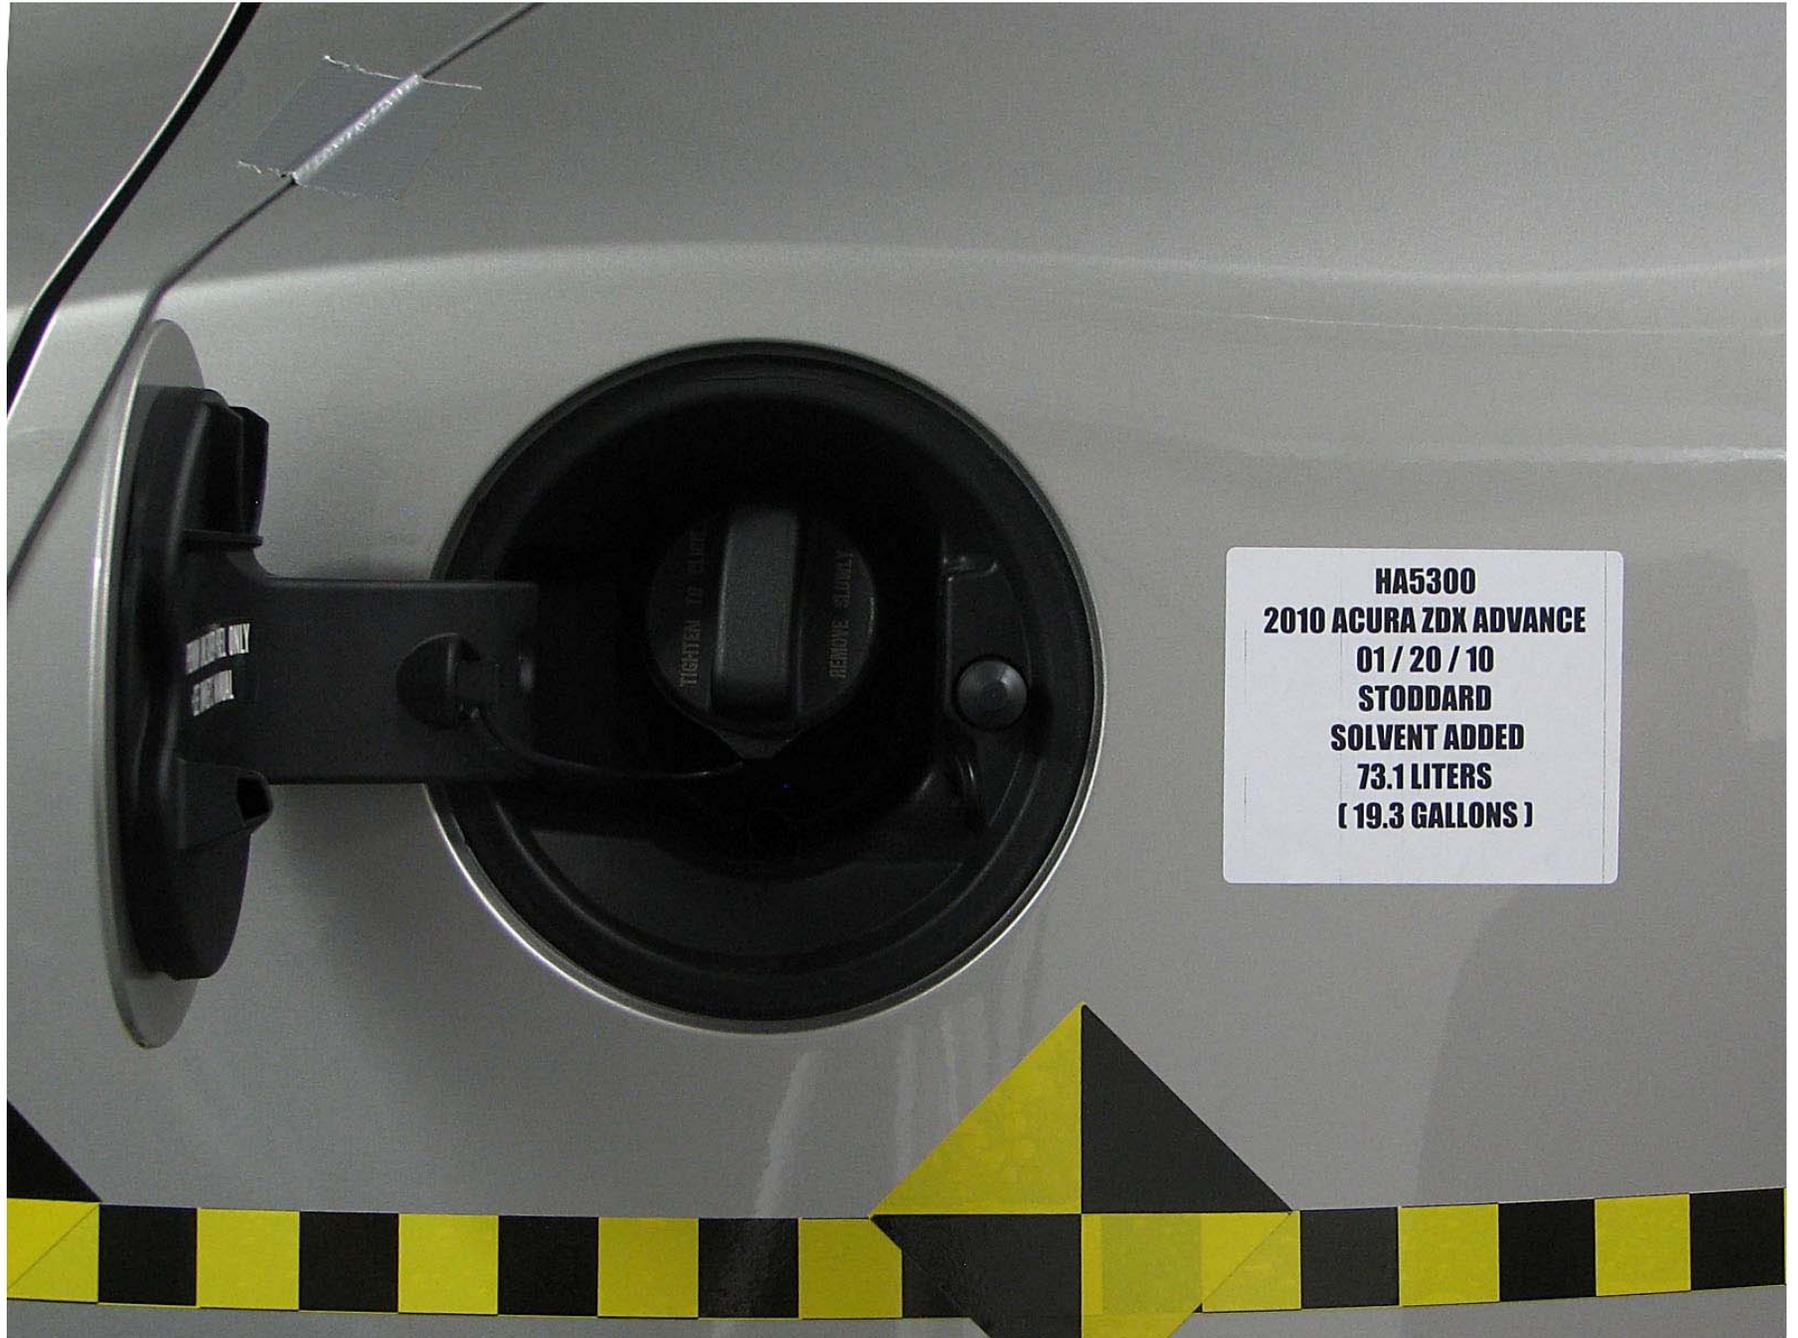
Figure A-22: Pre-Test Fuel Cap

HA5300
2010 ACURA ZDX ADVANCE
01 / 20 / 10
STODDARD
SOLVENT ADDED
73.1 LITERS
(19.3 GALLONS)

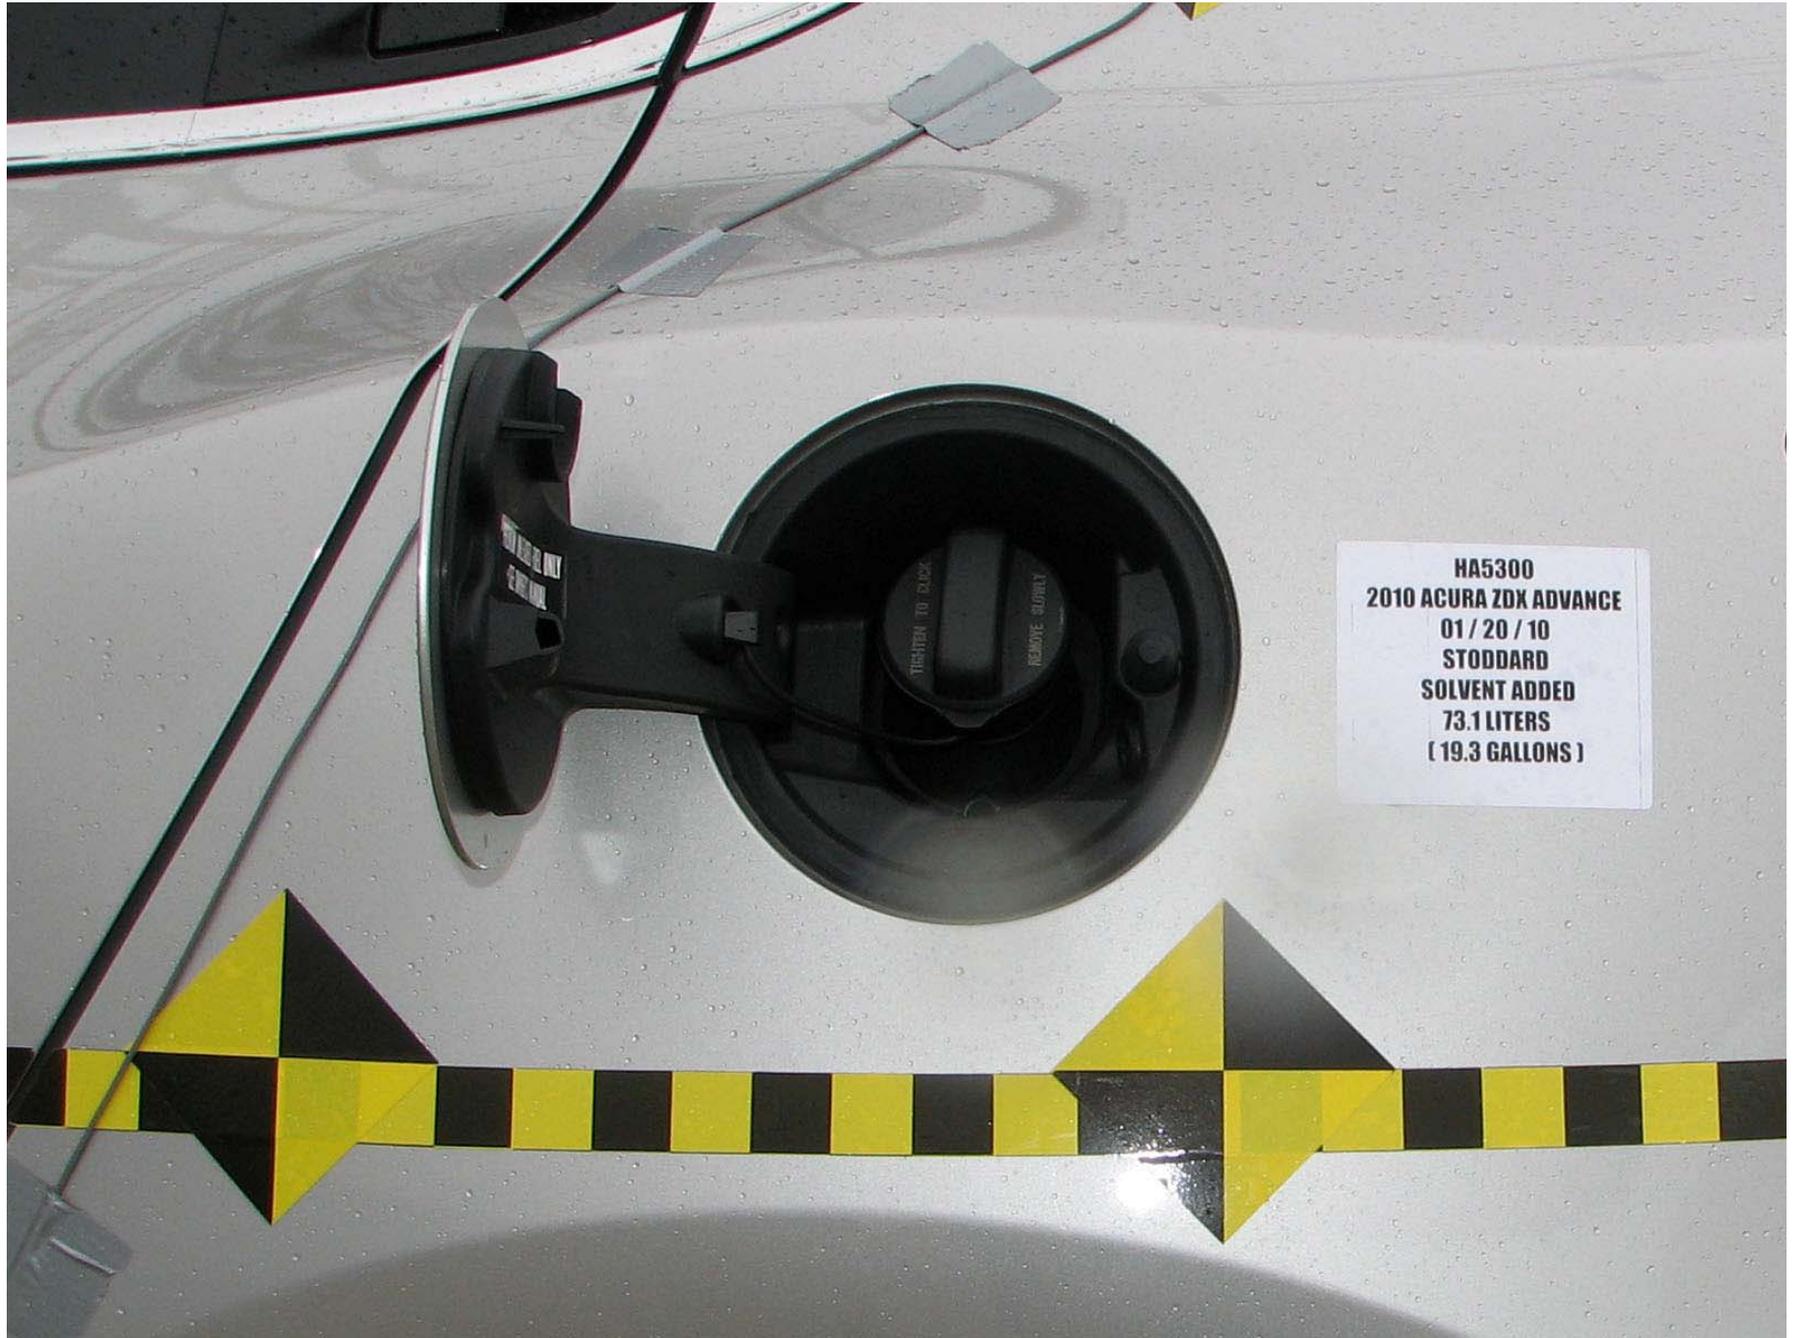
Figure A-23: Post-Test Fuel Cap

- A. From impact until vehicle motion ceases: 0
(Maximum allowable = 1 ounce)
- B. For the 5 minute period after motion ceases: 0
(Maximum allowable = 5 ounces)
- C. For the following 25 minutes: 0
(Maximum allowable = 1 oz/minute)
- D. Spillage Details: No leakage occurred.

HA5300
2010 ACURA ZDX ADVANCE
01 / 20 / 10
STODDARD
SOLVENT ADDED
73.1 LITERS
(19.3 GALLONS)

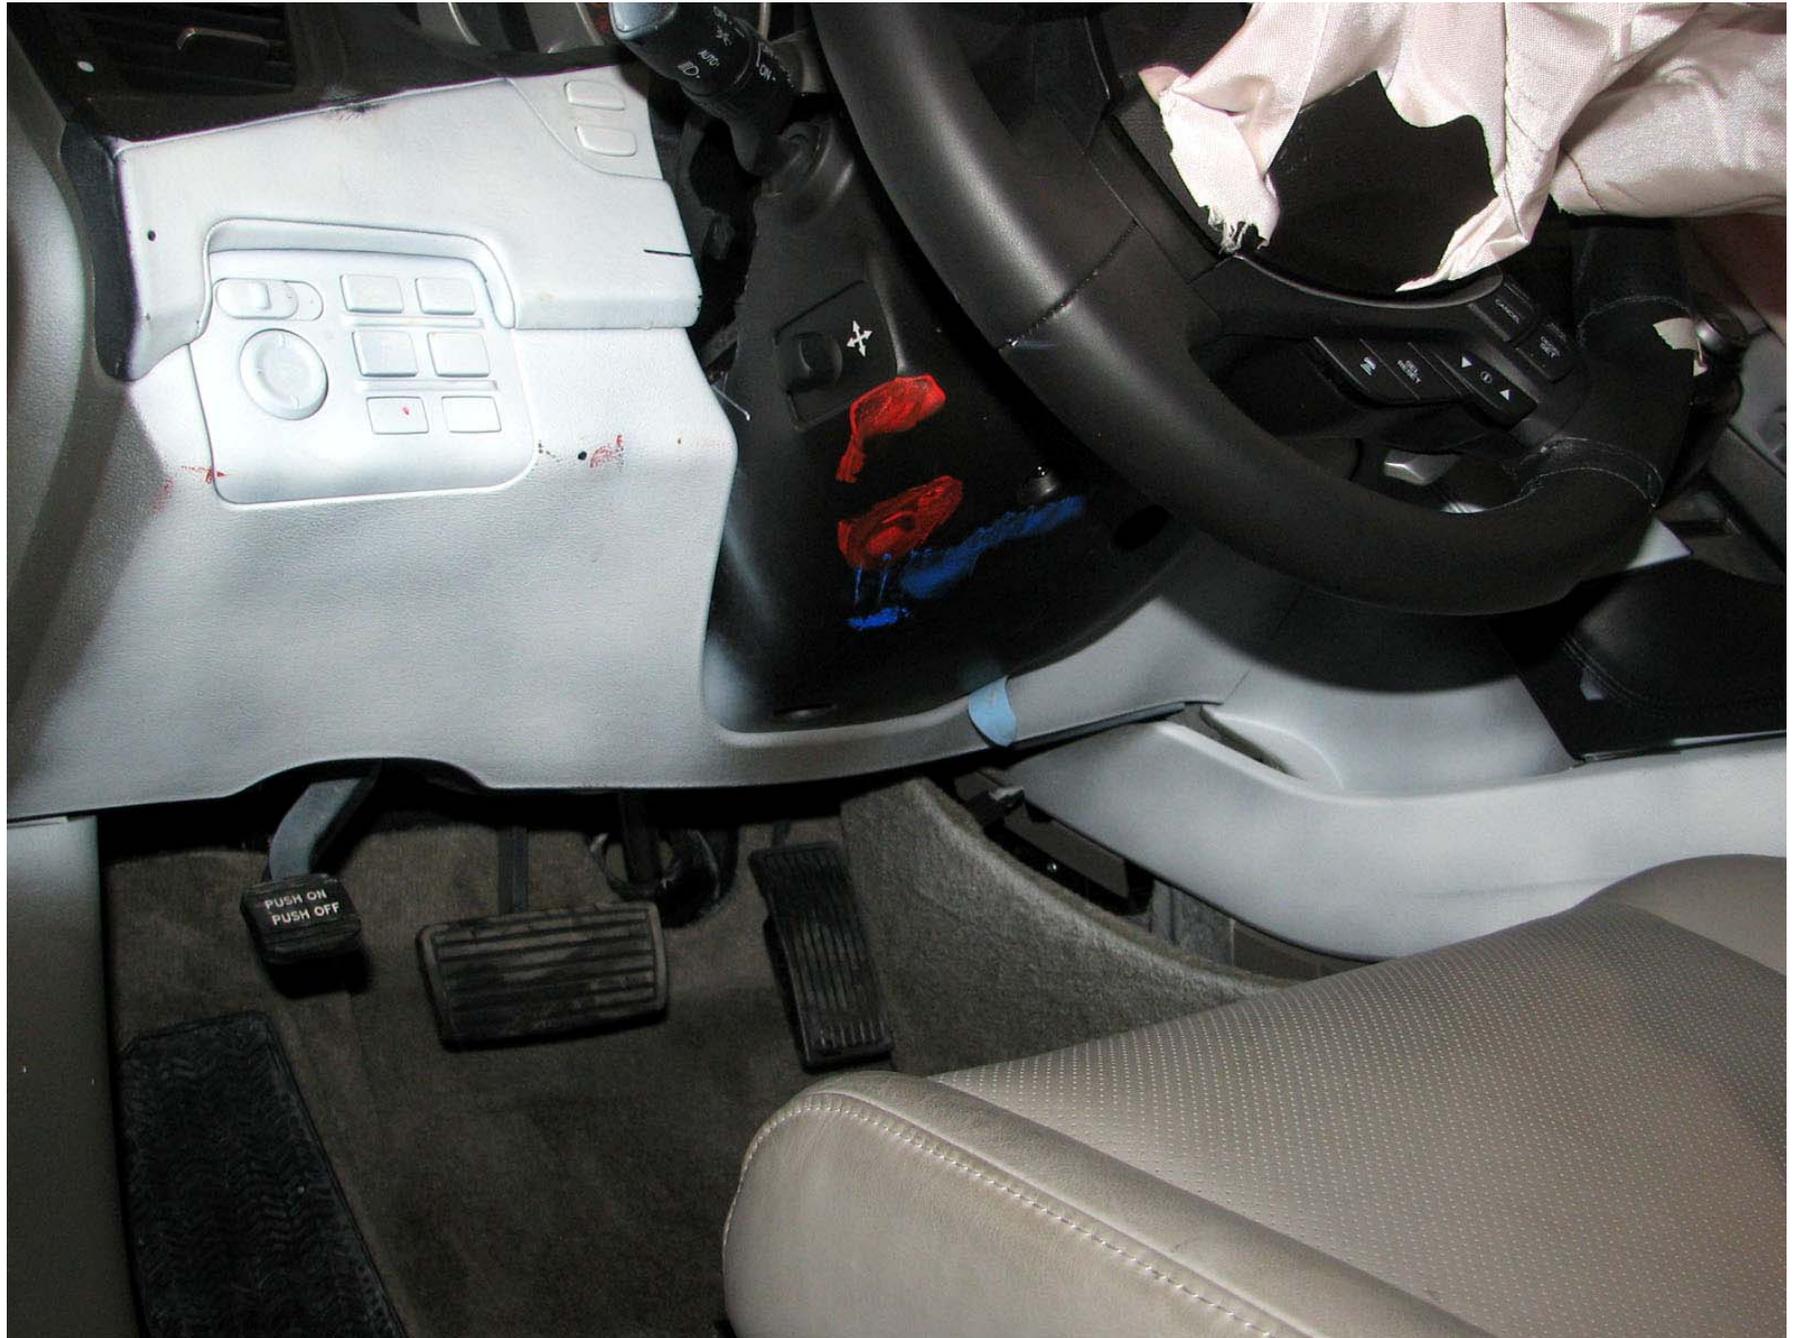
Figure A-39: Post-Test Driver Side Knee Bolster

The driver's visible contact points were as follows: The driver ATD's head and chest contacted the airbag. The head also contacted the headrest. Both knees contacted the knee bolster.

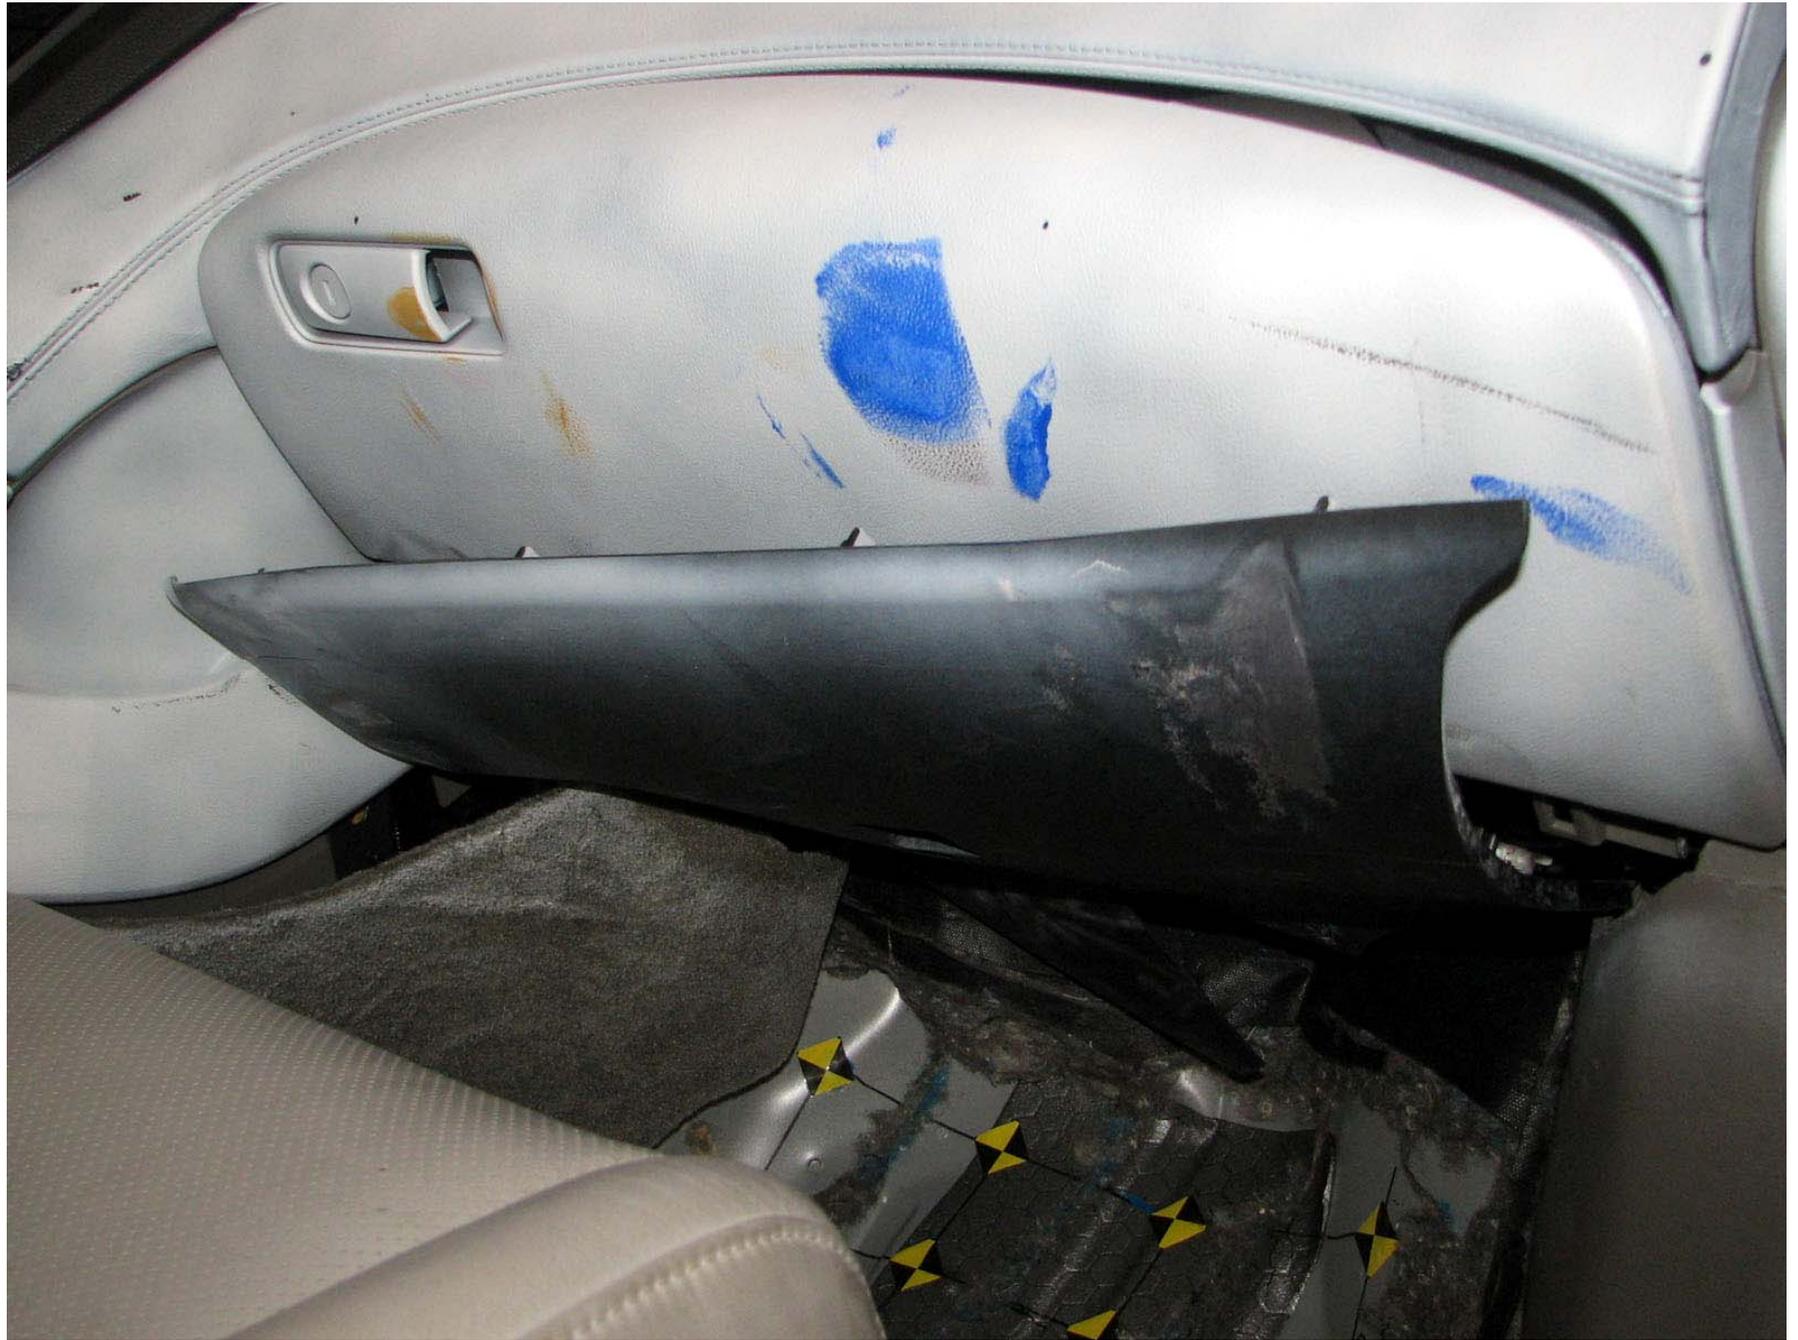
Figure A-53: Post-Test Passenger Side Glove Box

The passenger's visible contact points were as follows: The passenger ATD's head and chest contacted the airbag. The head also contacted the headrest. Both knees contacted the glovebox.

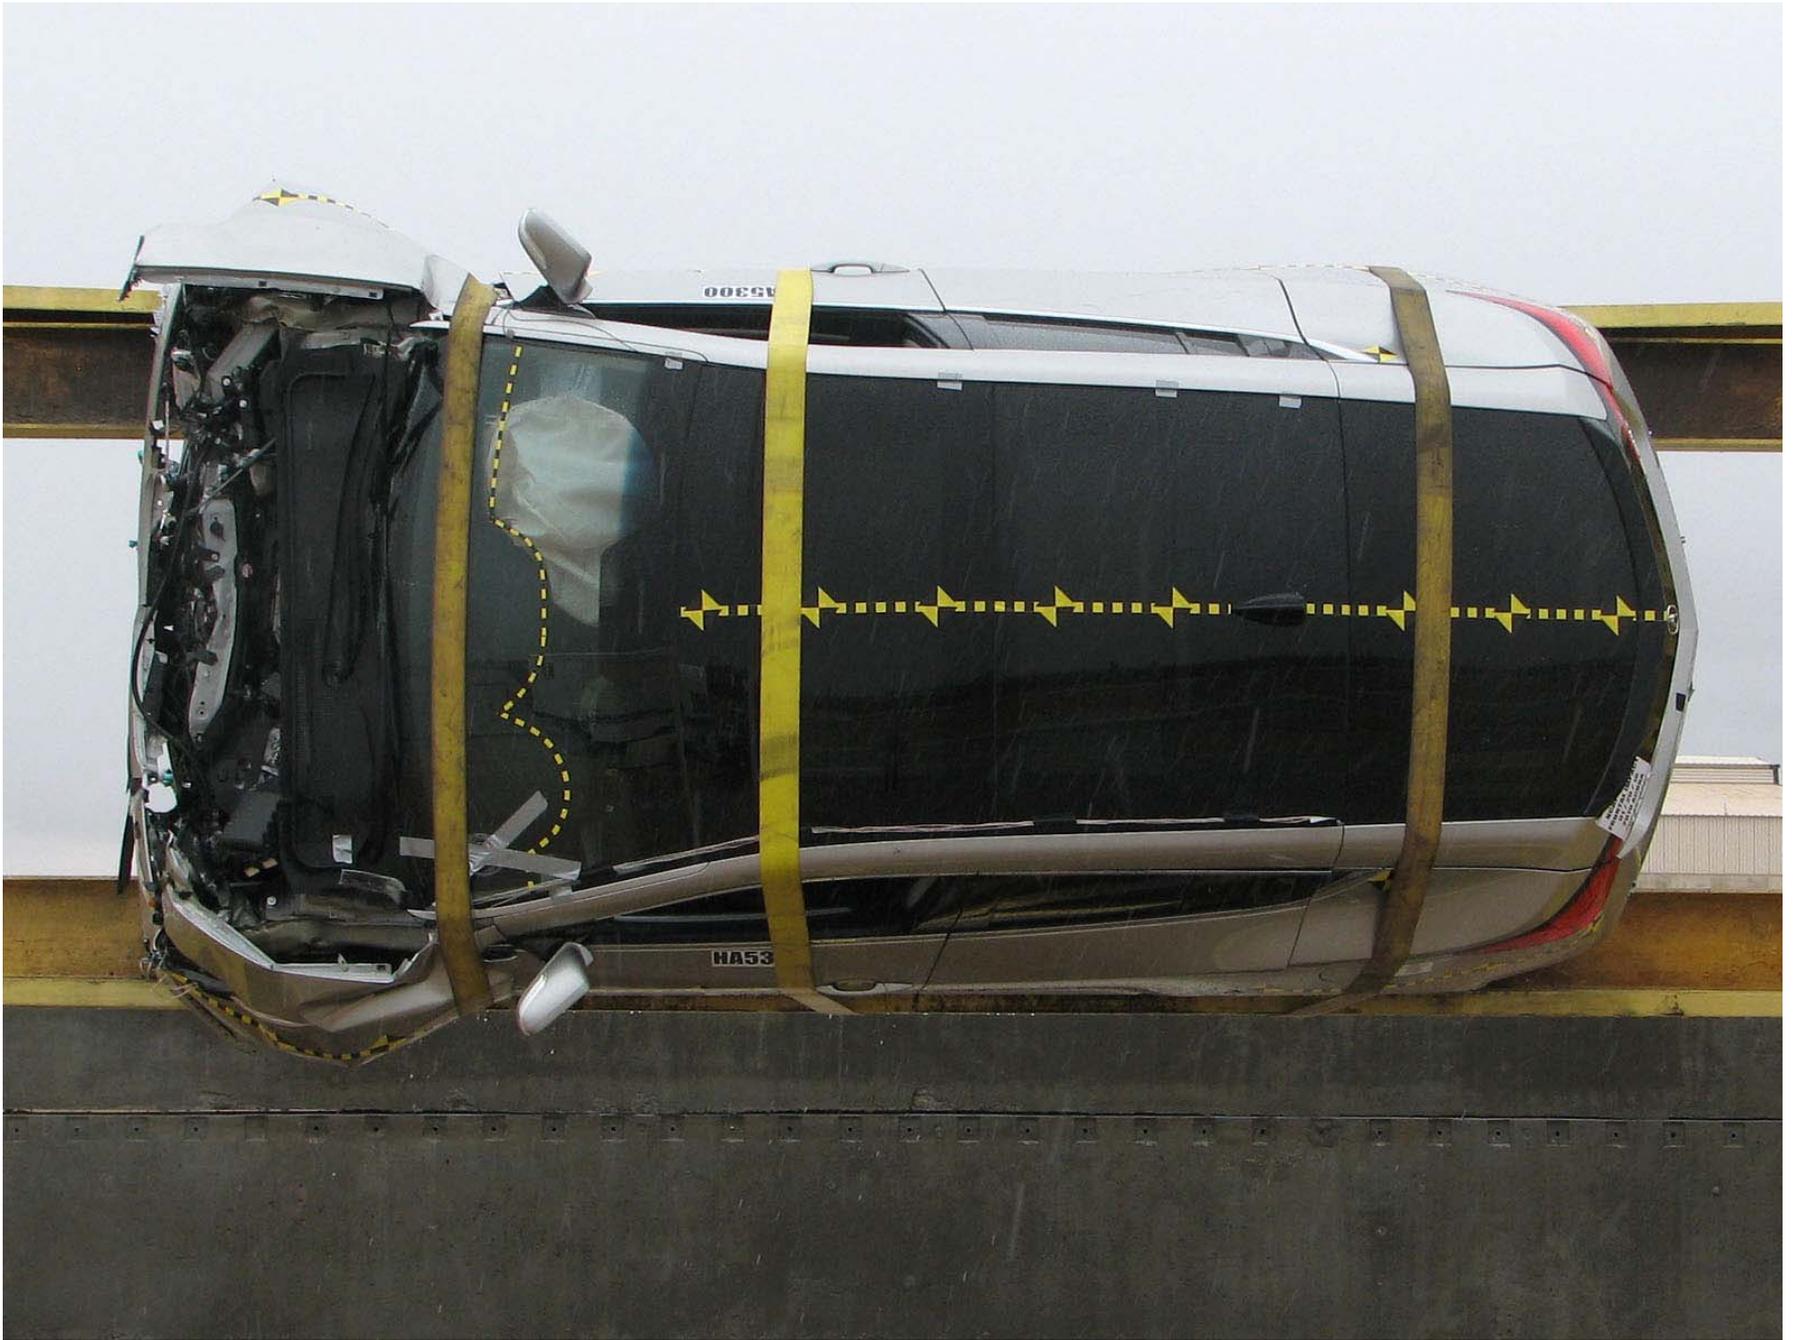
Figure A-59: Vehicle on Rollover Device (90°)

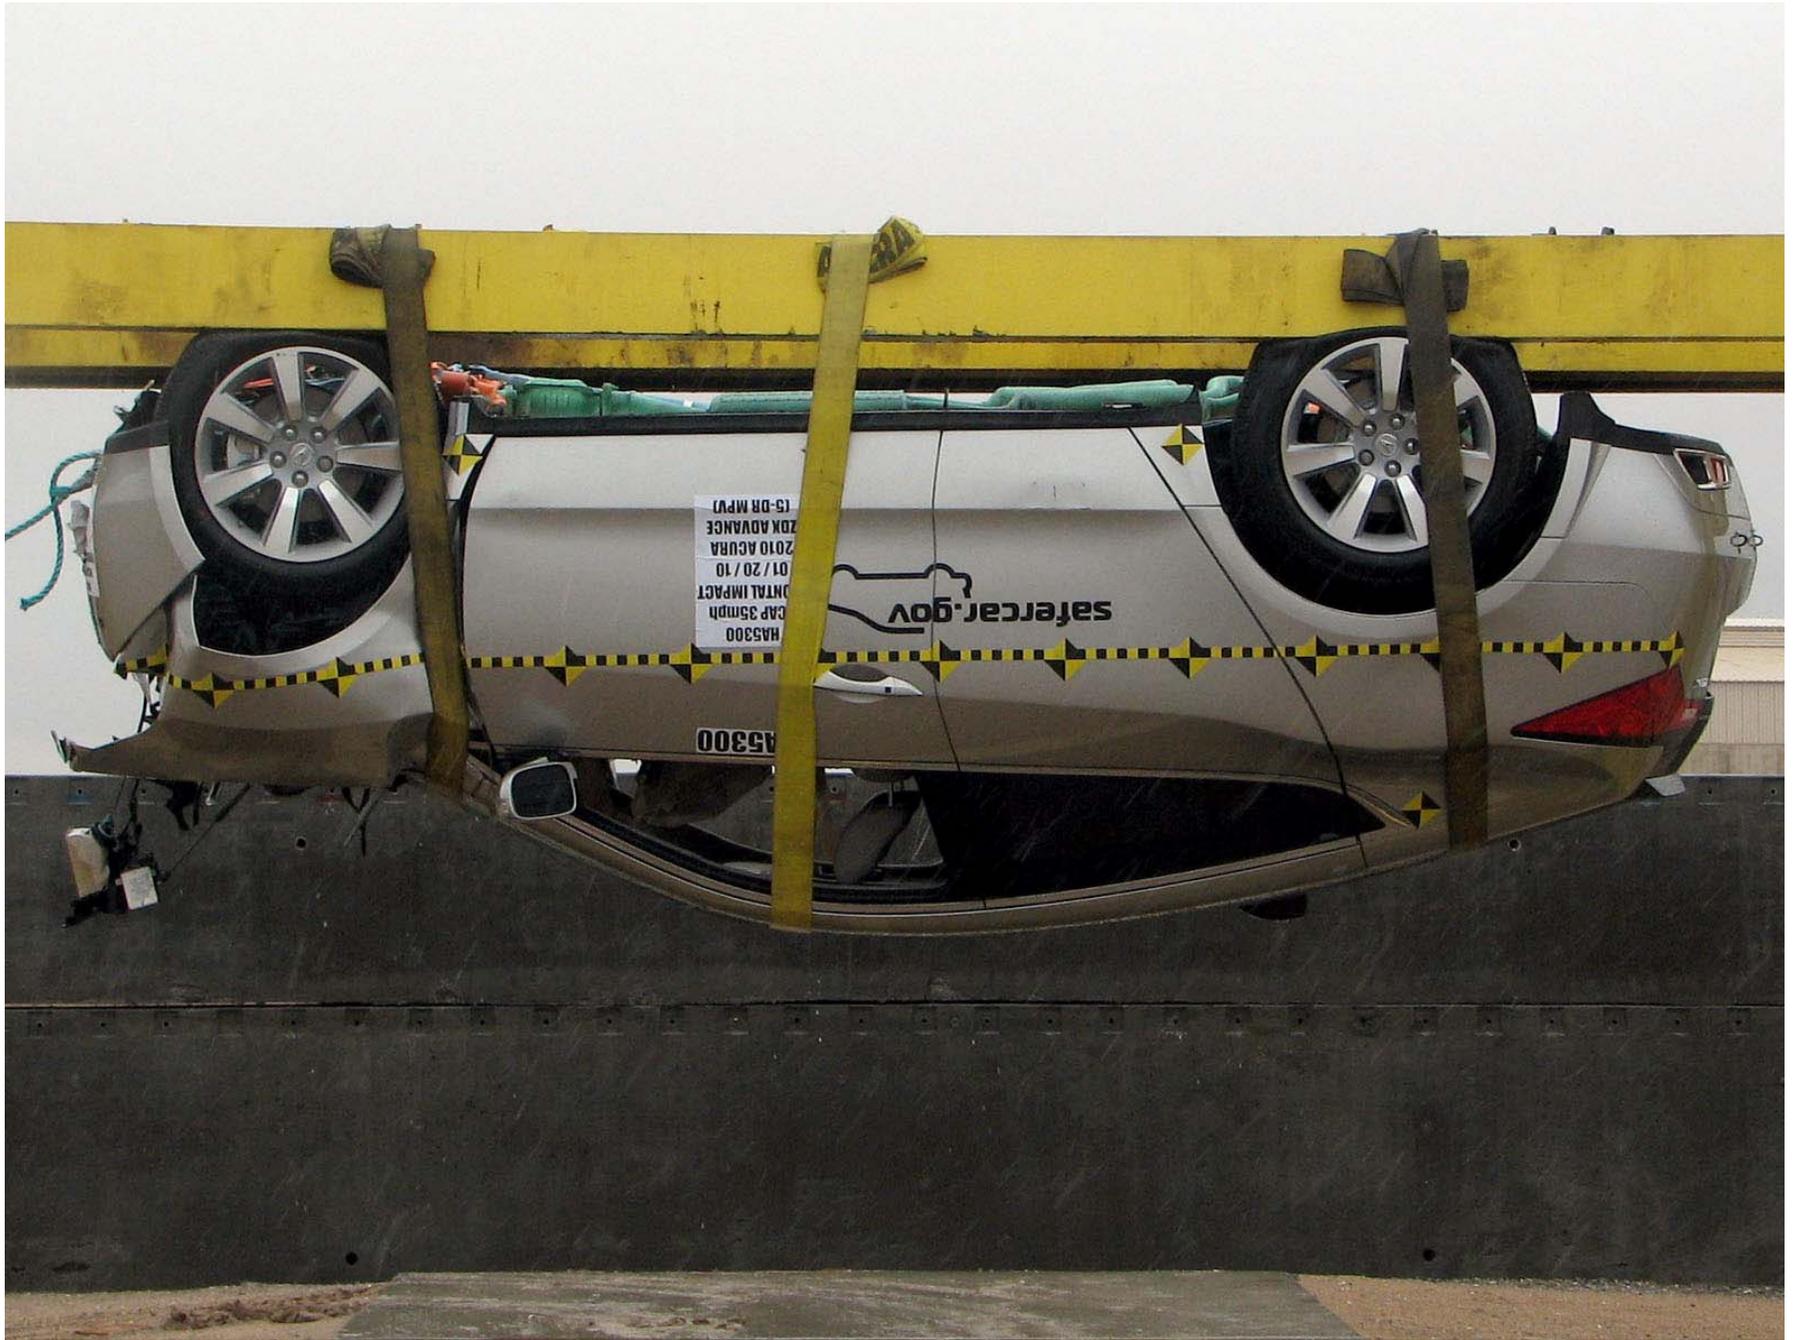
Figure A-60: Vehicle on Rollover Device (180°)
