REPORT NUMBER TR-P30017-01-NC

**NEW CAR ASSESSMENT PROGRAM
FRONTAL BARRIER IMPACT TEST**

**HONDA OF CANADA MFG.
2010 ACURA ZDX ADVANCE
5-DOOR MPV**

NHTSA NUMBER: HA5300

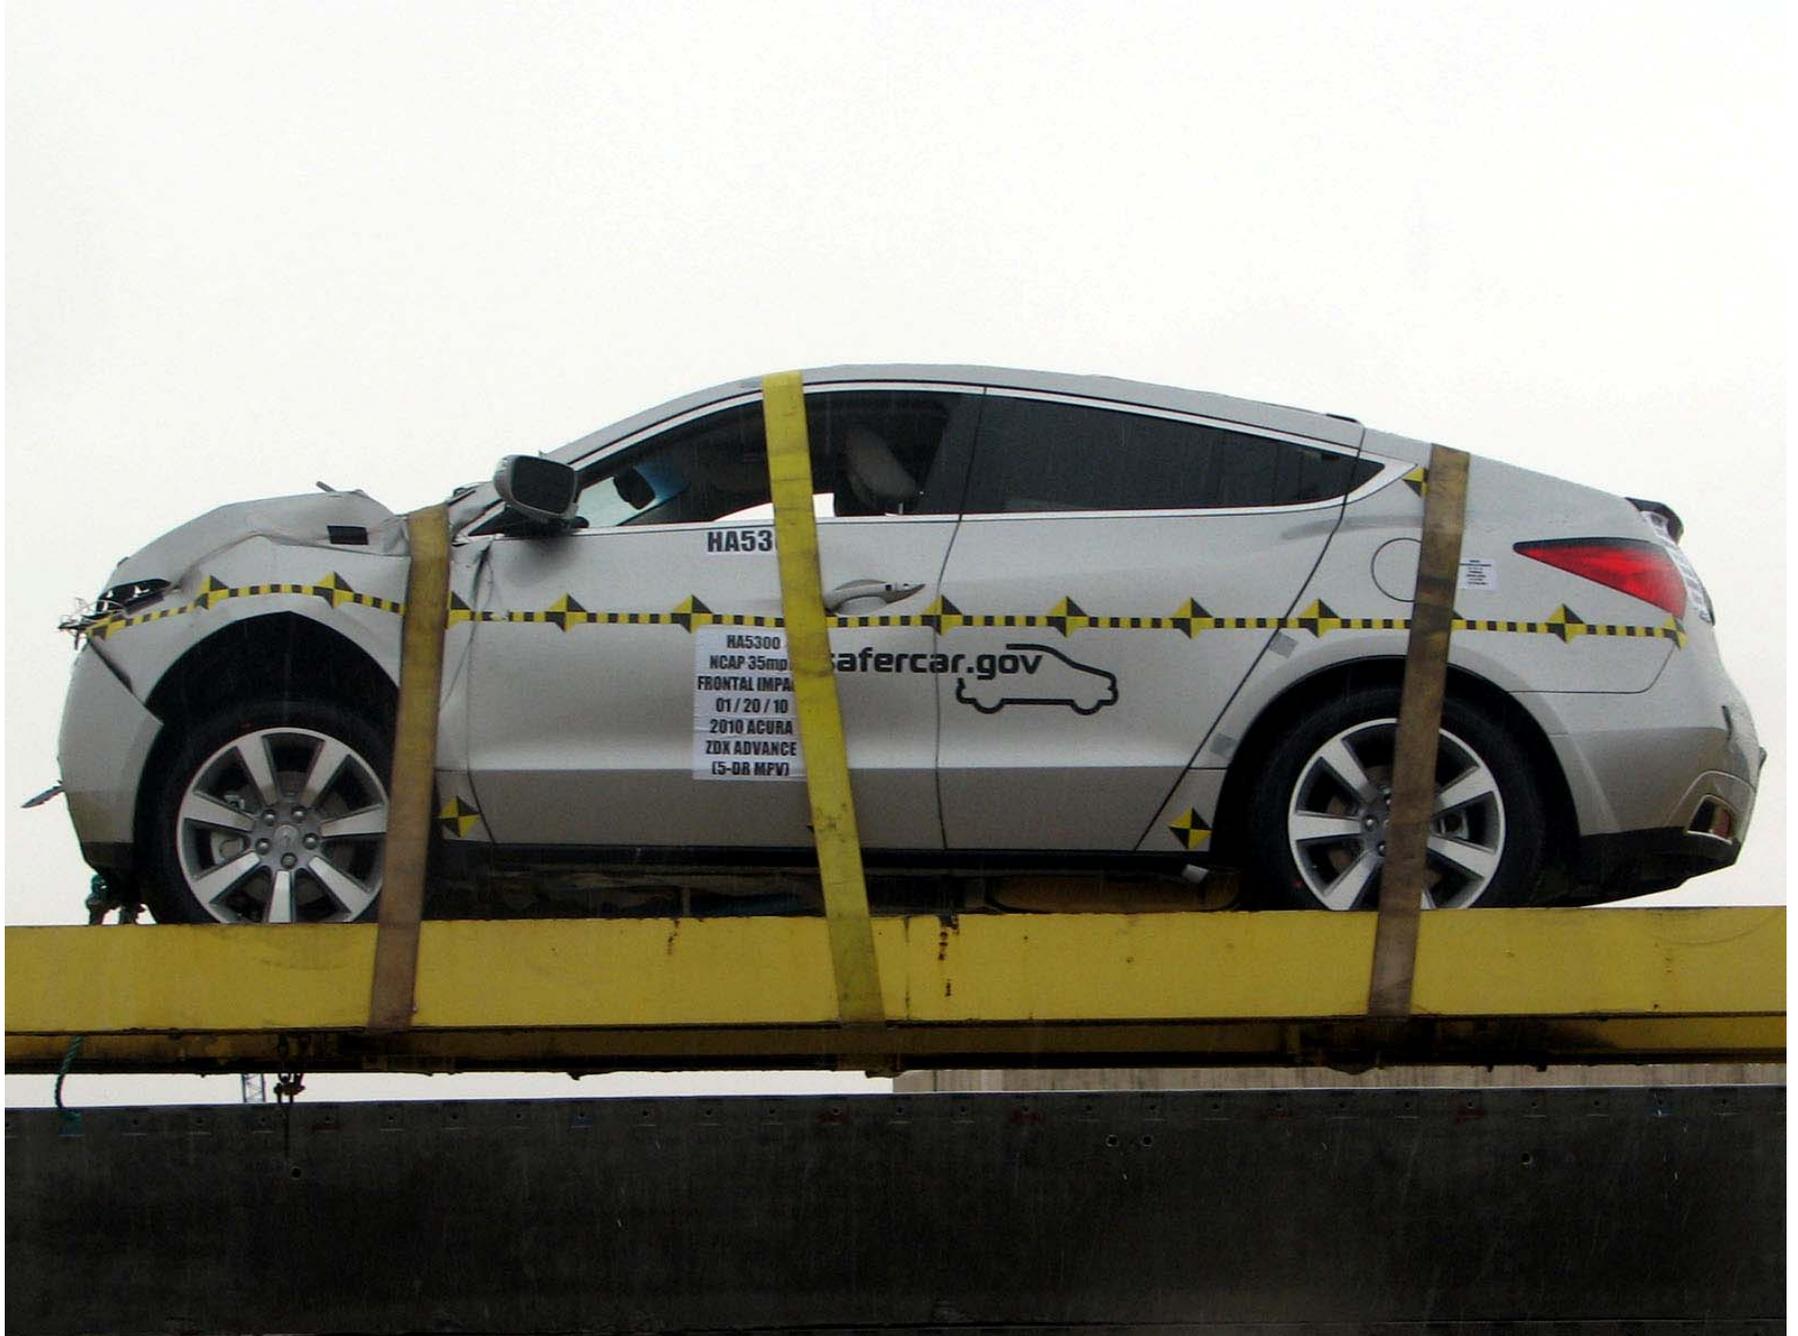
Figure A-62: Vehicle on Rollover Device (360°)

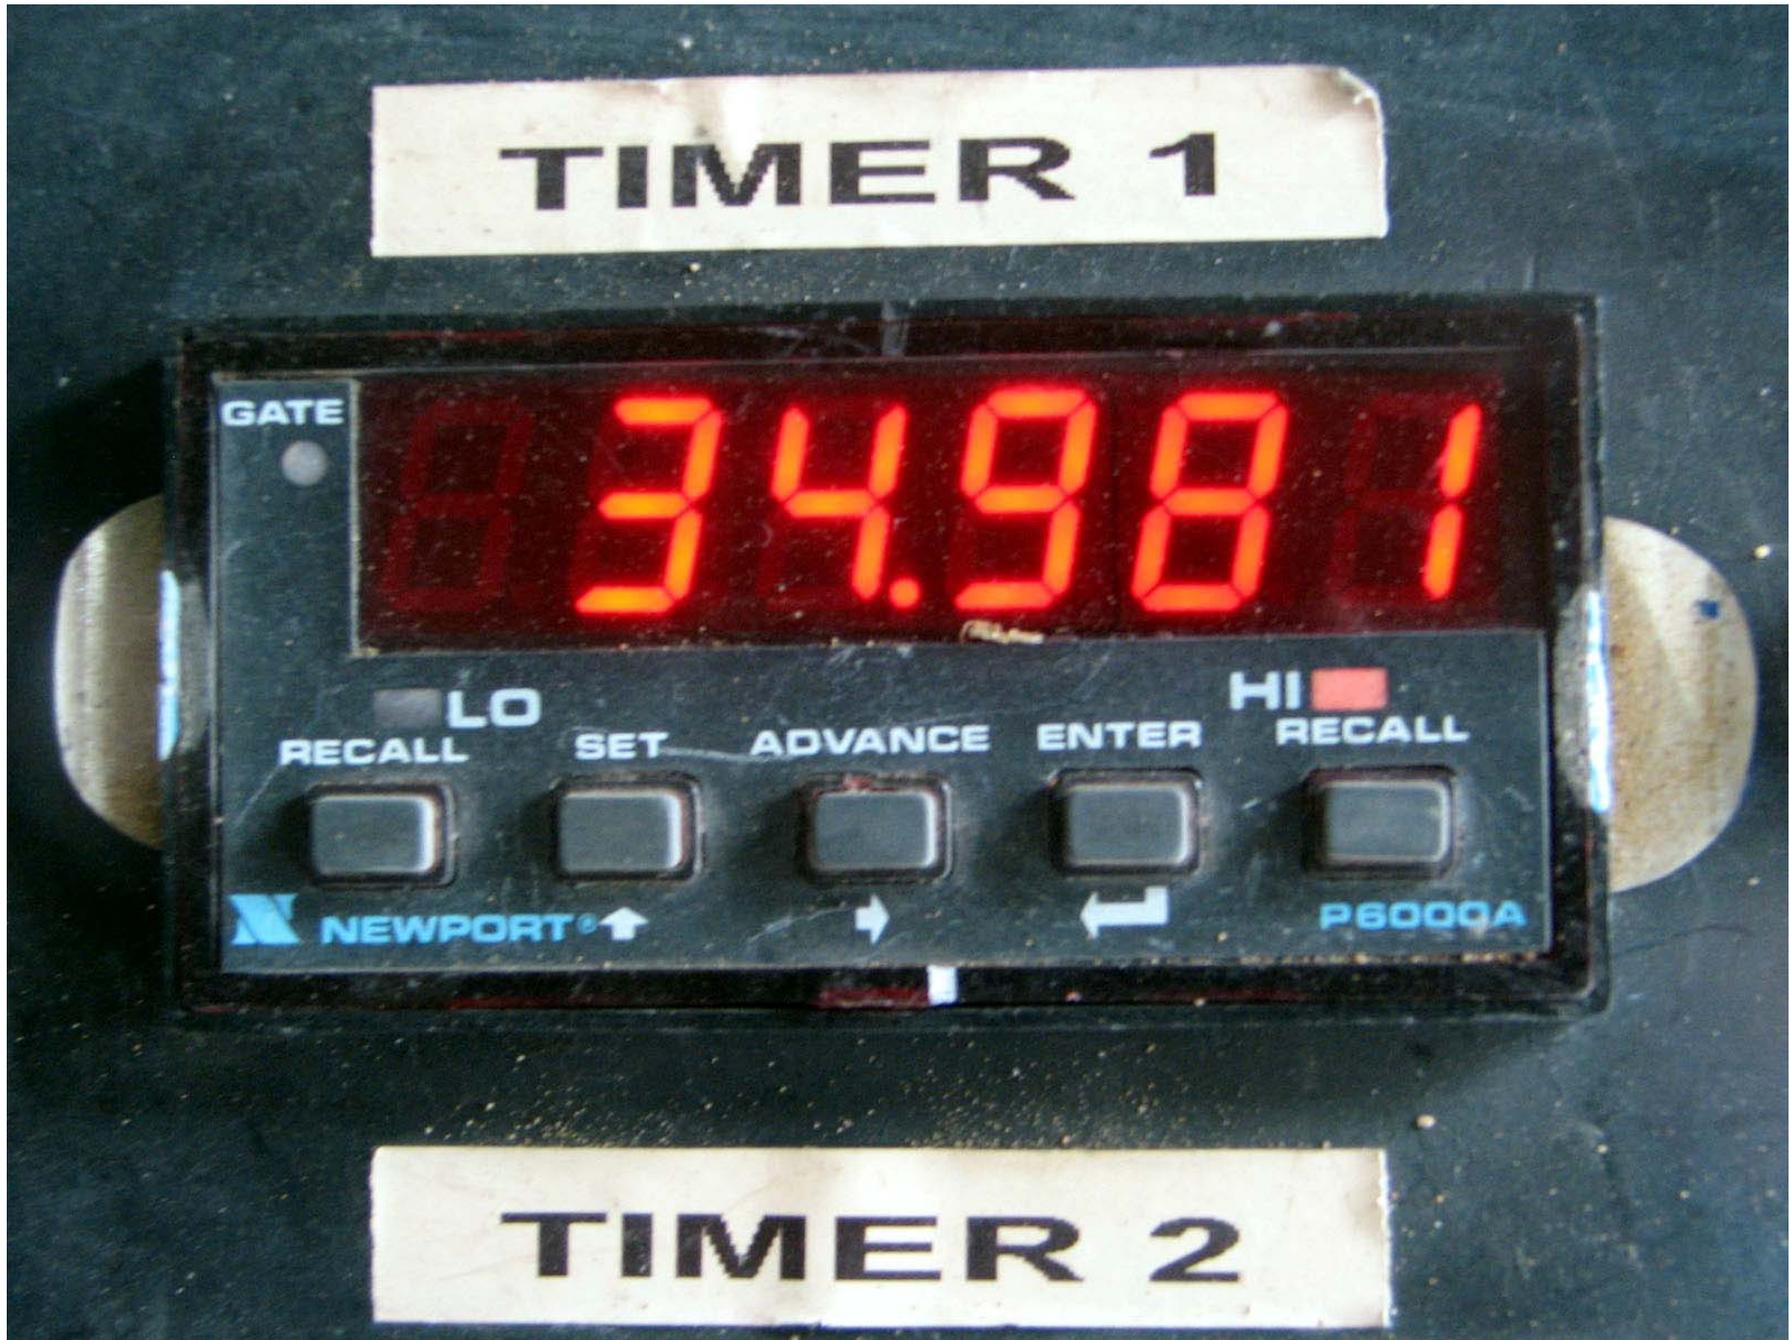
Figure A-63: Timers

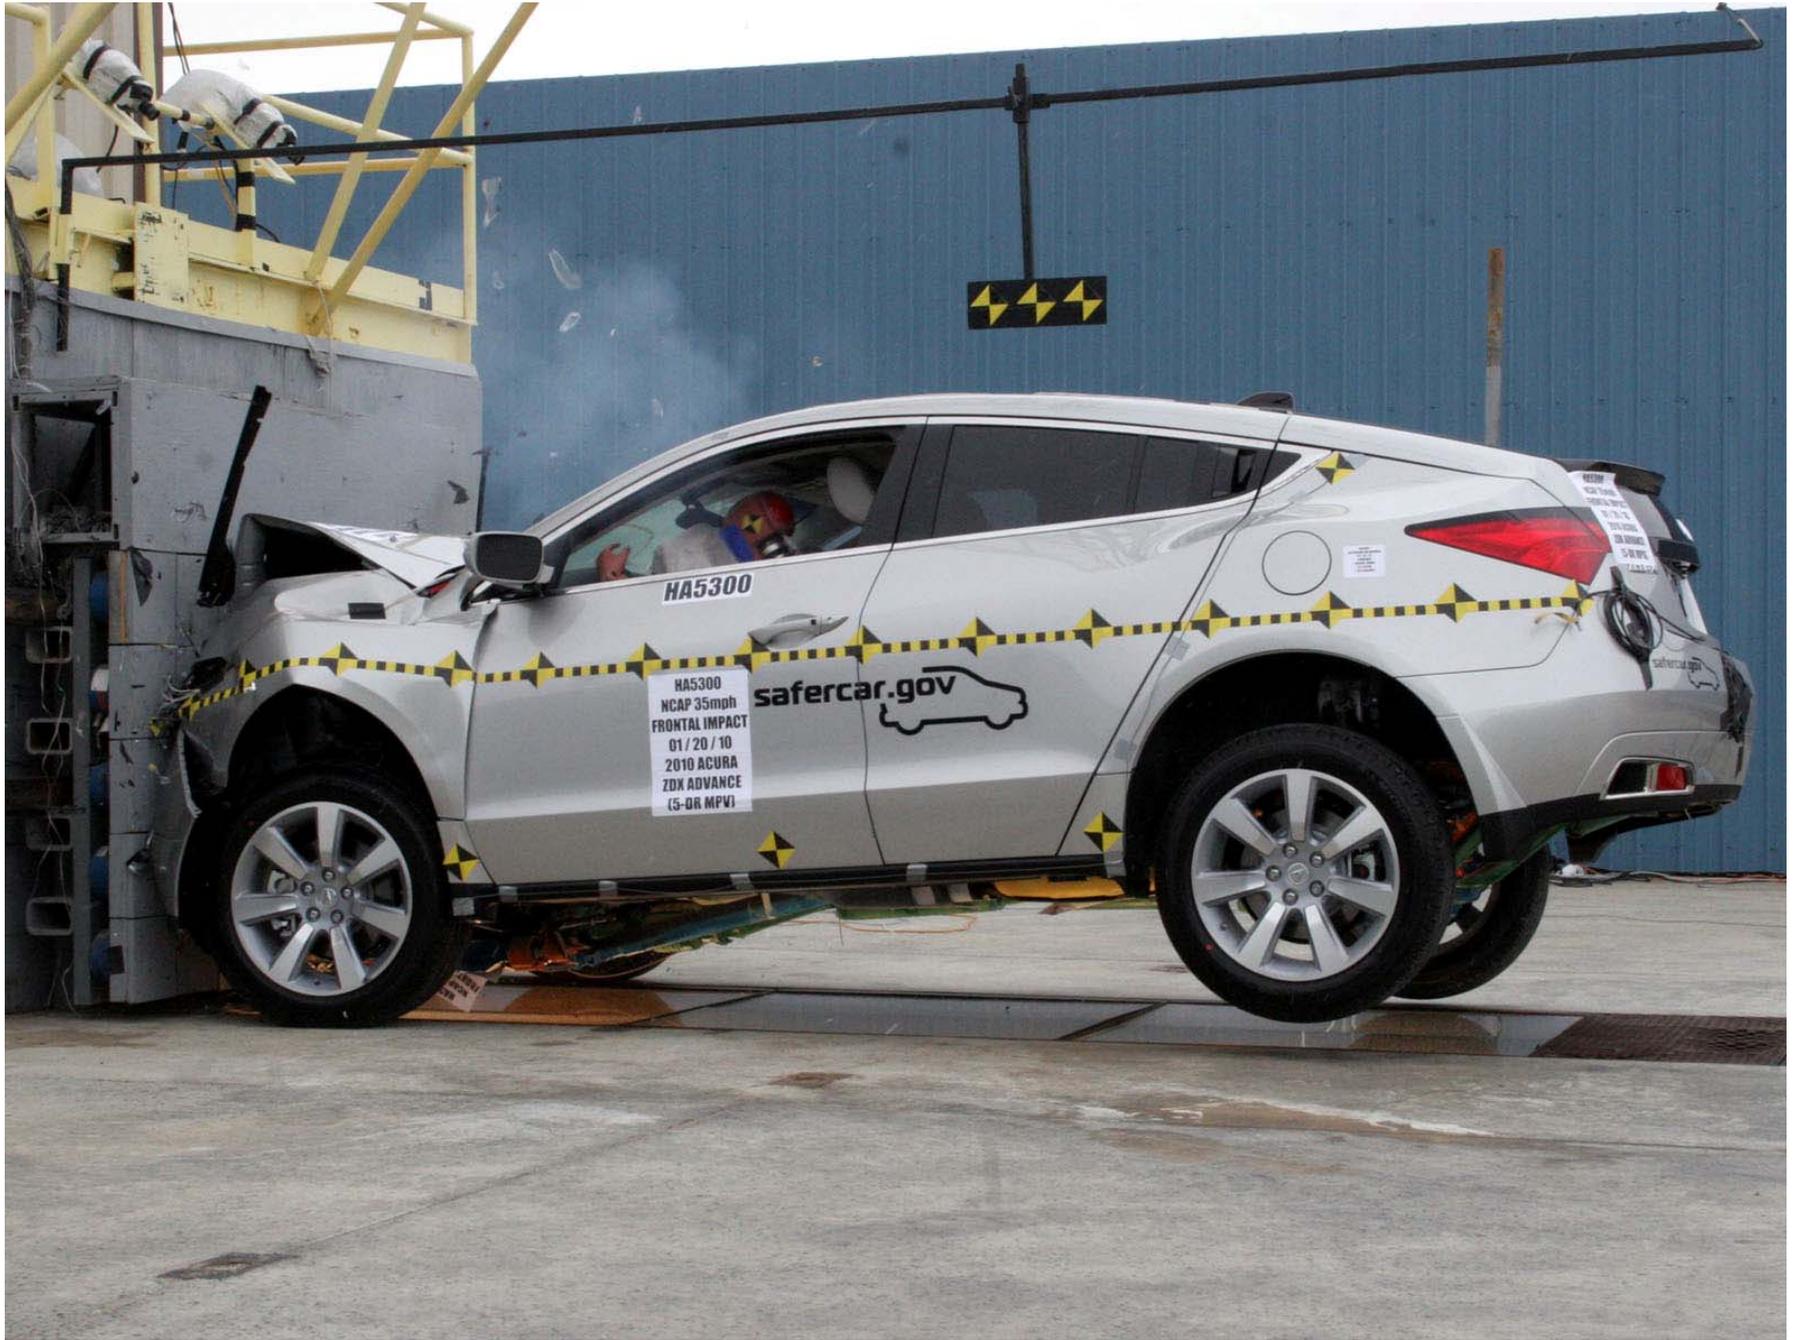
Figure A-64: Vehicle Impact

Collision Deformation Classification: 12FCEW2 Midpoint of Damage: Vehicle Centerline
 Damage Region Length: 1965 Impact Mode: Full frontal

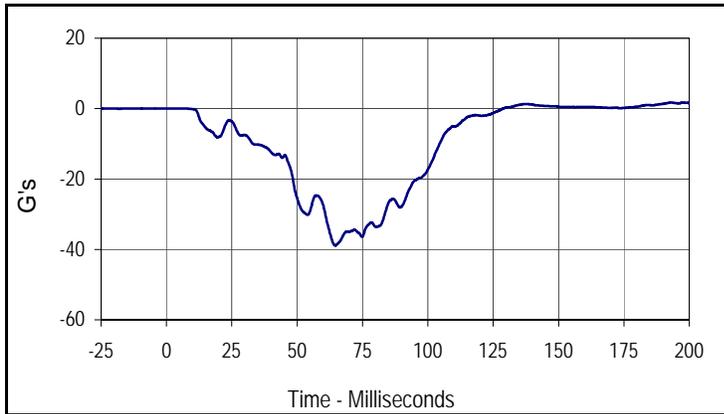
Curve Description			
Driver Chest Primary X			
CURNO	Type	SAE Class	Units
004	FIL	180	G's
Max	Time	Min	Time
1.7	193.0	-38.9	64.6

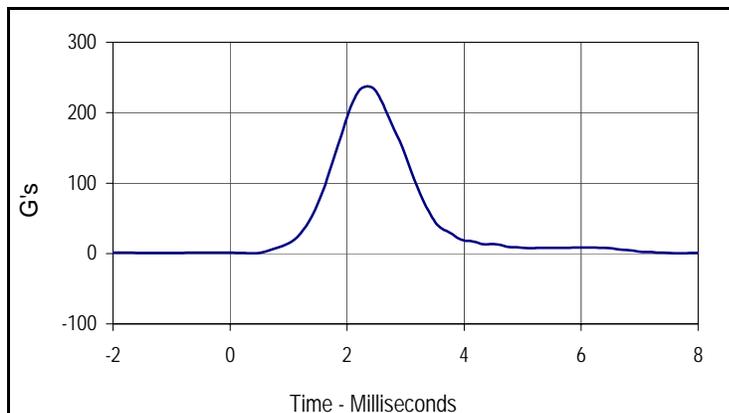
Curve Description			
Head Resultant			
CURNO	Type	SAE Class	Units
001	RES	1000	G's
Max	Time	Min	Time
236.8	2.4	0.1	0.4

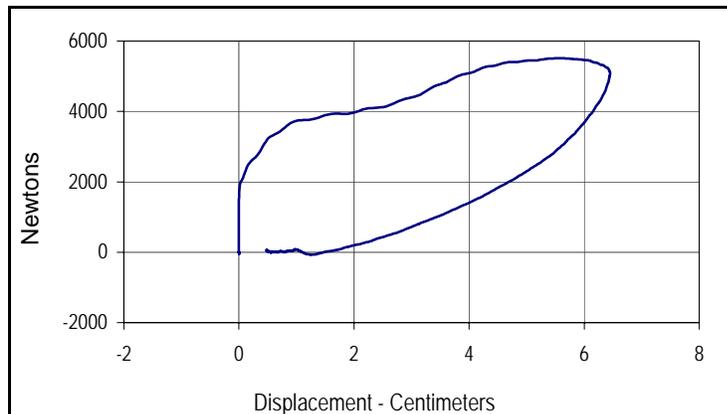
Curve Description			
Probe Force vs. Chest Deflection			
CURNO	Type	SAE Class	Hysteresis
001	FIL	180	71.8
Peak Probe Force		Peak Chest Deflection	
5514		6.45

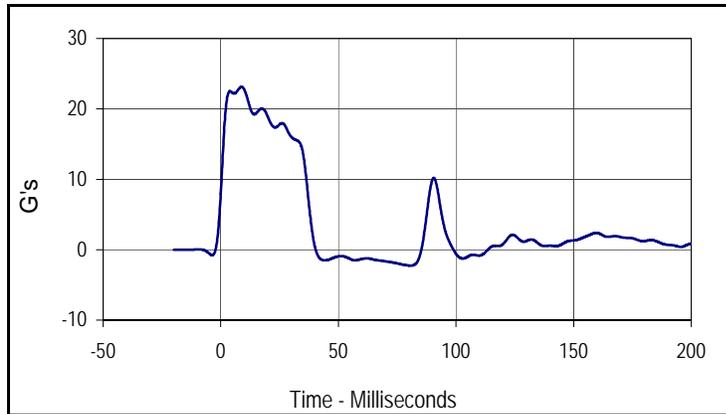
Curve Description			
Pendulum Deceleration			
CURNO	Type	SAE Class	Units
001	FIL	60	G's
Max	Time	Min	Time
23.1	8.8	-2.3	80.8

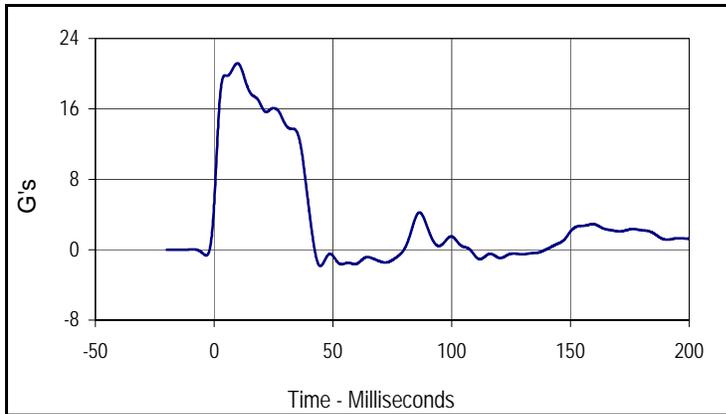
Curve Description			
Pendulum Deceleration			
CURNO	Type	SAE Class	Units
001	FIL	60	G's
Max	Time	Min	Time
21.2	9.8	-1.9	44.7

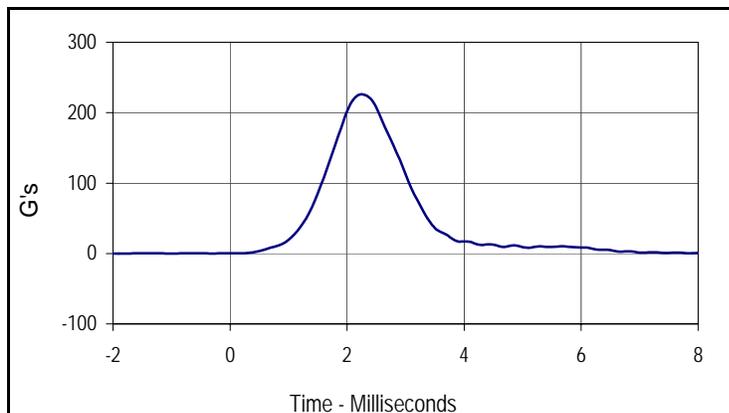
Curve Description			
Head Resultant			
CURNO	Type	SAE Class	Units
001	RES	1000	G's
Max	Time	Min	Time
225.5	2.3	0.1	-1.0

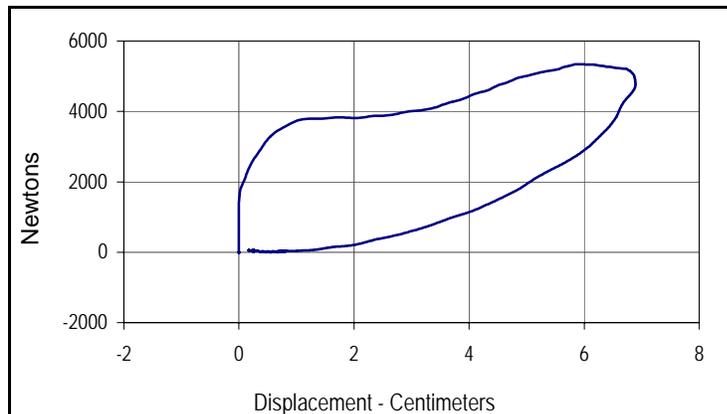
Curve Description			
Probe Force vs. Chest Deflection			
CURNO	Type	SAE Class	Hysteresis
001	FIL	180	70.8
Peak Probe Force		Peak Chest Deflection	
5343		6.89

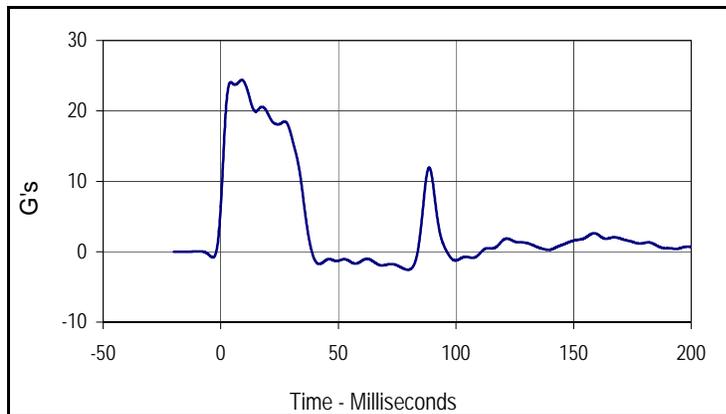
Curve Description			
Pendulum Deceleration			
CURNO	Type	SAE Class	Units
001	FIL	60	G's
Max	Time	Min	Time
24.4	8.9	-2.6	79.6

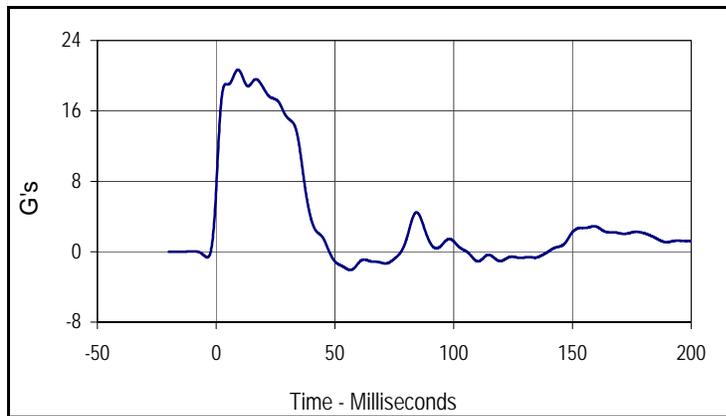
Curve Description			
Pendulum Deceleration			
CURNO	Type	SAE Class	Units
001	FIL	60	G's
Max	Time	Min	Time
20.7	9.2	-2.1	56.5
