DEVELOPMENT OF A NEW CRASH-CUSHION CONCEPT FOR COMPATIBILITY PURPOSES OF RIGID OBSTACLES NEAR THE ROAD

Graz University of Technology, Institute for Mechanics
Austria
Paper Number 98-S3-O-11

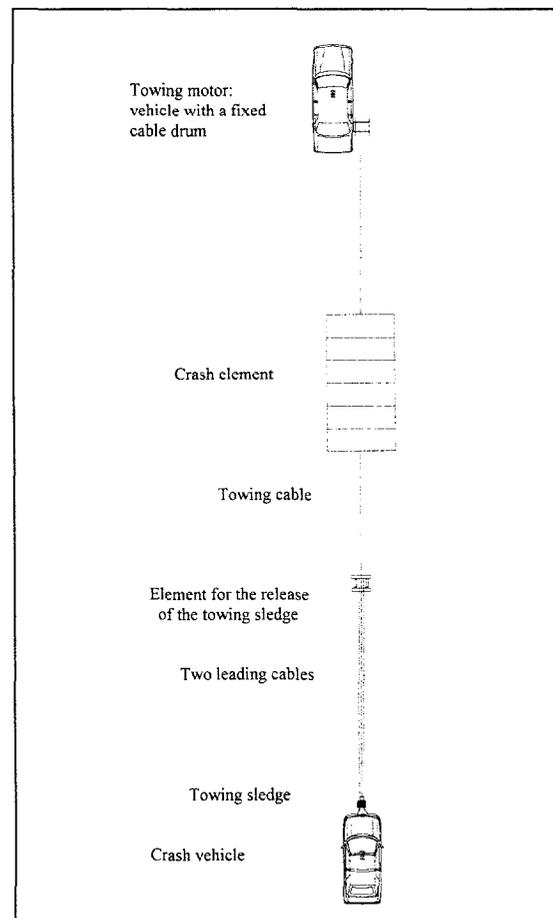
Figure 1. Crash Facility.

In a first step different materials and concepts were tested on a crash sled. Out of this experiments different crash cushions were designed and tested in a crash facility designed for such tests under similar crash conditions. The crash vehicles were accelerated towards a concrete block with a mass of 24.000 kg, using two fixed pretensioned ropes for leading the crash car and a towing rope for the acceleration. Few meters before the barrier the vehicle and the ropes were released by a special mechanism and the car crashed without external influence against the cushion, which was fixed in front of the concrete block (Figure 1.).

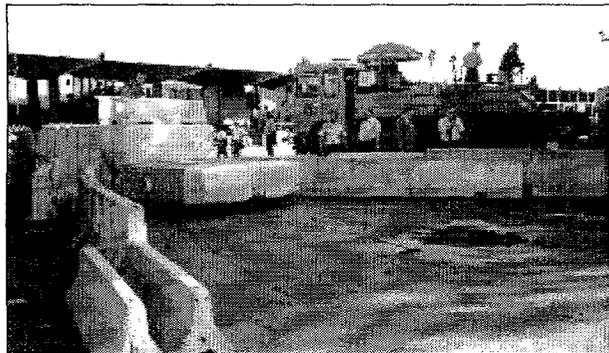
Figure 2. TMA.

The first crash was a Ford Escort against a so called TMA-element (Truck Mounted Attenuator) from Energy Absorption Systems, Inc., a construction which was designed to reduce severity of collisions with work vehicles. It consists of a Durashell Nose for low speed impacts and an aluminum construction for dissipating energy by impacts on higher speed levels. This element is used in some countries and the effectiveness has been proofed. The dimension of the tested TMA was 2,21 x

2,39 x 0,66 [m] and it was fixed 0,2 m above the ground (see Figure 2).

The impact velocity was 89 kph, the angle of impact was 0° with 100% overlap. The mean deceleration during a crash time of 200 ms was 136 m/s^2 with a maximum of 29 g. There were no intrusions into the passenger compartment and the doors opened without restriction. The pedals were displaced minor, the deformations of the vehicle front reached the front axle, the base plate, the A-pillar and the top were not damaged.

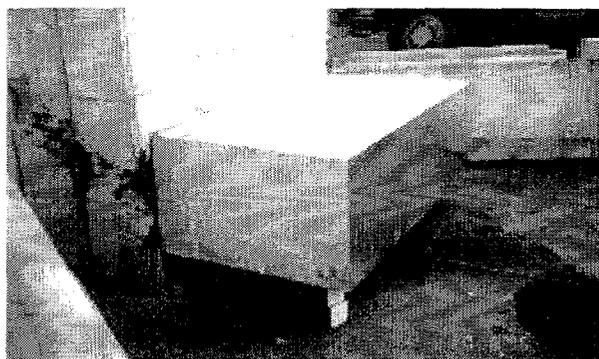
Figure 3. Styrodur-element.

Crash against an element consisting of 25 pasted plates of Styrodur and a 2 mm sheet-metal at the front.

The element was installed 0,20 m above the ground (dimension 1,02 x 1,88 x 0,60 [m]) and impacted by a Ford Escort with 100% overlap and an impact speed of 89 kph, the angle of impact was 0° . The mean deceleration during ca. 100 ms was 171 m/s^2 with a peak value of 33 g (see Appendix).

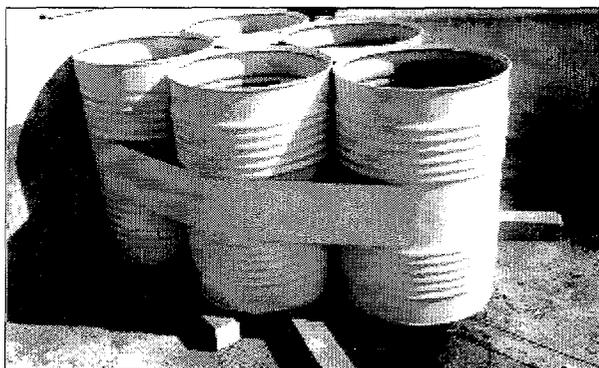
Figure 4. Tire pile.

The crash element contained tires which were stored in metal barrels (see Figure 4.). The element with the dimension 1,70 x 1,15 x 1,05 [m] was impacted by a Ford Escort with an impact speed of 93 km/h and 100% overlap. The mean deceleration was 125 m/s^2 , the peak value about 35g. The deceleration pulse showed three sections with peak values after 20, 50 and 110 ms (see Appendix).

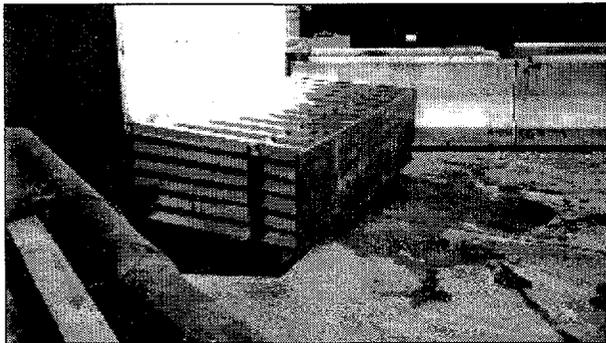
Figure 5. Honeycomb-element.

This element was built of 0,36 mm tinplate, which was buckled and welded to a honeycomb structure (see Figure 5.).

On the front a 4mm sheet-metal was fixed. The element was installed 0,20 m above the ground (dimension 1,10 x 2,08 x 0,59 [m]) and impacted by a Ford Escort with an impact speed of 88 km/h with 100% overlap. The mean deceleration during 120 ms was 229 m/s² with a peak value of 43 g (see Appendix).

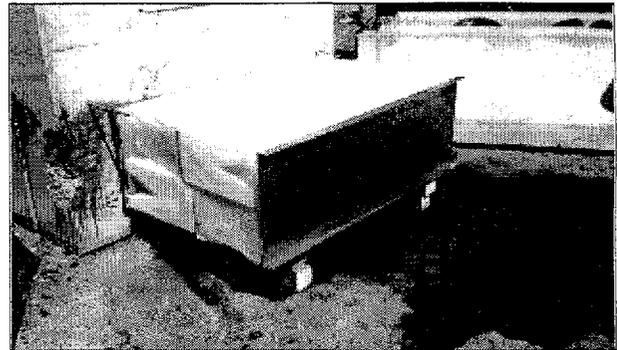
Figure 6. EEVC-element.

The crash element was built out of two EEVC (European Experimental Vehicle Committee) side impact elements built by the company Fritzmeier. This element is used for side impact crash tests in Europe. It consists of 6 PU-foam pieces with defined properties and a sheet-metal in front (see Figure 6.).

The element (dimension 0,94 x 1,50 x 0,50 [m]) was impacted by a Ford Escort with an impact speed of 80 km/h. The mean deceleration was 166 m/s² with a peak value of 32 g (see Appendix).

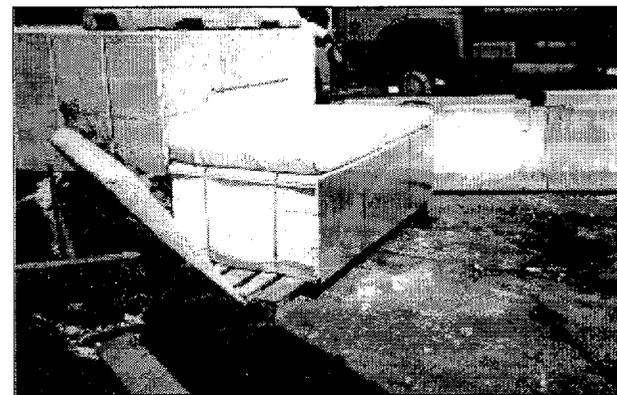
Figure 7. 'Styroporbeton'-element.

A mixture of concrete and granulated plastic (Protteolith®) was used for this element (see Figure 7.).

The element was installed 0,20 m above the ground (dimension 1,00 x 2,00 x 0,60 [m]) and impacted by a Ford Escort with an impact speed of 80 km/h and 100% overlap. The mean deceleration during 120 ms was 187 m/s² with a peak value of 31 g (see Appendix).

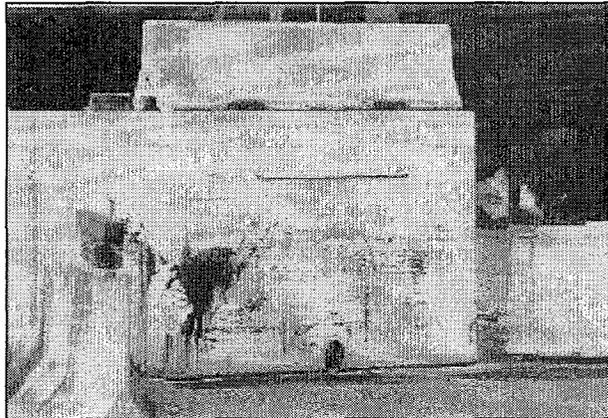
Figure 8. Rigid wall.

Crash against the concrete block with a impact speed of 89 km/h and 100% overlap. The mean deceleration during 120 ms was 217 m/s² with a peak value of 43 g.

The whole passenger compartment was destroyed, the pedals contacted with the seat and the headrests contacted with the roof. The dashboard, the base plate, the firewall, the roof and the A-pillar were damaged extremely.

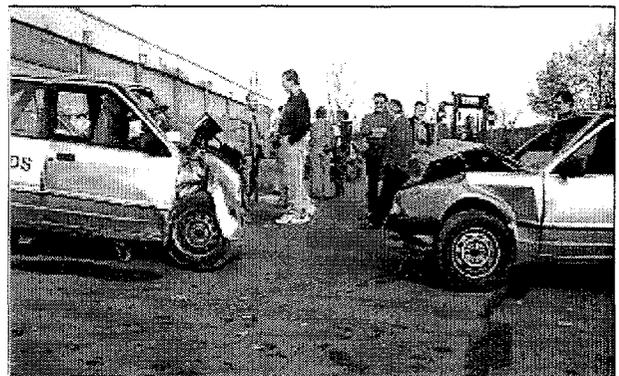
Figure 9. Vehicles after the impact against the rigid barrier with 83 kph (left) and impact against the 'Styroporbeton' cushion with 81 kph.

The vehicle front was shortened approx. 20 cm, the deformations reached up to the a-column. The wheel base left was shortened around 9 cm and on the right around 15 cm. The passenger space remained intact, the injury risk for the occupants depends mainly on the acceleration load.

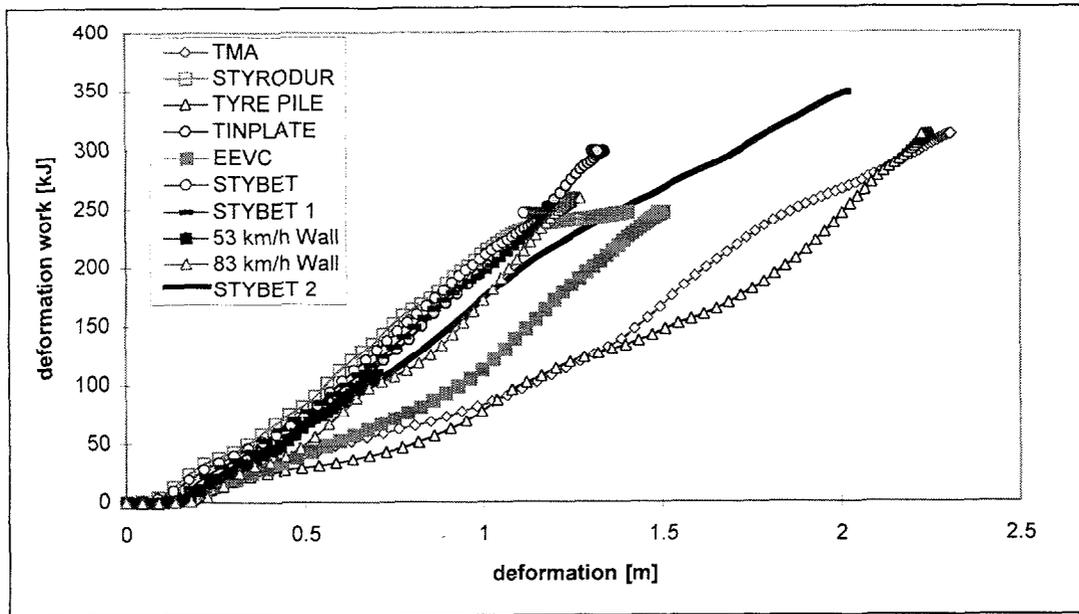
Figure 10. Deformation work and dynamic deformation for different elements

The 'Styroporbeton' element was designed harder than the TMA-element for a better utilization of the limited traffic space. So the vehicle front also deforms and the deformation distance for dissipating the energy can be reduced (see Figure 10.).

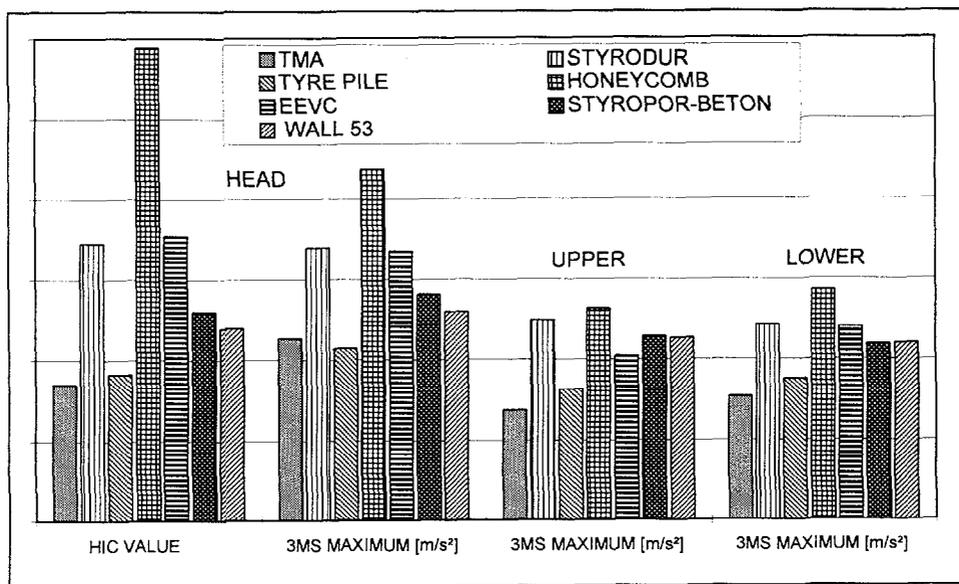
Figure 11. Comparison of injury parameters calculation for passenger side

dummy model was placed on the front-seat passenger side (see Figure 12.). Because of the different element dimensions a direct comparison is problematic but the values shows the tendencies of the passenger load. But the intrusions into the passenger compartment are not calculated and therefore for example the tyre pile shows relative low passenger loads but during the tests intrusions into the safety cell occurred and therefore the risk for the occupants will be higher than the 'Styroporbeton' impact (see Figure 11.).

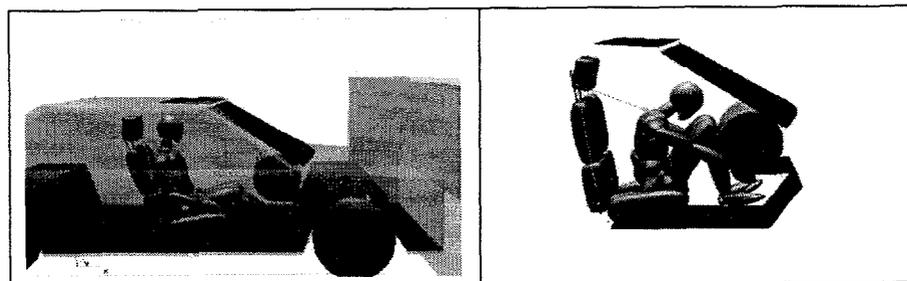
Figure 12. Model for simulation

For the computer simulations the measured vehicle accelerations were brought to a vehicle model in which a

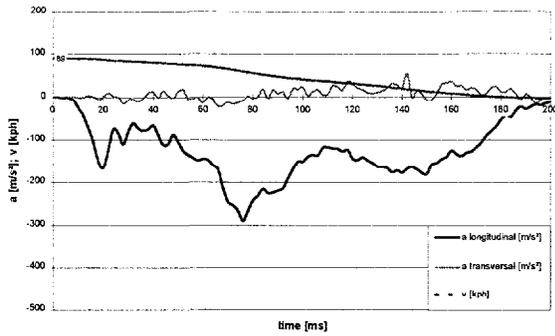
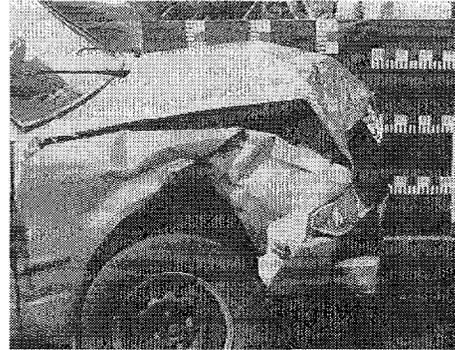
Case 1: TMA, 89 kph, 100%

The deceleration diagram (see Appendix) shows two peak values, the first 20 ms after the impact when the engine hits the element and the second peak value occurs after 80 ms when the wheels come into contact with the car-body. The elastic part of the crash is minor, remarkable is the break of the whole vehicle front into the cushion without major deformation.

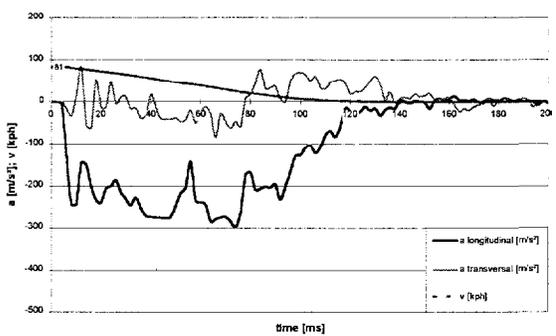
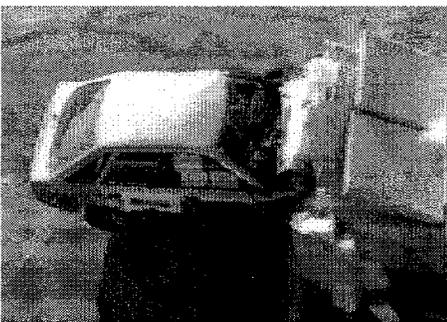
Case 8: Styroporbeton, 81 kph, 100%

The element was installed 0,20 m above the ground (dimension 1,80 x 0,80 x 1,60 [m]) and impacted by a Ford Escort with an impact speed of 81 kph and 100% overlap. The middle deceleration was 168 m/s² during a period of 140 ms, with a maximum value of 30 g (see Appendix).

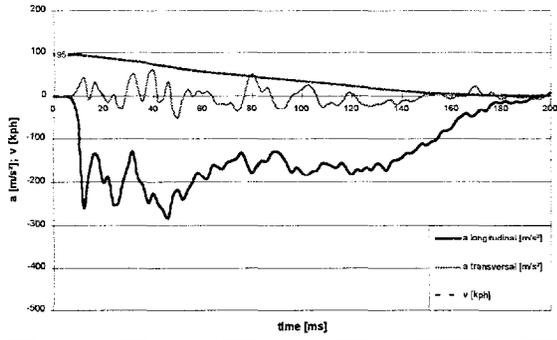
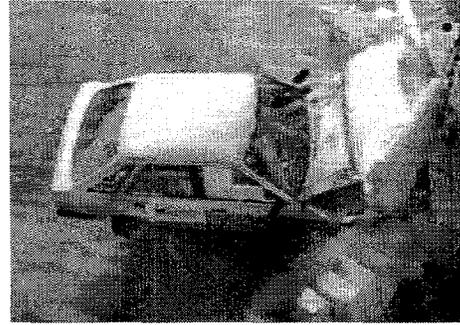
Case 9: Styroporbeton, 95 kph, 100%

A Ford Escort crashed with 94,5 kph with 100% overlap against the barrier with a homogeneous density. The deceleration during a time of 195 ms was 136 m/s² with a maximum value of 28 g (see Appendix). The frontal part of the vehicle was deformed approx. 30 cm.

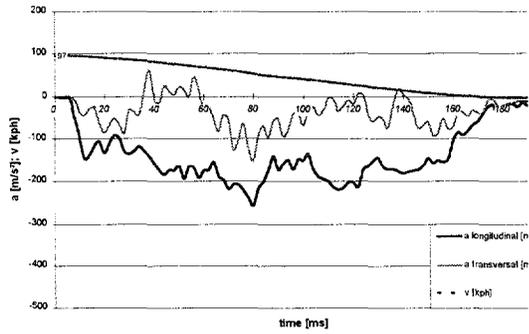
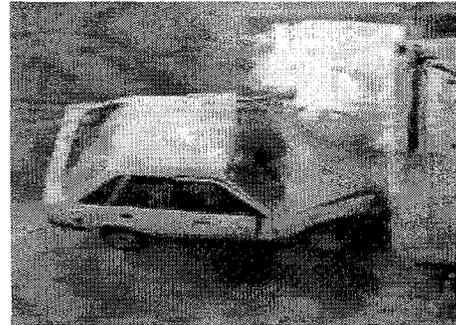
Case 10: Styroporbeton, 97 kph, 50%

Crash against an element with two different qualities of 'Styroporbeton' with an impact speed of 97 kph and 50% overlap.

The impacted barrier was deformed on the subjected side completely, the other side remained almost undeformed. After the barrier was used up, the rear of the vehicle rose highly, the vehicle made a 90° counter clockwise rotation and came approx. 1 m to the right and 1,5 m to the rear to the deadlock. On the impacted side of the vehicle it came to substantial deformations. The left side of the vehicle was destroyed up to the A-pillar. The driver's door was blocked after the crash, the roof was warped. The passenger compartment was reduced, the steering wheel and the pedals were shifted inward. The front of the vehicle was bent to the left and the frontal axle was shifted about 54 cm to the rear on the driver's side. On the other side the distance between front and rear wheel became larger.

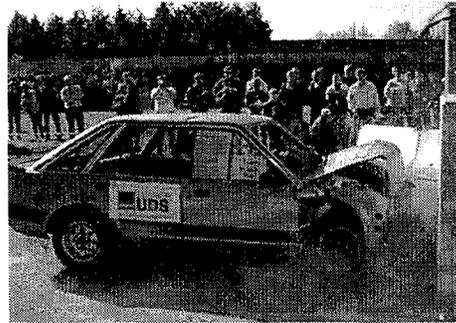
Case 11: rigid wall, 52 kph, 100%

Compared deformations

For instance the car deformation of a 95 km/h crash against the crash cushion can be compared with a crash against a rigid barrier with an impact velocity of 52 kph.

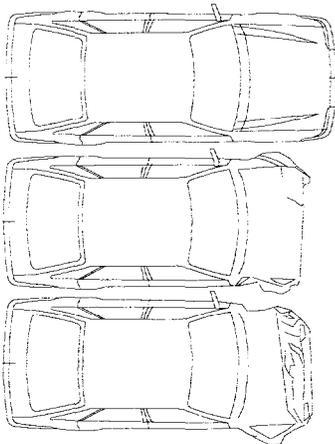
Ford Escort: original state

Ford Escort: 52 kph rigid wall impact

Ford Escort: 95 kph 'Styroporbeton' impact
