## **Thoracic Injury Mechanisms in Rollover Crashes**

J. R. Kerrigan, J. H. Ash, D. Bose, M. Sochor, J. Crandall, J. Funk, J. Cormier, S. Manoogian, S. Ridella, M. Scarboro, S. Summers

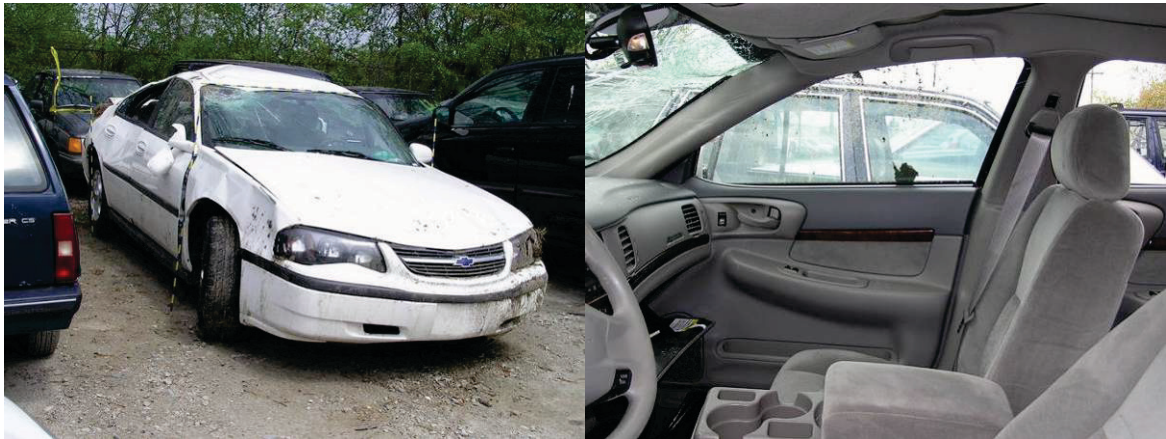
Figure 2. Vehicle images from case number 1. Case occupant was right front passenger in a far-side rollover.

In most cases, the thoracic injuries resulted from direct lateral (or antero-/posterolateral loading) loading to the thorax, however, in some cases the vehicles did not sustain any lateral intrusion to side with the case occupant. In cases 1 and 11, almost no lateral deformation/intrusion to right front passenger and driver's side doors were noted, respectively (Figure 2 and Figure 3). In both cases, the occupants sustained thoracic injuries resulting from posterolateral loading and in both cases the thoracic injuries were sourced to either the B-pillar or arm rest. Occupant contact to this area occurred as a result of lateral impacts to the rear of the vehicle that gave the occupant rearward and outboard trajectories. However, in some cases, the thoracic injuries were combined with significant lateral deformation of the vehicles and intrusion into the occupant compartment (Figure 4 and Figure 5).

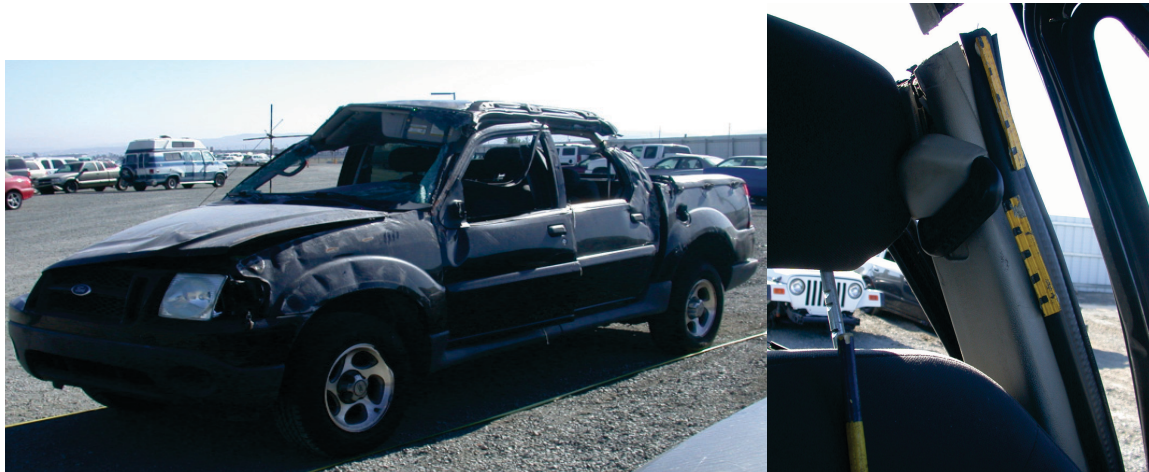
Figure 3. Vehicle images from case number 11. Case occupant was the driver in a near-side rollover.

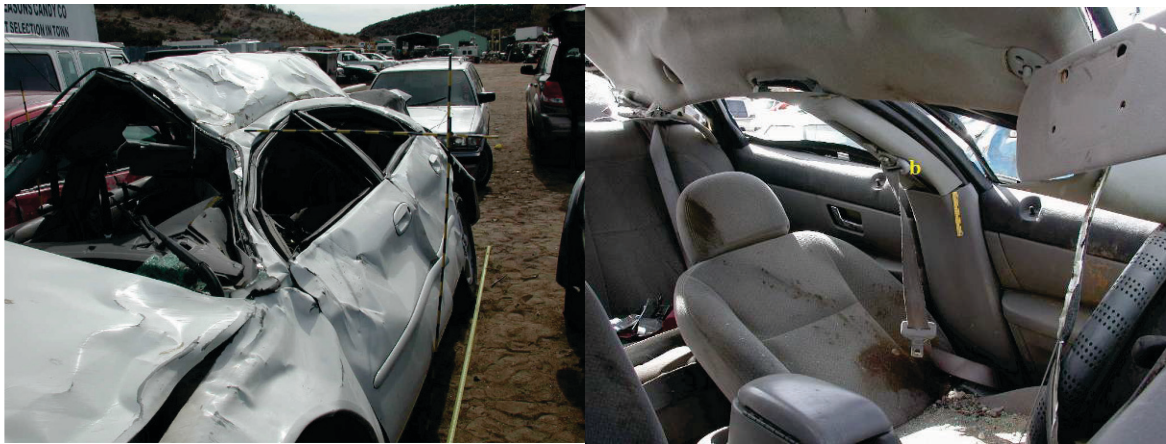
Figure 4. Vehicle images from case number 2. Case occupant was the driver in a far-side rollover.

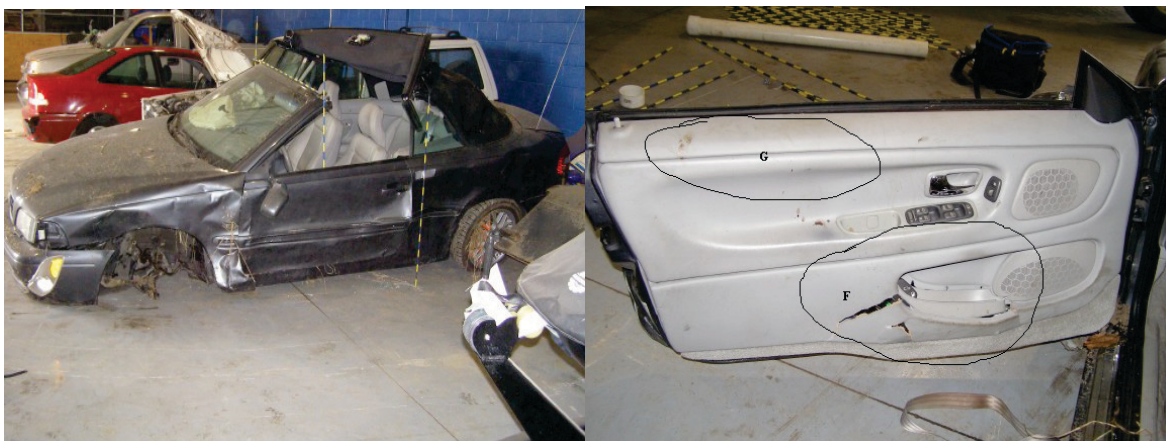
Figure 5. Vehicle images from case number 7. Case occupant was the driver in a near-side rollover.
