# COMPARISON OF 10 TO 100 KM/H RIGID BARRIER IMPACTS

Hermann Steffan  
Bertram C. Geigl  
Andreas Moser  
Heinz Hoschopf

Graz University of Technology, Institute for Mechanics  
Austria  
Paper Number 98-S3-P-12

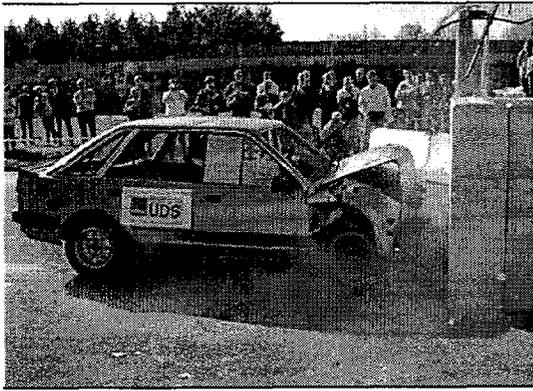
The static deformation was about 40 cm on both sides. The bumper deformed and the hood buckled, also the fenders showed already strong deformations. The front axis moved back to the A-pillar and so the distance between the front and rear axis was reduced about 20 cm (Figure 5.).

**Figure 5. Vehicle after 52km/h frontal crash.**

Also a typical deformation on the car roof in the area of the B-pillar could be seen, which is brought through the A-pillar to the cars top.

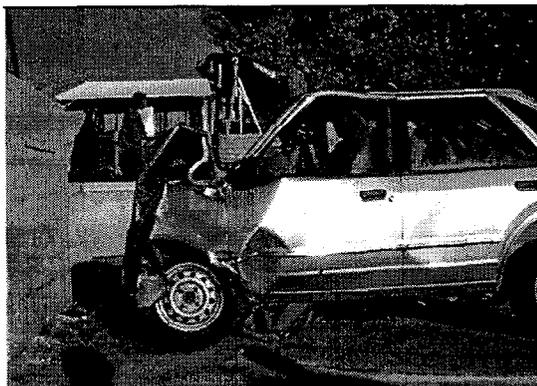
For the remaining deformation 60 cm were measured on both sides. The hood as well as the fenders buckled extremely and showed great deformations. The front axis moved back to the area of the A-pillar and so the wheel-base was reduced about 40 cm. Also the doors showed deformations and there were remarkable great intrusions into the passenger compartment. Finally the base plate was wrinkled (Figure 6.).

**Figure 6. Vehicle after 83km/h frontal crash.**

The Ford Escort hit the rigid barrier with a velocity of 83 km/h, the mean deceleration was 20g during 110ms, the maximum value was 42g.

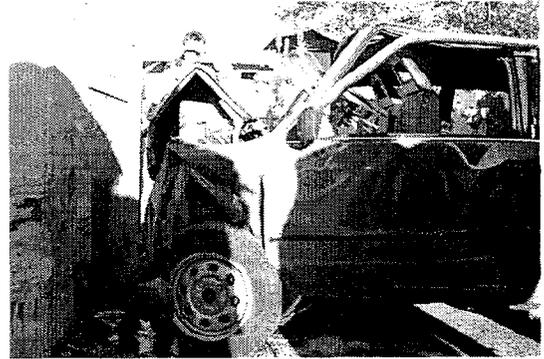
The remaining deformation was 70 cm on both sides. The front of the vehicle had deformed extremely, also the hood had great plastic deformations. The front axis moved back behind the A-pillar and so the distance between the front and rear axis was reduced more than 40 cm. Also the doors have deformations and there are great intrusions into the passenger compartment (Figure 7.) and the base plate was wrinkled.

**Figure 7. Vehicle after 95km/h frontal crash.**

For the last case the vehicle hit the rigid barrier with a velocity of 95 km/h, the mean deceleration was more than 20g during 110ms, the maximum value was at a level of 49g.
