POINTERS TOWARD THE IMPROVEMENT OF SAFETY IN BUSES, DERIVED FROM AN ANALYSIS OF 371 ACCIDENTS INVOLVING BUSES IN GERMANY AND FROM CRASH TEST RESULTS

F. Alexander Berg
Walter Niewöhner
DEKRA Automobil AG
Germany
Paper Number 98-S4-O-03

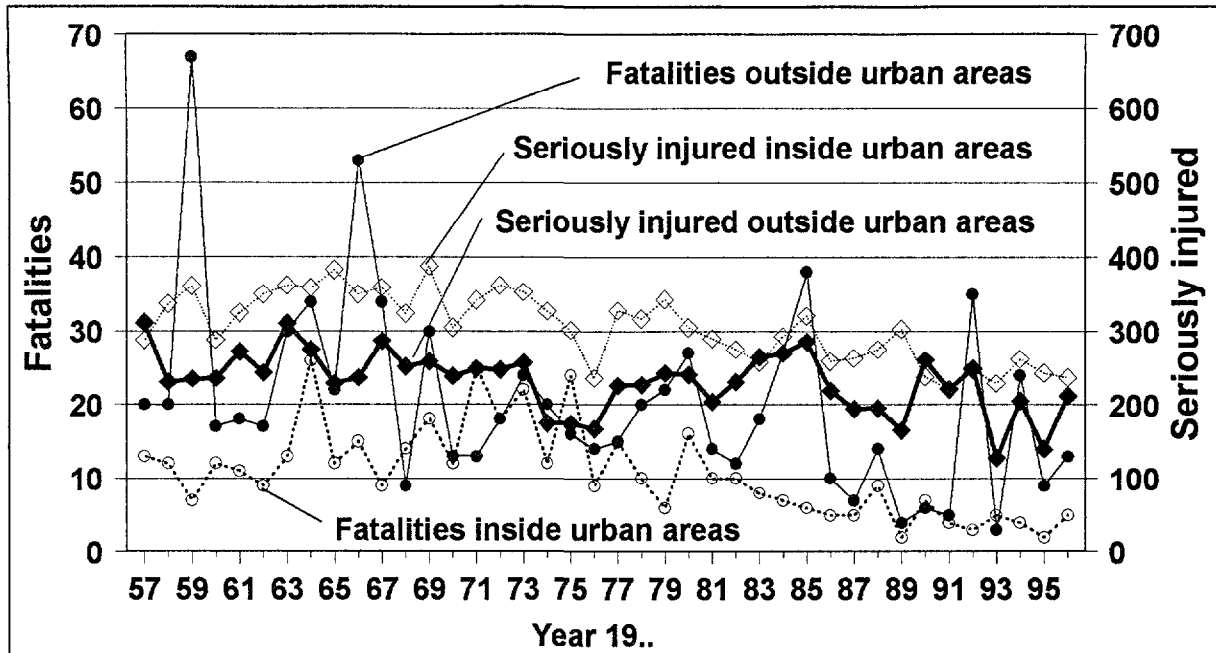
Figure 1. Absolute Frequency of fatal injured or severely injured occupants in buses in the former German countries within the period 1957 to 1996 (Source: German Federal Ministry of Statistics)

The number of bus passengers who have been either killed or injured either inside or outside urban areas is declining over the long-term. However, the number of bus passengers killed outside their urban areas has in particular been subject to considerable fluctuations in certain years. As can be seen from **Figure 1** in the former countries the number of bus passengers killed outside of their local area per year since the late 60's, with the exception of 1985 and 1992 has been consistently less than 30. In 1985, 38 bus passengers were killed, in 1992, the figure was 35. During the following year, in 1993, three bus passengers were killed outside of urban areas. The reasons behind such fluctuations are isolated tragic incidents during which many victims were either injured or killed in a bus involved in an accident. In both 1985 and

1992, 20 people were killed in one single accident. If these two accidents are excluded, the figures for the two years do not stand out from the general trend. Such accidents are reported repeatedly and in detail by the media. There is also enormous and lasting public interest in such incidents.

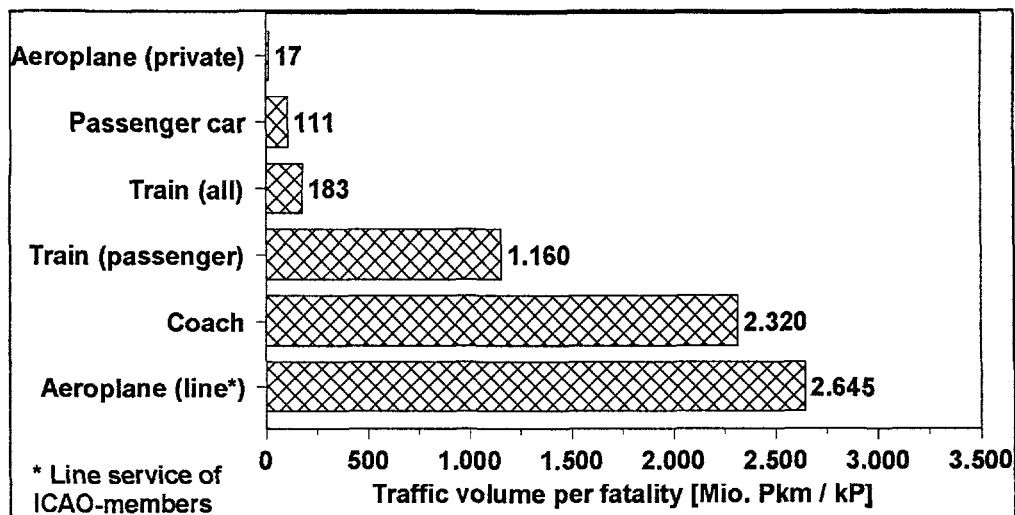
Figure 3. Comparison of the safety of means of transportation (Source: Schesky and Zernick, 1997)

metres per person per fatality shows the coach as one of the safest forms of transport, equal to an aircraft flying scheduled routes, Figure 3. (SCHESKY and ZERNICK, 1997). Correspondingly, the risk of a car passenger being killed is approximately 21 times greater than the equivalent risk to a coach passenger.

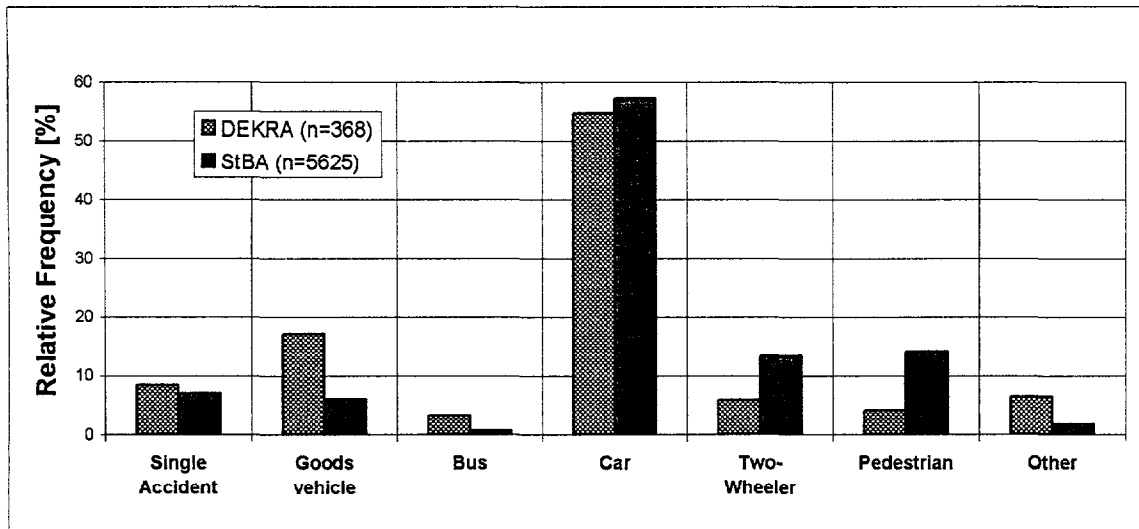
Figure 4. Single accidents of buses and bus opponents in accidents with two involved parties, comparison between German federal statistics (1996) and DEKRA database

The data sources for the real accident tests are accident analysis reports produced by DEKRA experts in Germany. These reports are being evaluated for scientific purposes in compliance with the Data Protection Act. Figure 4 shows the relative frequency of individual accidents and in the case of accidents involving a second party, the other vehicle concerned, as represented by the official statistics for road traffic accidents where physical injury has occurred (these are accidents whereby people have been either killed or injured) and for accidents with serious damage to vehicles in Germany during 1996. As a comparison, the same diagram shows the corresponding frequency distribution for 371 bus accidents in the

DEKRA database. The vehicle most often colliding with the bus is the car (57.1 % in official statistics, 53 % in DEKRA statistics). Individual bus accidents, bus/bus accidents and bus/heavy goods vehicle accidents occur more frequently within DEKRA than in official statistics. Bus/bicycle and bus/pedestrian accidents occur less frequently in the DEKRA database than in official statistics. Accidents which are relatively safe for bus passengers seldom occur in the DEKRA database.

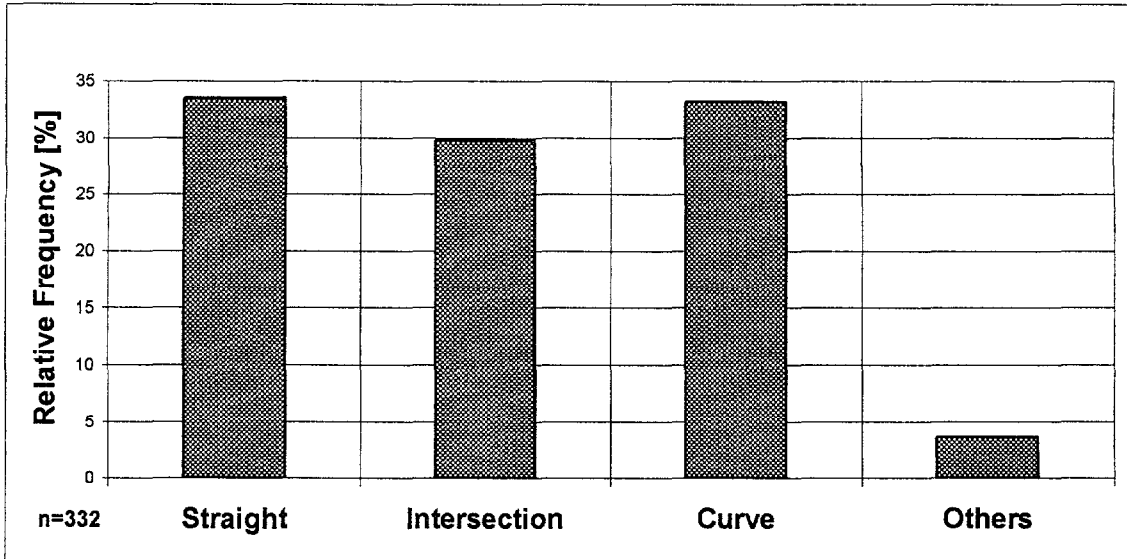
Figure 6. Relative frequency of road characteristics

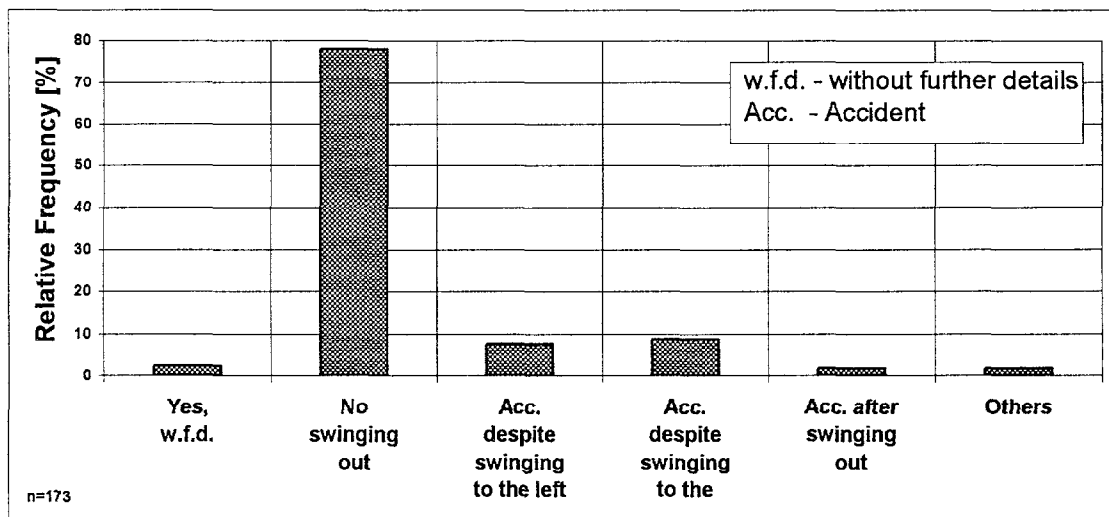
Figure 9. Relative frequency of swinging out manoeuvres

The majority of bus drivers involved in accidents (78 %) took no evasive action before the collision, **Figure 9**. Almost one of five bus drivers (18 %) was able to initiate at least one evasive manoeuvre before the collision occurred. In contrast to the evasive manoeuvre, three of five bus drivers (61 %) applied the brakes, **Figure 10**. In the majority of these cases, the brakes were fully applied.

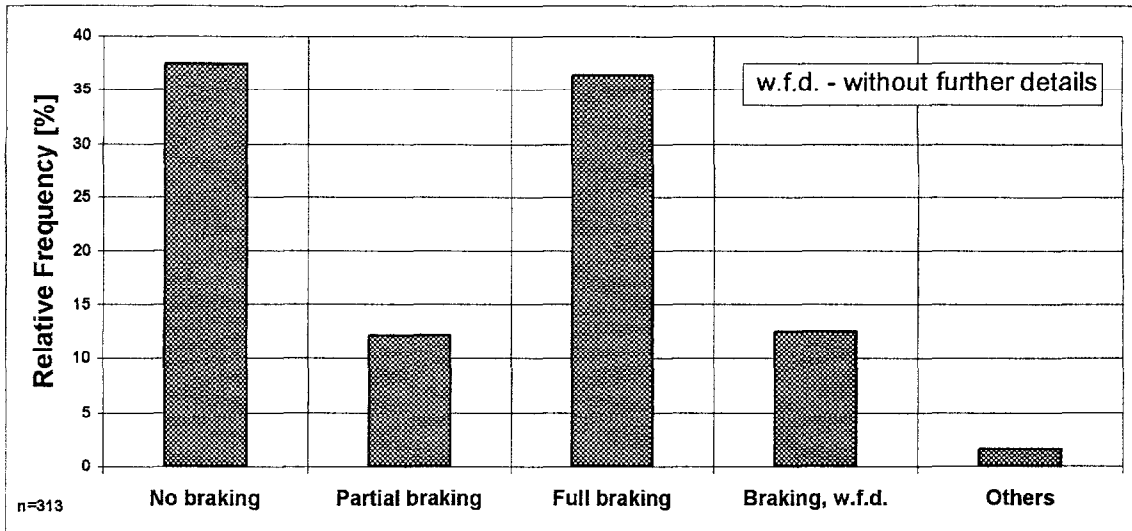
Figure 10. Relative frequency of braking

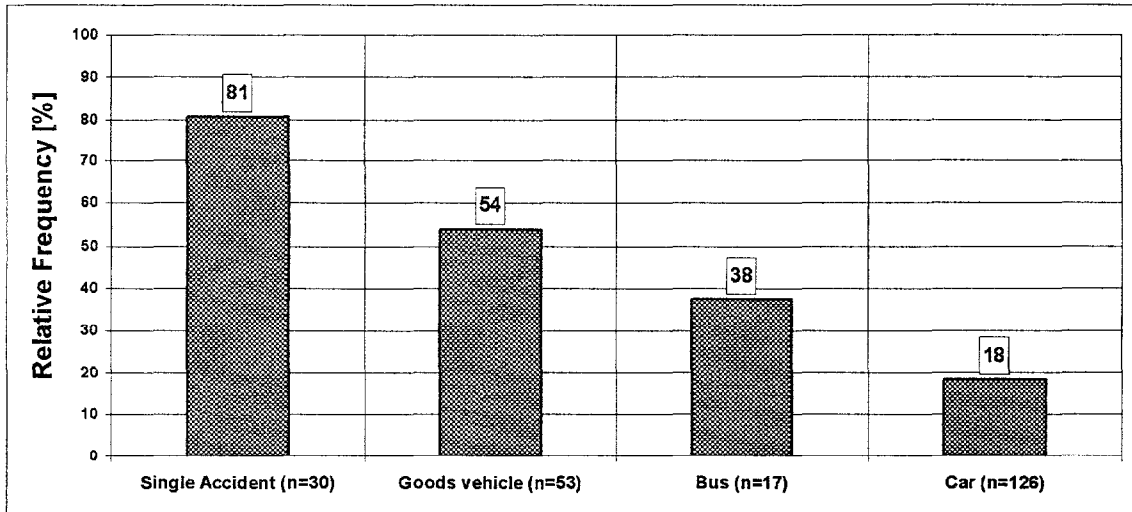
Figure 11. Share of accidents with severe injured or killed bus occupants separated to bus opponents

From the bus accidents investigated by DEKRA, bus passengers were seriously injured or killed in 81 % of individual accidents (see **Figure 11**). At 54 %, the risk of being killed or seriously injured in bus/truck accidents and at 38 % in bus/bus accidents, is essentially lower than in individual bus accidents. Only in 18 % of bus/car accidents the bus passengers were serious injured or killed. This figure of 18 % may initially appear high, given the type of the other vehicle involved. It must be understood however, that after colliding with a car, the bus can become unstable and the passengers will sustain serious injuries as a result of the subsequent crash.

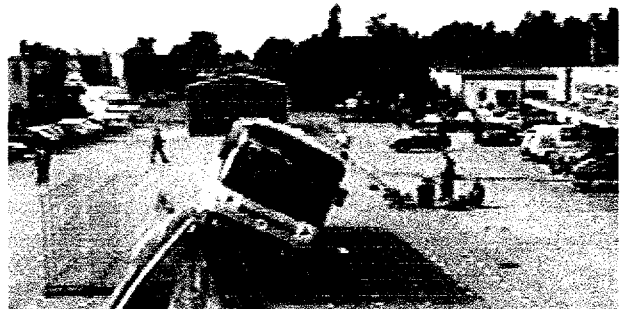
Figure 12. Bus tip over on a ramp

In order to investigate the dynamics of the passengers and also the impact to the seats and the supporting structures when a bus overturns, DEKRA performed dynamic tests in the crash centre at Neumünster. In contrast to the static tests carried out in accordance with ECE-R 66, in the tests carried out by DEKRA in the crash centre, the buses overturned dynamically on its side. As an example **Figure 12** shows a test carried out using a Neoplan N 216 coach.

The vehicle was accelerated by means of a cable drive from the DEKRA crash centre to a speed of 40 km/h and run with a constant transverse control of the movement over the vehicle's own steering system along an optically tracked guide mark with the right front wheel on a ramp. After the vehicle was also run with the right rear axle on the ramp, the traction cable was unhooked. Due to its inertia, the bus continued to run without drive and by means of the transverse control, with the right wheels

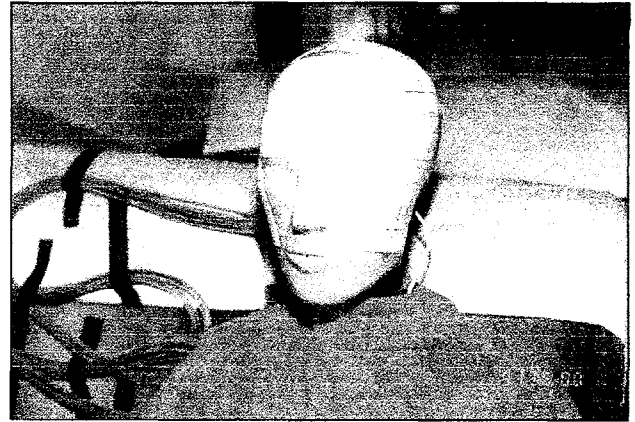
Figure 15. Dummy head with applied pressure detection foil

In order to obtain more information on facial loadings caused by direct contact with the seat or bus structures using the standard options of the instrumented dummies (D1 to D4) (according to GRÖSCH et al., 1990), pressure-sensitive film (known as Fuji film) was used, Figure 15.

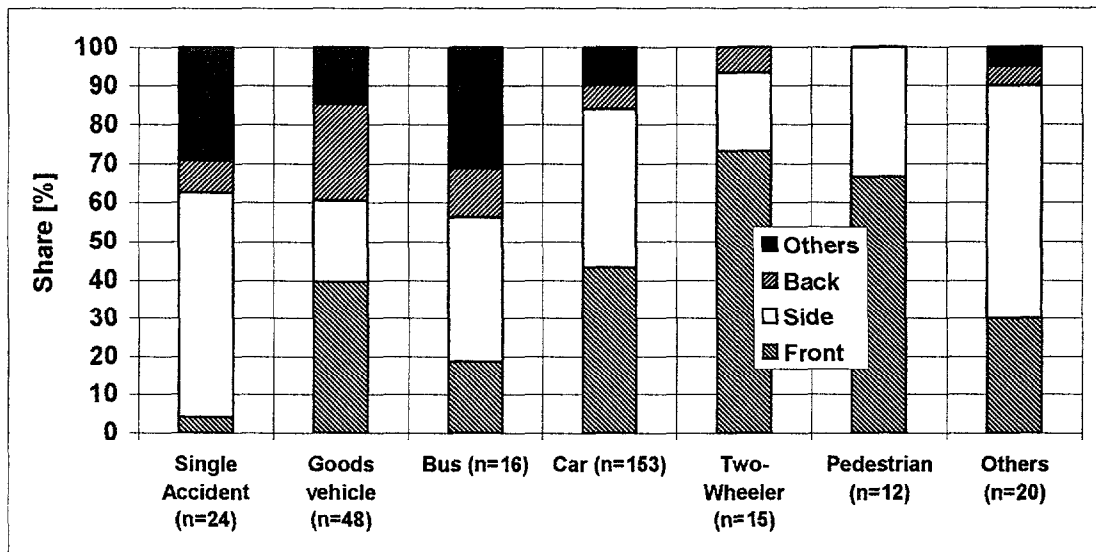
Figure 17. Relative frequency of main damaged bus areas separated to the different opponents

The distribution of major damage areas on the potential other vehicle (Figure 17.), shows that in the case of the individual accident, the major damage is predominantly sustained in the side areas of the vehicle. In the case of individual accidents, the explanation lies in the frequent number of overturns. In the case of a collision with a truck, most of the damage is sustained at the front. With this accident group (bus/truck), the causes lie in frontal collisions (front bus/front truck) and rear end collisions (front bus/rear truck). Primary collisions bet-

ween buses and cars cause the most serious deformation, virtually equally distributed between front and side areas. Some of this damage is caused by secondary collisions (also see Figure 11.). In the case of motorcycles and pedestrians, most of the damage is sustained at the front and is caused almost exclusively as a result of direct contact with the other vehicle.

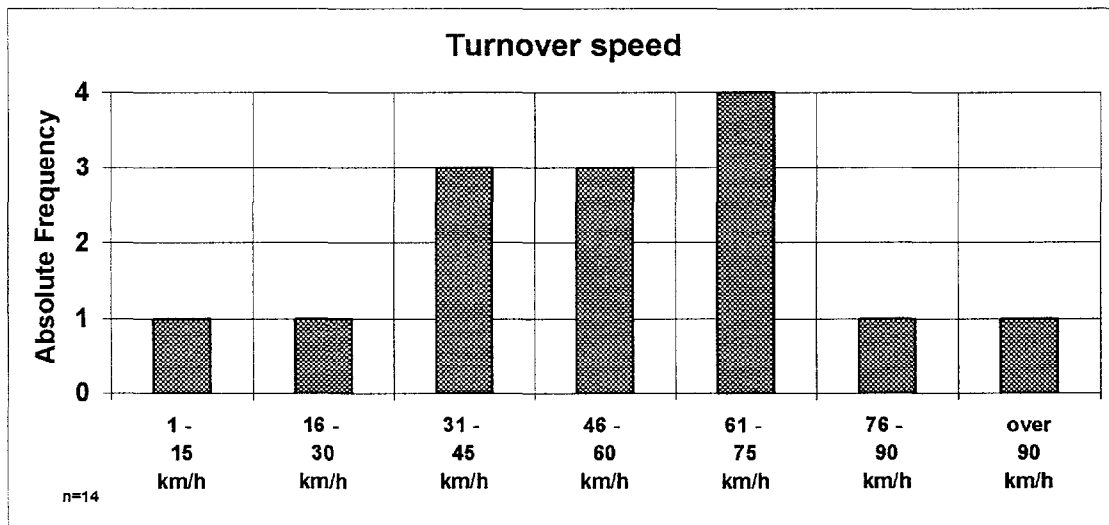
Figure 19. Absolute frequency of the speed when the bus turned over

The overturn speeds of the examined buses are distributed over the full speed range. There are more overturn speeds in the 31 to 75 km/h speed range (Figure 19.).

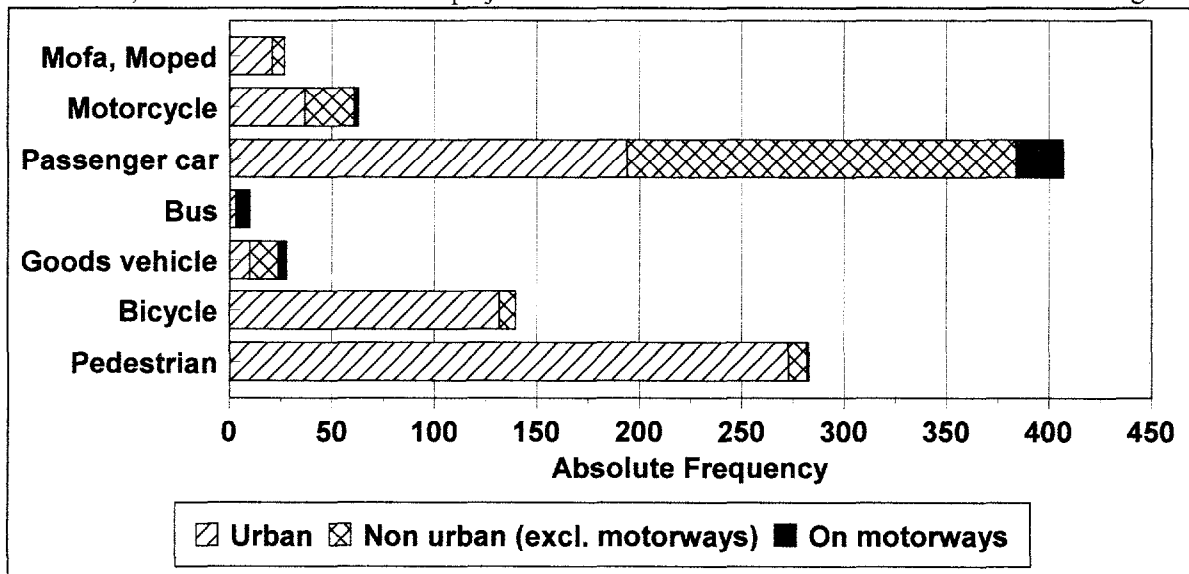
Figure 23. In accidents with buses killed and severe injured opponents

The number of people injured and killed in individual accidents and accidents with two participants can be taken from the official road traffic accident statistics. These figures are separated into accidents within the urban areas, outside urban areas, and on motorways. For 1996, the figures shown in Figure 22 for accidents in Germany, show the number people in the other vehicle who were either killed or injured.

With the exception of cars and trucks, with all other vehicles involved in accidents with buses, the highest number of people are either killed or injured within urban areas. The motorcyclist and the pedestrian are of particular importance. It is not yet possible to use official statistics to differentiate between bus and coach. One can however correctly assume, that the other vehicle involved the motorcycle or pedestrian accidents shown in Figure 4 was usually a bus travelling within urban areas. By the very nature of their intended purpose, buses travel almost exclusively within the inner city area. These buses travel in close proximity to cyclists and pedestrians when at bus stops and also on the road. Therefore, the probability of a collision with these un-motorized road users is relatively high. In addition, only public transport has access to traffic free zones in town and city centres and the un-motorized road user moves around carelessly and without paying attention.
