AIR BAG COLLISION PERFORMANCE IN A RESTRAINED OCCUPANT POPULATION

Transport Canada

Paper Number 98-S5-O-04

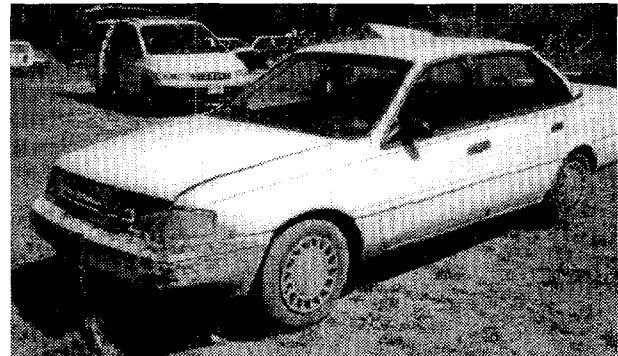
Figure 2. 1992 Ford Tempo.

ASF2-1505: A 1992 Ford Tempo was travelling southbound along a two-lane, undivided rural highway. The road was wet as there was light precipitation. A vehicle ahead of the Tempo braked. The Tempo's driver also braked, but lost directional control. The car crossed the centre line and entered the east ditch. The front of the Tempo struck the back slope of the ditch (12FDEW1) at which point the driver's air bag deployed.

The driver (79 years, female, 155 cm, 77 kg) was fully restrained with her seat in the forward of middle position. Emergency medical personnel arrived within 15 minutes of the collision. The driver was coherent and complaining of chest pain. She was removed from the vehicle and transported to hospital. Later the same day, medical complications arose and the driver was transported to a trauma centre where she died early the next morning. The driver sustained a comminuted fracture of the left lateral mass of C1, multiple bilateral rib fractures, a lacerated aorta, a fractured sternum, minor contusions, lacerations and abrasions to the face, chest and extremities.

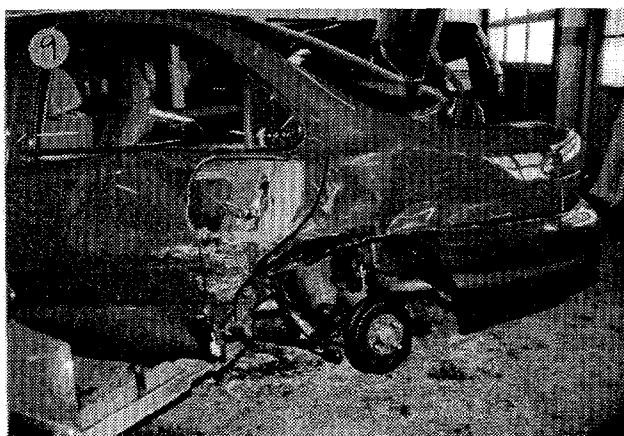
Figure 3. 1998 Ford Contour

ACR4-1108: A 1998 Ford Contour was turning left out of a parking lot. The Contour's driver observed a vehicle approaching from her left, but believed she had sufficient time to complete the turn. The driver of the oncoming 1990 Oldsmobile Ciera braked but was unable to avoid a collision. The front of the Ciera (12FYEW1) struck the left rear quarter panel of the Contour (09LZEW2). Both front air bags in the Contour deployed.

The Contour's driver (54 years, female, 157 cm, 54 kg) was fully restrained, with her seat adjusted to the forward of middle position. The driver sustained contusions over the hips and left shoulder as a result of seat belt loading, a contusion to the right elbow from contact by the deploying air bag, and a contusion to the left knee from contact with the door interior (MAIS 1).

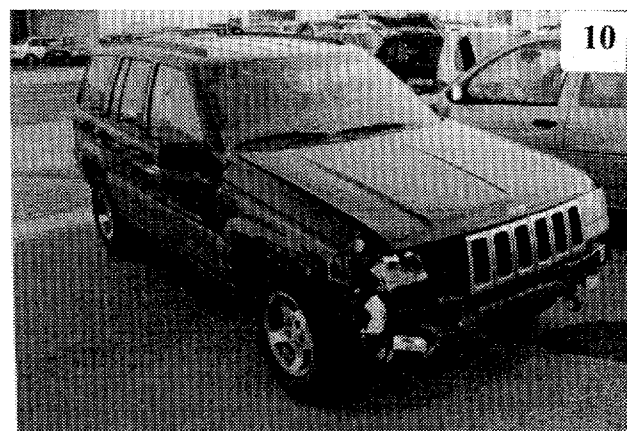
Figure 8. 1998 Jeep Grand Cherokee

ACR4-1508: A 1998 Jeep Grand Cherokee was travelling southbound on an urban arterial at night. Snow was falling and the road was wet with icy sections. The vehicle entered a moderate downgrade at which point the driver lost directional control. The Cherokee rotated clockwise through 360 degrees and its front bumper struck (11FDEW2) a retaining wall on the west side of the road. Both air bags in the vehicle deployed in the impact.

The driver (26 years, male, 188 cm, 91 kg) was accompanied by a right front passenger (33 years, female,

173 cm, 68 kg). Both occupants were fully restrained. The driver's seat was fully rearward, while the passenger's seat was in the middle position.

Both occupants braced prior to impact with the wall. The driver was uninjured (MAIS 0). The passenger, sustained abrasions to both thighs from contact by the air bag (MAIS 1). She also complained of numbness to the left nostril and of lower back pain.
