# IN-DEPTH INVESTIGATION AND RECONSTRUCTION OF AN AIR BAG INDUCED CHILD FATALITY

**Alan German**  
**Dainius Dalmotas**  
**Jean-Louis Comeau**  
**Brian Monk**  
**Pierre Contant**  
Transport Canada  
**Michel Gou**  
**Serge Carignan**  
**Louis-Philippe Lussier**  
École Polytechnique de Montréal  
**James Newman**  
**Christopher Withnall**  
Biokinetics & Associates Ltd.  
Canada  
Paper Number 98-S5-W-19

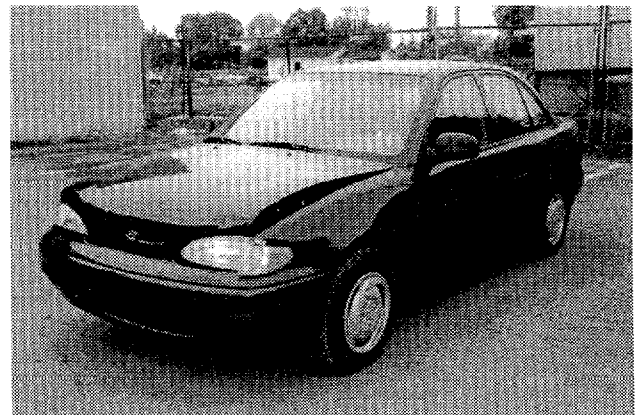
Minor damage resulted to the front bumper and hood of the Accent (CDC: 12FDEW1). Maximum residual crush, measured at the level of the front bumper, was 5 cm. The radiator support was lightly twisted on both ends and the radiator was leaking. Both headlights were partially detached but were unbroken.

Figure 2. Left-front three-quarter view of the Accent.

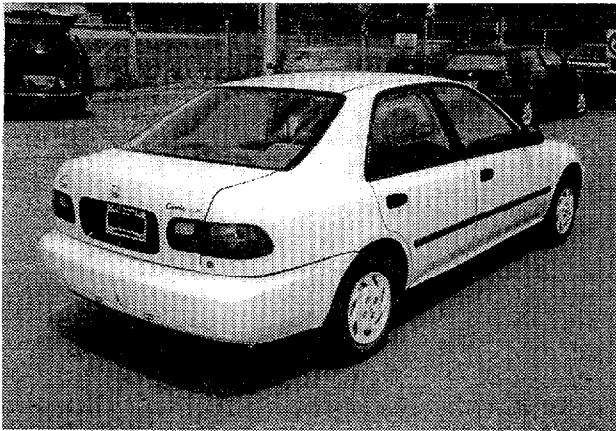
The corresponding direct damage to the rear of the Civic was limited to the rear bumper assembly, with induced damage to the trunk lid and the spare wheel well (CDC: 06BDLW1).

**Figure 3. Right-rear three quarter view of the Civic.**
