NHTSA RESEARCH ON IMPROVED RESTRAINTS IN ROLLOVERS

Paper Number 11-0213

ABSTRACT

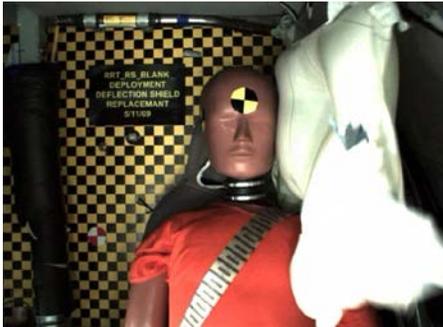
The original RRT was modified to include a roof and door structure along with an inflatable curtain and was renamed the rollover reaction surface tester (RRST). The cab structure (the roof and door structure) was taken from a 2006 Honda Ridgeline truck cab, and the inflatable curtain was from a 2007 Chevrolet Silverado 1500. This structure was enhanced by various support beams to ensure multiple testing could be conducted. Although a headliner was not used, a deflection pan was fabricated to ensure a repeatable inflation into the cab structure. Figure 1 shows the curtain inflated in the cab structure. The original characteristics and framework^{1,2} of the device remained the same.

Figure 1: Deployed Airbag

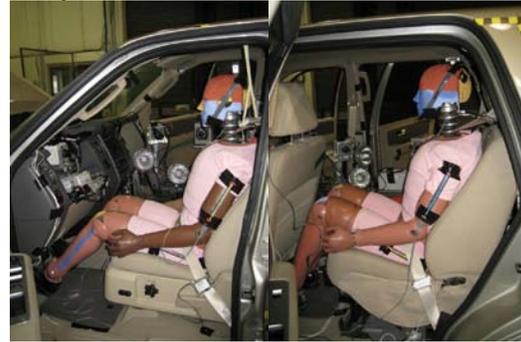
Table 2 shows the test matrix and what restraints were used for all occupants. The front-to-rear comparisons were set-up on the trailing side of the vehicle, which differed depending on the test mode. For each test, the trailing edge dummies were seated similarly using a FARO Arm (FARO Technologies, Inc.). Figure 6 shows the two dummies placed in the vehicle.

Figure 6: Trailing Front and Rear Occupants

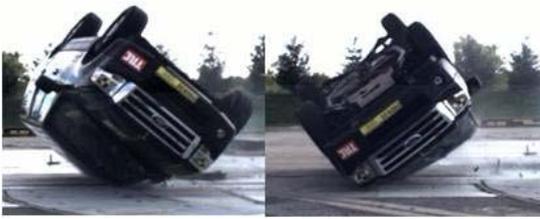
In a typical dolly test, the vehicle comes off the platform with some rotational velocity. Then the leading side tires (right side for these tests) interact with the ground, tripping the vehicle and

causing it to rotate one or more quarter turns (Figure 11).

Figure 11: FMVSS No. 208 Dolly Test

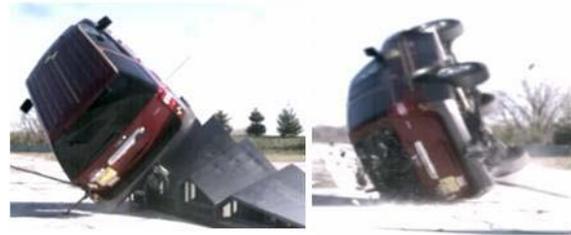
These tests were conducted such that the trailing side was the right side of the vehicle. The vehicles were released at the base of the ramp at 30 mph. As the vehicles rolled up the ramp, the right front corner rose rapidly, and the vehicles rolled counter clockwise (Figure 15).

Figure 15: Corkscrew Ramp

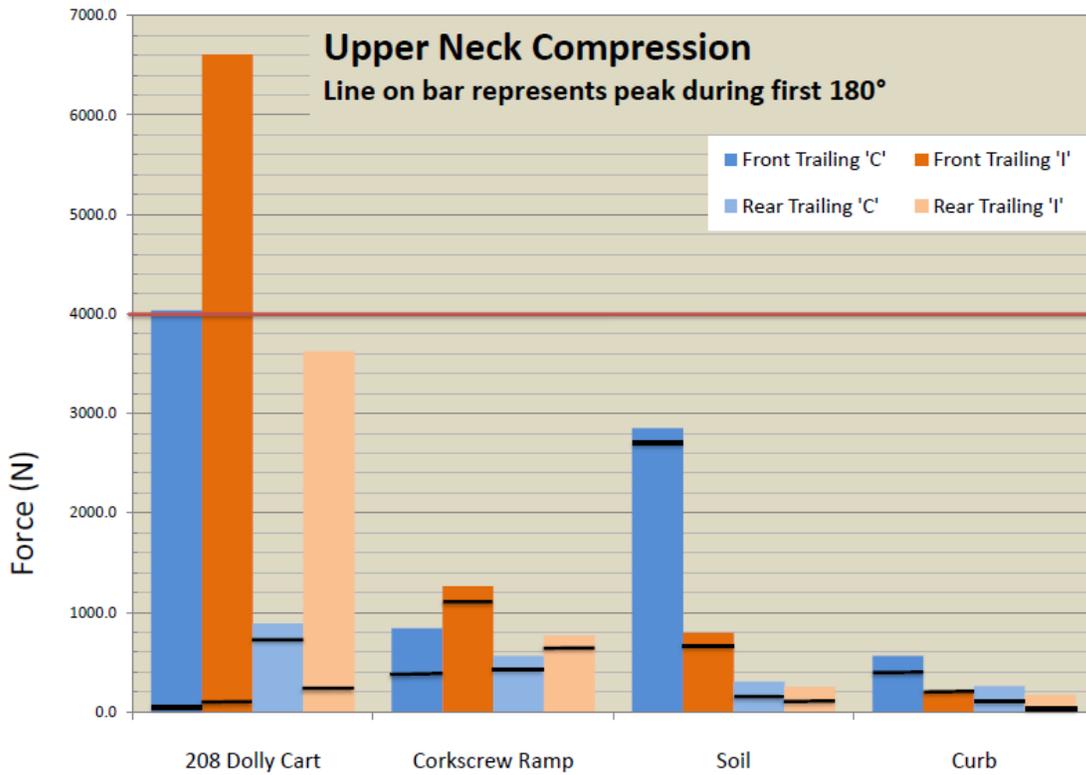
Appendix A, Plot 4, shows the neck compression results of the comparable tests. The blue bars represent Configuration C and the orange bars represent Configuration I. The black lines in the bars represent the peak neck compression when the vehicle was at 180 degrees.

PLOT 4: Trailing Side Front and Rear Occupant Upper Neck Compression Configuration C vs I

The high neck responses in both the trailing side front and the rear occupant locations can be attributed to a combination of pillar and roof crush and the dummies slipping out of the shoulder belts. Other injury criteria including Head Injury Criterion (HIC) and the Neck Injury Criterion (N_{ij}) were low for all occupants. See Figure 13 and Appendix A, Plot 4, for additional details.

In test 1, the trailing side front occupant’s belt slipped off the shoulder late in the first roll of the event (vehicle at 294°). The dummy’s peak upper neck compression was recorded as 2853 N, which is 71% of the IARV. In association with high neck compression, the roof and A-pillar were crushing into the vehicle (Figure 20). In the comparative test with Configuration I, the neck response was 791 N. The dummy remained in its shoulder belt during the first roll and did not contact the roof. See Appendix A, Plot 4 for additional information.
