Ford Inova Fairfax Hospital CIREN Team

Ford Motor Company

Case Studies in SUV Performance in Gross Size Mismatched Crashes

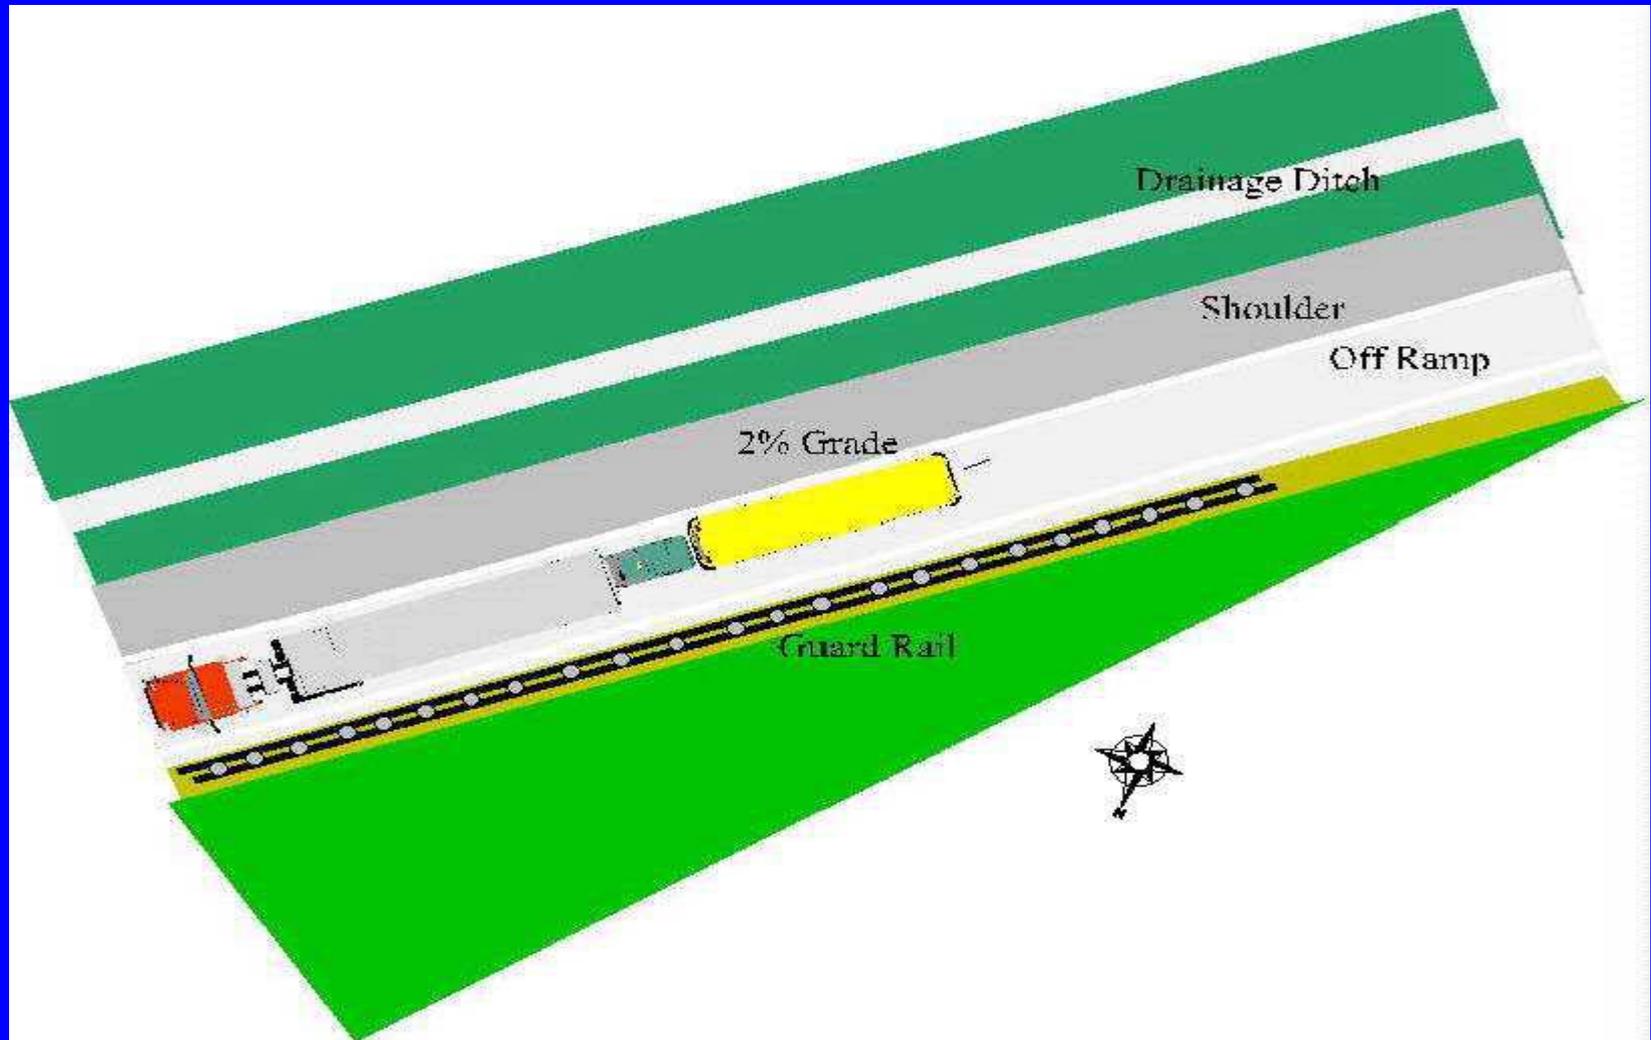
Scene

PDOF	180°	0°
CDC	06BDAW6	12FDAW4
Max crush	38 cm	44 cm

Total ΔV	40 km/h	-46 km/h
Longitudinal ΔV	40 km/h	-46 km/h
Lateral ΔV	0 km/h	0 km/h

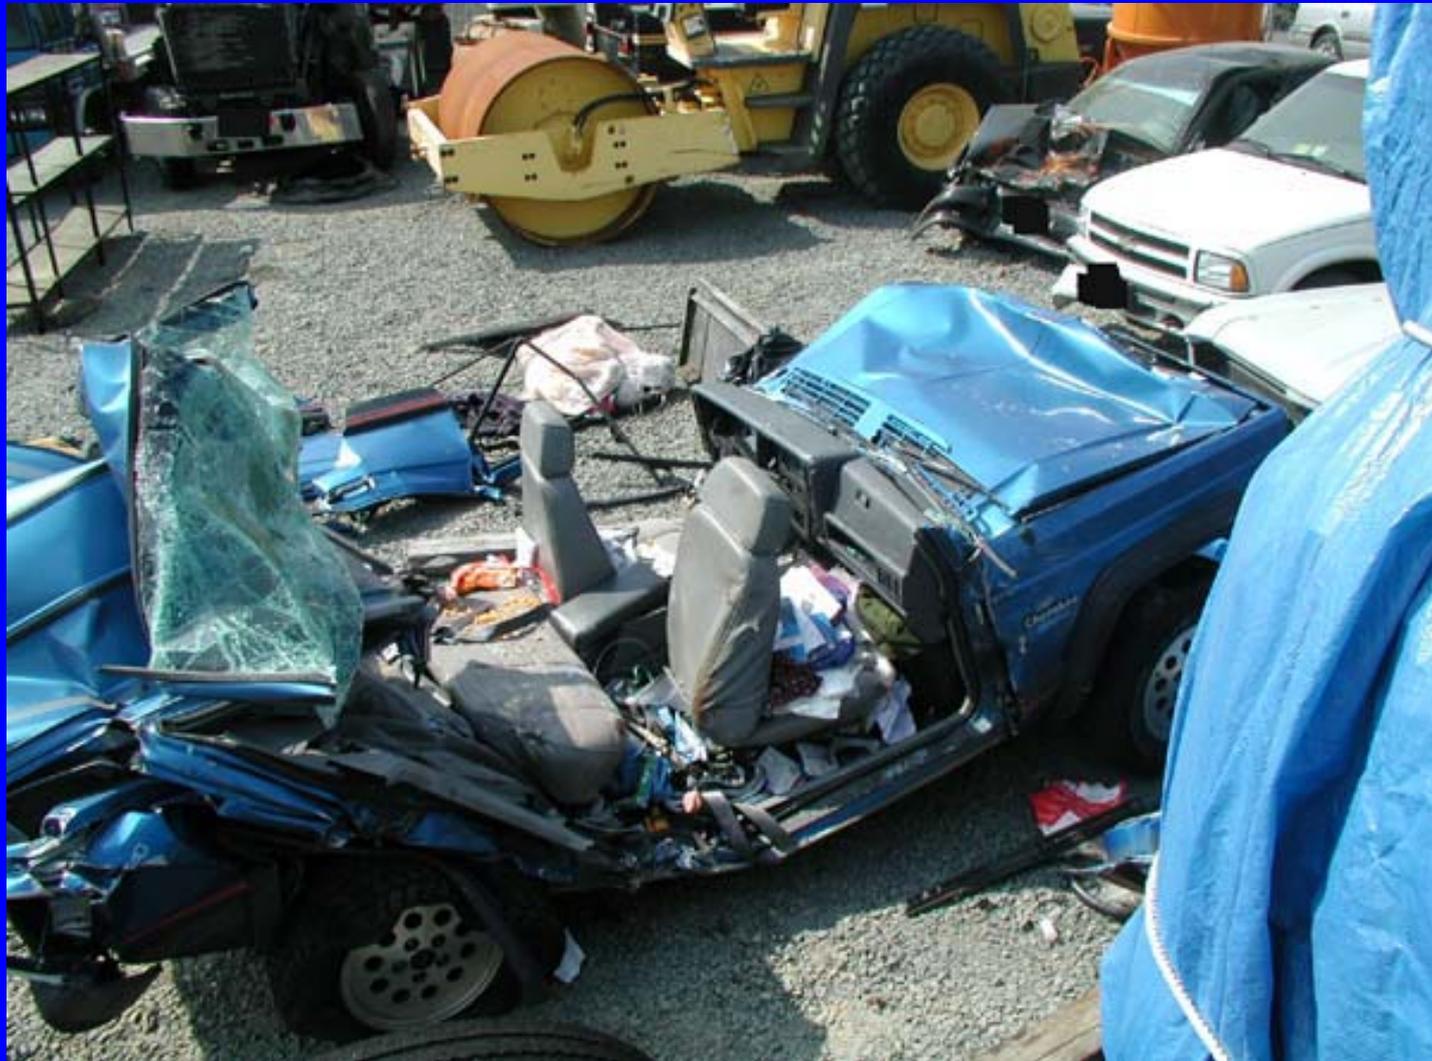
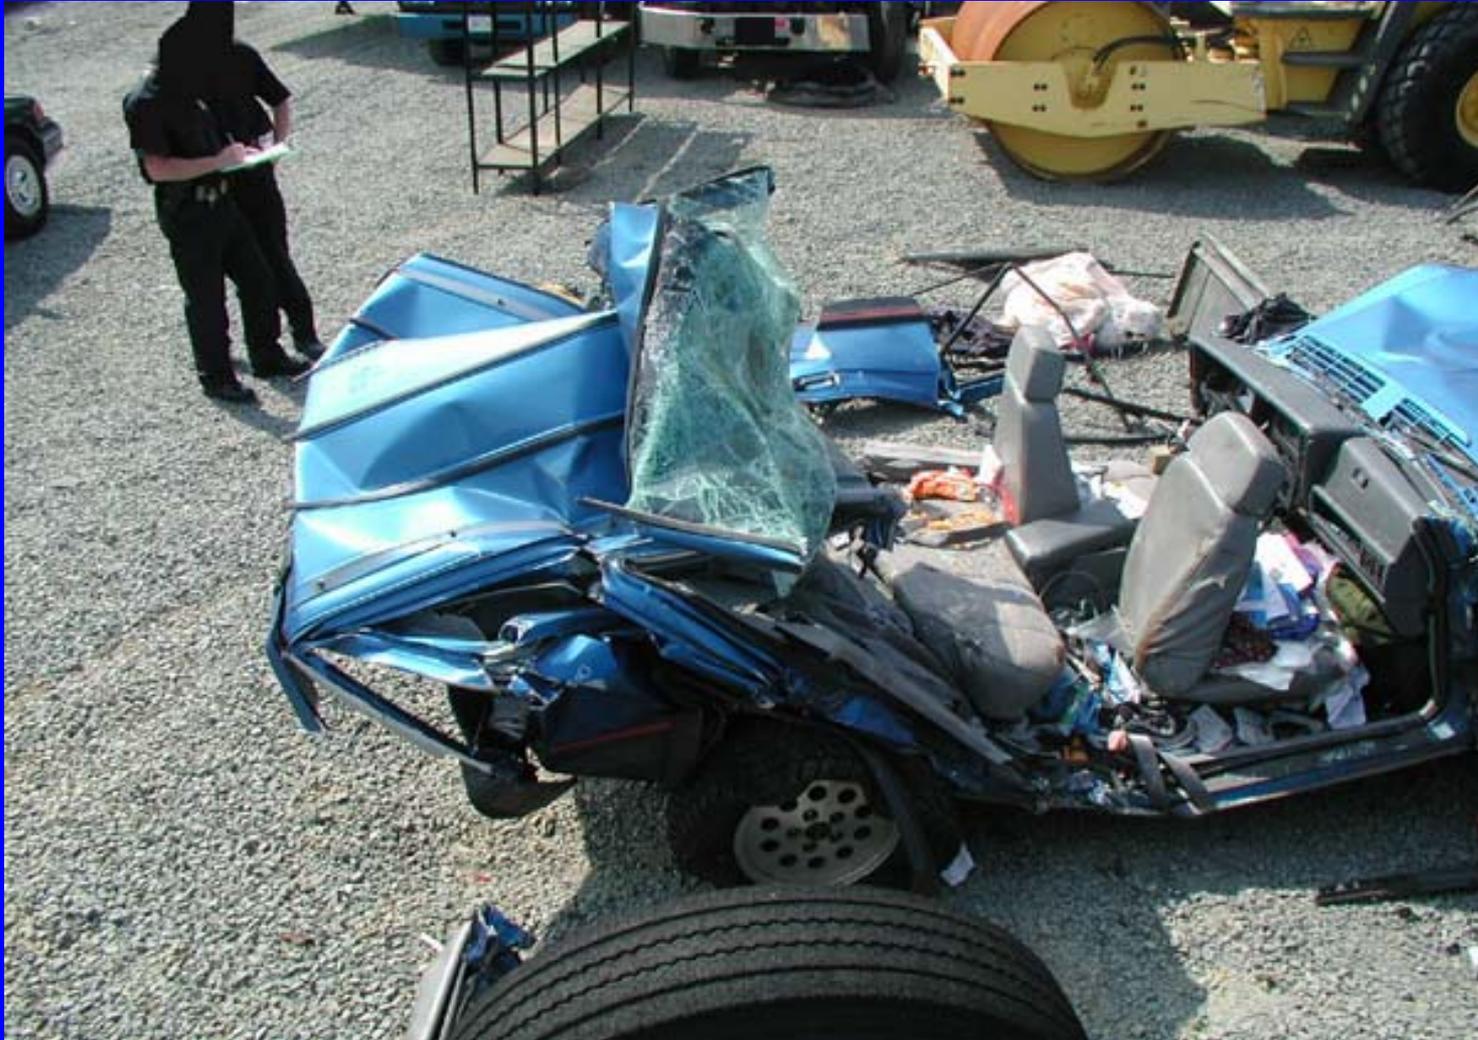
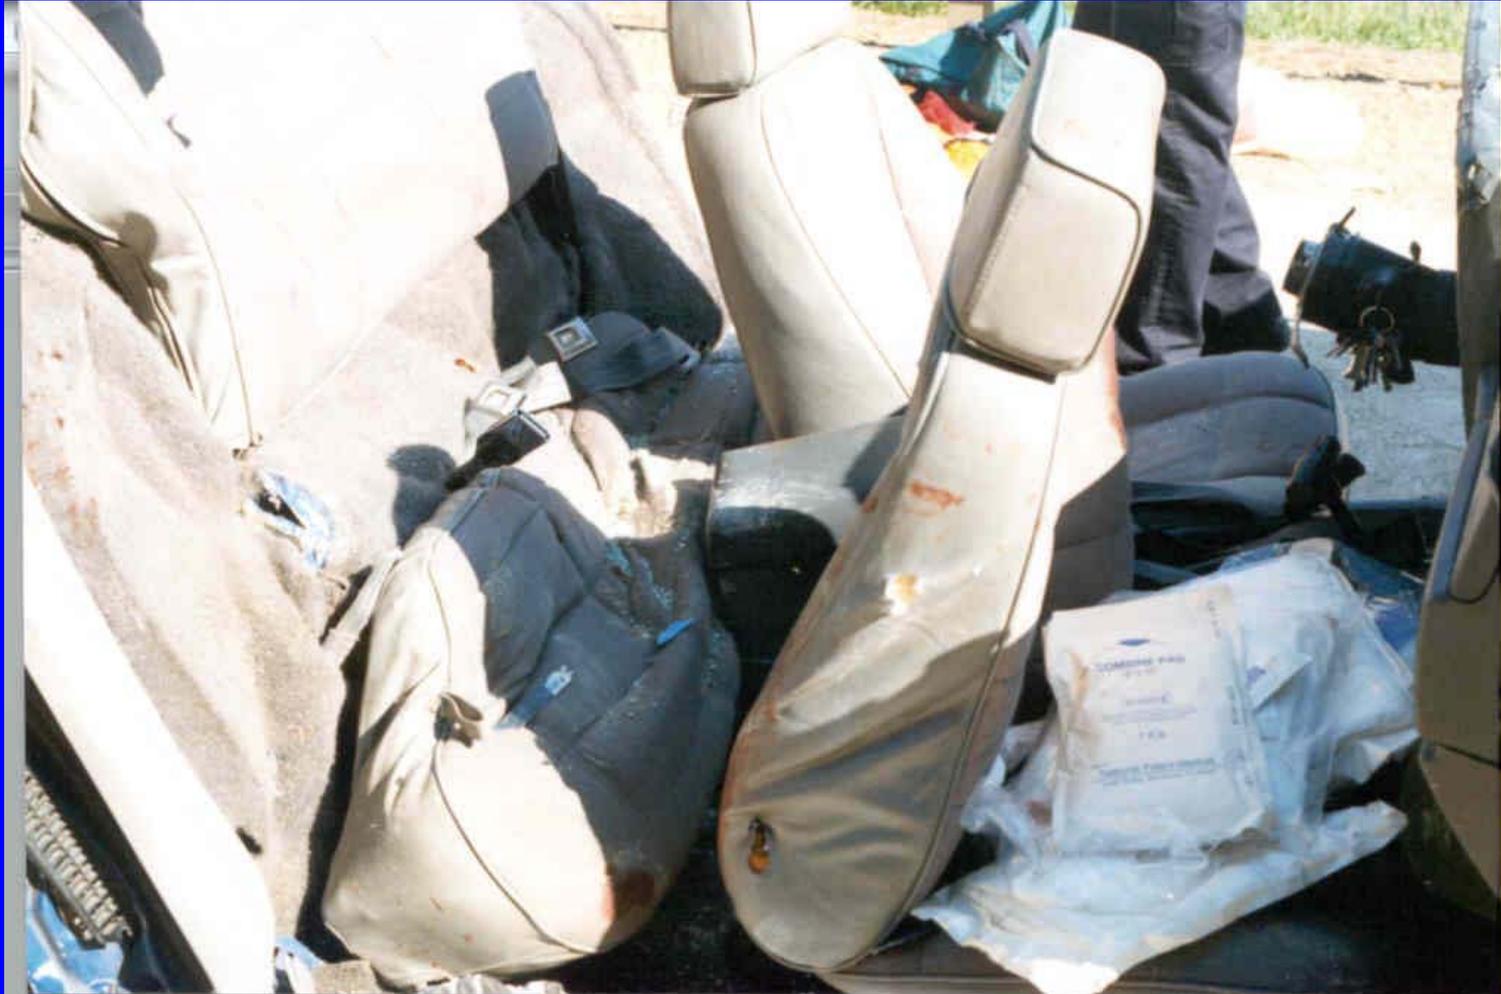
Vehicle 1

- The 3 occupants were still restrained, awake and oriented.
- The windshield as well as all 4 doors and the roof required removal to access the patients.
- A chain was attached to the rear of the case vehicle for a “reversed dash rollup.”
- The steering wheel was removed, which was not bent and the column intact.
- Total extrication time was 35 minutes.

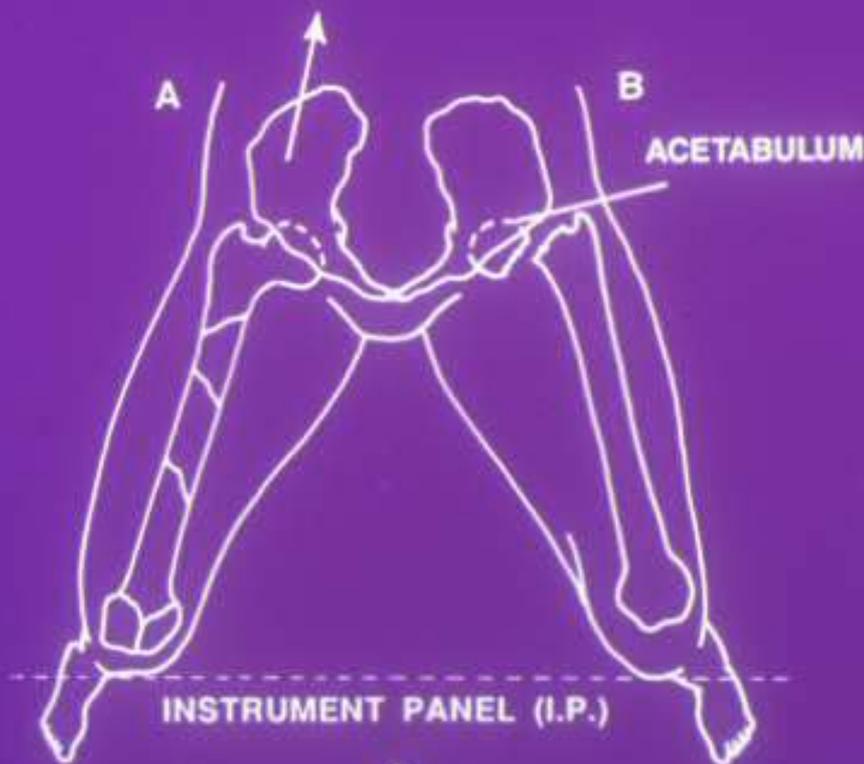
THIGH FLEXED AND ABDUCTED

- A** FRACTURE OF FEMORAL SHAFT AND/OR CONDYLAR FRACTURES
- B** DISLOCATION OF PROXIMAL FEMUR AND/OR SHEARED HEAD OF FEMUR

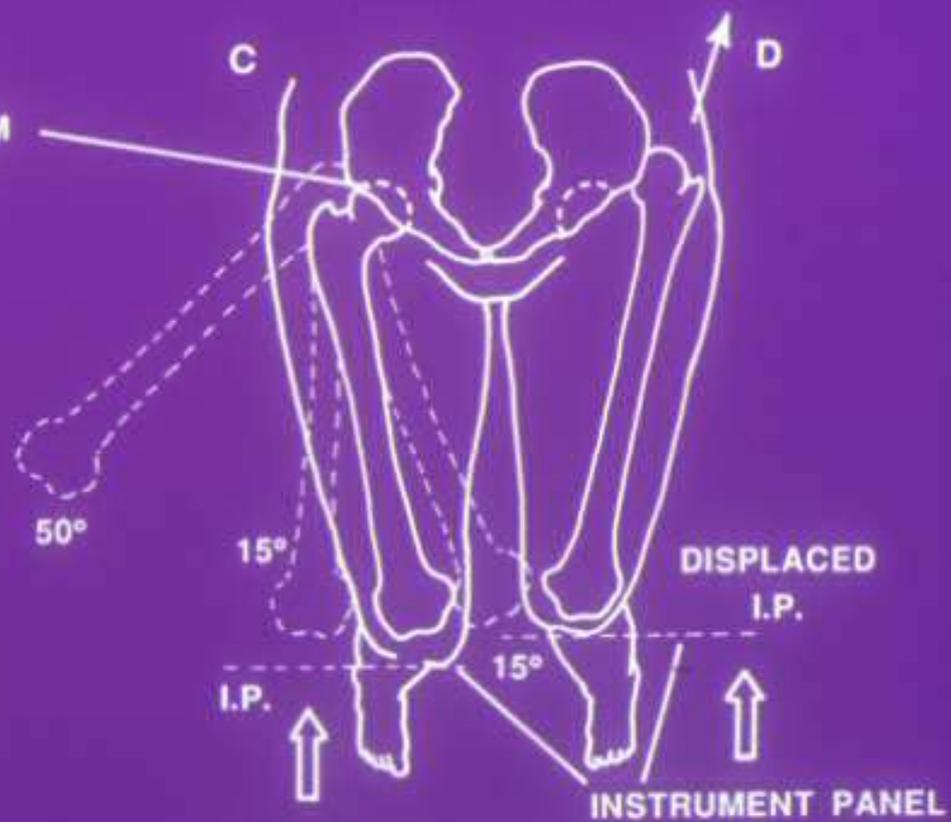
THIGH FLEXED AND ADDUCTED

- C** ACETABULAR FRACTURE OR
- D** POSTERIOR DISLOCATION OF FEMUR

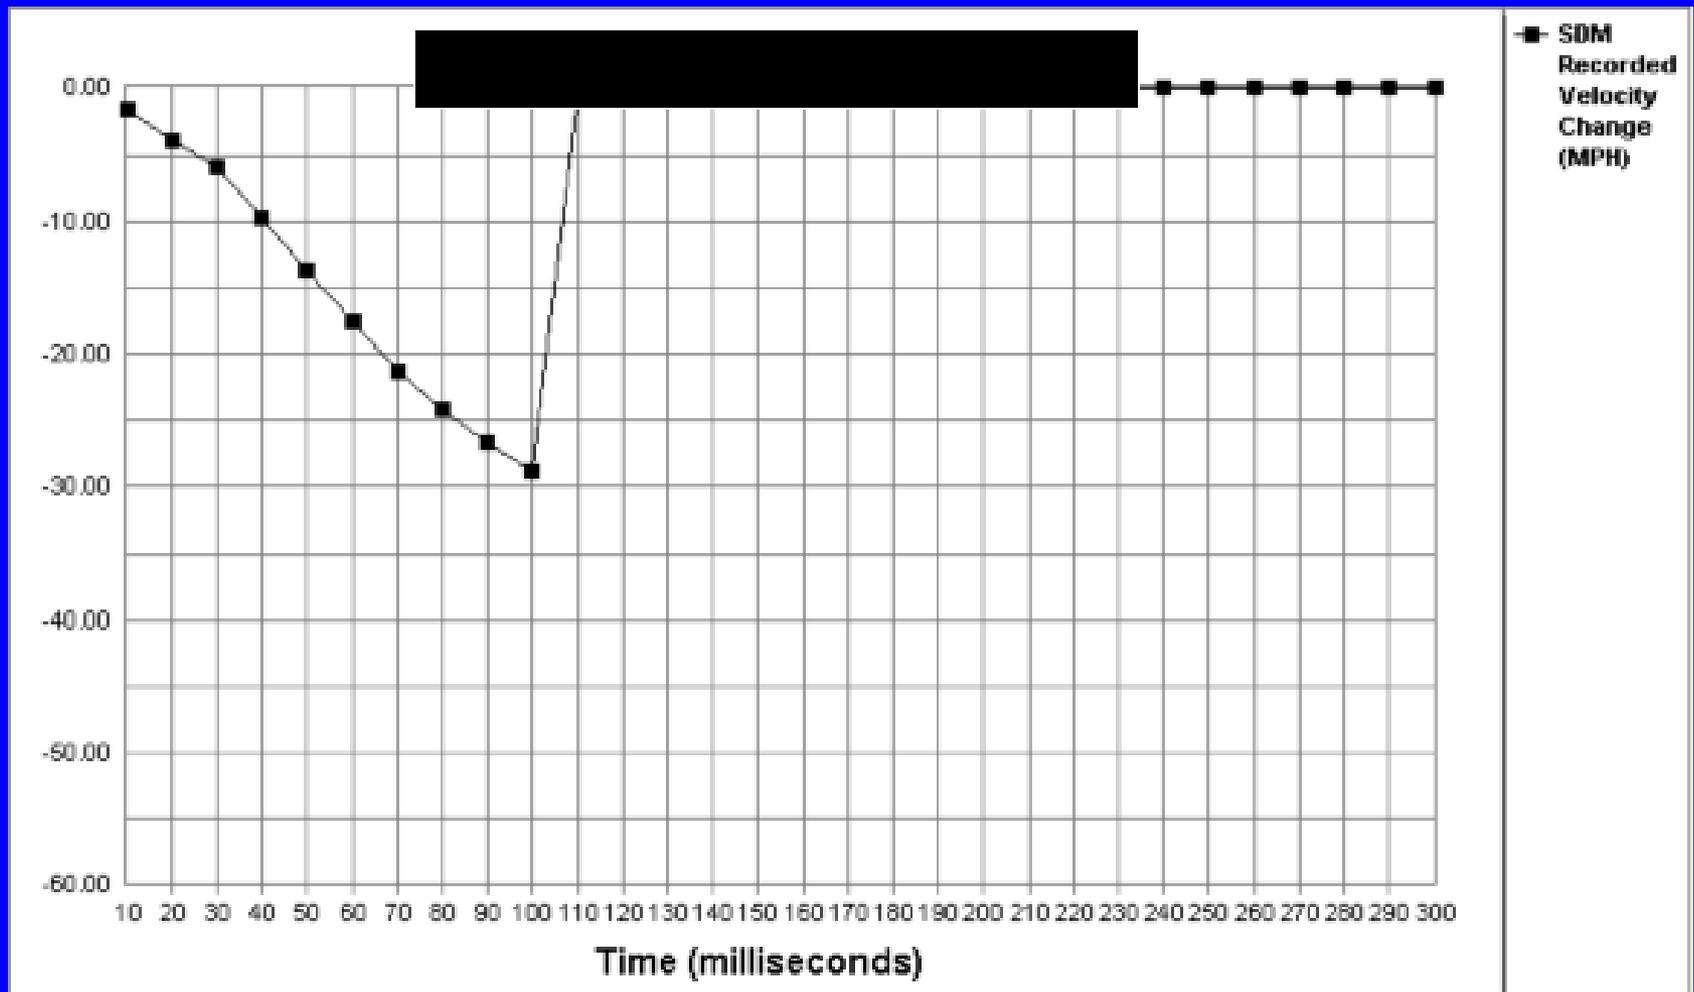
EVENT DATA RECORDER

System Status At Deployment	
SIR Warning Lamp Status	OFF
Driver's Belt Switch Circuit Status	UNBUCKLED
Passenger Front Air Bag Suppression Switch Circuit Status	ON
Ignition Cycles At Deployment	0
Ignition Cycles At Investigation	5970
Time From Algorithm Enable To Deployment Command (msec)	10
Time From Near Deployment To Deployment (msec)	0

Time (milliseconds)	10	20	30	40	50	60	70	80	90	100	110	120	130	140	150
Recorded Velocity Change (MPH)	-1.54	-3.95	-5.92	-9.65	-13.60	-17.55	-21.28	-24.13	-26.55	-28.74	0.00	0.00	0.00	0.00	0.00
Time (milliseconds)	160	170	180	190	200	210	220	230	240	250	260	270	280	290	300
Recorded Velocity Change (MPH)	0.00	0.00	0.00	0.00	0.00	0.00	0.00	0.00	0.00	0.00	0.00	0.00	0.00	0.00	0.00

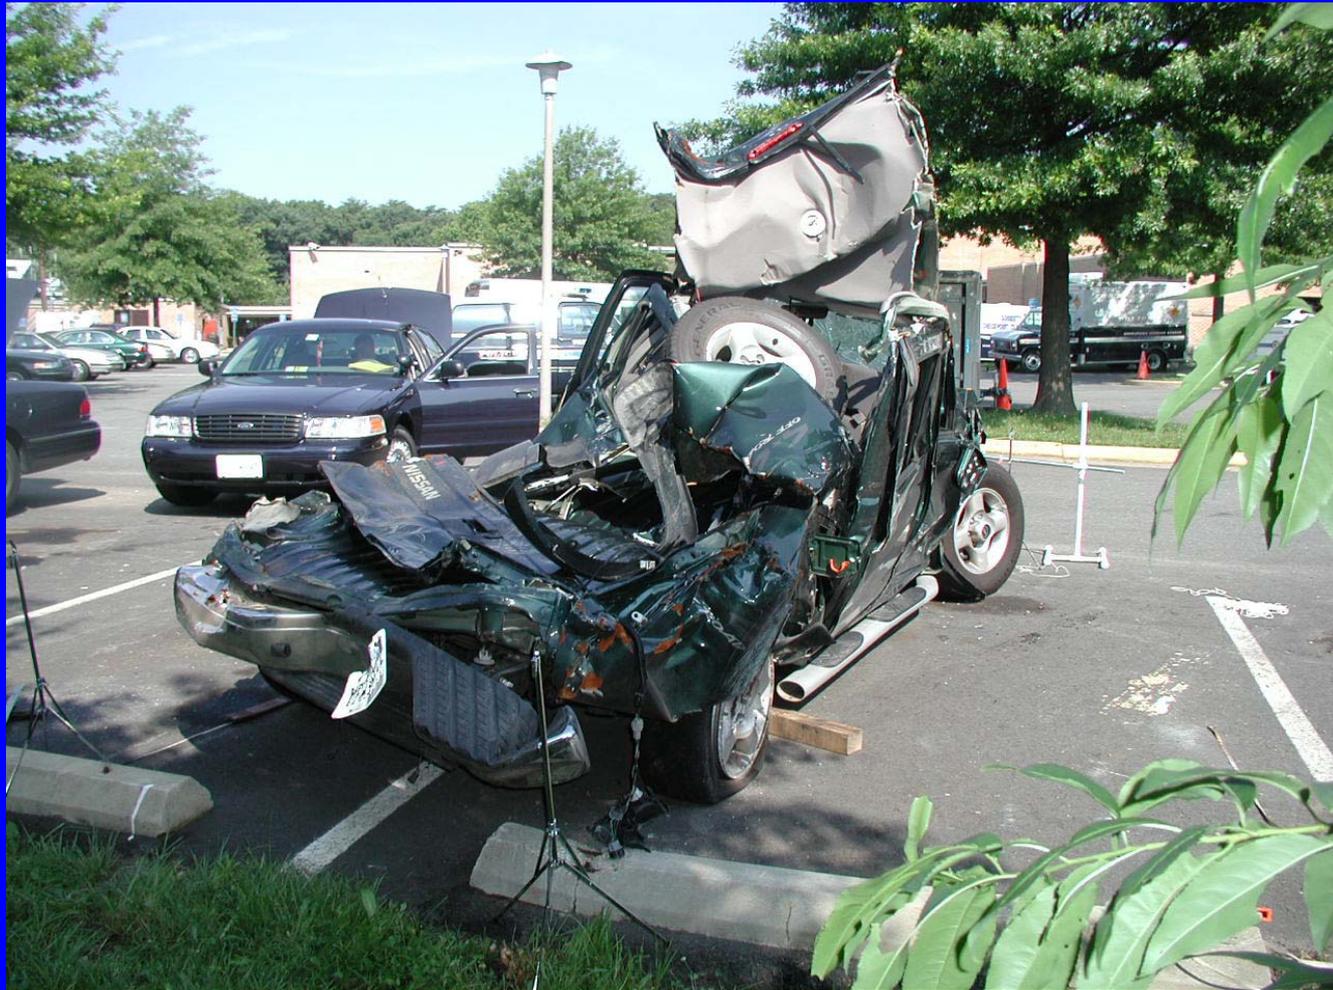
Event 1 Damage - Case Vehicle

Event 1

Impact with Tow Truck

CDC: 00BDHW9
PDOF: Non-horizontal

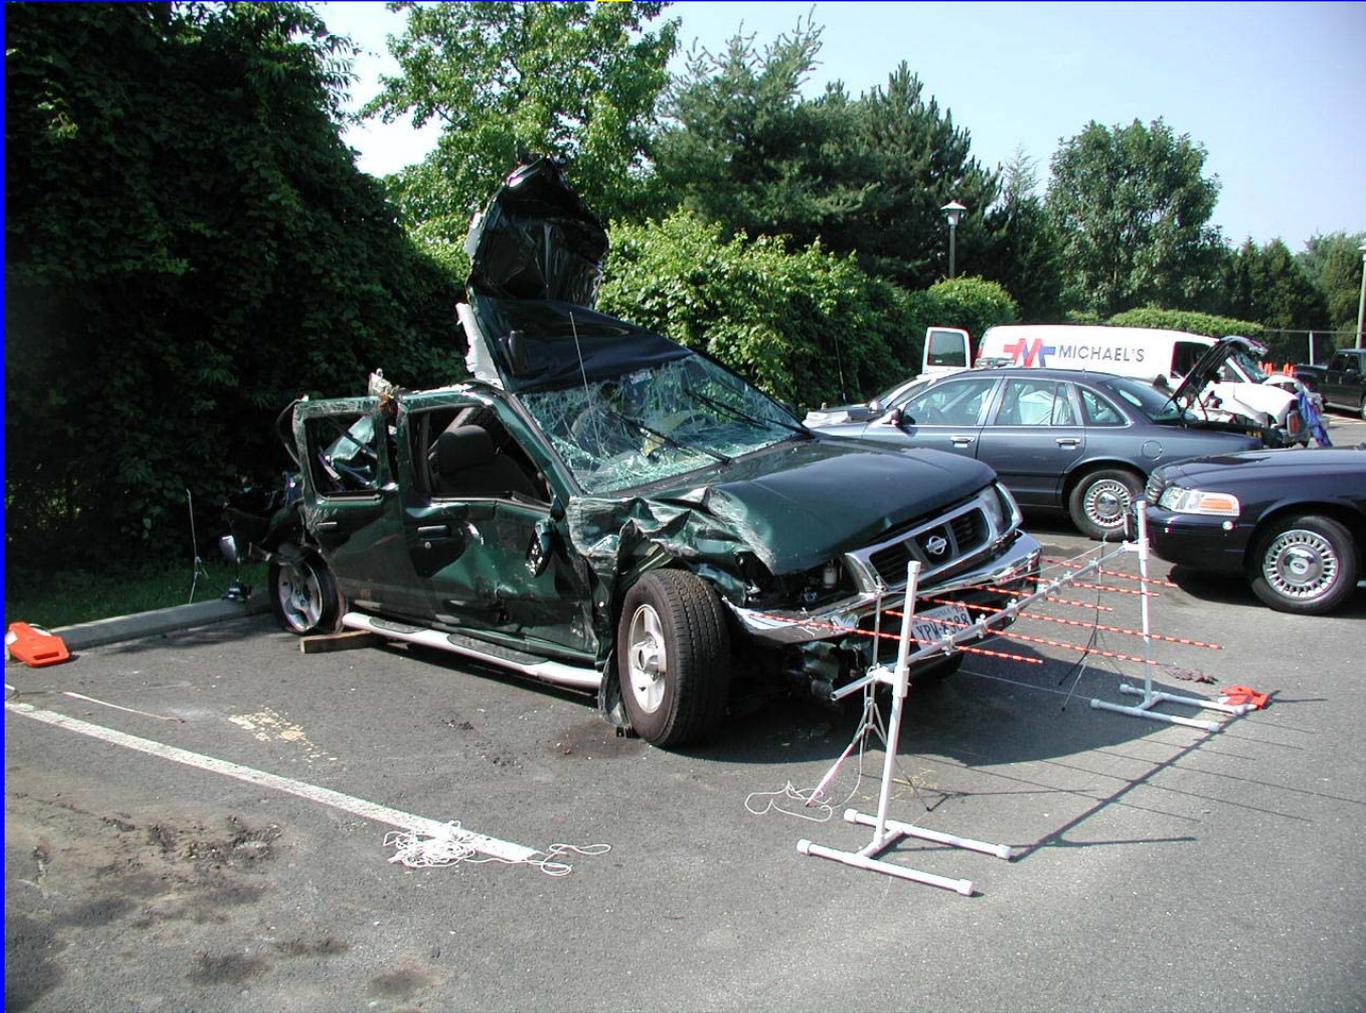
Event 2 Damage - Case Vehicle

Event 2

Impact with Chevrolet Camaro

CDC: 01FREE8
PDOF: 20 degrees
