Mercedes-Benz CIREN Center **UAB Center for Injury Sciences**

Splenic Injury in Side Impact Motor Vehicle Collisions – The Role of Seatbelts

Biomechanical Response of the Pelvis to Side Impact

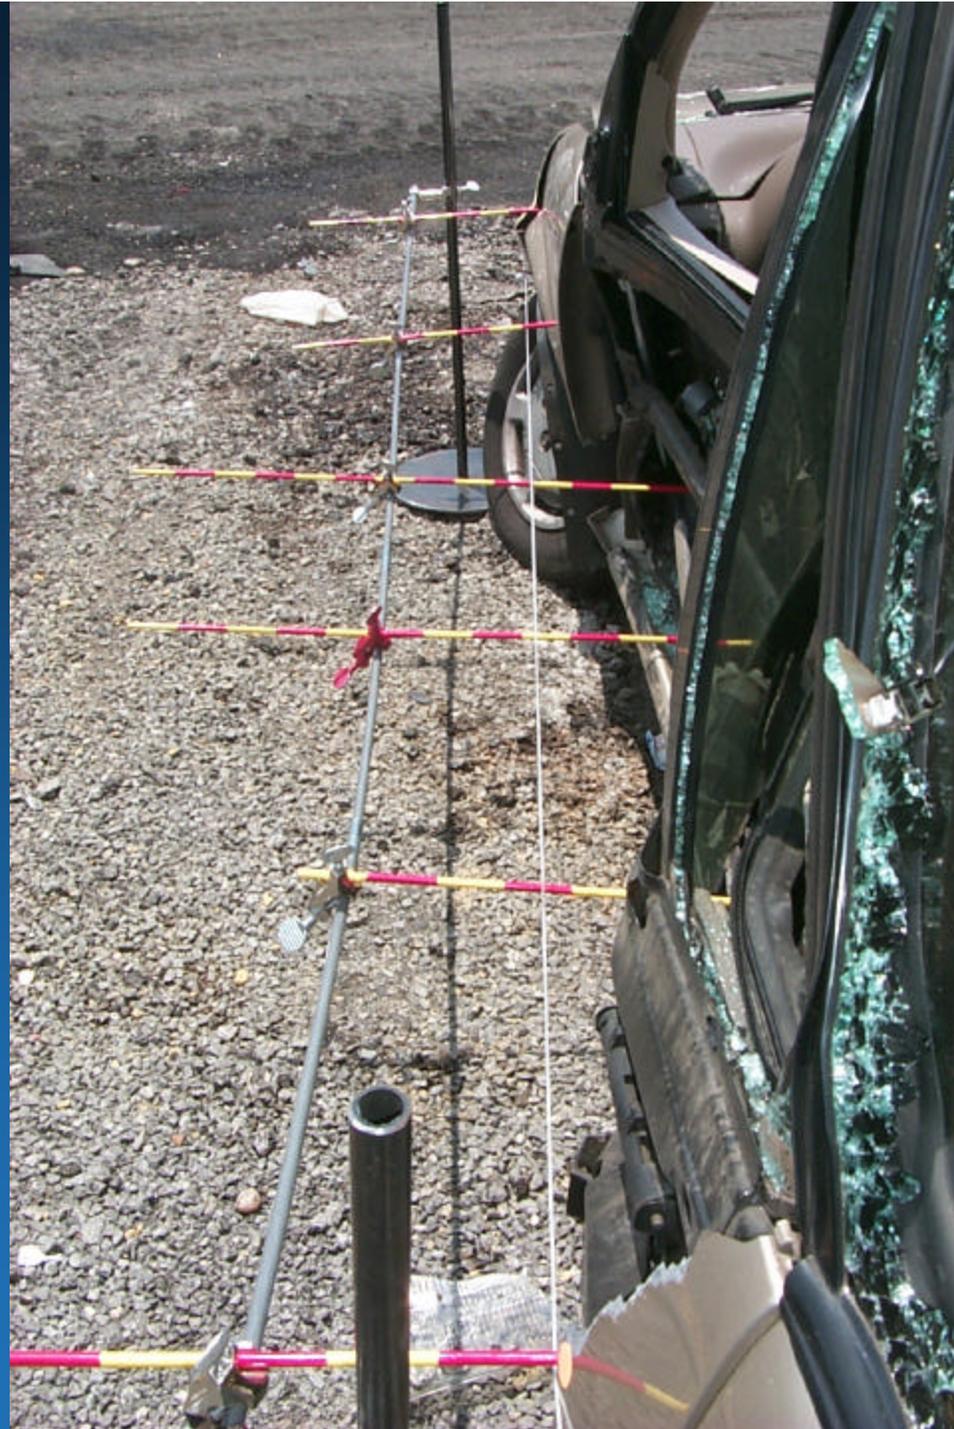
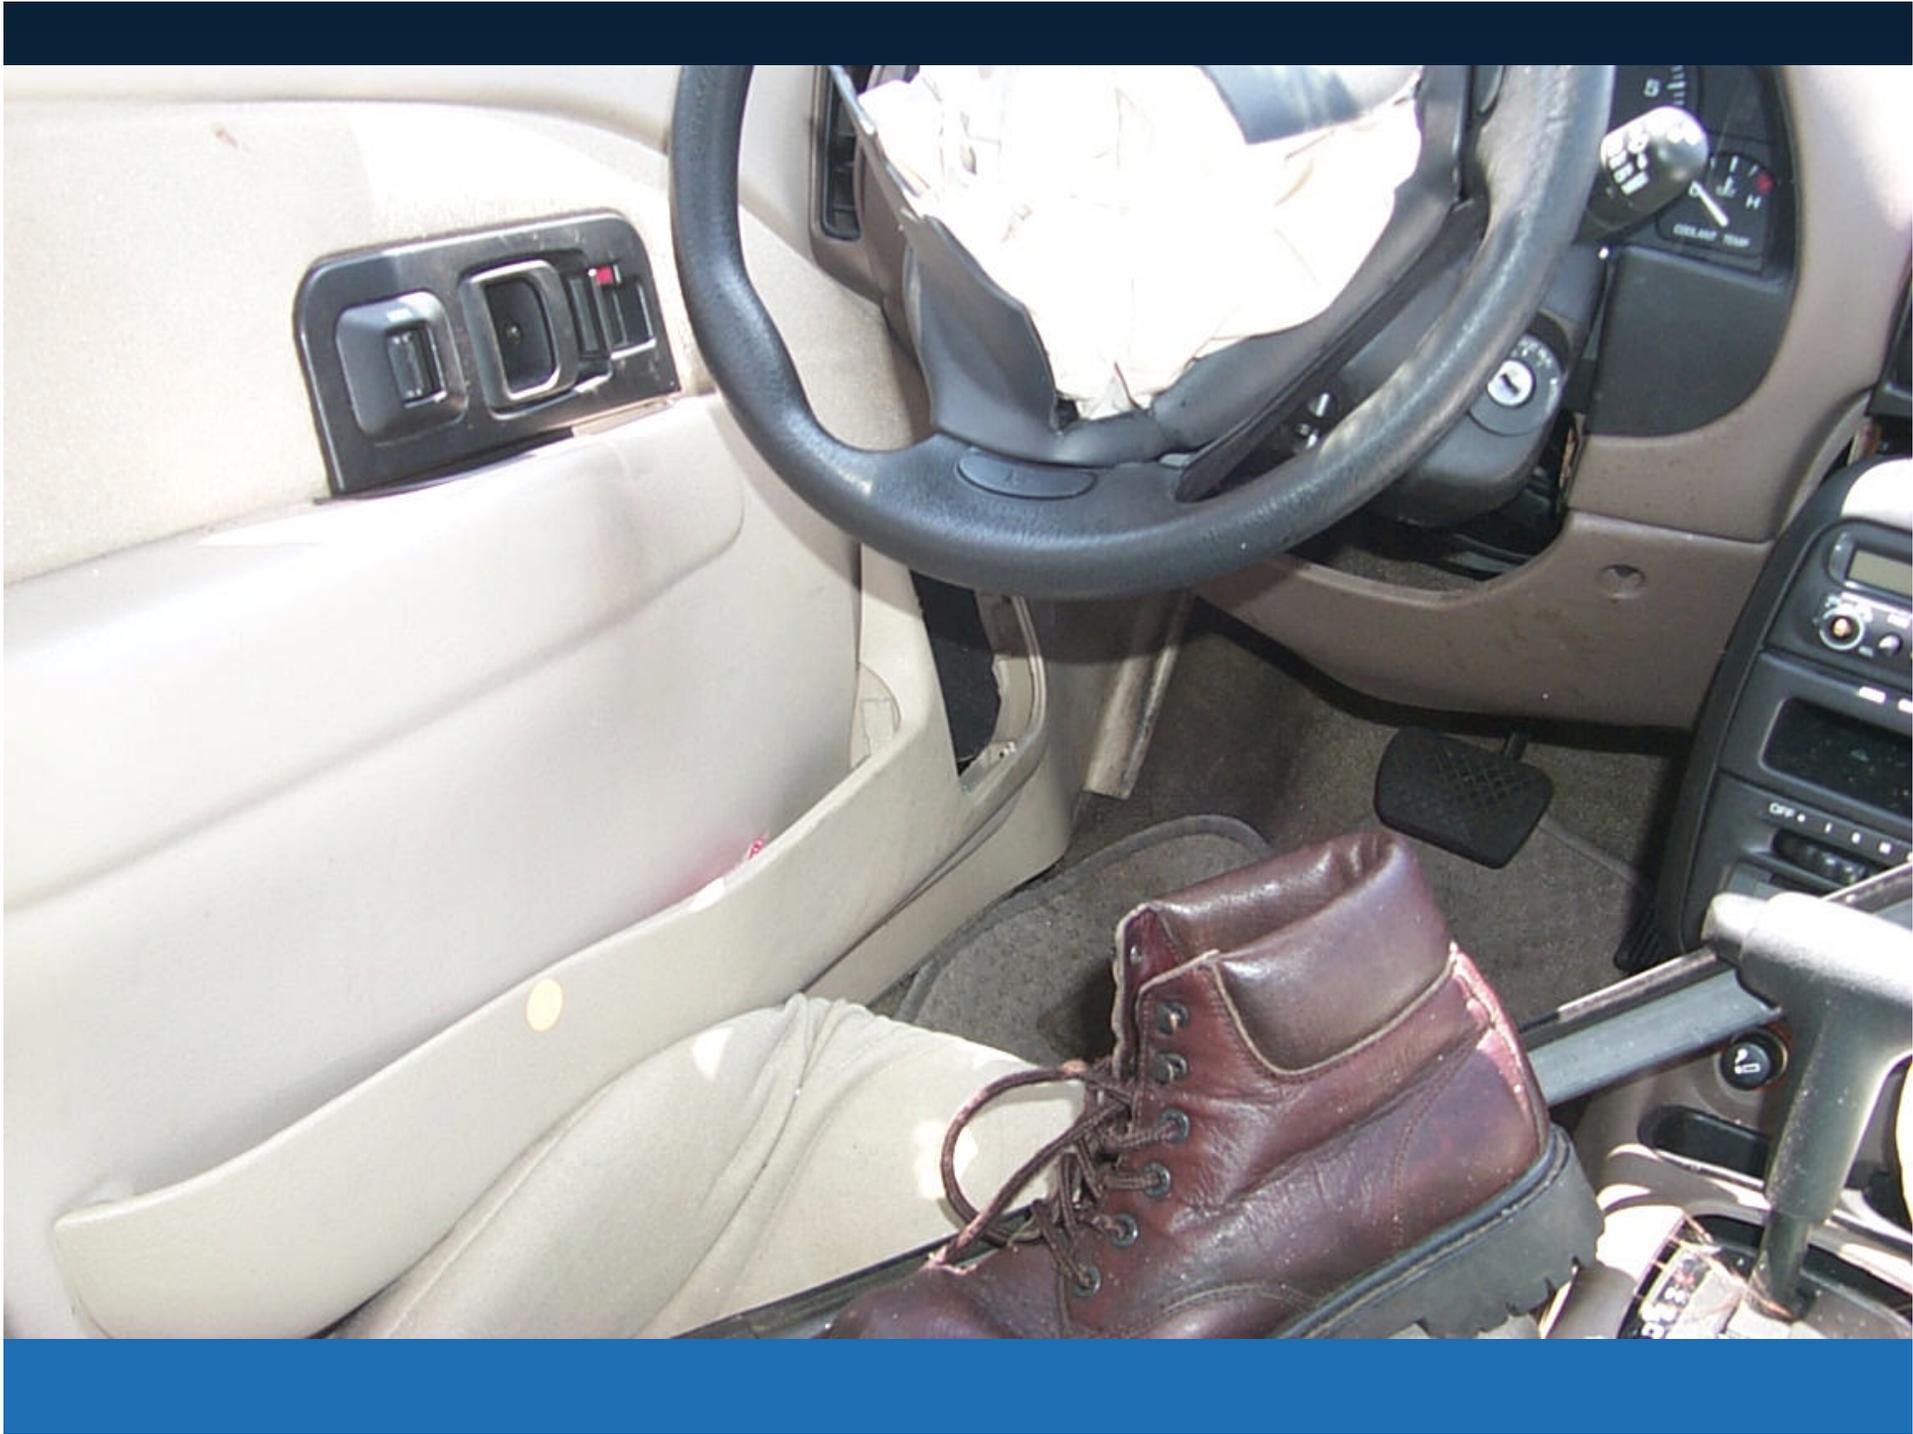
**MAXIMUM
CRUSH =
29 cm. / 11 in.**

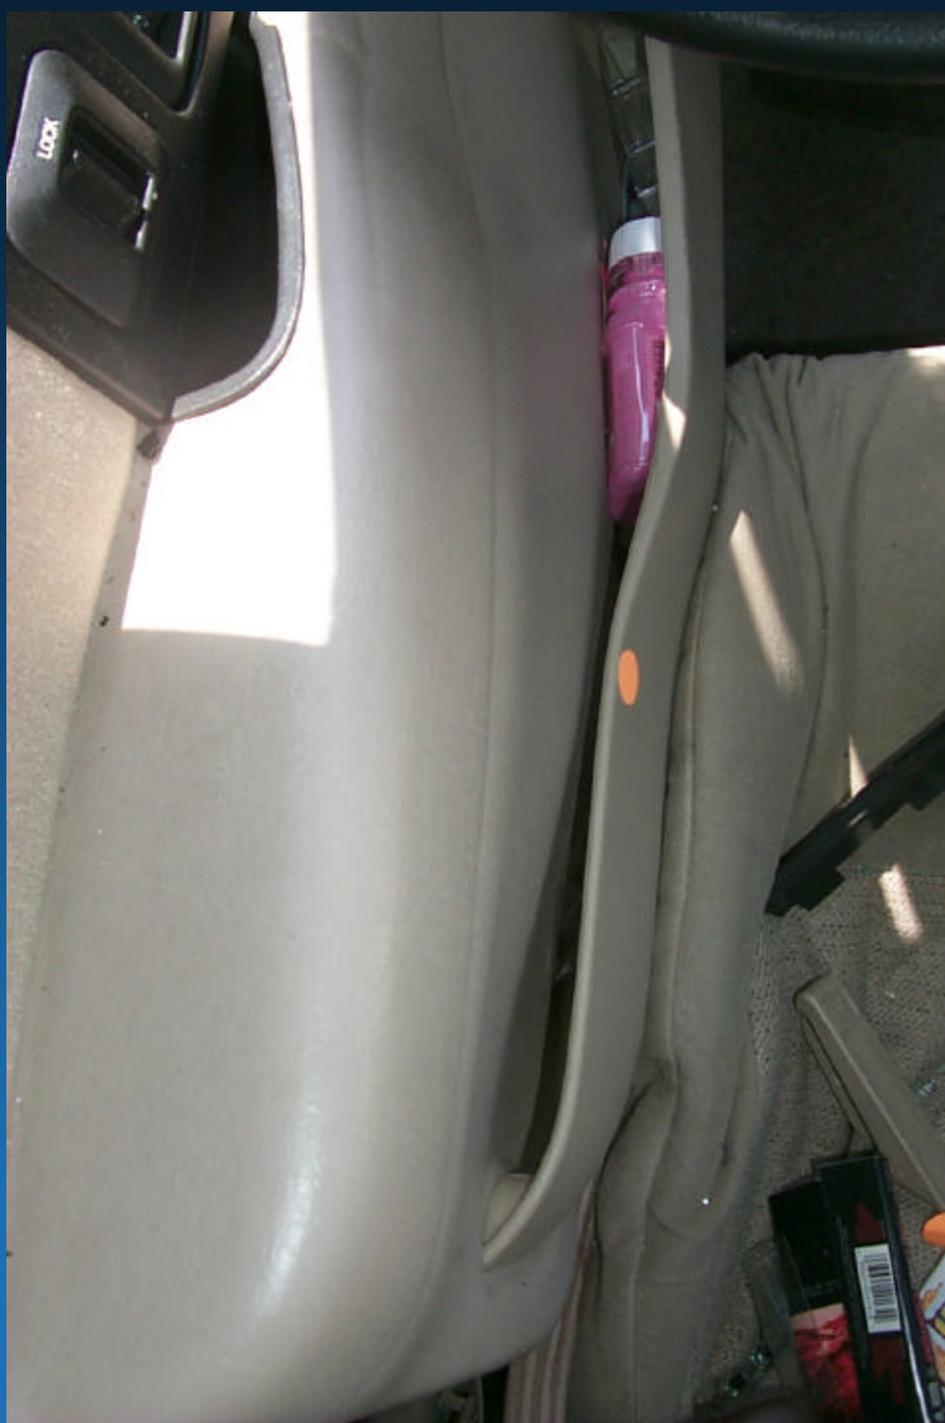
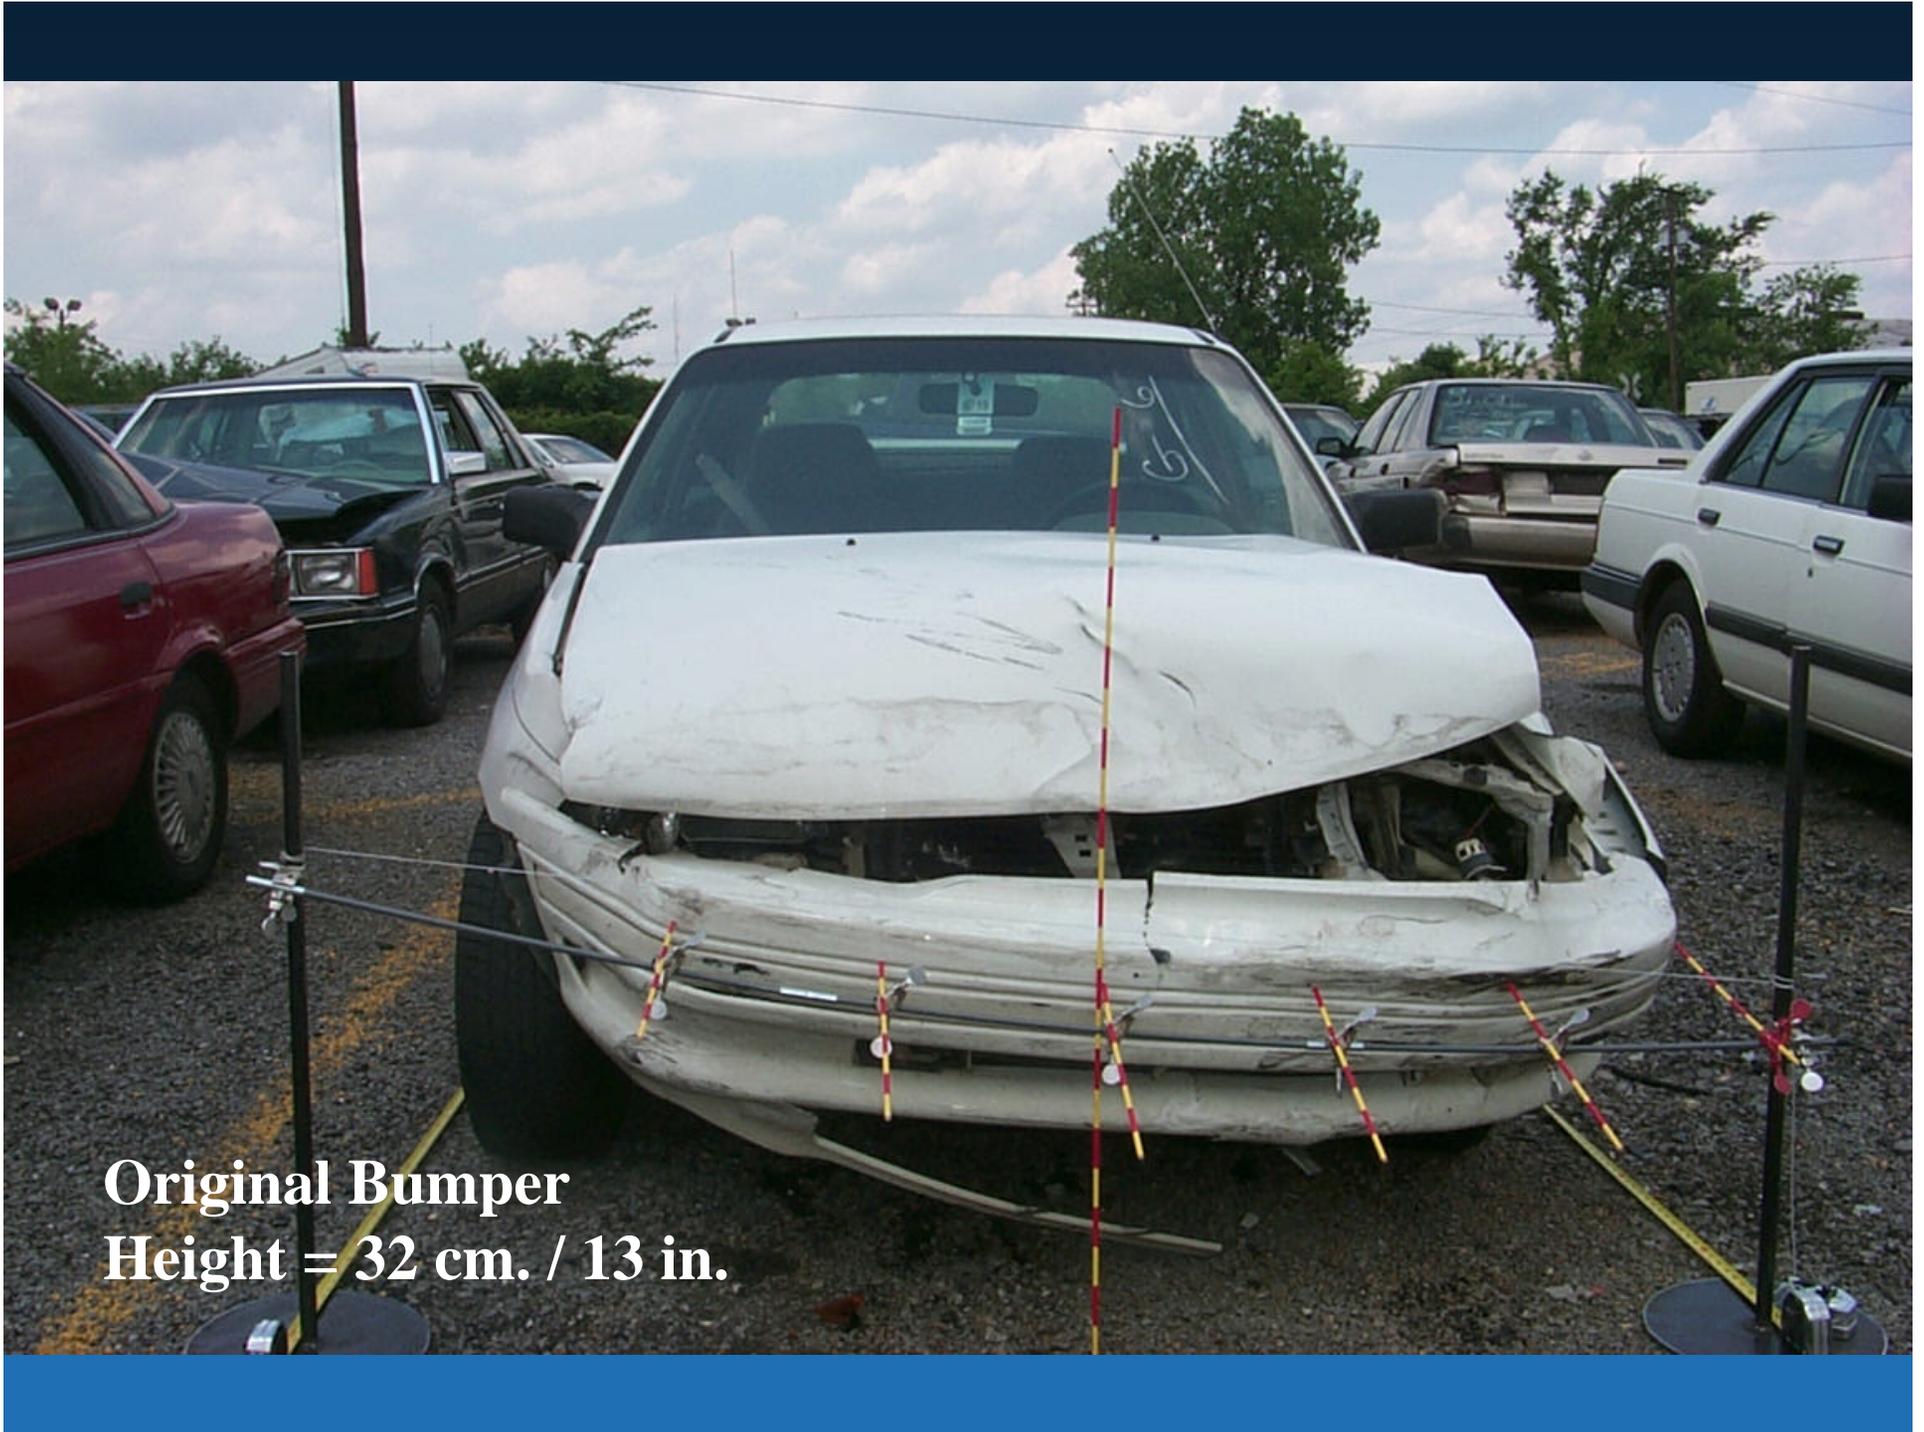
**MAXIMUM
INTRUSION =
20 cm. / 8 in.**

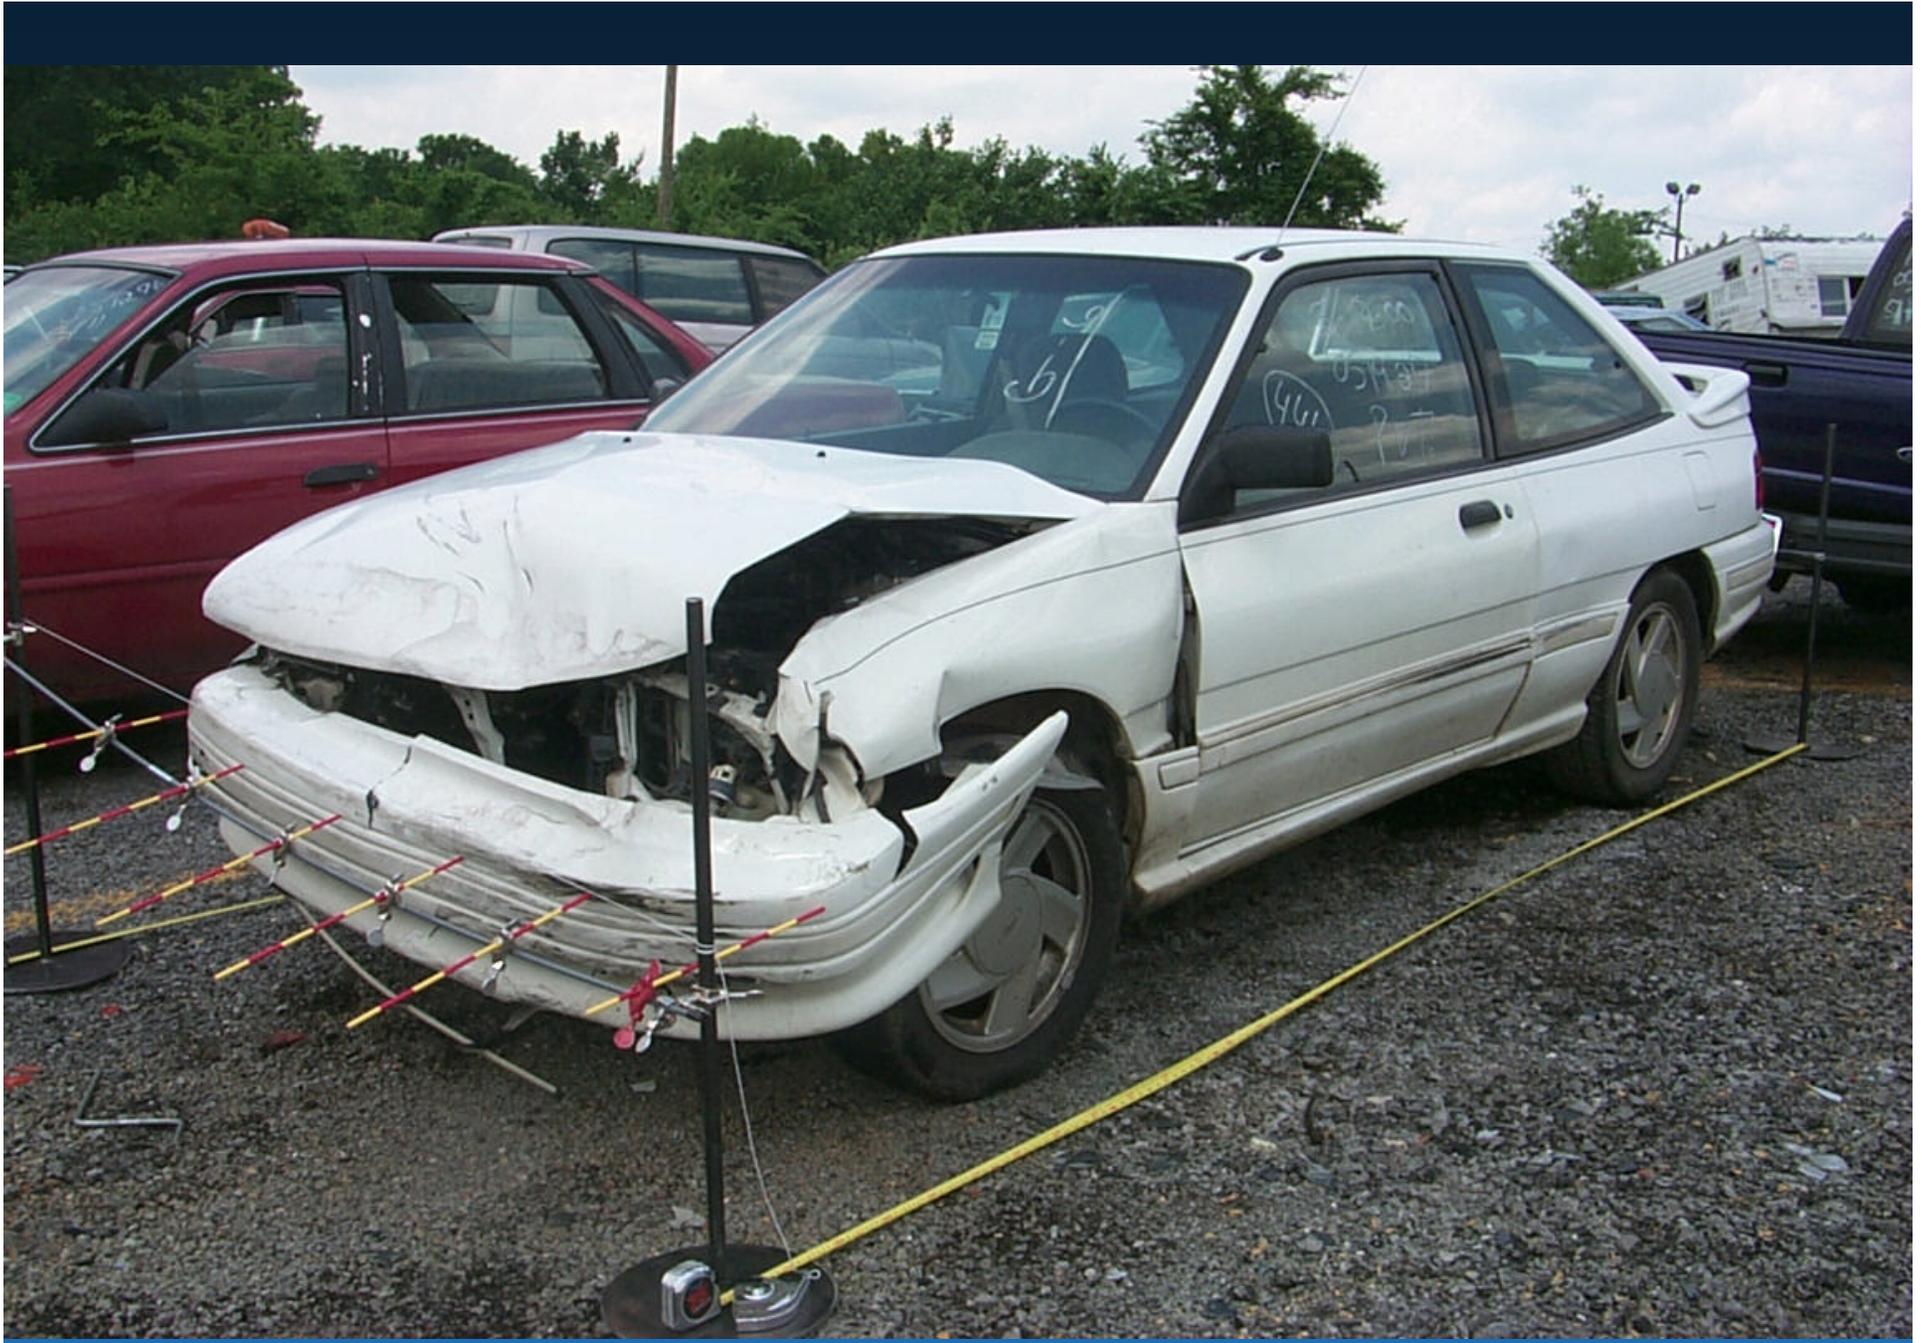
**Original Bumper
Height = 32 cm. / 13 in.**

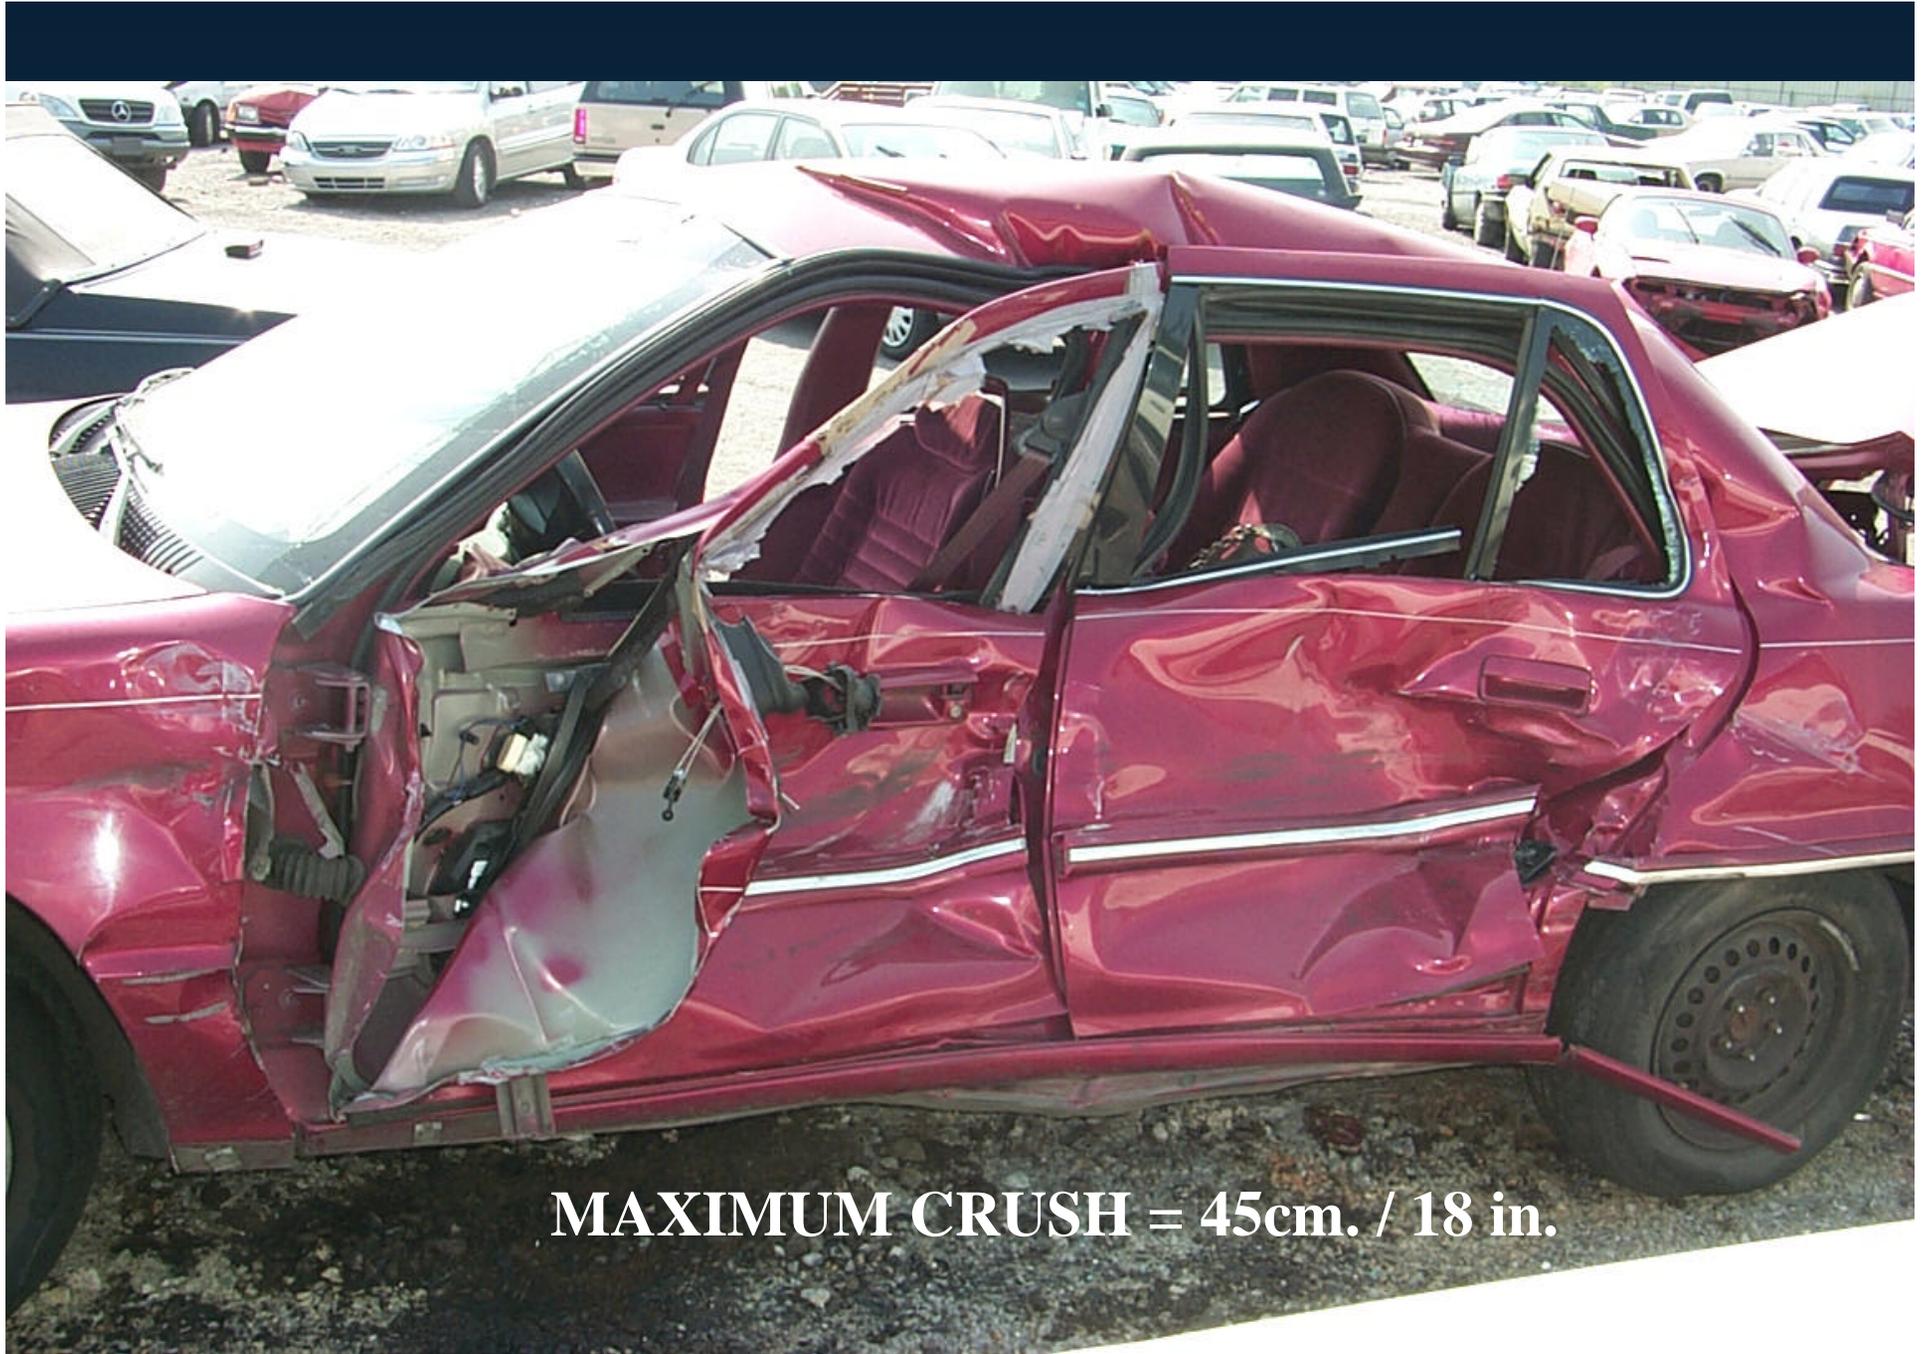
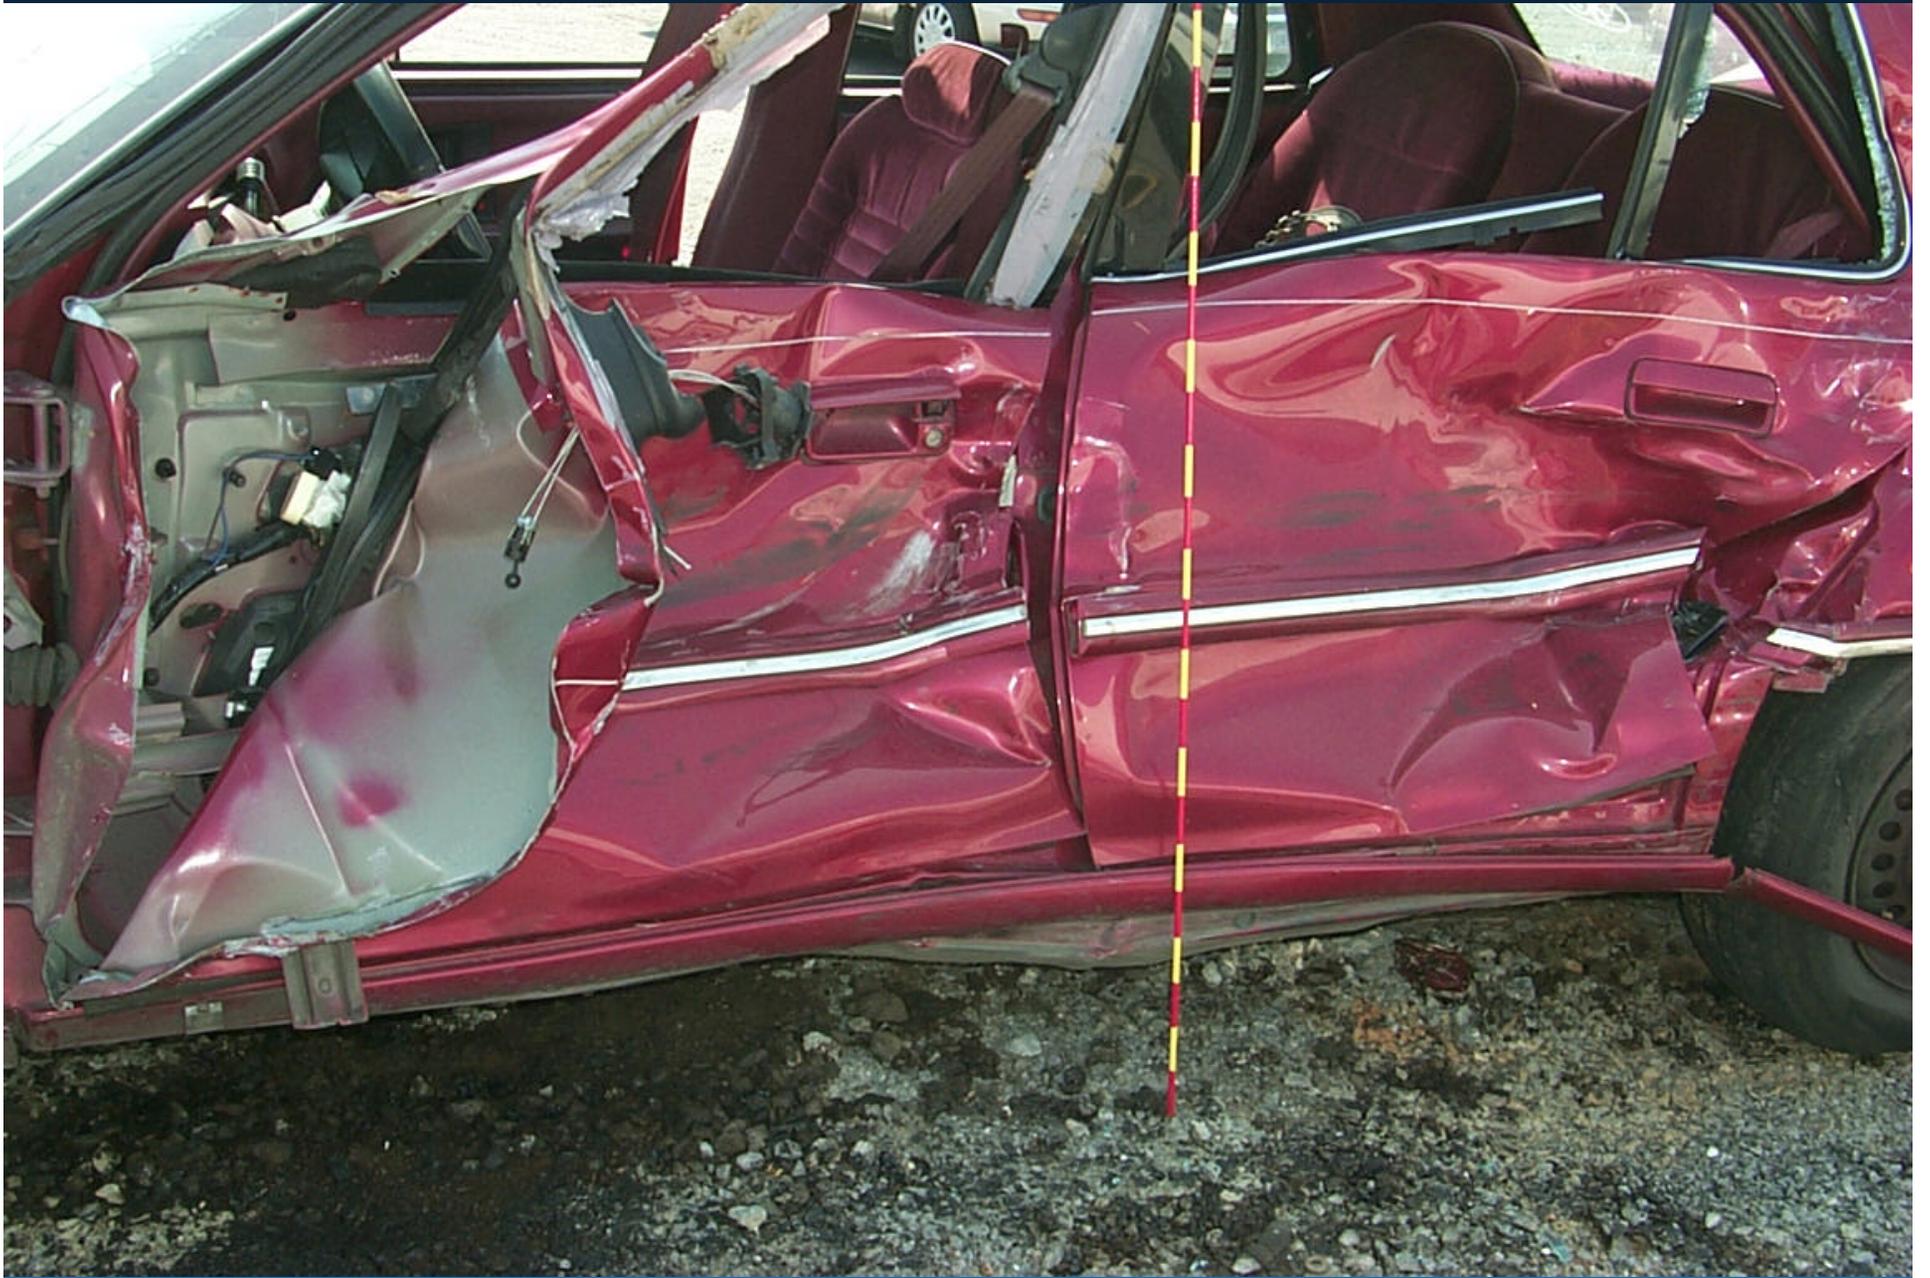
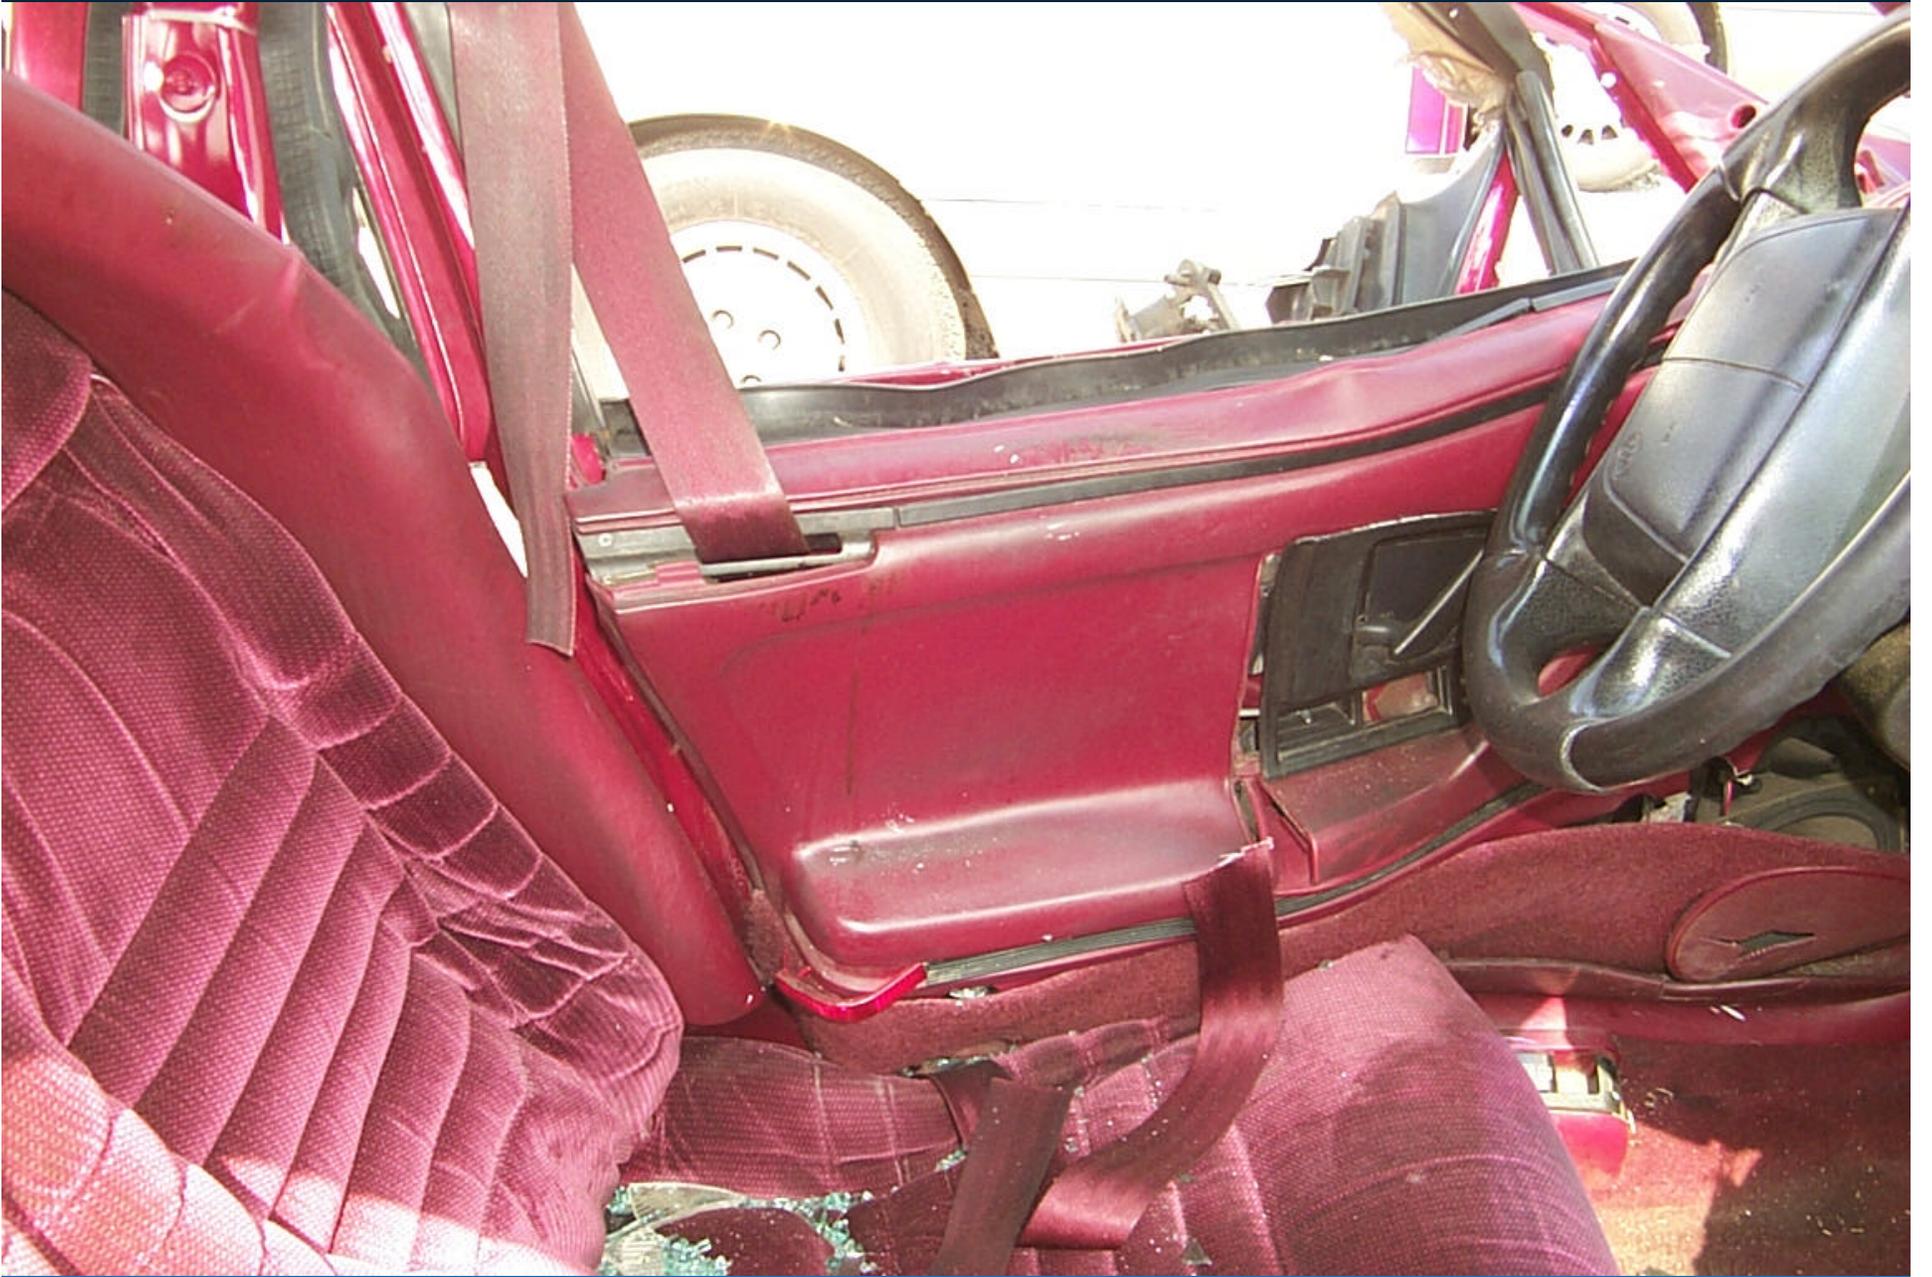
MAXIMUM CRUSH = 45cm. / 18 in.
