Mercedes-Benz CIREN Center **UAB Center for Injury Sciences**

Splenic Injury in Side Impact Motor Vehicle Collisions – The Role of Seatbelts

Biomechanical Response of the Pelvis to Side Impact

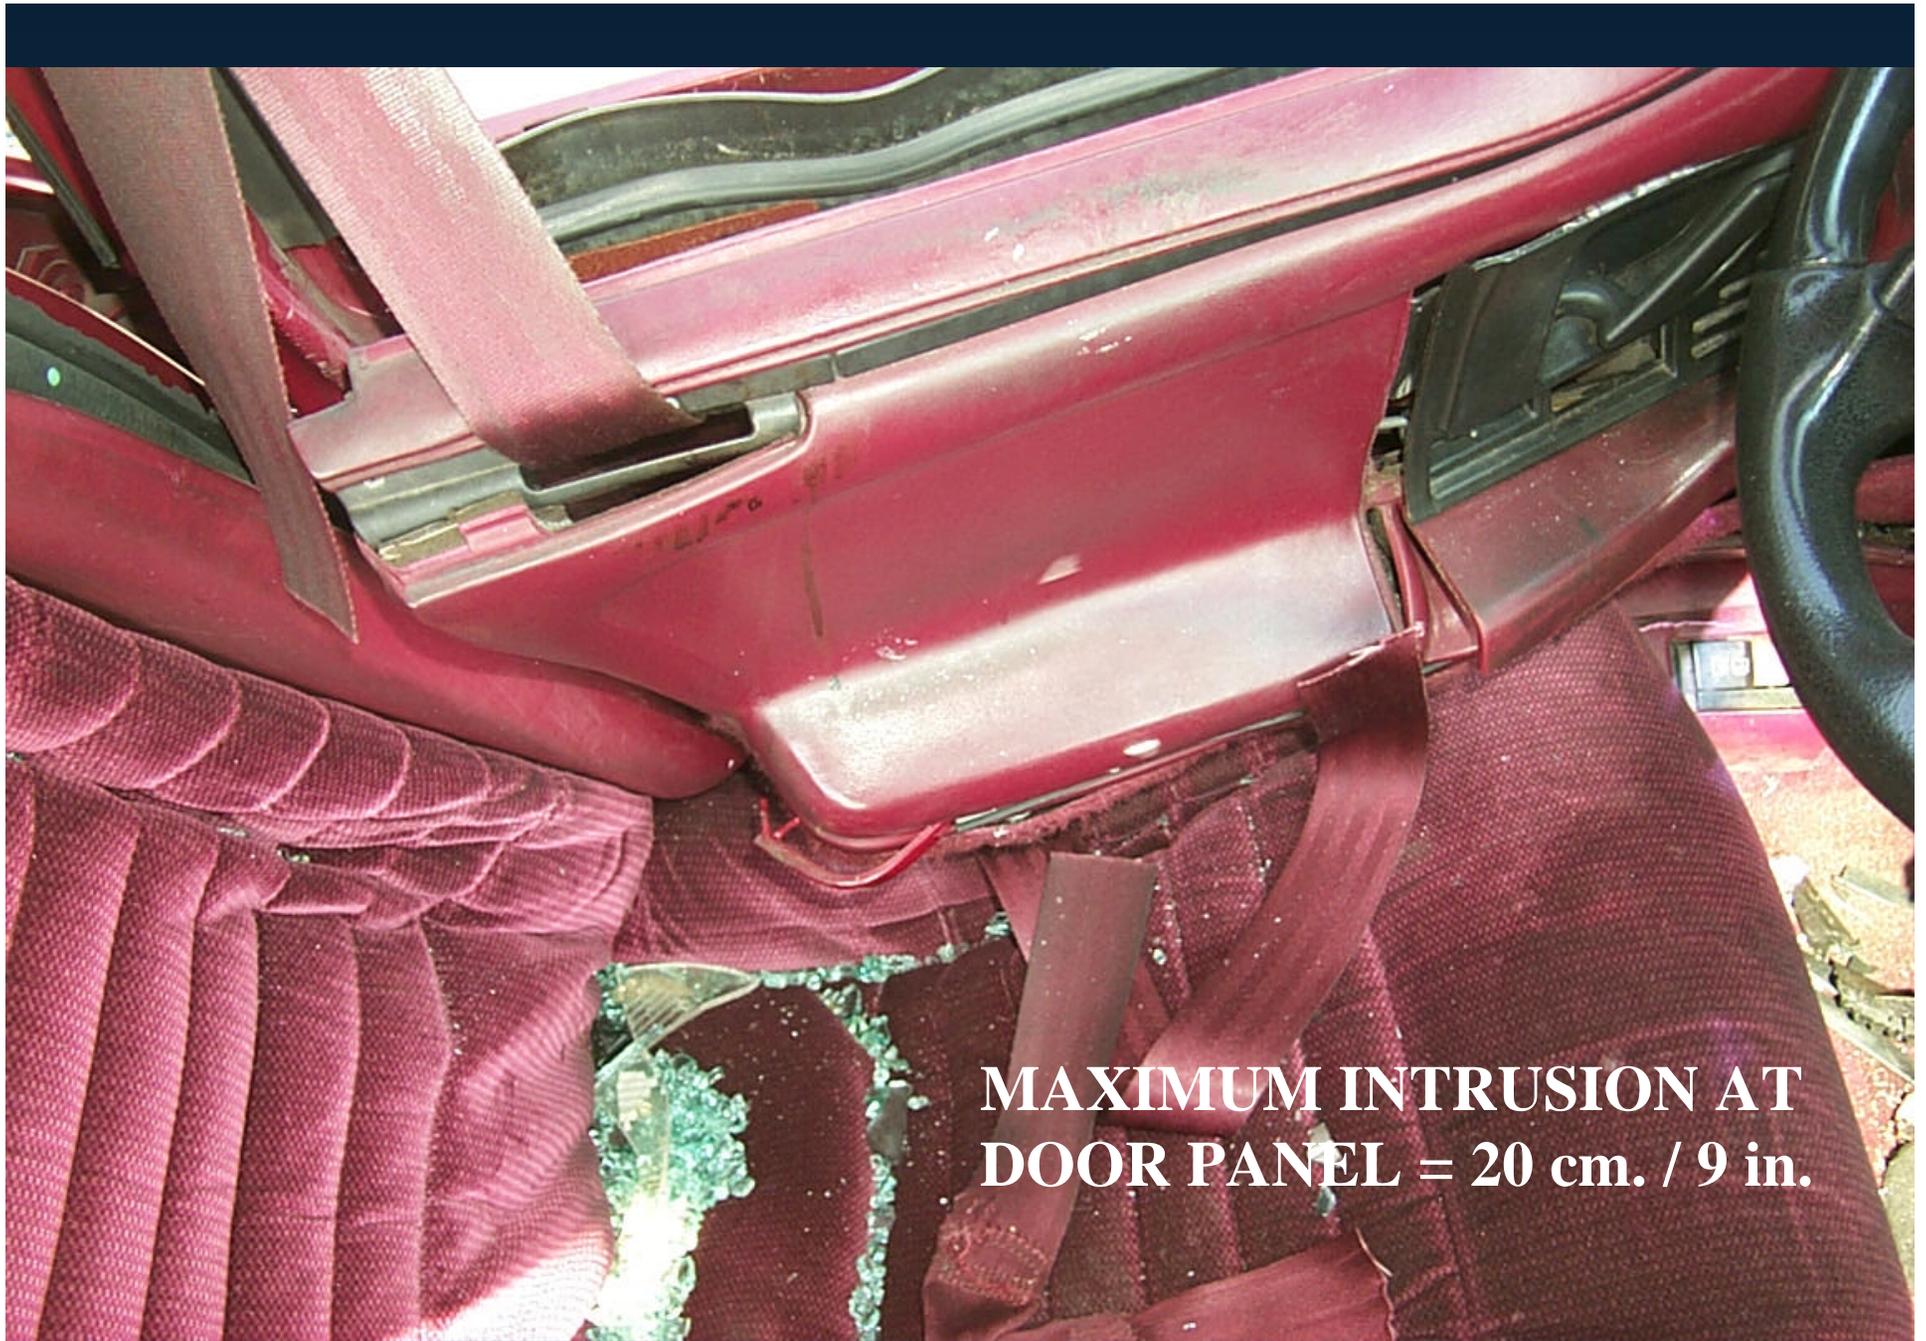
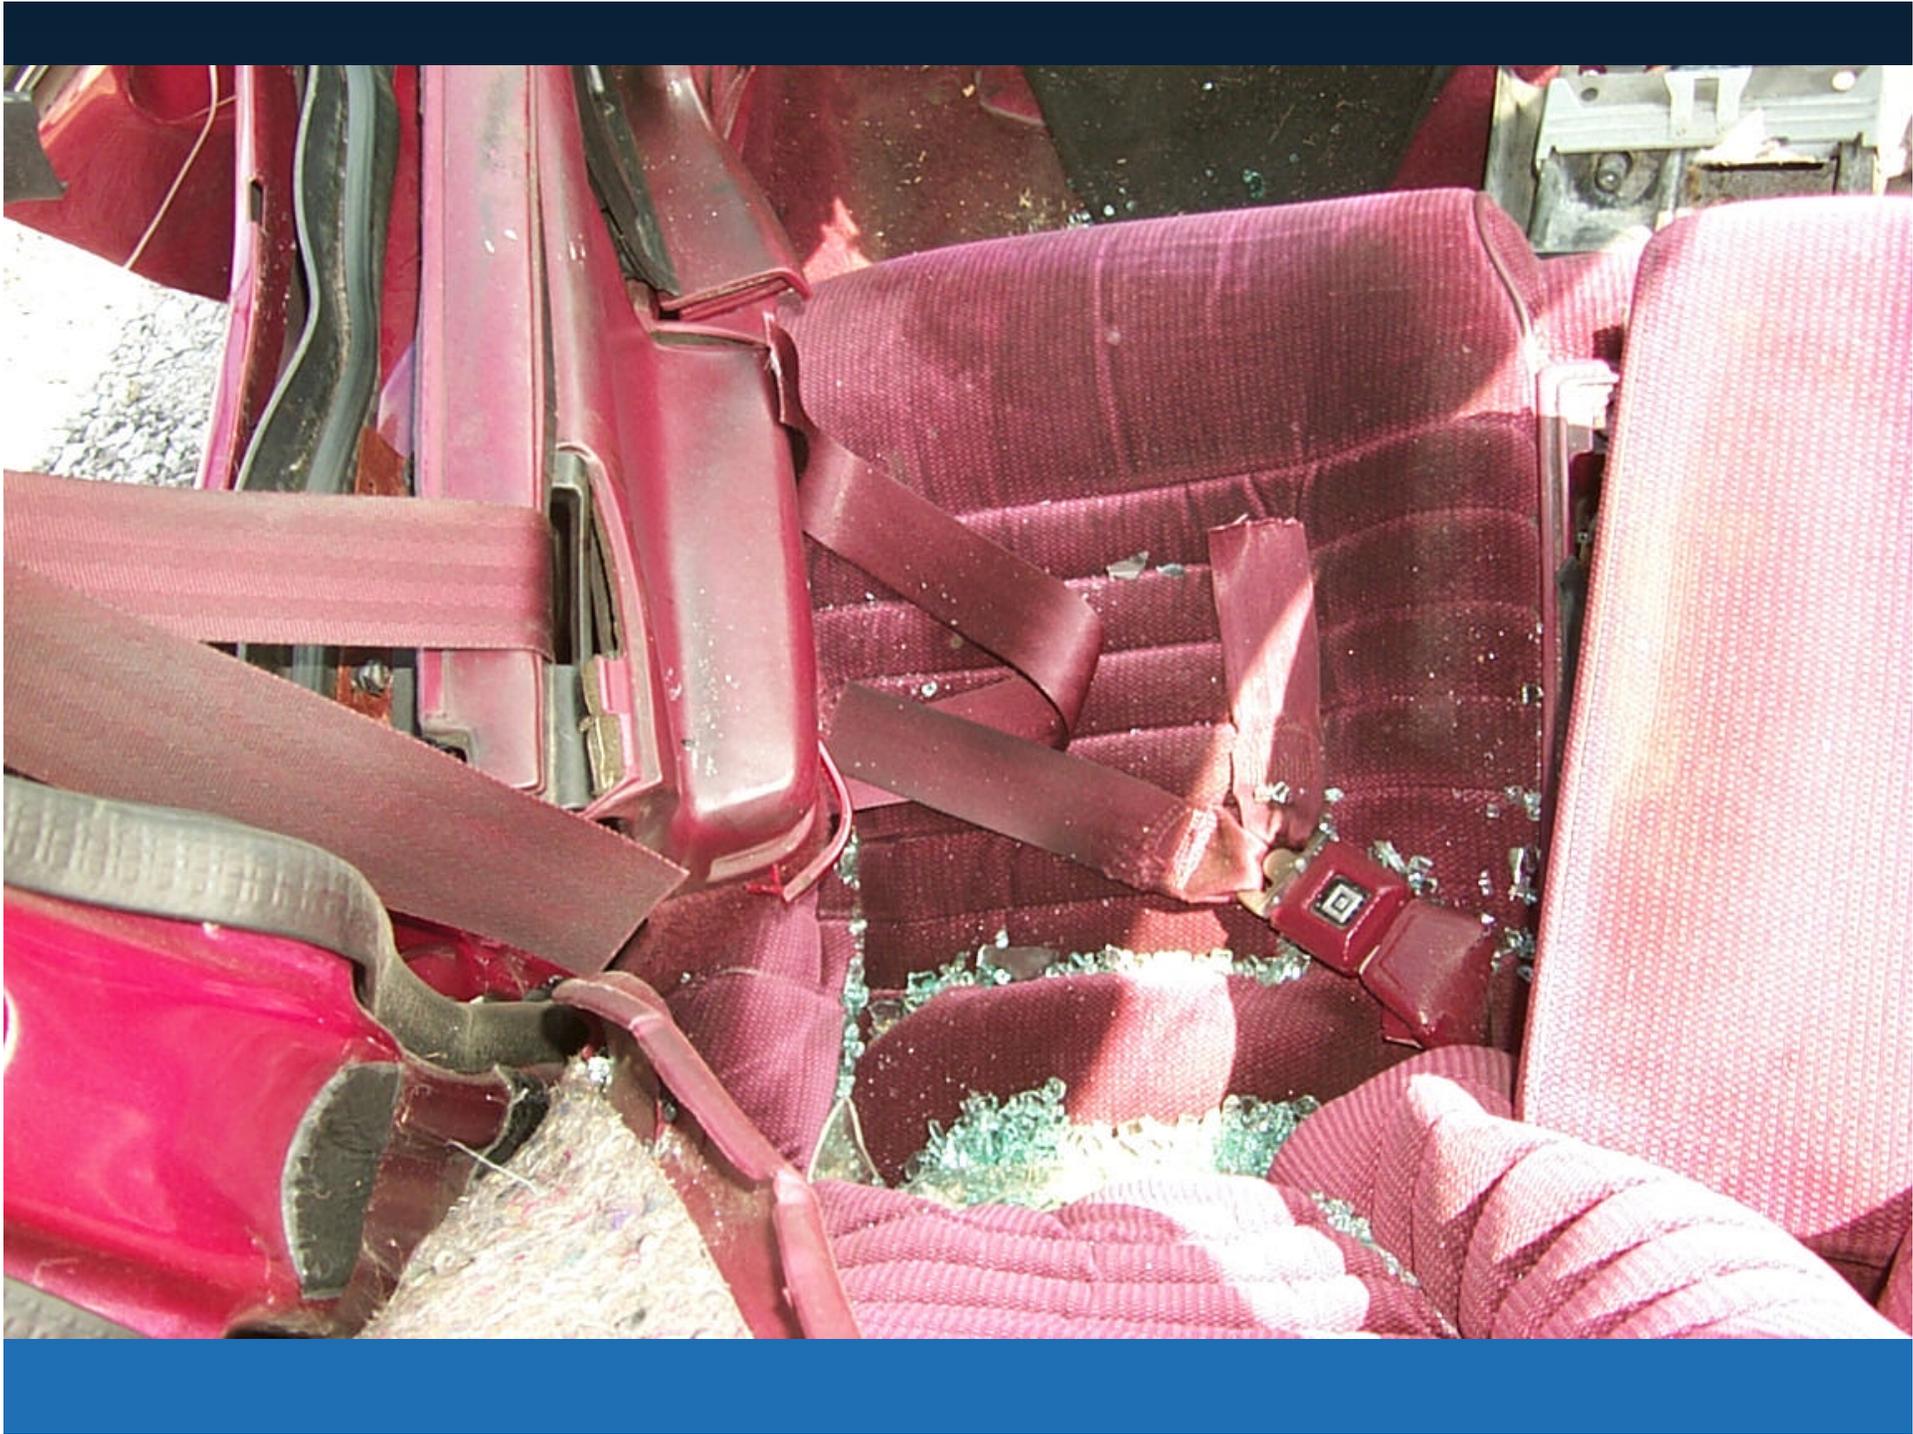
**MAXIMUM INTRUSION AT
DOOR PANEL = 20 cm. / 9 in.**
