# **SEVERE THORACIC TRAUMA**

# CIREN INVESTIGATION

**SECOND GENERATION AIRBAGS**

University of Maryland

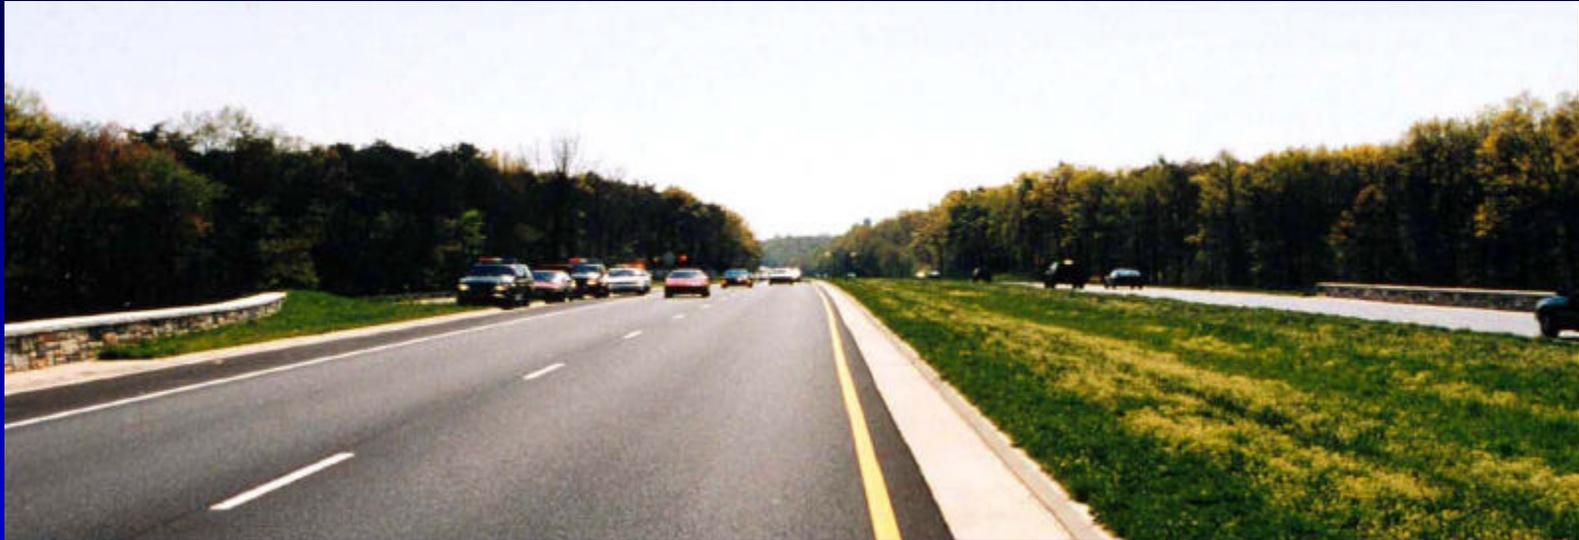
# ROADWAY

- **2 lane asphalt paved 35 foot travel lanes of ...**
- **A 4 lane, divided, limited access trafficway**
- **Roadway is straight and level**
- **Posted speed limit is 55 mph**

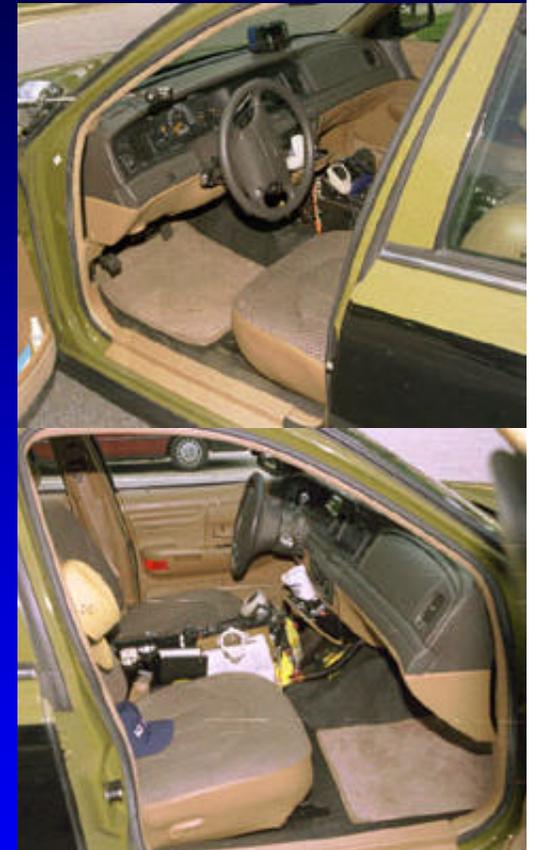
**1996 Ford Crown Victoria  
Marked state police car**

**Dual airbags**

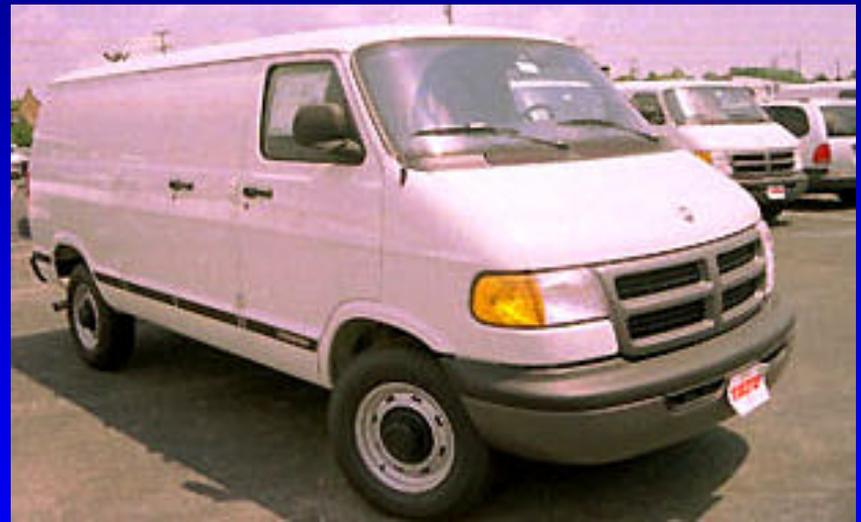
# VEHICLE 2

- 1994 Dodge Ram 250 van
- 500 pounds of cargo
- Driver: 30 y/o male
- No ht or wt given
- Restraint availability/usage unknown

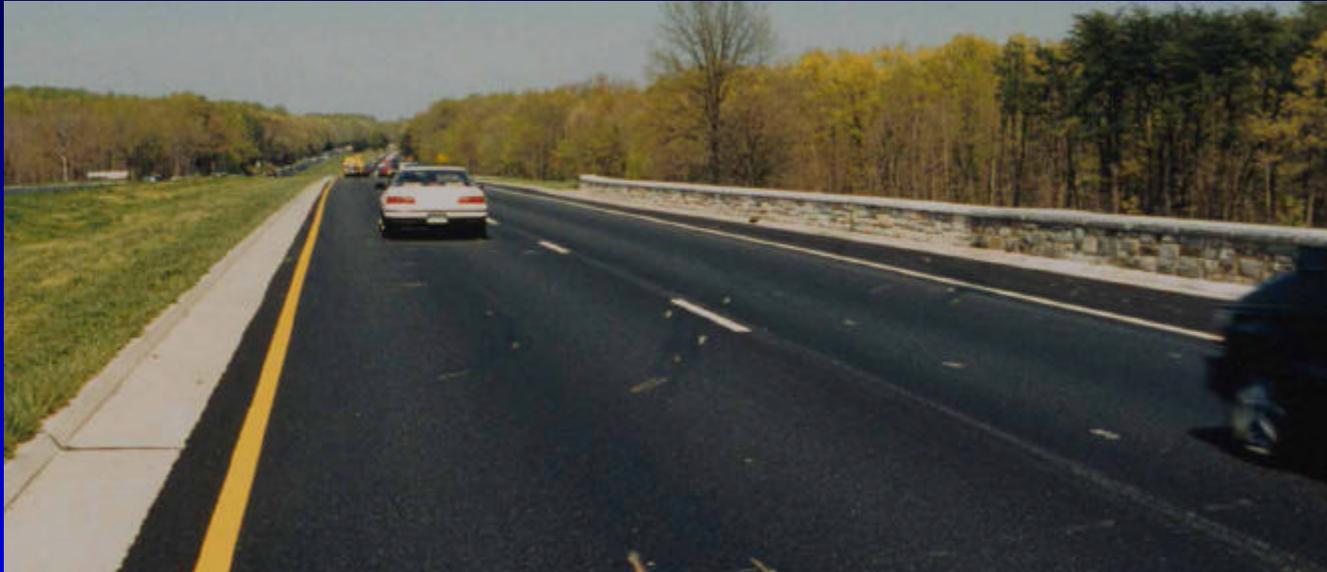
# CRASH

- **V1 was being driven north, estimated speed 70-75 mph. Vehicles 2, 3, 4 were stopped, facing north in N/B travel lane, due to road construction**

- **Upon seeing V2 stopped in his travel path, the driver of V1 applied the brakes and steered sharply right (30 ft skid) in an unsuccessful effort to avoid V2**

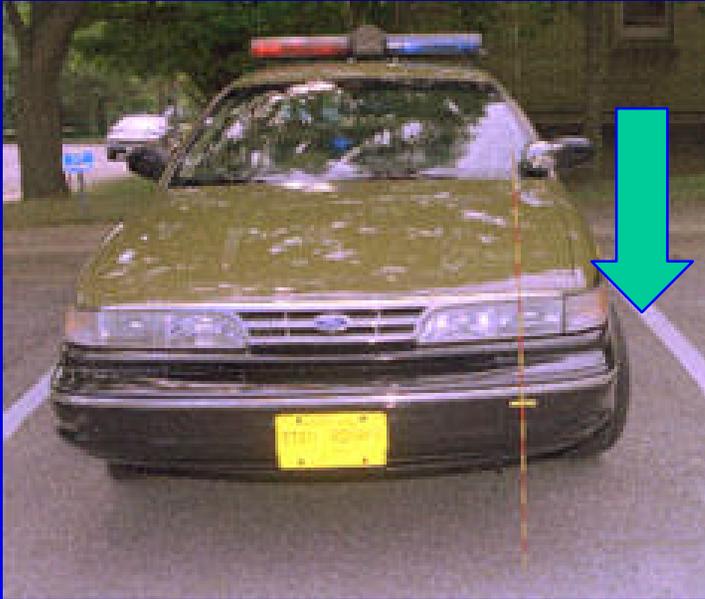
# MISMATCH

**Deceleration**

- The L/F corner of V1 impacted the R/R corner of V2. The front bumper of V1 *severely underrode* the rear bumper of V2 at impact

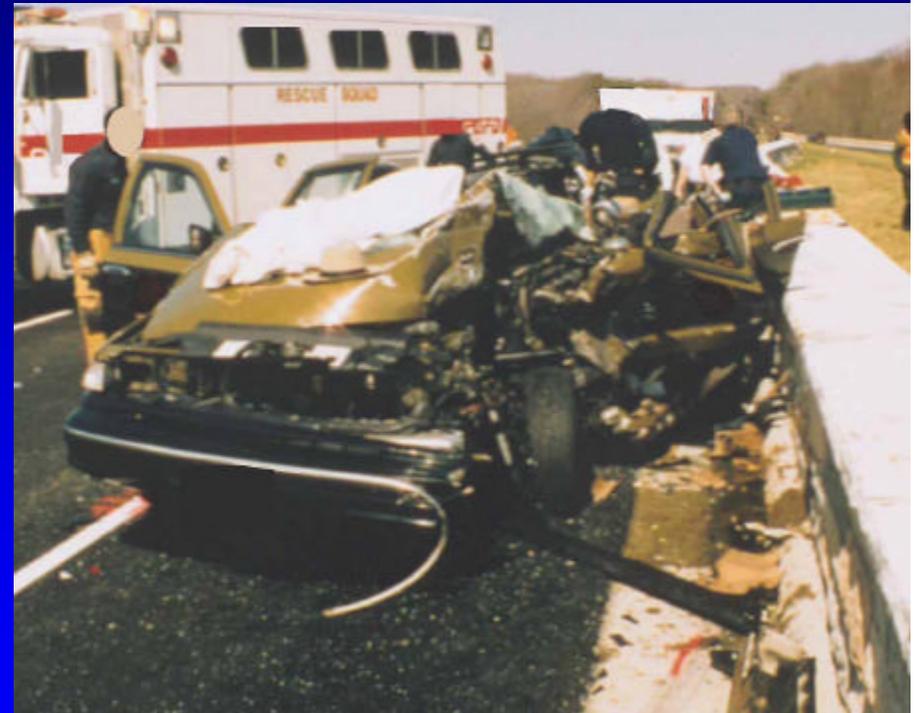
- The effects to the passenger compartment are catastrophic

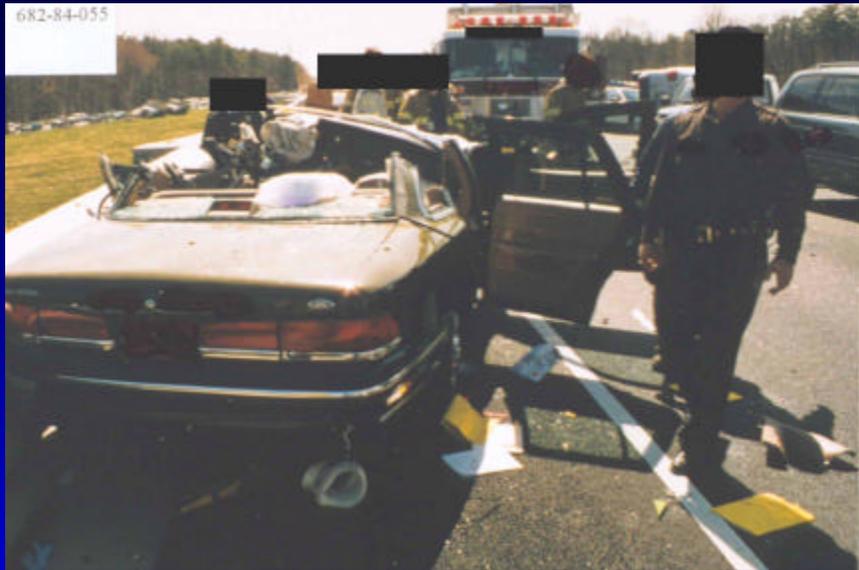
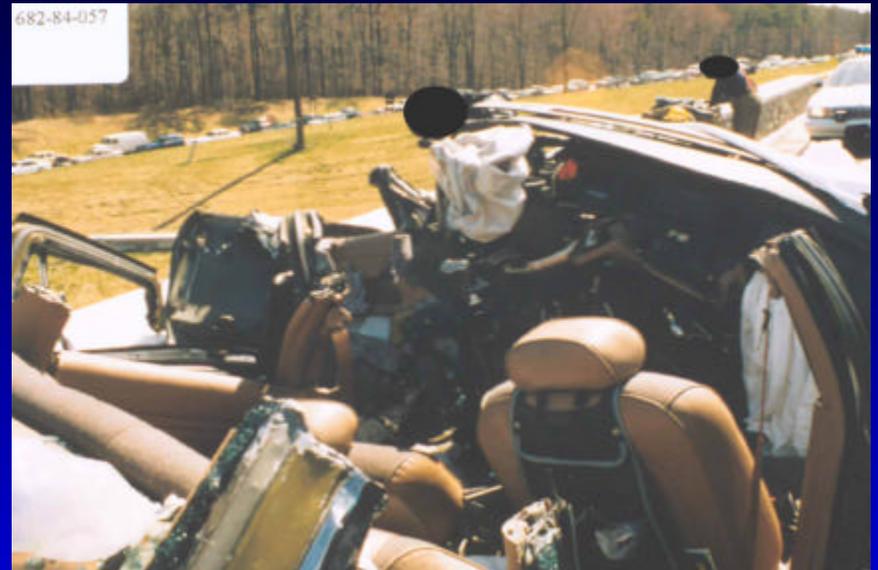
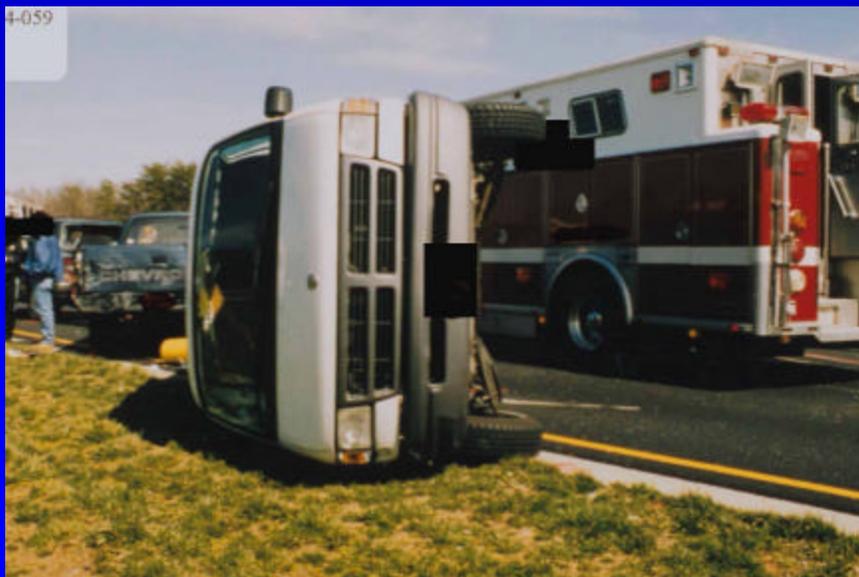
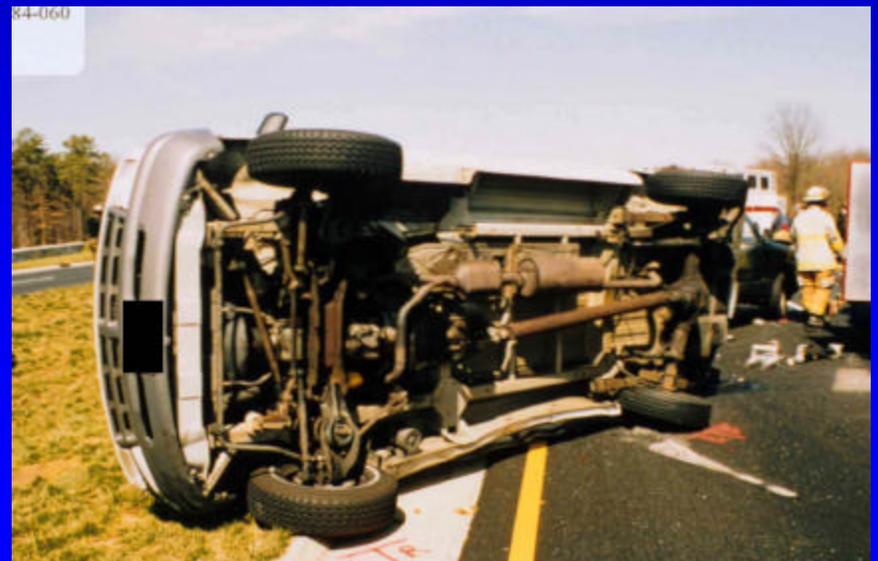
# SCENE DATA

- **The forces involved in the initial impact exceeded the SRS threshold, both driver's and passenger's airbags deployed.**
- **The right rear of V2 rested on the L front of V1 while both remained together for about thirty feet, at which time V2 "fell off" V1 and rolled onto its right side plane.**

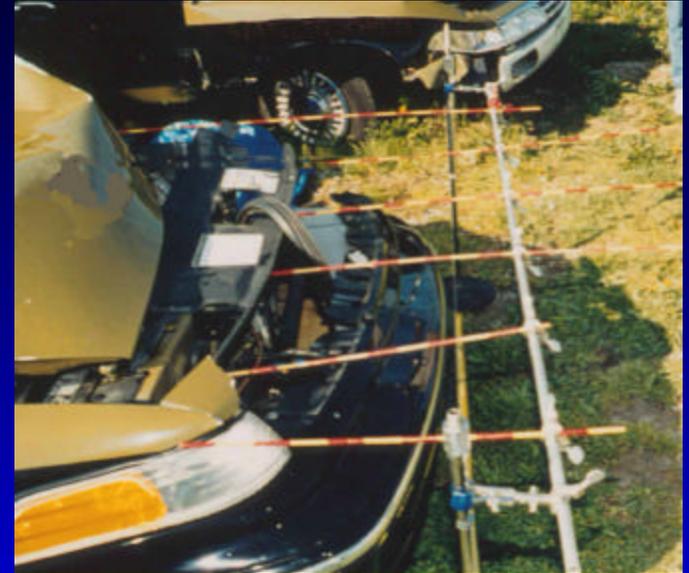
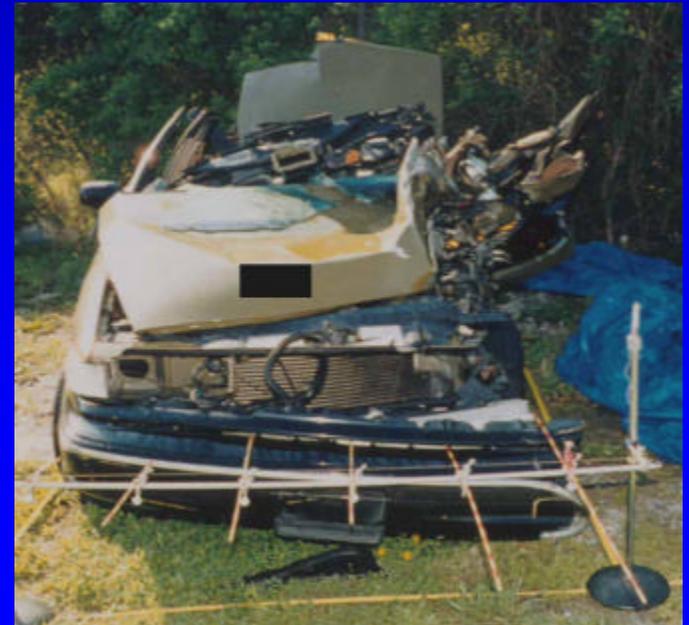
- No participation by the lower “frame” components in managing the energy of the crash
- No participation of the right side of the vehicle in managing the energy of the crash

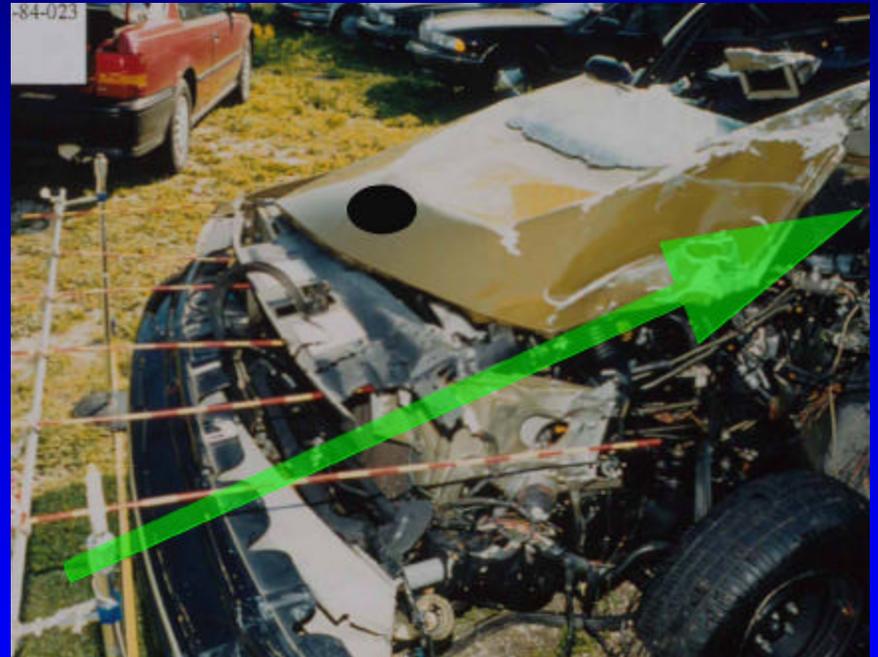
- The Crown Victoria is a “front steerer”
- The steering box is forward of the engine in this front-engine, rear drive car
- This may permit early, concentrated engagement of steering column

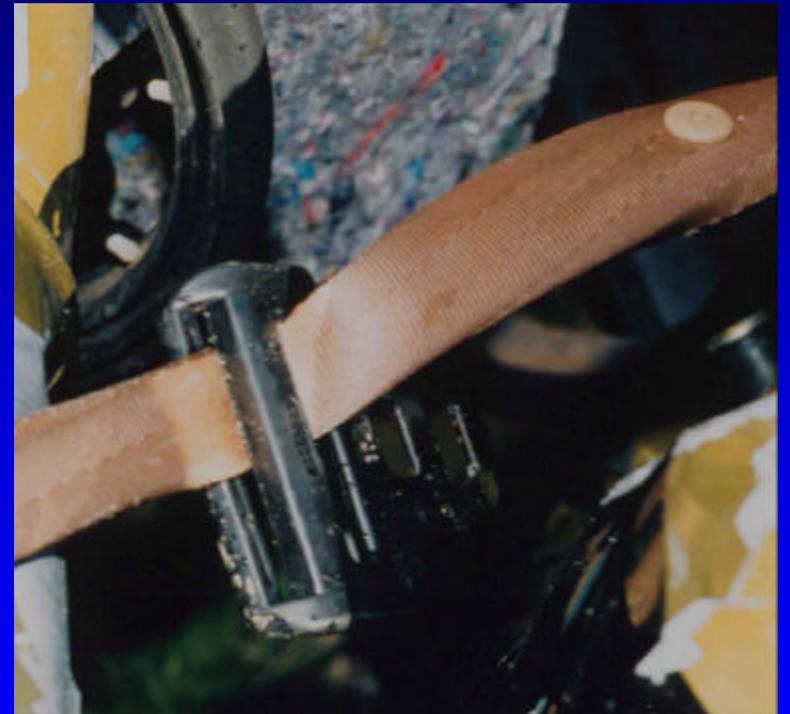
# INJURIES AND KINEMATICS

- At impact, the driver of V1 was projected forward and slightly left, loading the shoulder restraint ...

- At impact, the driver of V1 was projected forward and slightly left, loading the shoulder restraint ...
- Resulting in a...

**4 inch laceration of the neck**

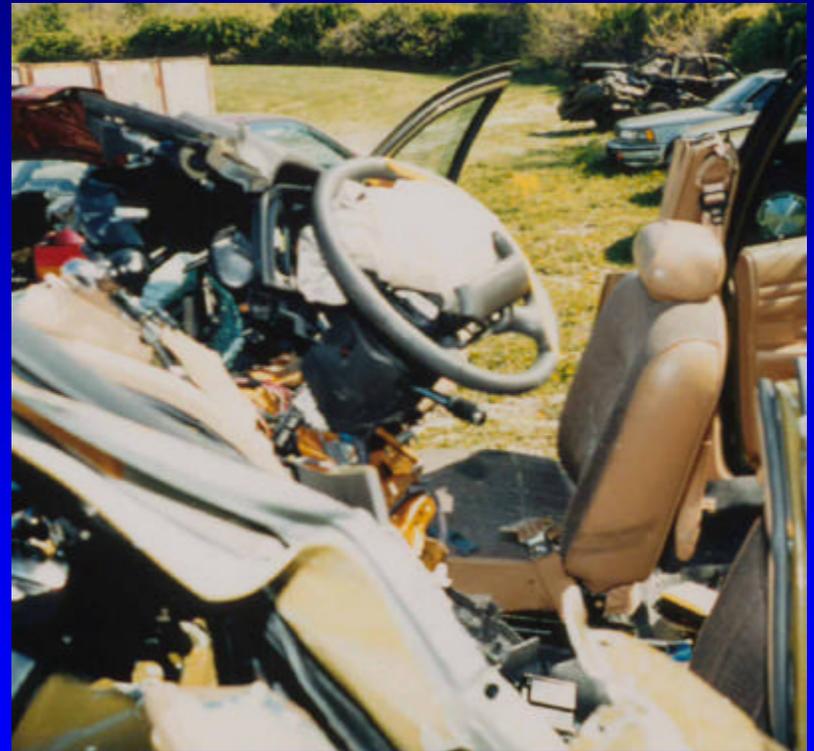
- After activation (and deflation ?) of the airbag, the steering wheel rim/hub/spoke impacted the driver's torso through the vest.

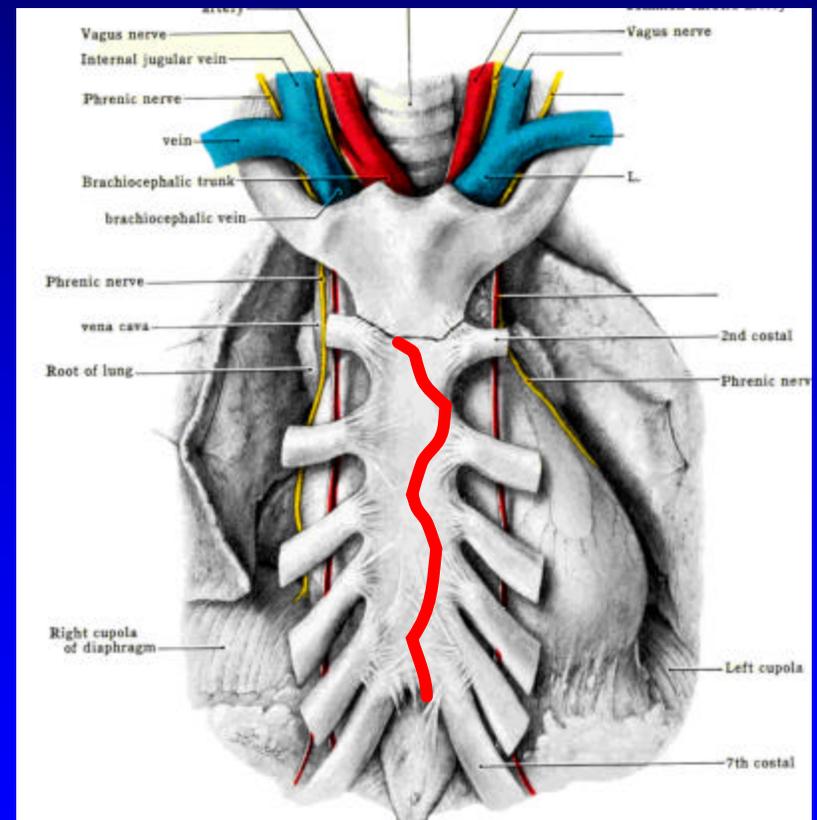
- After activation (and deflation ?) of the airbag, the steering wheel rim/hub/spoke impacted the driver's torso through the vest.

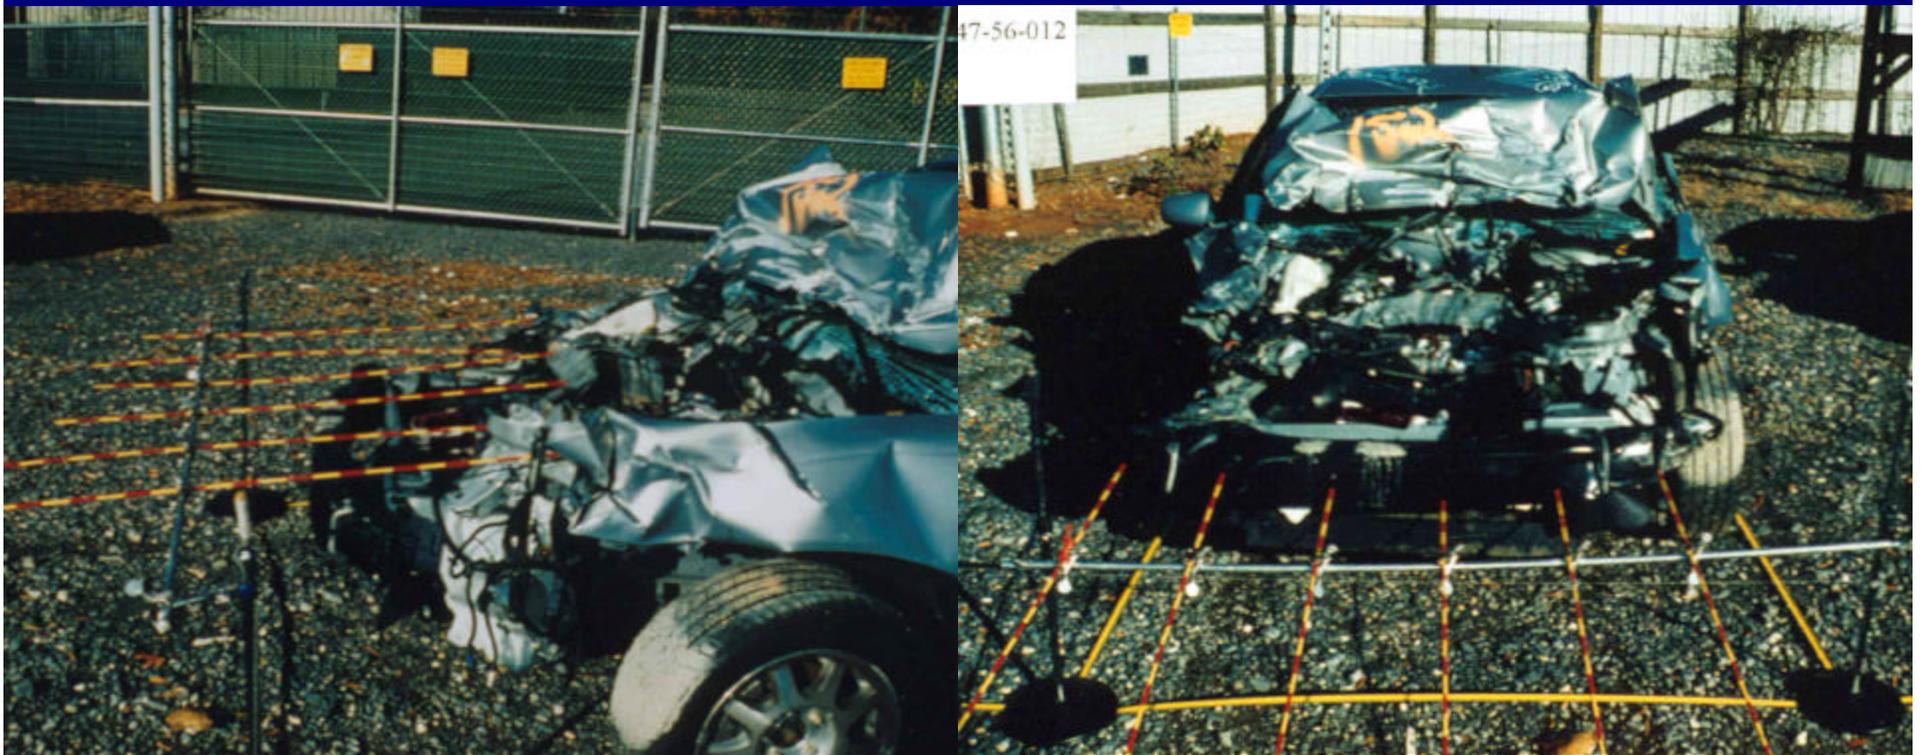
# CRASH RECONSTRUCTION

- The size of V2 places crash outside scope of computer's reconstruction program
- Therefore, a Delta V was not computed
- Maximum crush of 26 in

- **Using these figures, a Speed Estimate was computed as 23 mph**
- **This estimate appears somewhat low**

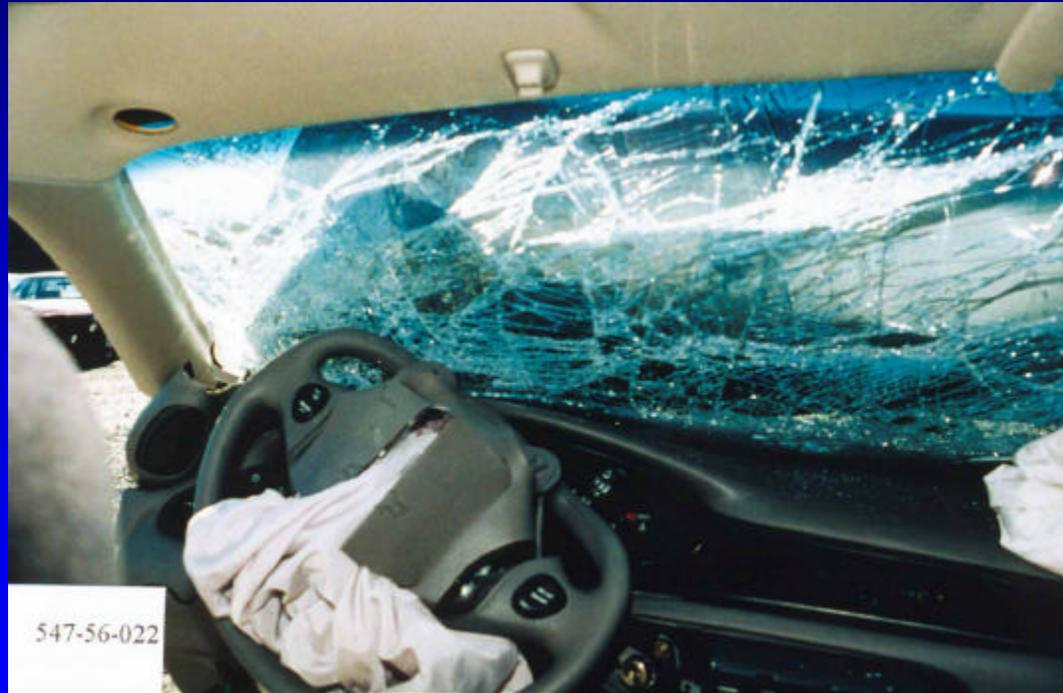
# SECOND GENERATION AIRBAGS

- **Not damaged P119078-01F---**
- **No evidence of occupant contact**
- **Measures 58cm (23in) in diameter**
- **Two vent ports**

- Both driver's side and passenger's side depowered airbags deployed

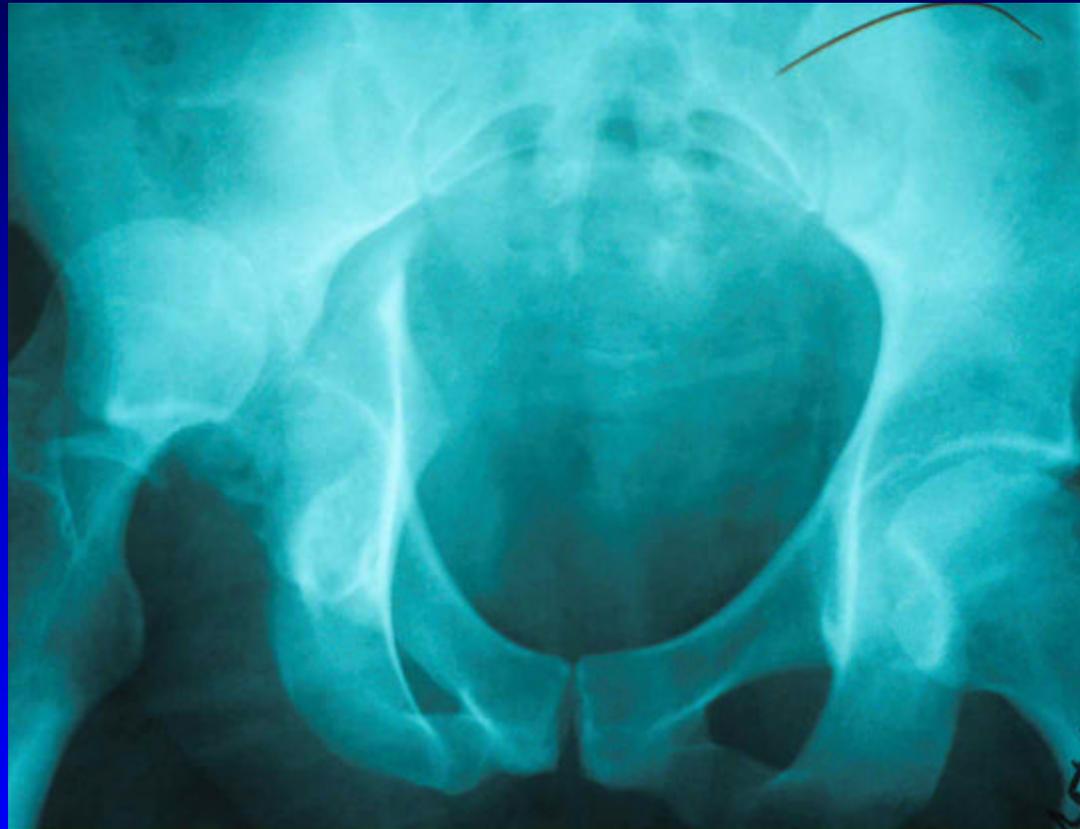
# INJURIES

**Acetabular fracture-dislocation**

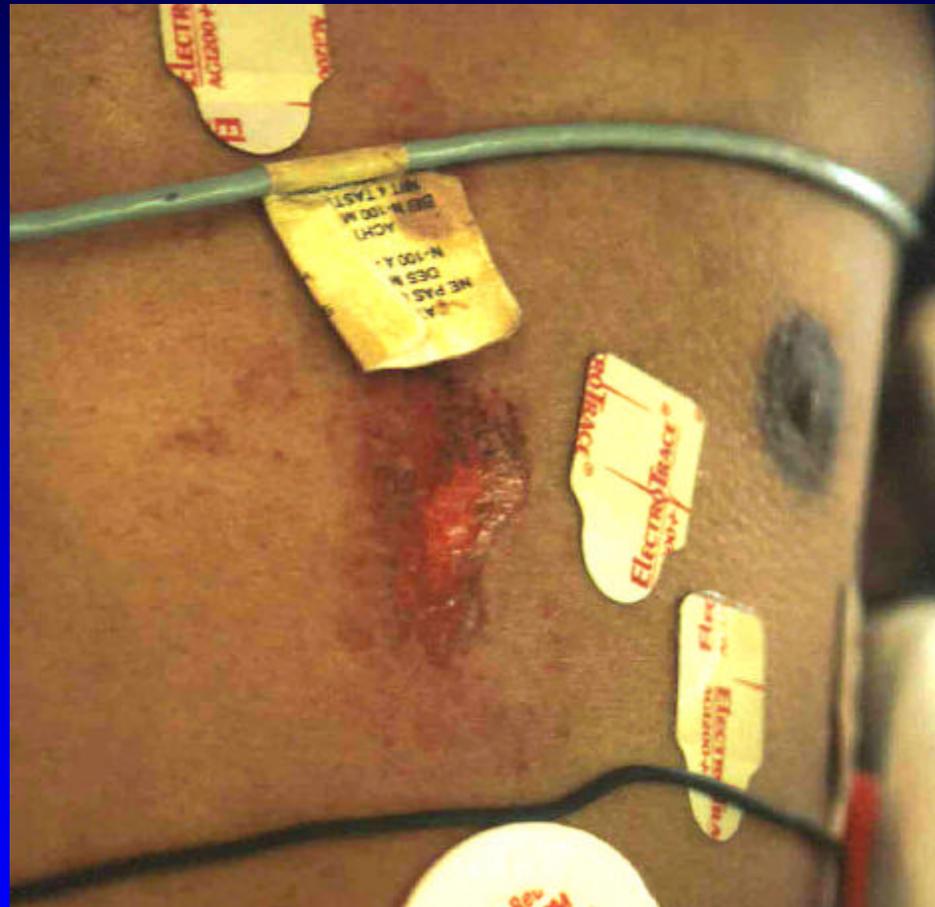
Atypical for shoulder restraint

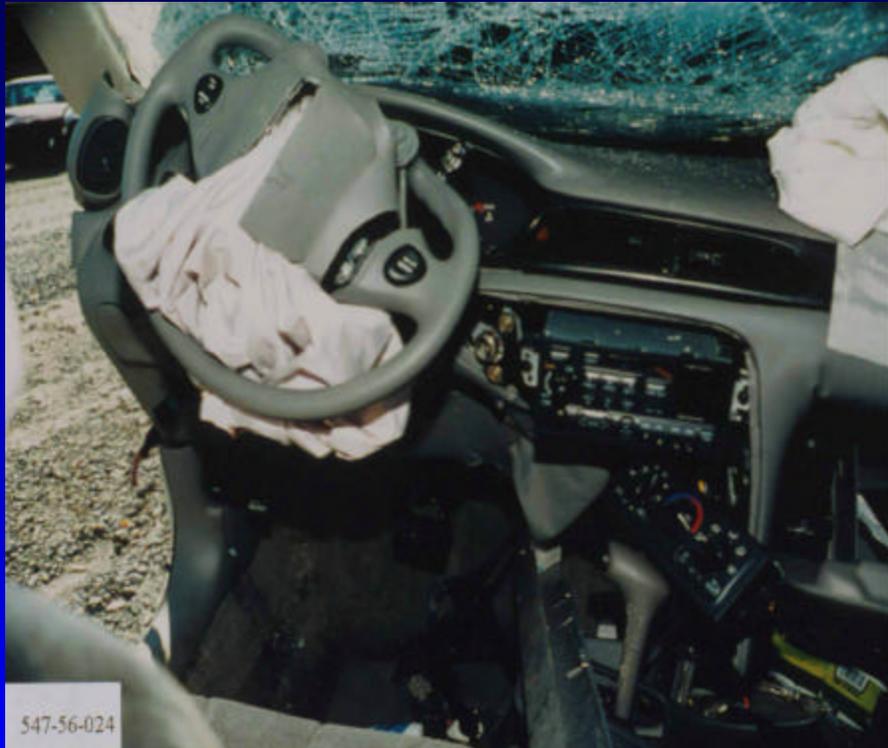
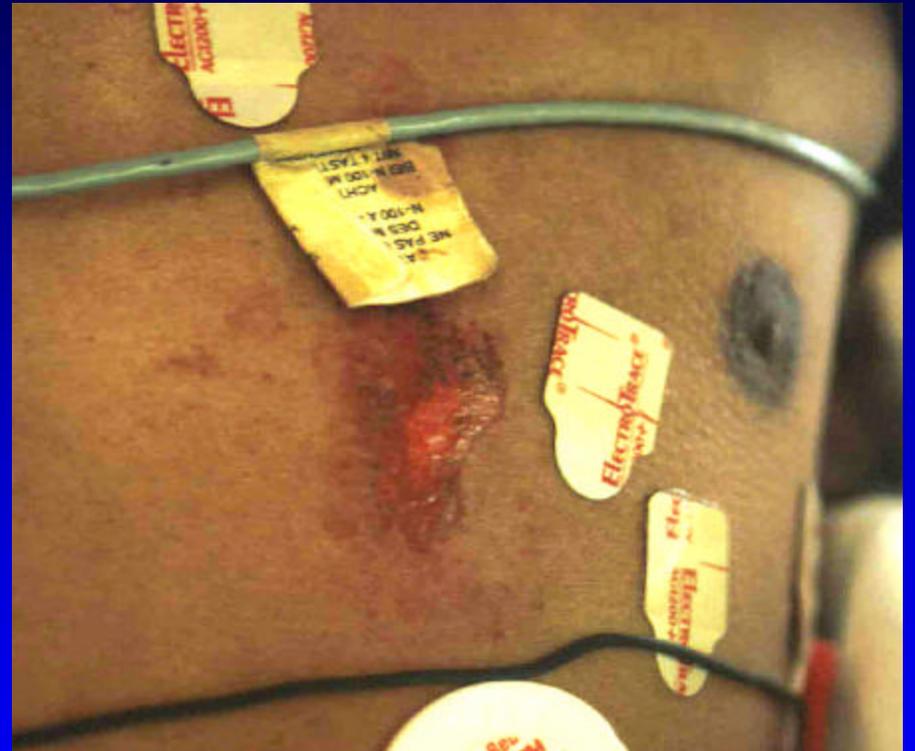
Typical for “barn door” airbag covers

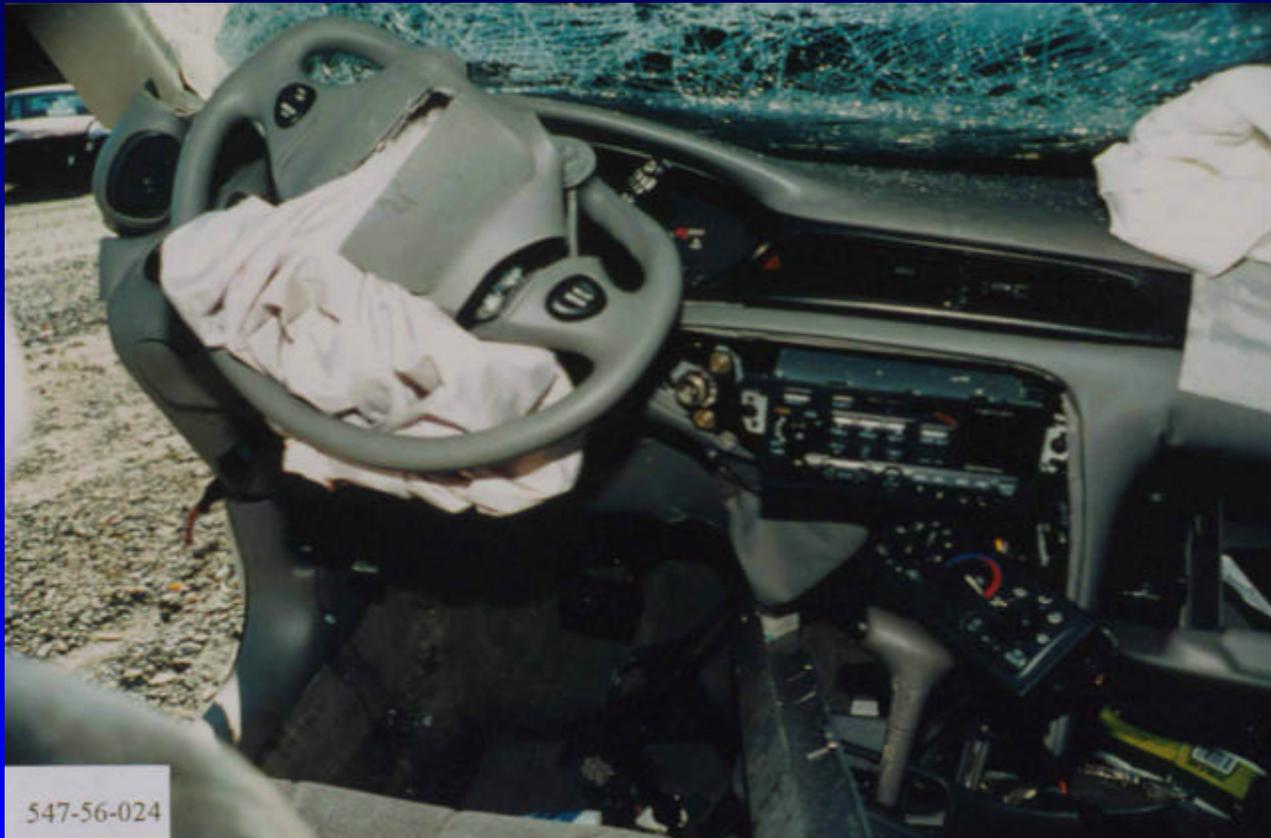
# BILATERAL PULMONARY CONTUSIONS

In restrained, tall driver with “soft” airbags

- An “average” case were it not for our interest in second generation airbags
- Our investigation indicated Delta V of 23 mph
- Seatbelt assessment indicated usage at time of crash
- Bilateral pulmonary contusions were caused by the shoulder restraint by 1st assessment
