Ford Inova Fairfax Hospital  
CIREN Team

# A Case Study in Offset Frontal Collision

Vehicle #1: 1998 Chevy Lumina 4door

Vehicle #2: 1999 Honda Civic 2door

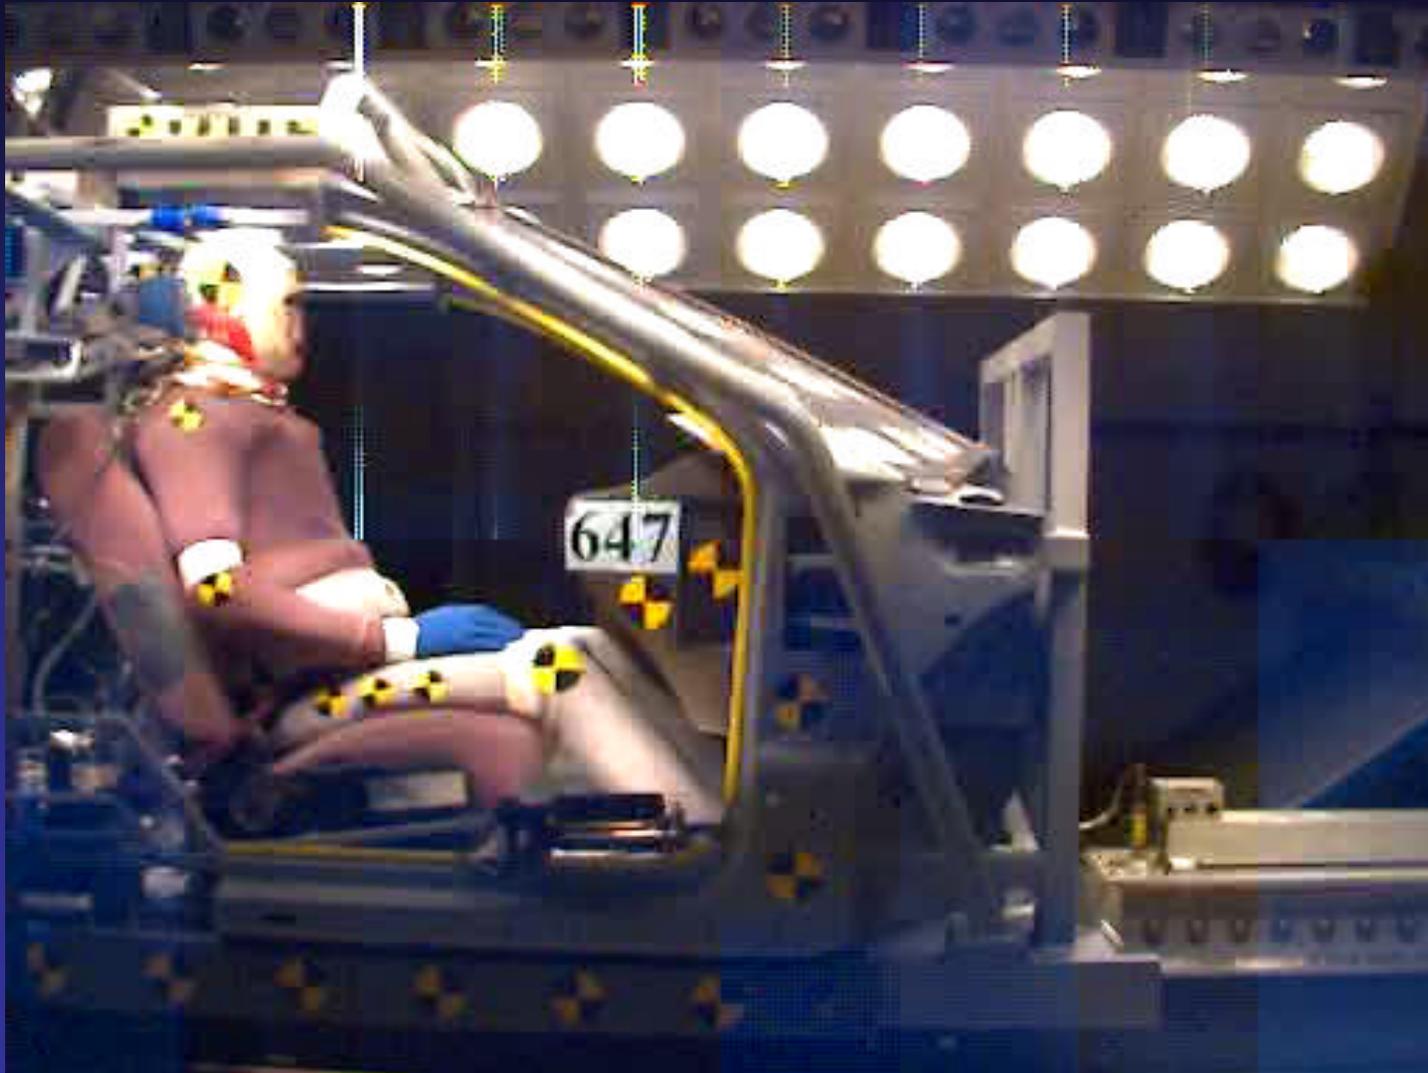
Folding of  
Ligamentum  
Flavum

Cadaver, lap belt, airbag, 56 km/h frontal pulse  
Head contacts roof/header causing neck extension

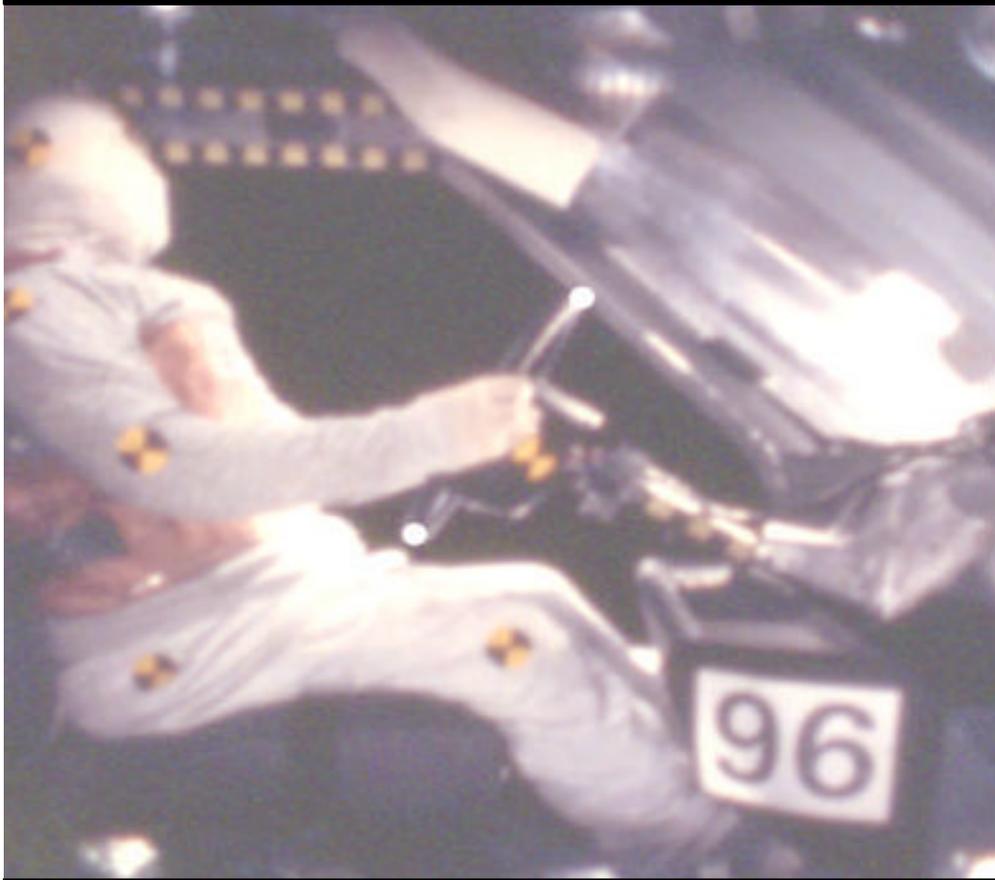
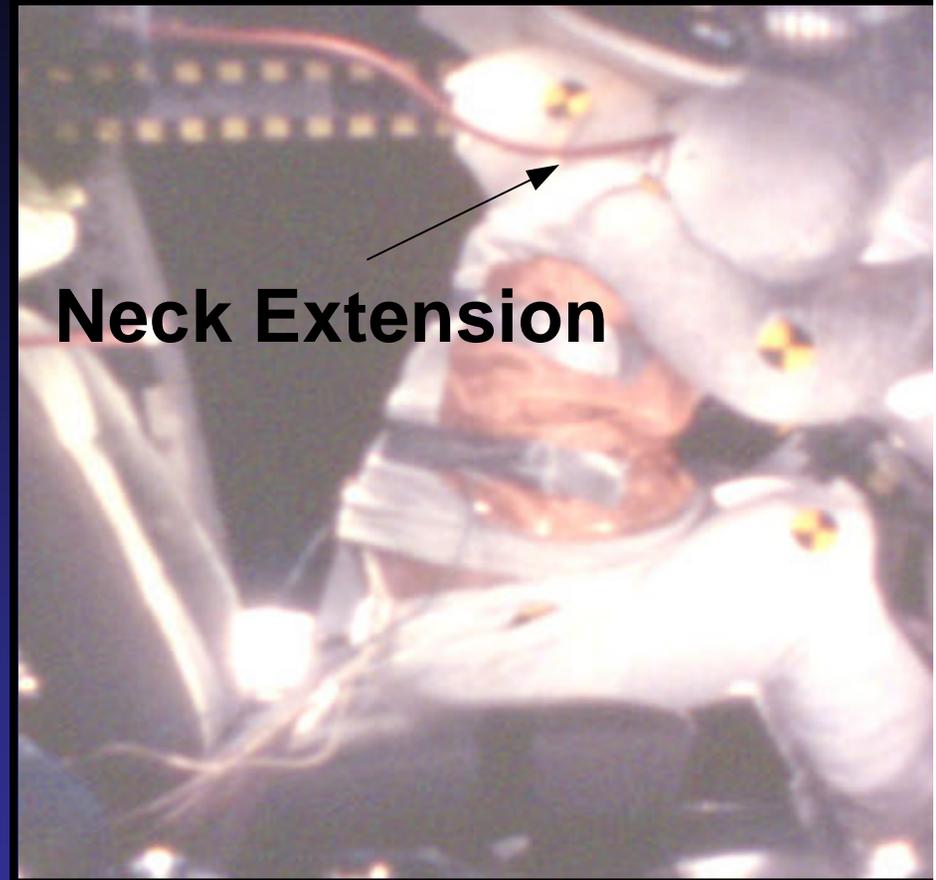
Cadaver, unbelted, airbag, 34 km/h frontal pulse

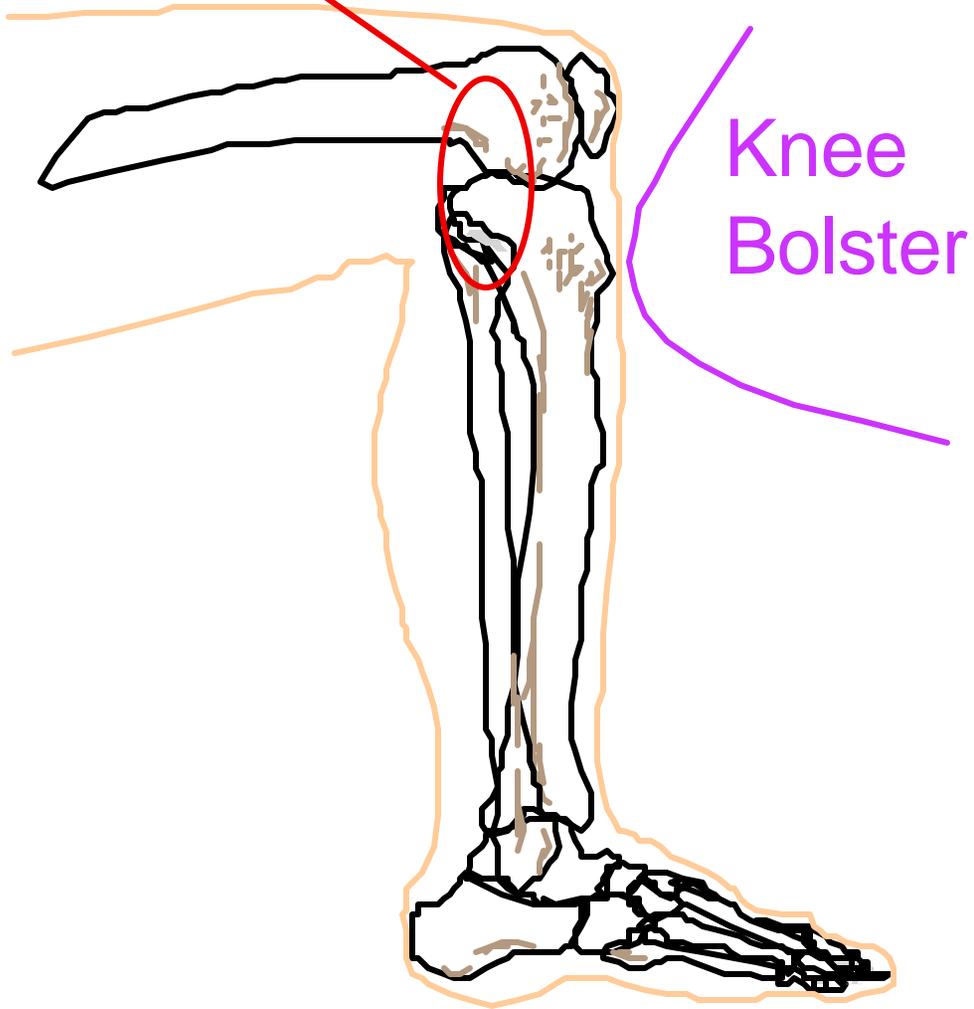
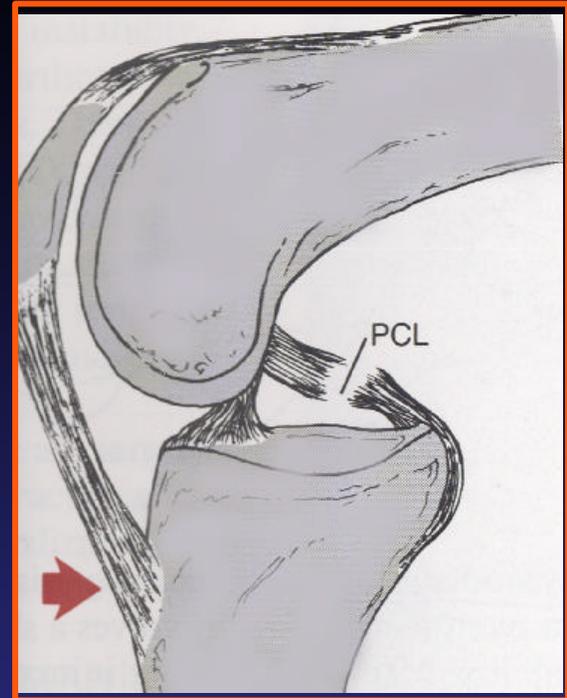
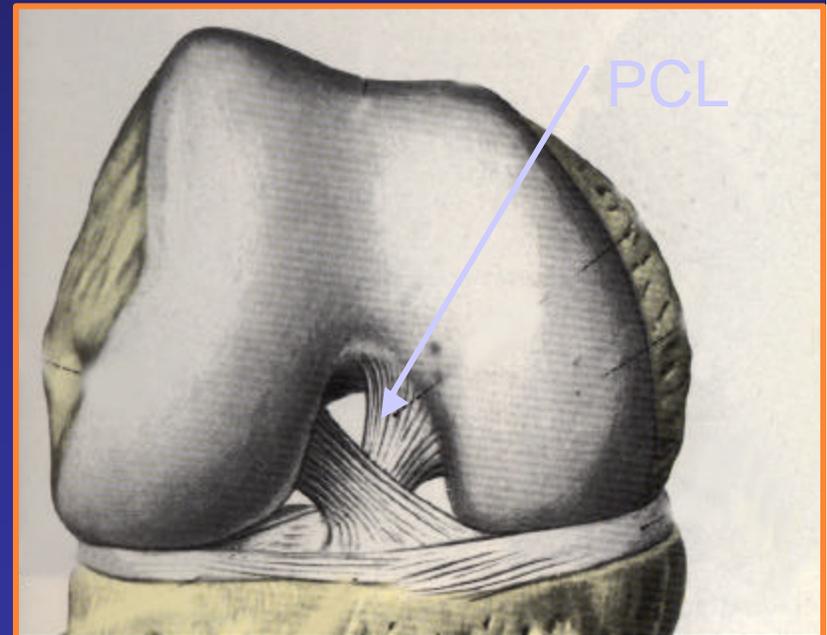
# Posterior Cruciate Ligament Tear

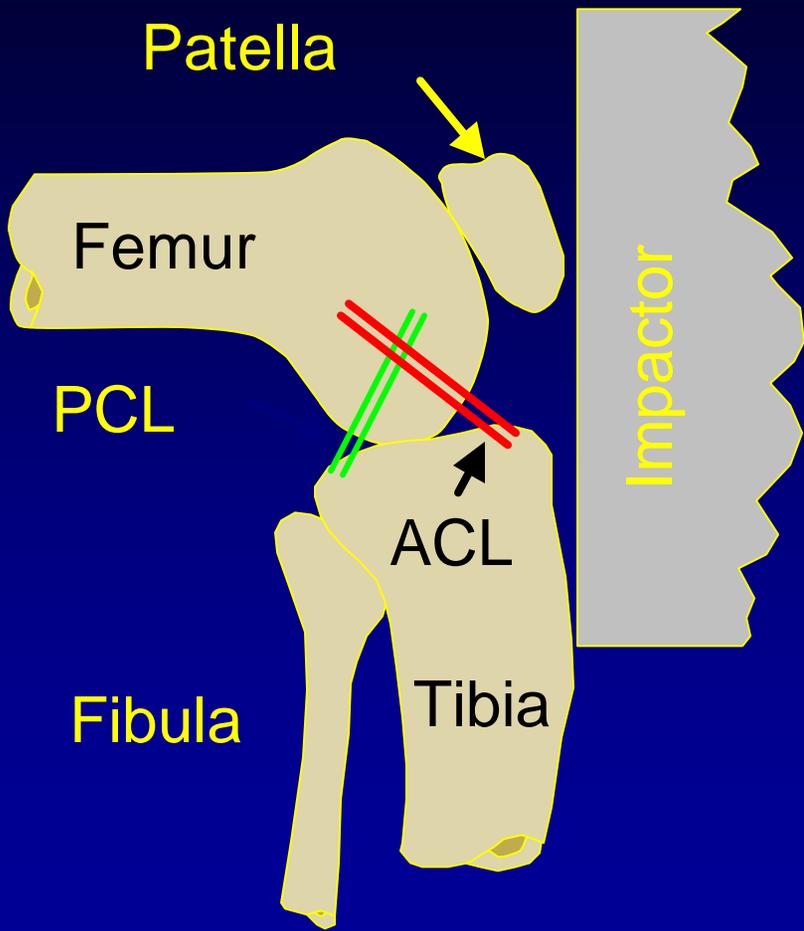
Femoral Shaft Deformation

Patellar Displacement and Wedging

Tibial/Fibular Displacement

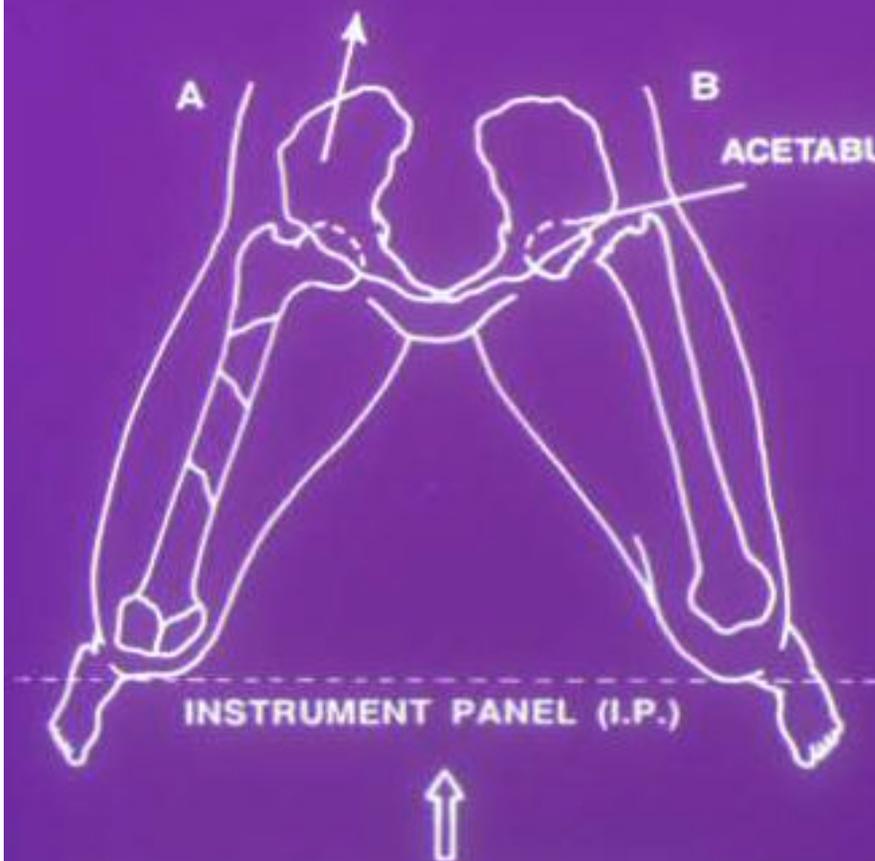
**THIGH FLEXED AND ABDUCTED**

**FRACTURE OF FEMORAL SHAFT  
AND/OR CONDYLAR FRACTURES**

**DISLOCATION OF PROXIMAL FEMUR  
AND/OR SHEARED HEAD OF FEMUR**

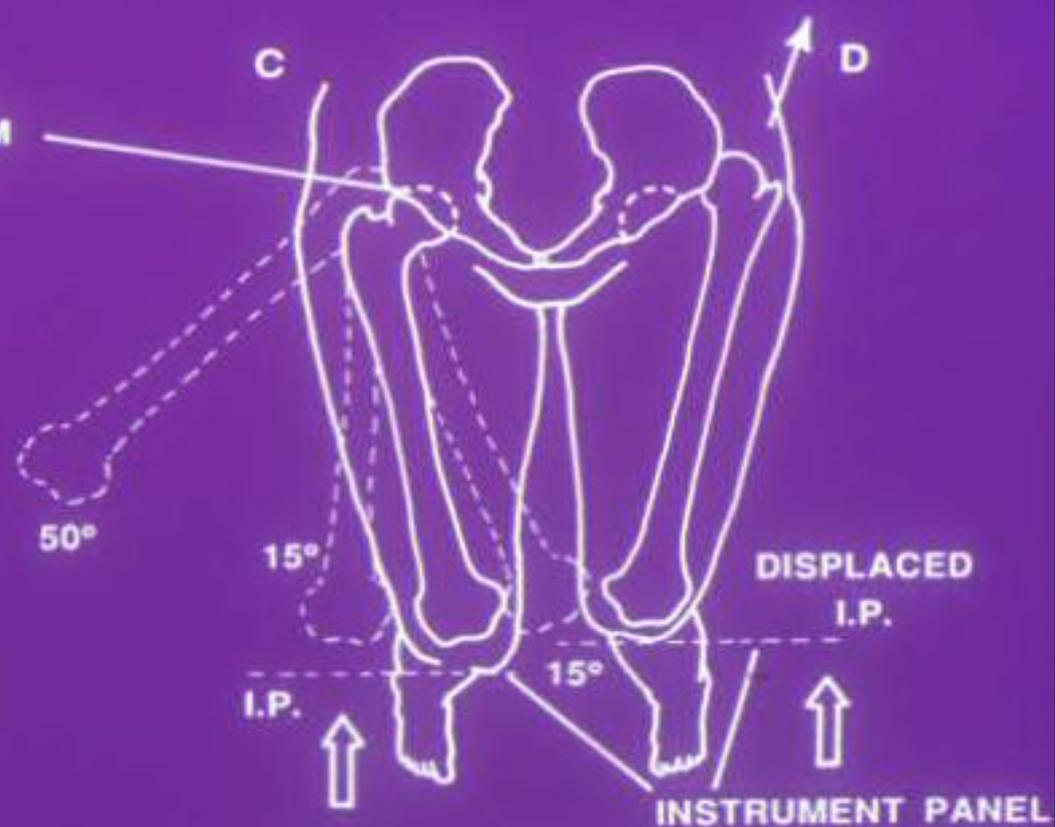
**THIGH FLEXED AND ADDUCTED**

**C ACETABULAR FRACTURE OR**

**D POSTERIOR DISLOCATION OF FEMUR**

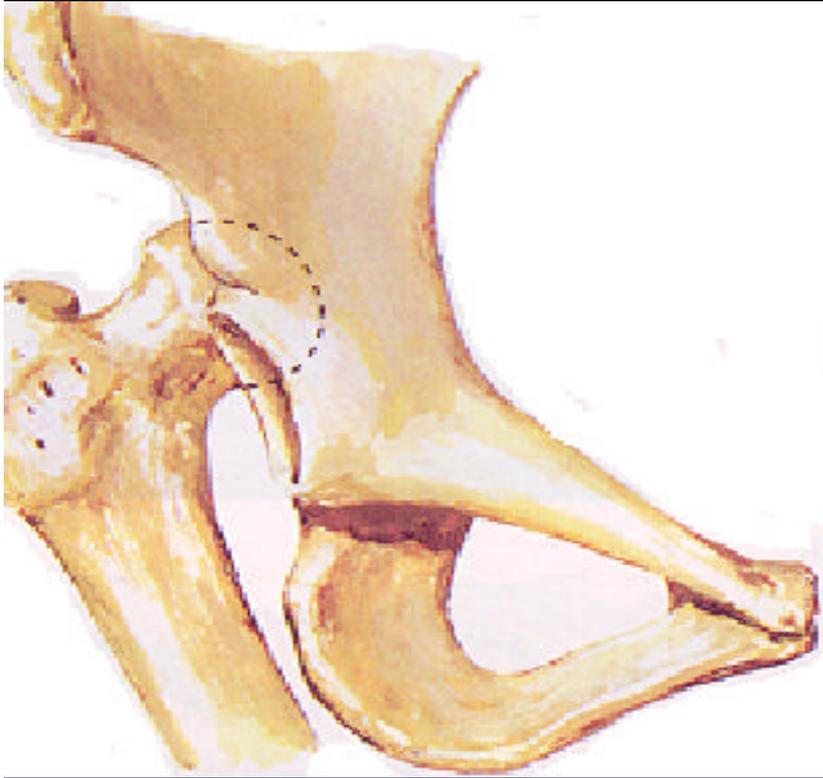
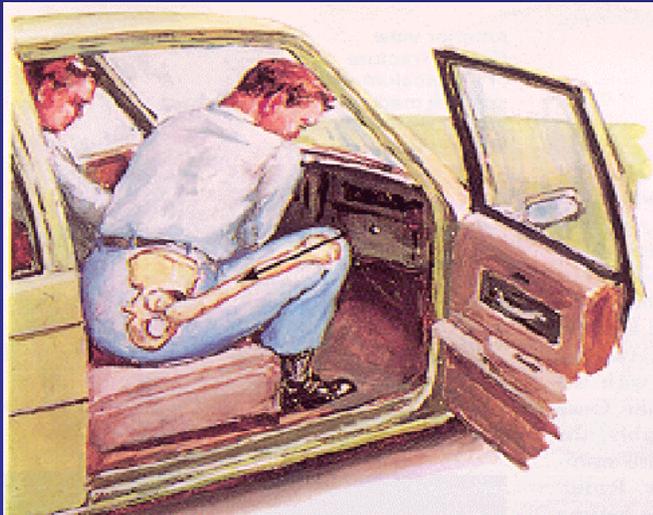
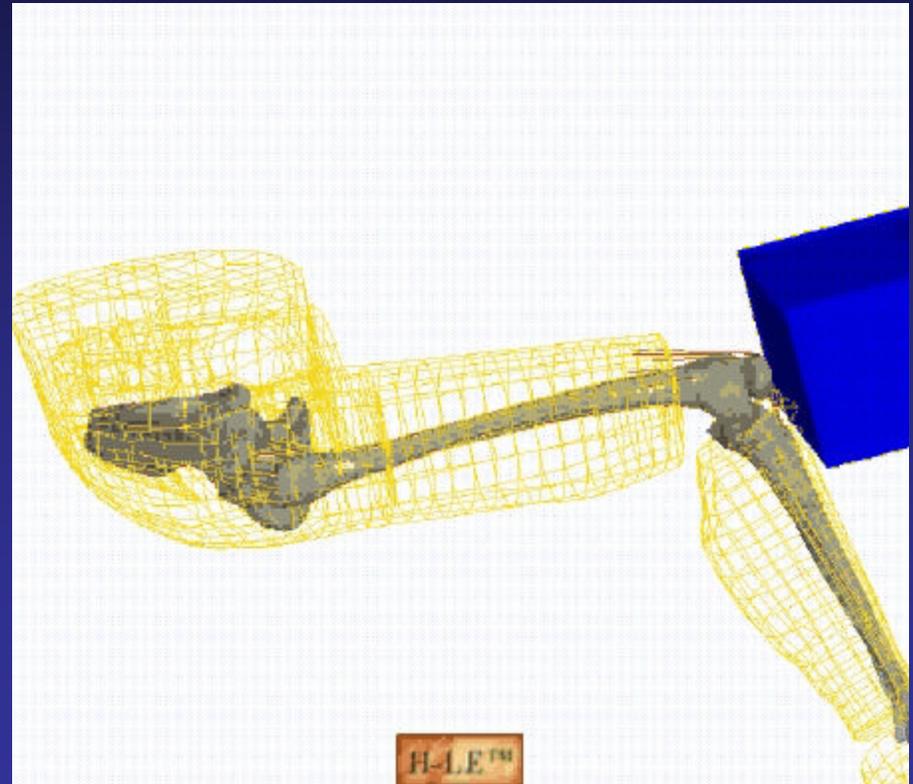
# Hip Dislocation

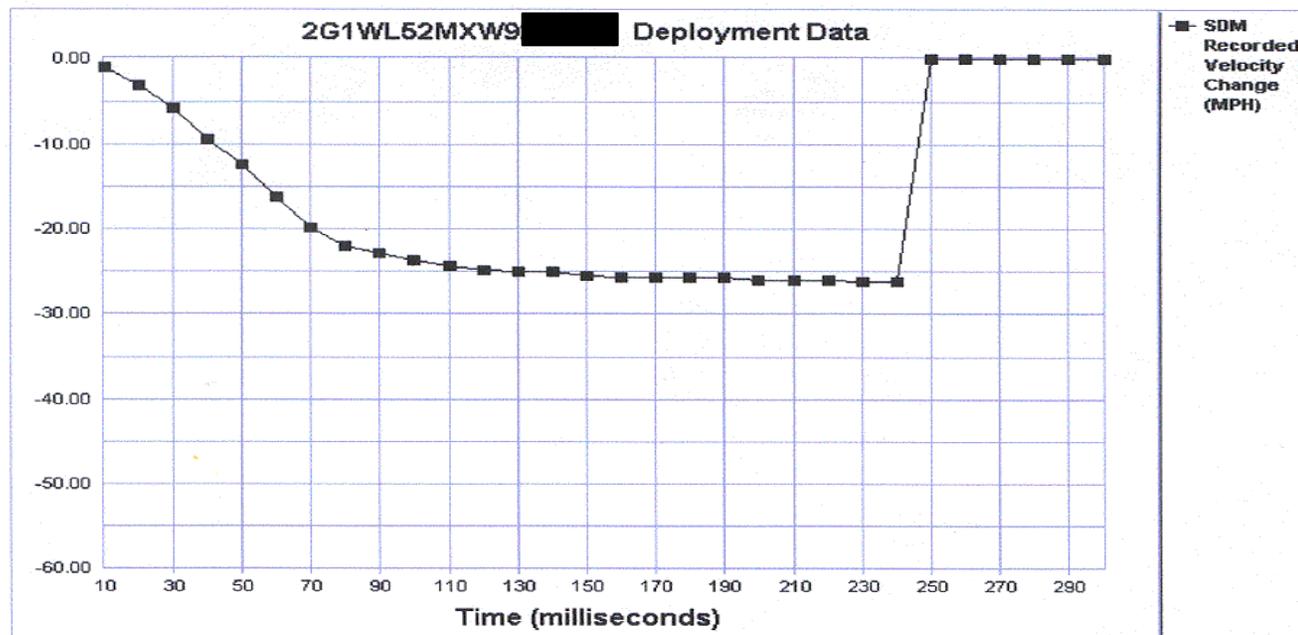
# Event Data Recorder - Vehicle # 1

2G1WL52MXW9 System Status At Deployment

SIR Warning Lamp Status	OFF
Driver's Belt Switch Circuit Status	UNBUCKLED
Passenger Front Air Bag Suppression Switch Circuit Status	ON
Ignition Cycles At Deployment	0
Ignition Cycles At Investigation	5898
Time From Algorithm Enable To Deployment Command (msec)	17.5
Time From Near Deployment To Deployment (msec)	0

Recorded Velocity Change (MPH)	-0.88	-3.07	-5.70	-9.43	-12.29	-16.24	-19.75	-21.94	-22.82	-23.70	-24.35	-24.79	-25.01	-25.01	-26.11
Time (milliseconds)	160	170	180	190	200	210	220	230	240	250	260	270	280	290	300
Recorded Velocity Change (MPH)	-25.67	-25.67	-25.67	-25.67	-25.89	-25.89	-25.89	-26.11	-26.11	0.00	0.00	0.00	0.00	0.00	0.00
