# **Real-Life Injuries in Offset Frontal Collisions**

**San Diego CIREN Team**

**March 16, 2001**

# Offset Frontal Case # 1

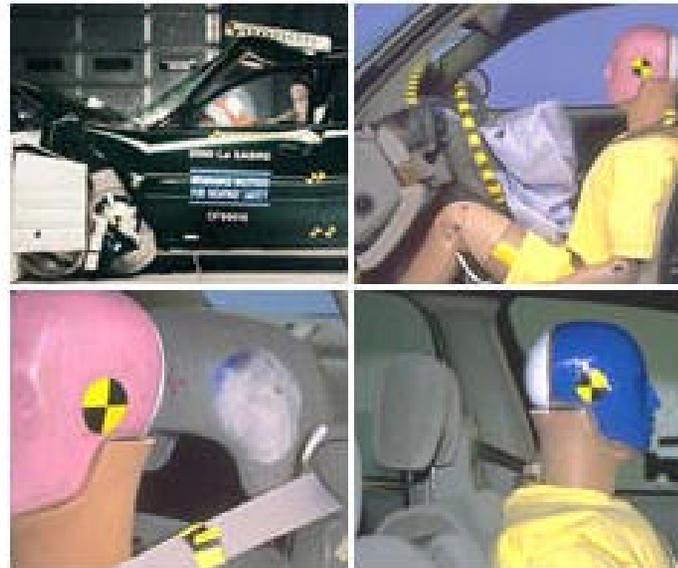
**TOP LEFT:** Action shot taken during the frontal offset crash test [Larger photo](#)

**TOP RIGHT:** The dummy's position in relation to the steering wheel and instrument panel after the crash test indicates that the driver's survival space was maintained well. [Larger photo](#)

**BOTTOM LEFT:** Smeared greasepaint indicates where the dummy's head contacted the head restraint and shoulder belt housing during rebound. Front lap/shoulder belts are mounted to the seats. [Larger photo](#)

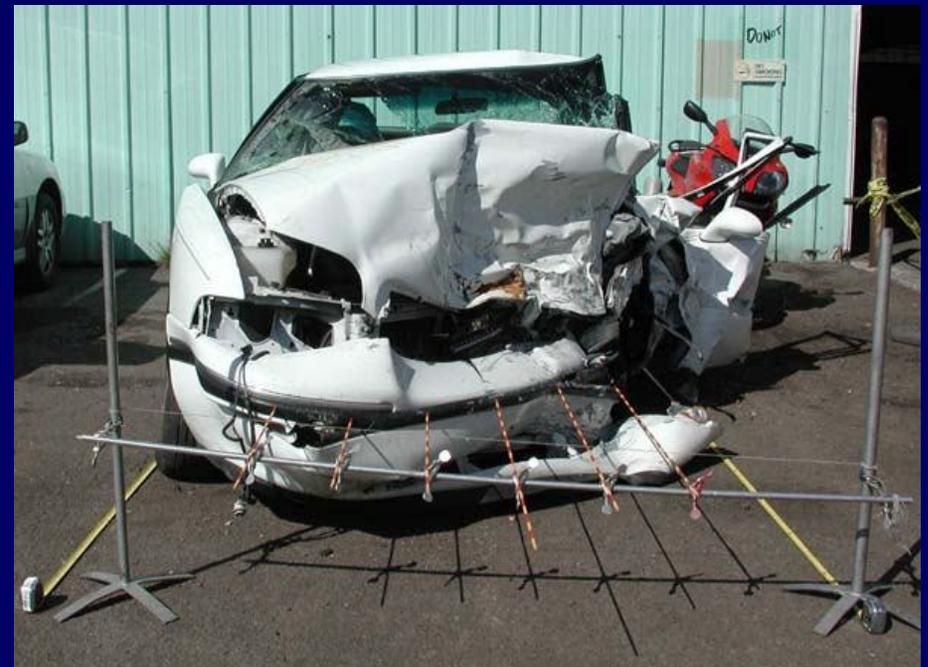
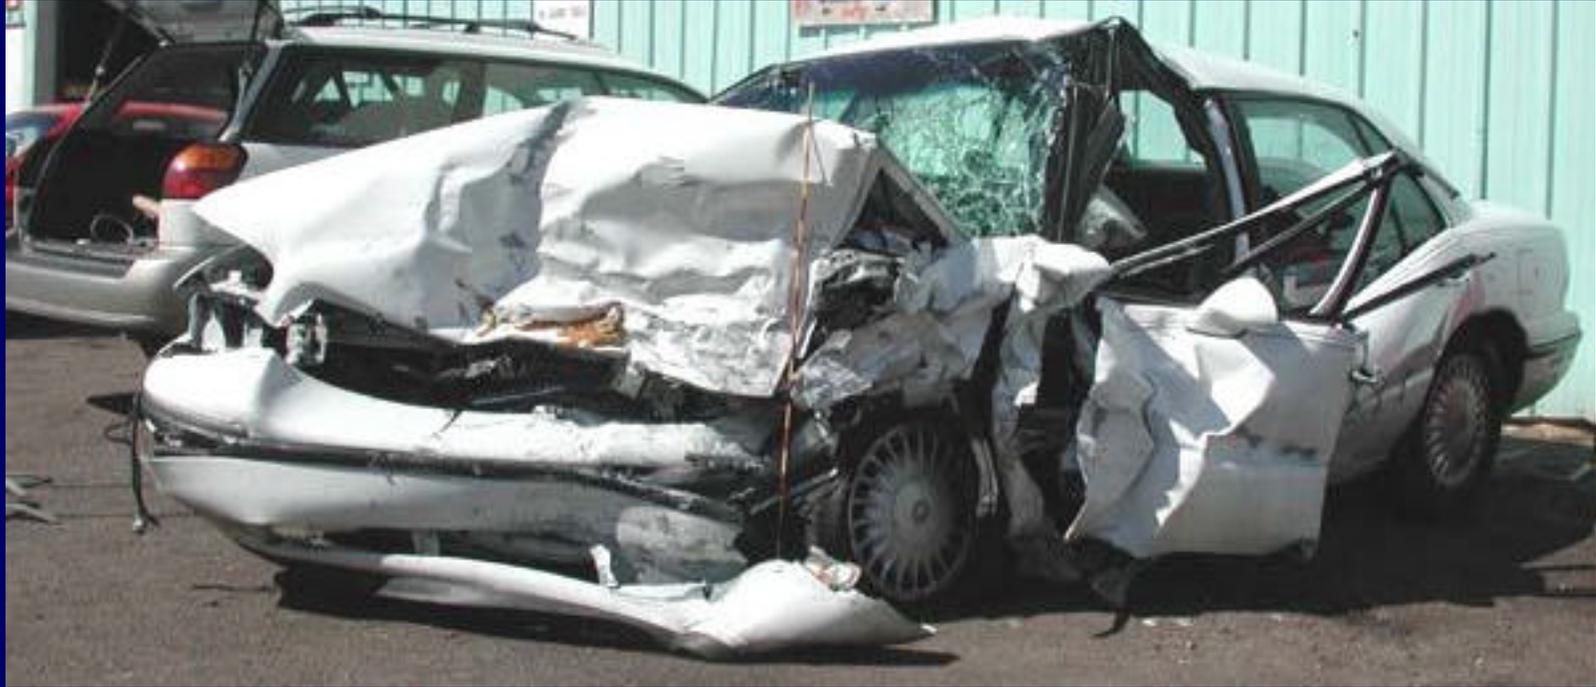
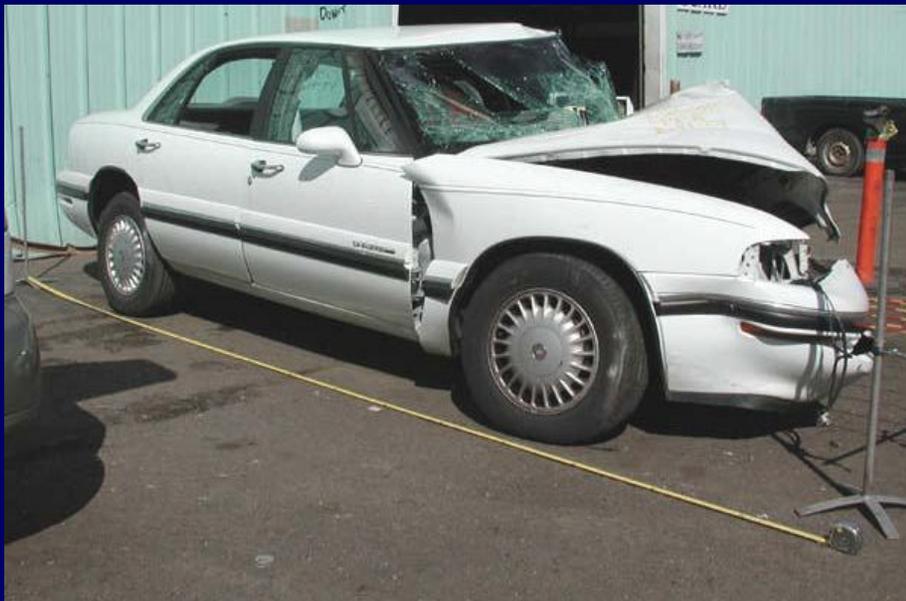
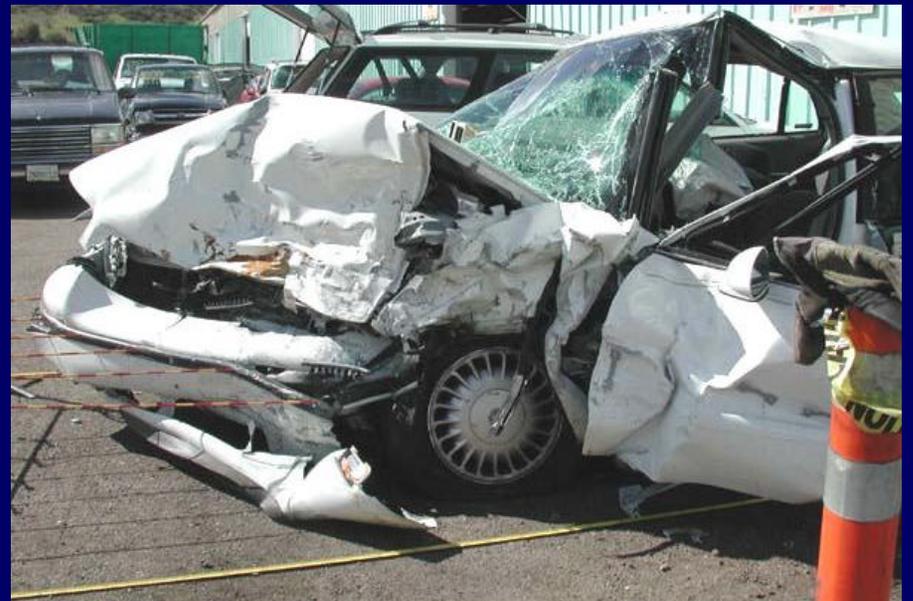
# Subject Vehicle

Direct Damage = 60 cm (40% offset)

PDOF = Zero

Maximum Crush = 97 cm

WinSmash Delta V (ROLDMISS)

Total = 87.8 kph (55 mph)

Longitudinal = -87.8 kph

Barrier Equivalent = 69 kph (43 mph)

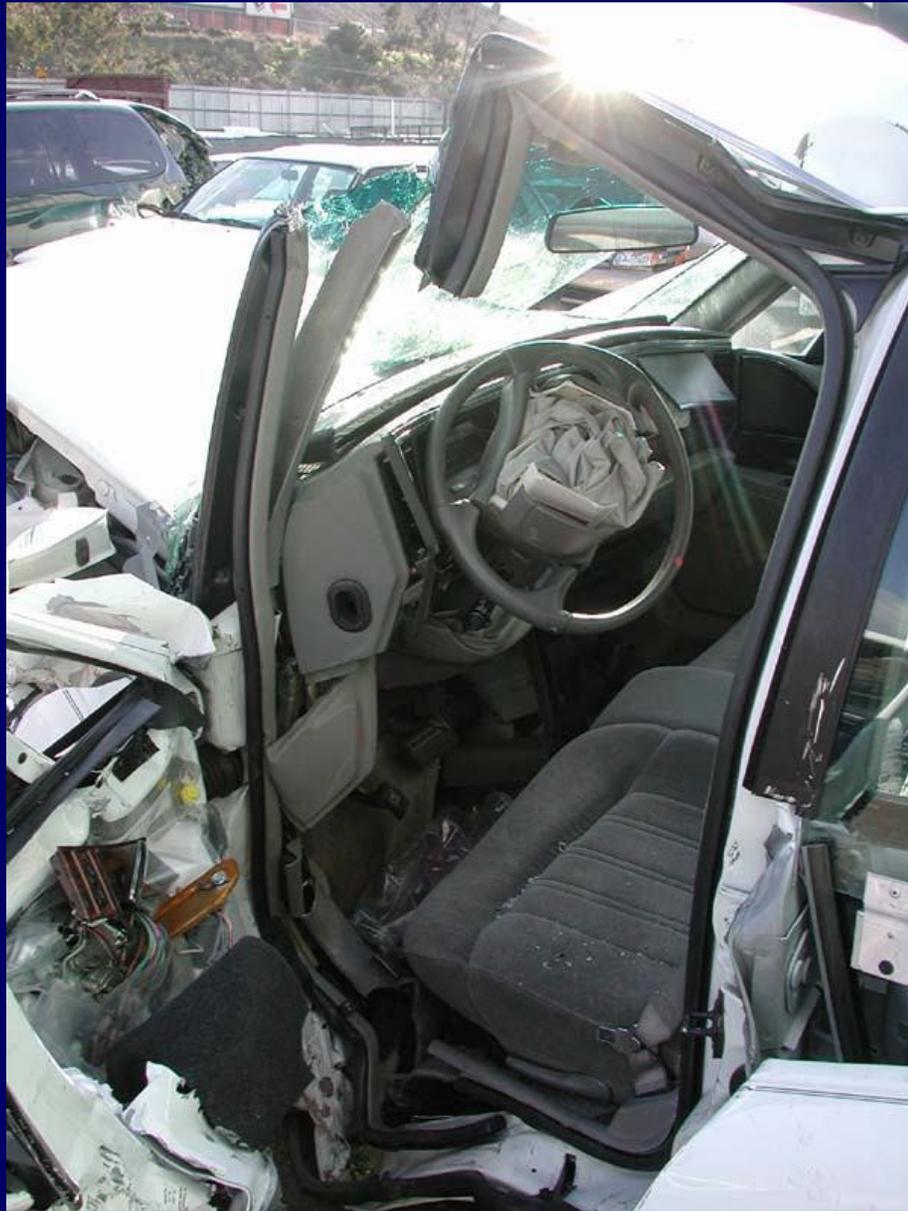
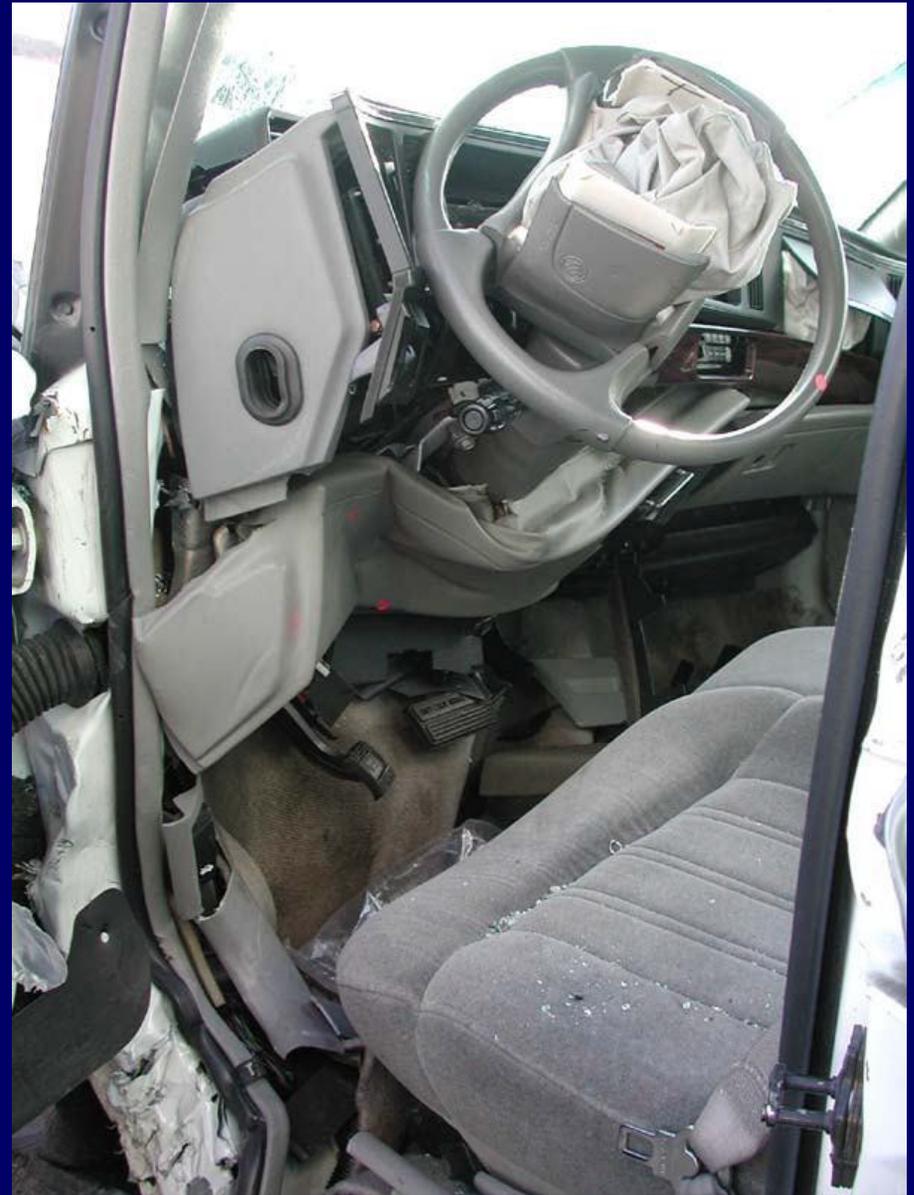
## Intrusions Include:

LF Toe Pan - 28 cm/ LF Dash - 26 cm

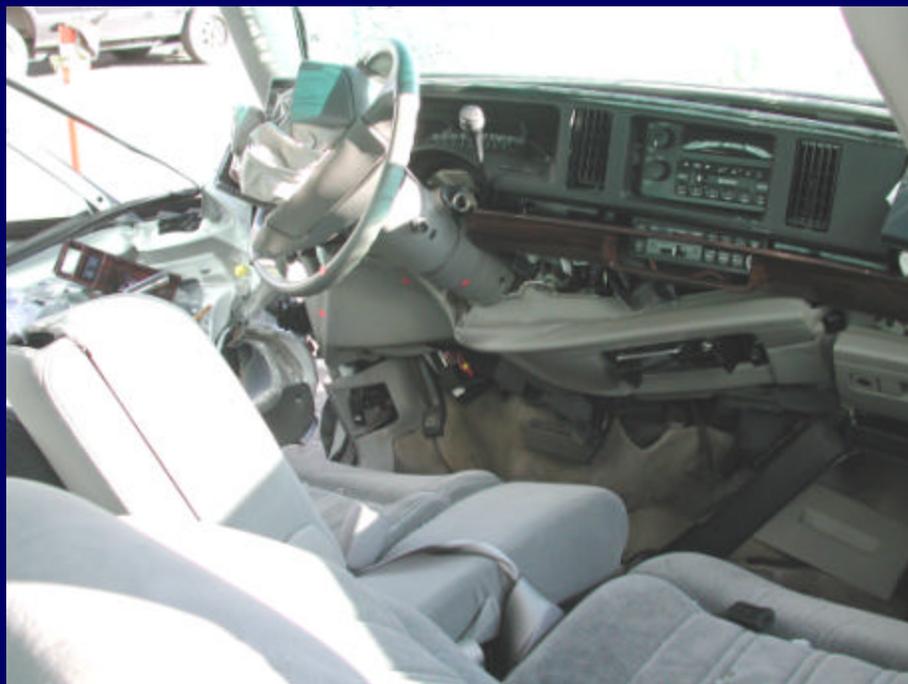
Contact Points Include:  
Steering Wheel Rim (deformed)  
Steering Column Base (transfer)

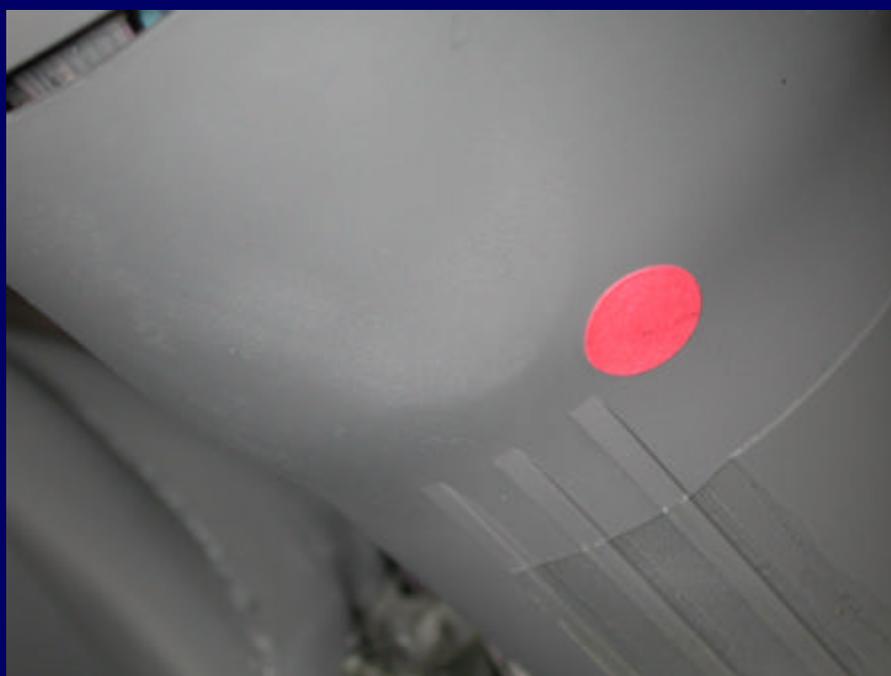
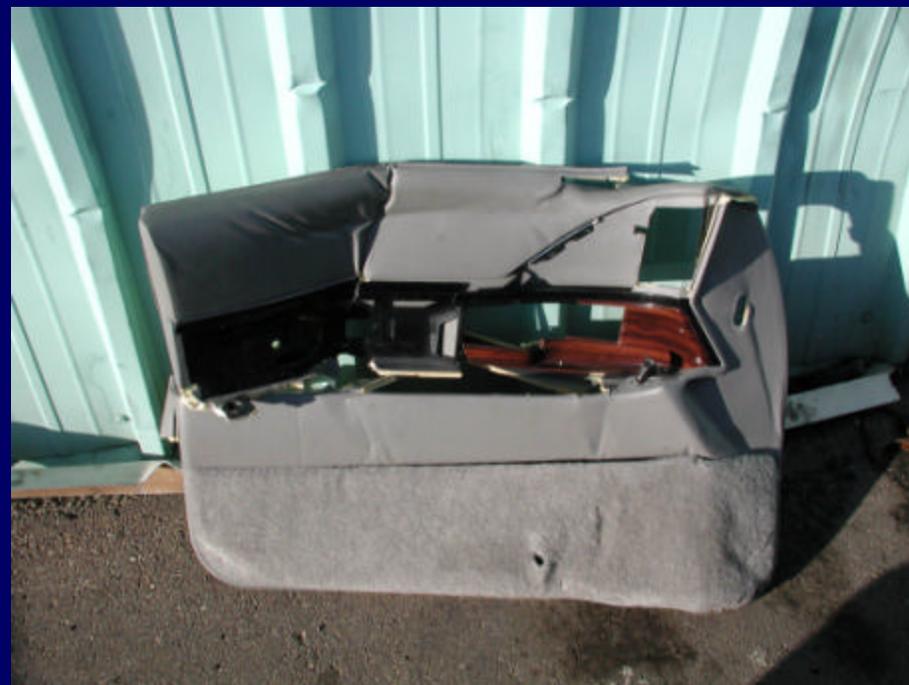
Suspected contact to driver door panel  
(contaminated during extrication)

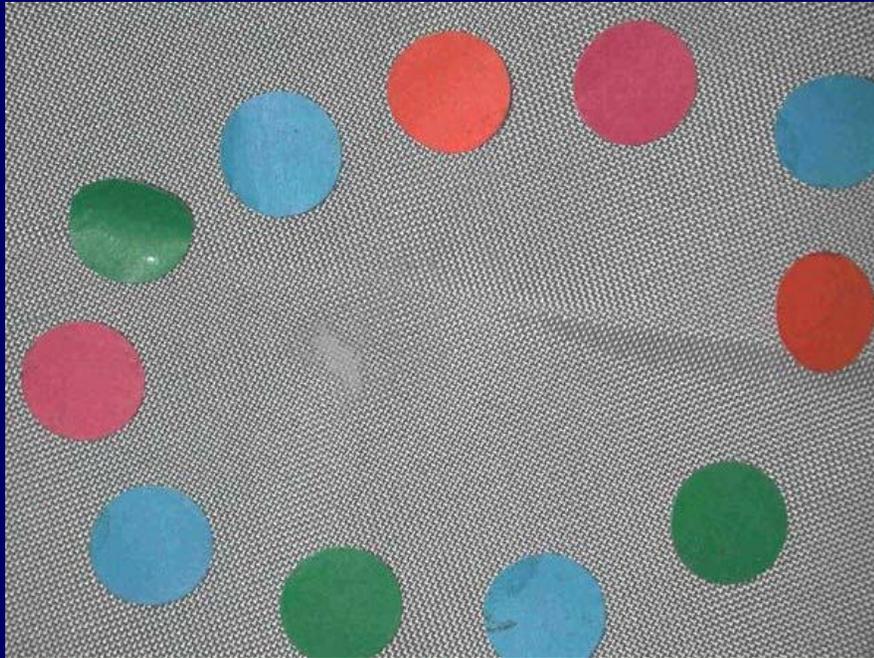
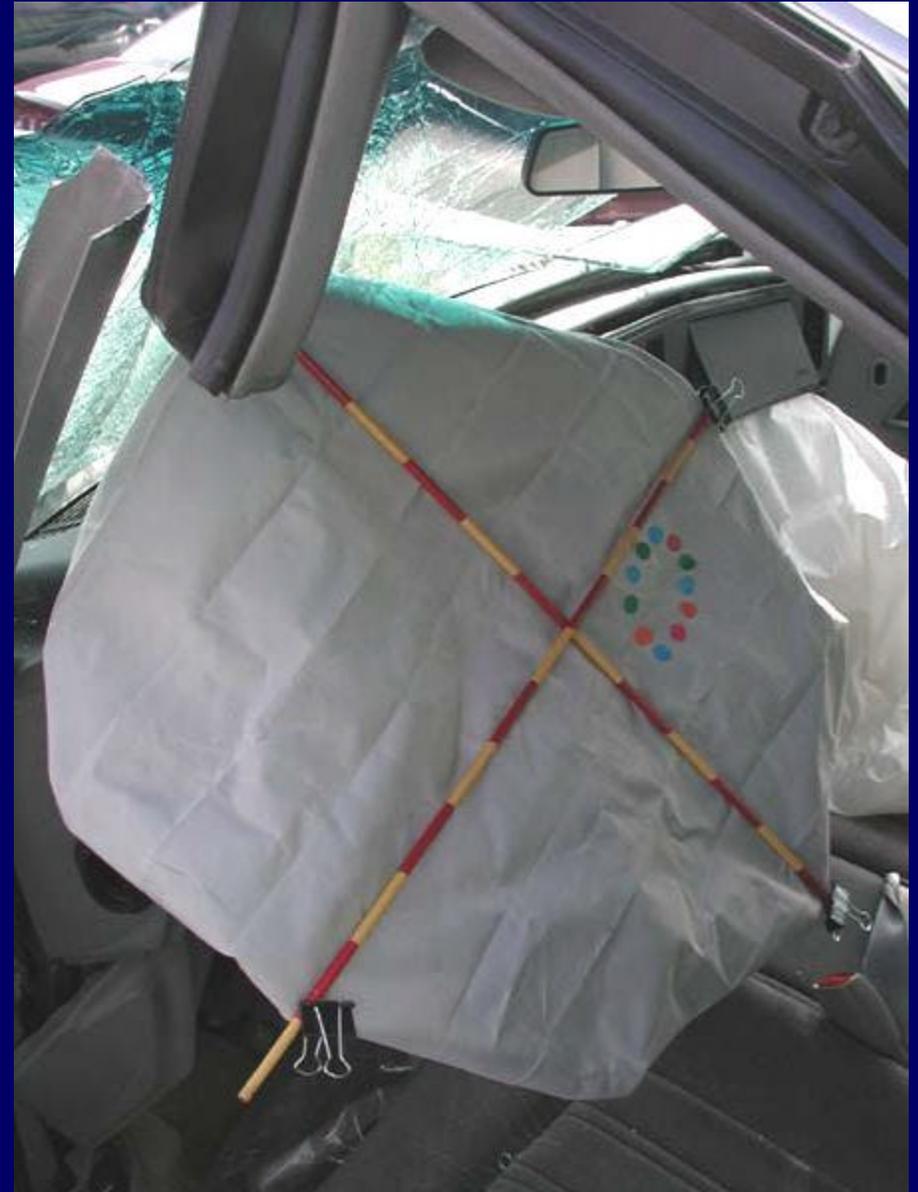
Air bag (fluid transfer)

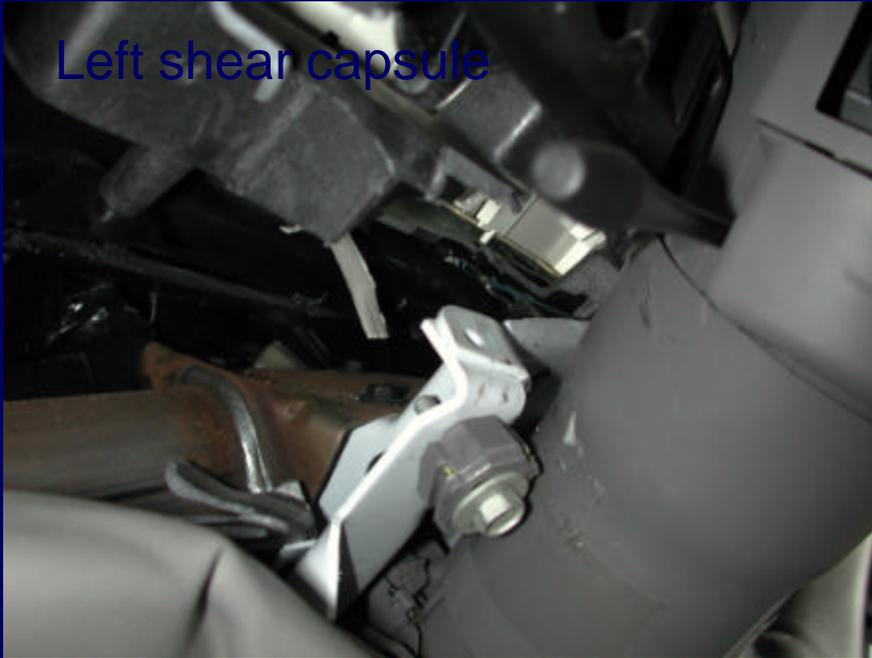
Left shear capsule

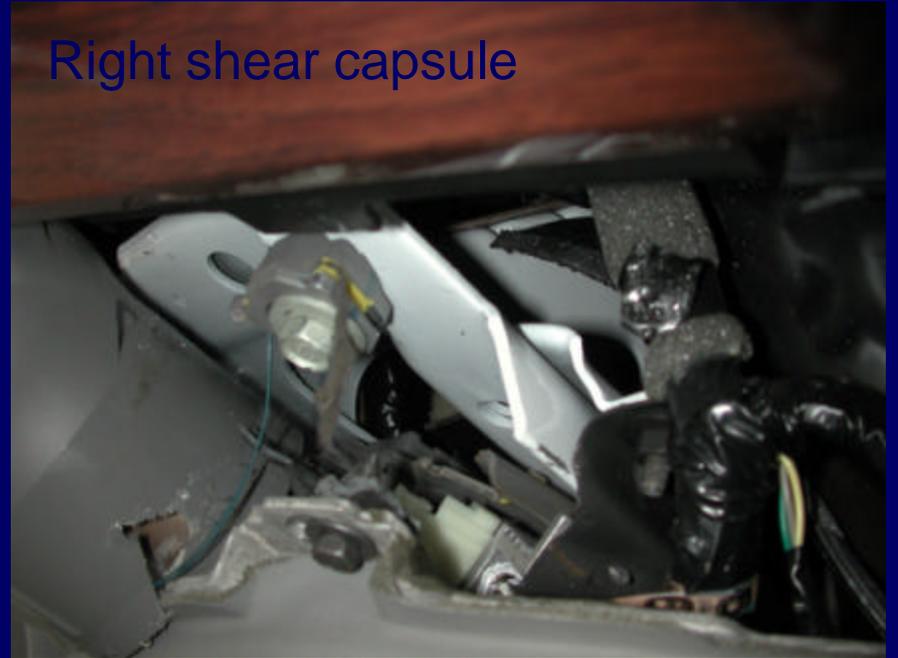
Right shear capsule

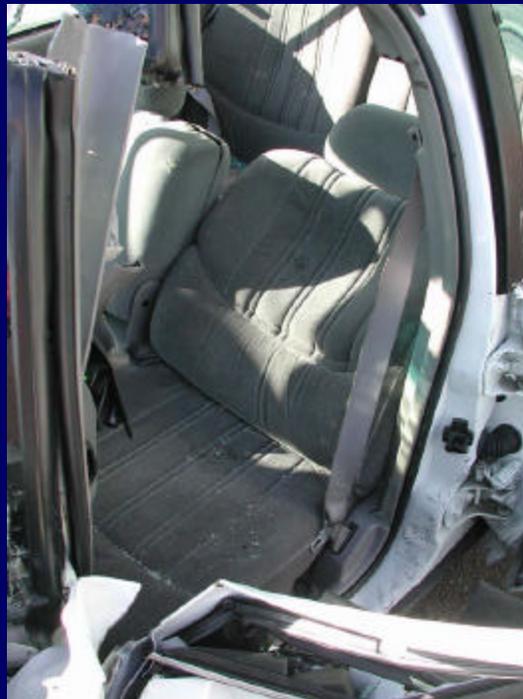
Driver  
seat,  
subject's  
location.

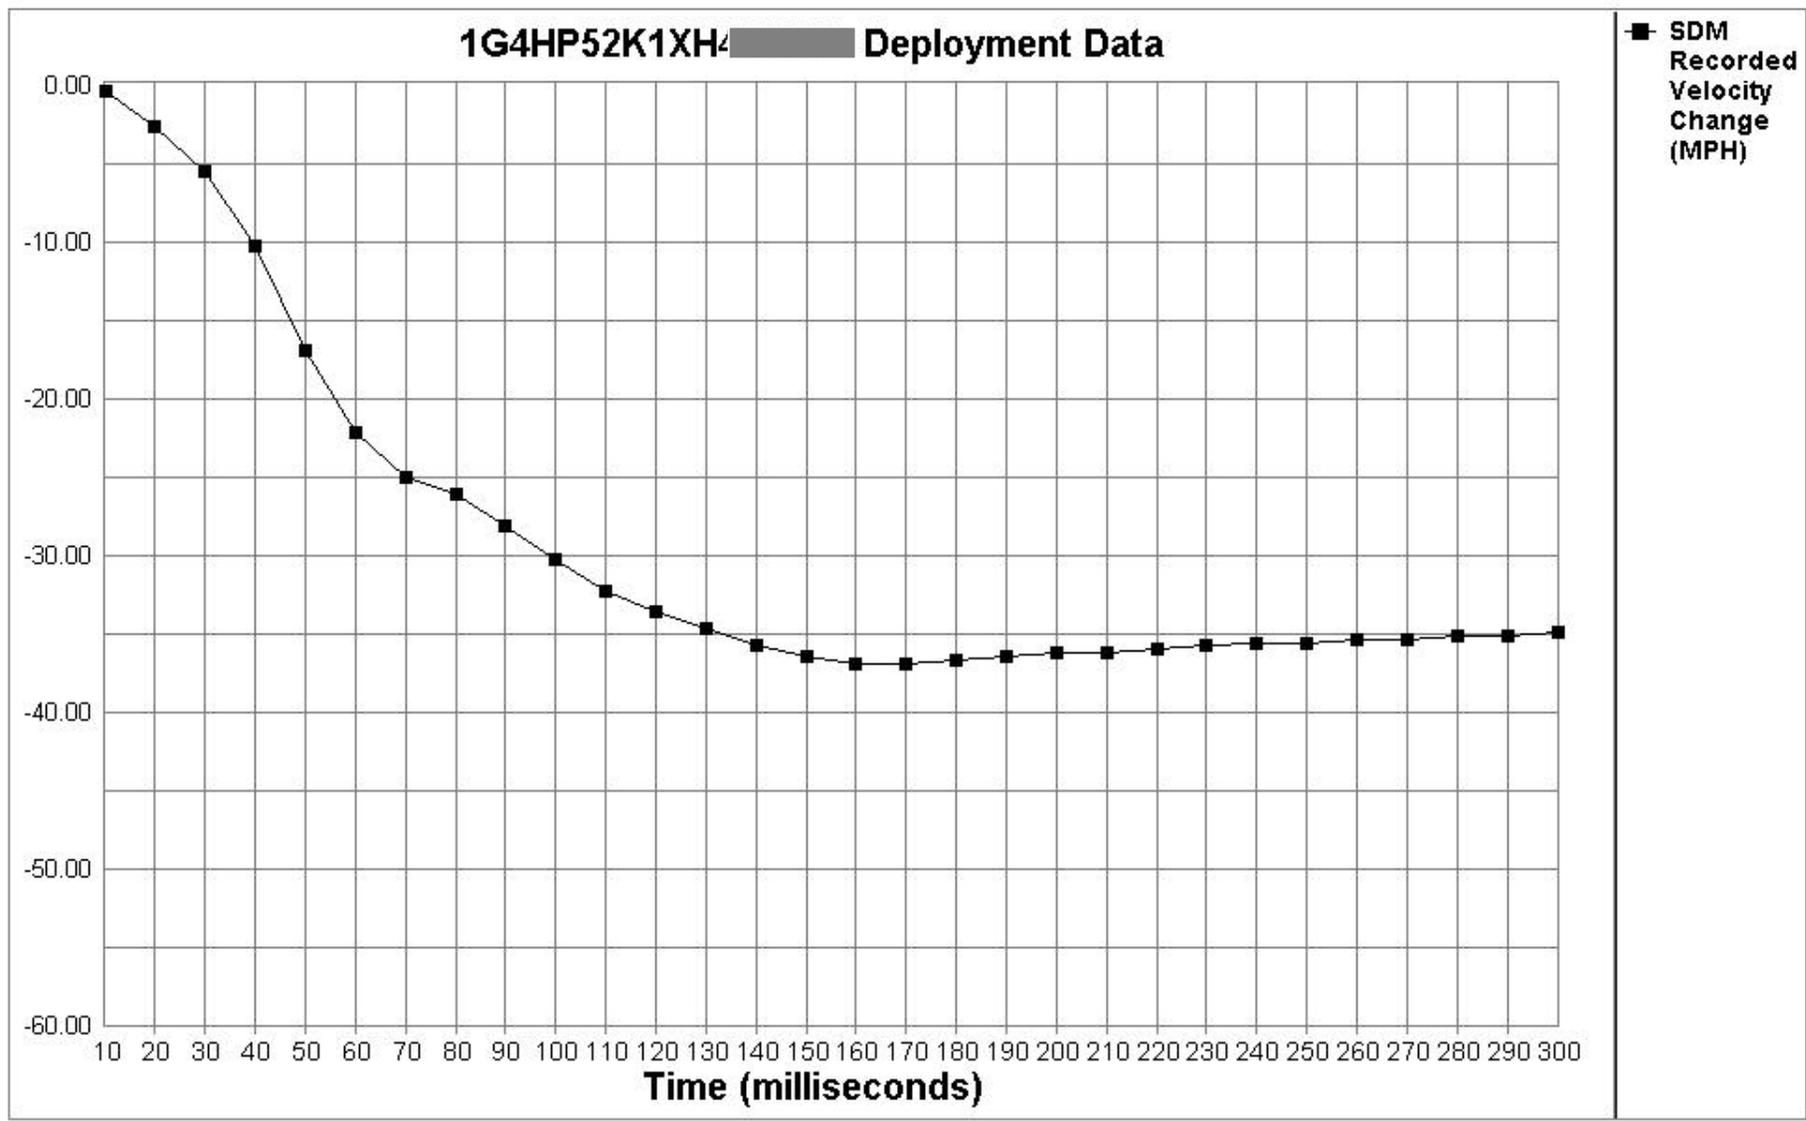
1G4HP52K1 System Status At Deployment	
SIR Warning Lamp Status	OFF
Driver's Belt Switch Circuit Status	BUCKLED
Passenger Front Air Bag Suppression Switch Circuit Status	ON
Ignition Cycles At Deployment	3338
Ignition Cycles At Investigation	3340
Time From Algorithm Enable To Deployment Command (msec)	10
Time From Near Deployment To Deployment (msec)	N/A

Time (milliseconds)	10	20	30	40	50	60	70	80	90	100	110	120	130	140	150
Recorded Velocity Change (MPH)	-0.44	-2.63	-5.49	-10.31	-16.89	-22.16	-25.01	-26.11	-28.08	-30.28	-32.25	-33.57	-34.67	-35.76	-36.42
Time (milliseconds)	160	170	180	190	200	210	220	230	240	250	260	270	280	290	300
Recorded Velocity Change (MPH)	-36.86	-36.86	-36.64	-36.42	-36.20	-36.20	-35.98	-35.76	-35.54	-35.54	-35.32	-35.32	-35.10	-35.10	-34.88

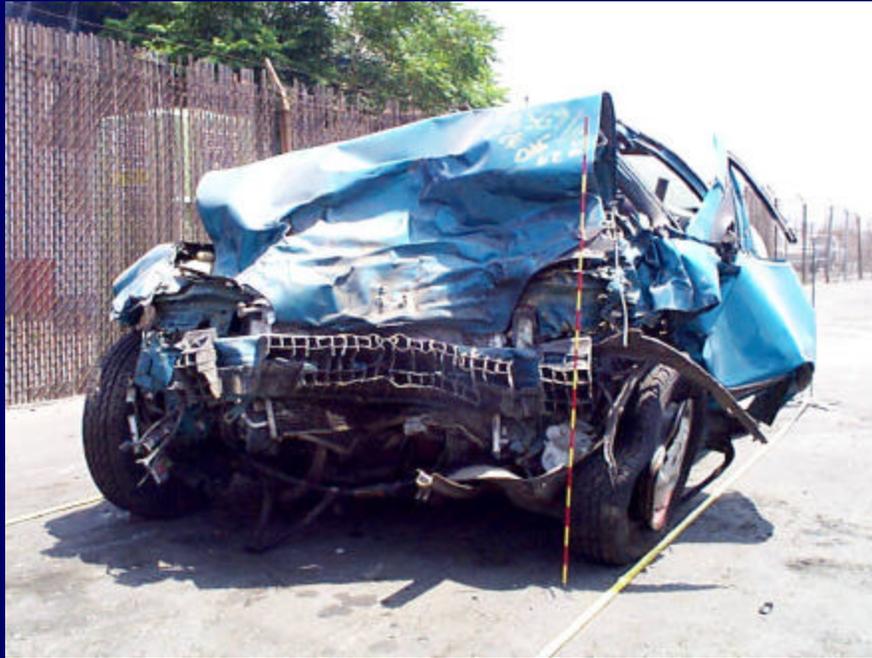
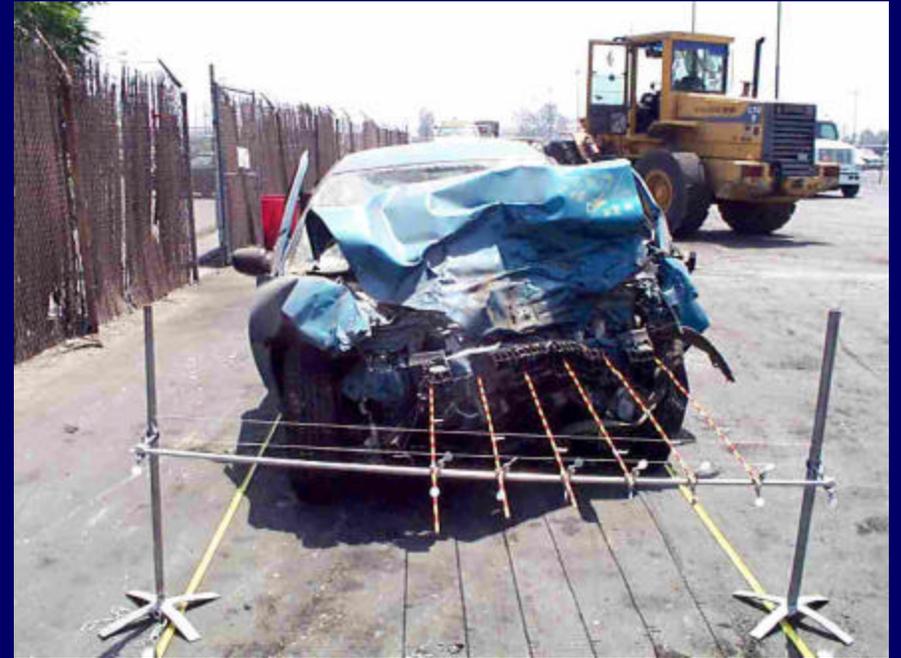
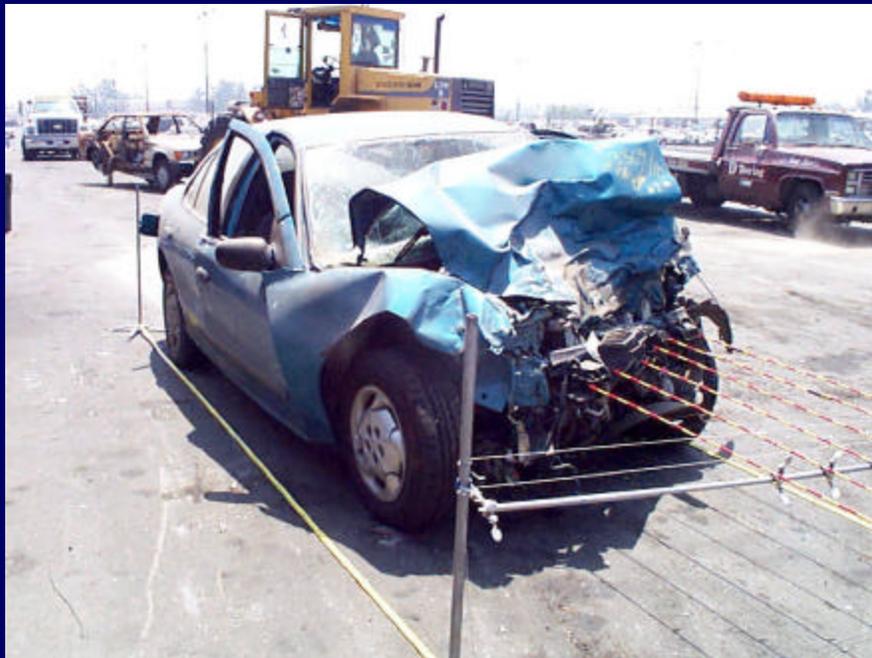
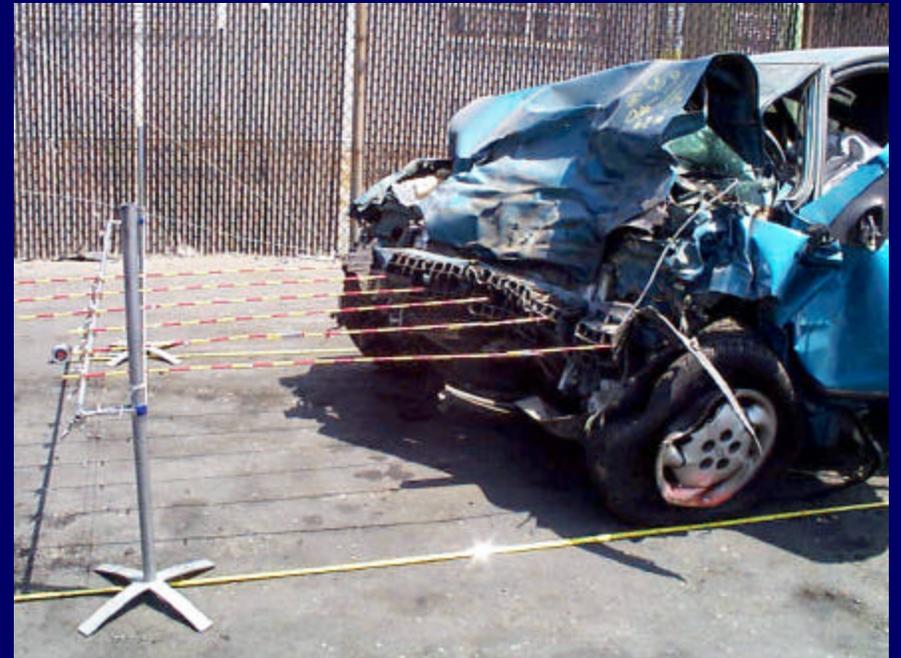
**Subject Vehicle**

**Maximum Crush**

**104 cm**

**PDOF -10 degrees**

Total Delta V (ROLDMISS)

68 kph (42 mph)\*
